Bridge #01378(Routine, Underwater type 2)

Us70/Sec-19/L22.45 over Drainage Canal

Team Lead: Myron Futrell Inspection Date: January 19, 2021

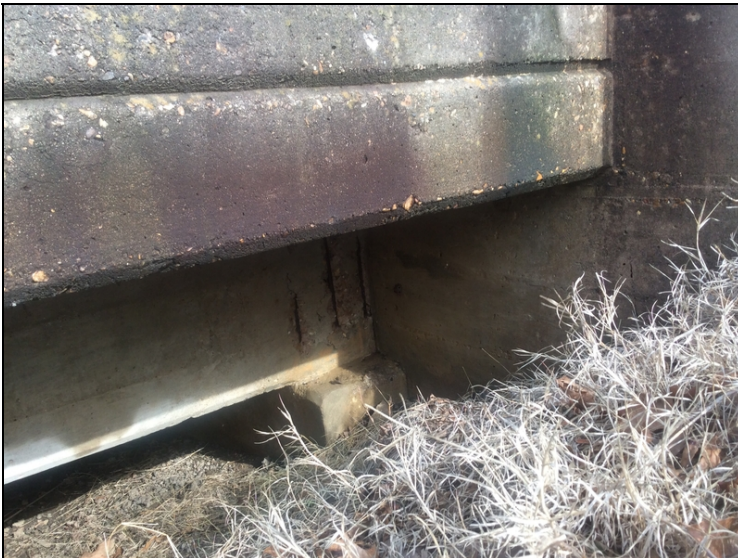
Girder #1 at bent #2 left side has a six inch spall with rebar exposed.

Girder #1 at abutment #2

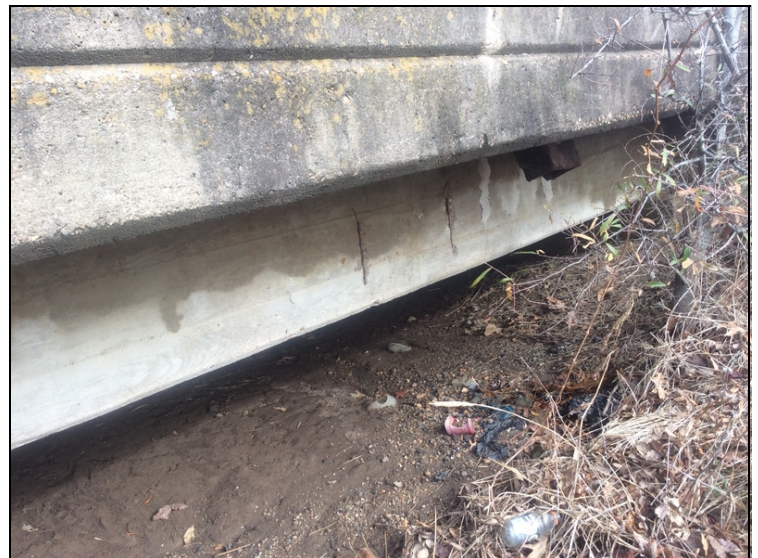
Bent #2 girders #4,5 have areas of spalling on web near girder ends with rebar exposed with 5% section loss.

Girder #5 at bent #1 has a six inch spall with exposed rebar, and a one foot delamination on right side.

Girder #5 at bent #2 has two one foot spalls with rebar exposed, and several one foot delaminations on right side.

Typical sides of girders with exposed secondary rebar

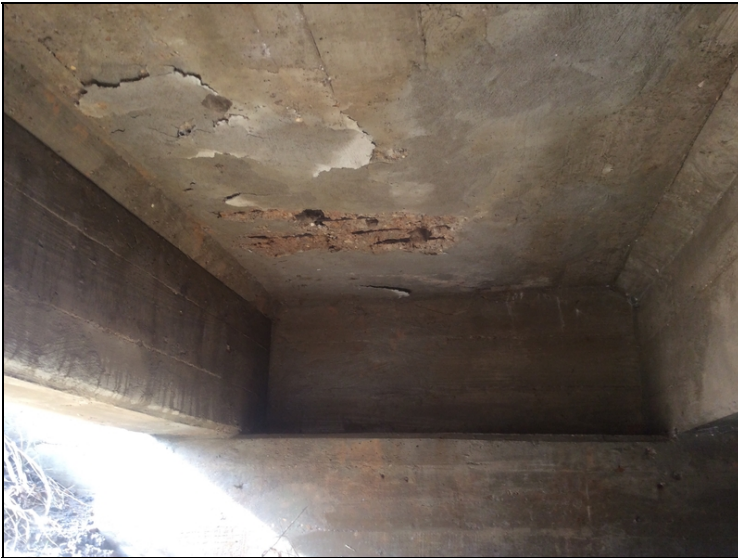
Soffit between girders #4,5 near bent #1 has a three foot spall with exposed rebar with 5% section loss, and several delaminations.

Soffit over hangs have several areas of delaminations and one foot spalls with rebar exposed with 5% section loss.

Bay #4 soffit at abutment #1.

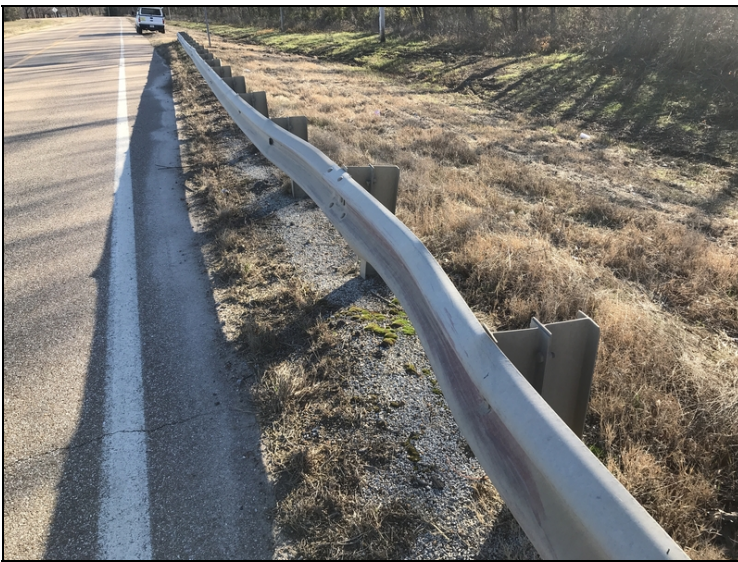
Abutment #2 right approach rail has collision damage twenty feet from bridge end.

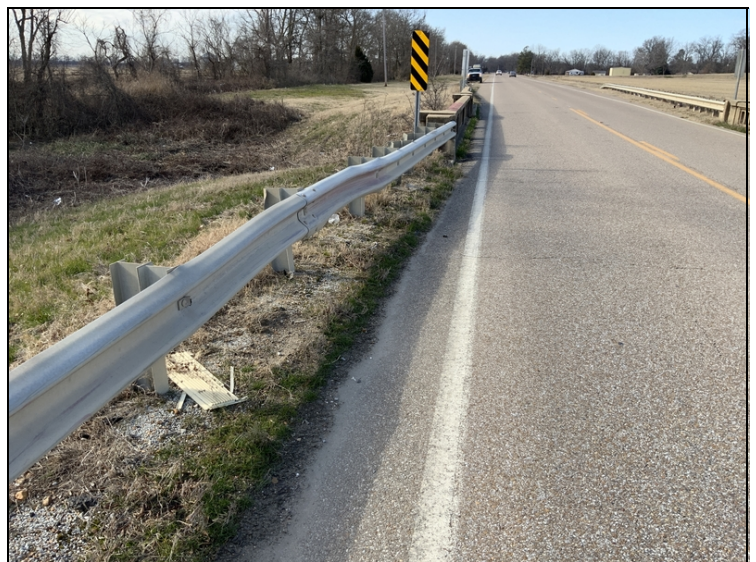
Abutment #2 right approach rail damage.

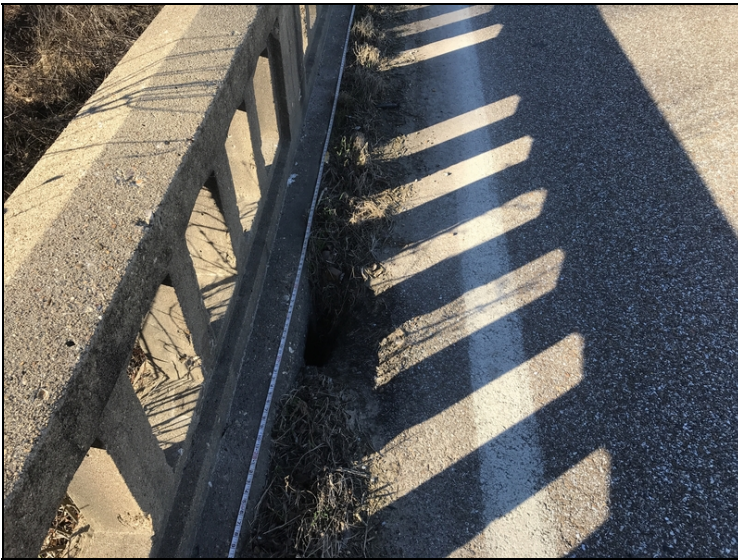
Gutters are full of dirt and debris with vegetation growing in them.

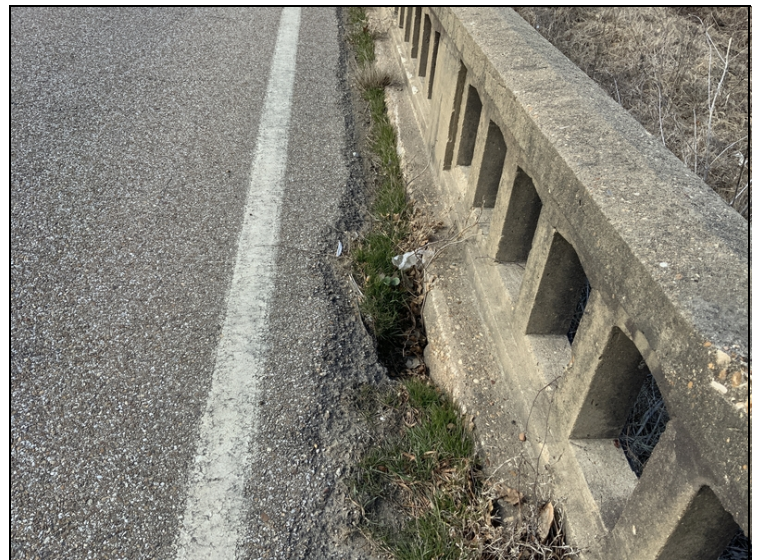
Dirt, debris and vegetation in gutters.

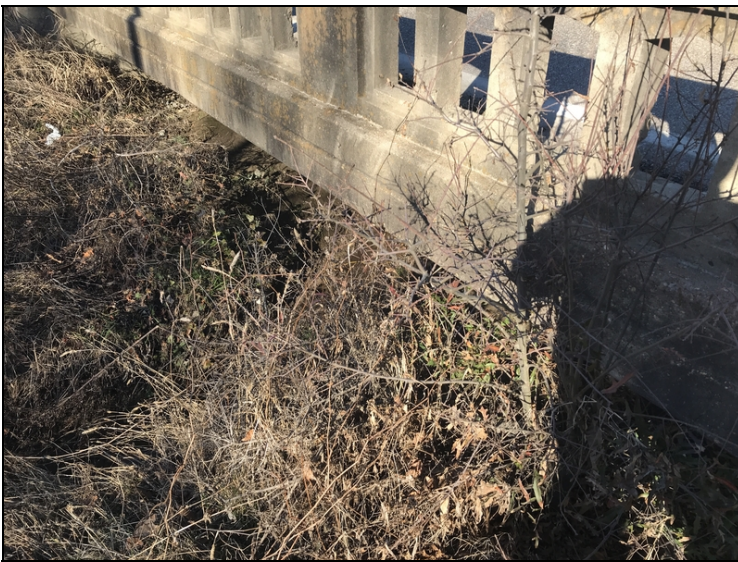
Small trees and vegetation are growing beside and under bridge.

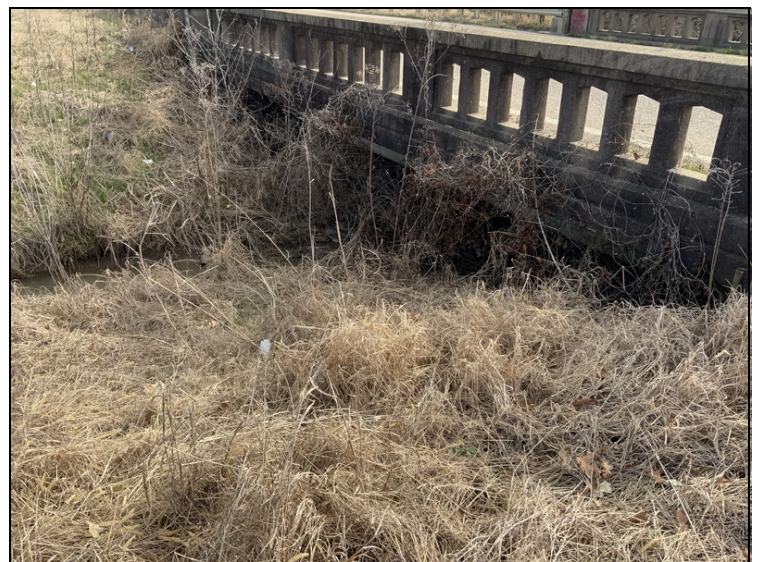
Vegetation growing beside and under bridge.
