Bridge #01379(Routine, Underwater type 2)

Us70/Sec-19/L24.01 over Jeka Slough

Location: 1.01 Mi Sw Crittenden Co

Team Lead: Myron Futrell Inspection Date: January 19, 2021

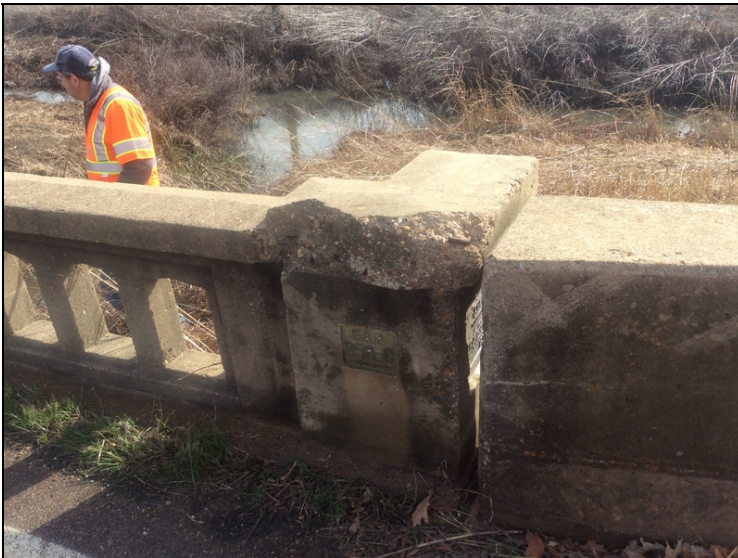
Abutment #1 right side and abutment #2 left monument posts have collision damage on top with rebar exposed.

Abutment #1 right monument post

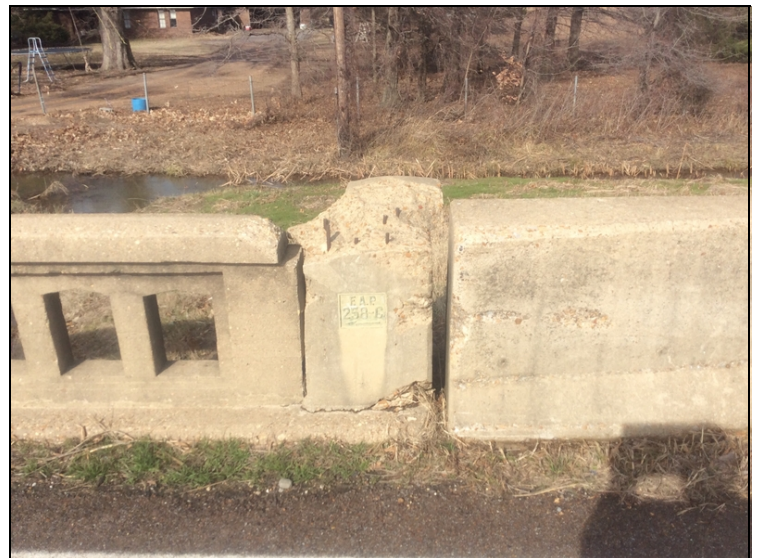
Abutment #2 left monument post

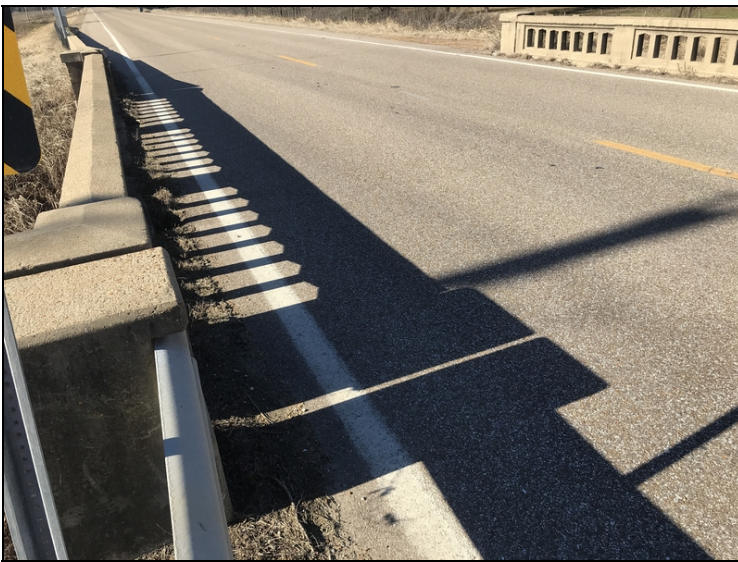
Gutters are full of dirt and debris.

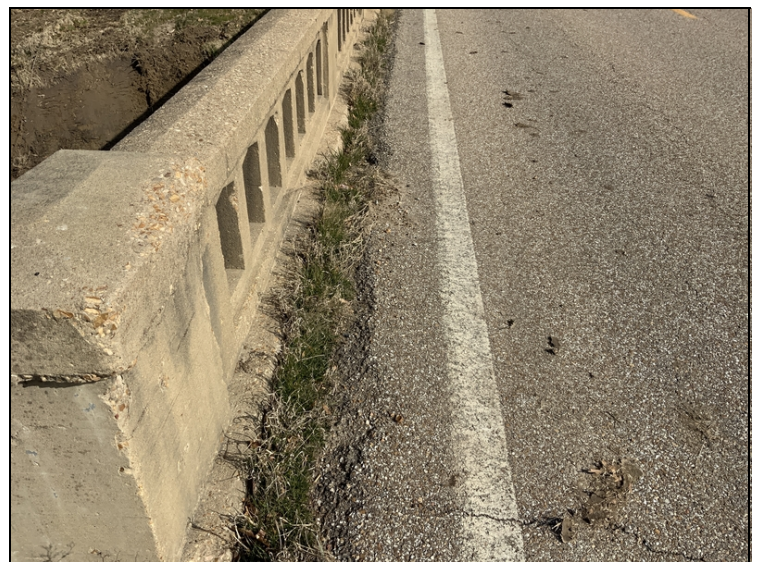
Dirt, debris and vegetation growing in gutters.

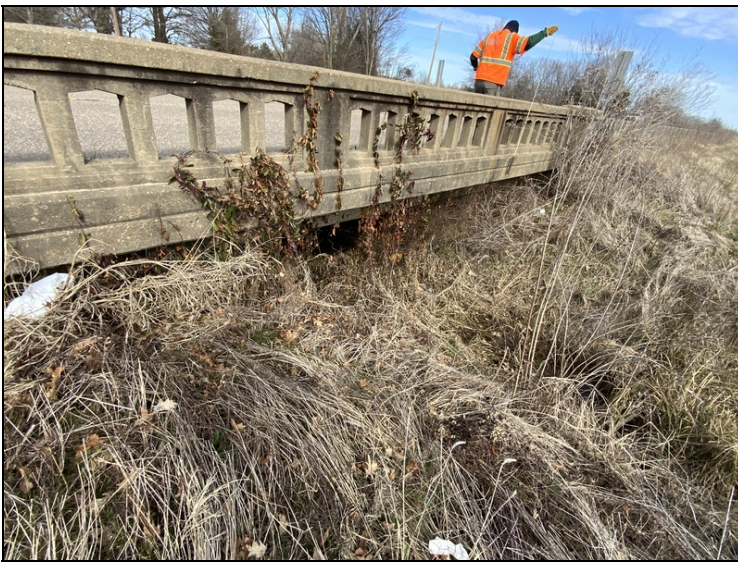
Brush and vegetation growing beside and under bridge.

Vegetation growing beside and under bridge.

Type of Work: Clean
