Bridge #01380(Routine, Underwater type 2)

Us-70/sec-19/L24.9 over Drainage Canal

Team Lead: Myron Futrell Inspection Date: January 13, 2020

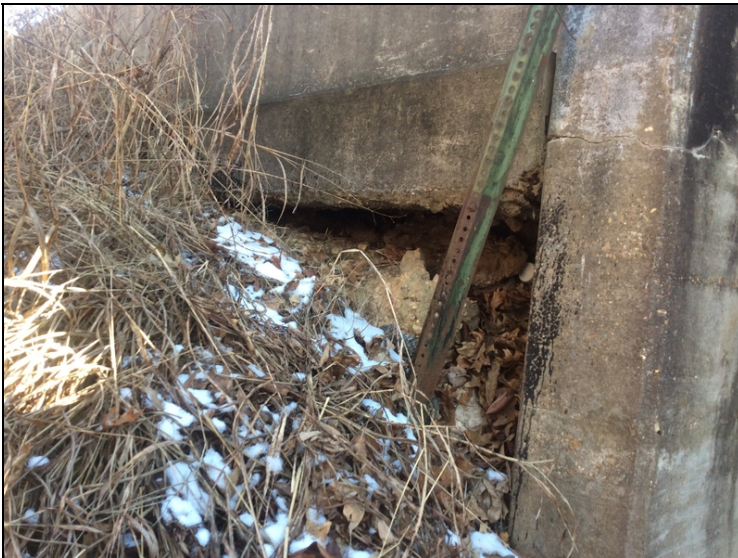
Erosion under abutment #2 left approach gutter

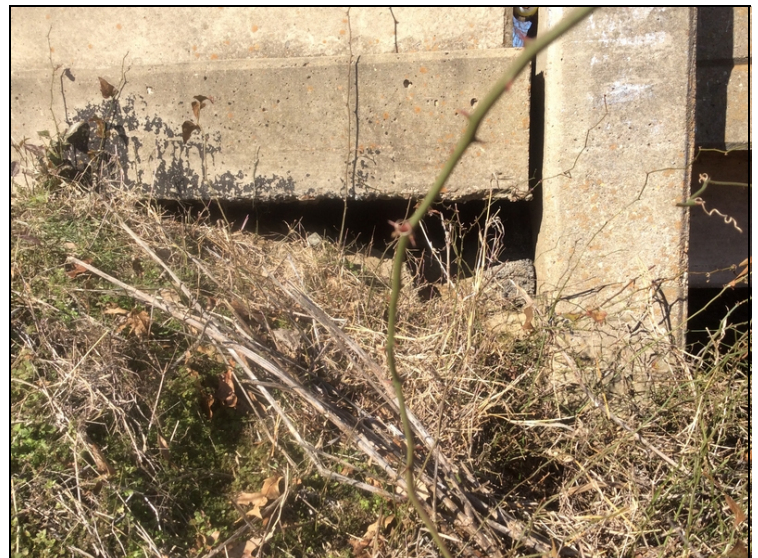
Approach slabs abutment #1 right side and abutment #2 both sides have voids under slabs at bridge ends up to 2' deep with minor amounts of settlement.

Large void under approach slab abutment #1 right side.

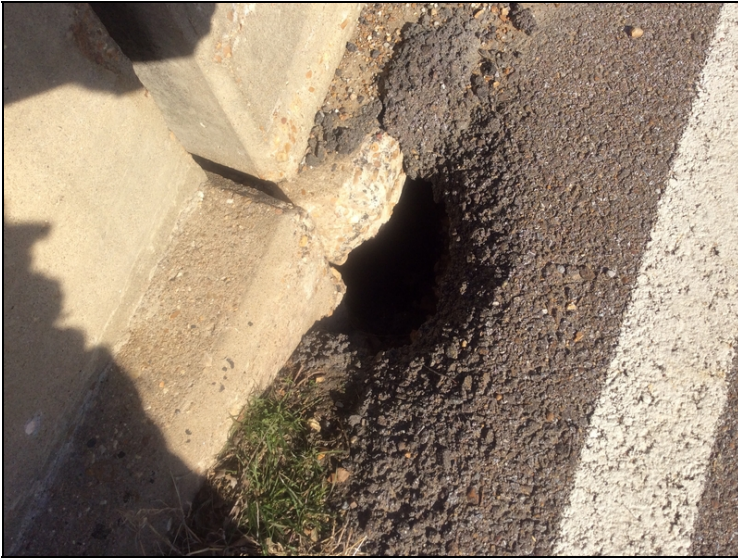
Void under approach slab abutment #2 left side.

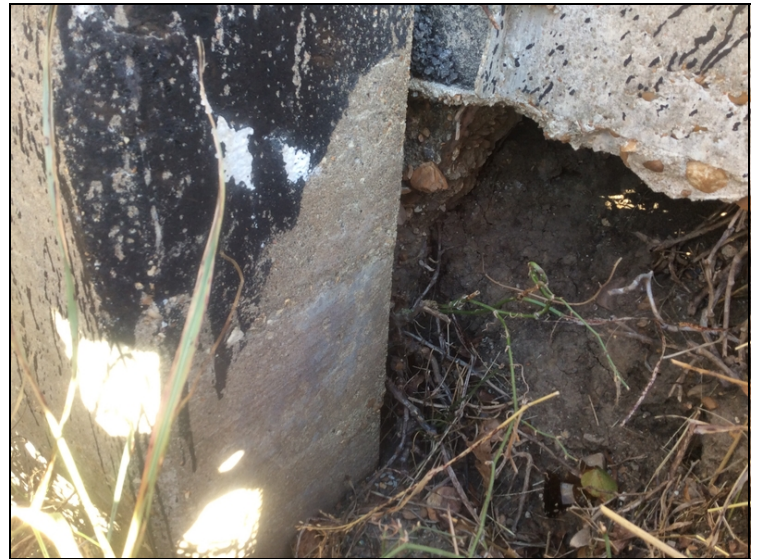
Monument post abutment #2 right side undermined

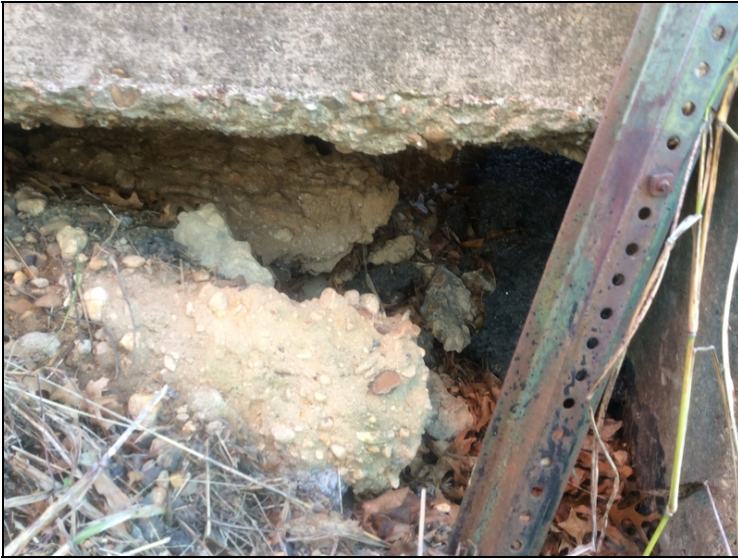
Large void under approach slab abutment #2 left side

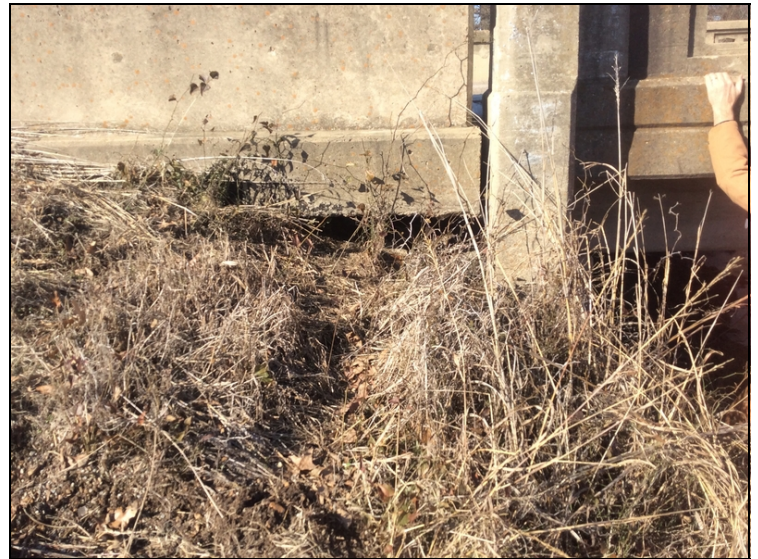
Ab #1. Right approach gutter undermined

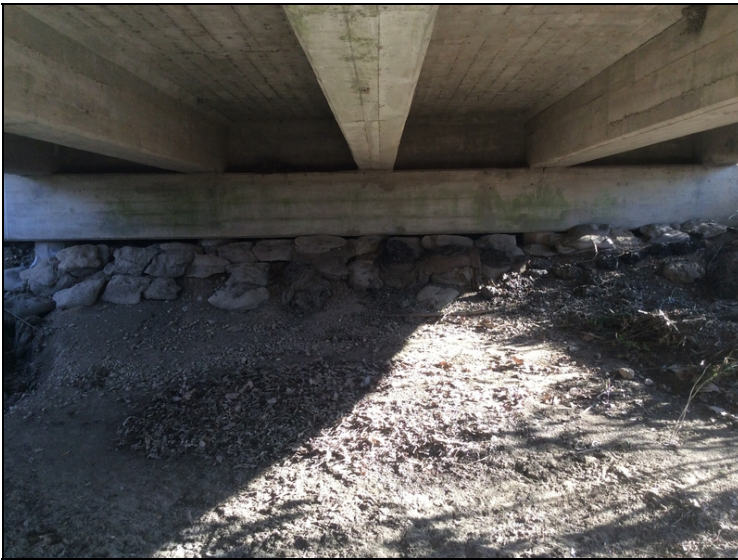
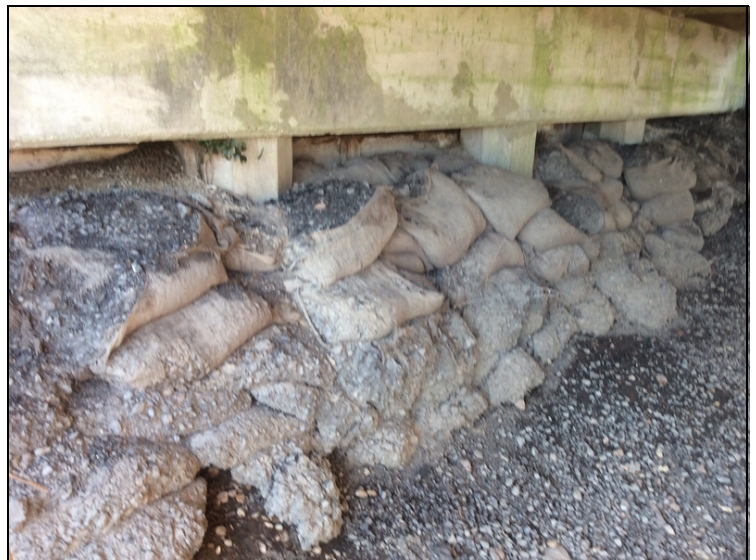
Abutment #2

Sand bags at both abutments are in place but deteriorating allowing erosion to continue.

01/05/2018 Lowered substructure from 7 to 6 do to erosion at abutments.

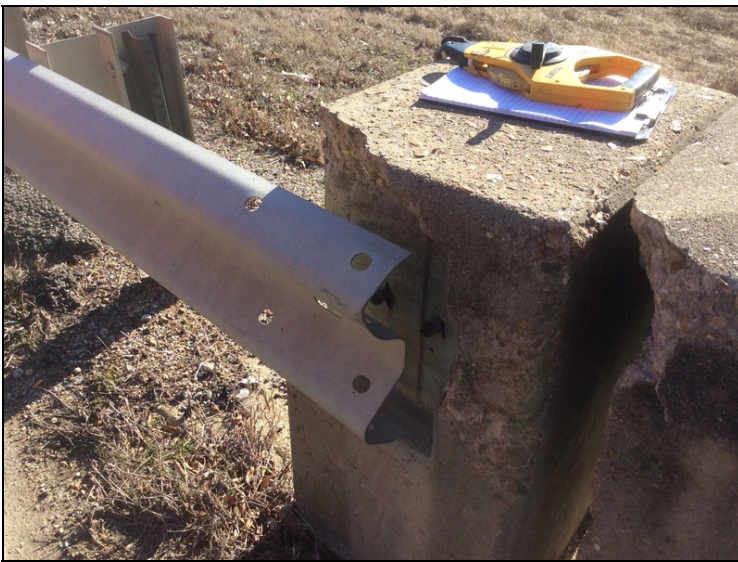
Abutment #2 right approach rail is not connected to bridge.

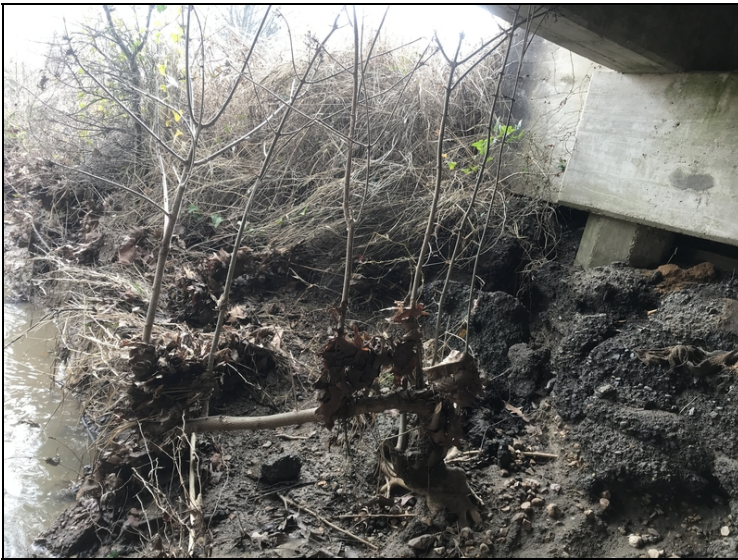
Small trees growing under and beside bridge.

Small trees and vegetation growing beside and under bridge.

01-13-2020-Small trees an vegetation growing under and beside bridge.

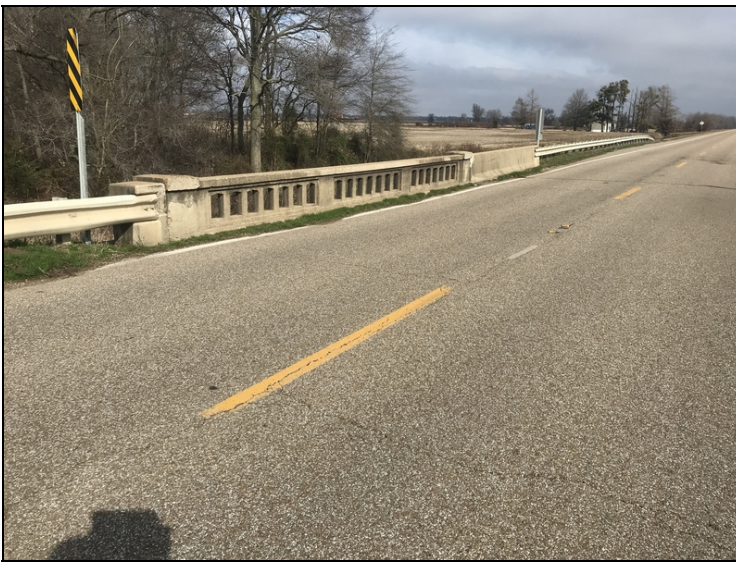
Dirt and vegetation growing in gutters.

01-13-2020-Gutters have dirt and vegetation growing in them.
