# Bridge #01391(Fracture Critical, Routine)

## Us-70/Sec-19/L5.19 over St. Francis River

### Location: 5.19 Miles East Of Sh 1

Team Lead: Drew Melton Inspection Date: May 10, 2021

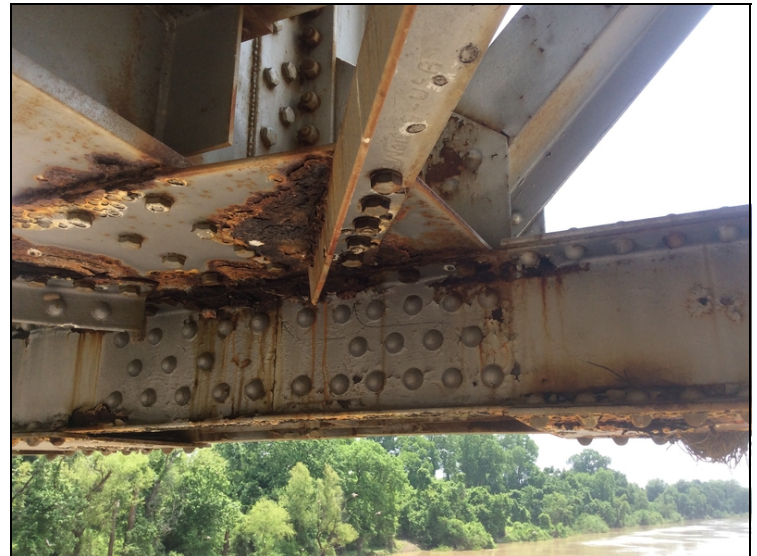
Span #5 right side of bridge at vertical L2 lower inside web of bottom chord has holes rusted through bottom hole is 7" long top hole is size of a dime.

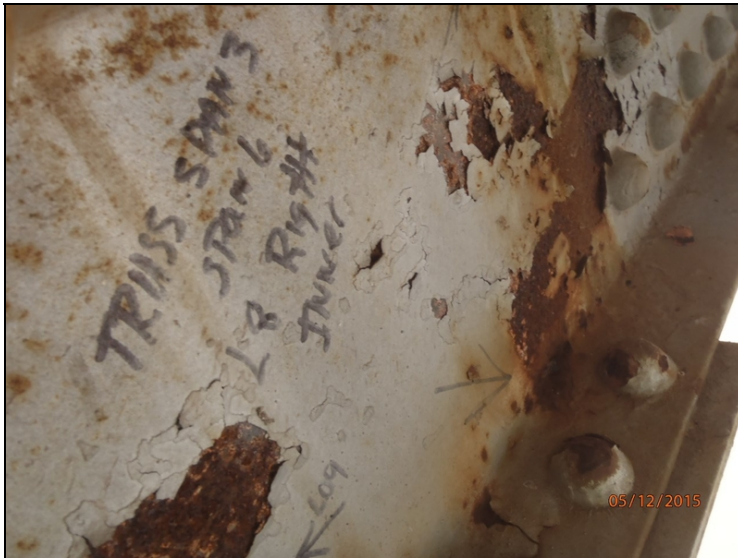
Span #6 right side of bridge at vertical L8 lower inside web of bottom chord has holes rusted through.

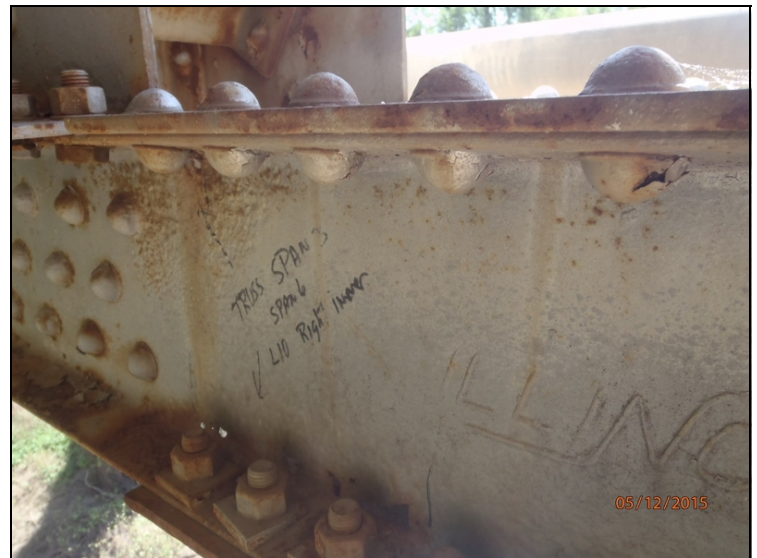
Span #6 right side of bridge at vertical L10 upper and lower inside web of bottom chord has areas of holes rusted through.

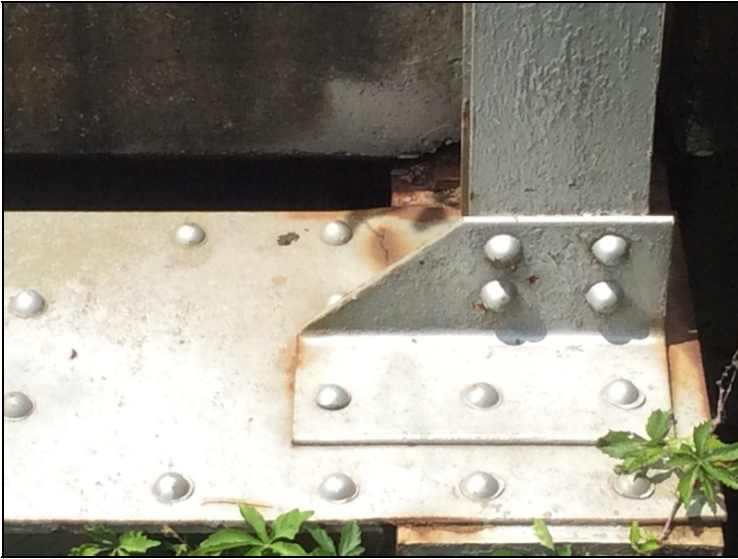
Span #7 lower chord cover plate at end of truss on right side L8 connection has two inch crack at floor beam connection.

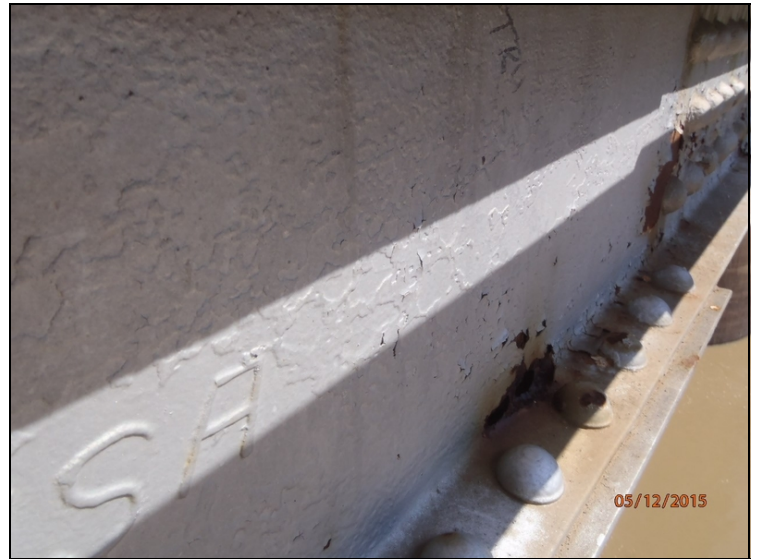
Span #5 right side of bridge at vertical location L2 lower outside web of bottom chord has area of hole in web.

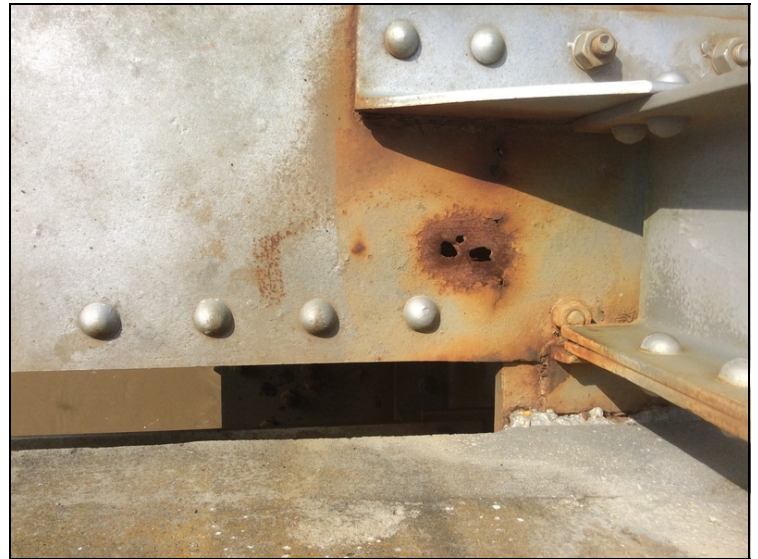
Span #5 cover plate on lower chord right side of bridge at L0 connection has holes rusted through with cracks staring to propagate.

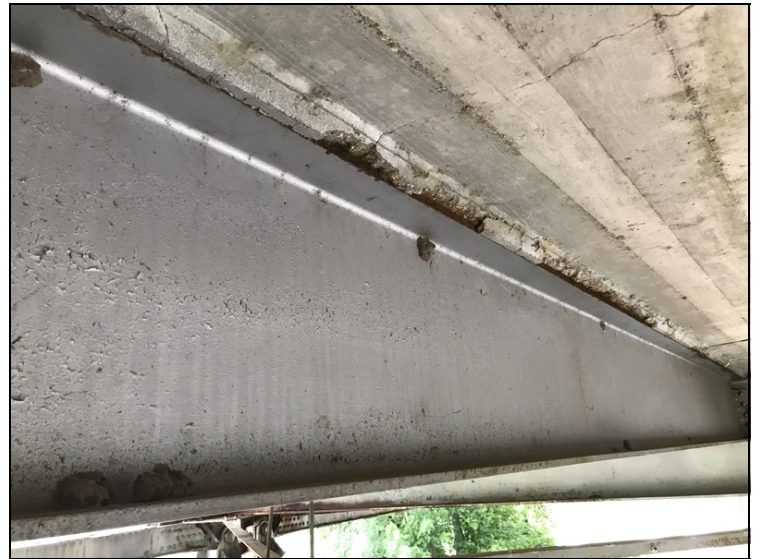
Typical areas beside stringers spalling due to pack rust on stringers top flange.

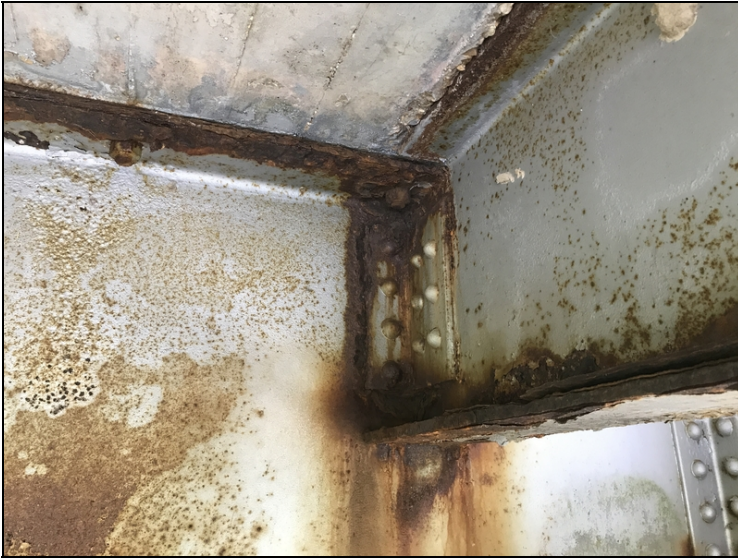
Bent #4 span #4 stringer #1 bottom flange last 3' has up to 20% section loss.

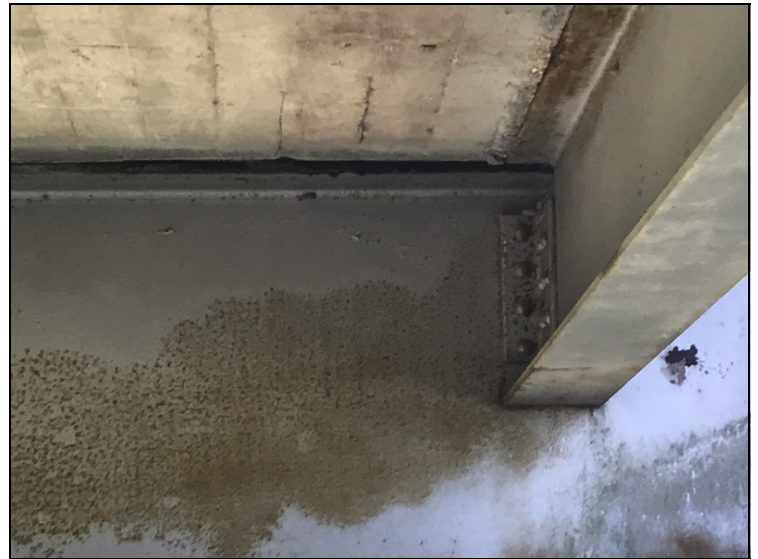
Typical corrosion on top flange of floor beam ends everywhere but ends of truss.

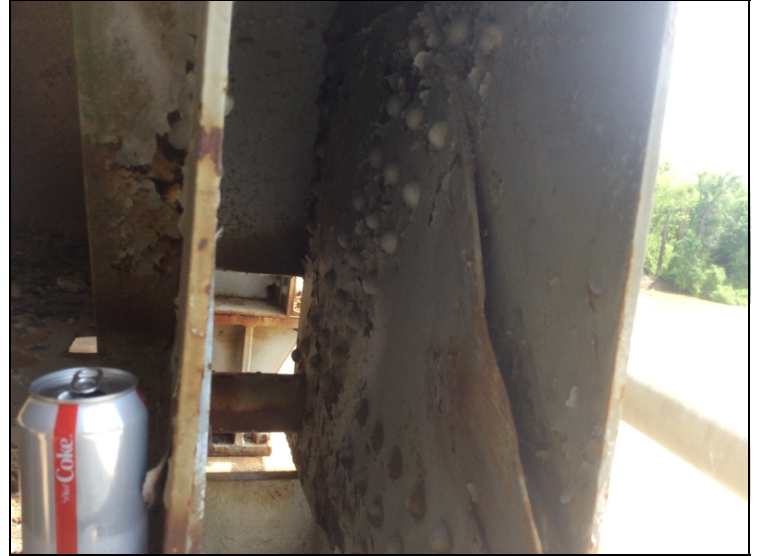
Gusset plate span #4 end diagonal location L8 right side of bridge back side of right gusset plate has active corrosion. One and a half inches of pack rust has formed between diagonal and gusset plate with section loss up to 0.239" to gusset plate.

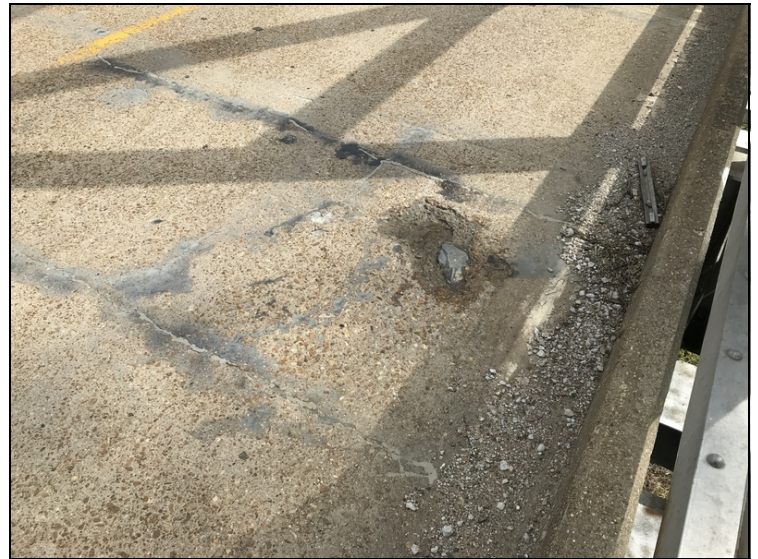
Span #3 right lane 1/4 span has one foot spall no rebar exposed.

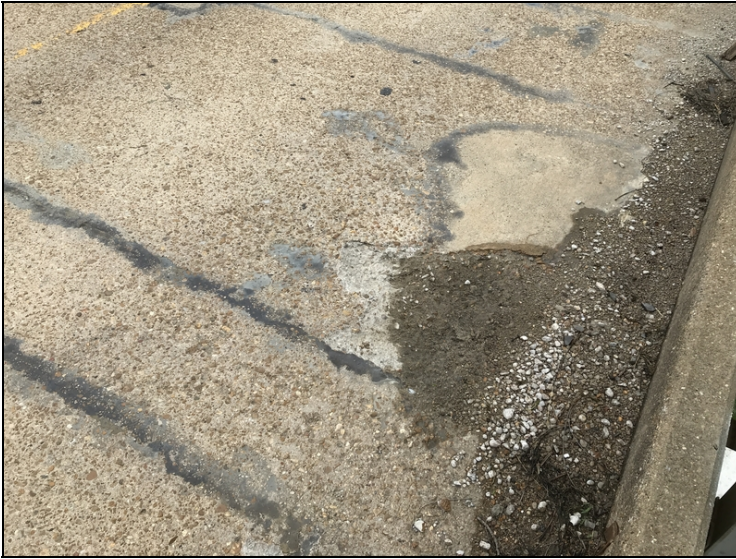
Span #3 right lane 1/2 span has two foot spall no rebar exposed.

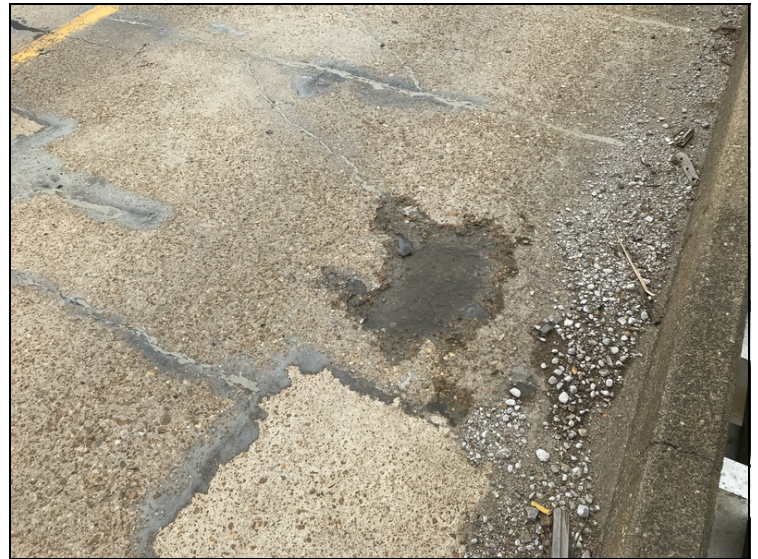
Span #3 right lane 3/4 span has two foot spall no rebar exposed.

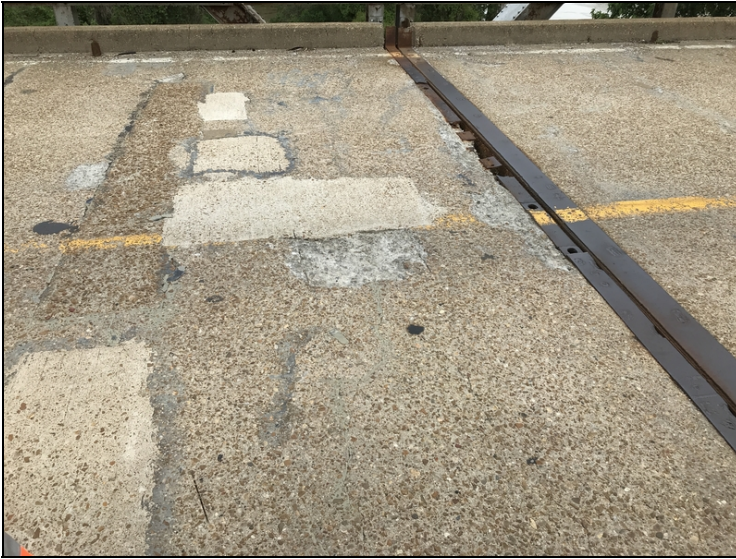
Span #3 both lanes at bent #4 has multiple spalls.

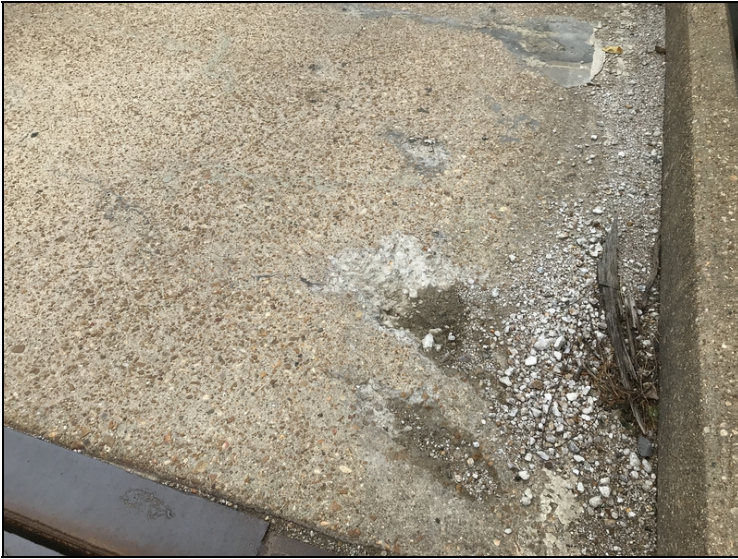
Span #4 right lane at bent #4 has one foot spall no rebar.

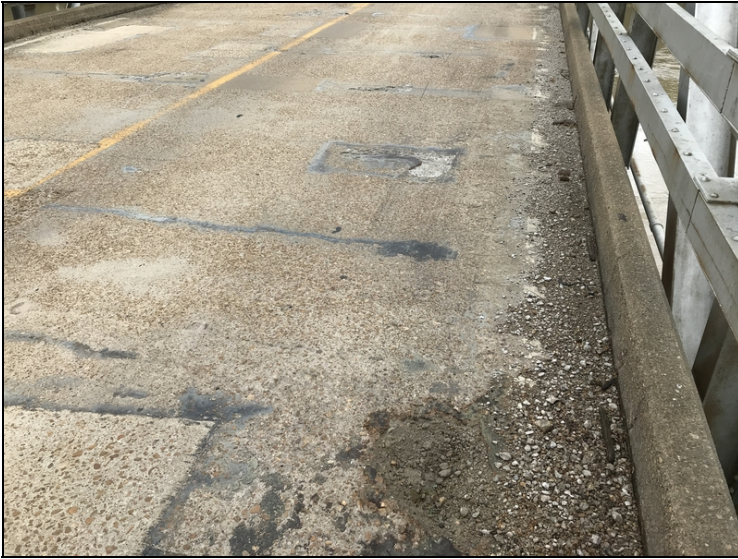
Span #4 right lane 3/4 span has four one foot spalls no rebar exposed.

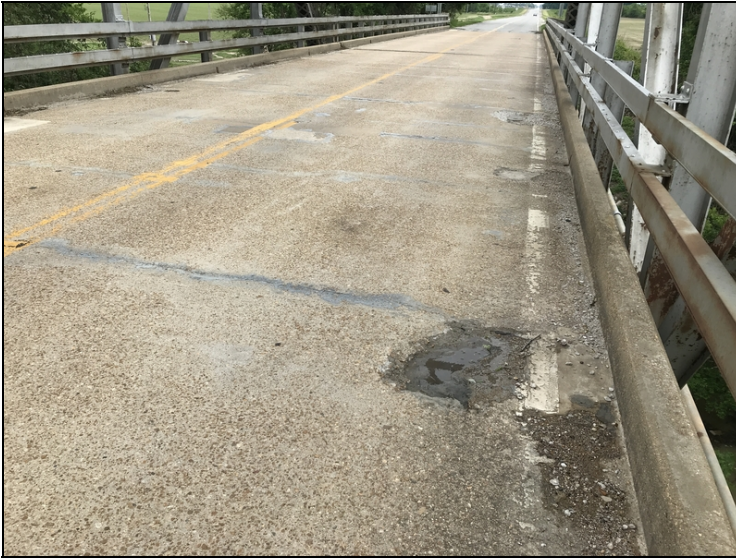
Span #7 right side at gutter spalls.

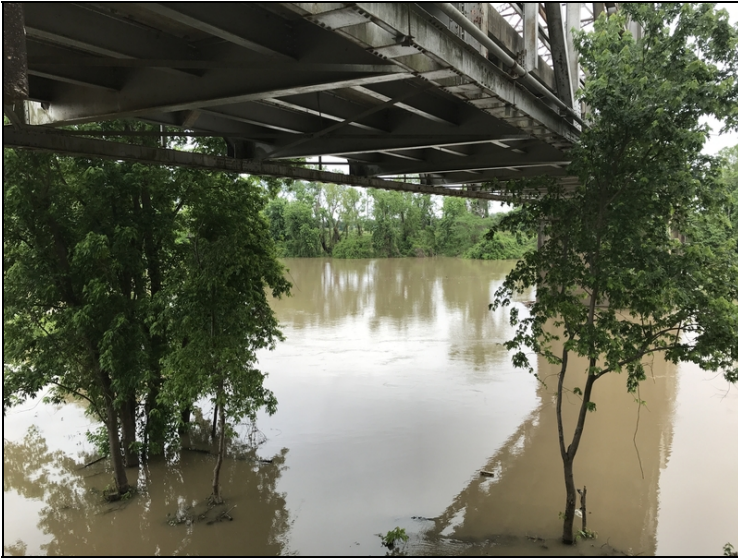
Typical vegetation growing beside and onto bridge  
hindering access to inspection.

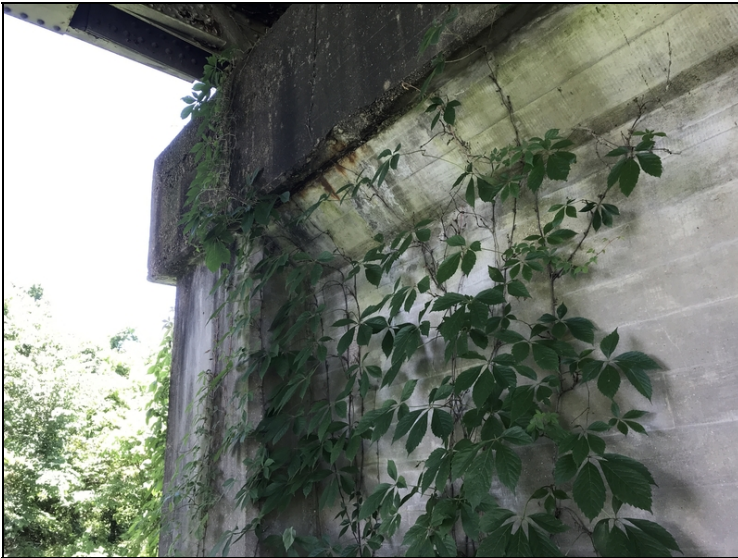
Bent #8 cap back face by column #1 has three foot long spall with exposed rebar to bottom where cap meets pier wall.

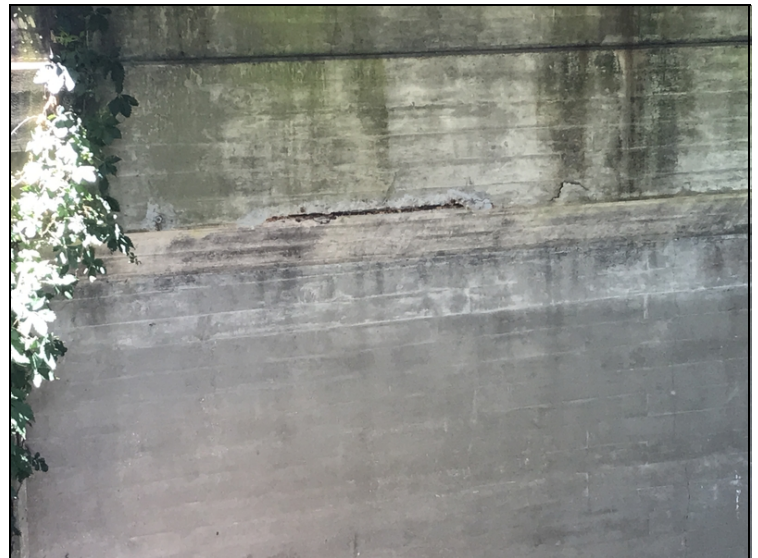
Bent #8 cap ahead face close to column #2 has a three foot piece of rebar exposed where cap meets pier wall with 10% section loss.

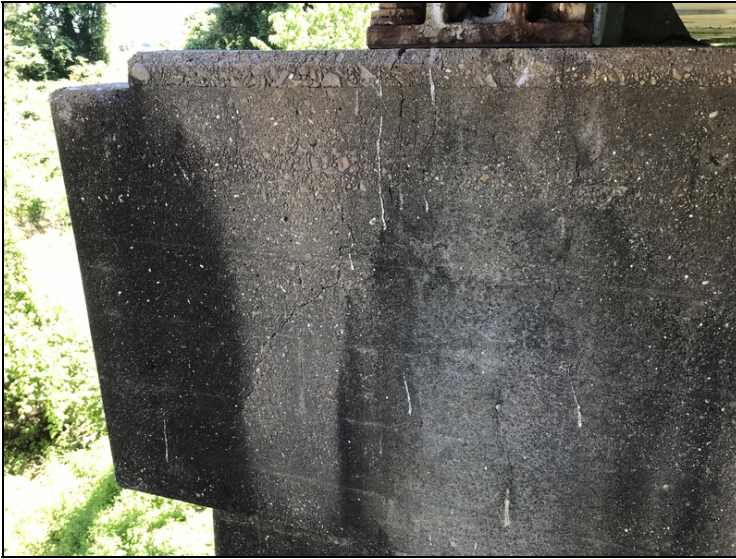
Bent #7 cap back face left side has some cs2 cracks under bearing.

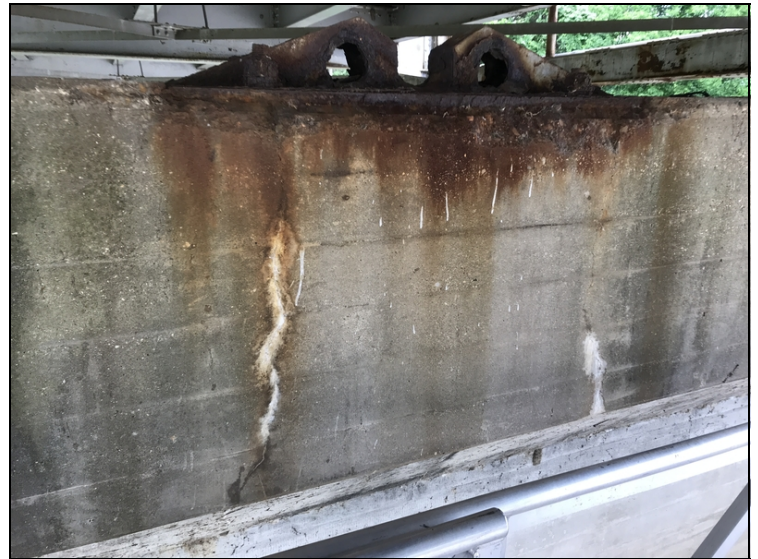
Bent #7 cap back face in center has two cs2 vertical cracks with light efflorescence.

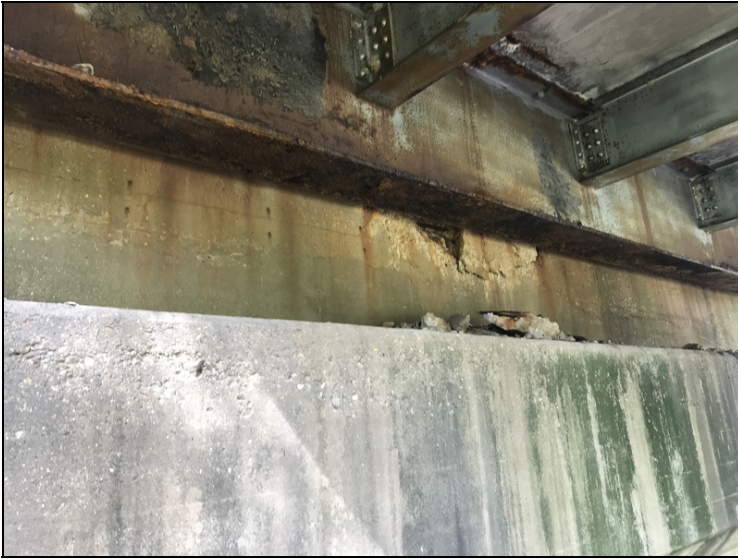
Bent #3 cap center ahead face has three foot delaminated area with two foot spall exposed rebar with 10% section loss.

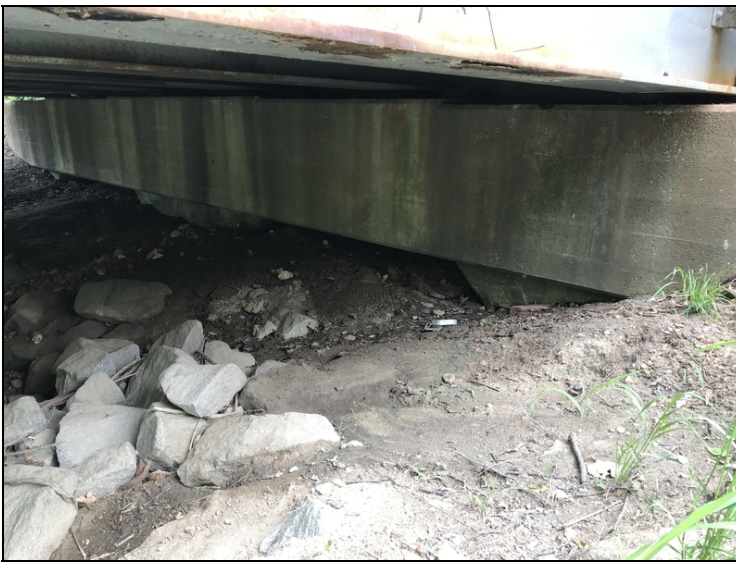
(215)							
Abutment #2 cap is undermined full length up to 1'.							
234	Reinforced Concrete Pier Cap	LF	259	211	29	14	5
1080	Delamination/Spall/Patched Area	LF	13	0	10	3	0
1090	Exposed Rebar	LF	15	0	0	10	5
1130	Cracking (RC and Other)	LF	10	0	10	0	0

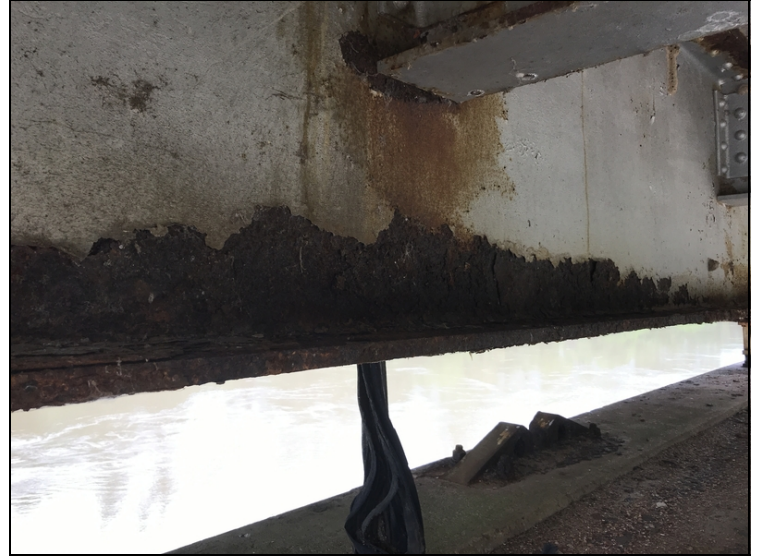
Span #4 at bent #5 floor beam #9 lower flange has corrosion with laminations full length leading into lower web with up to 20% section loss.

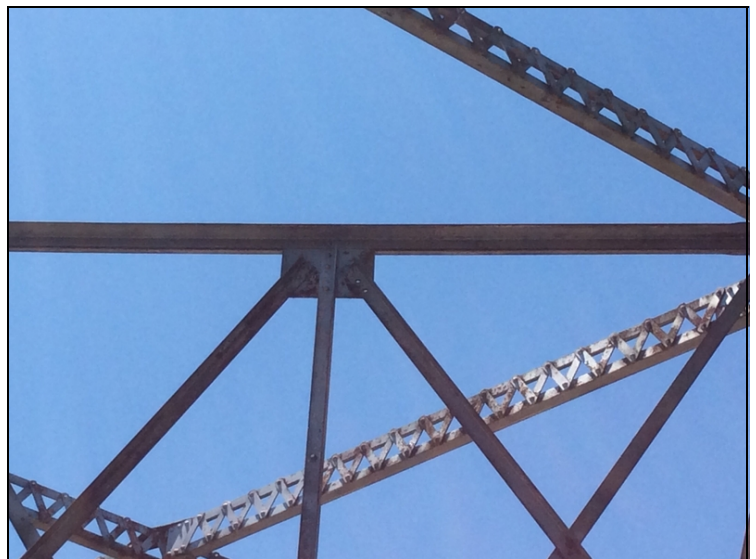
Span #5 3rd cross brace in upper truss top angle brace over left lane has two missing rivets.

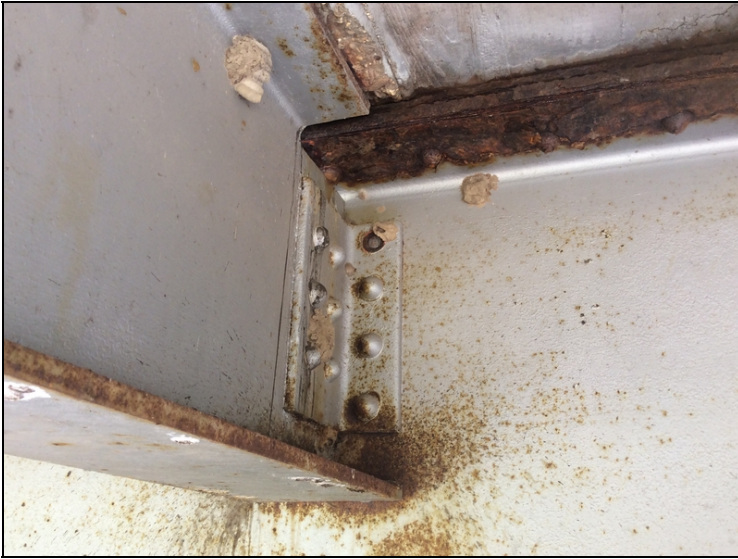
Bent #5 span #4 stringer #4 has right side top rivet sheared off.

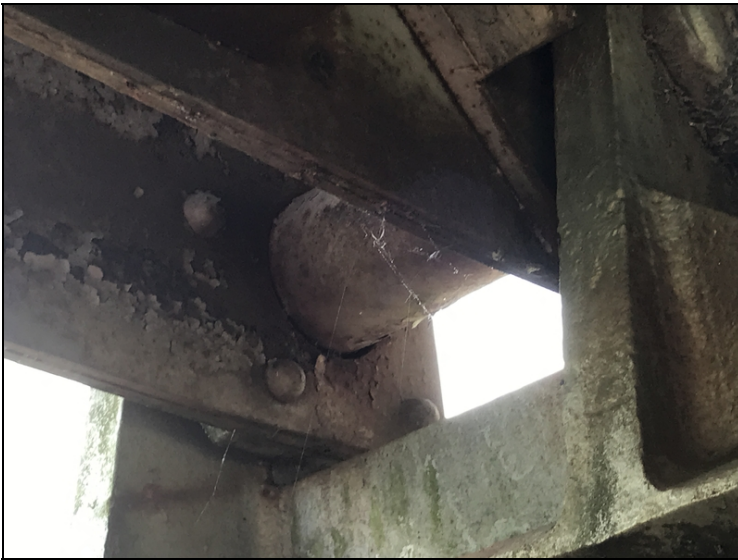
Typical wear in pins to bearing connection on truss.

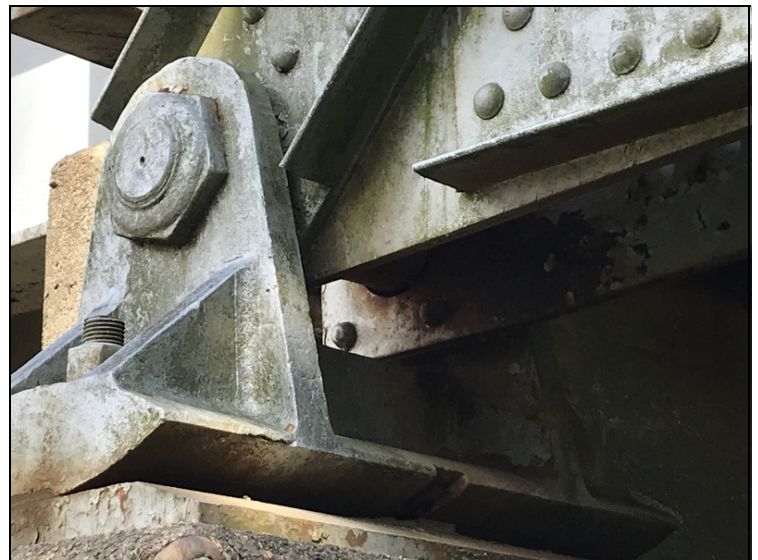
Typical wear in pins to bearing connection on truss.

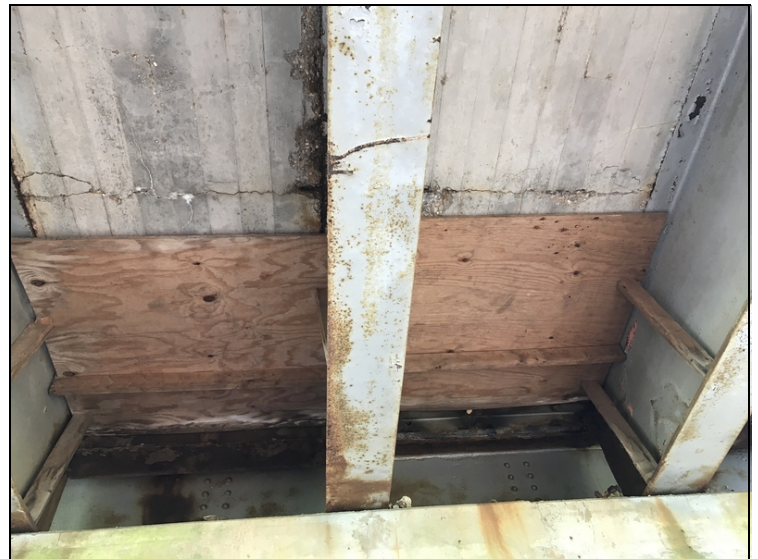
Typical form left in place

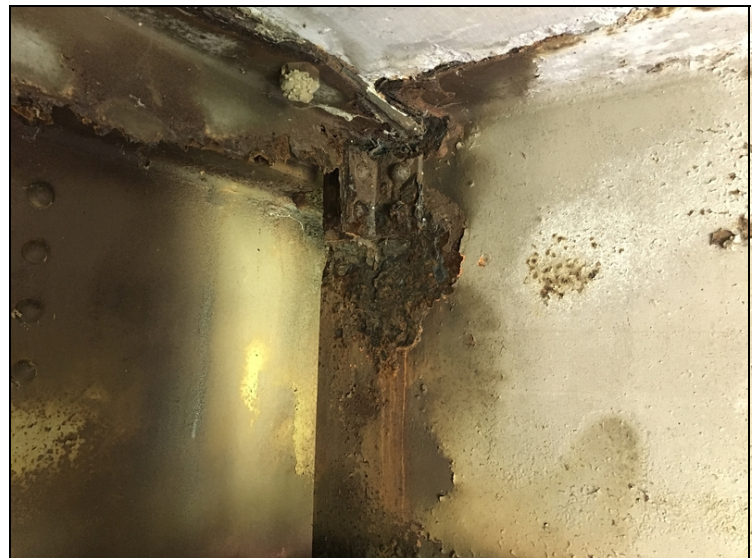
Span #8 bent #8 girder #2 web first foot at top at diaphragm connection has corrosion with laminations and section loss up to 50%.

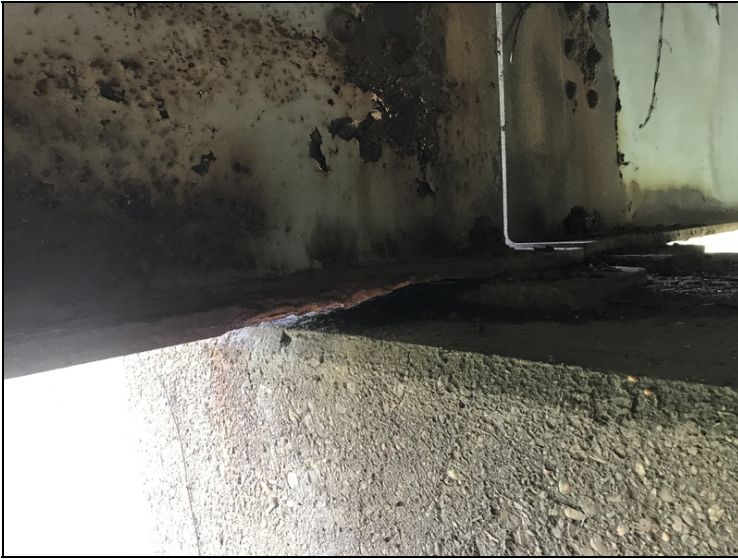
Span #8 bent #9 girder #1,5 first two feet of bottom flange has corrosion up to a knife edge.

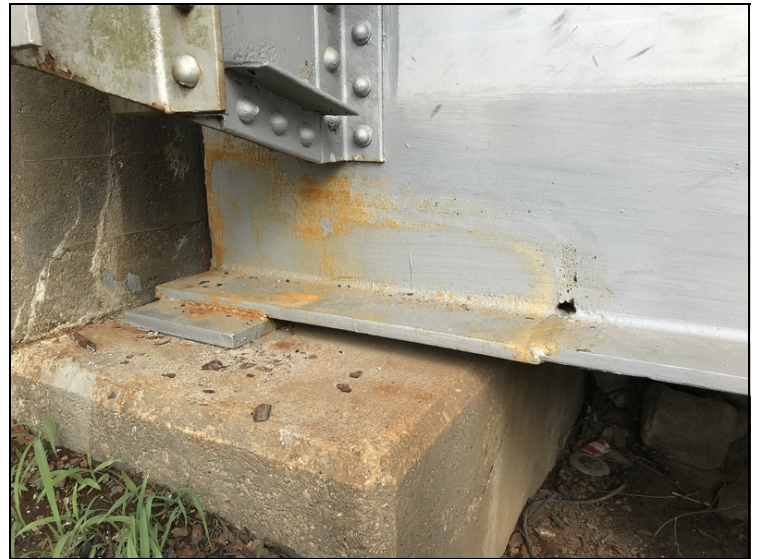
Span #1 girder #6 bent #1 has a t-splice first two feet six inches tall.

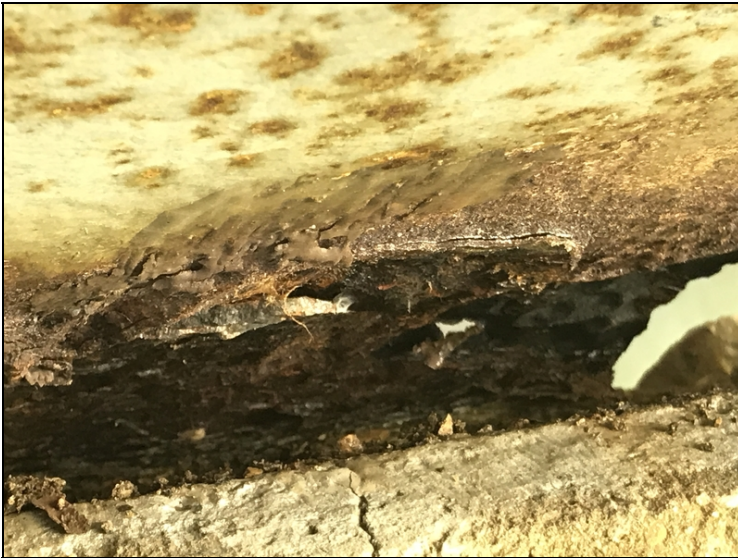
Span #2 girder #3 at bent #2 bottom flange has 3/4" hole rusted through ahead of bearing.

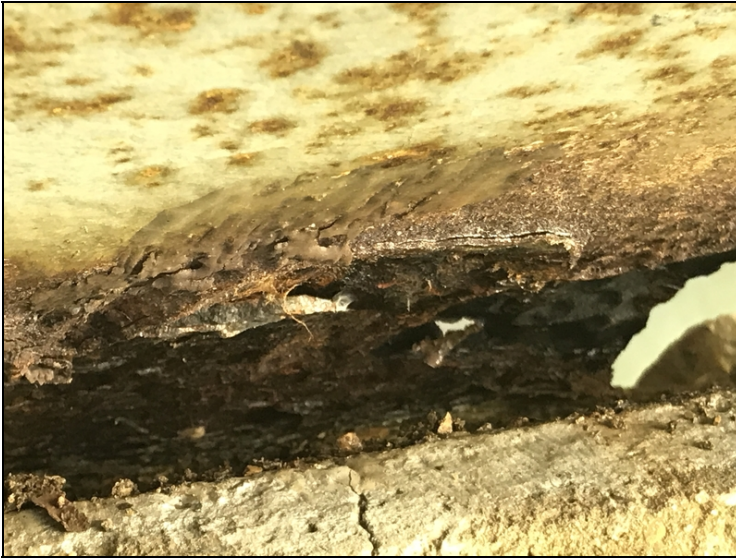
Span #2 girder #3 at bent #2 bottom flange has 3/4" hole rusted through ahead of bearing.

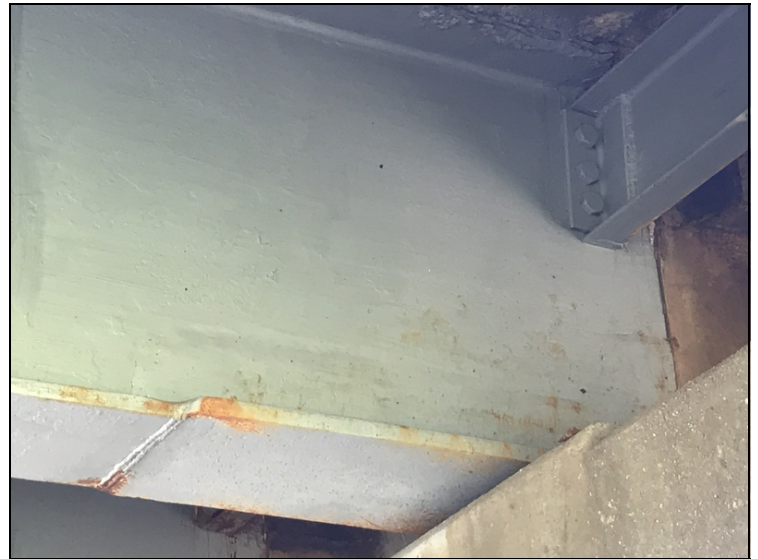
Span #2 bent #2 girder #2 has an L shape t-splice two foot long.

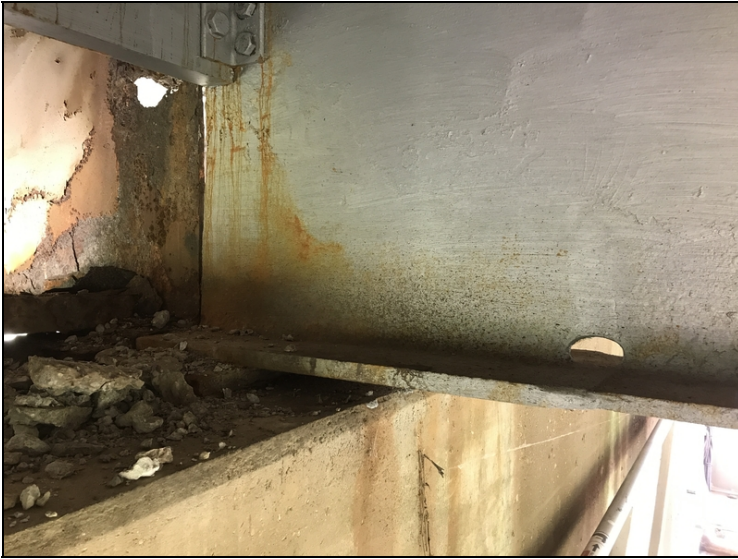
Span #8 bent #9 girder #4 has a t-splice that is two feet long by ten inches tall.

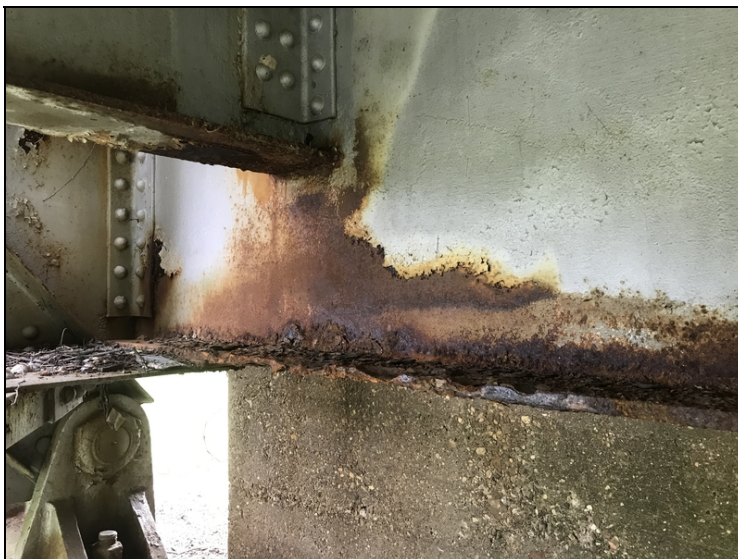
Span #7 floor beam #9 left end for three feet lower flange into web has corrosion with laminations and section loss up to 90%.

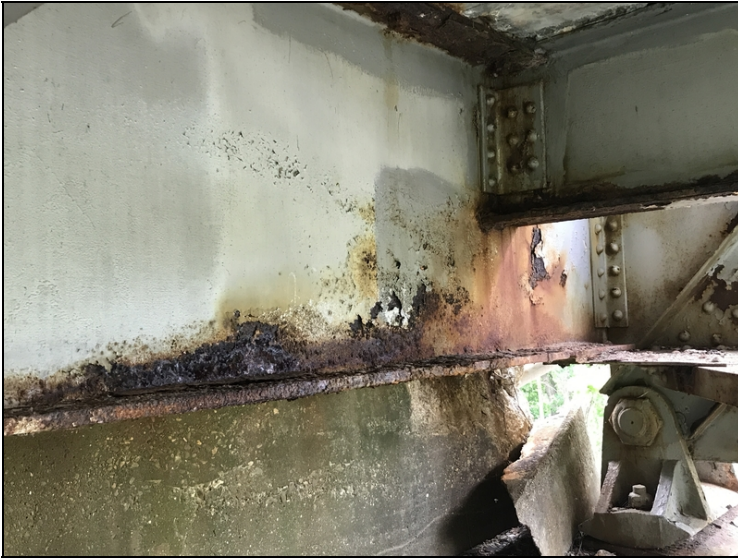
Span #7 floor beam #9 right end for three feet lower flange into web has corrosion with laminations and section loss up to 50%.

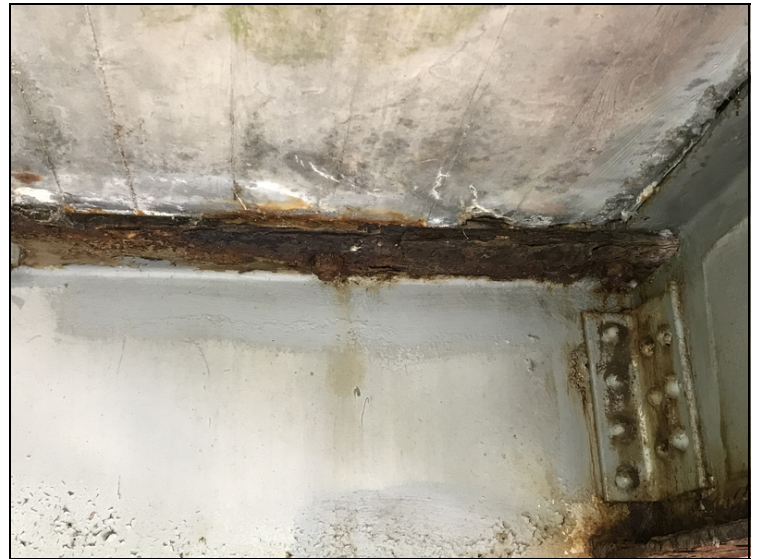
Span #7 floor beam #9 on ends for four feet top flange has corrosion laminations and section loss up to 50%.

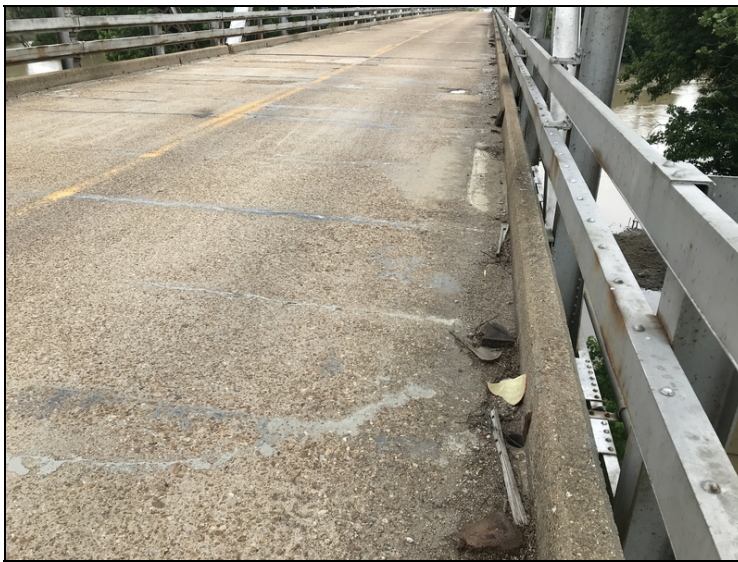
Typical debris in gutters.

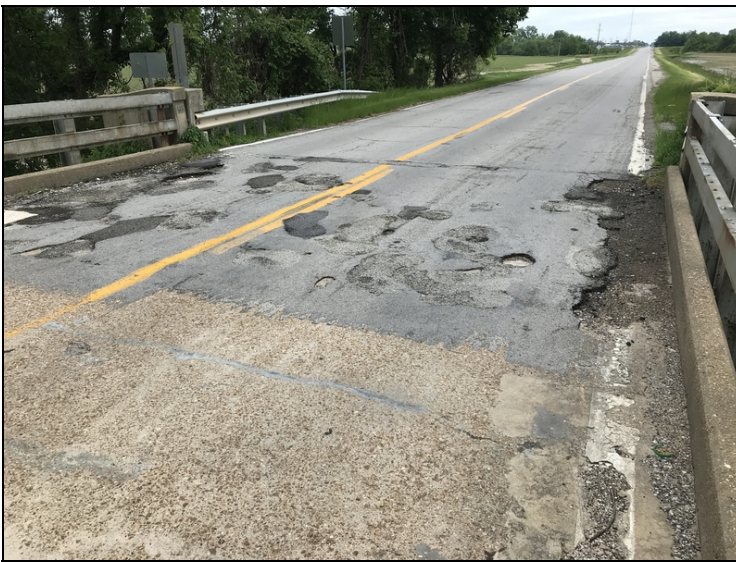
Abutment #2 span #9 asphalt area on end of deck has multiple spalls and patched areas.

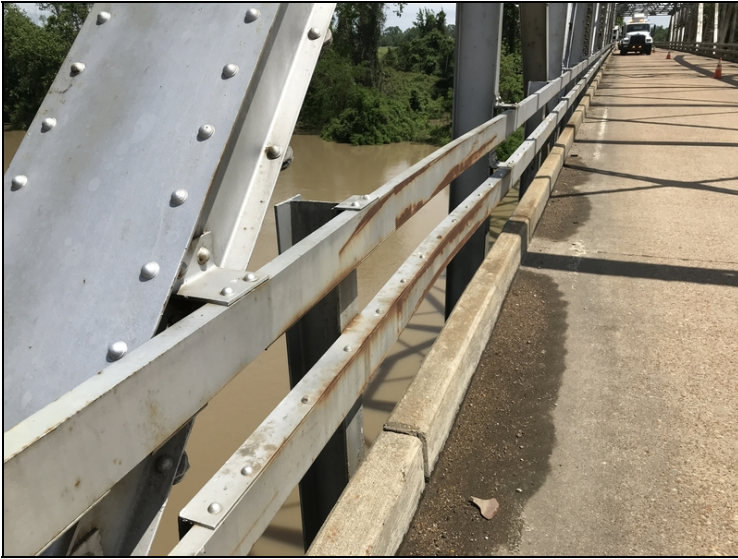
Span #5 left rail damage near bent #5.

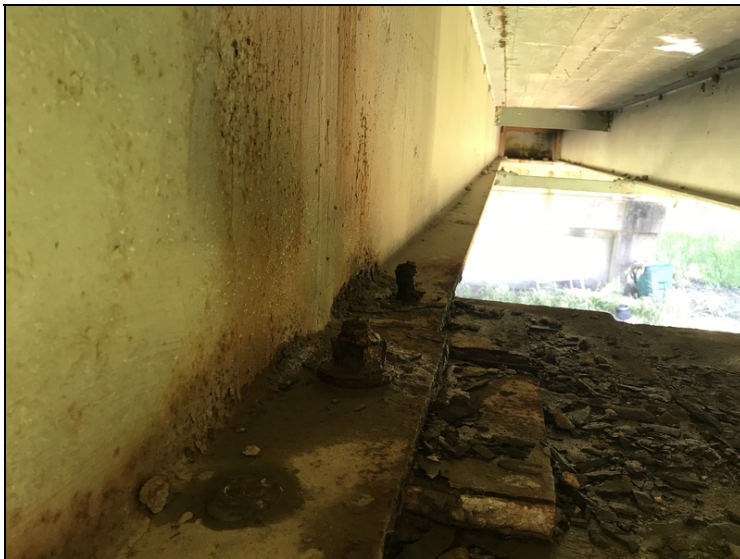
Span #2 girder #4 right anchor nut rusted off.

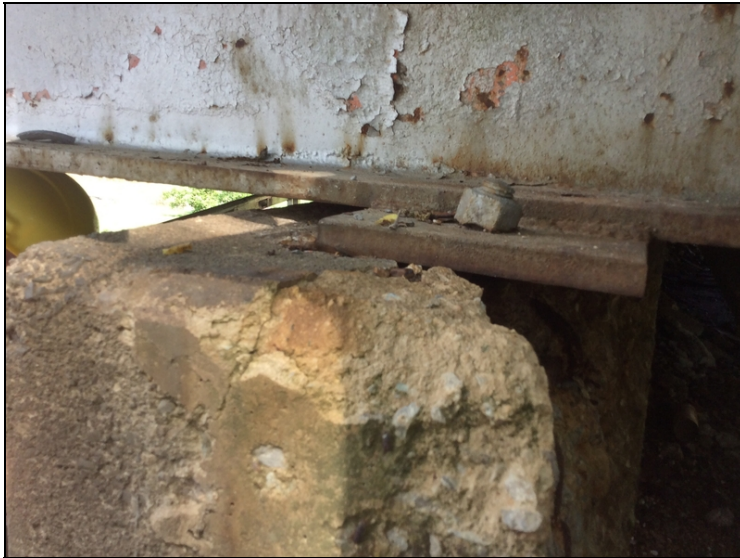
Bent #3 span # 2 cap spalled reduced bearing area to 50%.

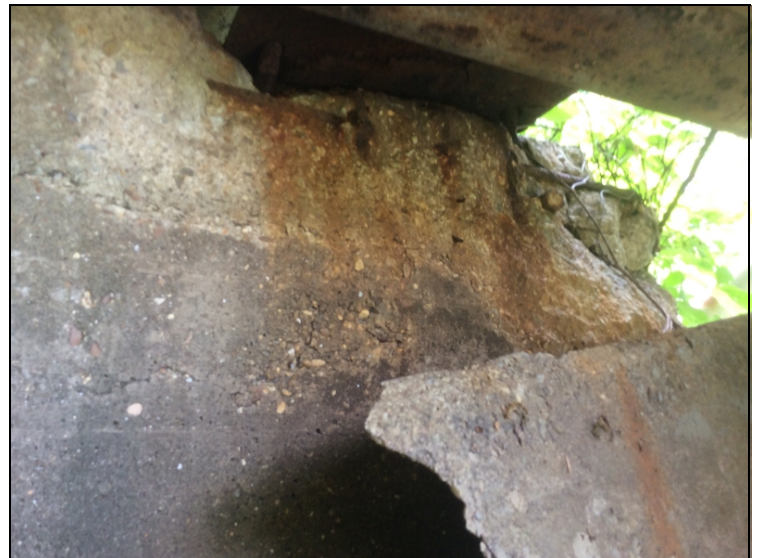
Bent #8 front face has a two foot spall at top right side under bearing of girder #6 with exposed rebar with 5% section loss and 50% loss of bearing.

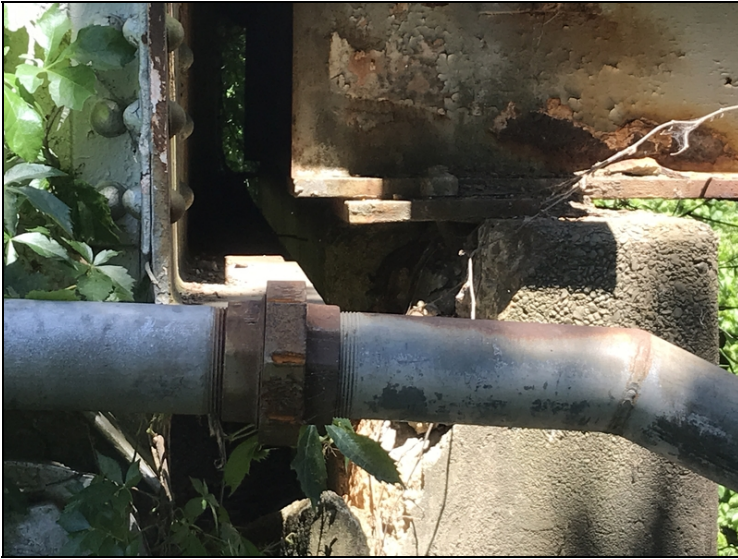
Bent #8 back face has a two foot spall at top right side under bearing of girder #6 with exposed rebar with 5% section loss and 50% loss of bearing.

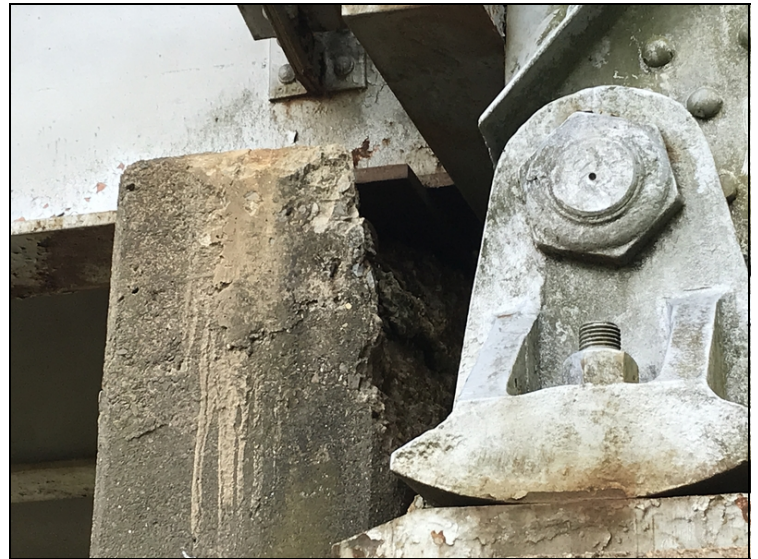
Bent #3 cap right side has large spall exposing bearing plate for span #2 girder #6.

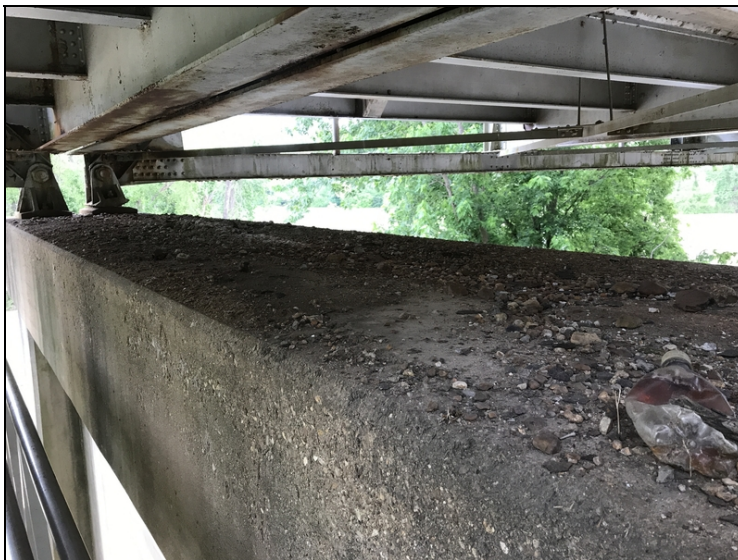
Caps have debris on them due to joints.

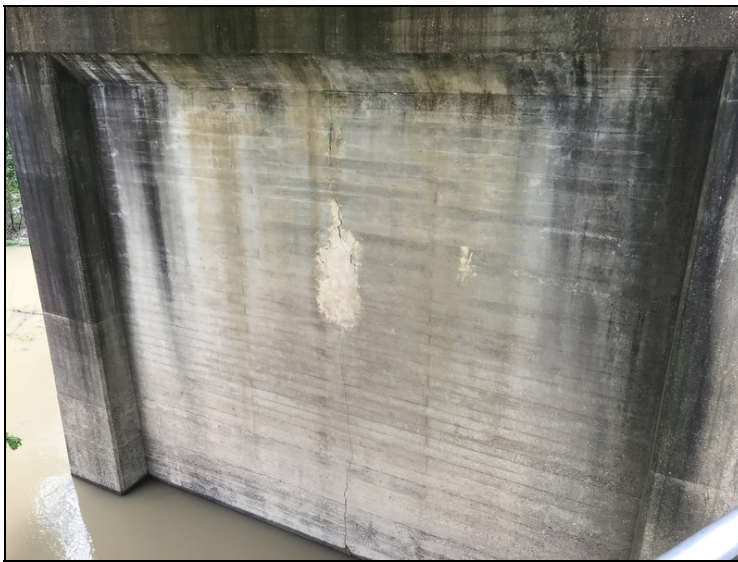
Bent #4 ahead face cs3 crack in center of pier wall.
