Bridge #01535(Routine, Underwater type 2)

Us-70/Sec-18/L6.09 over Big Creek

Team Lead: Myron Futrell Inspection Date: January 13, 2020

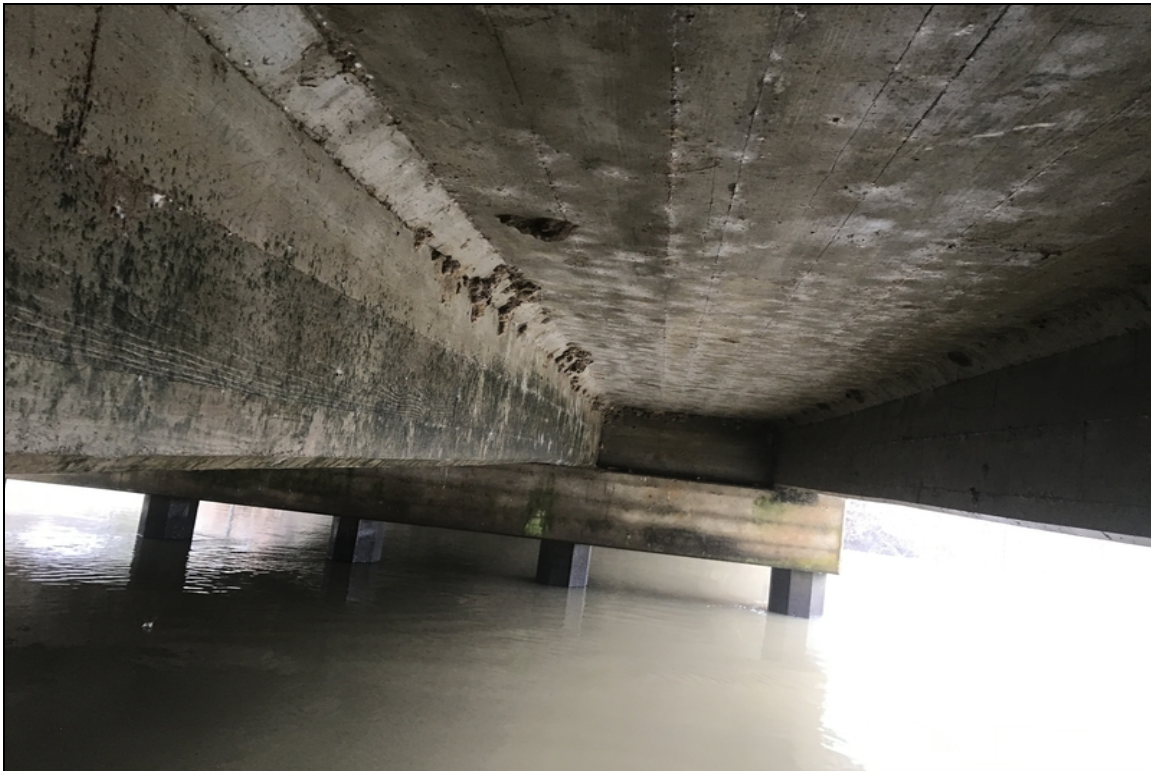
(16) Soffit has a few hairline cracks in each bay both spans near bents some having light to moderate efflorescences and rust staining. Wearing surface has map cracking, longitudinal cracking, and transverse cracking full length. Soffit span #1 bay #4 has a two foot spall at abutment with exposed rebar with 10% section loss.							
110	Reinforced Concrete Open Girder/Beam	LF	345	325	20	0	0
1090	Exposed Rebar	LF	20	0	20	0	0

Typical soffit.

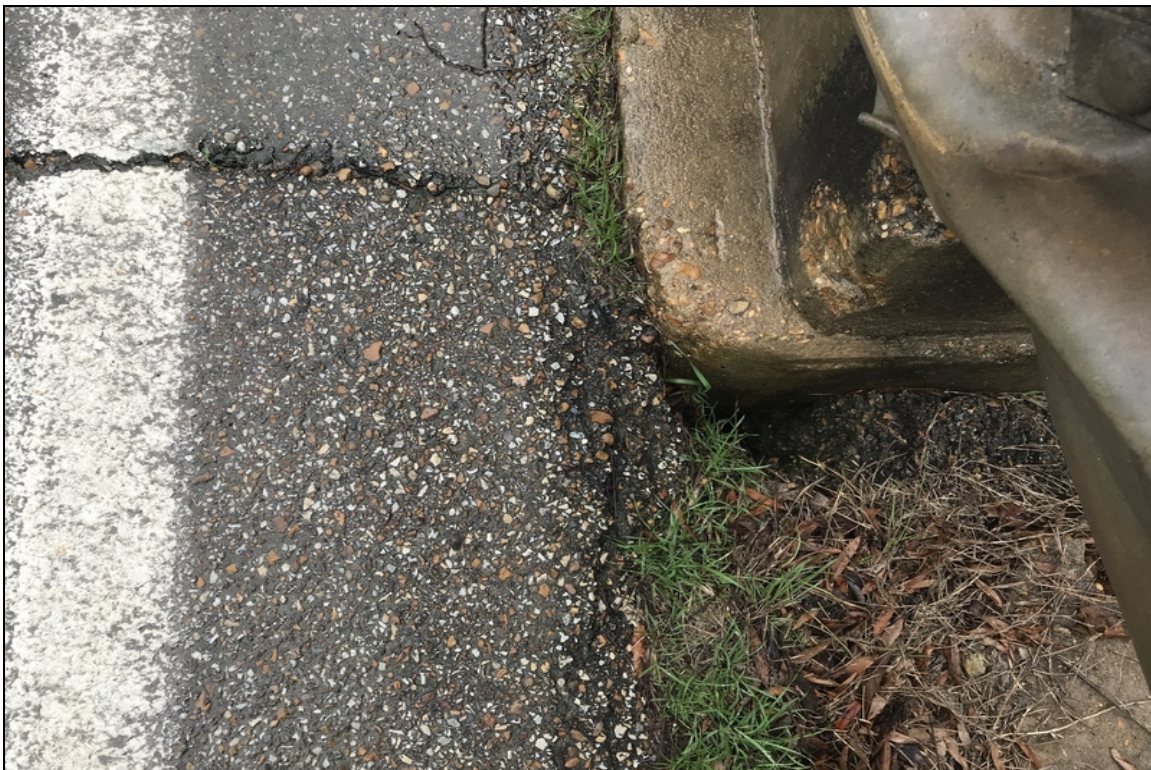
Hole in shoulder at abutment 1 right side.

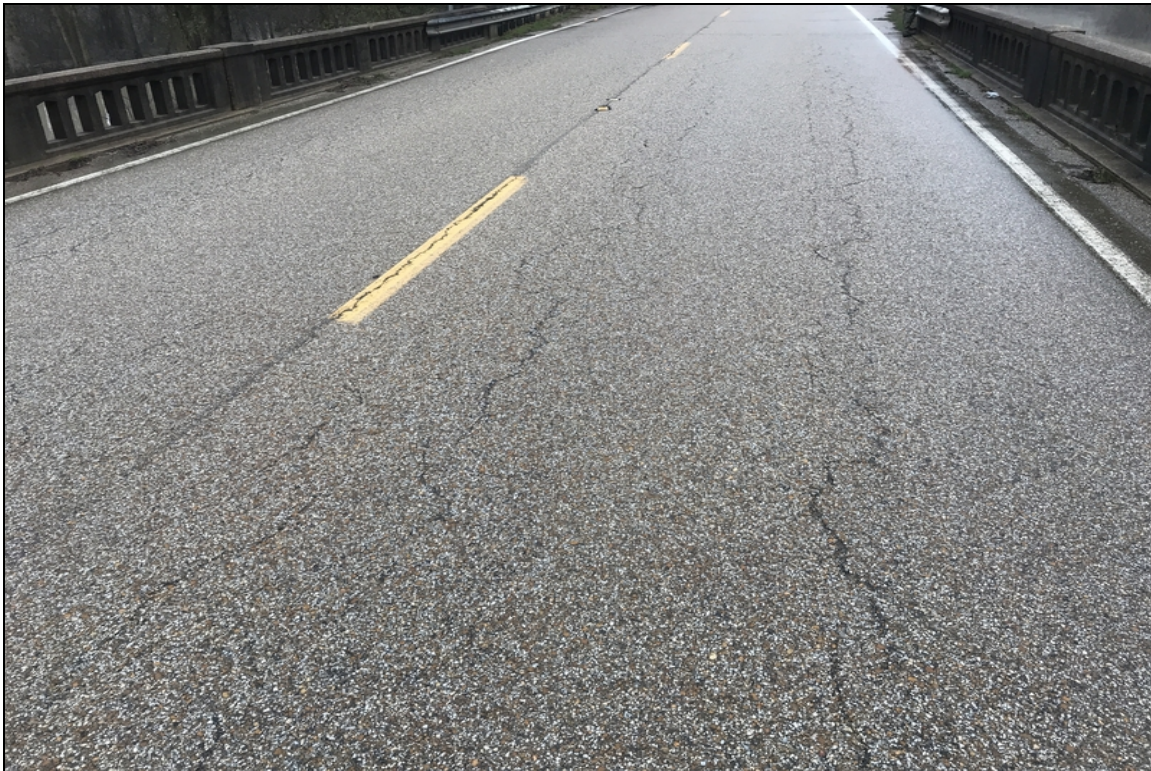
Typical deck.

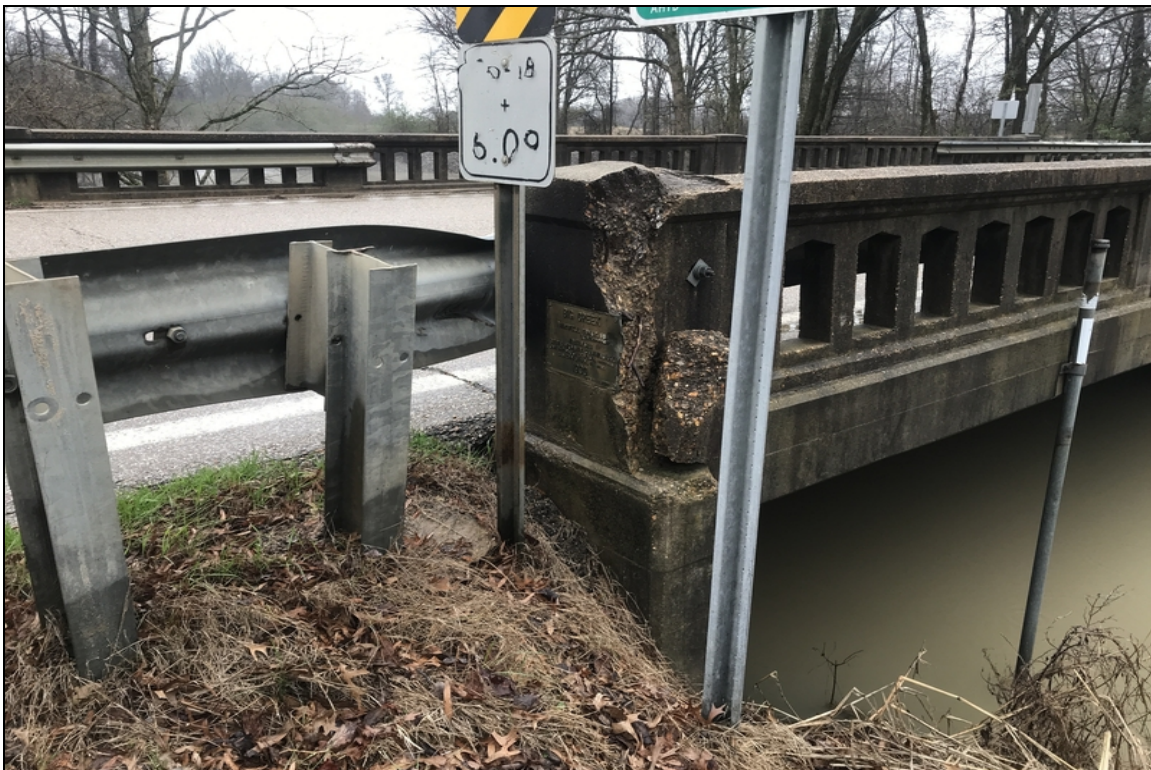
Abutment 1 right monument post damage.

Abutment #1 right monument post has collision damage and is broken.

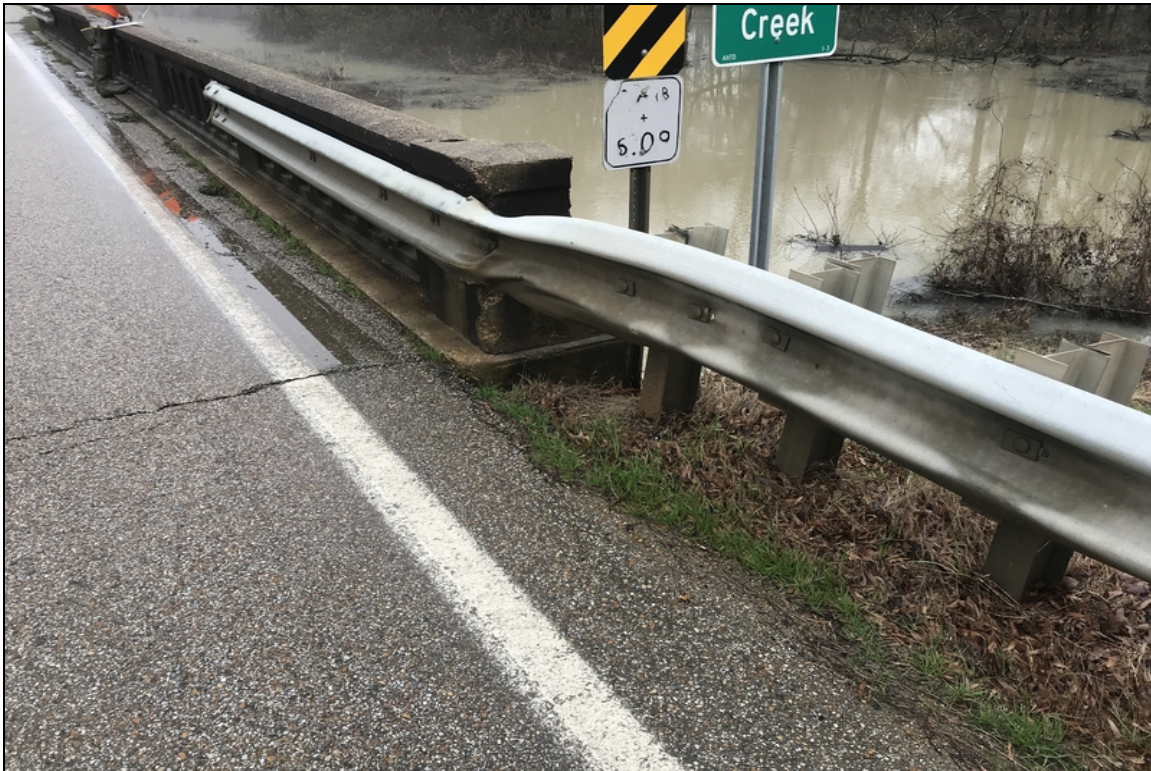
Right approach rail damage at abutment 1.

Approach rail abutment #1 tight side at bridge has collision damage.

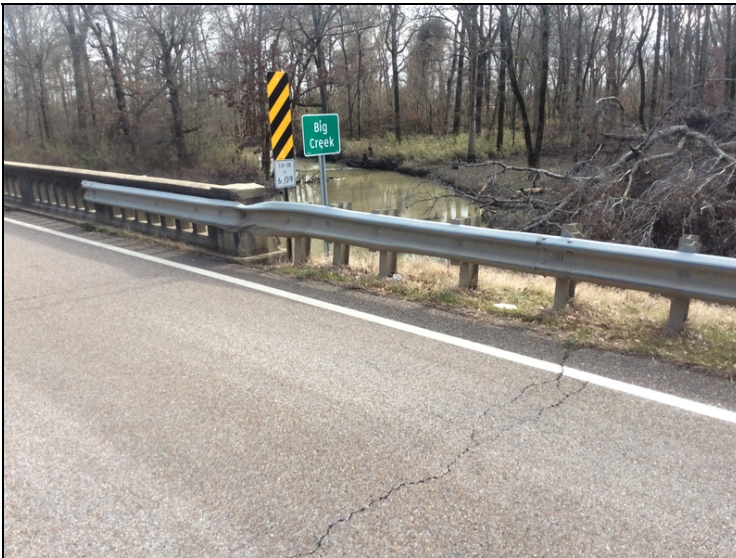
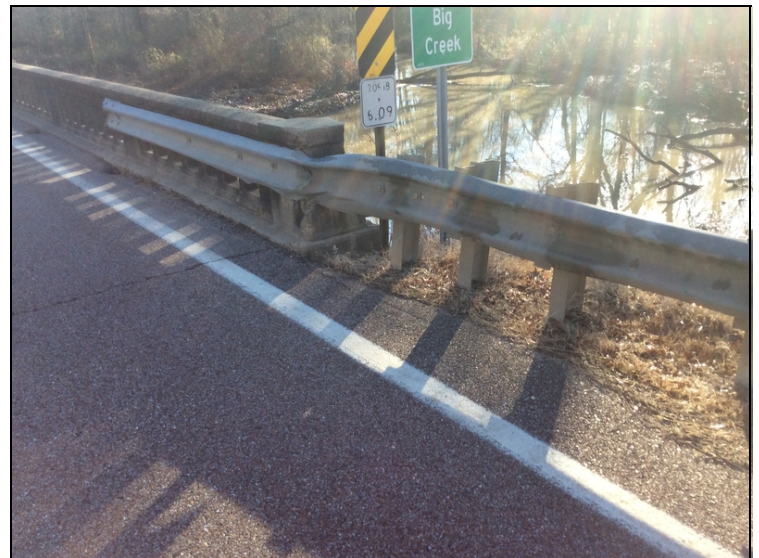
Abutment #1 right approach rail damage.

Abutment #1 right side approach rail.

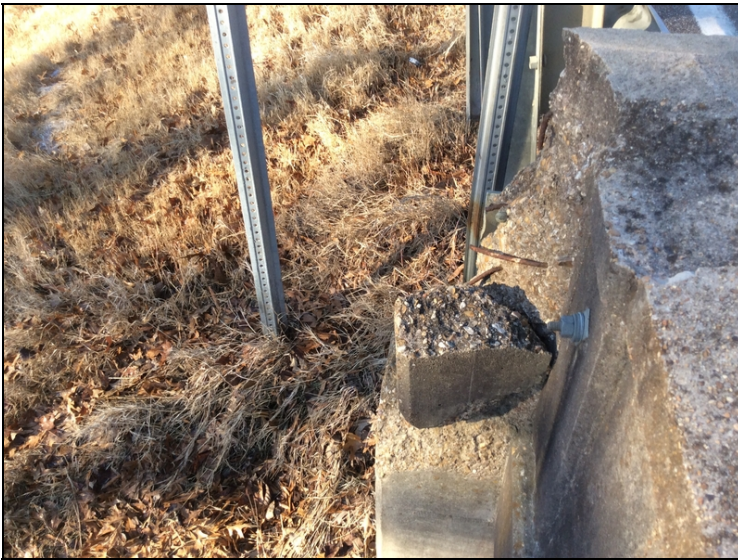
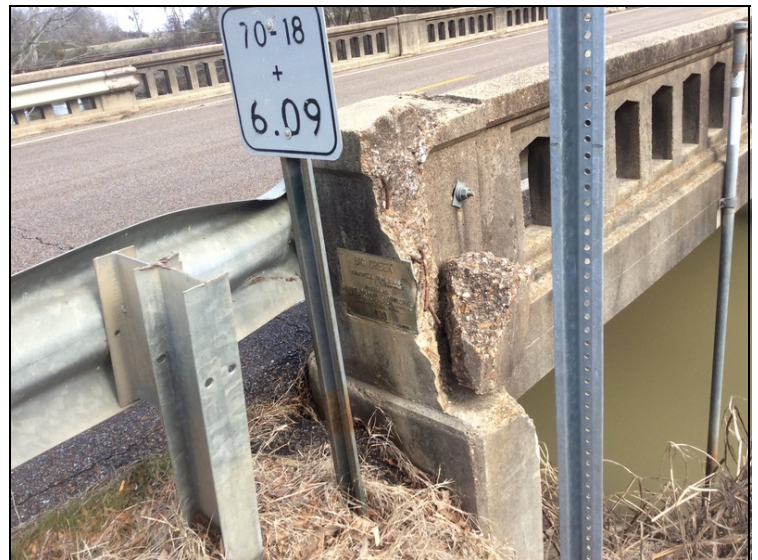
Abutment #1 right side monument post.

Abutment #1 right monument post.

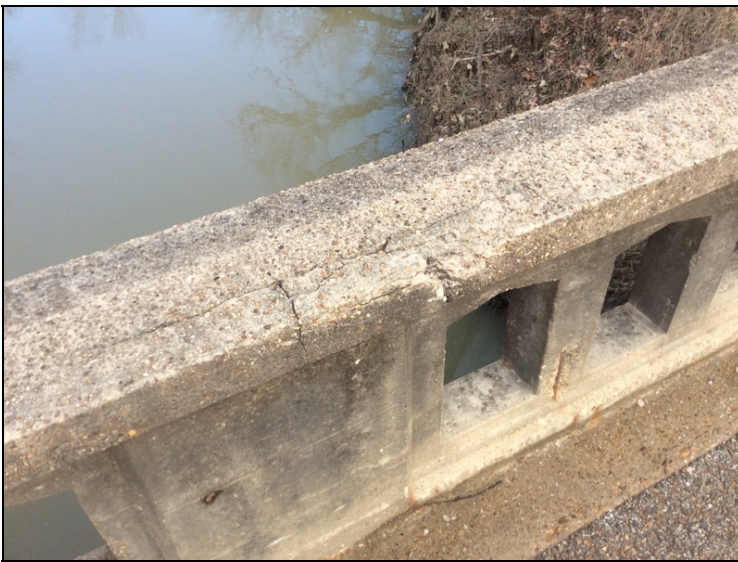
Left rail 17' back from abutment #2 top of rail has a 3' crack and delamination.

Right guard rail 17' back from abutment #2

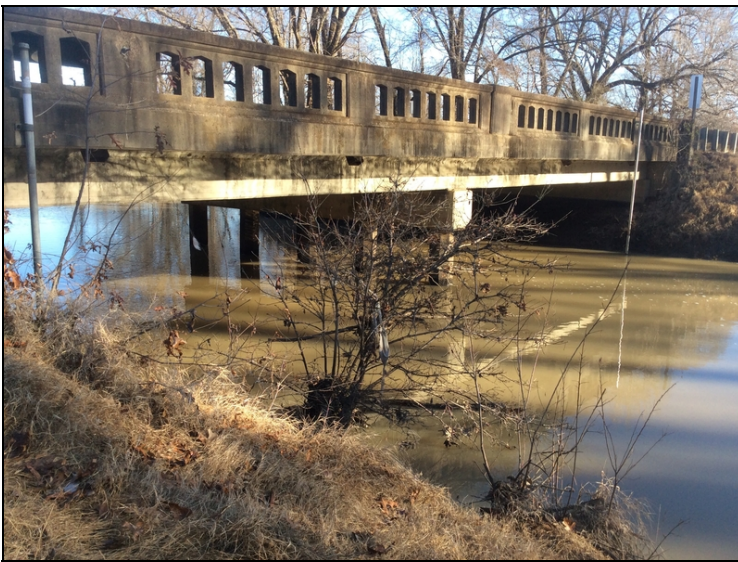
Small trees and bushes are growing beside bridge.
01/15/2020-Brush has been cleared at time of inspection.

Small trees and bushes are growing beside bridge.

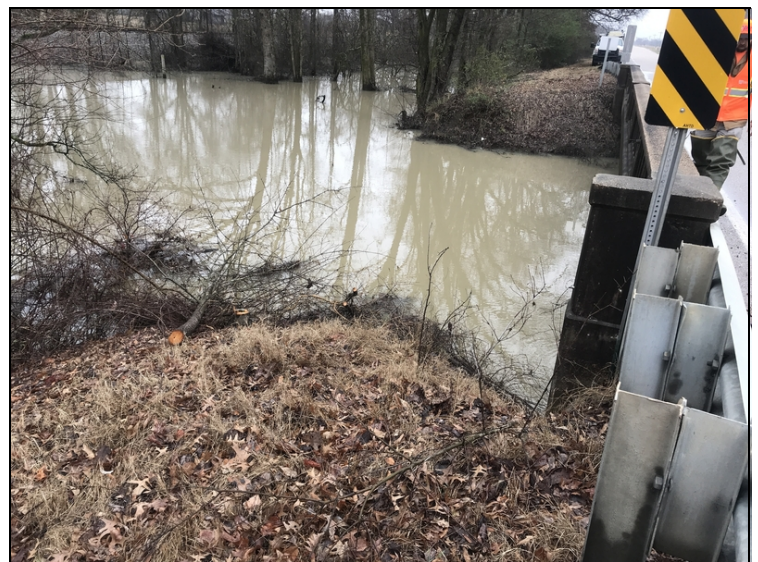
Brush has been cleared beside bridge.

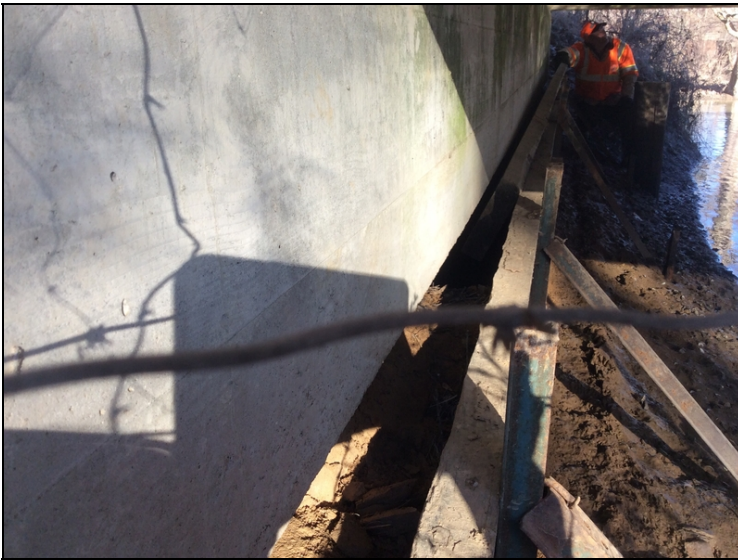
Abutment #1 is undermined behind wood abutment several feet.

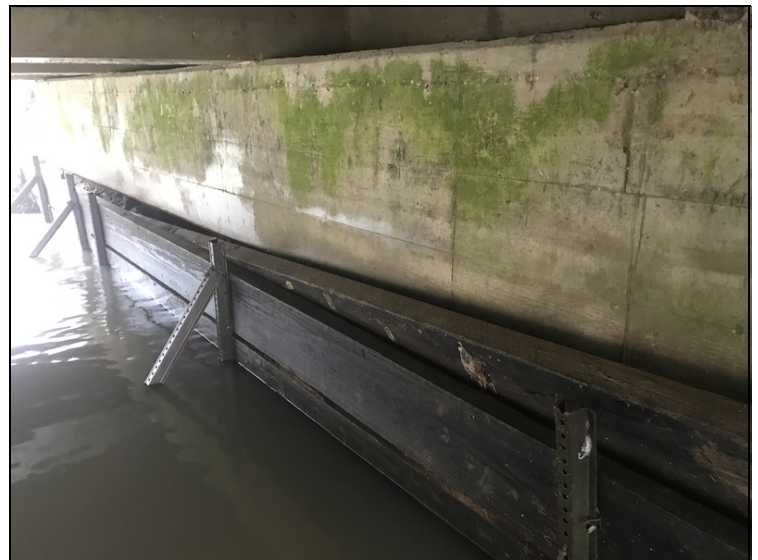
Top board of abutment 1 timber abutment has fallen down.

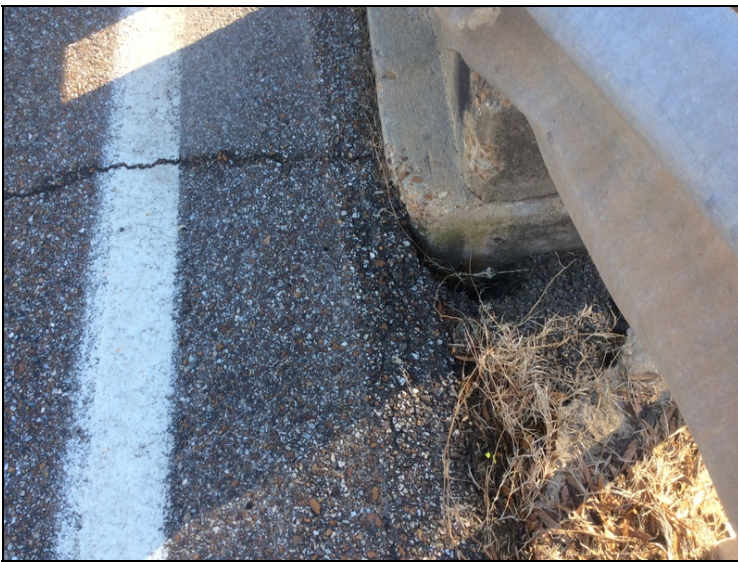
Abutment #1 each side approach roadway at bridge end has six inch hole leading to large void behind cap.

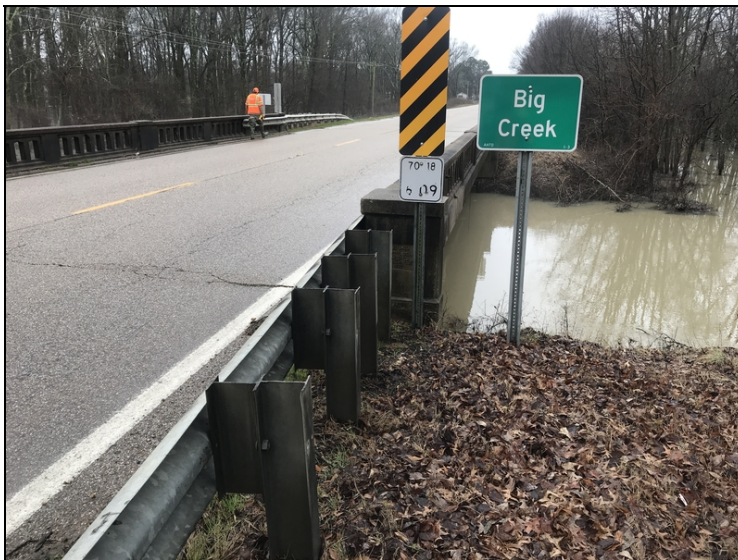
Log mile signs are difficult to read.

Abutment 2 log mile sign is hard to read.

Type of Work: Replace

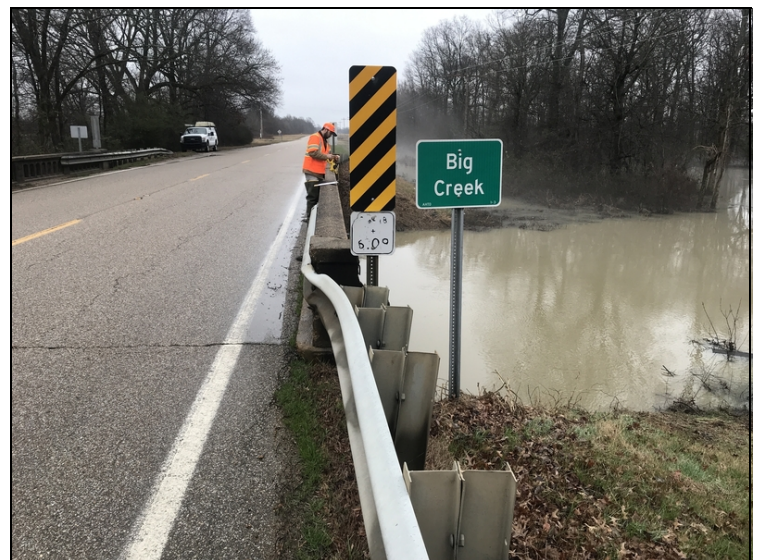
Abutment 1 log mile sign is hard to read.

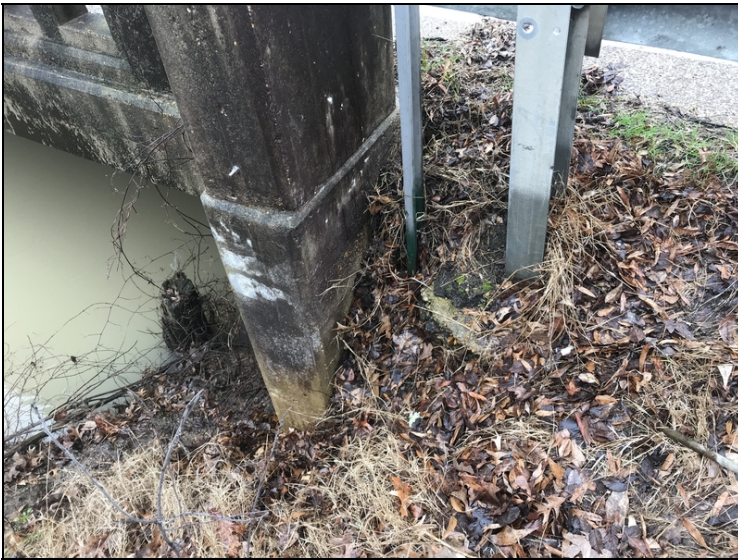
Abutment 1, left side, at bridge end, has minor slope erosion.

Erosion at abutment 1 left side.

Date Reported: 01/15/2020
Priority: C - Important
Type of Work: Repair
Status: Open
Component: Approach
