District 01, St. Francis County

Bridge #01578(Routine, Underwater type 2)
Us70/Sec-18/L13.54 over Languille River Relief

Location: .9 M E Of Jct Sh 261

Team Lead: Myron Futrell Inspection Date: August 27, 2020

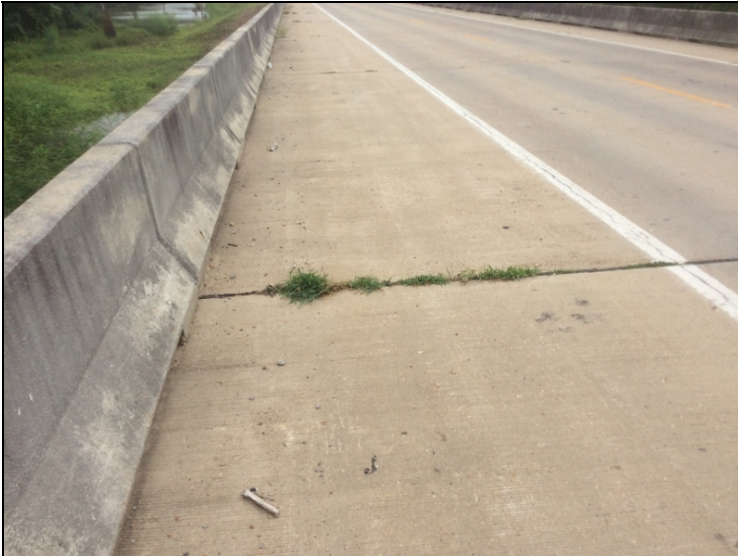
Joints have vegetation growing in them.

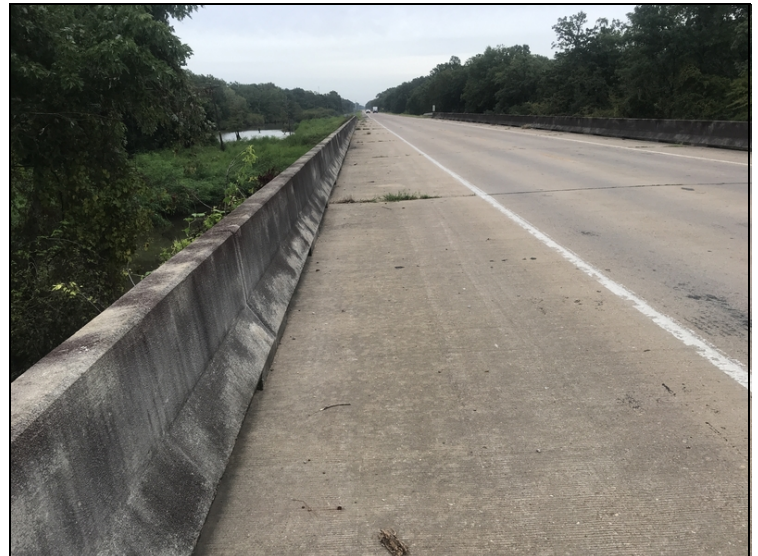
Vegetation growing in gutters at joints.

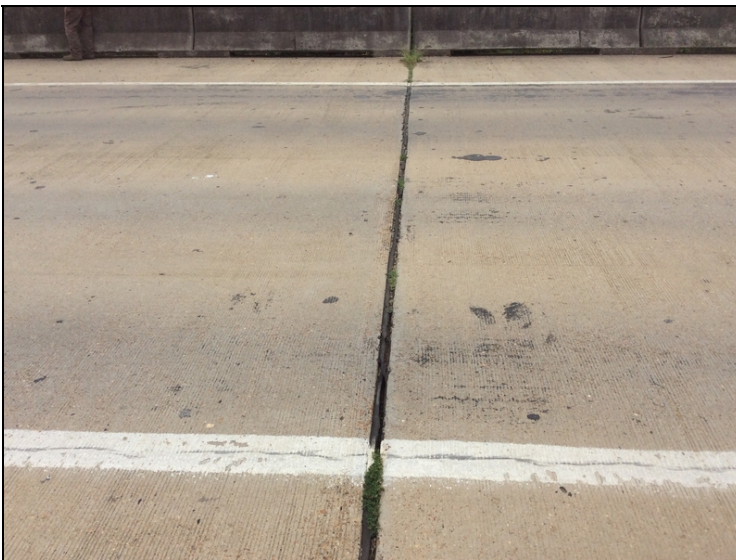
Joints are cracked and weathered allowing non compressible material to enter.

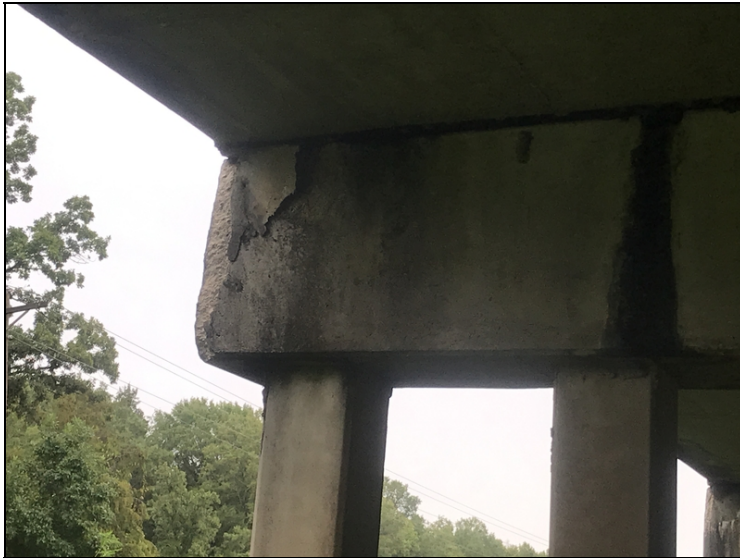
Bent #7 cap left end back face has a two foot by three foot delamination.

Span #7 cap left side back face spalled and delaminated.

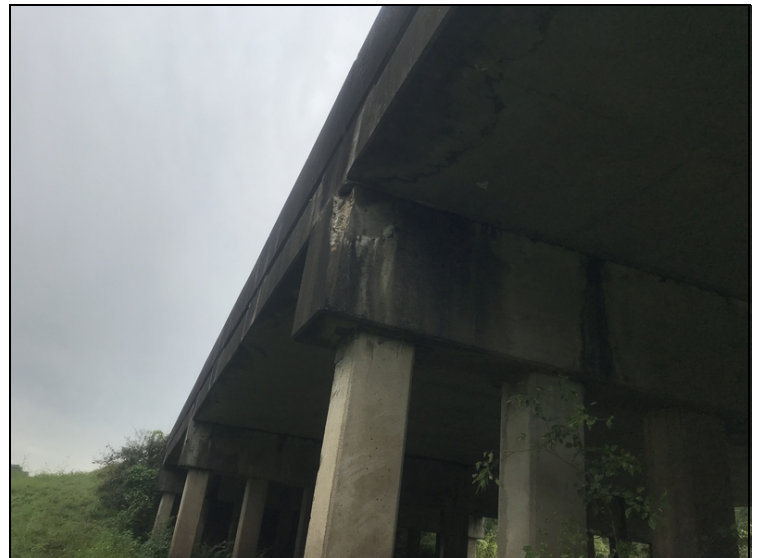
Bent #8 cap left end back face.

Bent #8 cap left end has a one foot spall no rebar exposed.

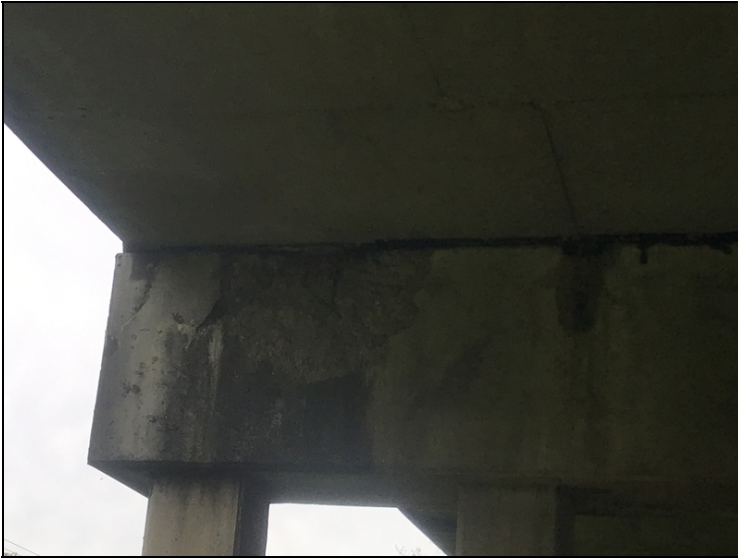
Bent #9 cap back face left end.

Bent #9 cap left end back face has 3' spall with exposed rebar with 5% section loss and 1' delamination.

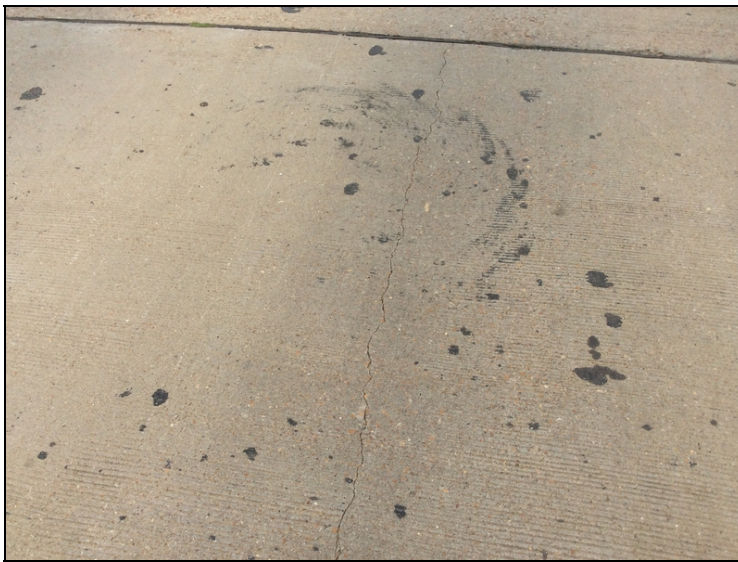
Deck each span has open longitudinal crack in center.

Typical longitudinal deck crack.

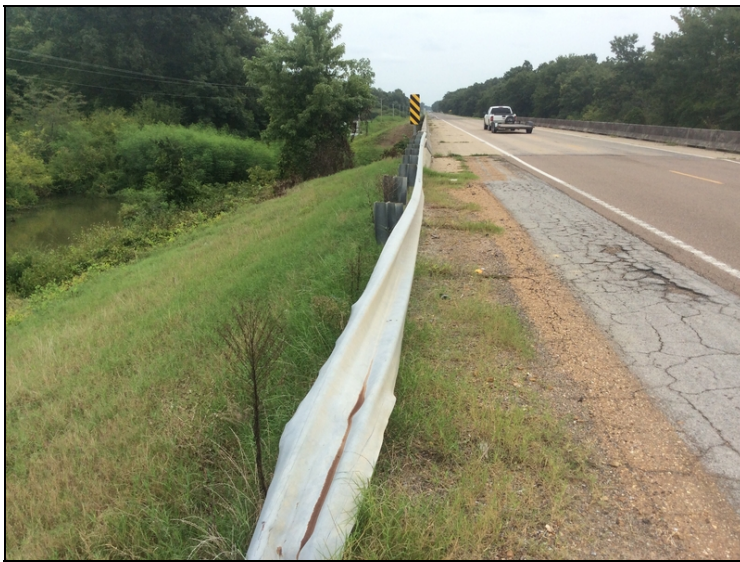
Abutment #1 left approach rail.

Approach rail abutment #1 left side has collision damage first forty feet of rail.
Abutment #1 right approach rail has 40'+- of collision damage 90' +- from bridge end.

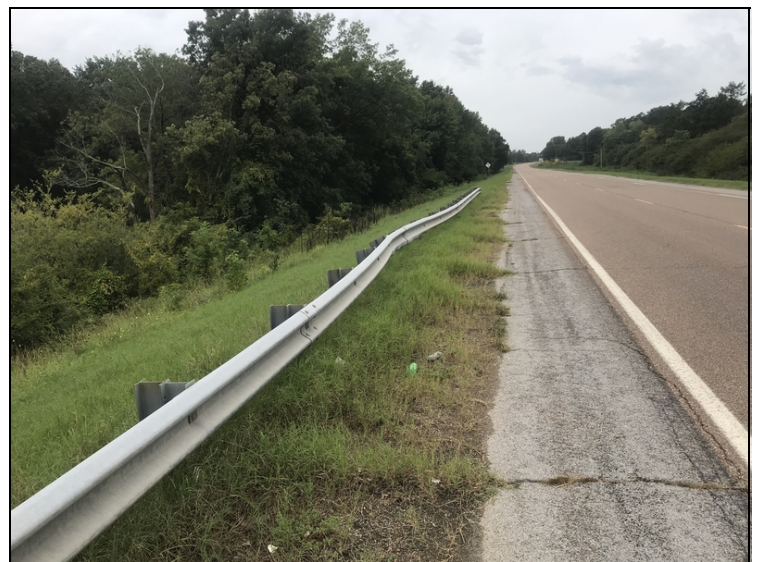
Abutment #1 right approach rail has 40'+- of collision damage 90' +- from bridge end.

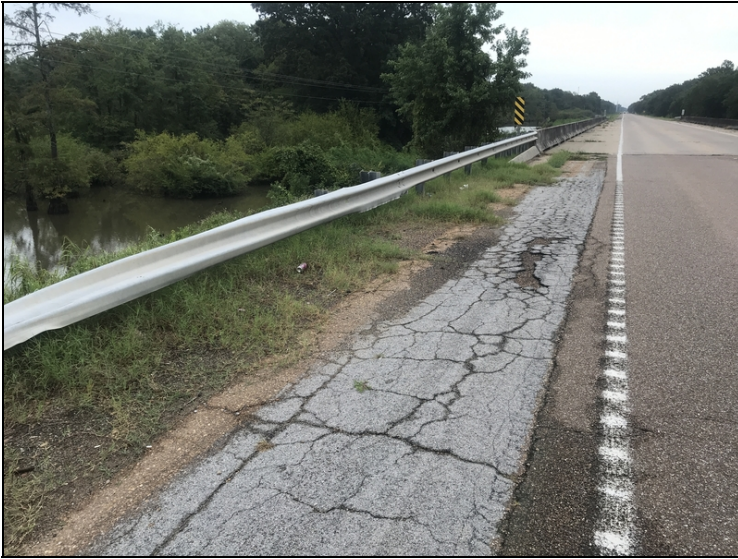
Abutment #1 left approach rail has minor collision damage first two rail posts are damaged and not connected.

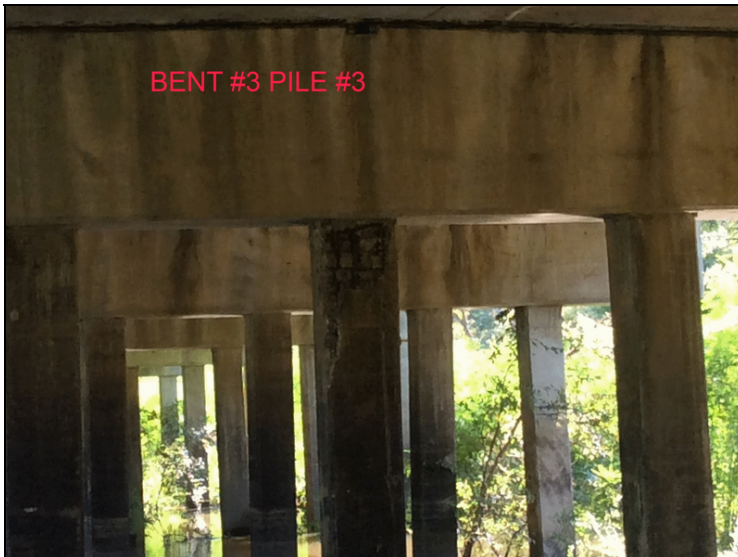
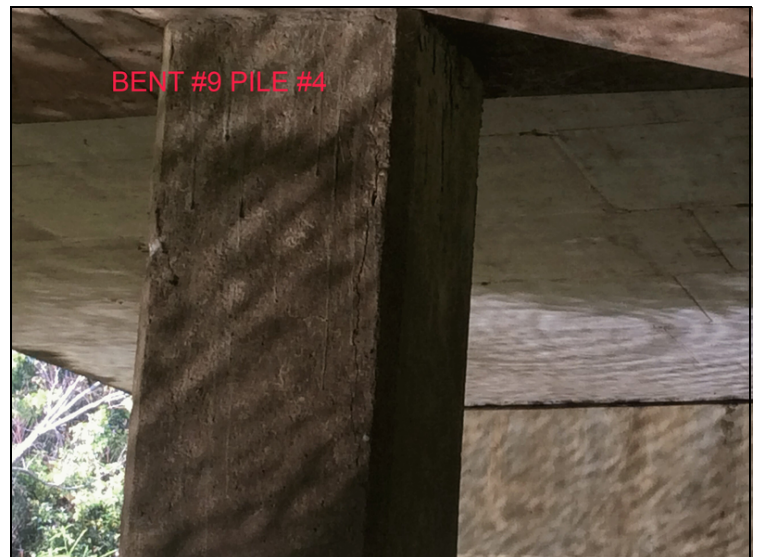
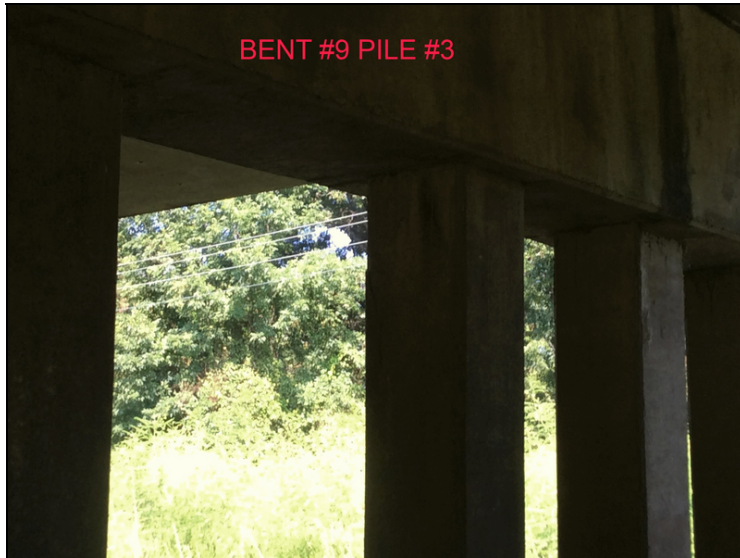
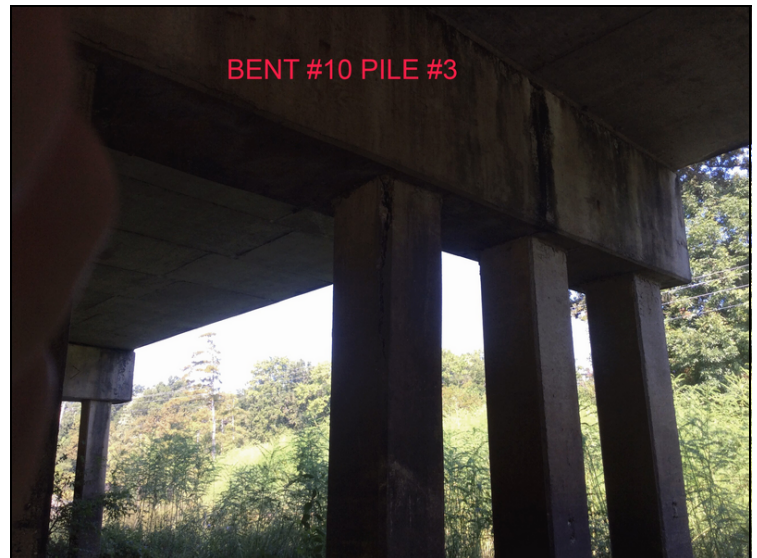
Bent #3 pile #5 is cracked, delaminated and spalled at top with exposed rebar with 5% section loss.

Bent #7 pile #3 is cracked, delaminated and spalled at top with exposed rebar with 5% section loss.

Bent #7 piles #4,5 are cracked at top.

Bent #9 piles #3,4 are cracked, delaminated and spalled at top with exposed rebar with 5% section loss.

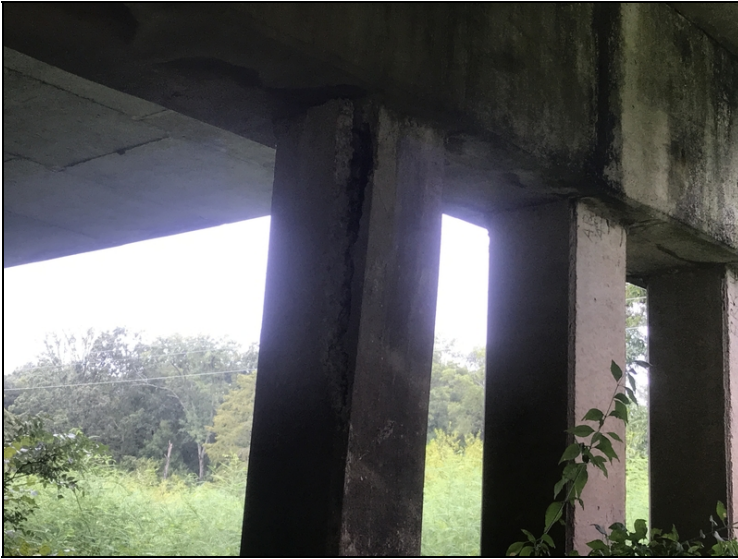
Bent #7 pile #3 is cracked, delaminated and spalled at top with exposed rebar with 5% section loss.

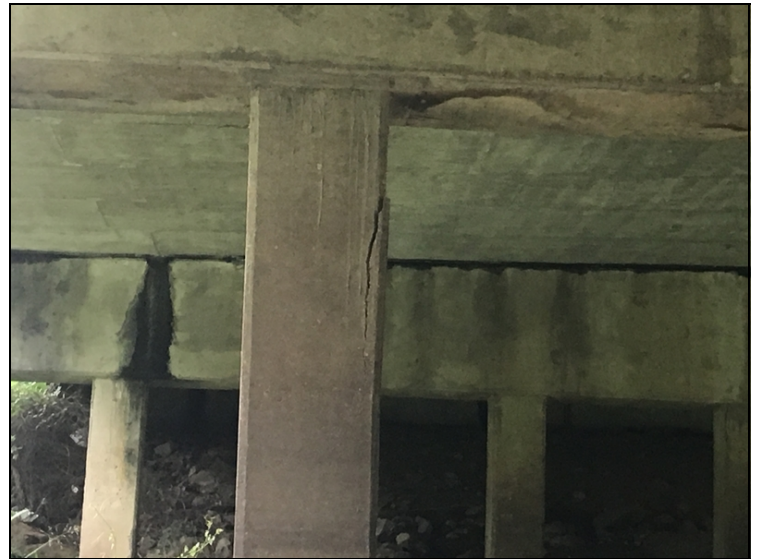
Bent #8 pile #3.

Bent #8 pile #3 cracked and delaminated at top for 2'.

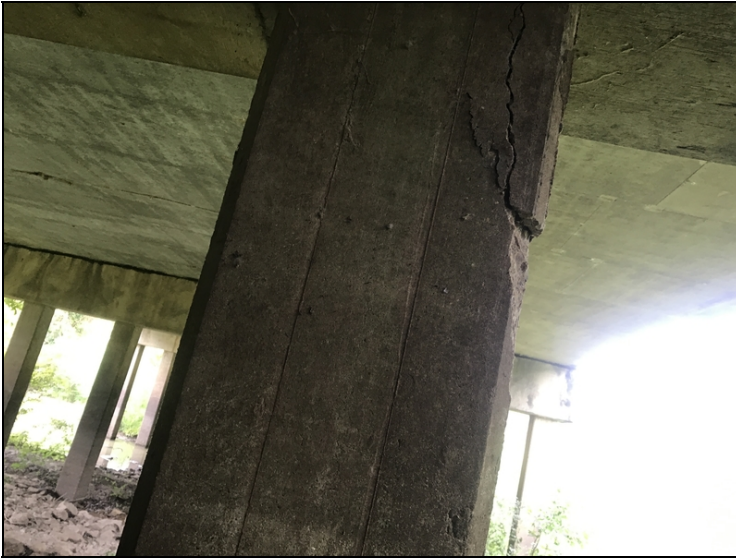
Bent #10 pile #3 is cracked, delaminated and spalled at top with exposed rebar with 5% section loss.

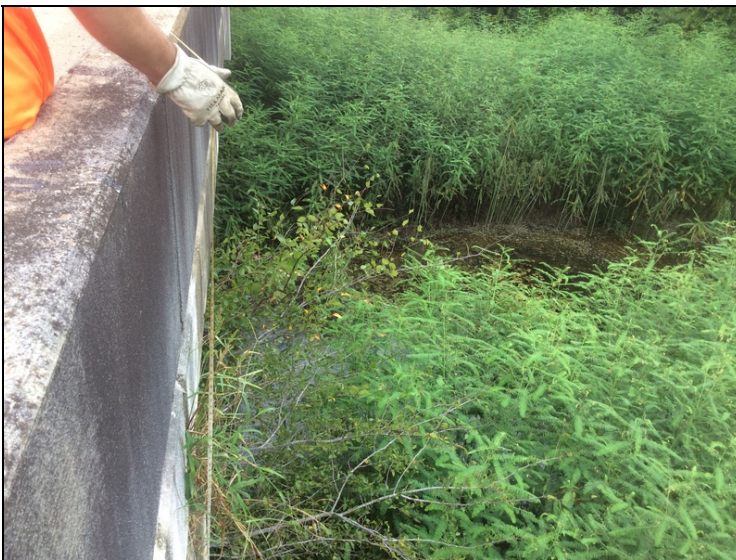
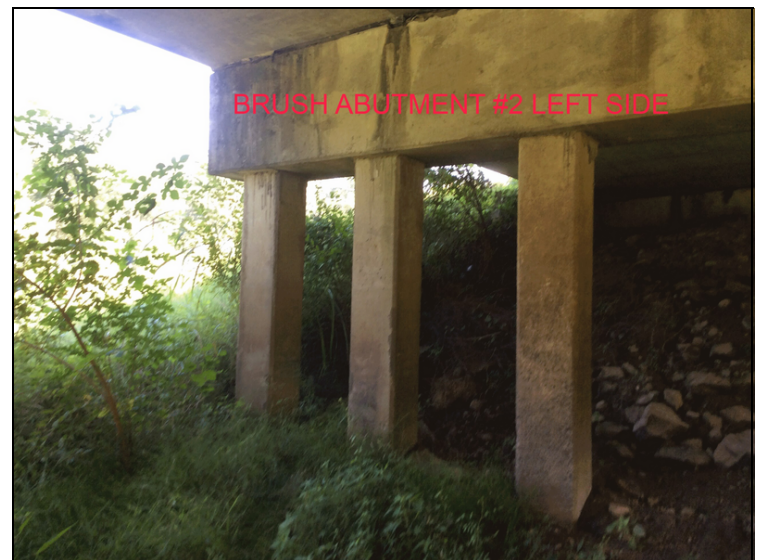
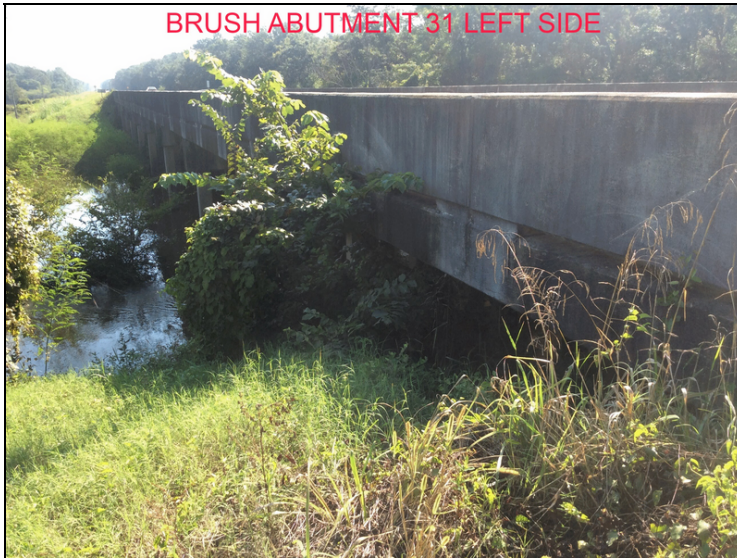
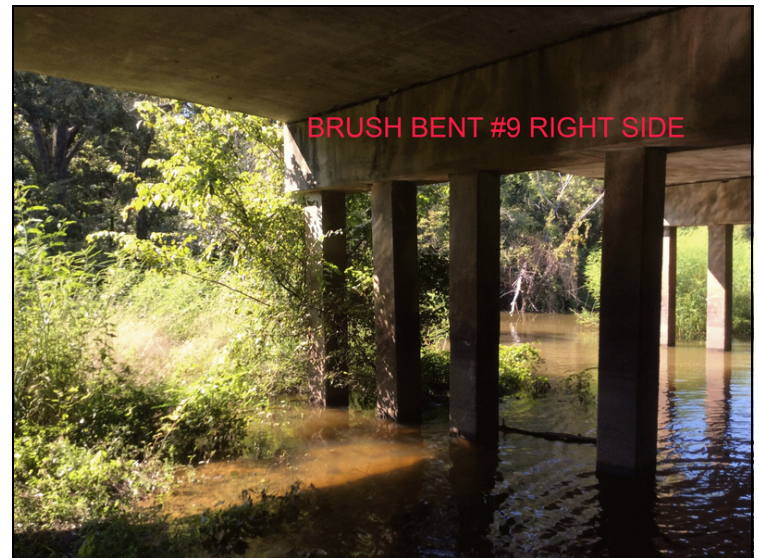
Trees and vegetation are growing beside and under bridge.

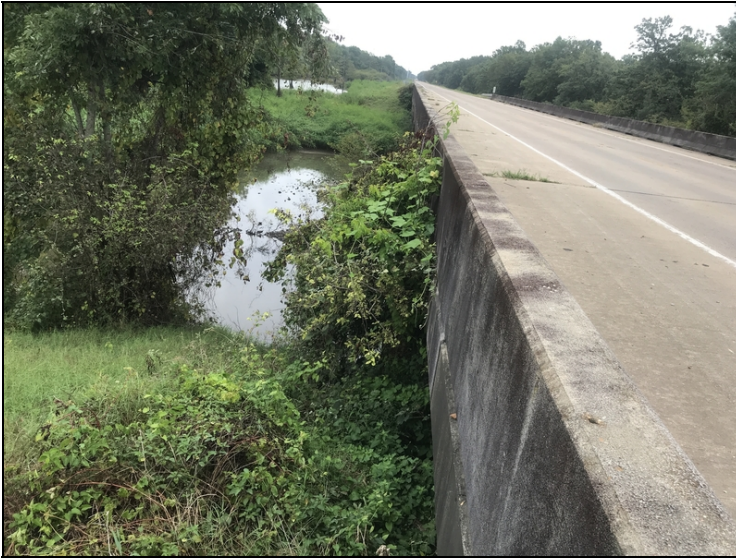
Trees and vegetation growing beside and under bridge.

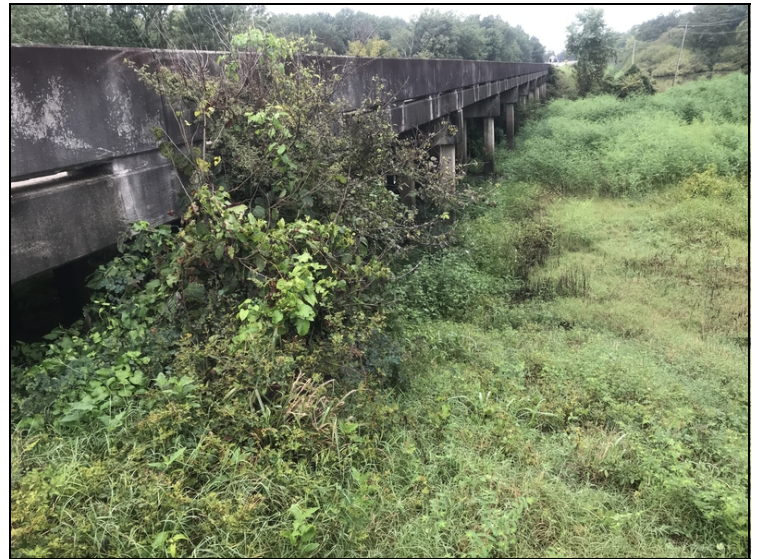
Vegetation growing beside and under bridge.

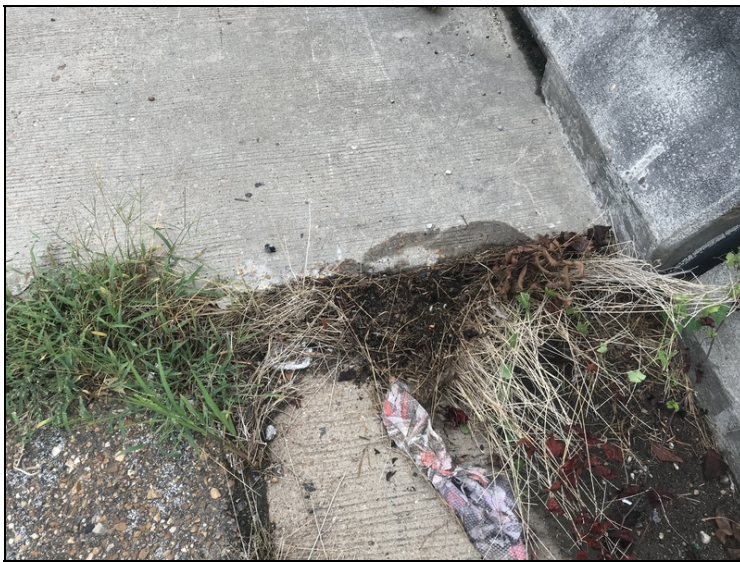
Approach gutters have settled 1" to 2".
