**Bridge #07015(Routine, Underwater type 2)**

**Us-70/Sec15/L14.12 over Beaver Slough**

**Team Lead: Myron Futrell Inspection Date: April 09, 2020**

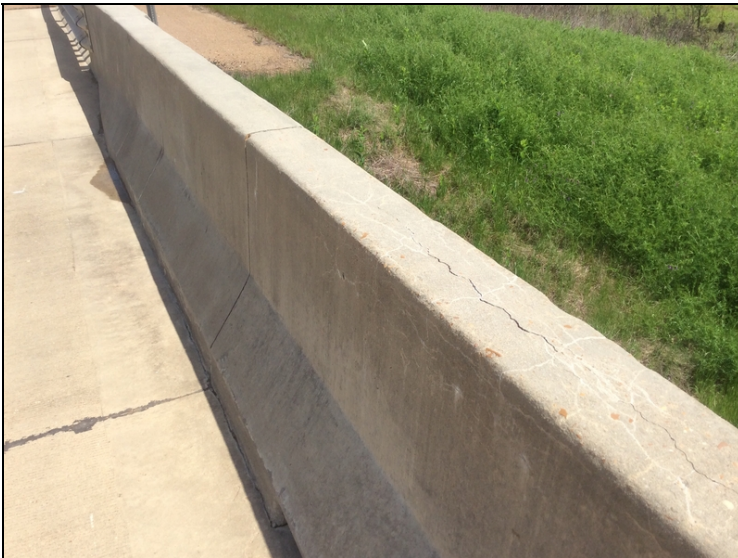
(331)							
Span #3 left and right wall have longitudinal and map cracking on top. Each span has several vertical cracks with light efflorescence 25' total.

Span #3 left and right parapet walls are cracked at top.

Span #3 left and right parapet wall cracked at top.

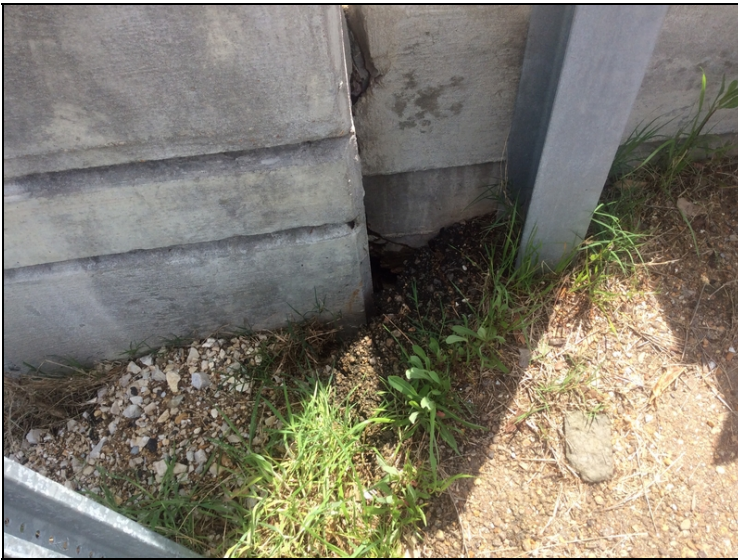
Abutment #1 left and right side has minor erosion under approach slab at bridge ends.

Minor erosion under approach slab abutment #1  
left and right side

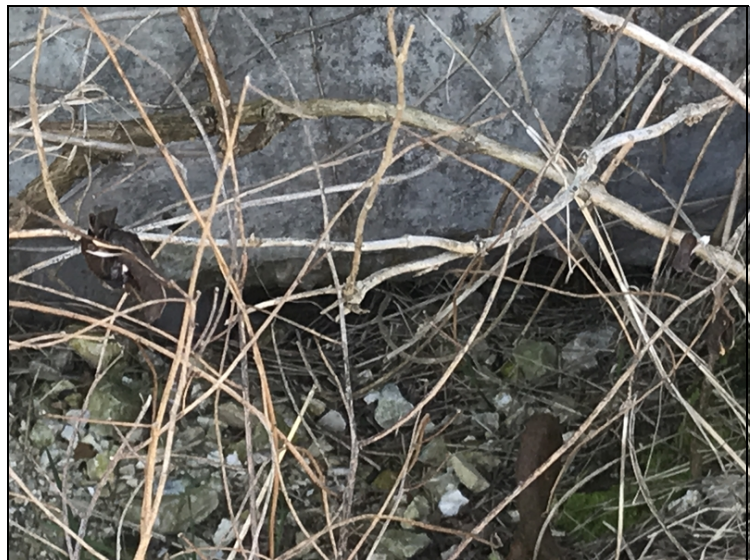
Abutment 1 approach gutter left side.

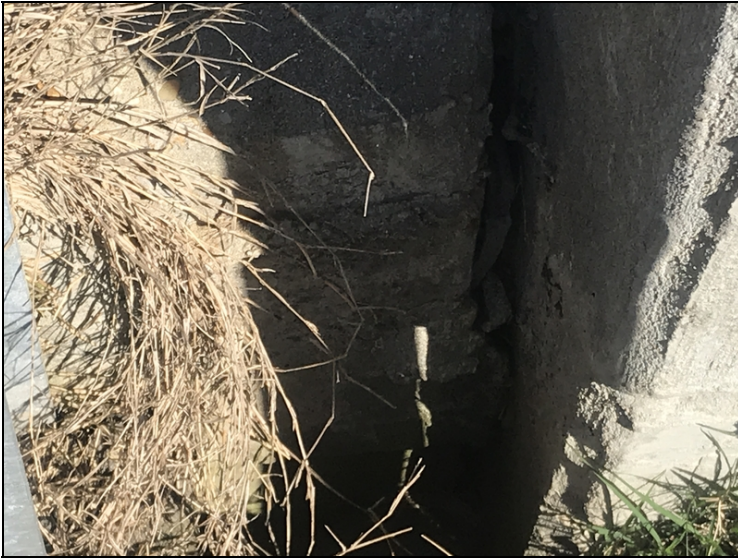
Abutment 1 approach gutter right side.

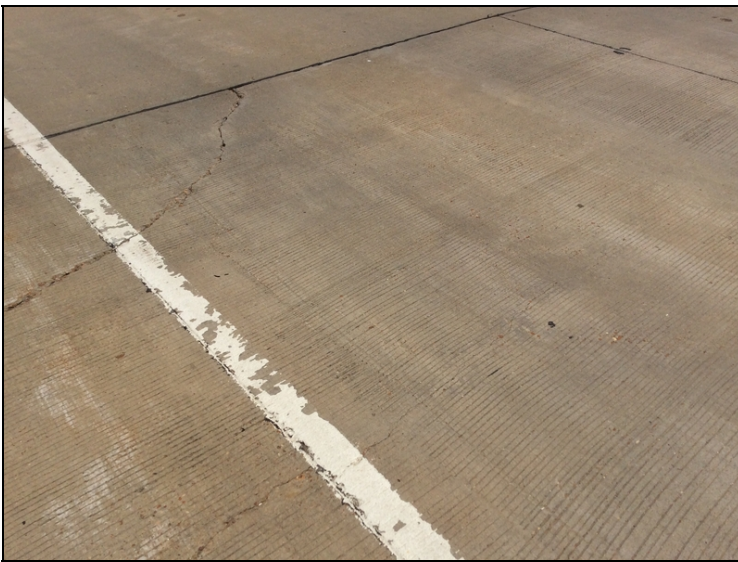
Both approach slabs have open transverse and diagonal cracks.

Abutment #1 approach slab cracks

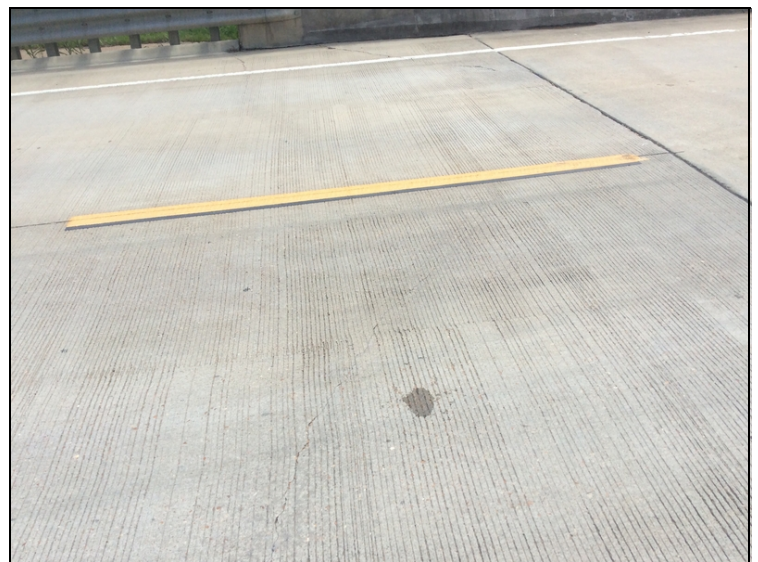
Abutment #2 approach slab cracks

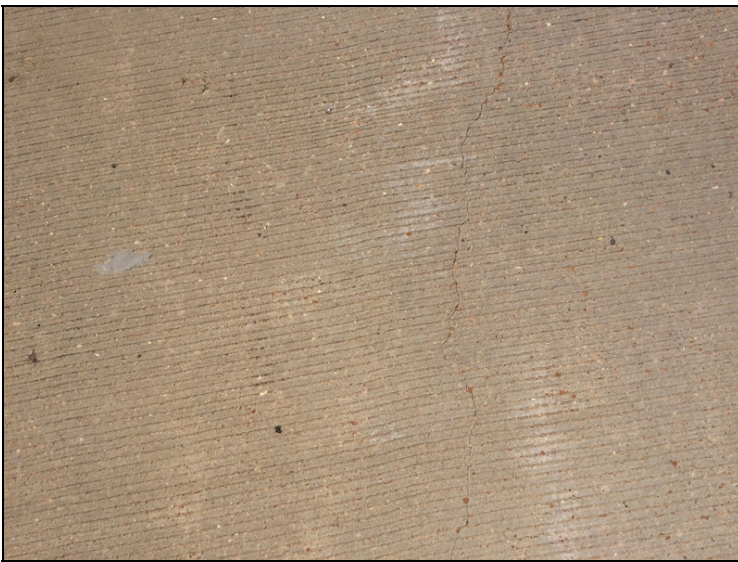
Each span has open transverse cracks spaced 10' and open longitudinal cracks spaced 6'.

Typical longitudinal deck crack

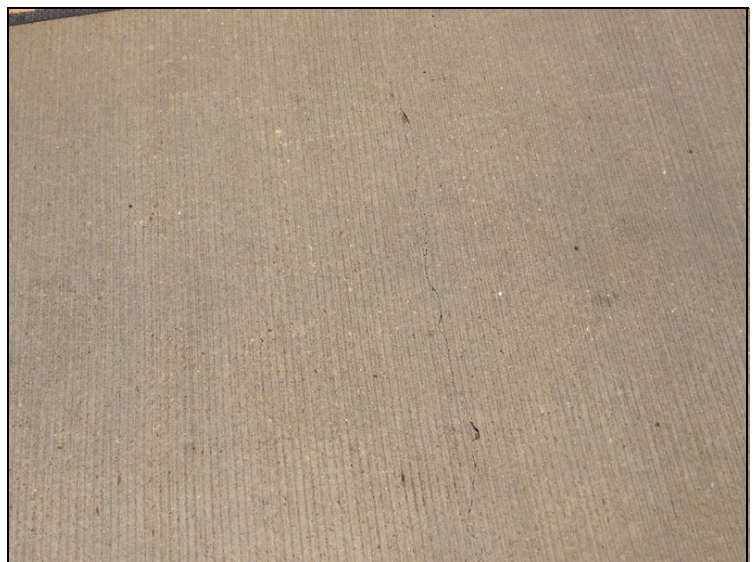
Typical transverse deck crack

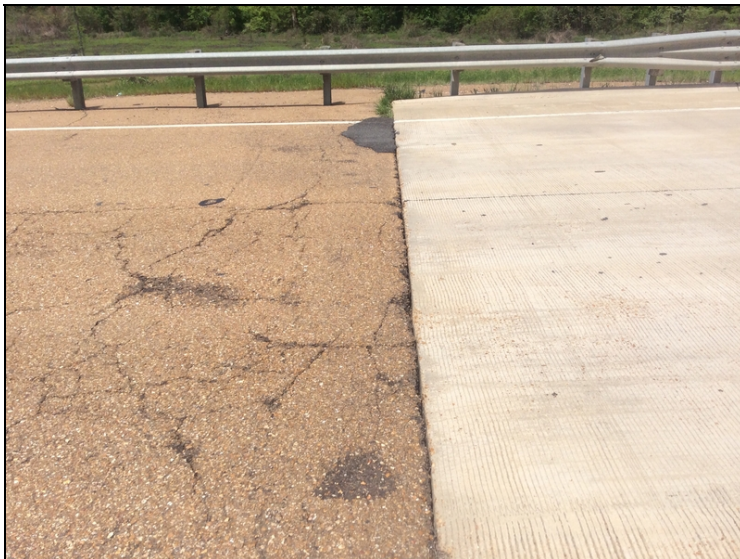
Abutments #1&2 joints between approach slabs and roadway is open and roadway has settled causing increased impact on approach slabs.

Abutment #1 joint at approach slab. And roadway settlement

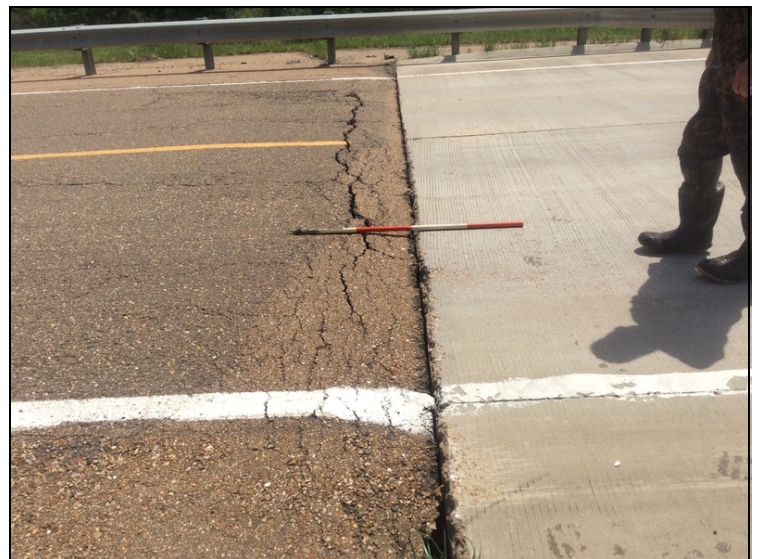
Abutment #2 roadway settlement

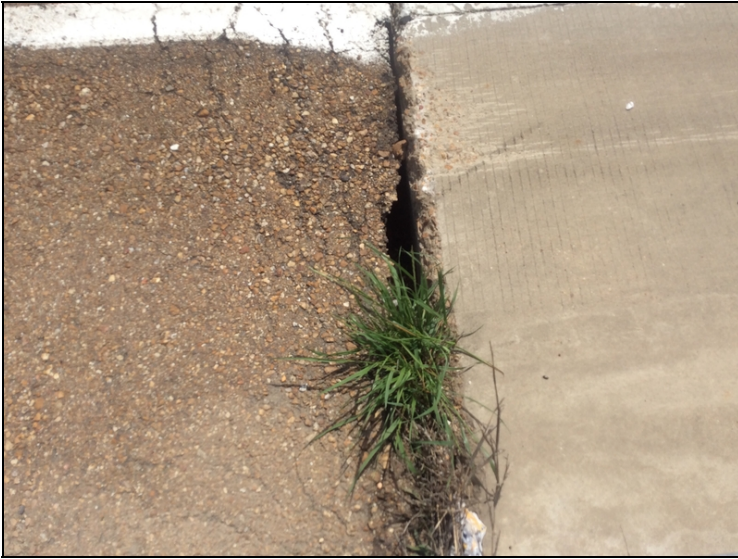
Abutment #2 open joint between roadway and approach slab

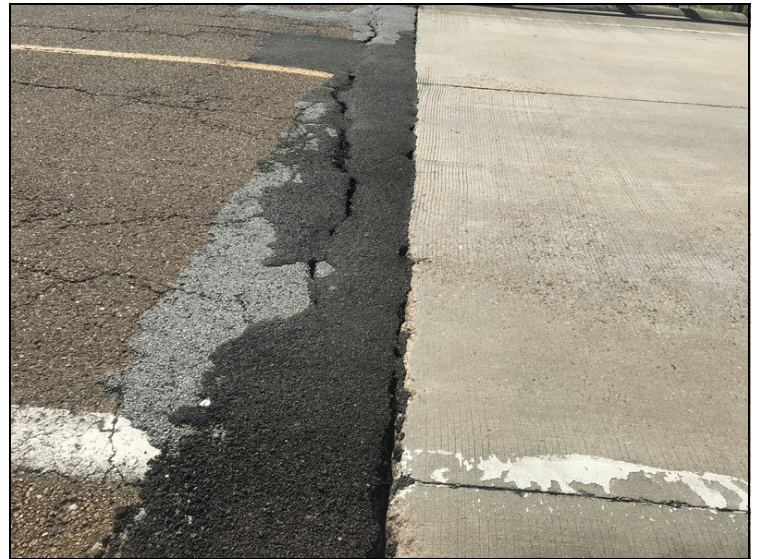
04/09/2020-abutment #2 approach roadway has achm patching added-still rough.

Abutment 2 approach roadway..
