Bridge #07016(Routine, Underwater type 2)

Us-70/Sec19/L15.28 over Bevins Bayou

Team Lead: Myron Futrell Inspection Date: January 13, 2020

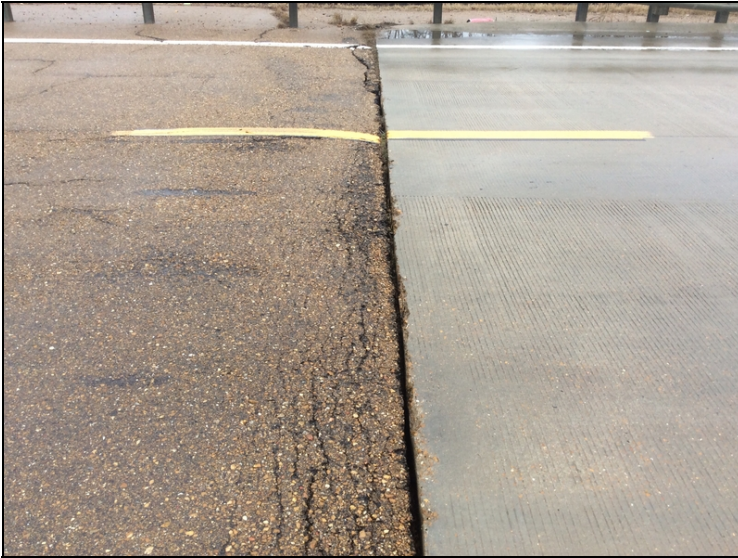
Abutment #2 approach roadway has settled 1" increasing impact loading on bridge.

Abutment #2 approach roadway

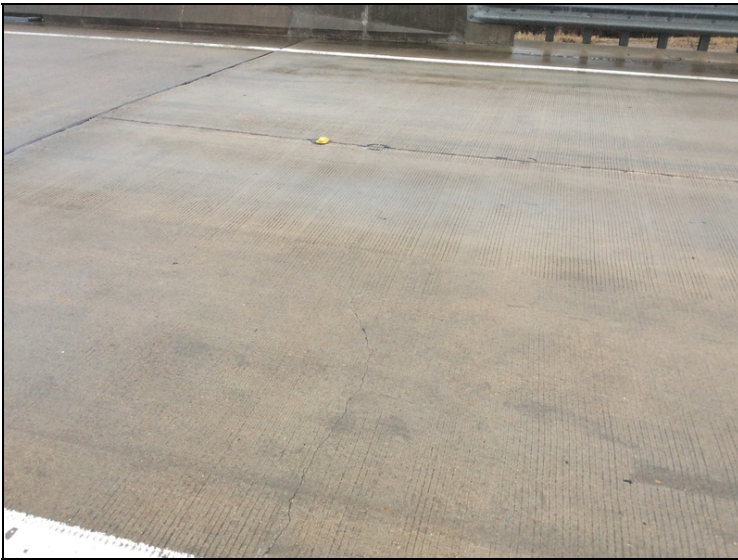
(321) Each approach slab has two diagonal cracks in corners and one transverse crack.							
331	Reinforced Concrete Bridge Railing	LF	354	336	18	0	0
1120	Efflorescence/Rust Staining	LF	18	0	18	0	0

Each approach slab has two diagonal cracks in corners and one transverse crack.

Typical approach slab cracks.

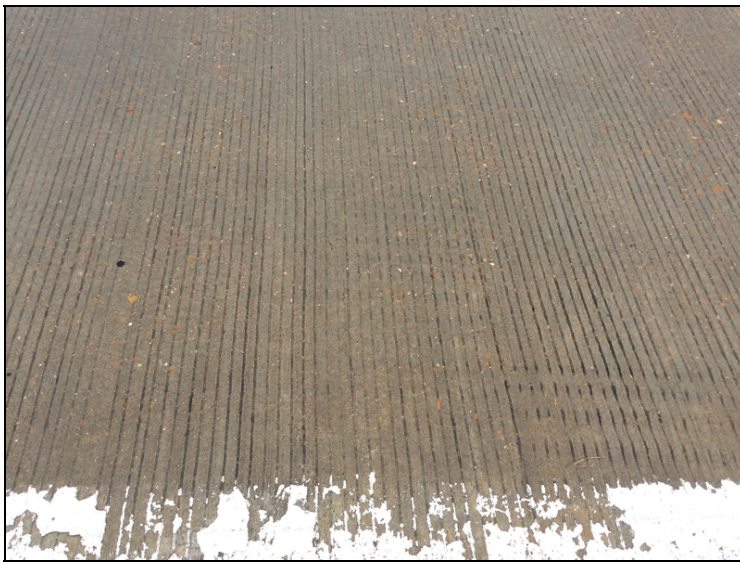
(12) Each span has transverse cracks spaced 5', a few longitudinal cracks, and diagonal cracks in corners of spans. Deck soffit overhangs have transverse cracks with moderate efflorescence spaced 10' apart.							
107	Steel Open Girder/Beam	LF	875	875	0	0	0
515	Steel Protective Coating	SF	6558	6558	0	0	0
215	Reinforced Concrete Abutment	LF	78	70	8	0	0
1120	Efflorescence/Rust Staining	LF	8	0	8	0	0

Each span has transverse cracks spaced 5', a few longitudinal cracks, and diagonal cracks in corners of spans. Deck soffit overhangs have transverse cracks with moderate efflorescence spaced 10' apart.

Typical deck cracks

01/08/2018 lowered deck from 8 to 7 due to sealable deck cracks.

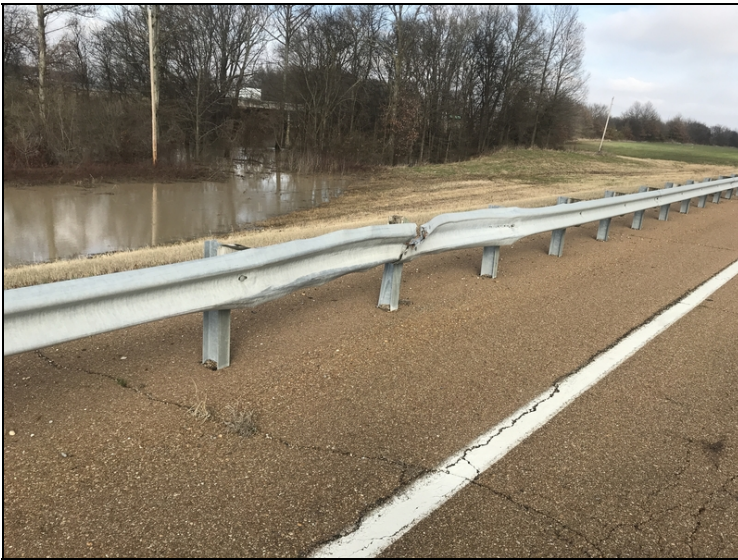
Abutment 2 left approach rail has collision damage 60' from bridge end.

Abutment 2 left approach rail damage 60' from bridge end.

Date Reported: 01/13/2020
Priority: C - Important
Type of Work: Repair
Status: Open
Component: Approach
