## Bridge 03767 Inspection Report

Route:78 Section:01 Log:5.1

Arnold Road ID:68x78x1xA, Arnold Log mile:5.12

Team Lead: Anthony Caudel, Inspection Date: 02/26/2024

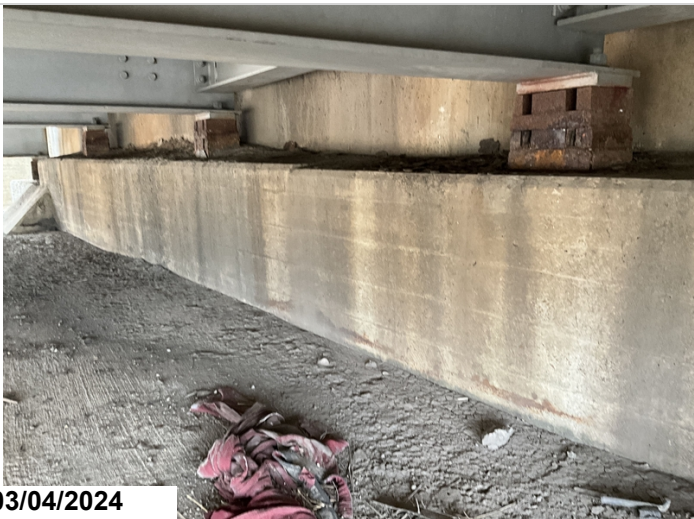
Bent 5 typical condition of fixed bearings. CS3  
This is typical condition of all bearings

All beam ends, and bearings need to be sandblasted and painted after holes in girders are repaired.

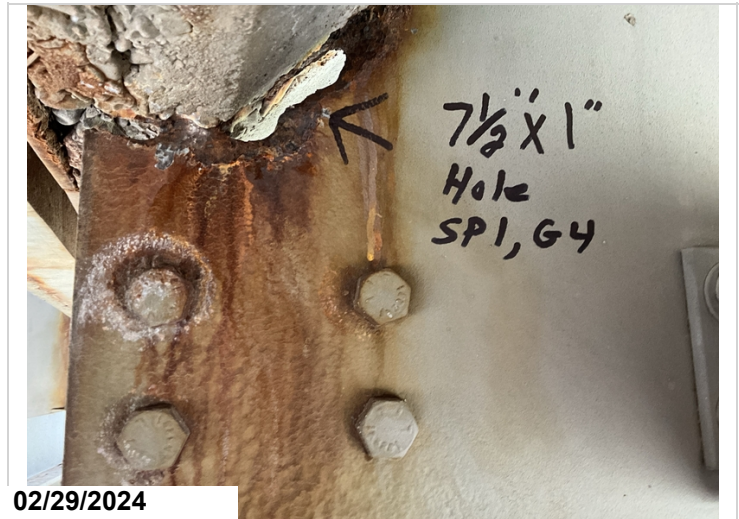
Span 1, Bent 2, girder 4 in haunch area has a 7 1/2"x1" hole.  
CS3

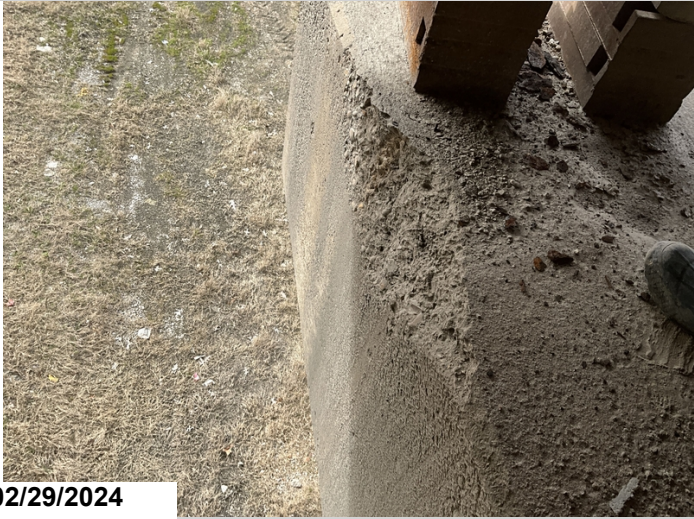
Bent 3 ahead, right side has large spall near bearing area. CS3

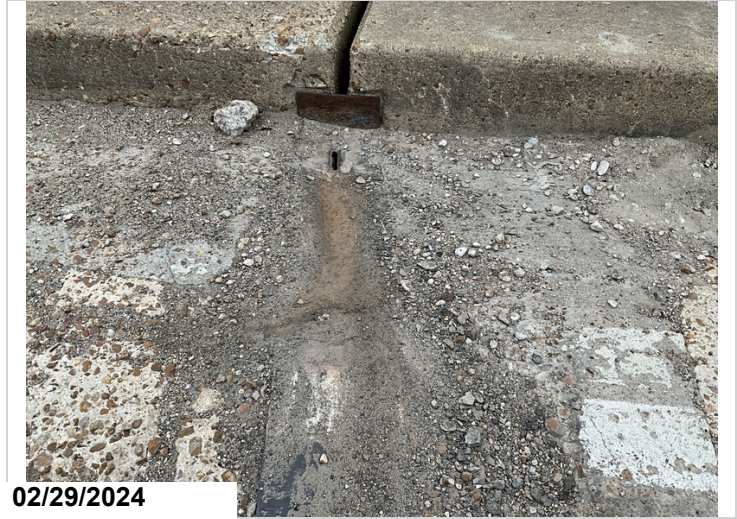
Bent 2 assembly joint has holes rusted on both shoulders.  
CS4 2':  
CS3 2' corrosion.

Assembly joints are in poor condition and need to be replaced.

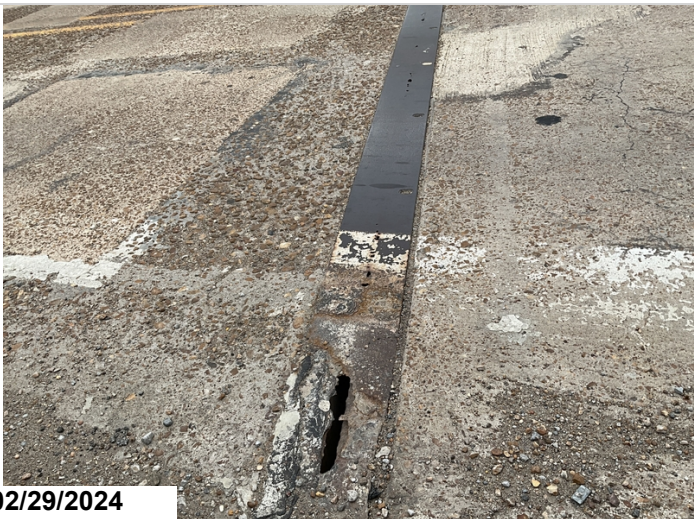
Bent 3 assembly joint has holes rusted 10' CS4: 3' CS3

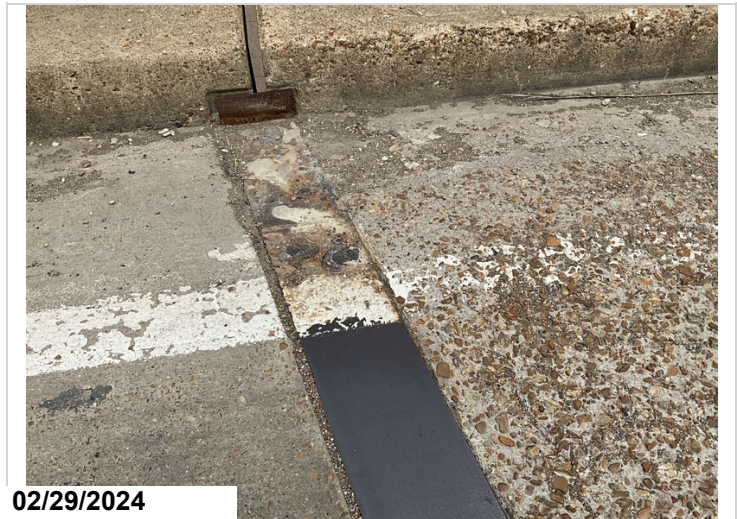
Bent 4 right side assembly joint has corrosion with heavy section loss. Both shoulders CS3

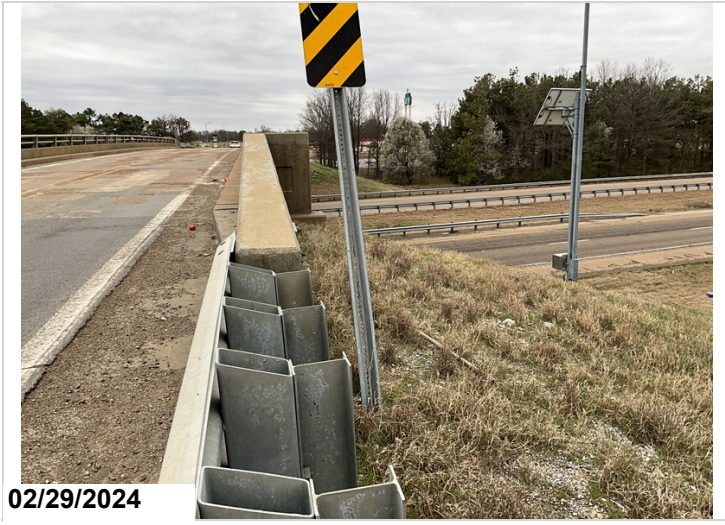
No log mile sign

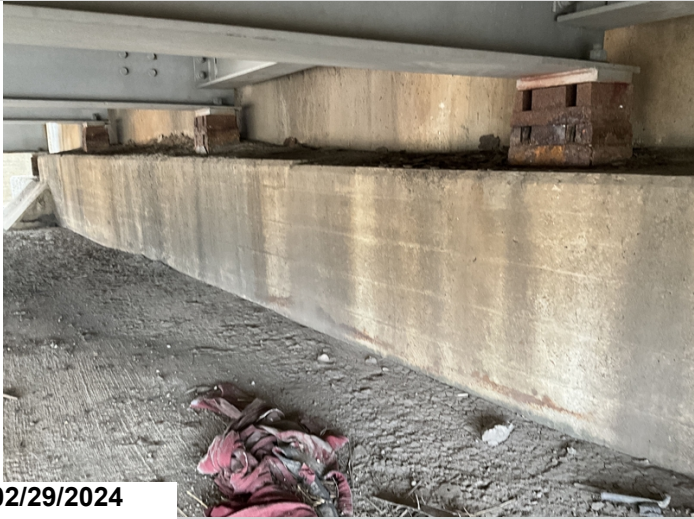
Bent 5 typical condition of fixed bearings. CS3

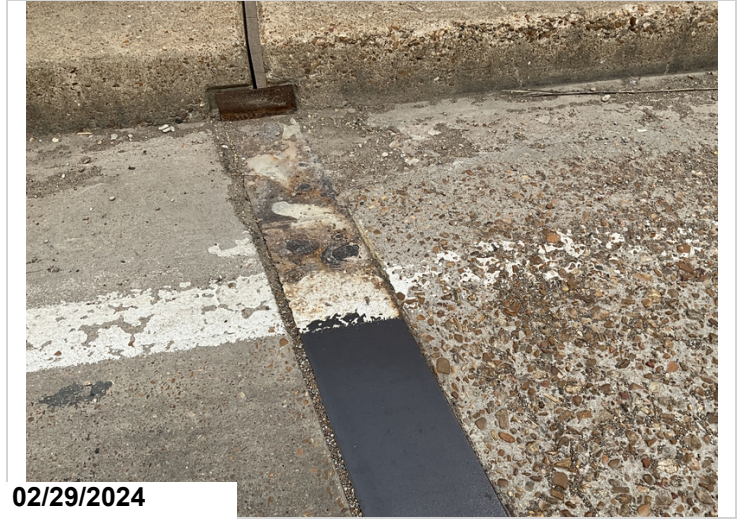
Bent 4 right side assembly joint has corrosion with heavy section loss. Both shoulders CS3

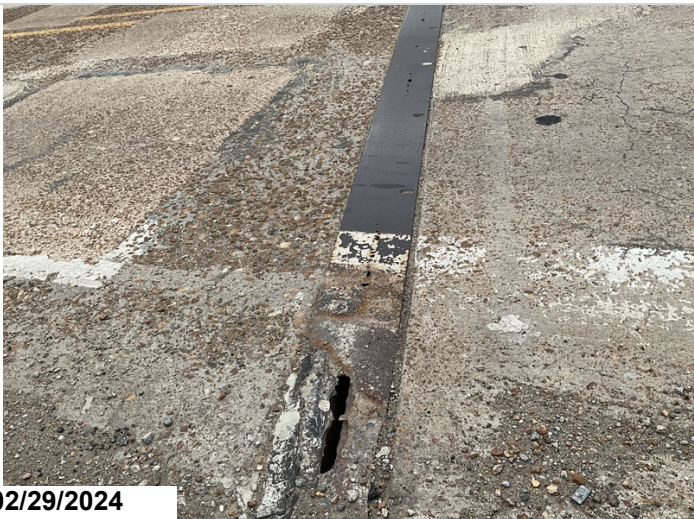
Bent 3 assembly joint has holes rusted 10' CS4: 3' CS3

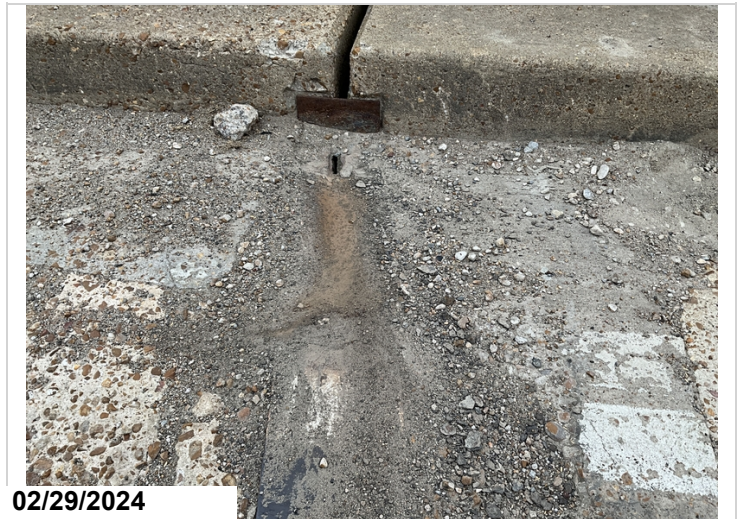
Bent 2 assembly joint has holes rusted on both shoulders.  
CS4 2':  
CS3 2' corrosion.

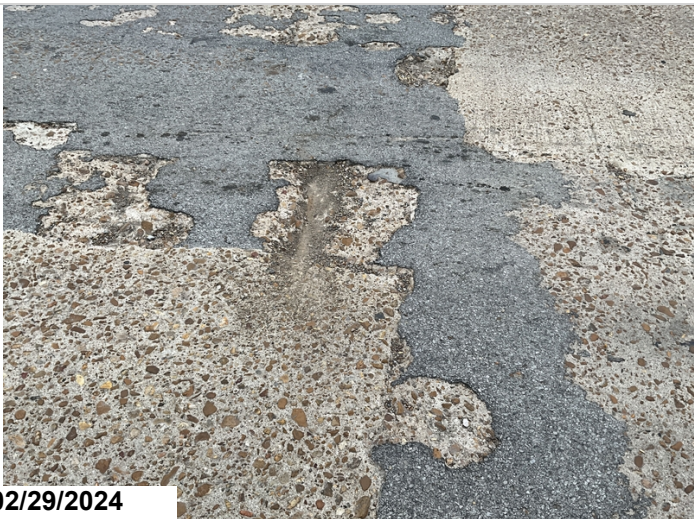
Span 1, left lane has spalling with exposed reinforcing steel with section loss. CS3

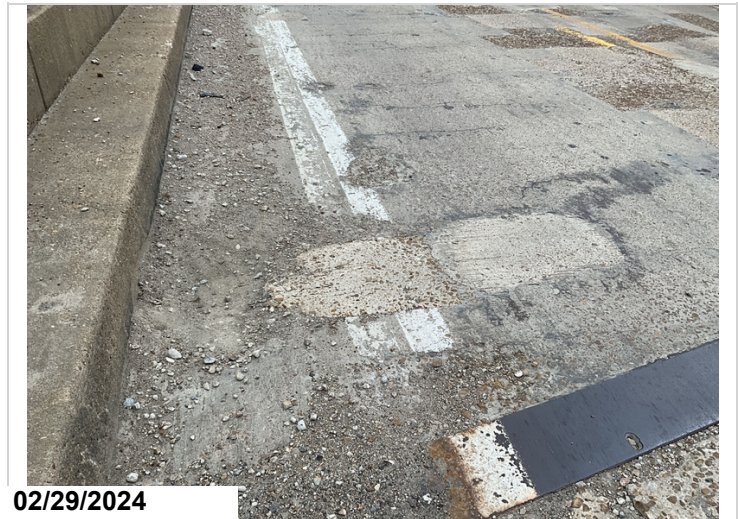
Span 2, left lane has large spalled areas. CS3

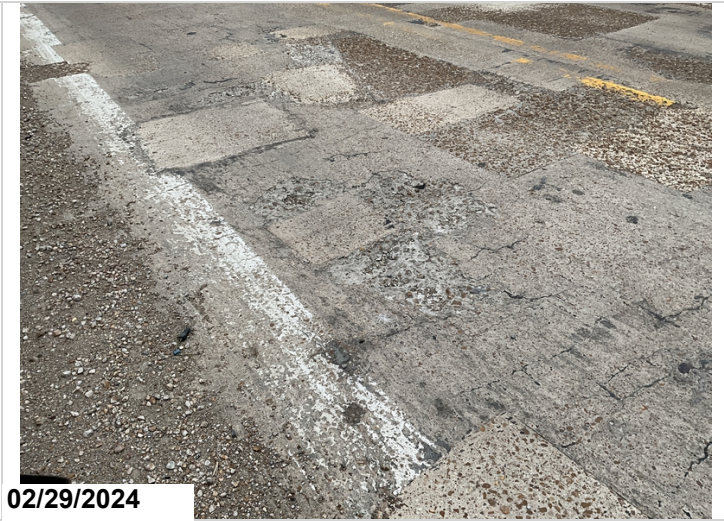
Span 2, left lane has large spalled areas. CS3

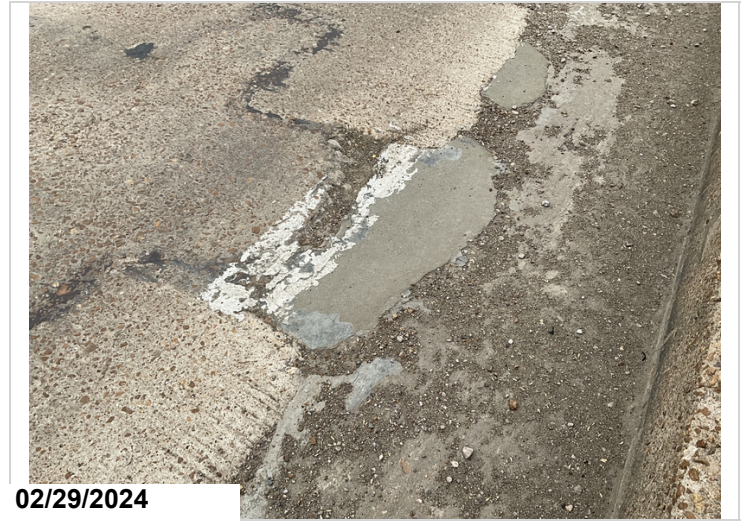
Span 3, right lane has spall next to shoulder. CS3

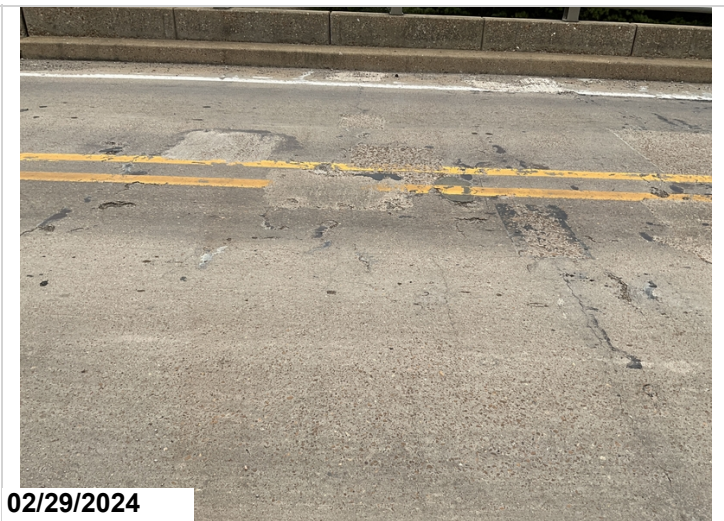
Span 4 has scattered areas of spalls/delam. CS3

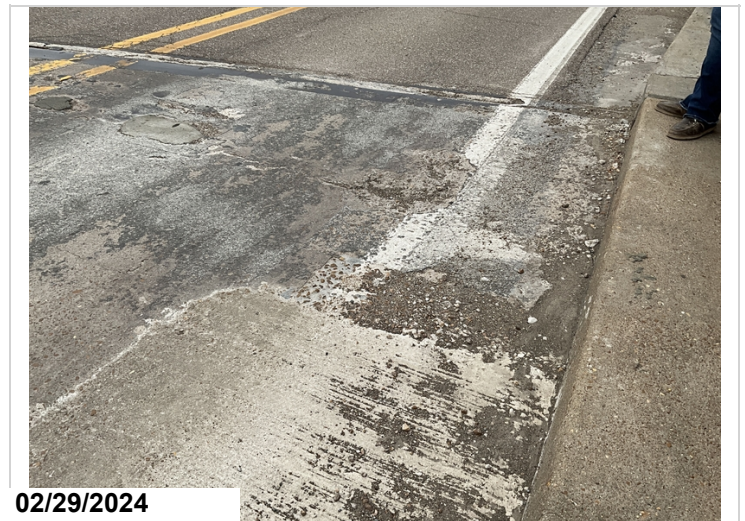
Span 4, right lane has large spalls . CS3

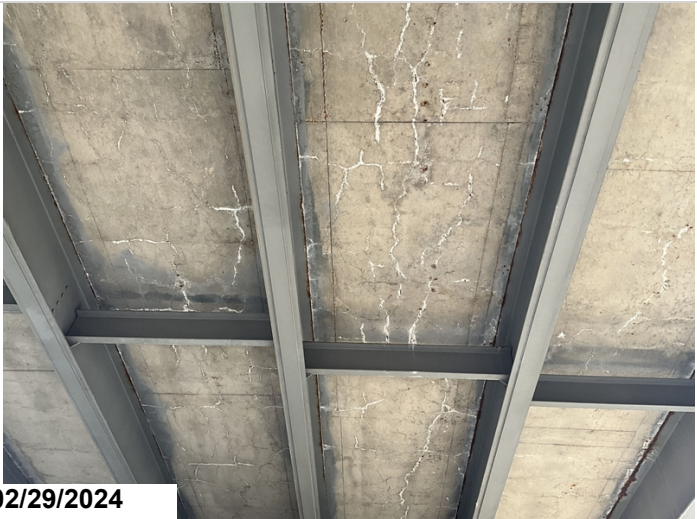
Span 1 under surface showing heavy leaching throughout. CS3

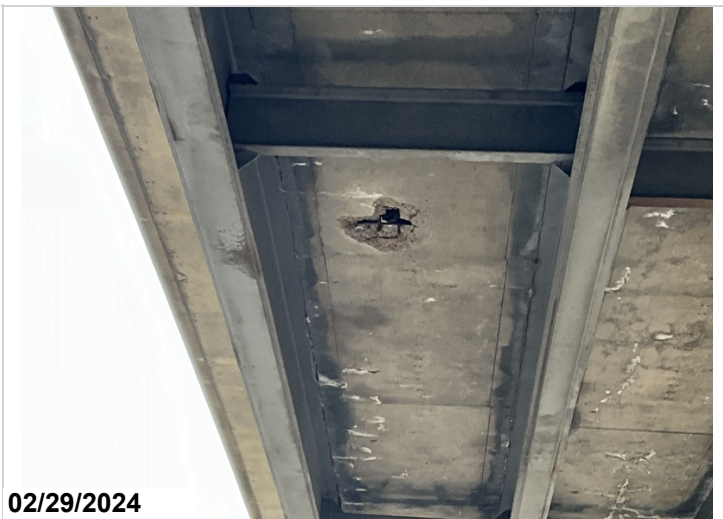
Span 3, bay 4 has large spall with reinforcing steel exposed with section loss. CS3

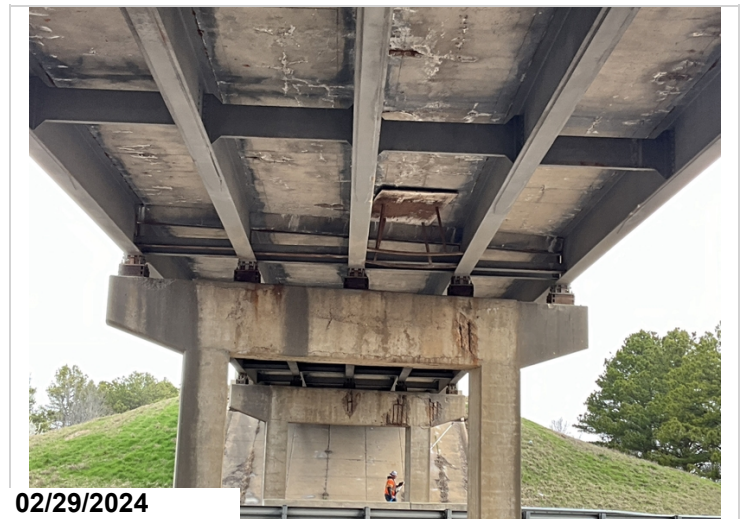
Bent 3, ahead, span 3 , bay 2 has full depth repaired area.

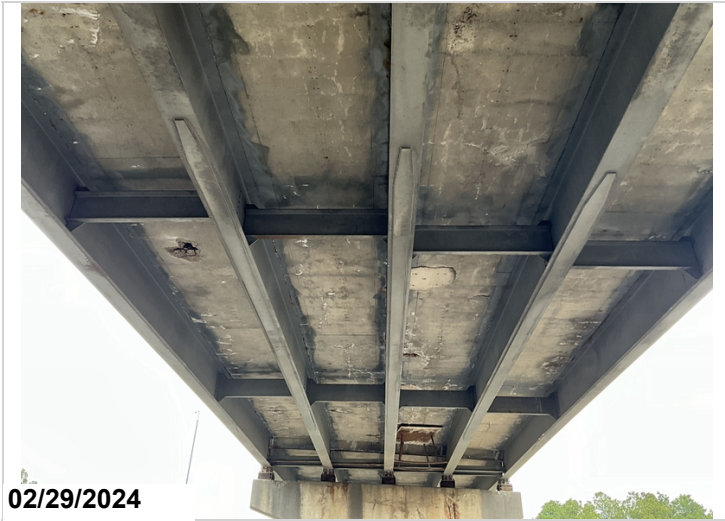
Span 3 has efflorescent leaching throughout at scattered locations. CS3

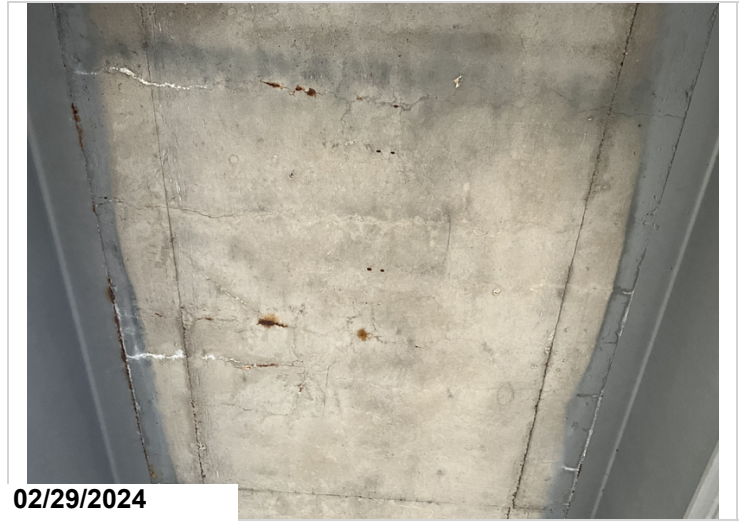
Span 4, bay 1 has efflorescent leaching with rust staining. CS3

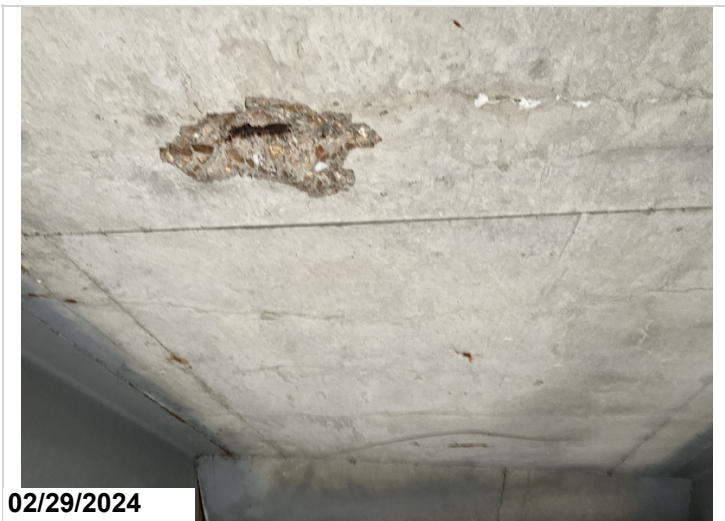
Span 4, bay 1 has spalling with exposed reinforcing steel with section loss. CS3

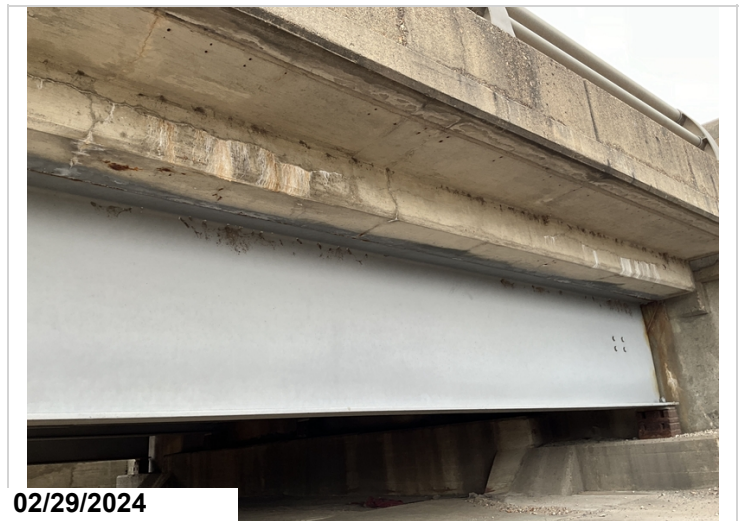
Span 4, Bent 5, right side deck has efflorescent leaching. CS3

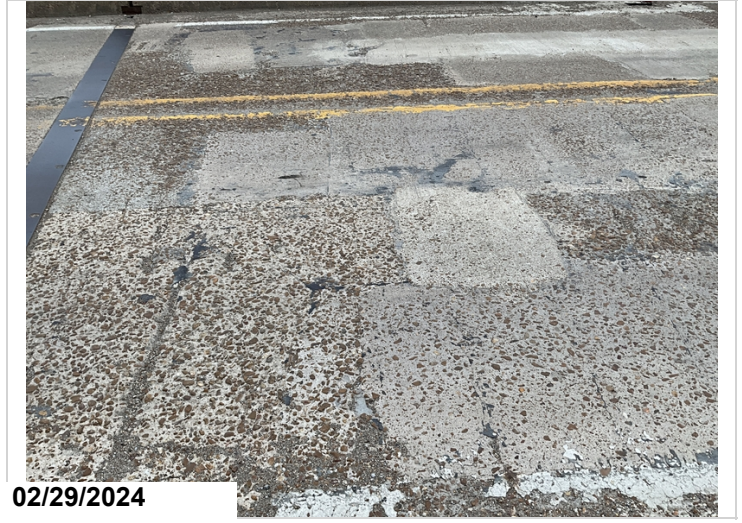
Span 1, left lane has sealed and a few unsealed transverse cracks. CS3

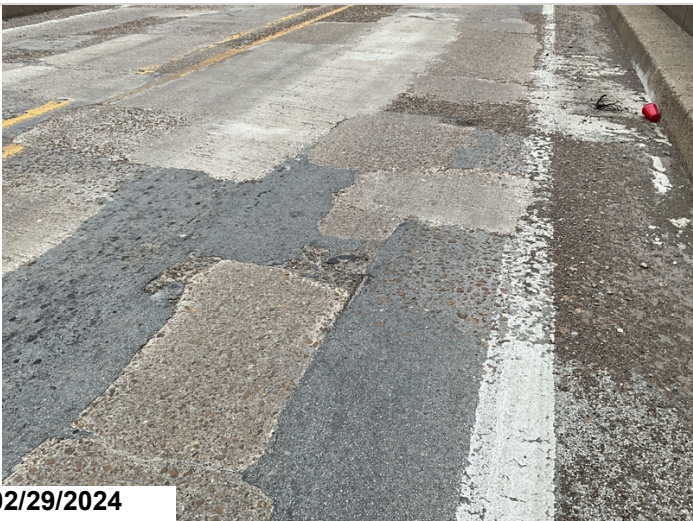
Span 1, right lane has shallow spalled areas. CS3

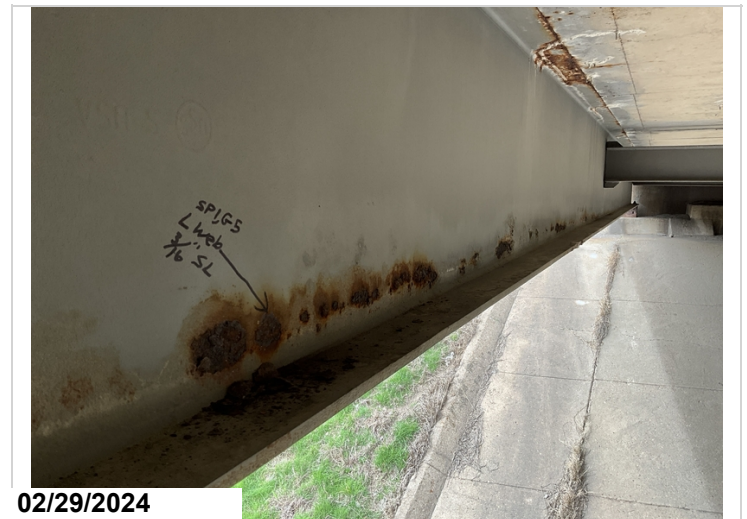
Span 1, girder 5, 5' back of bent 2, has areas with up to 3/16" section loss at mid span there are several other locations that appear to have the same amount of corrosion. CS3

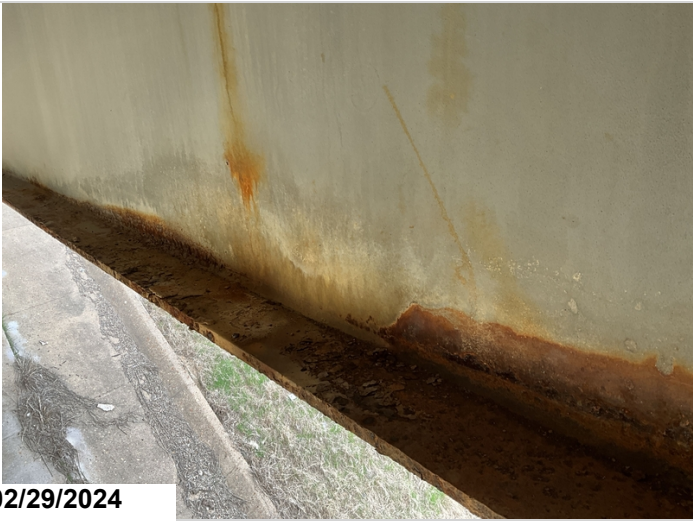
Span 1, bent 2, girder 1, bottom web flange juncture has section loss up to 15'. CS3

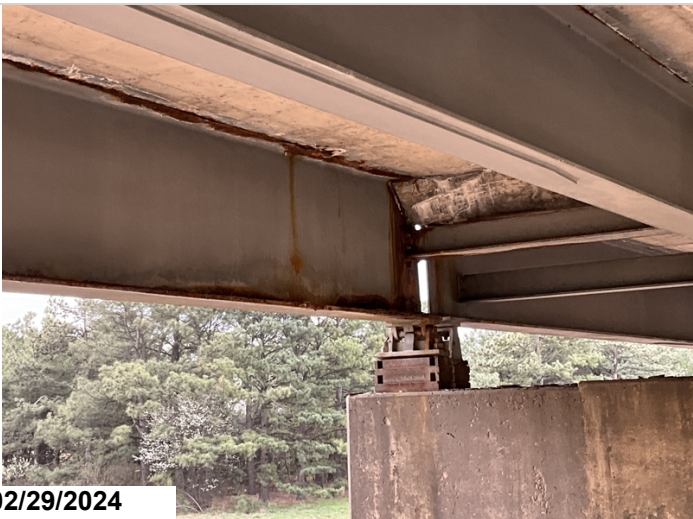
Span 1 girder 1 has flaking rust to the top and bottom flange.

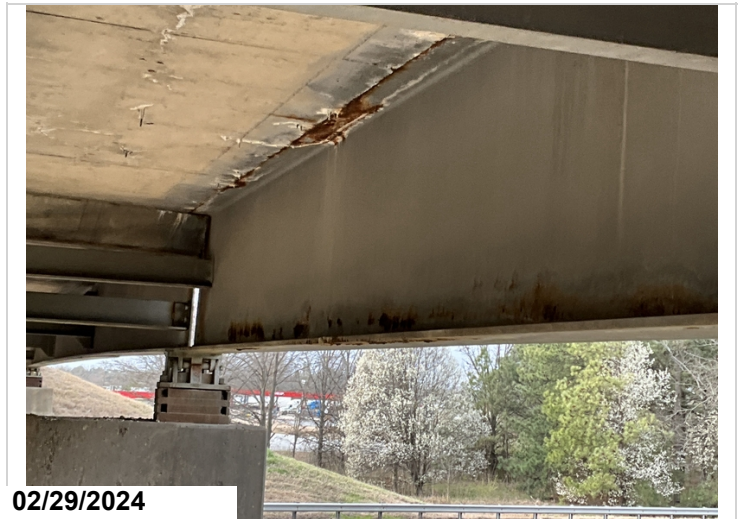
Span 1 girder 5 has active corrosion to top flange and bottom flange area.

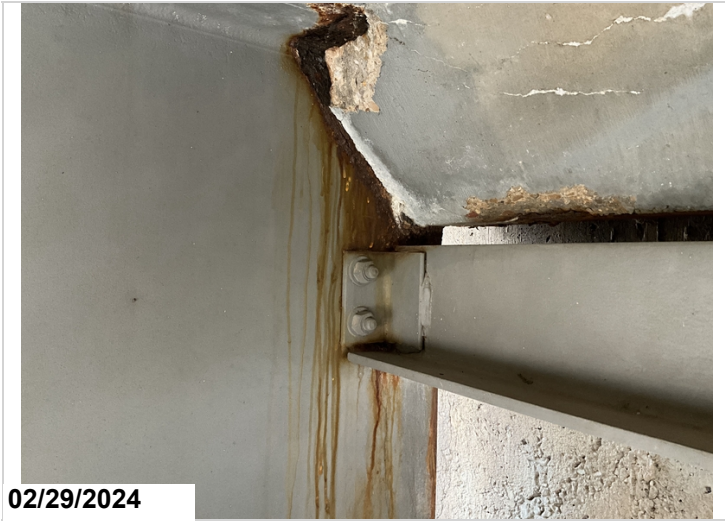
Abutment 1 girder 5 at haunch area has active corrosion with section loss. 1/16". CS3

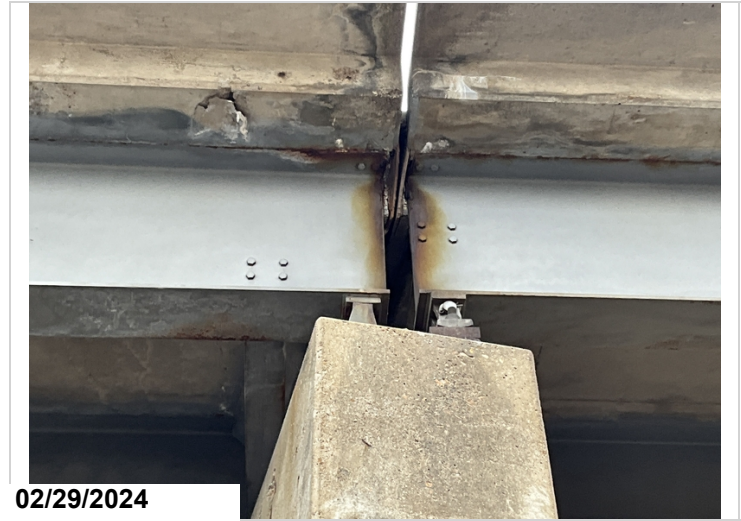
Bent 3 girders 5 has surface corrosion with minor section loss to end of girder. 1/16" CS3

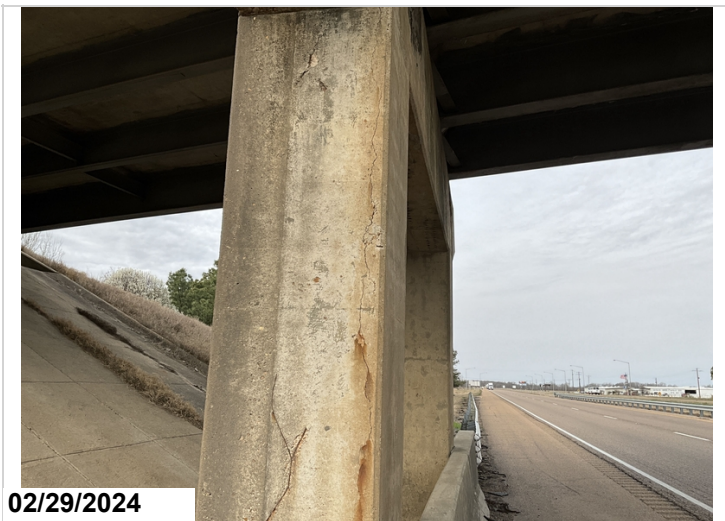
Bent 4, column 1, left side has vertical crack with rust staining. CS3

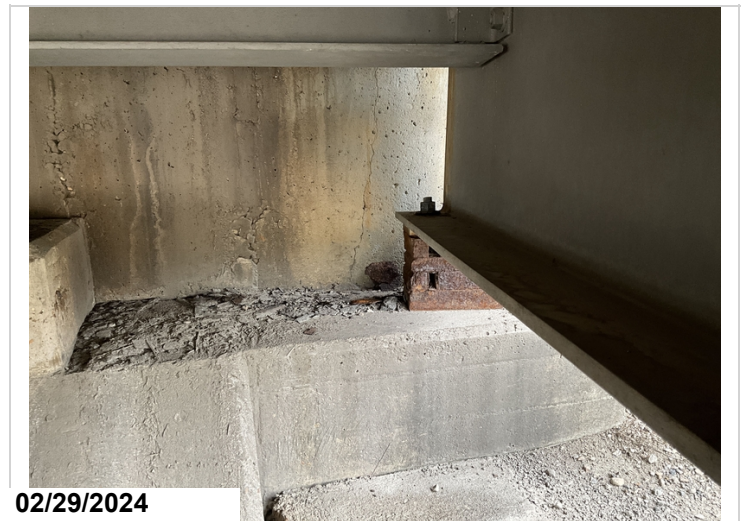
Bent 5, bay 4, vertical cracks. CS2

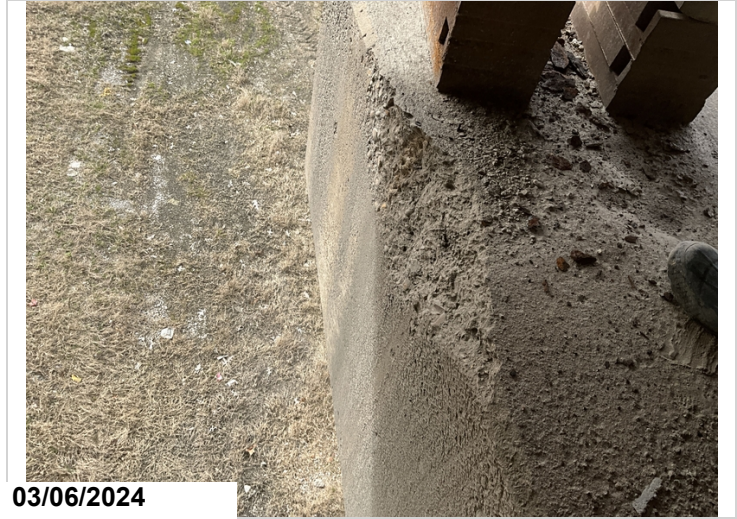
Bent 3 ahead, right side has large spall near bearing area. CS3

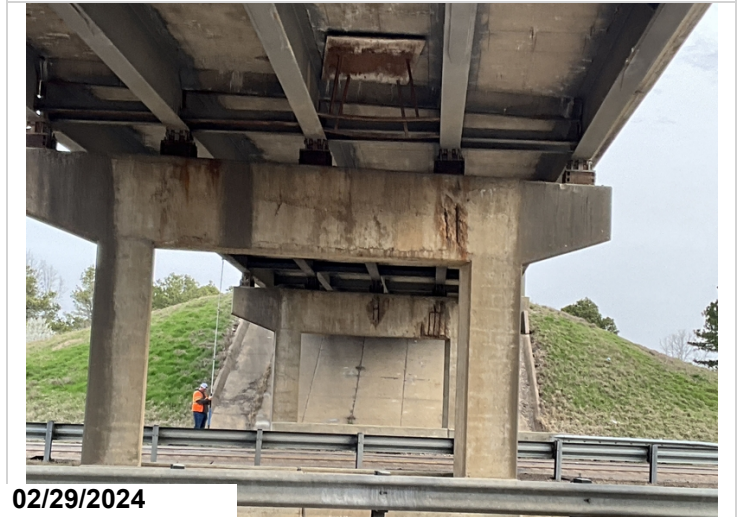
Bent 3, lower ahead face has large longitudinal cracking, and large spalled area above column 1. Both defects CS3

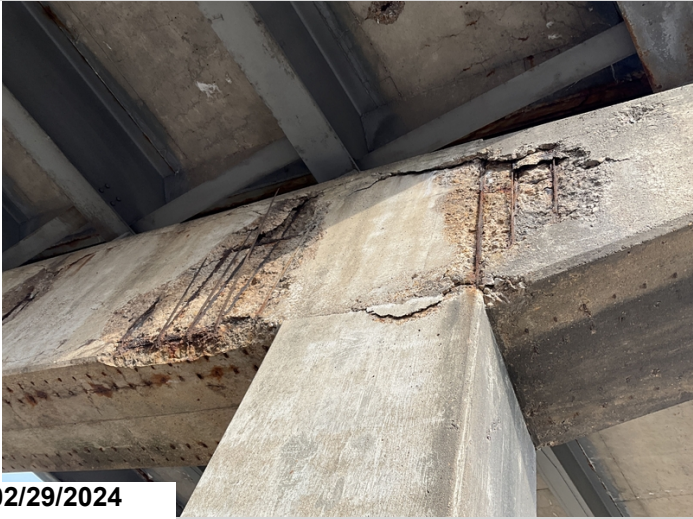
Bent 2, ahead has large area of exposed reinforcing steel with heavy section loss to rebar. CS3

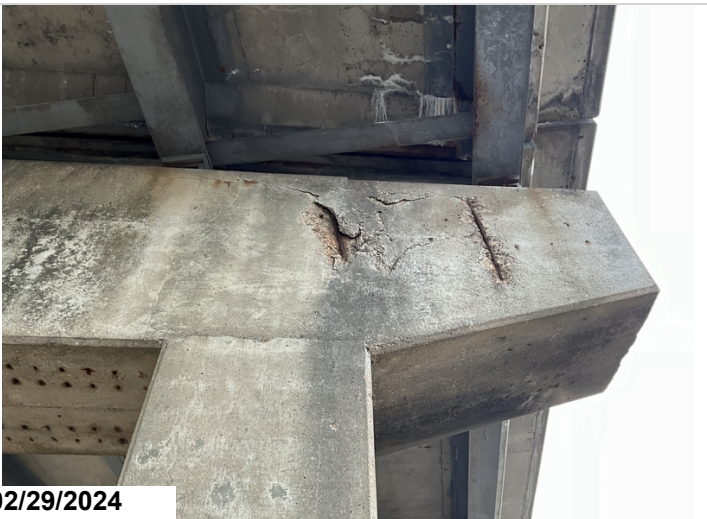
Bent 4, backside, above column 2 has large spalled area with exposed reinforcing steel with section loss. CS3

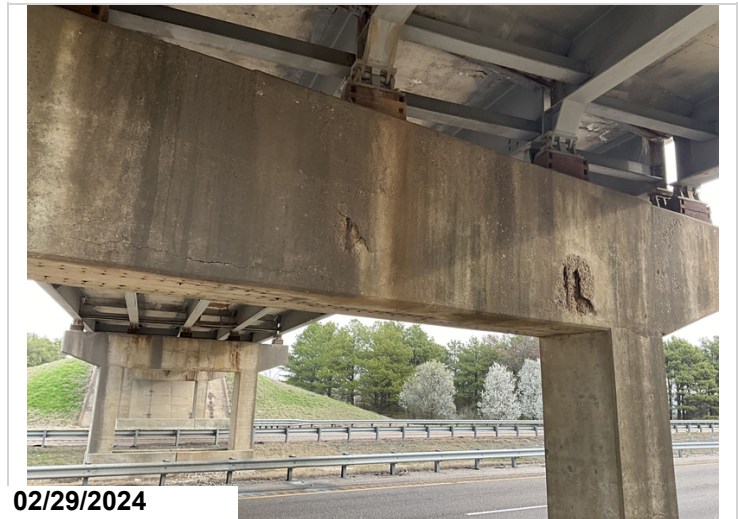
Bent 4, ahead has large spalls with exposed reinforcing steel with section loss. CS3

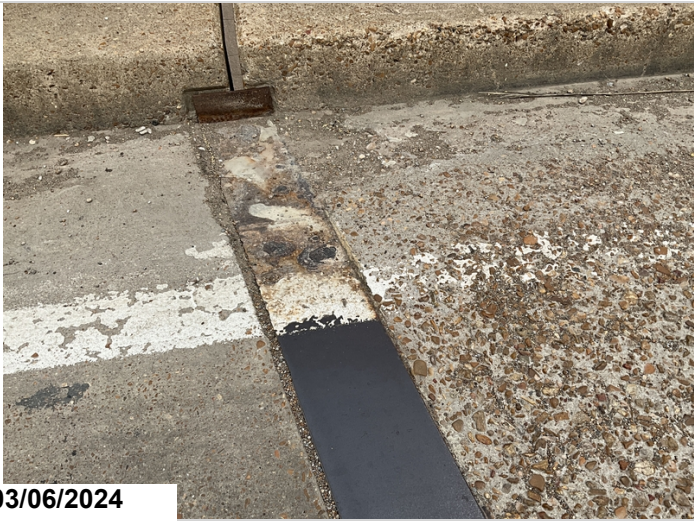
Bent 4 right side assembly joint has corrosion with heavy section loss. Both shoulders CS3

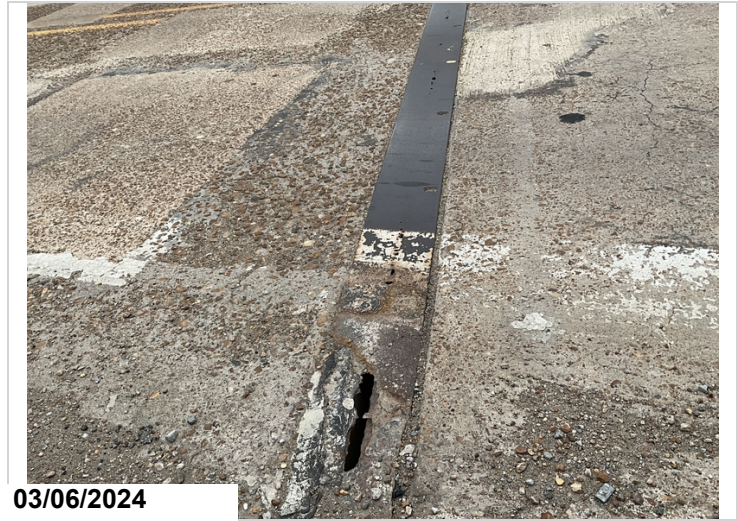
Bent 3 assembly joint has holes rusted 10' CS4: 3' CS3

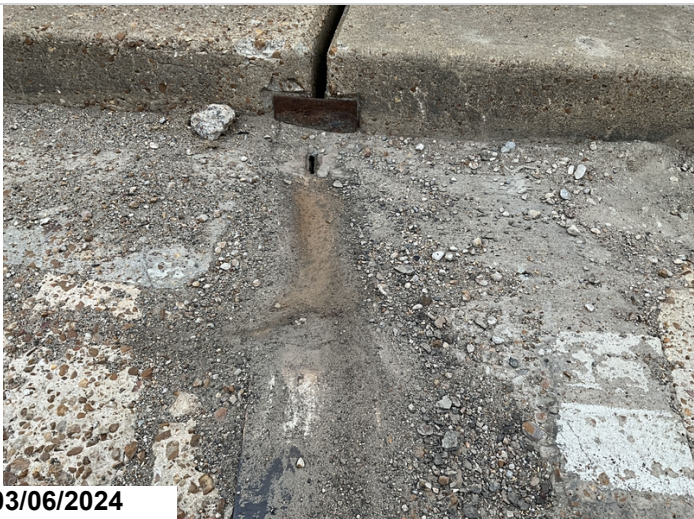
Bent 2 assembly joint has holes rusted on both shoulders.  
CS4 2':  
CS3 2' corrosion.

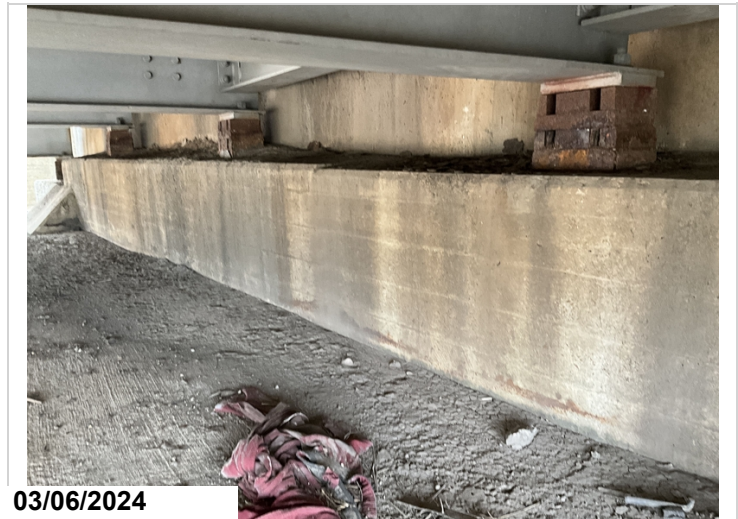
Bent 5 typical condition of fixed bearings. CS3  
This is typical condition of all bearings

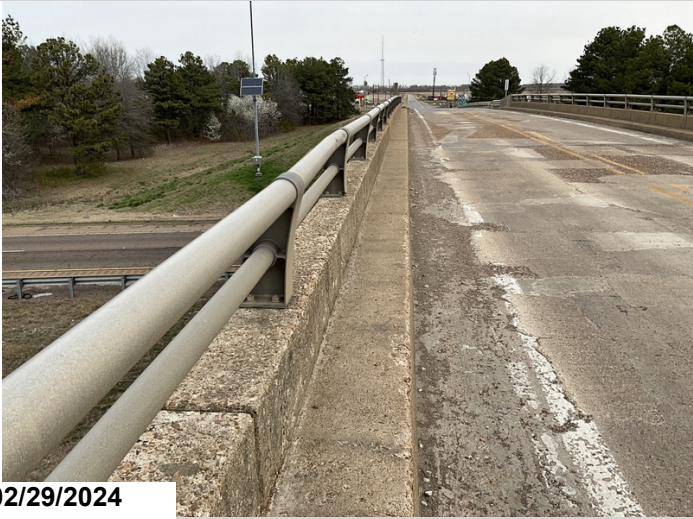
Span 3 right rail has minor collision damage. CS2

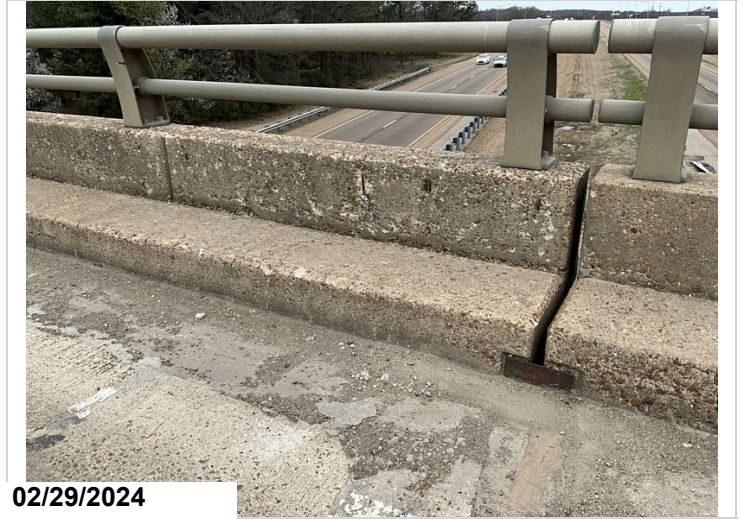
Span 3 right side has spalls with exposed reinforcing steel with no section loss. CS3 Spalling

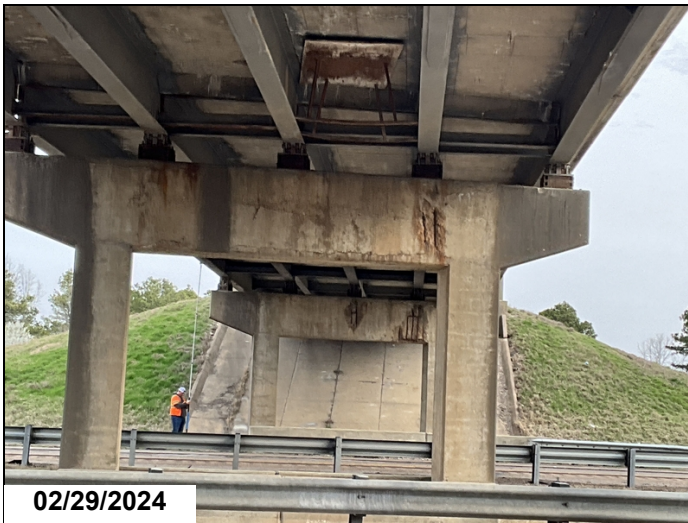
Bent 3, lower ahead face has large longitudinal cracking, and large spalled area above column 1. Both defects CS3

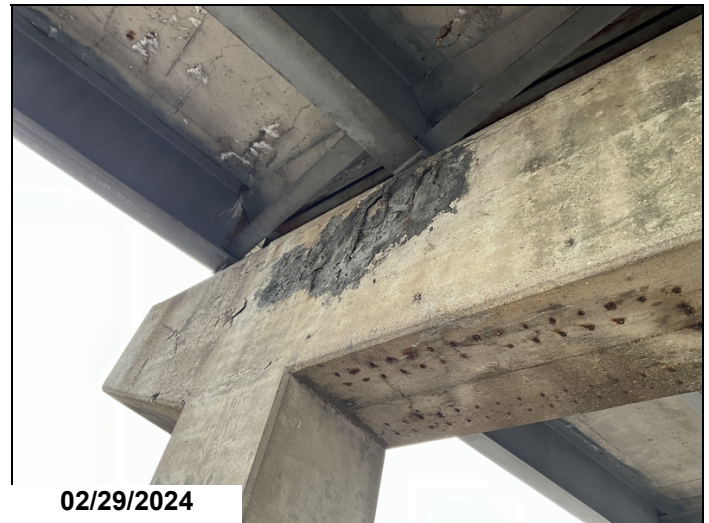
Bent 4, backside, above column 1 has large spalled area with exposed reinforcing steel with section loss. CS3

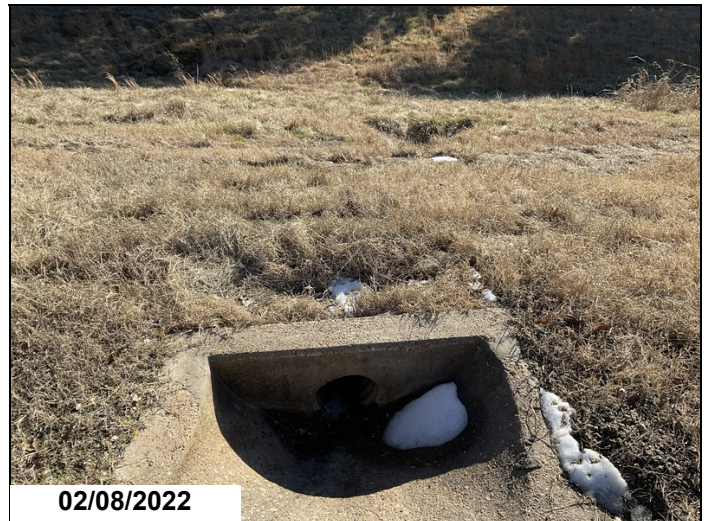
Bent 5, left side drain is broken and washing out slope.

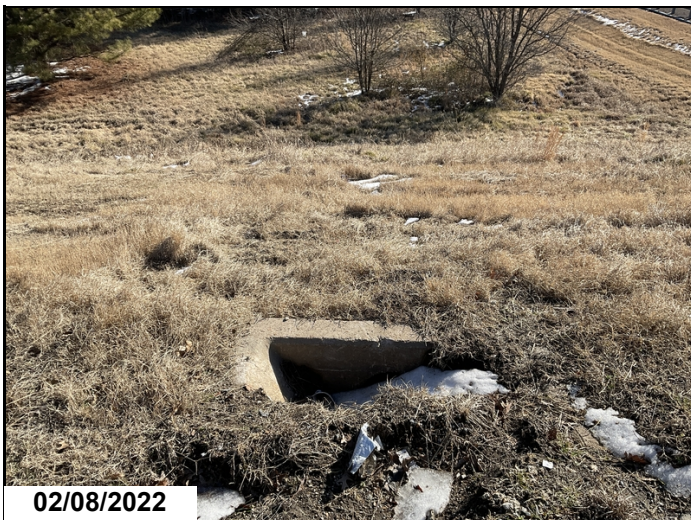
Bent 1, left side drain stopped up pipe and has been disconnected.

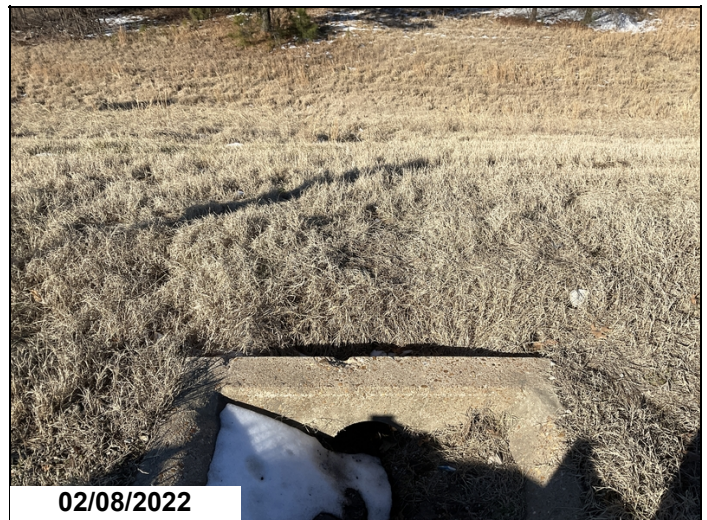
Bent 1, right side drain is broken and washing out slope.

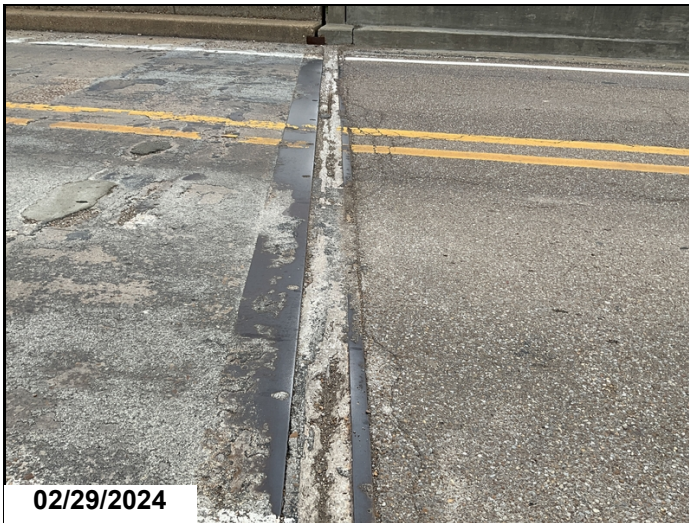
Bent 5 has spalling all the way across back wall, with exposed reinforcing steel in areas. CS3 Spalling, and exposed rebar.

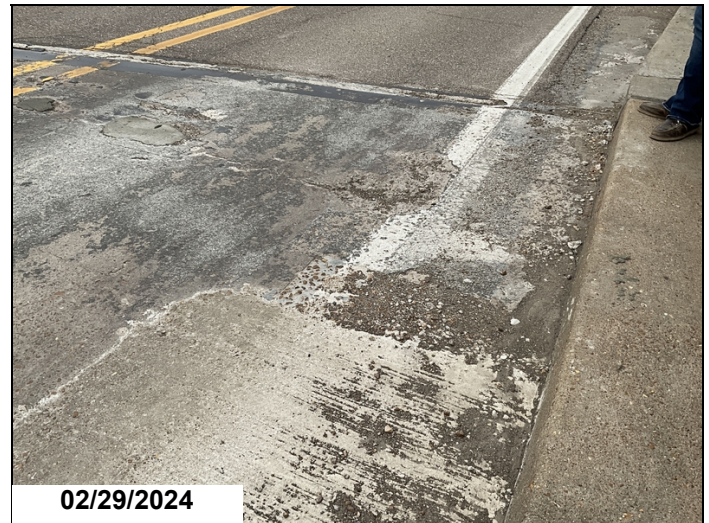
Span 4, right lane has large spalls . CS3

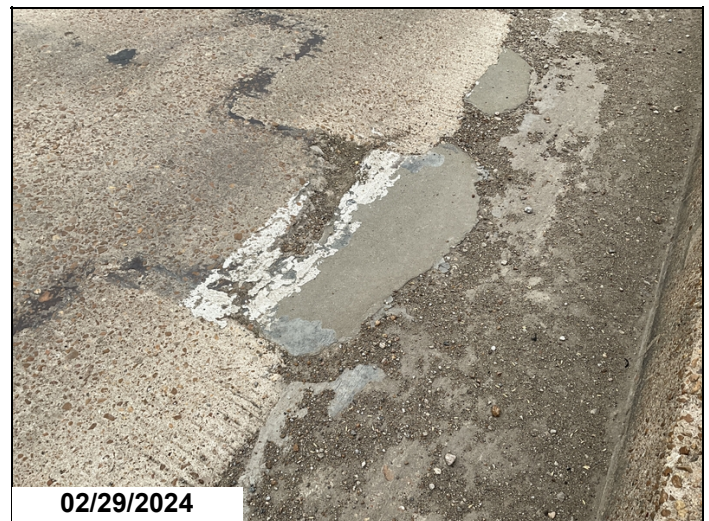
Span 3, right lane has spall next to shoulder. CS3

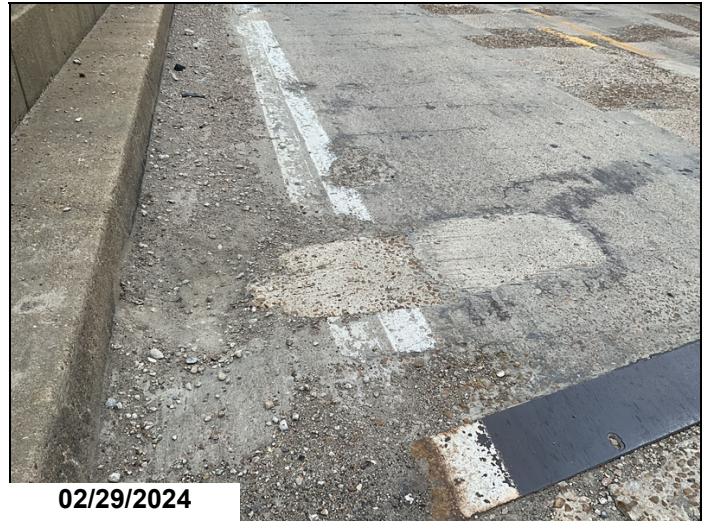
Span 2, left lane has large spalled areas. CS3

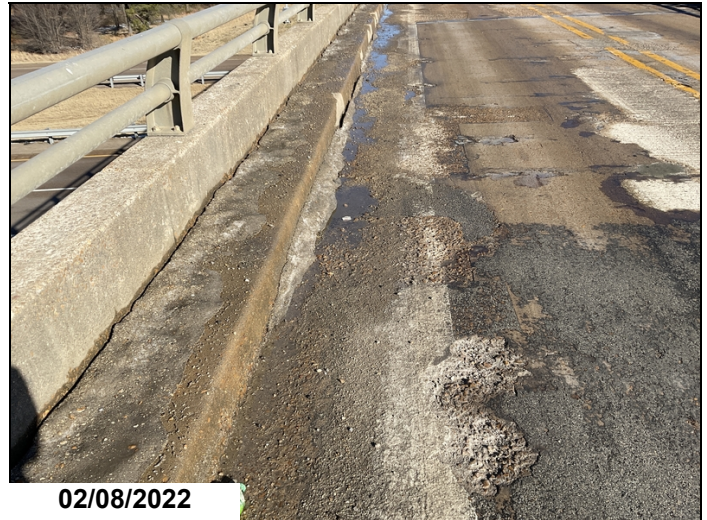
Span #4 has 20 square feet of shallow spalling near or in gutters.

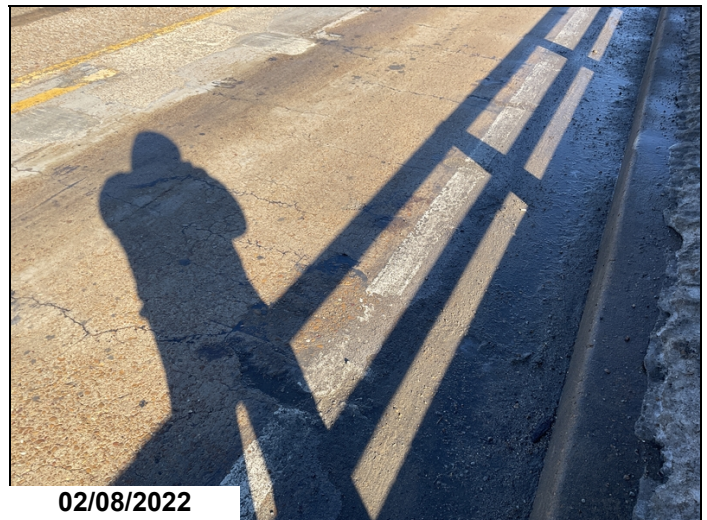
Span #2 has 6 square feet of small spalls with no rebar exposed.

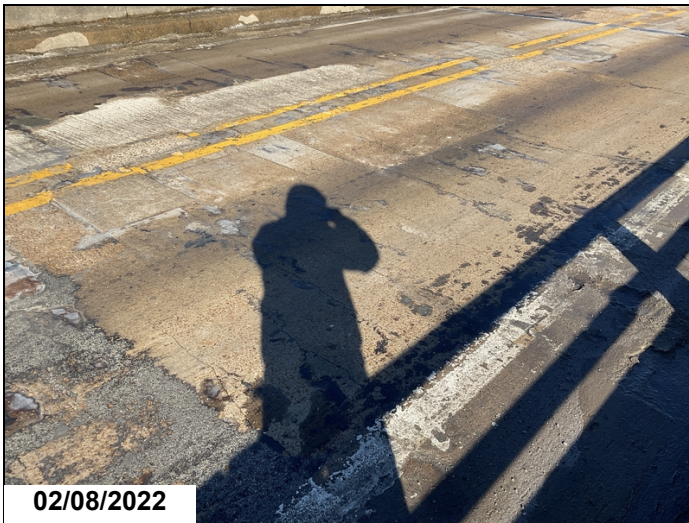
Typical deck cracks.

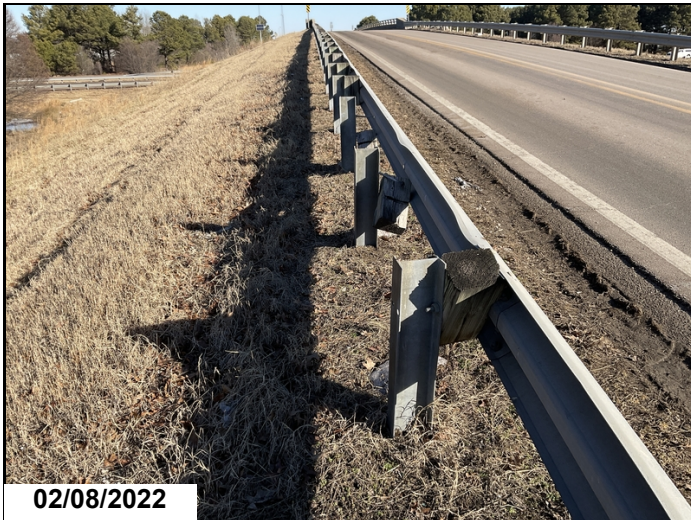
Bent 5, right side, mid ways down approach rail has collision damage with three connecting blocks broken and one connecting bolt pulled out of rail.
