## Bridge 03767 Inspection Report

Route:78 Section:01 Log:5.1

Arnold Road ID:68x78x1xA, Arnold Log mile:5.12

Team Lead: Anthony Caudel, Inspection Date: 02/26/2024

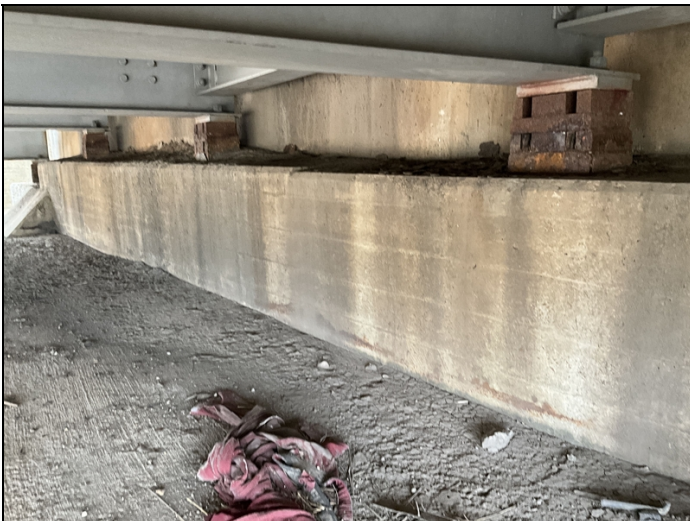
Bent 5 typical condition of fixed bearings. CS3  
This is typical condition of all bearings

All beam ends, and bearings need to be sandblasted and painted after holes in girders are repaired.

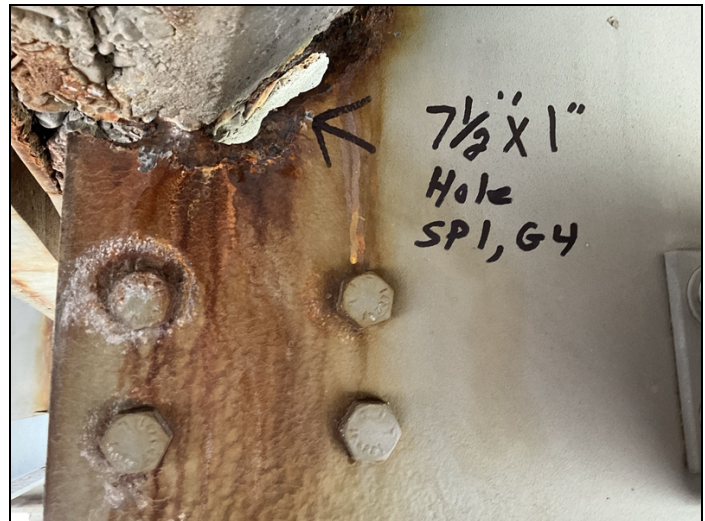
Span 1, Bent 2, girder 4 in haunch area has a 7 1/2"x1" hole. CS3

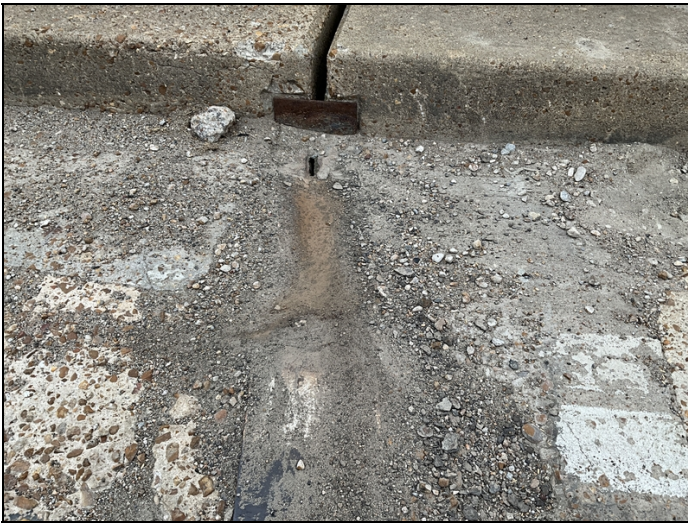
Bent 2 assembly joint has holes rusted on both shoulders. CS4 2':  
CS3 2' corrosion.

Assembly joints are in poor condition and need to be replaced.

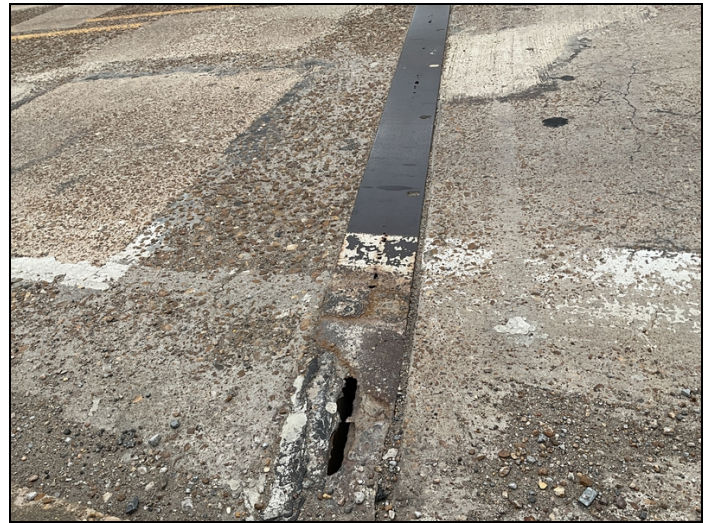
Bent 3 assembly joint has holes rusted 10' CS4: 3' CS3

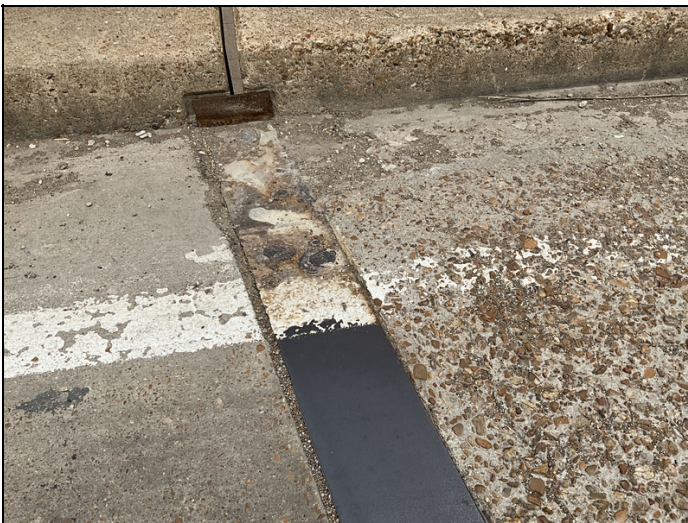
Bent 4 right side assembly joint has corrosion with heavy  
section loss. Both shoulders CS3

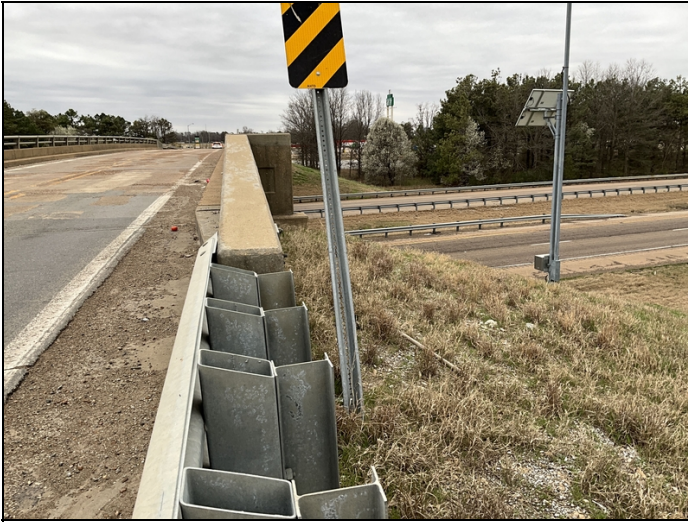
No log mile sign
