## Bridge 07069 Inspection Report

**Asset #07069**(Routine)

**Us-49/Sec-8/L-6.96 over I-40/Sec-43/L-215.74**

**Team Lead: Myron Futrell Inspection Date: 10/17/2023**

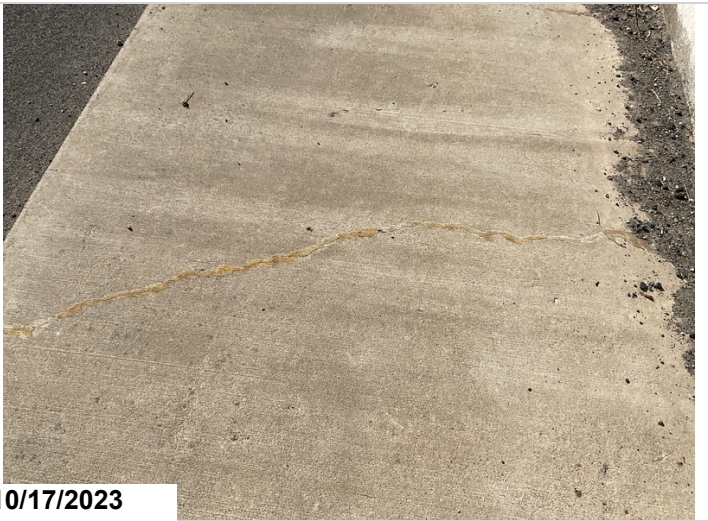
Typical sealed sidewalk crack

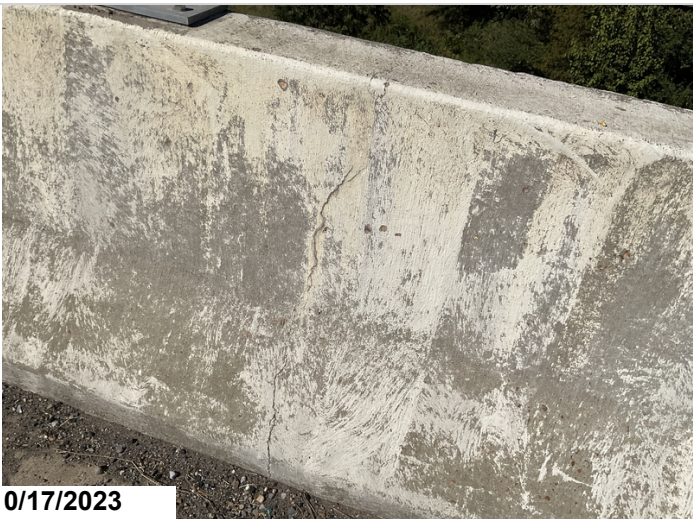
Typical vertical crack in concrete bridge rail

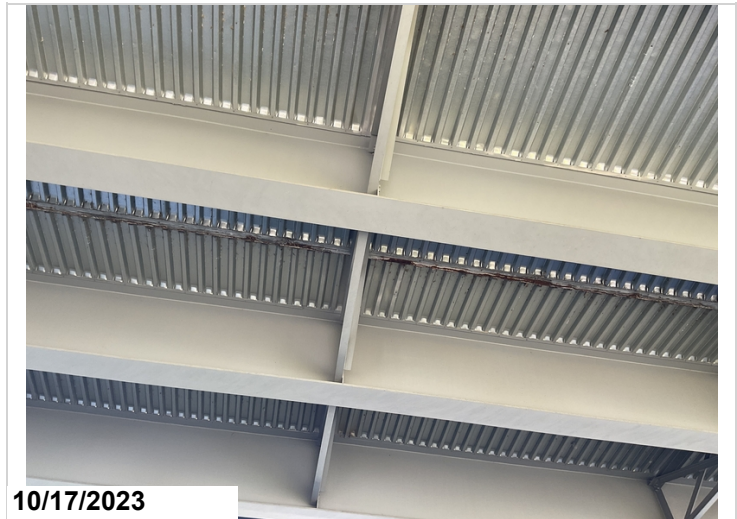
Deck appears to be in overall good condition. Top of deck has epoxy overlay and is no longer visible. Deck cracks have been sealed by epoxy overlay. Sidewalks have transverse cracking, most of which have been sealed. Underside of deck is not visible due to stay in place forms except for overhangs, which have transverse cracking with light to moderate efflorescence. Stay in place forms have minor corrosion at centerline of both spans.

Span #2 stay in place forms beginning to corrode at centerline

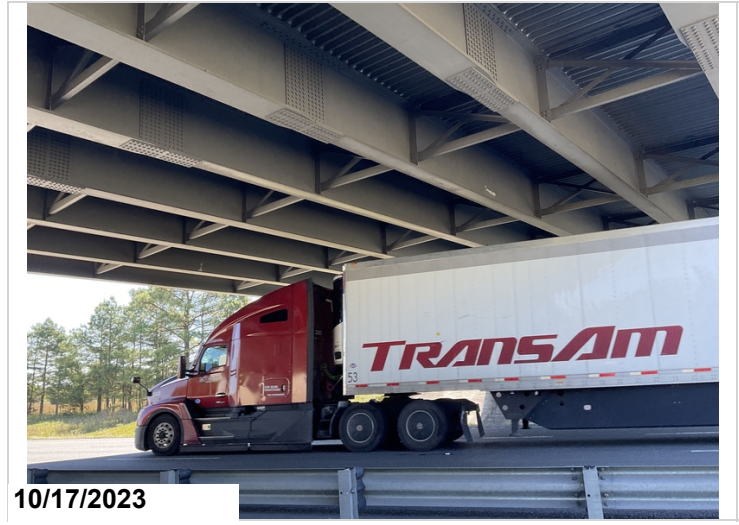
Steel girders of superstructure are in overall very good condition with the only problems notes being a few small areas where paint is beginning to peel. Elastomeric bearings appear to be in overall good condition as well.

Paint peeling span #2 girders #2 and 6 right side

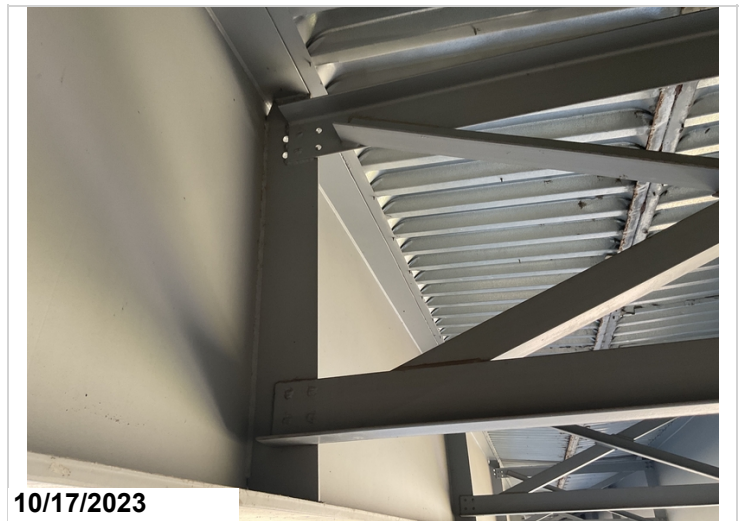
Diaphragms span #2 last 6 of them on right side are welded instead of bolted between girders #4,5.

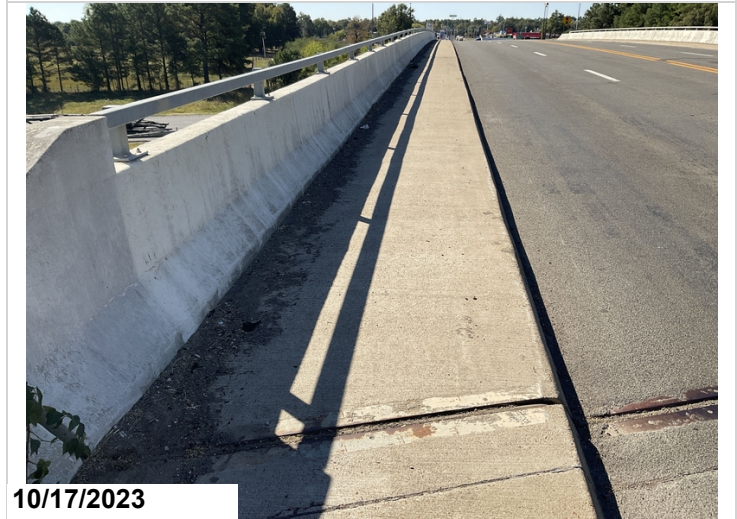
Dirt and debris on sidewalks

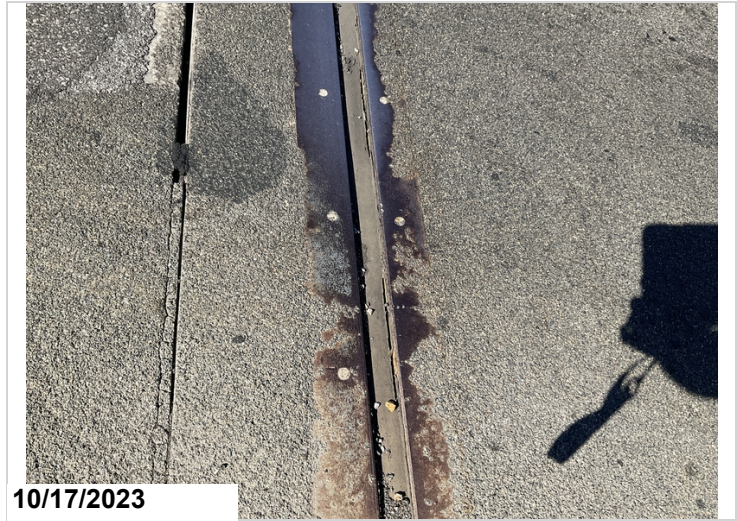
Abutment #2 joint seal has several areas where seal has lost adhesion allowing leakage.

Abutment #2 joint seal has several areas of lost adhesion allowing leakage through joint.

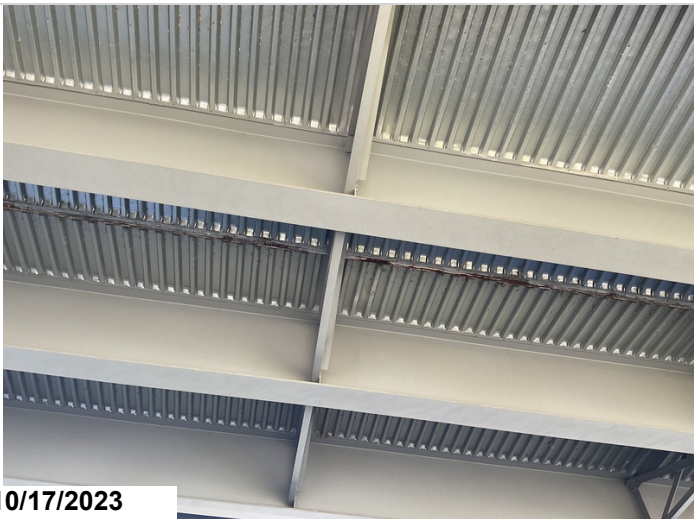
Span #2 stay in place forms beginning to corrode at centerline

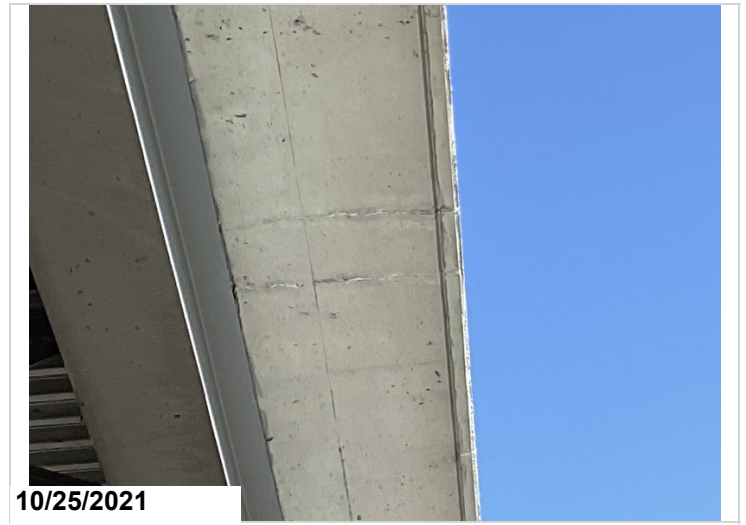
Typical soffit-under surface over hang efflorescence.

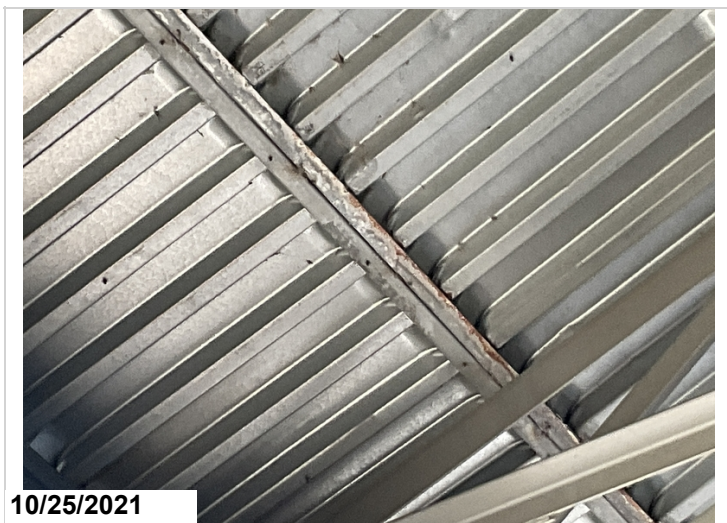
Stay in place forms in center where forms are joined together are starting to corroded.

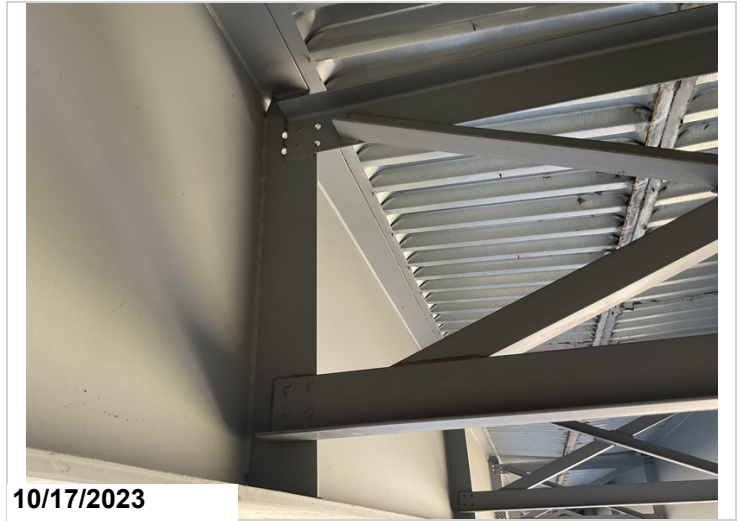
Diaphragms span #2 last 6 of them on right side are welded instead of bolted between girders #4,5.

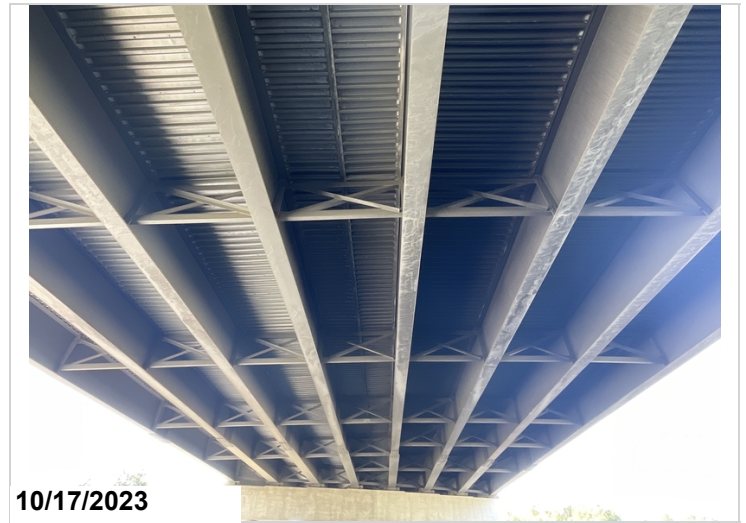
Paint peeling span #2 girders #2 and 6 right side

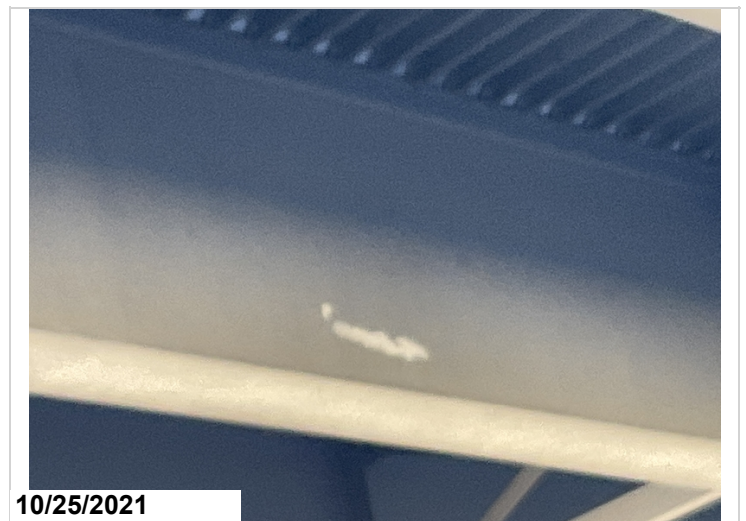
Span #2 girder #6 right side area where paint is peeling.

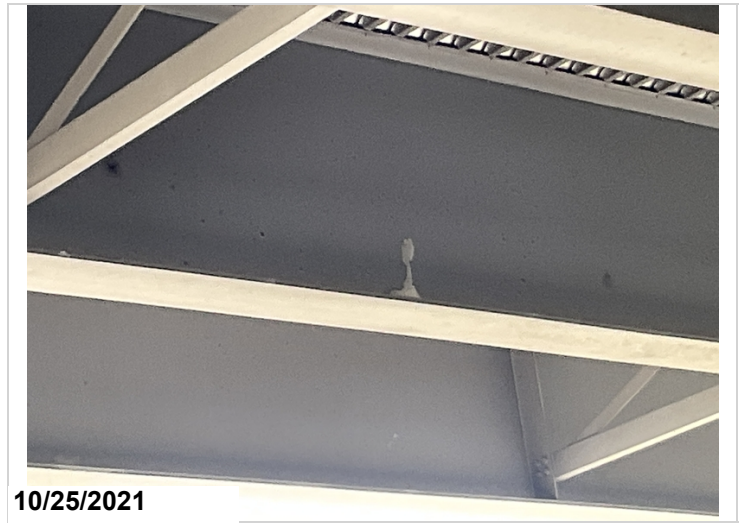
Span #2 girder #2 right side area where paint is peeling.

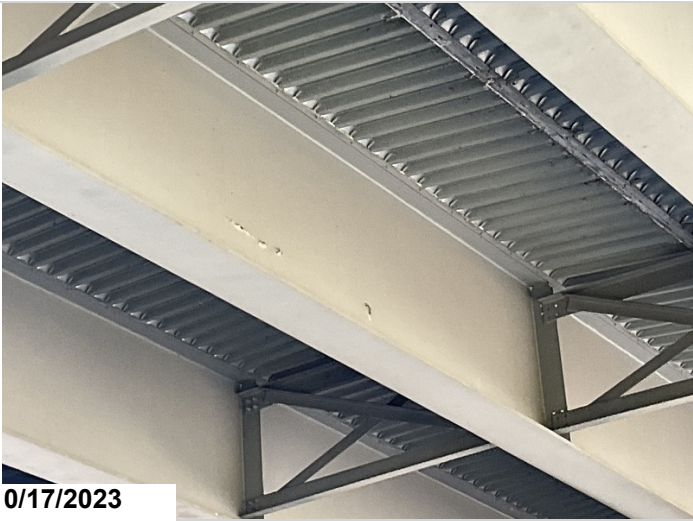
Span #2 girder #5 left side has one foot of paint beginning to peel.

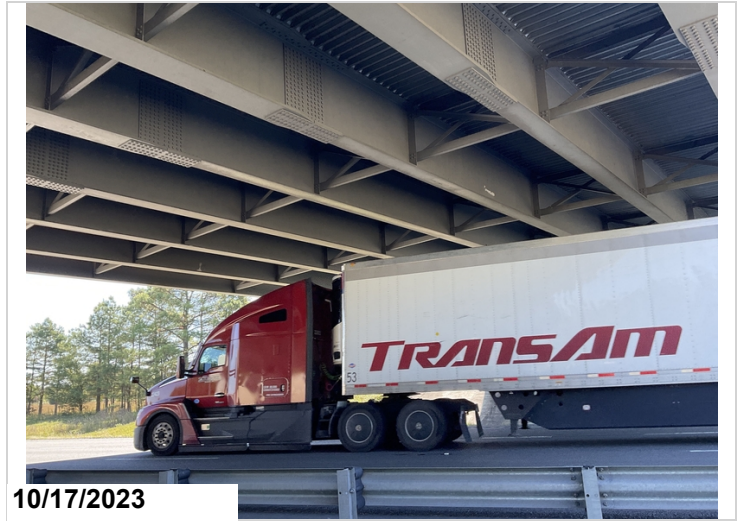
Paint peeling span #2 girders #2 and 6 right side

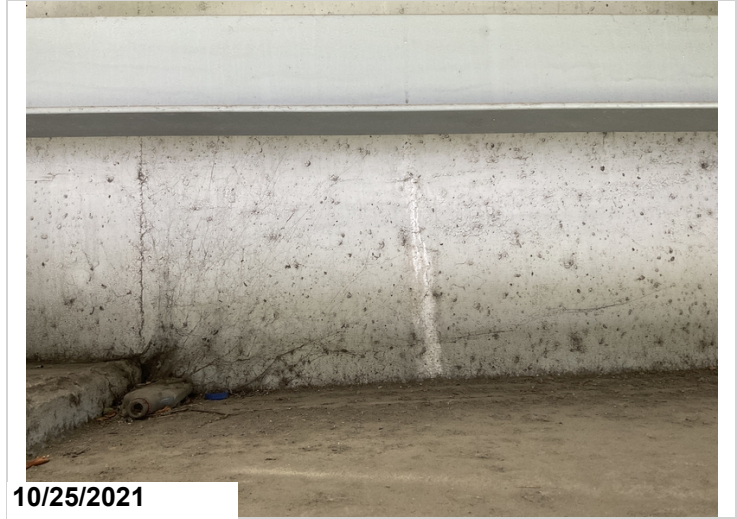
Substructure is in overall very good condition backwalls have a few vertical hairline cracks with light efflorescence and there are a few spots in abutments where the ends of rebar show through the concrete.

Typical abutment back wall crack

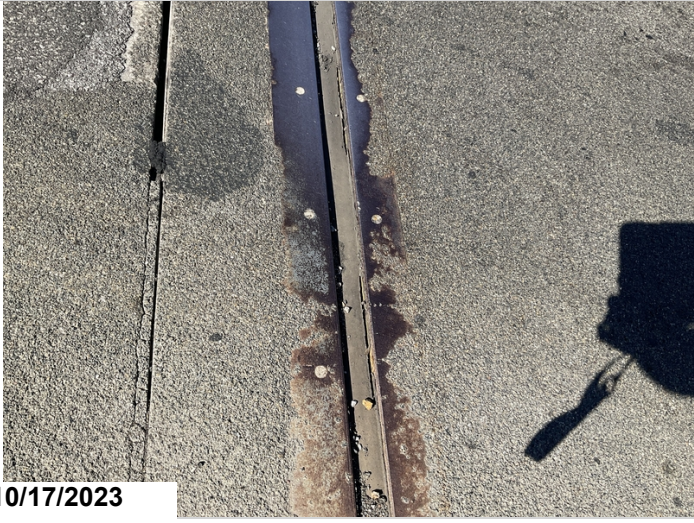
Abutment #2 joint seal has several areas of lost adhesion allowing leakage through joint.

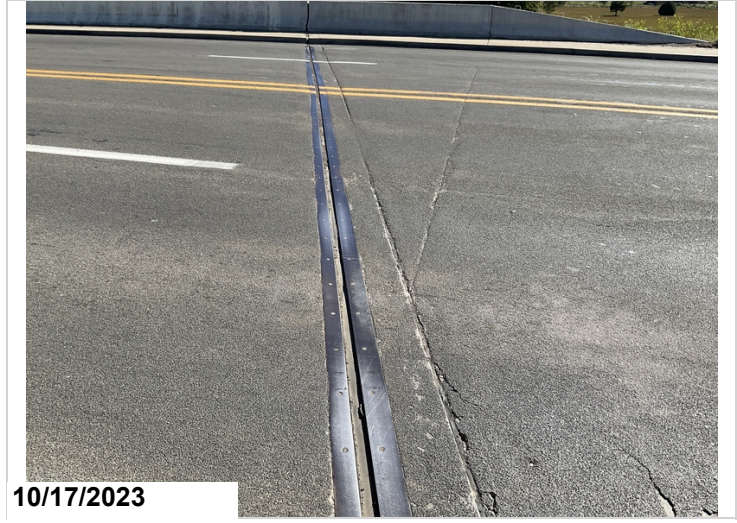
Abutment #2 joint seal right outside lane has one foot of lost adhesion

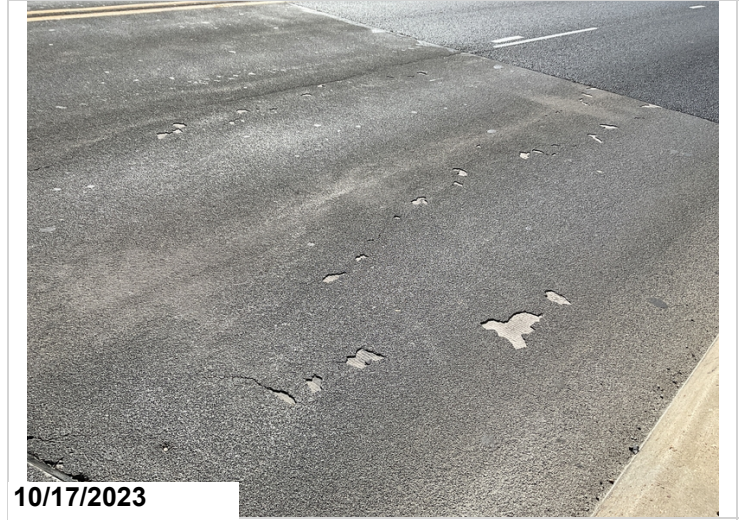
(321) Approach slabs have been sealed with and epoxy overlay. Abutment #2 approach slab right outside lane has several small areas where epoxy overlay is spalled off approximately 20' total affected.							
330	Metal Bridge Railing	LF	565	565	0	0	0
515	Steel Protective Coating	SF	565	565	0	0	0

Abutment #2 approach slab right outside lane has several small areas where epoxy overlay is spalled off approximately 20' total affected.

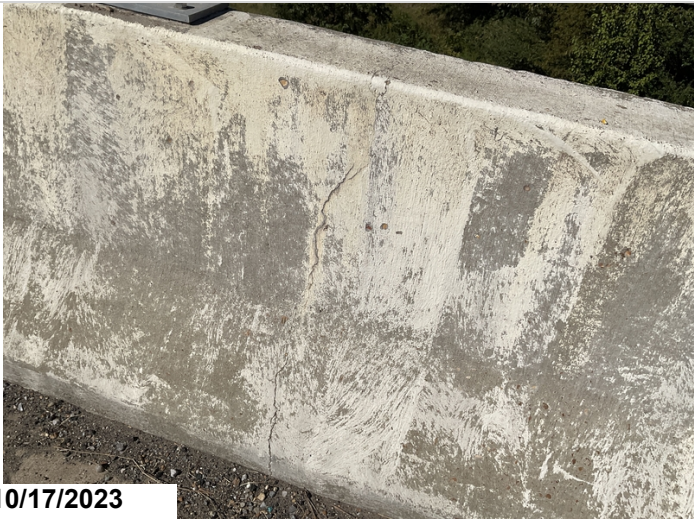
ELEMENTS	DESCRIPTION	UNITS	TOTAL	CS1	CS2	CS3	CS4
331	Reinforced Concrete Bridge Railing	LF	565	424	141	0	0
1120	Efflorescence/Rust Staining	LF	41	0	41	0	0
1130	Cracking (RC and Other)	LF	100	0	100	0	0
(331) Concrete bridge rails have open vertical cracks spaced 4' some with light efflorescence. Metal bridge rail?

Typical vertical crack in concrete bridge rail

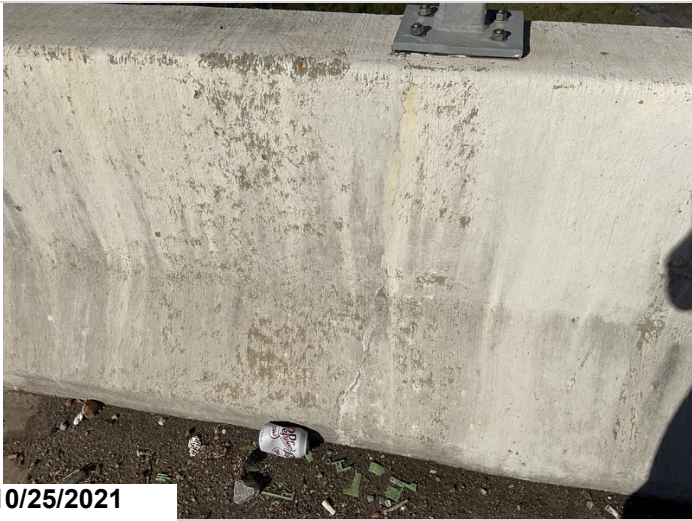
Typical bridge rail crack

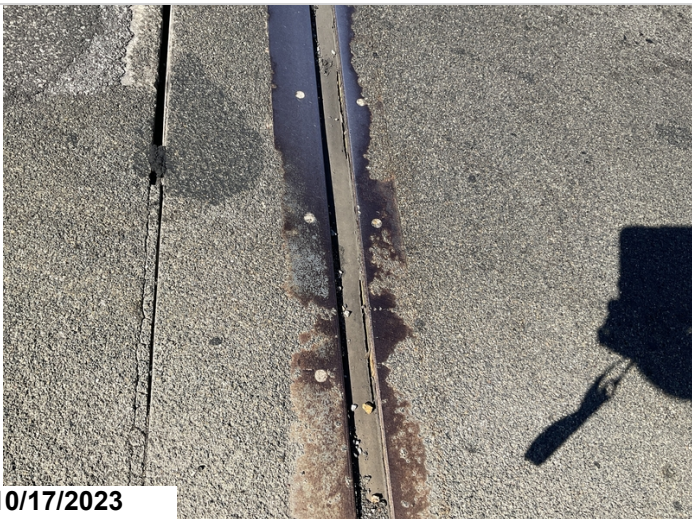
Abutment #2 joint seal has several areas of lost adhesion allowing leakage through joint.

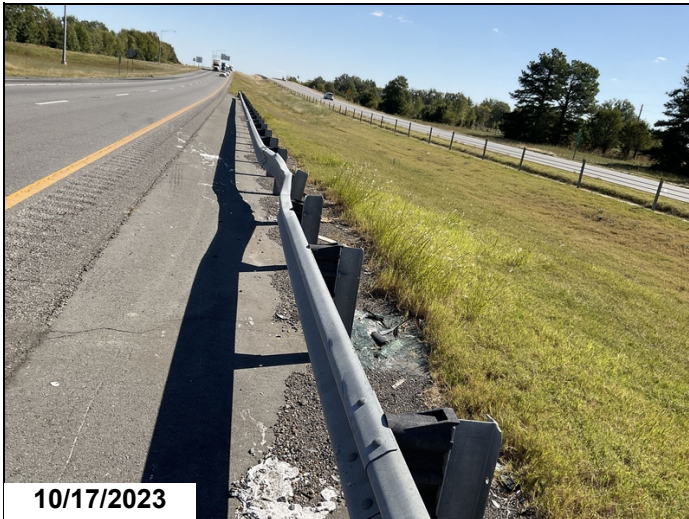
West bound roadway under bridge left lane has guardrail near beginning that has ten feet of collision damage.

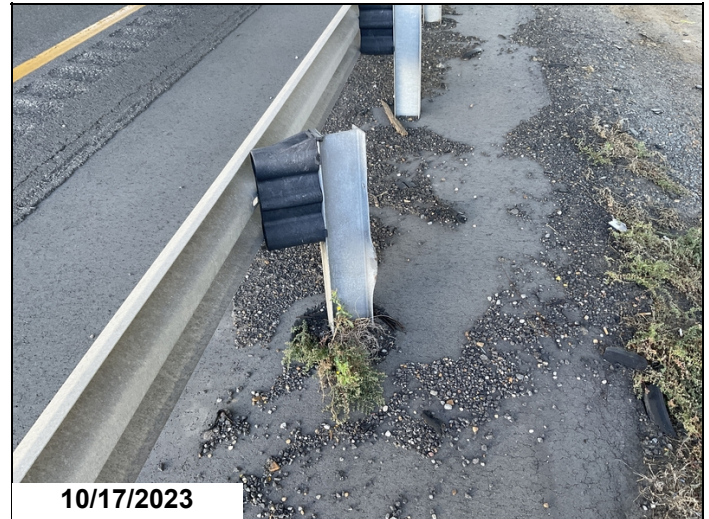
Twisted rail post west bound left rail

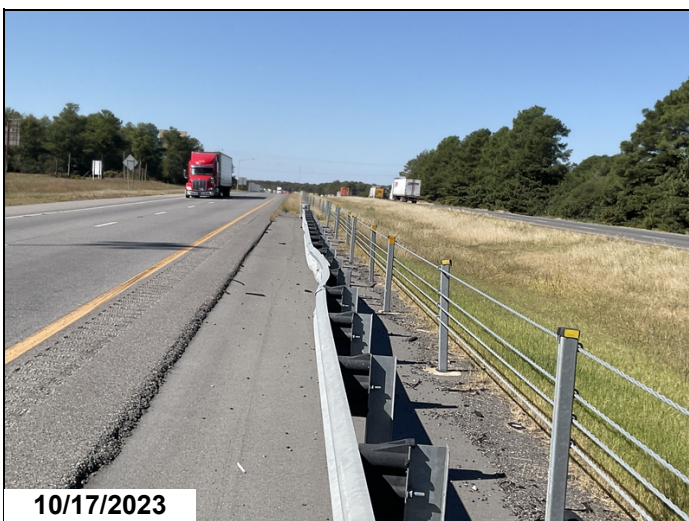
East bound lanes under bridge left lane near beginning of rail has ten feet of collision damage.

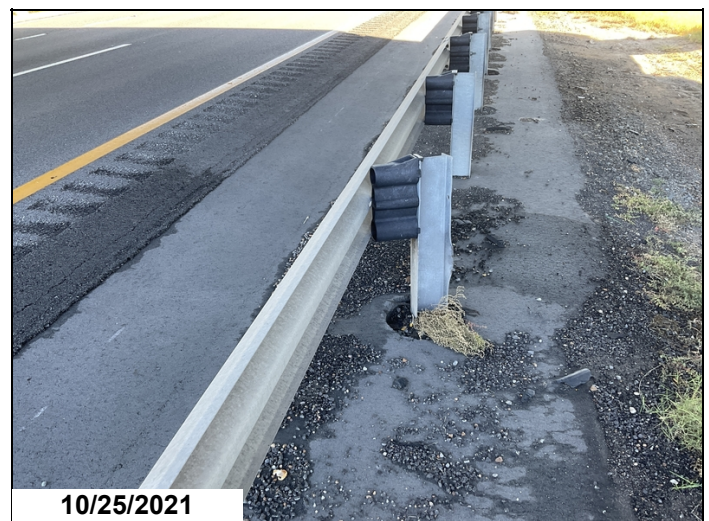
West bound roadway under bridge left lane has guardrail post twisted.

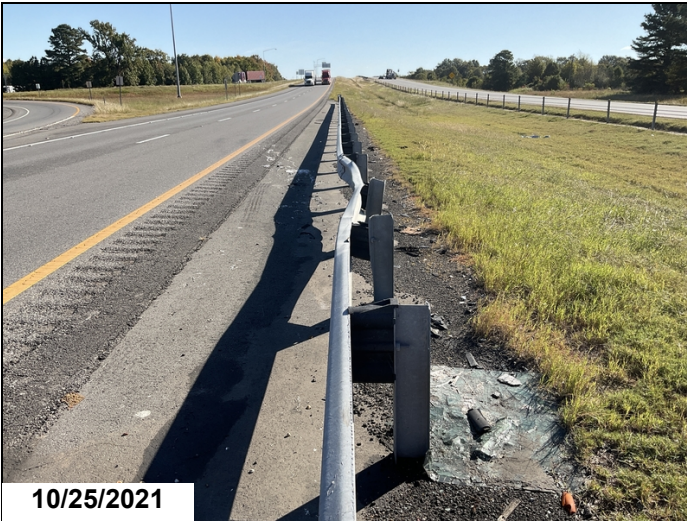
West bound roadway under bridge left lane has guardrail near beginning that has ten feet of collision damage.

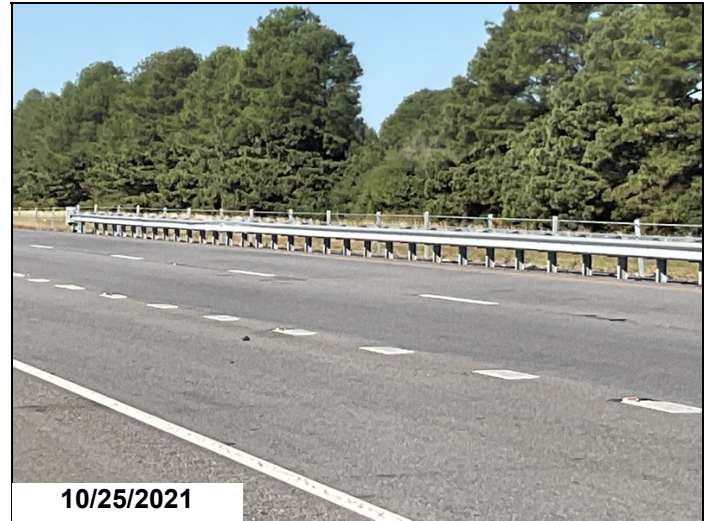
East bound lanes under bridge left lane near beginning of rail has ten feet of collision damage.

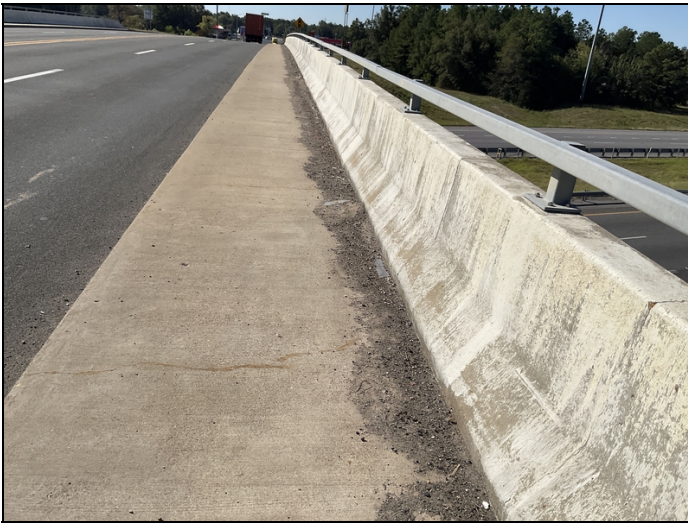
**A-55 - Deck Washing Needed (Yes)**  
Sidewalks have dirt and debris in them.

Dirt and debris in sidewalks

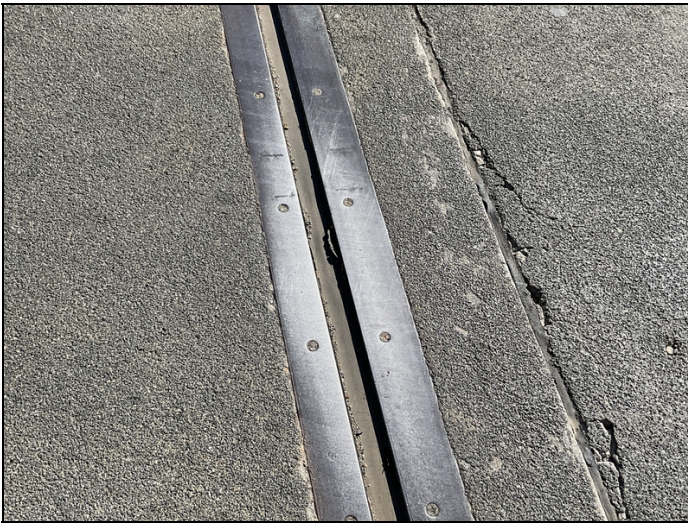
Abutment #2 joint seal right outside lane has one foot of lost adhesion

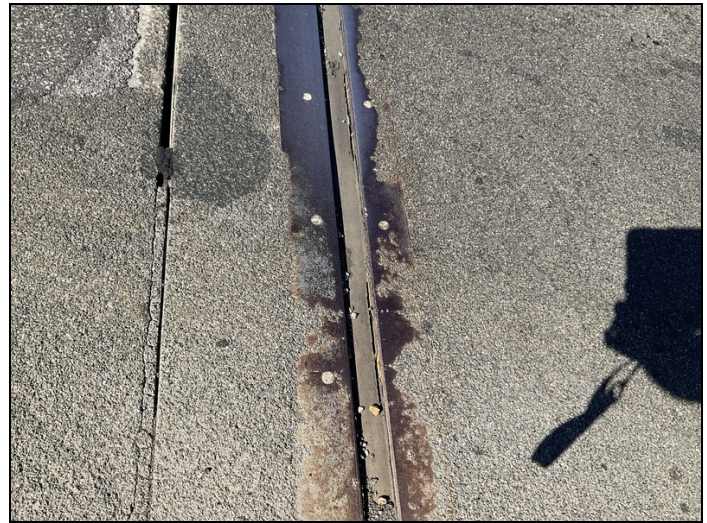
Abutment #2 joint seal has several areas where seal has lost adhesion allowing leakage.

Abutment #2 joint seal has several areas of lost adhesion allowing leakage through joint.

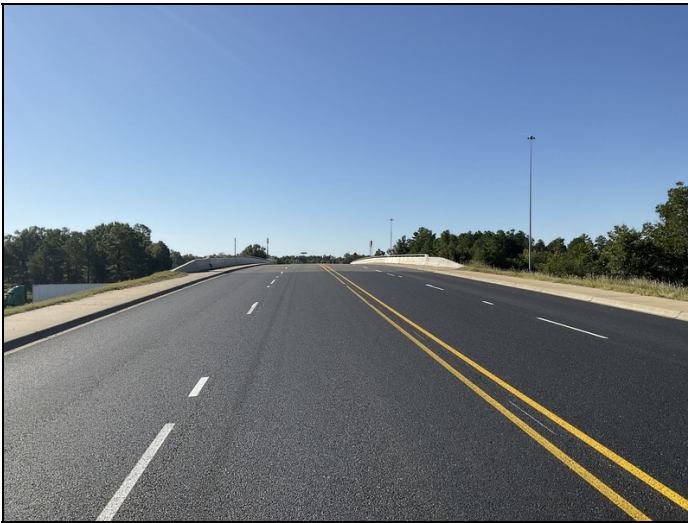
No log mile signs in place.
