Bridge 07232 Inspection Report

Asset #07232(Routine)

Sh-261/Sec-2/L-5.5 over I-40/Sec-51/L233.17

Team Lead: Myron Futrell Inspection Date: 07/10/2024

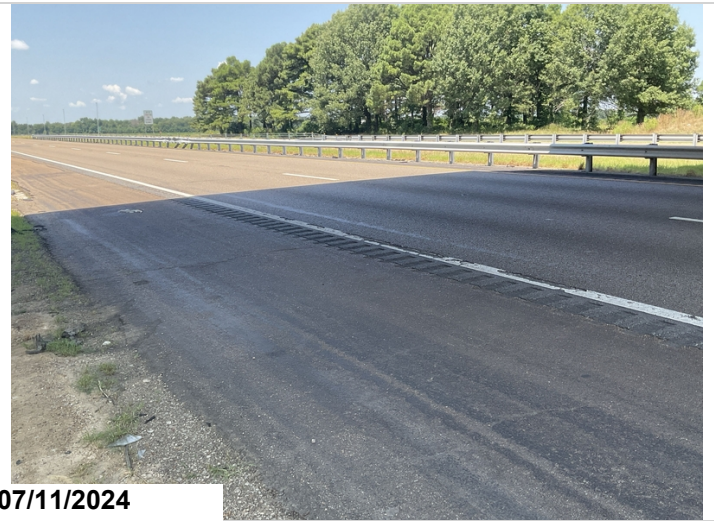
Typical guardrail east bound side 90' west has collision damage for 20'

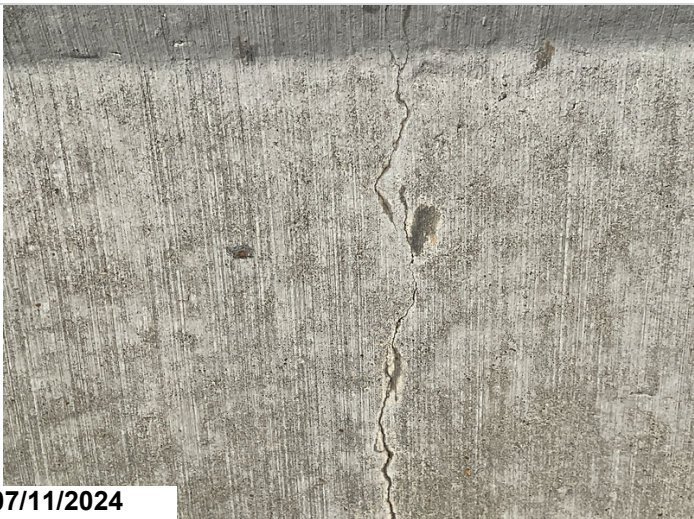
Typical bridge rail crack.

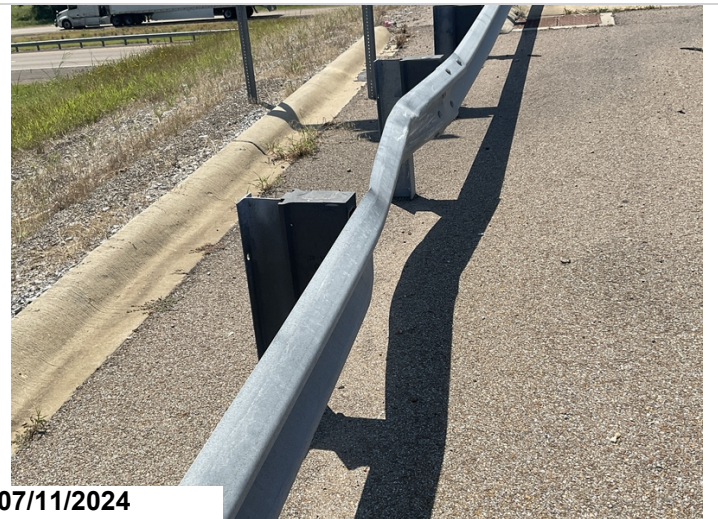
Abutment 2 right side guardrail has collision damage for 6' 12 posts from abutment 2.

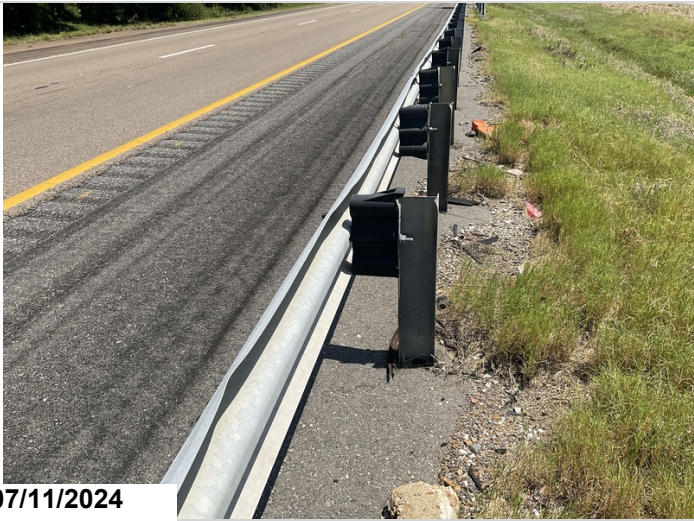
Guard rail has collision damage for 10' 120' east of bridge and 3 guard rail post damaged.

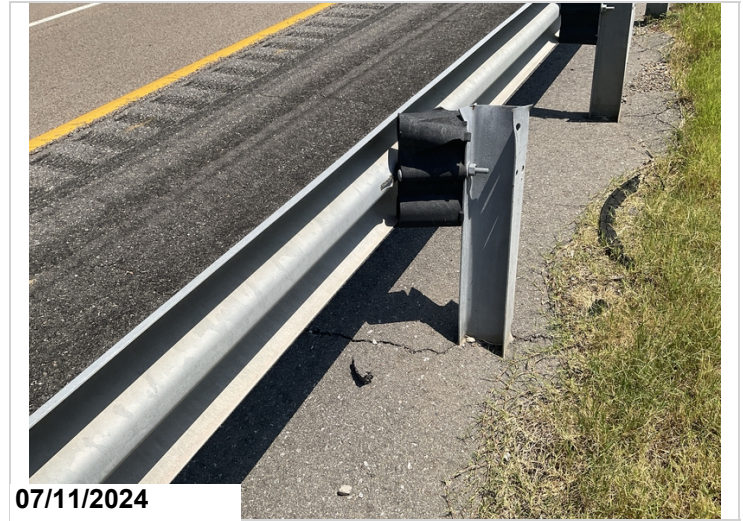
Guard rail posts damaged west bound side.

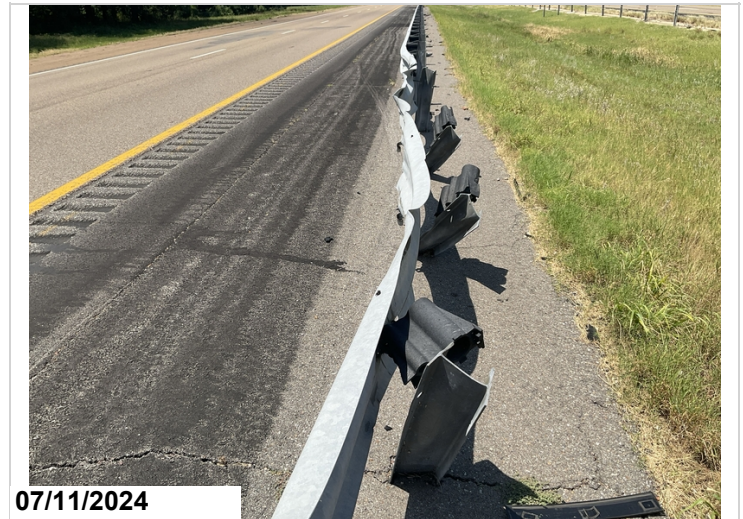
Typical guardrail east bound side 90' west has collision damage for 20' with 4 rail post damaged

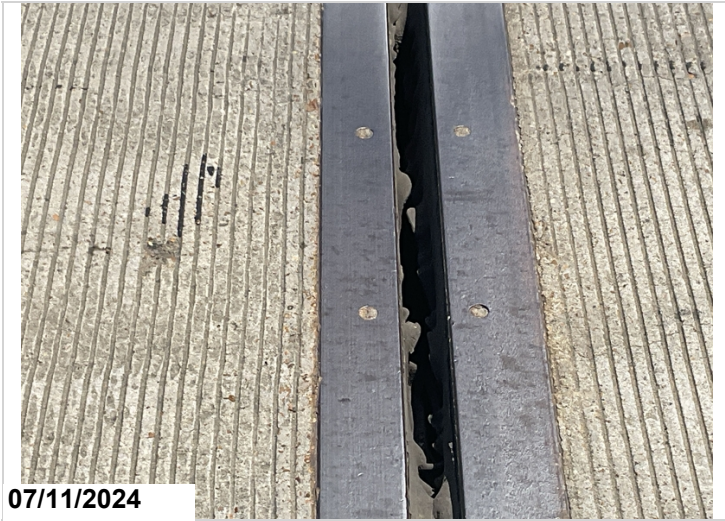
Deck is in overall very good condition. Deck has a few minor cracks and the approach slabs have some sealed cracks. The deck joint seal on abutment 1 has up to 30' damaged and missing.

Typical joint seal has fell in for 30'.

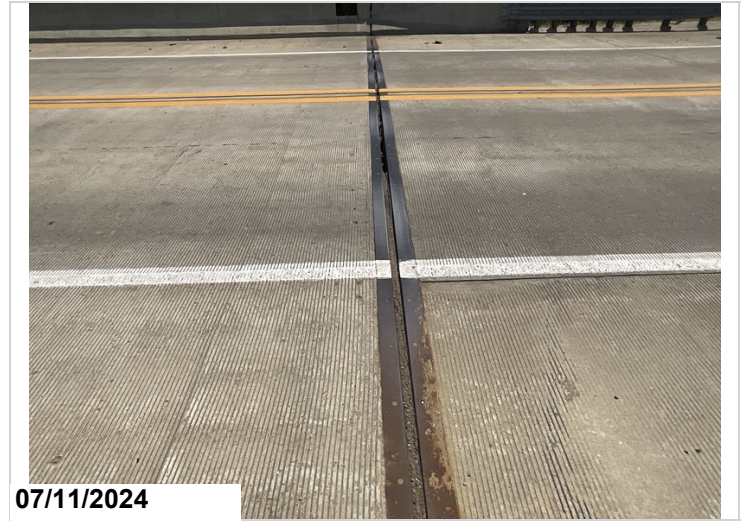
Abutment 1 joint seal is torn and missing for up to 30' and abutment 2 has small hole and dirt and debris in it.

Abutment 1 typical joint.

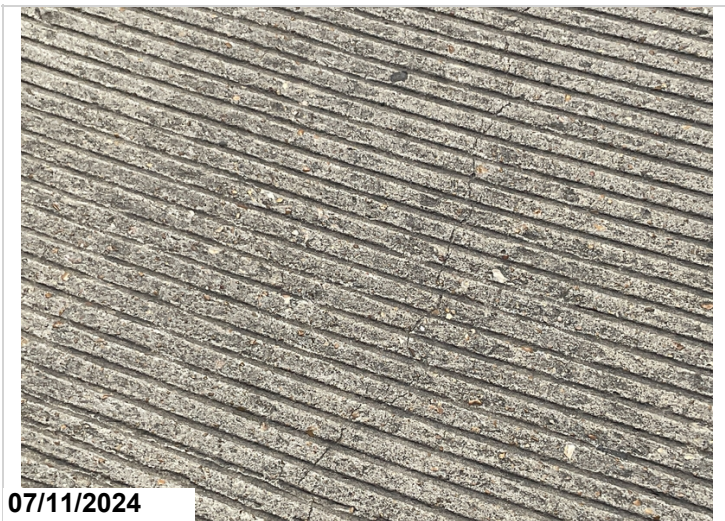
Typical deck crack span 3 midways

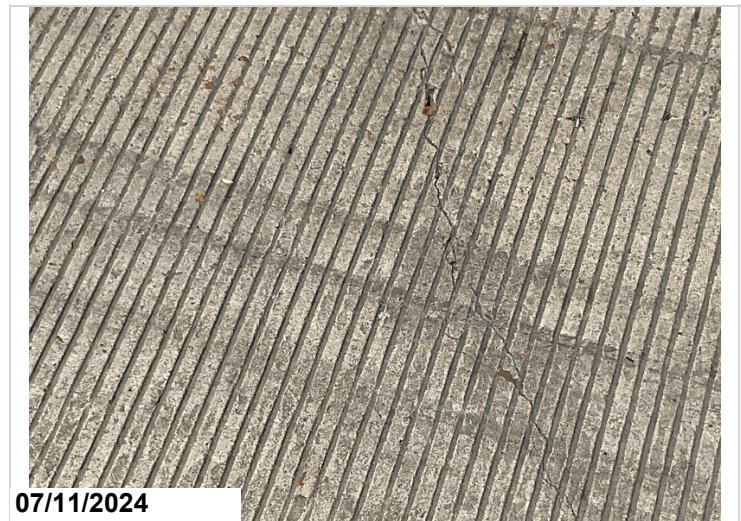
Approach slabs have some sealable deck cracks.

Abutment 2 approach slab typical crack.

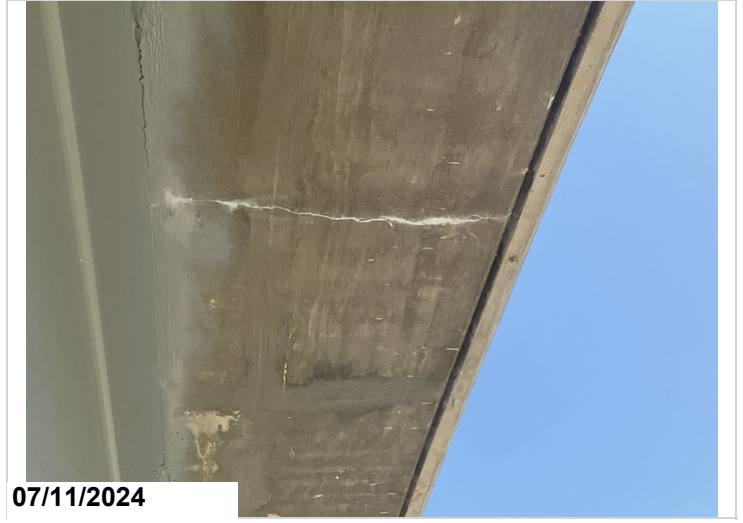
Superstructure is in overall excellent condition. Undersurface has a few cracks with efflorescence on the overhangs. The girders have been painted and in excellent condition.

Typical transverse crack right side undersurface.

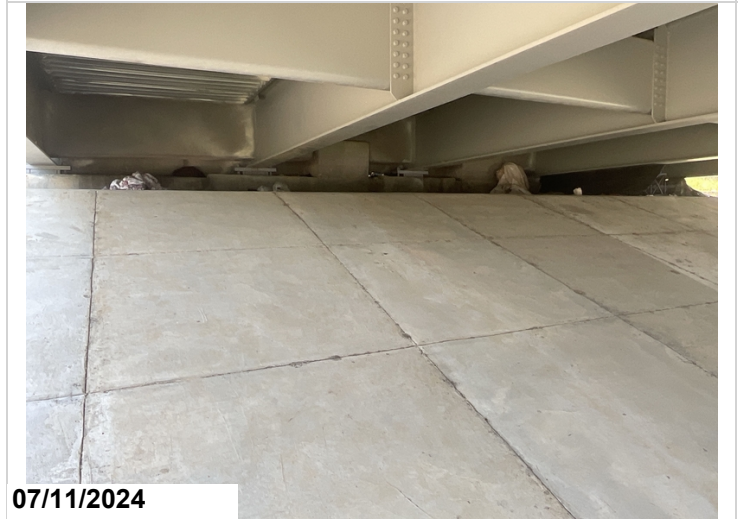
Substructure is in overall very good condition. Abutment 2 back wall has a crack with light efflorescence.

7/23/2020-Lowered substructure from 9 to 8 due to crack in abutment #2 back wall with light efflorescence.

Abutment 2.

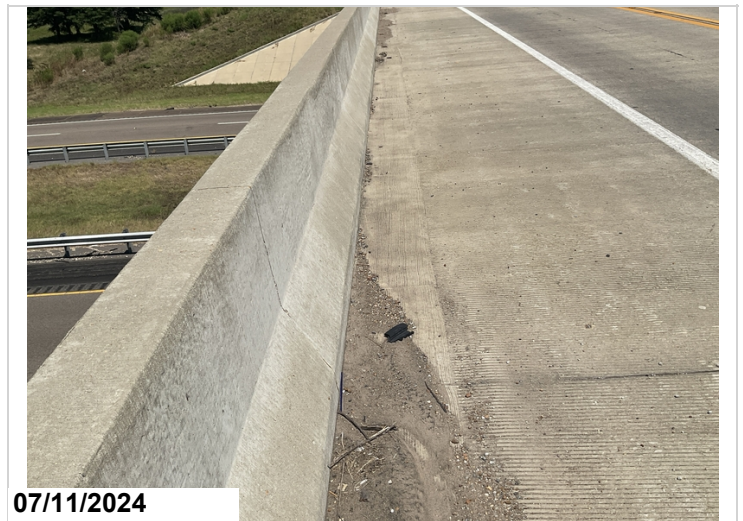
Dirt and debris in gutters.

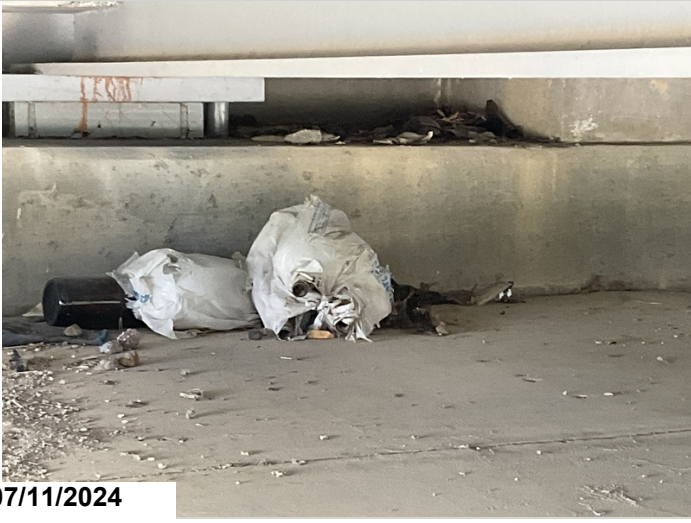
Both abutment caps have dirt and debris on them.

Caps at both abutments have dirt and debris on them

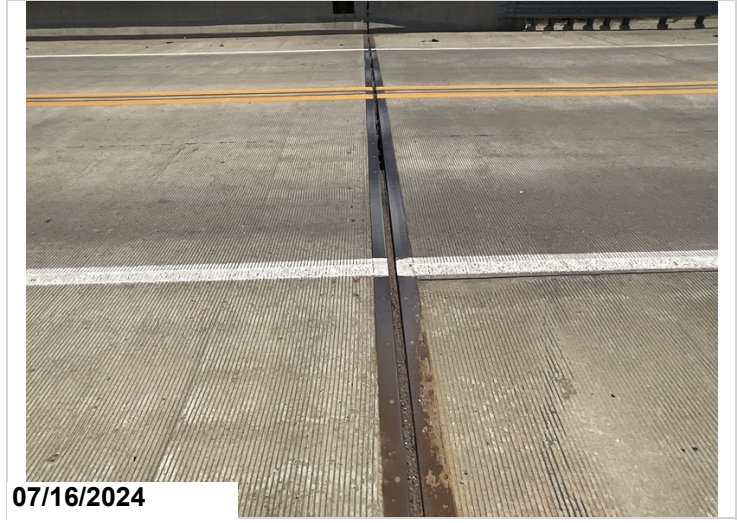
Abutment 1 typical joint.

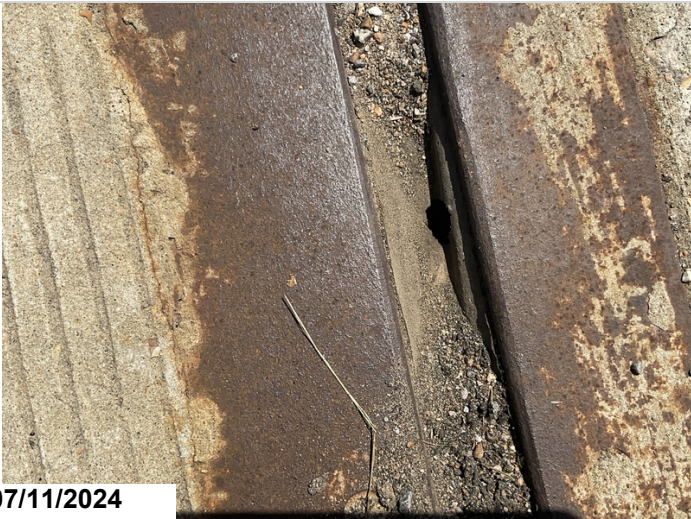
Abutment 2 left side joint seal has small hole.

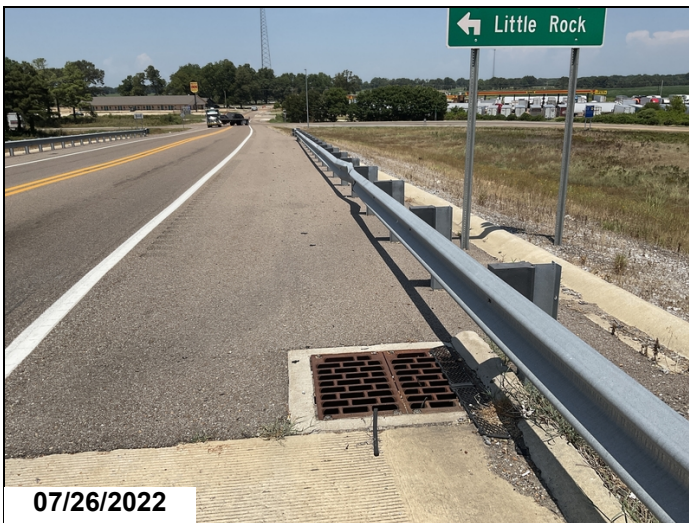
Abutment #2 right approach rail has minor collision damage
East bound under bridge rail has moderate collision damage.

Abutment #2 right approach rail has minor collision damage

Type of Work: Approach Leveling/Maintenance

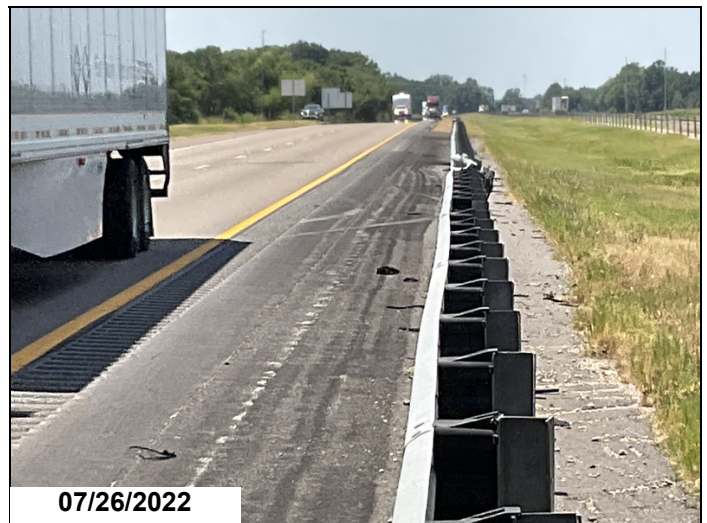
East bound under bridge rail has moderate collision damage.

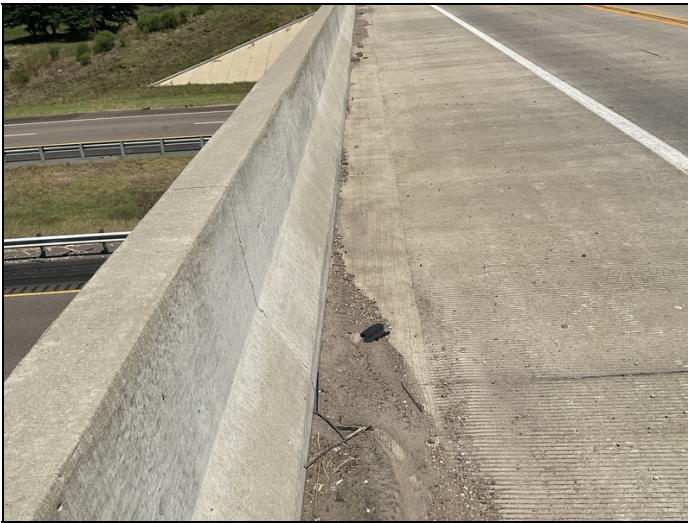
Dirt and debris in gutters.

A-55 - Deck Washing Needed (Yes)

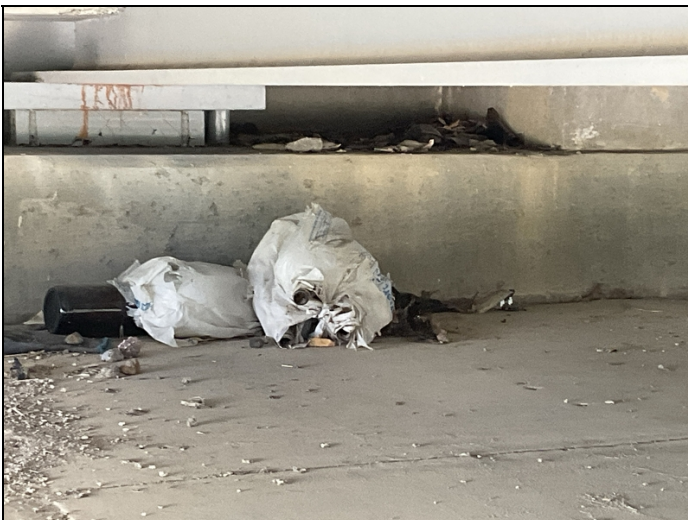
Both abutment caps have dirt and debris on them.

Caps at both abutments have dirt and debris on them

A-58 - Cap Cleaning/Flushing Needed (Yes)

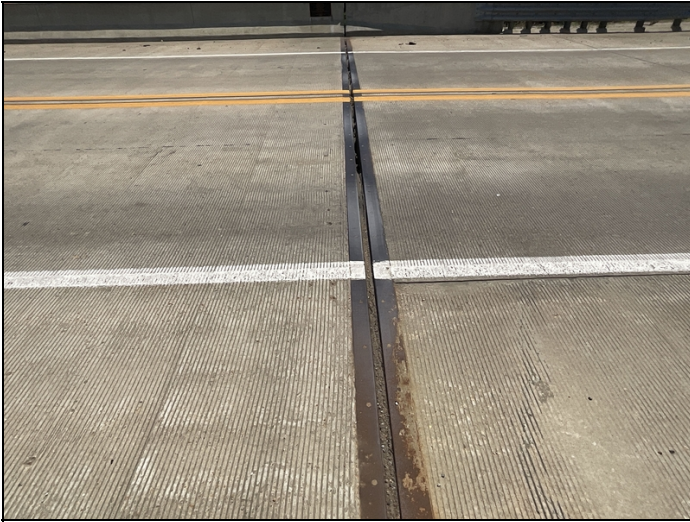
Abutment 1 joint seal is torn and missing for up to 30' and abutment 2 has small hole and dirt and debris in it.

Abutment 1 typical joint.

A-59 - Joint Repair Needed (Yes)

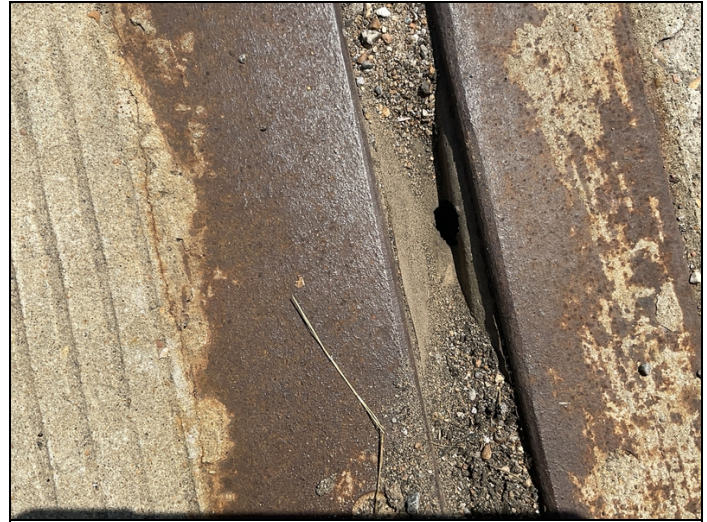
Abutment 2 left side joint seal has small hole.
