Bridge B6770 Inspection Report

Asset #B6770(Routine)

Sh-1/Sec-12/L-2.18 over I-40/Sec-51/L-239.04

Team Lead: Austin Janes **Inspection Date:** 10/15/2024

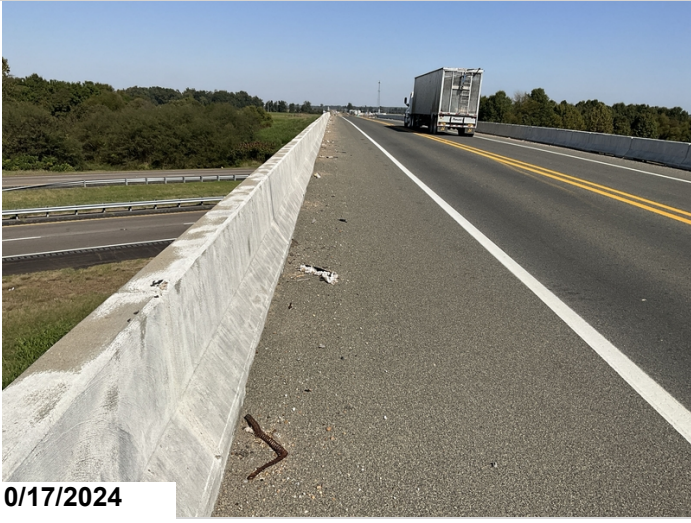
10/17/2024

Deck has dirt & debris along gutter lines.

A-55 - Deck Washing Needed (Y)

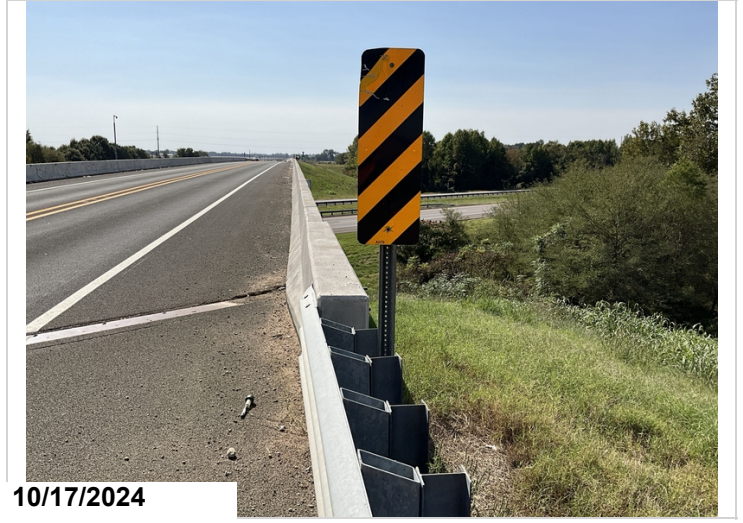
10/17/2024

Log mile signs missing.

A-63 - Missing/Incorrect Log Mile Signage (Y)

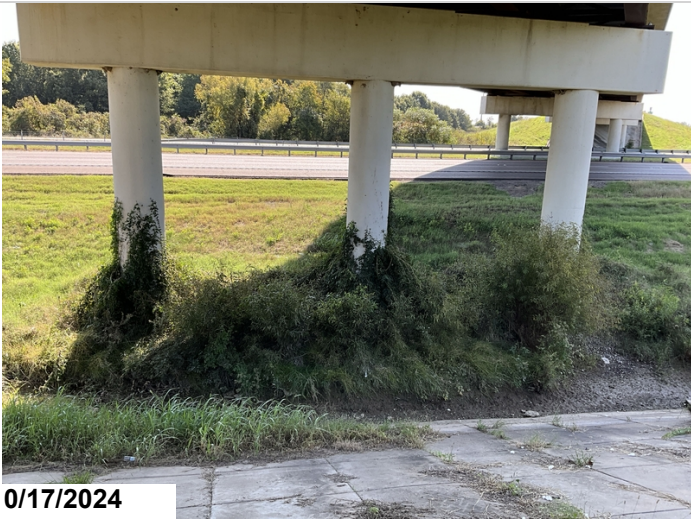
10/17/2024

Bent 4: Vegetation growth.

A-64 - Vegetation Removal Requested (Y)

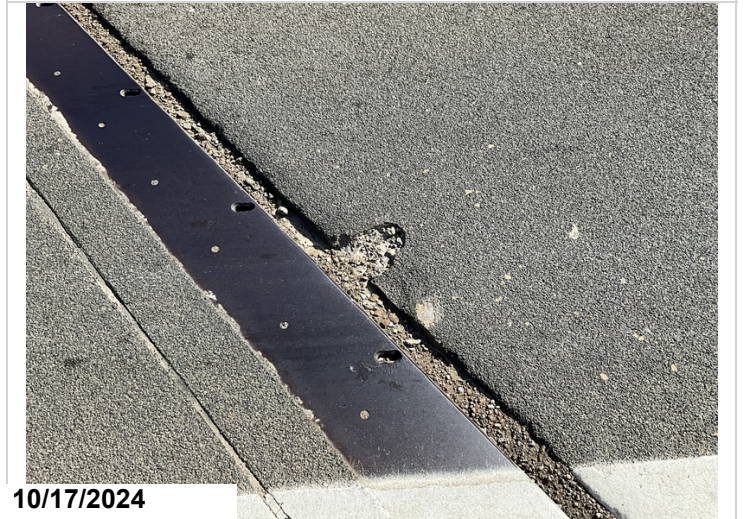
10/17/2024

Span 4, Bent 5: Spalling. 1' CS3.

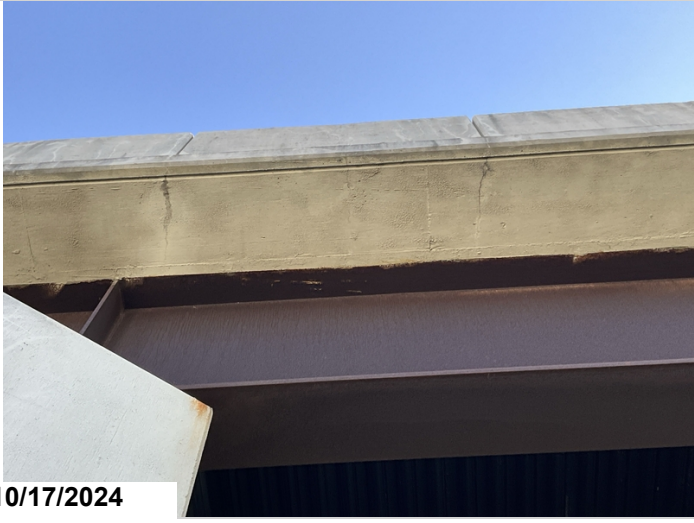
Overall, the Deck is in Good condition with a polymer overlay along the driving surface and transverse cracking along both overhangs throughout the structure.

Span 1, Left Overhang: 23 SF CS2 cracking. right 29.
Spans 2 & 3, Left Overhang: 47' CS2 Cracking. Right
Overhang: 58' CS2 cracking.
Span 4, Right: 27'. Left: 32'.

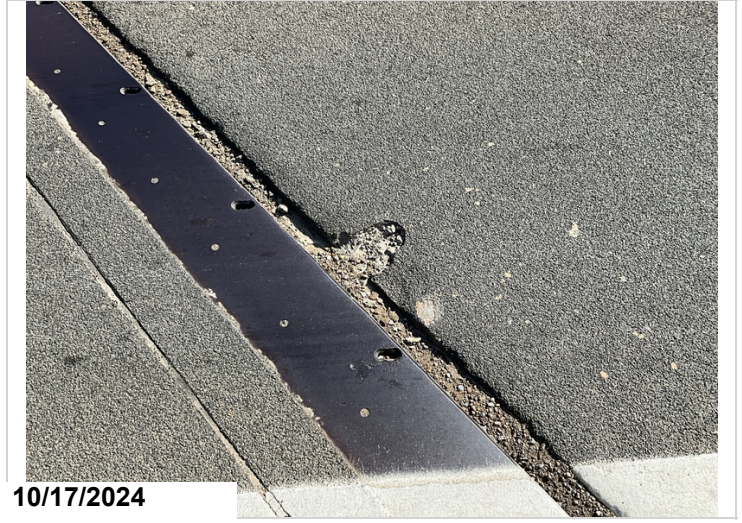
Span 4, Bent 5: Spalling. 1' CS3.

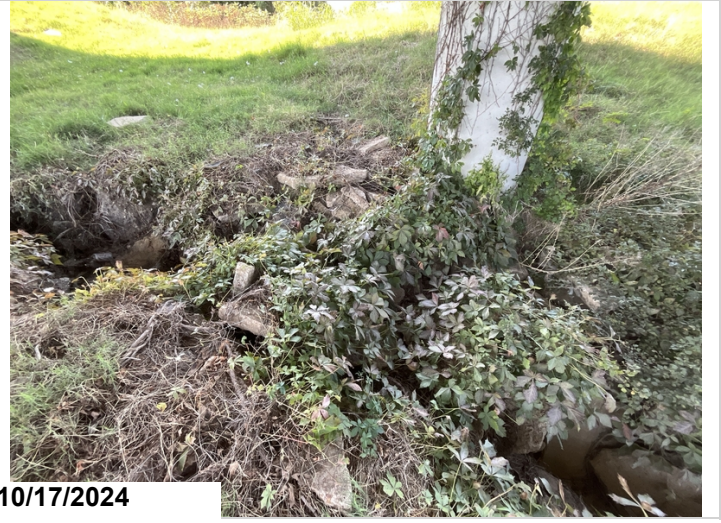
Overall the scour condition is in good condition with minor erosion around bent 2, Column 1.

Bent 2, Column 1: Minor erosion around the column, 1EA, CS2.

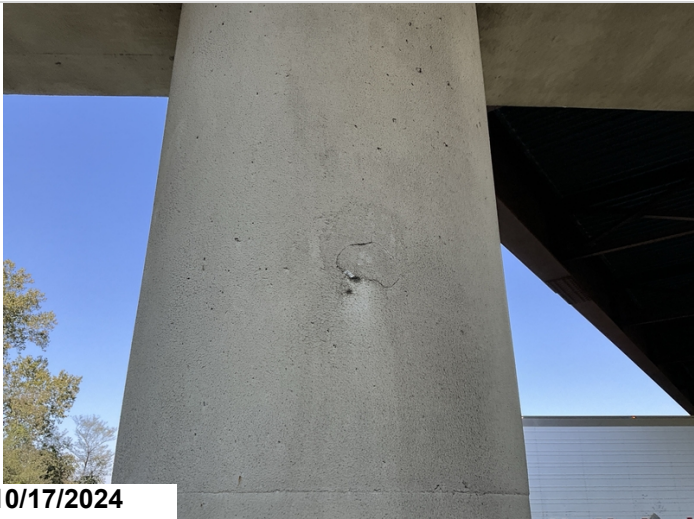
Overall, the Substructure is in Good condition with only minor vertical cracking and efflorescence in the back walls of the abutments. Column 1 at Bent 3 is cracking, and erosion is along column 1 at Bent 2.

Bent 3, Column 1: Cracking, 1EA CS2.

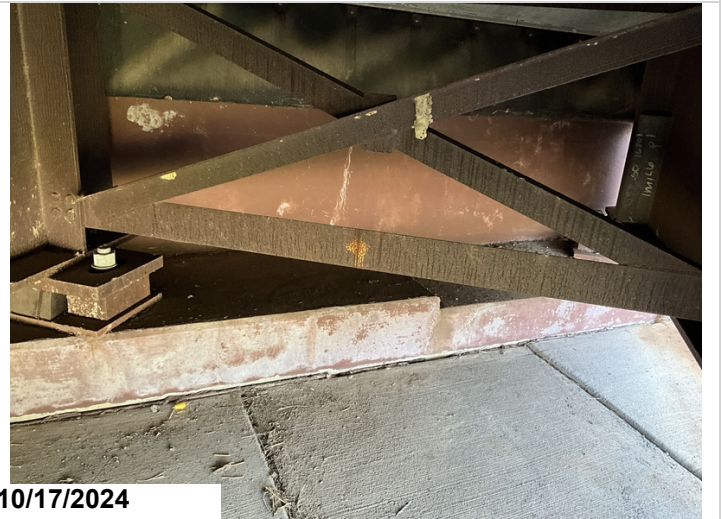
Bent 1: Vertical cracking with efflorescence. 2' CS2.

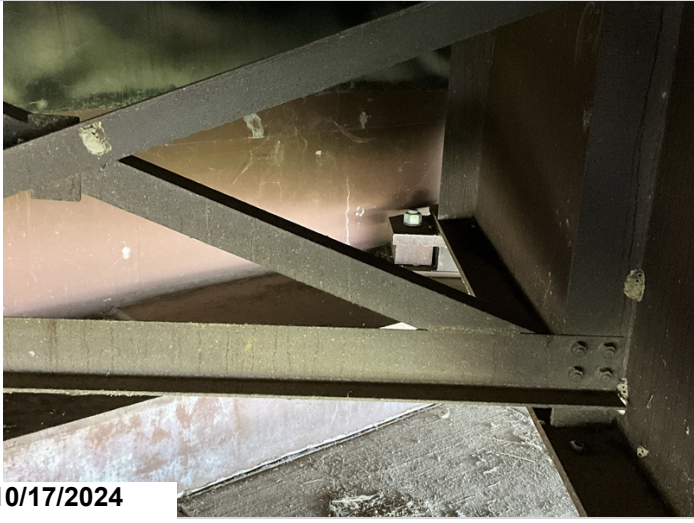
Bent 5: Vertical cracking with efflorescence. CS2. 1'.

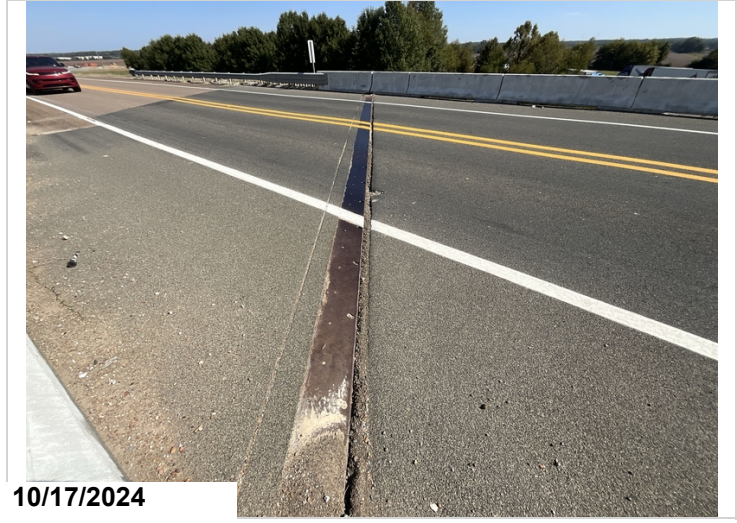
Overall the joints are in satisfactory condition with widespread minor debris impaction and some spalling adjacent to header.

Bent 5, Joint: Debris impaction. 38LF CS2.

Joints have debris impaction, needing flushed/cleaned.

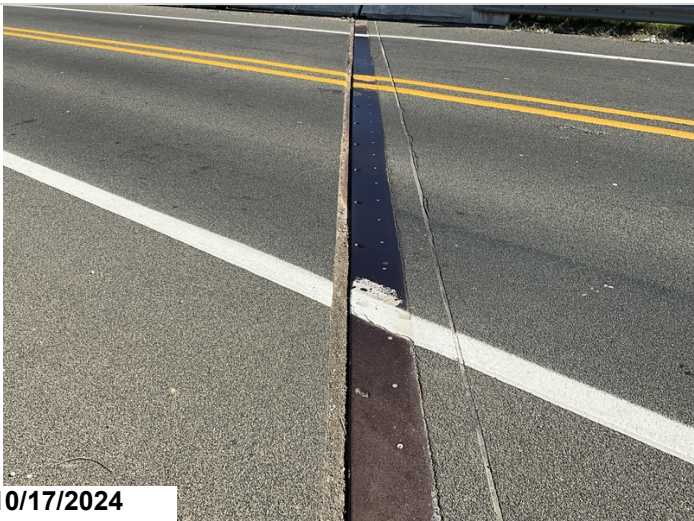
Bent 1, Joint: Debris impaction. 41LF CS2.

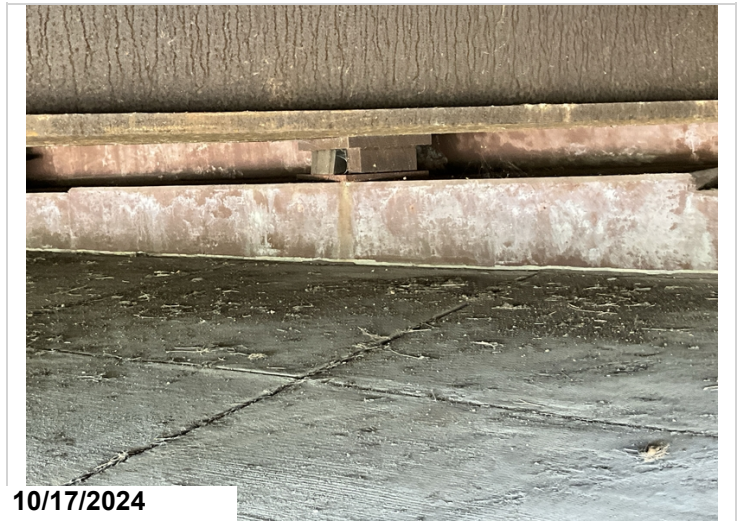
Overall the bearings are in good condition with some having minor misalignment.

Bent 1, Bearing: Leaning towards Bent 1. 67 degrees on 10/15/2024.

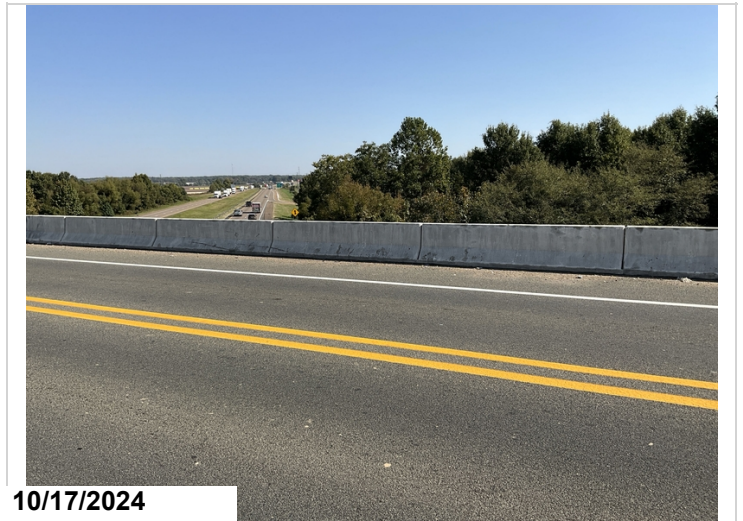
Overall the bridge railing is in good condition with minor vertical cracking and some damage.

Span 2, Right: Minor collision damage. 10'.

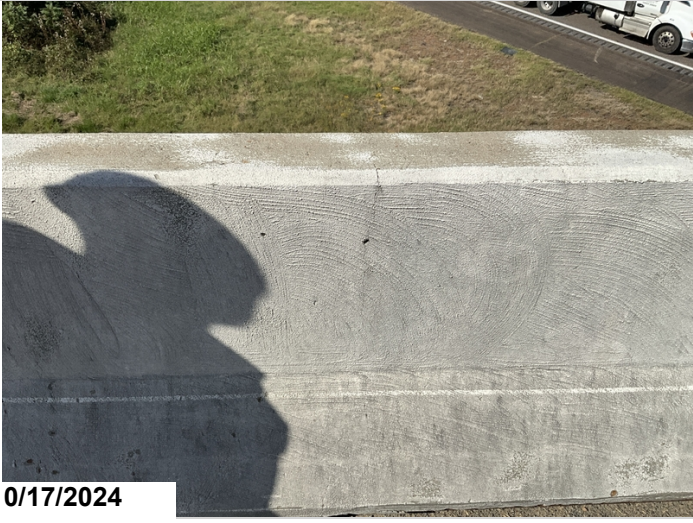
Typical vertical cracking. CS2.

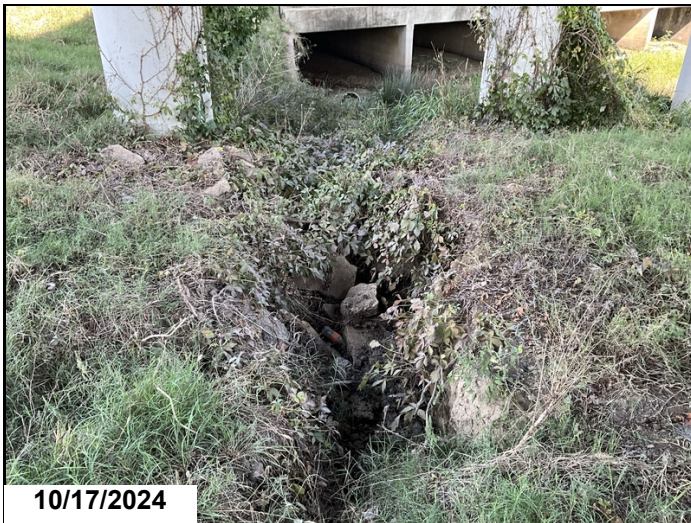
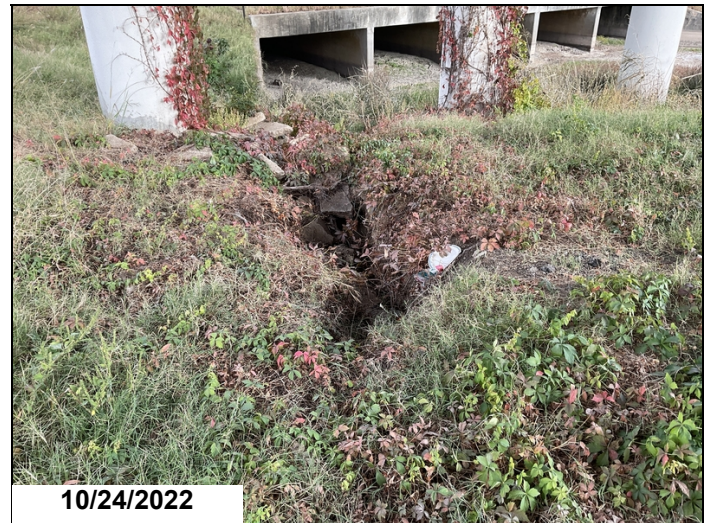
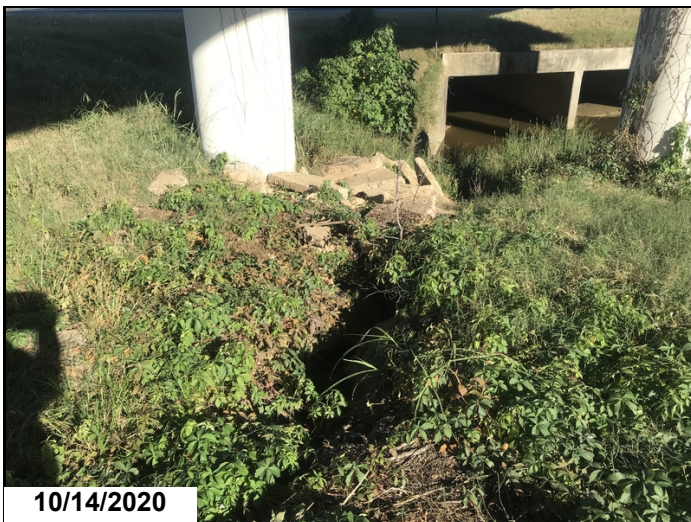
Span #1, near bent #2 column #1 has 3' wide by 3' deep vein of erosion.

Span 1, Bent 2: Erosion around Column 1.

Erosion span #1 near bent #2

Type of Work: Repair (General)

Status: Monitor

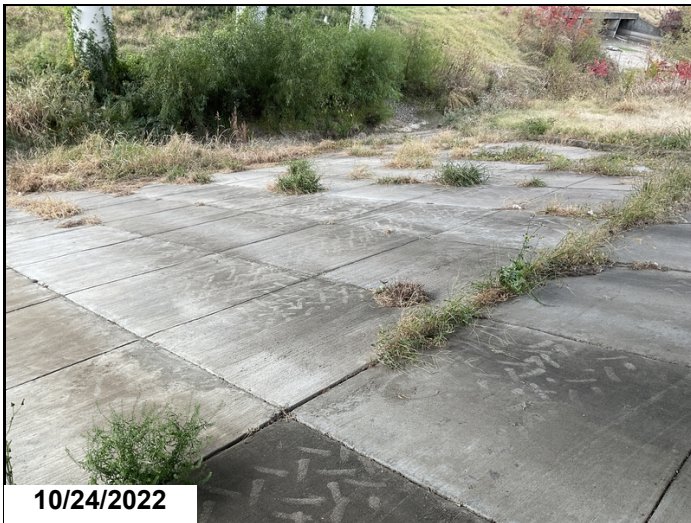
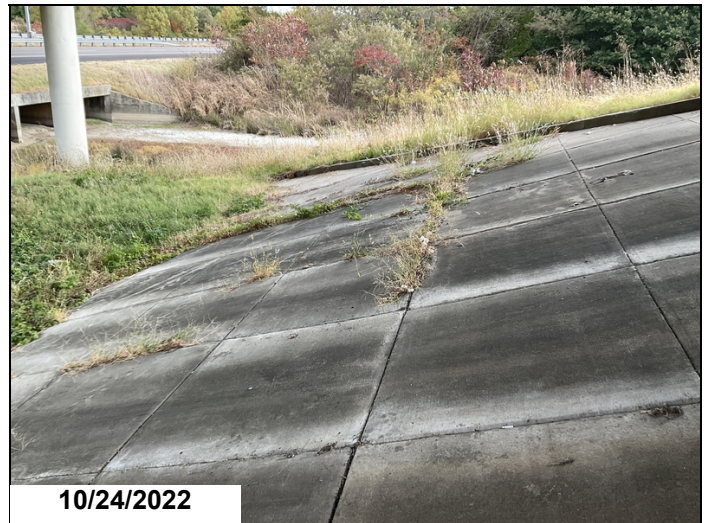
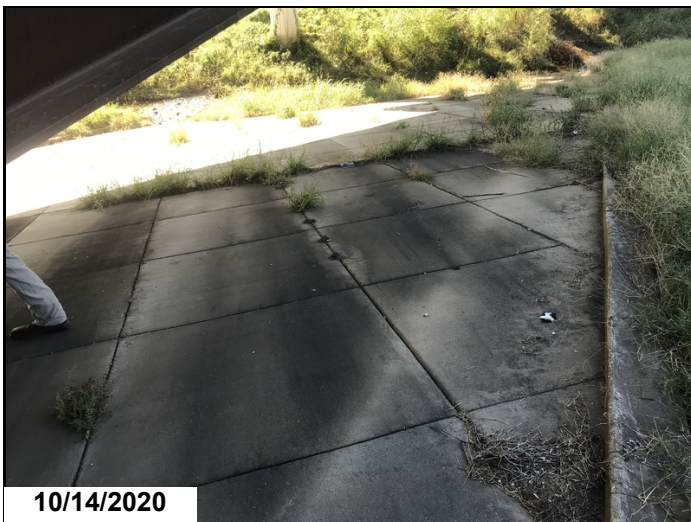
Slope paving has vegetation growing in joints.

Vegetation growing in slope pavement joints abutment #2

Vegetation growing in slope pavement joints abutment #1

Vegetation growing in slope paving joints.

Type of Work: Miscellaneous

Status: Monitor

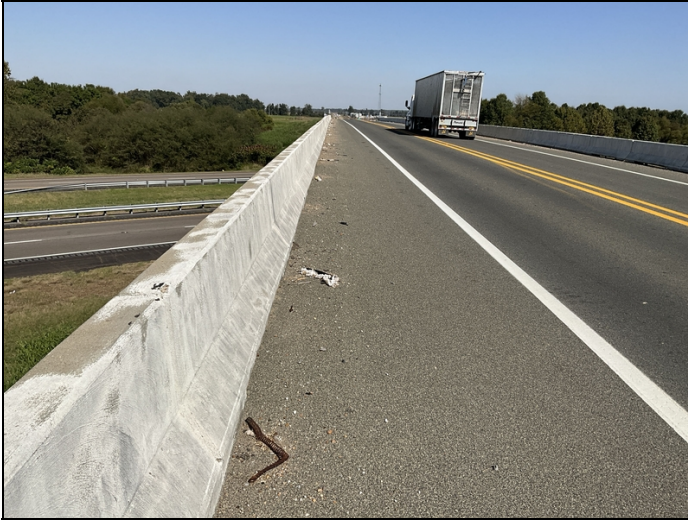
Deck has dirt & debris along gutter lines.

A-55 - Deck Washing Needed (Yes)
Deck has dirt & debris along gutter lines.

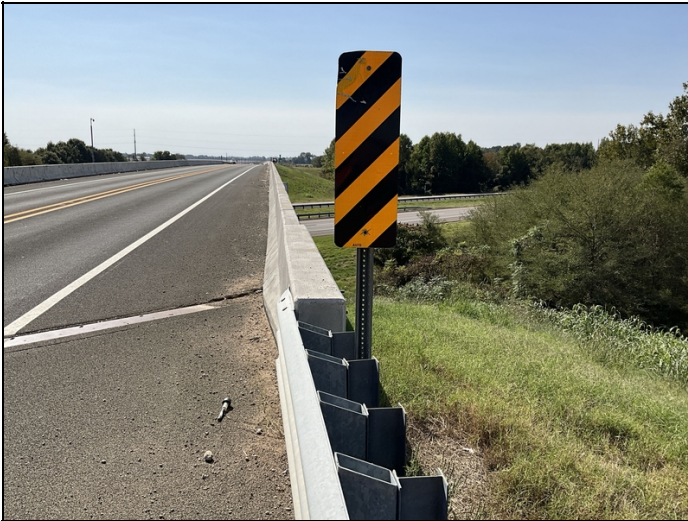
Log mile signs missing.

A-63 - Missing/Incorrect Log Mile Signage (Yes)
Log mile signs missing.

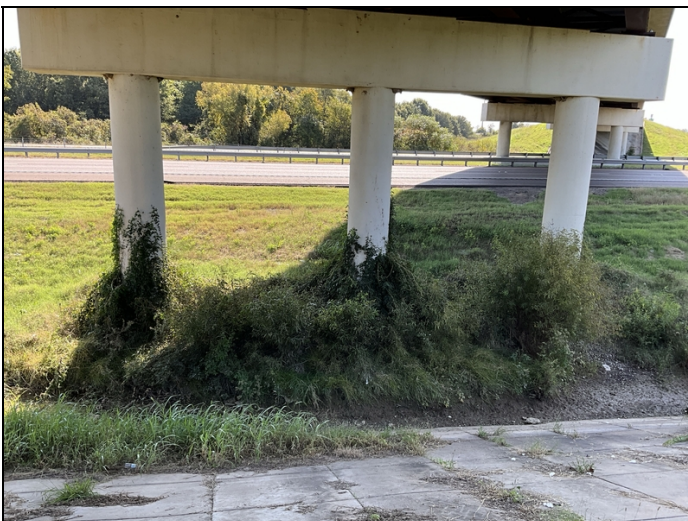
Bent 4: Vegetation growth.

A-64 - Vegetation Removal Requested (Yes)
Bent 4: Vegetation growth.
