Bridge A3732 Inspection Report

Asset #A3732(Routine, Underwater type 2)

I-40WB/Se43/217.76 over Piney Ditch

Team Lead: Myron Futrell Inspection Date: 12/19/2024

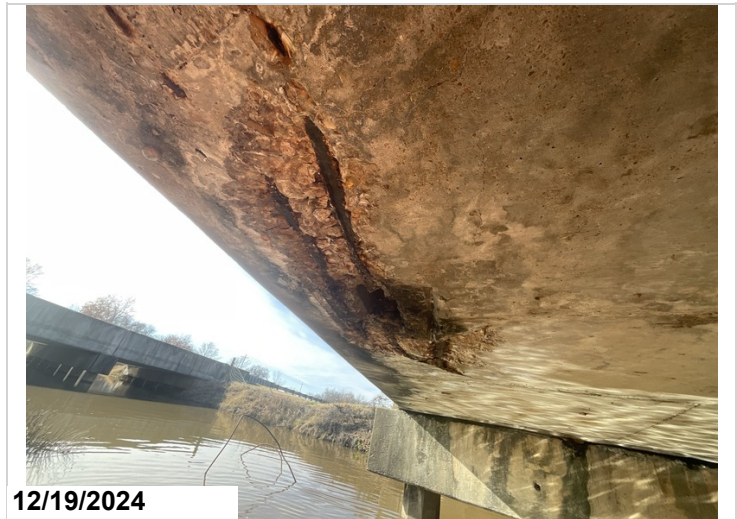
Span 2, undersurface of deck, at right deck drain: spalled at right deck drain with exposed reinforcing steel with moderate section loss, 1' by 3'.

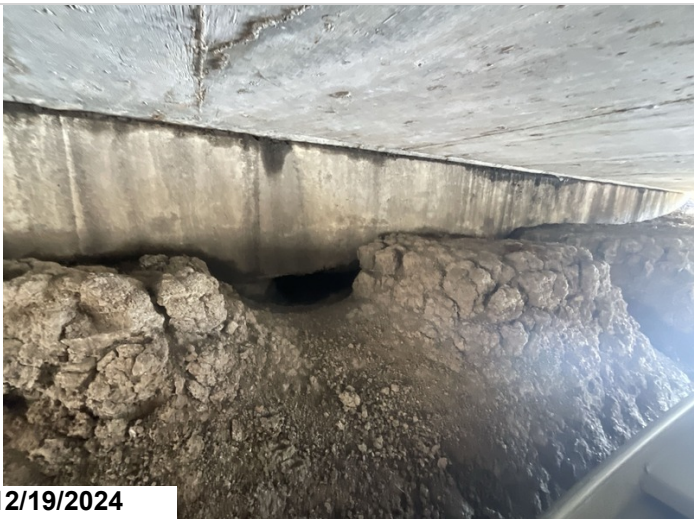
Abutment 2, by pile 3: large animal hole under cap exposing pile 3 up to 1'.

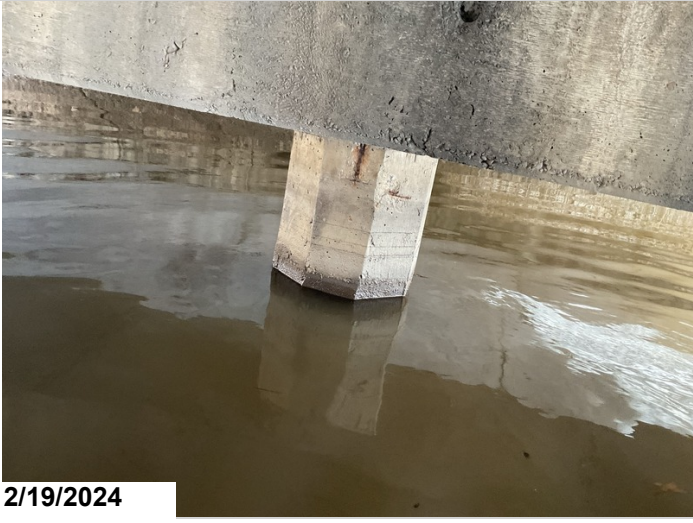
Bent 2, pile 4, at top: two small pieces of exposed reinforcing steel due to poor concrete coverage.

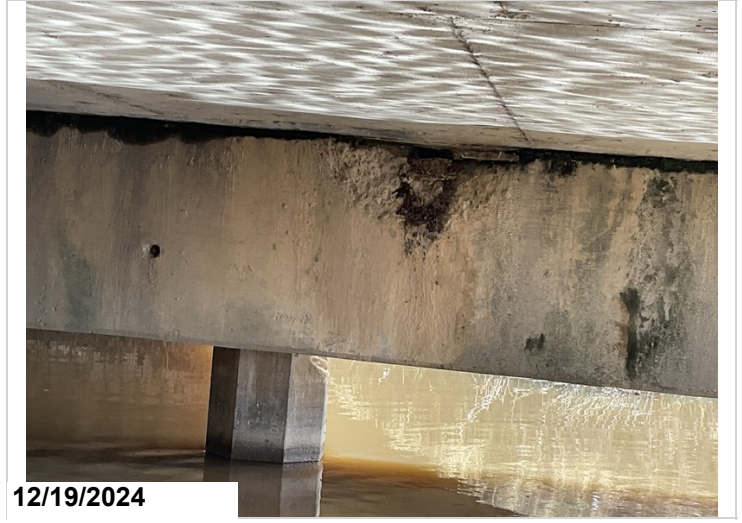
Reinforced concrete substructure is in overall fair condition. Abutment 1 cap has minor erosion. Bent 2 cap has a moderate spall with no exposed reinforcing steel and bent 2 piles have minor abrasion.

Bent 2, pier cap, back, between piles 6 and 7, at top: spalled with no exposed reinforcing steel.

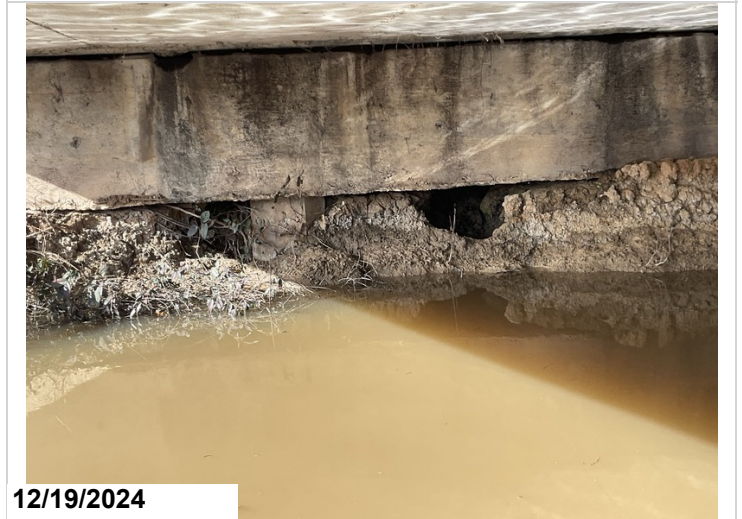
Channel banks are vegetated with minor slumping channel has large amounts of debris restrictions. Slopes have moderate erosion at abutments exposing several piles.

Abutment 1, right side: cap undermined 6' up to 2' deep exposing pile 6.

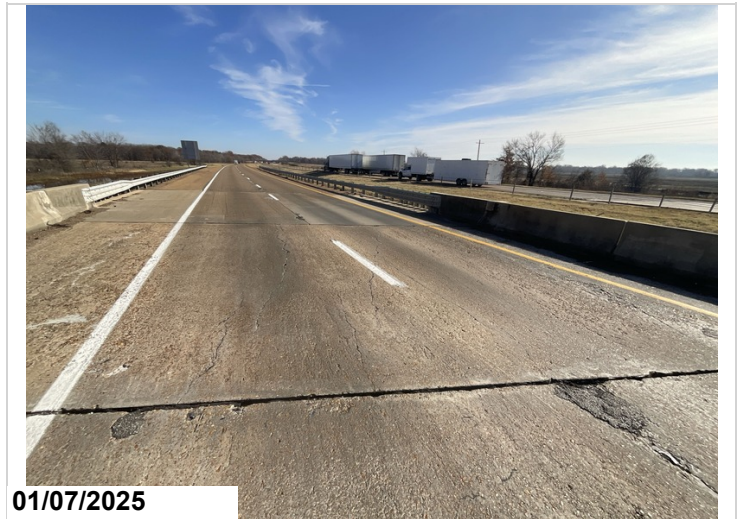
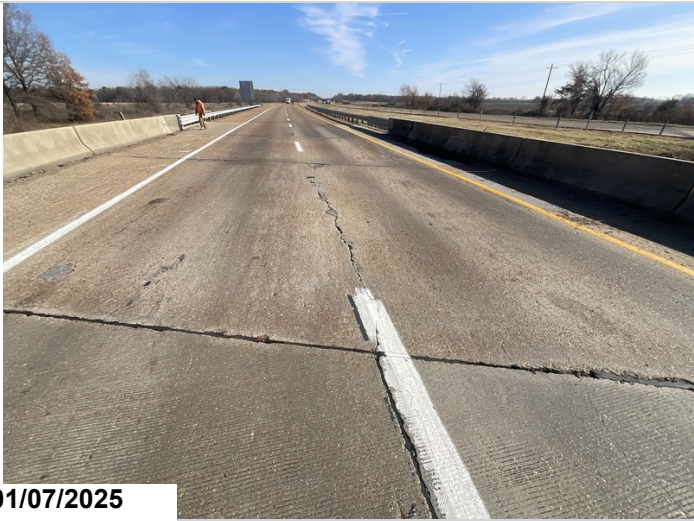
Deck has multiple sealable cracks.

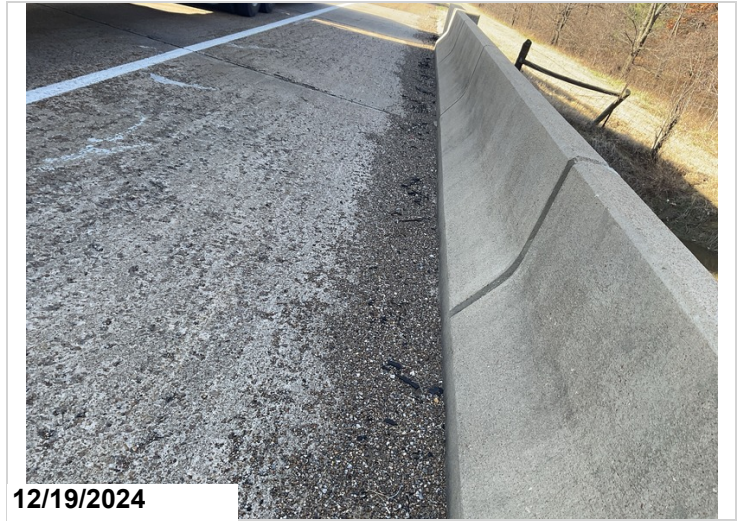
Dirt and debris in gutters.

Dirt and debris in gutters

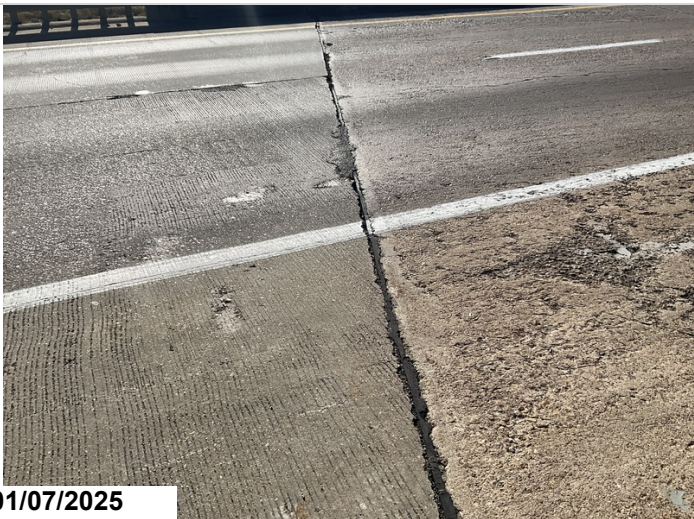
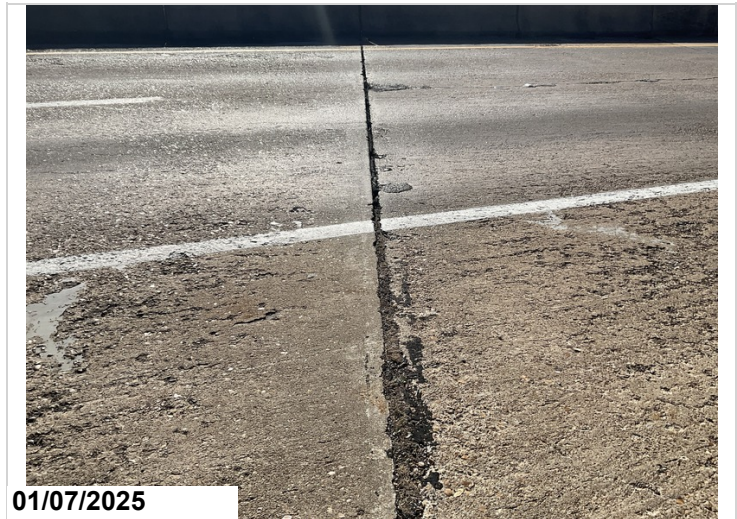
Joints have areas of missing or damaged material.

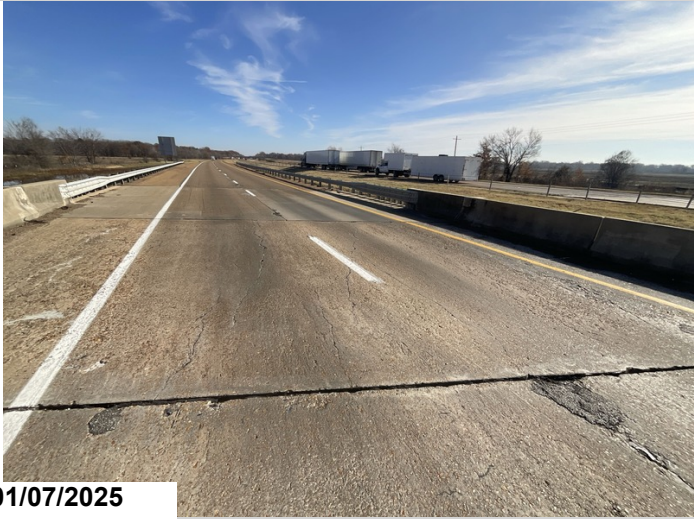
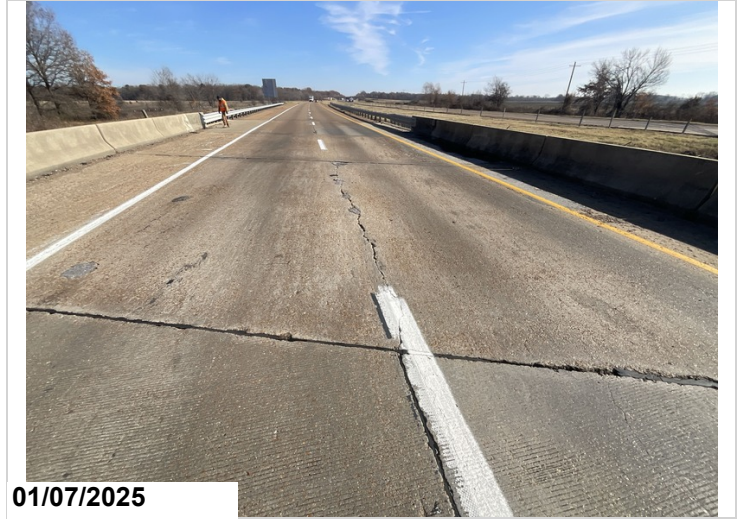
Deck has numerous longitudinal cracks, and areas of heavy scaling.

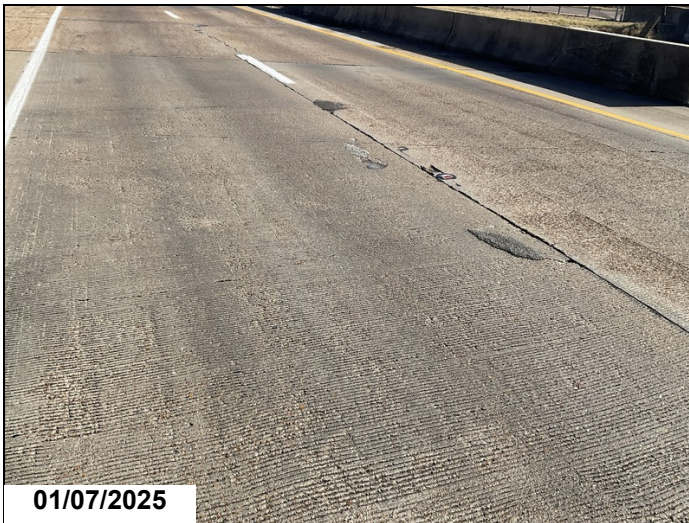
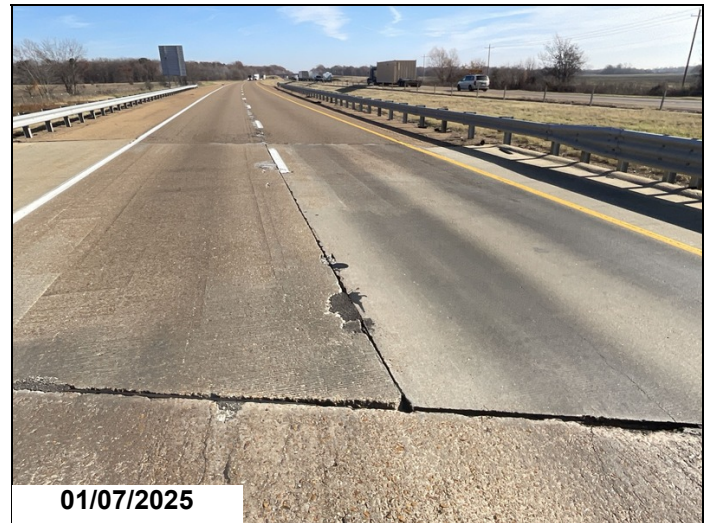
Approach slabs: moderate sized open cracks.

Type of Work: Approach Leveling/Maintenance

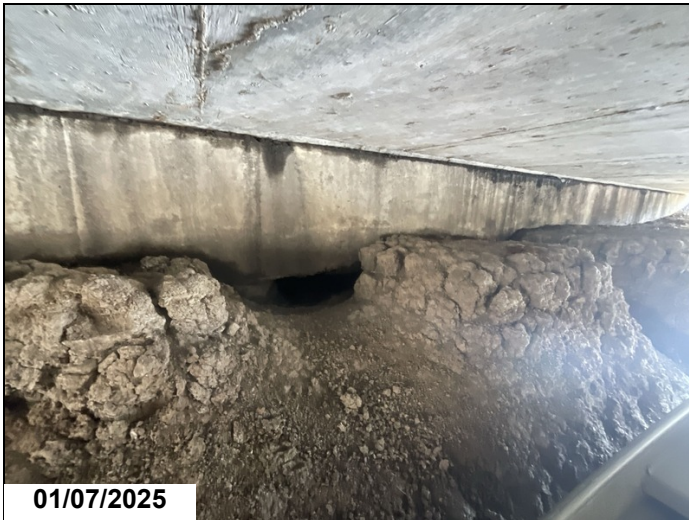
01/07/2025

Abutment 2, pier cap: large animal hole under cap exposing pile 3 up to 1'.

Abutment 2, by pile 3: large animal hole under cap exposing pile 3 up to 1'.

Type of Work: Channel Work/Drift Removal

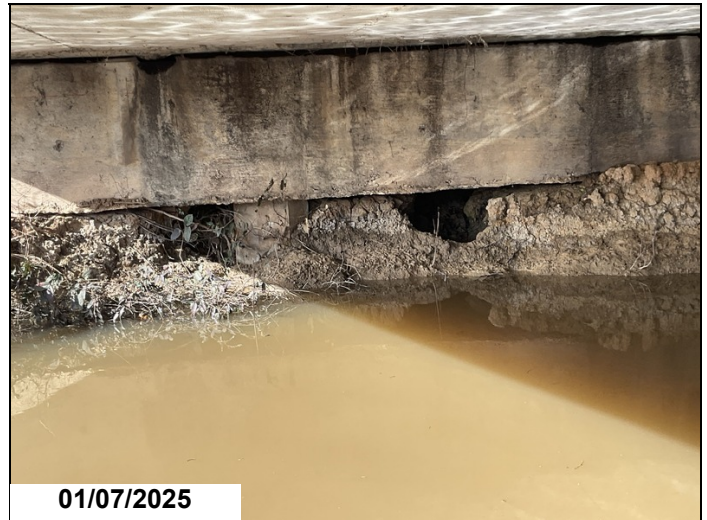
01/07/2025

Abutment 1, pier cap, right side: undermined 4' up to 1' deep exposing one pile.

Abutment 1, right side: cap undermined 6' up to 2' deep exposing pile 6.

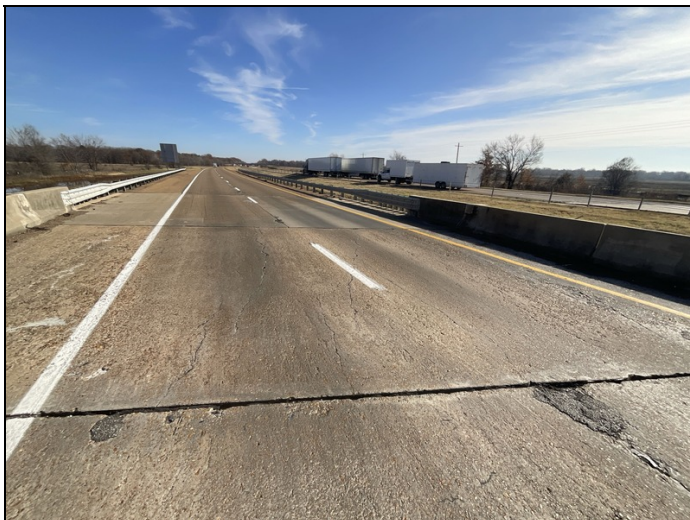
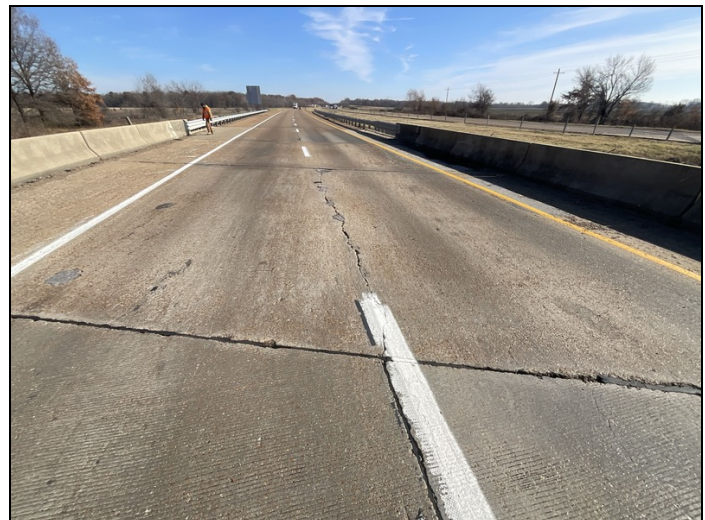
Deck has multiple sealable cracks.

A-54 - Sealable Deck Cracks (Yes)

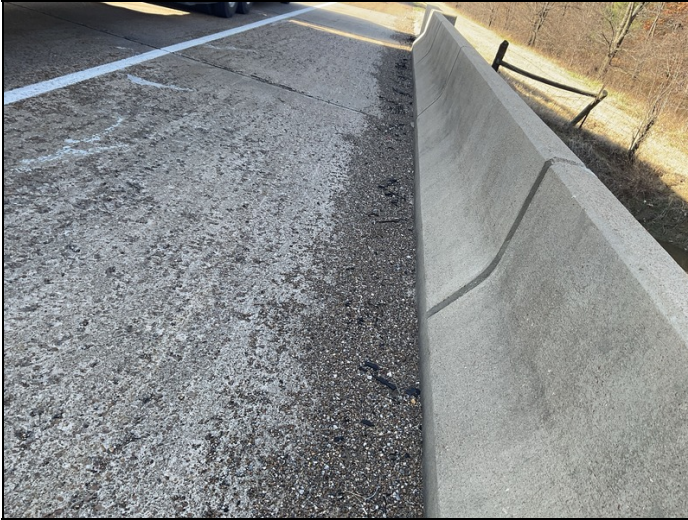
Dirt and debris in gutters.

Dirt and debris in gutters

A-55 - Deck Washing Needed (Yes)

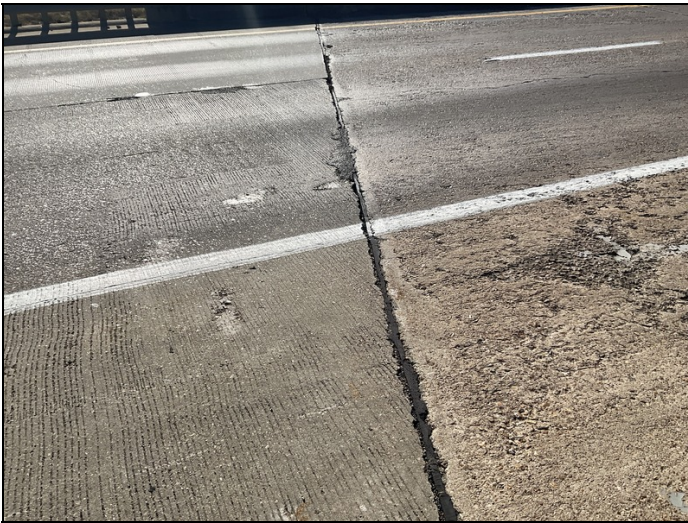
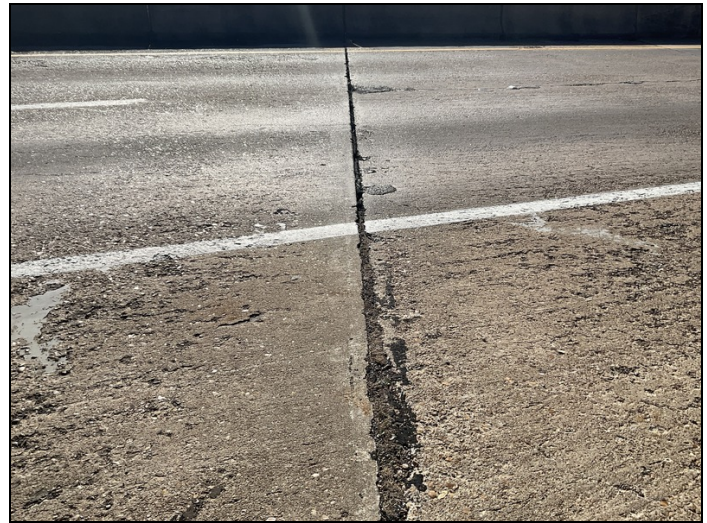
Joints have areas of missing or damaged material.

A-59 - Joint Repair Needed (Yes)

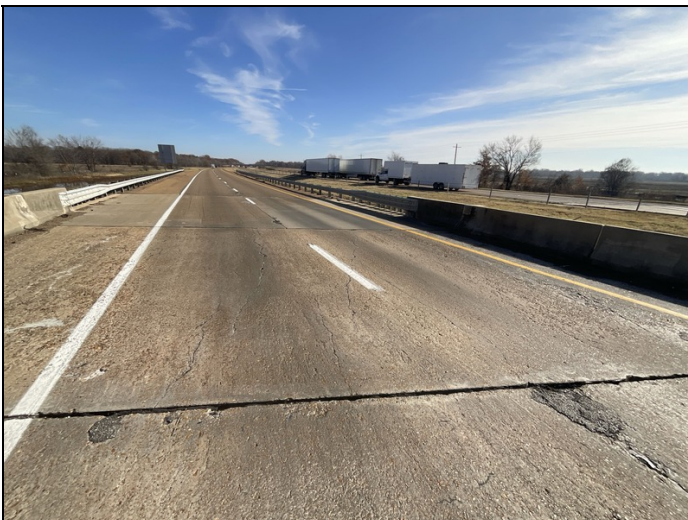
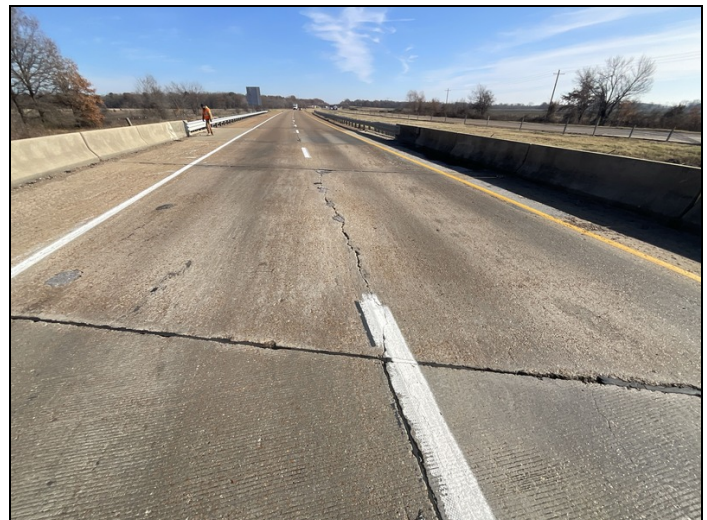
Deck has numerous longitudinal cracks, and areas of heavy scaling.

A-62 - Hydro and LMC Advised (Yes)
