Bridge A3766 Inspection Report

Asset #A3766(Routine, Underwater type 2)

I-40WB/Se51/219.89 over Flat Fork Creek

Team Lead: Myron Futrell Inspection Date: 02/06/2024

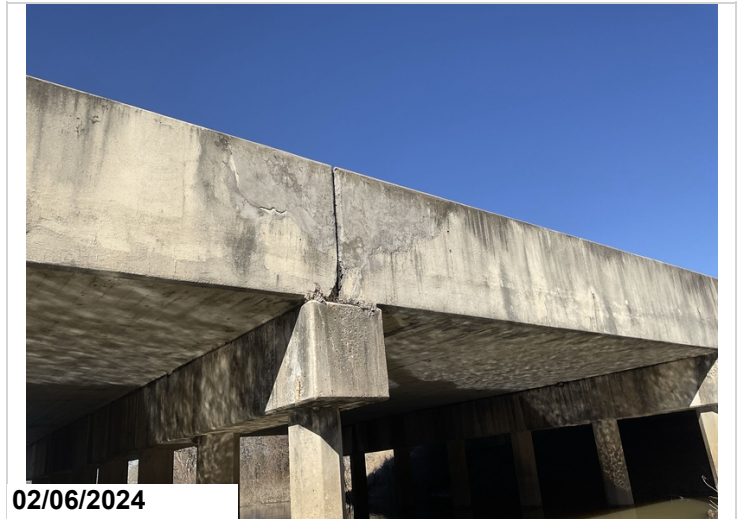
Spans #3 and 4 right bridge rail patched

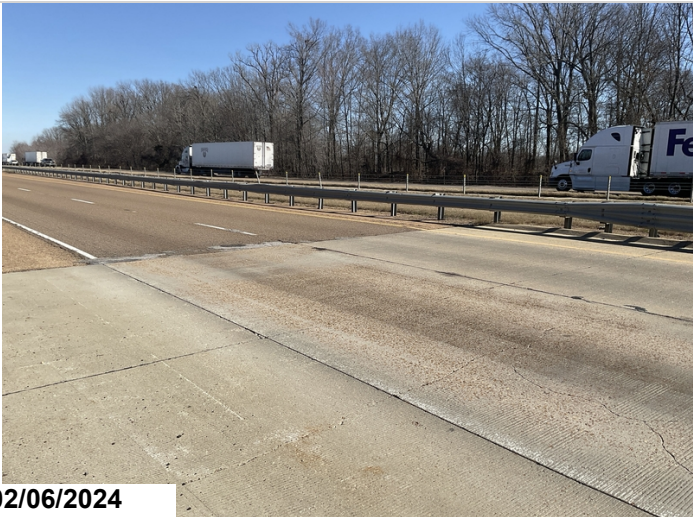
Abutment #2 right approach rail has several areas of moderate collision damage

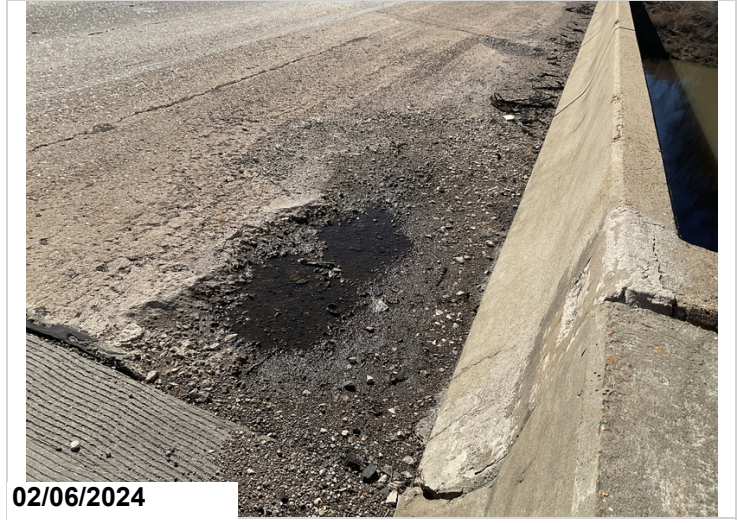
Heavy scaling in span #5 left gutter

Span #5 left gutter has two areas of heavy scaling seventeen square feet total one at each bent.

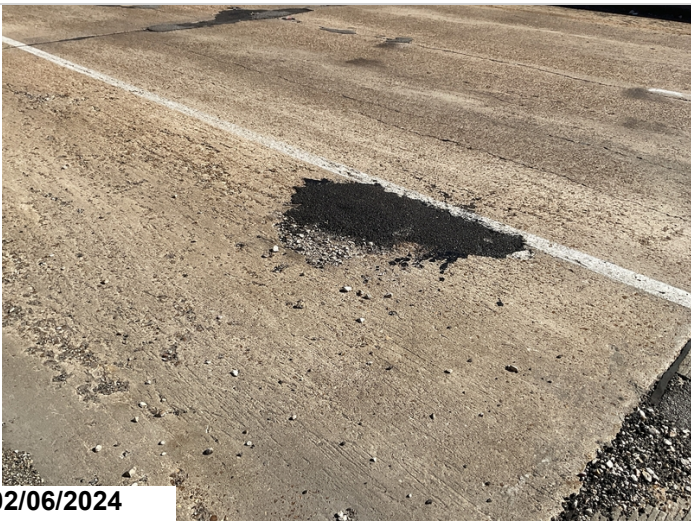
ACHM patch in span #1 left lane

Span #1 has 12 square feet of asphalt repairs with spalling around edges and eight square feet of sound concrete repair at bent #2.

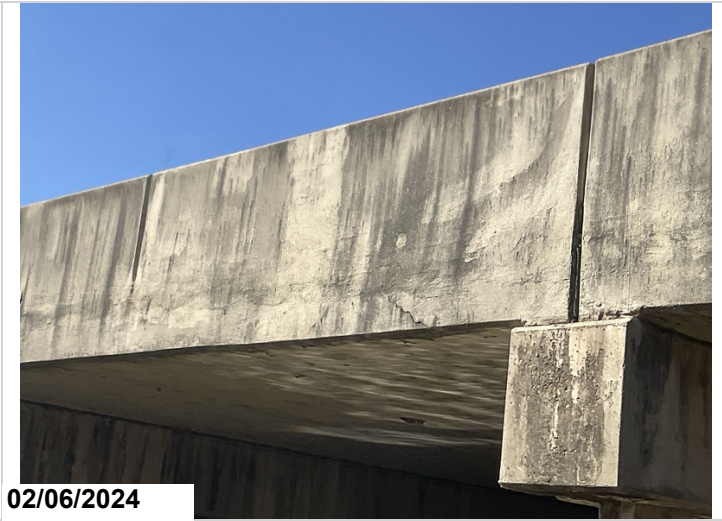
Span #2 right side of slab at bent #3 cracked

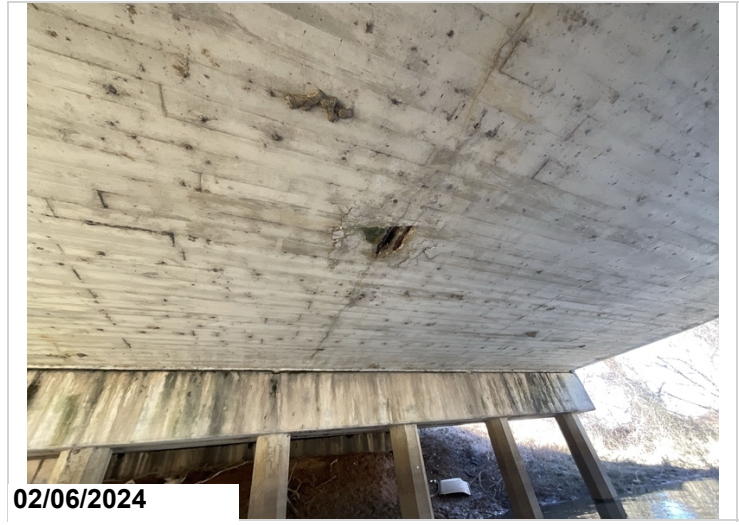
Typical soffit spall with exposed rebar

Soffit-under surface all spans have one foot spalls at sona-void drains with exposed rebar with minor section loss.

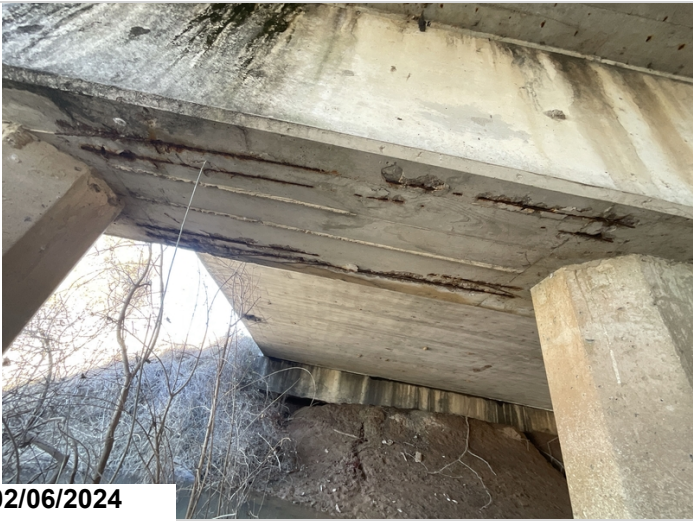
Concrete substructure is in overall satisfactory condition. Caps have moderate amounts of exposed rebar due to spalling and poor concrete coverage. Piles have minor abrasion with no loose aggregate. Abutment #2 cap left side is undermined up to one foot for six feet with one exposed pile.

02/13/2018 lowered substructure from 7 to 6 due to spalls on caps.

Typical exposed rebar on bottom face of caps

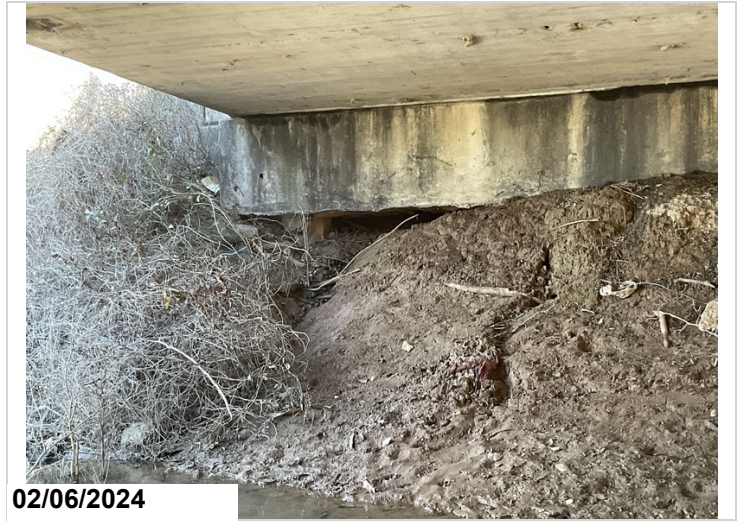
Channel is in overall satisfactory condition. Banks are slumping somewhat and there is moderate erosion at abutment #2 exposing one pile. Channel alignment is good and there is some vegetation growing into channel.

Abutment #2 left side undermined up to one foot for six feet exposing pile #2

Abutment #2 slope cap is undermined up to one foot for six fee exposing pile #1.

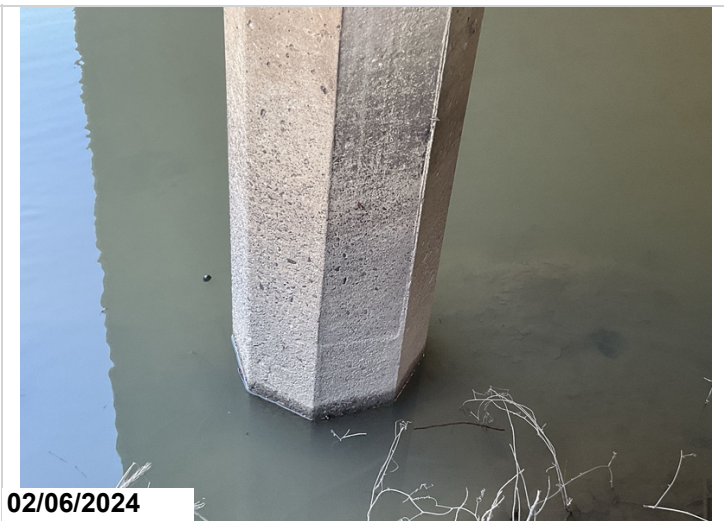
Typical light abrasion on piles

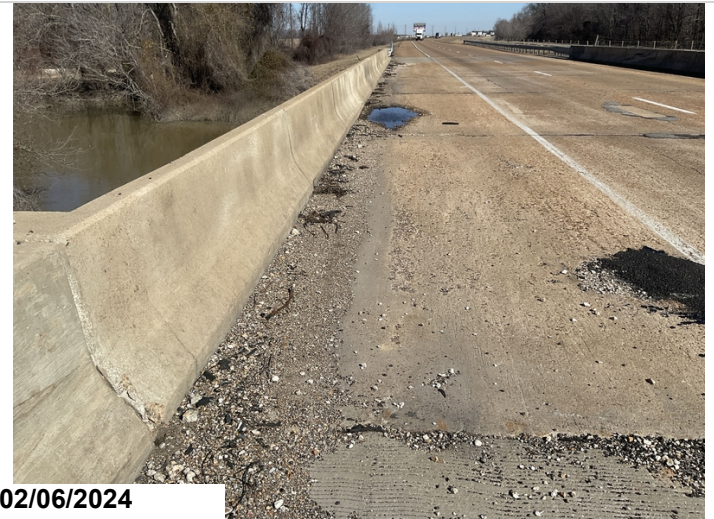
Gutters have dirt and debris in them.

Dirt and debris in gutters

A-55 - Deck Washing Needed (Y)

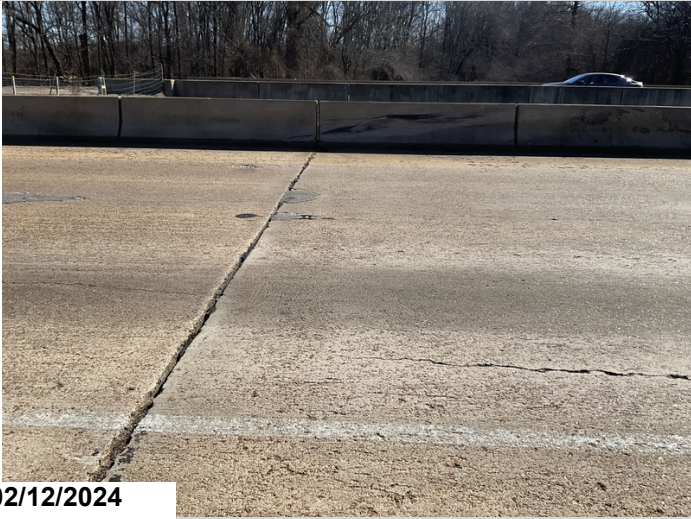
Deck joints have areas of missing and damaged joint sealer.

Bent #5 joint

A-59 - Joint Repair Needed (Yes)

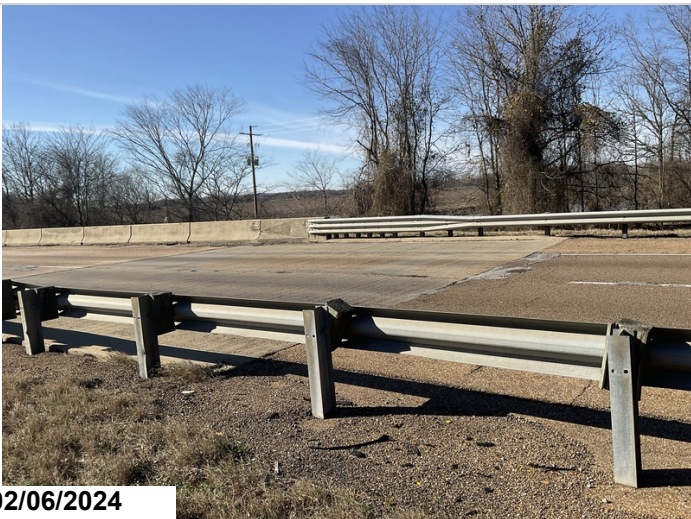
No log mile signs in place.

No log mile sign

A-63 - Missing/Incorrect Log Mile Signage (Y)

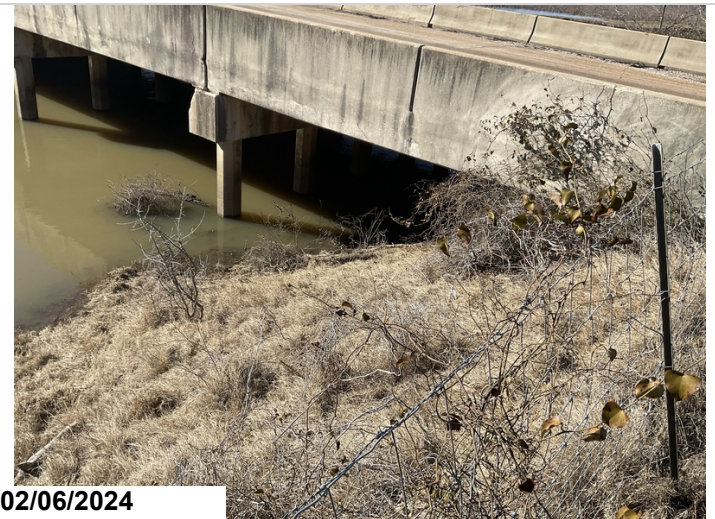
Small trees and vegetation growing beside bridge at abutments.

Vegetation growing beside bridge.

A-64 - Vegetation Removal Requested (Y)

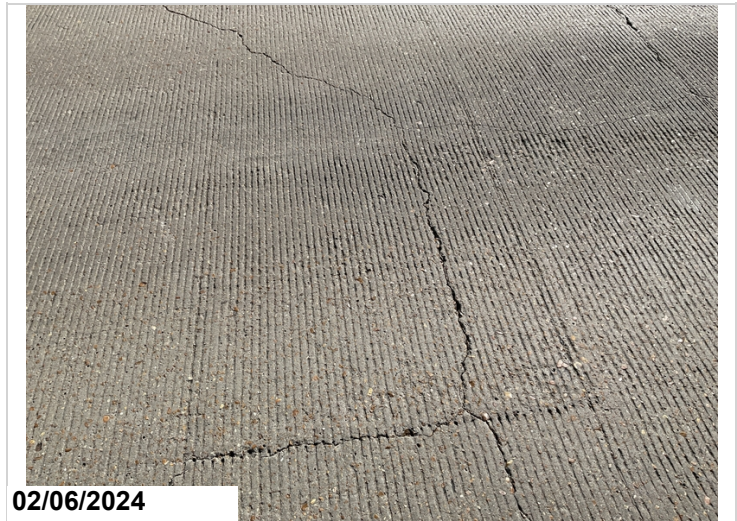
Typical approach slab cracks

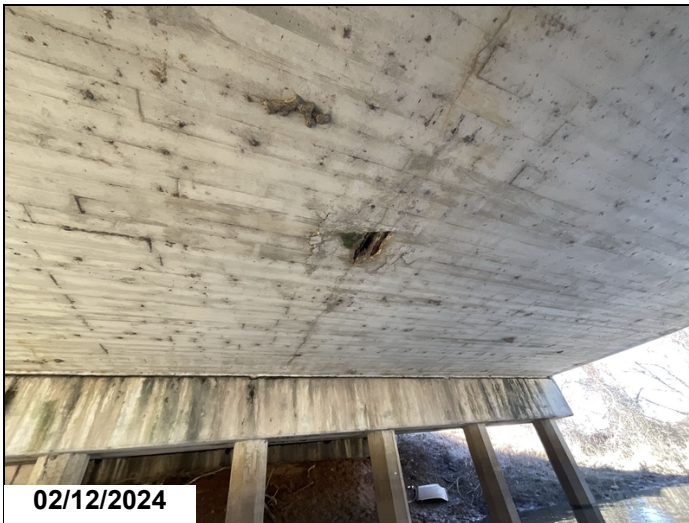
Typical soffit spall with exposed rebar

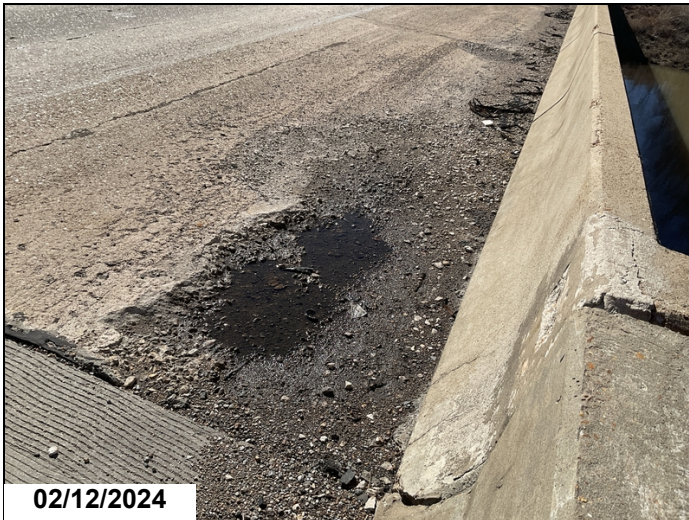
Heavy scaling in span #5 left gutter

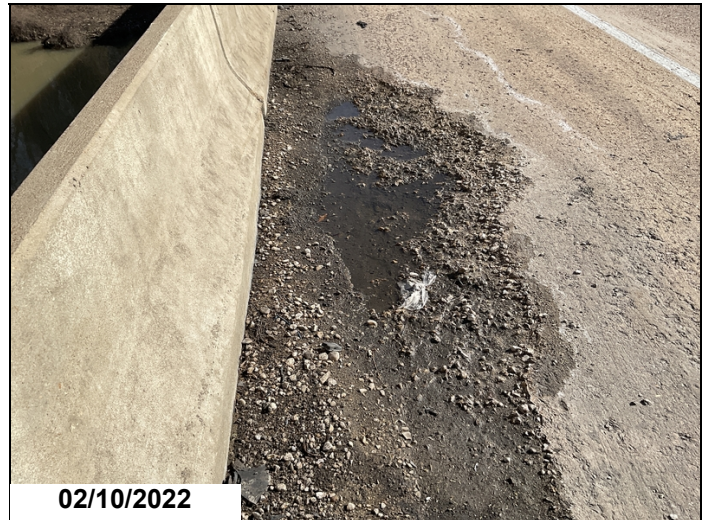
Span #2 left gutter has a 36' area 1" deep scaled area.

Span #2 left gutter has 36' of heavy scaling.

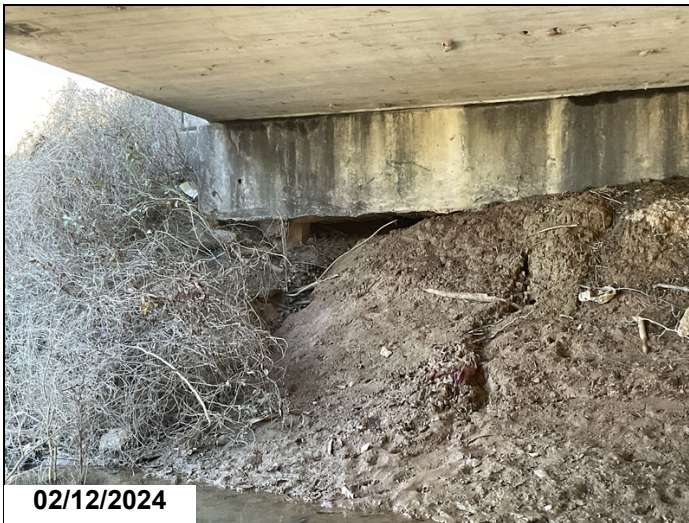
Abutment #2 left side undermined up to one foot for six feet exposing pile #2

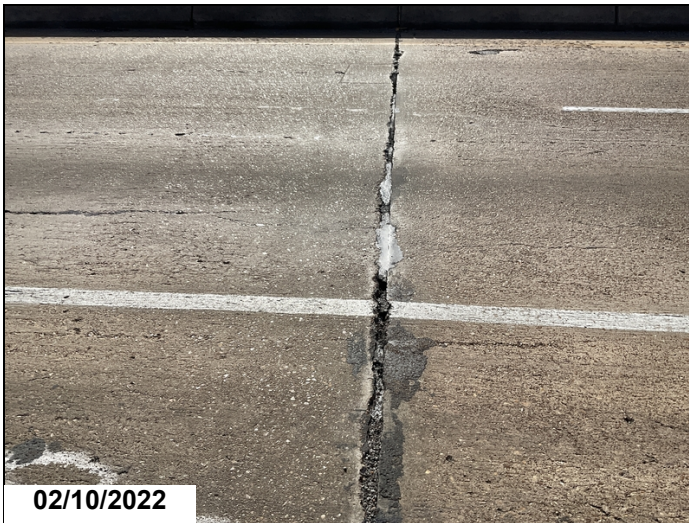
All joint seals are cracked leaking and allowing debris to enter.

Typical joint

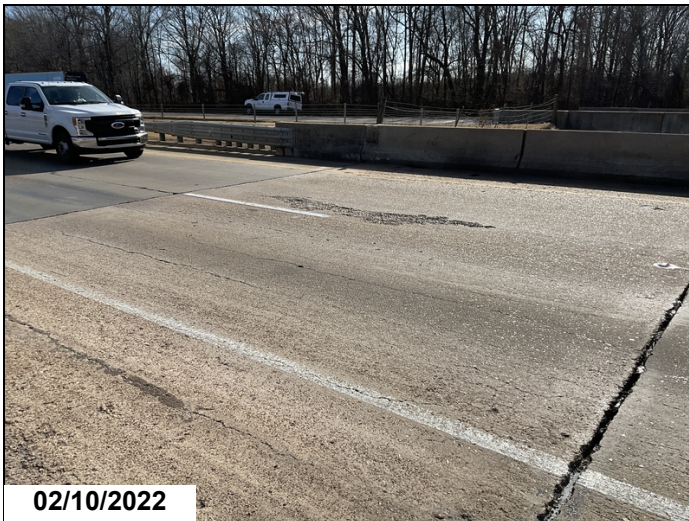
Span #5 right lane has a eight foot shallow spall with no exposed rebar.

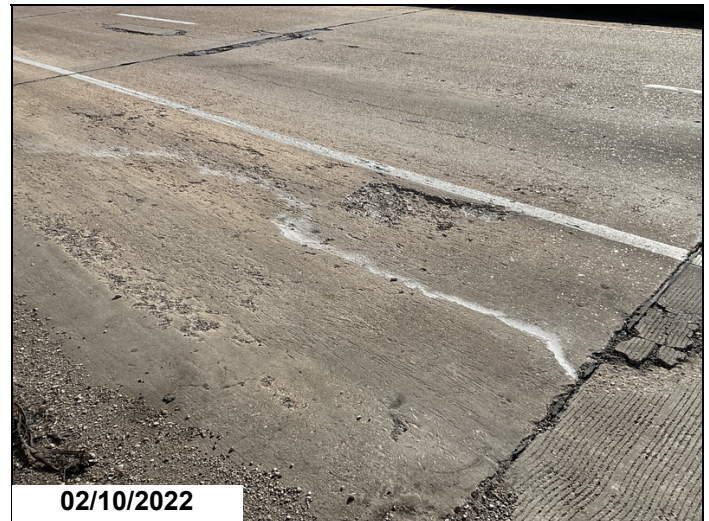
Span #1 left shoulder has two-foot spall no rebar exposed.

Span #1 left shoulder has two foot spall no rebar exposed.

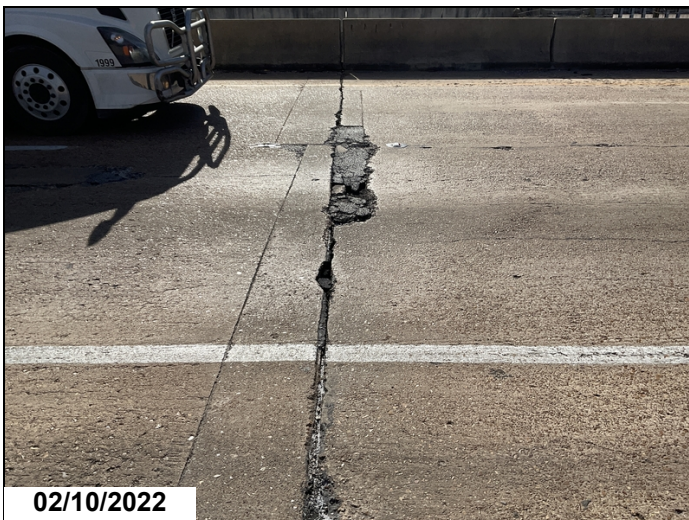
Span #1 has 4 square feet of asphalt repairs with spalling around edges, left lane and a 1'

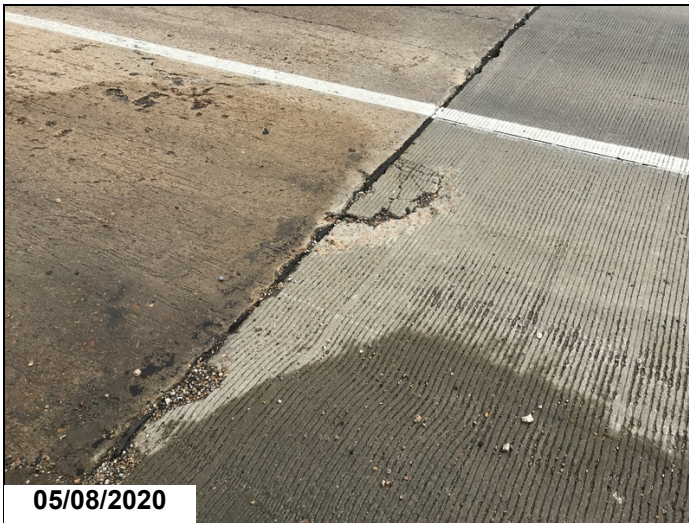
Abutment 1 left approach gutter 1' x 2' delamination and spall.

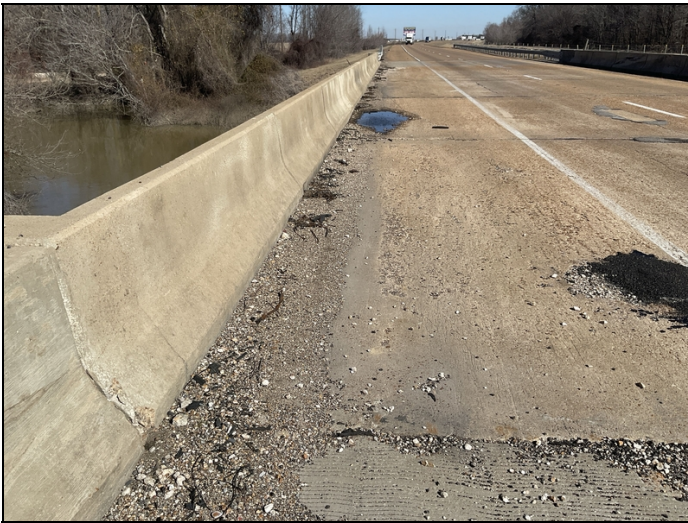
Gutters have dirt and debris in them.

Dirt and debris in gutters

A-55 - Deck Washing Needed (Yes)

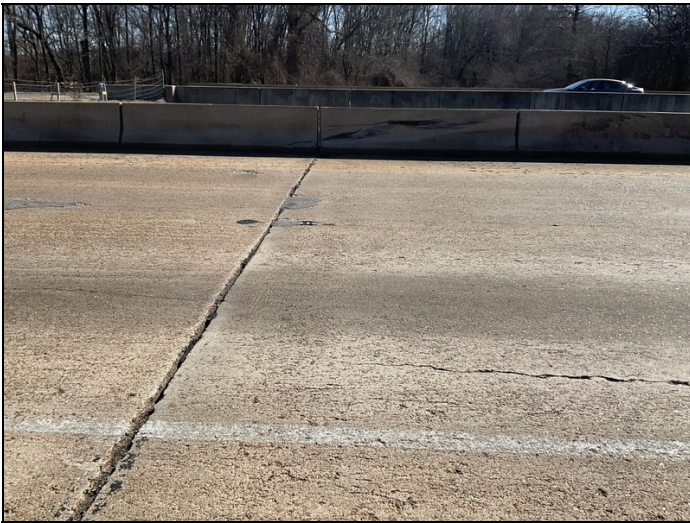
Deck joints have areas of missing and damaged joint sealer.

Bent #5 joint

A-59 - Joint Repair Needed (Yes)

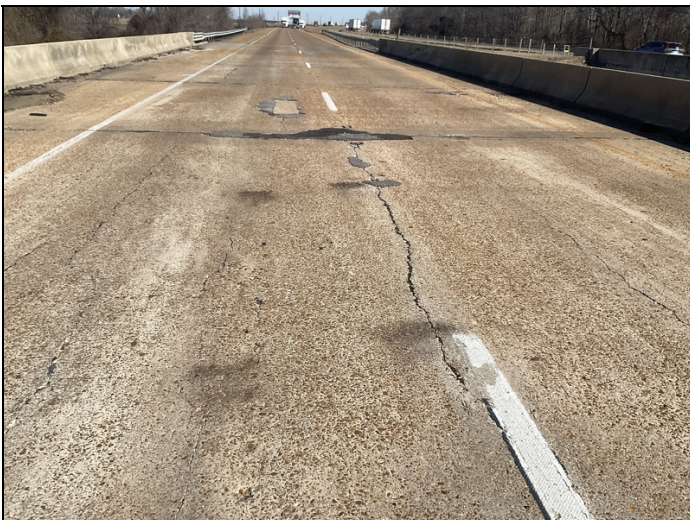
Deck has cracking, spalled and patched areas.

Typical deck

A-62 - Hydro and LMC Advised (Yes)

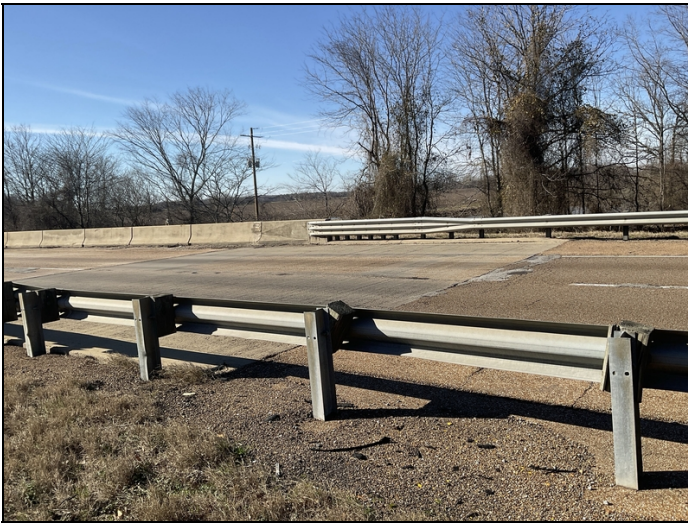
No log mile signs in place.

No log mile sign

A-63 - Missing/Incorrect Log Mile Signage (Yes)

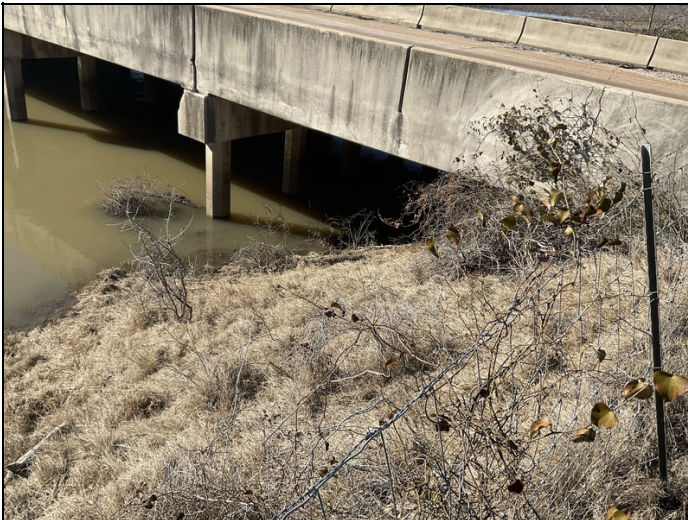
Small trees and vegetation growing beside bridge at abutments.

Vegetation growing beside bridge.

A-64 - Vegetation Removal Requested (Yes)
