Bridge A3769 Inspection Report

Asset #A3769(Record Change)

I-40WB/Se51/226.19 over Big Creek

Team Lead: Myron Futrell Inspection Date: 04/09/2024

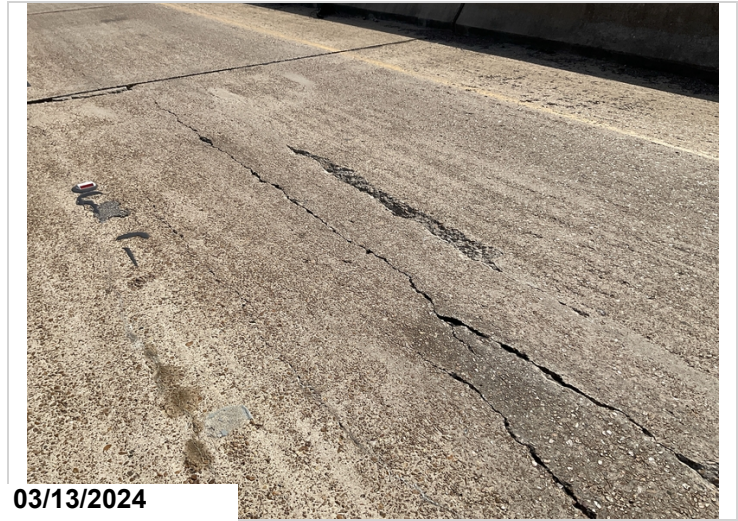
Deck, Span 3, right lane: spalled along crack, typical of left lane.

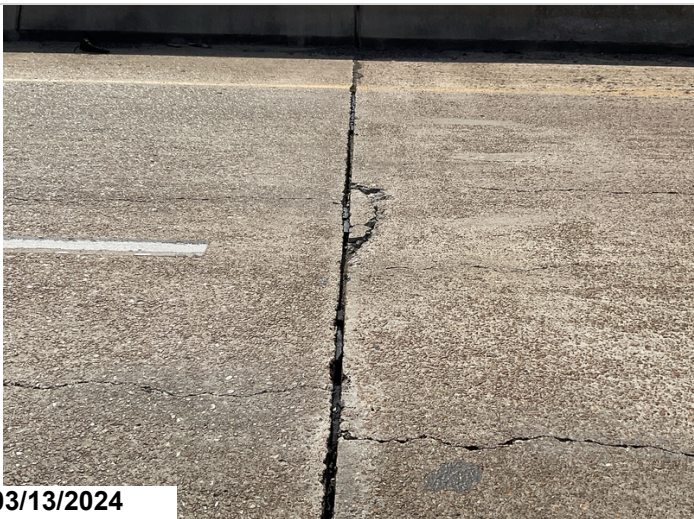
Deck, Span 3, Bent 4, Right Lane: 1' wide by 2' long spall / delaminated area. CS3

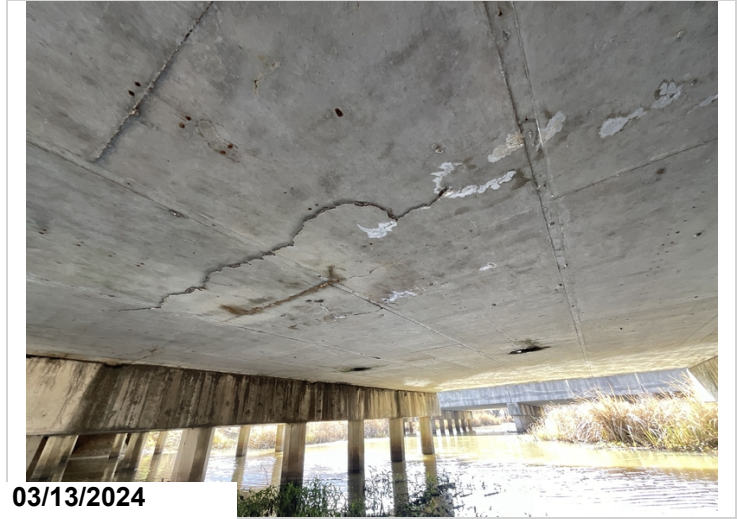
Span 2, soffit / under surface of deck, left side: has 4' wide by 6' long delaminated area

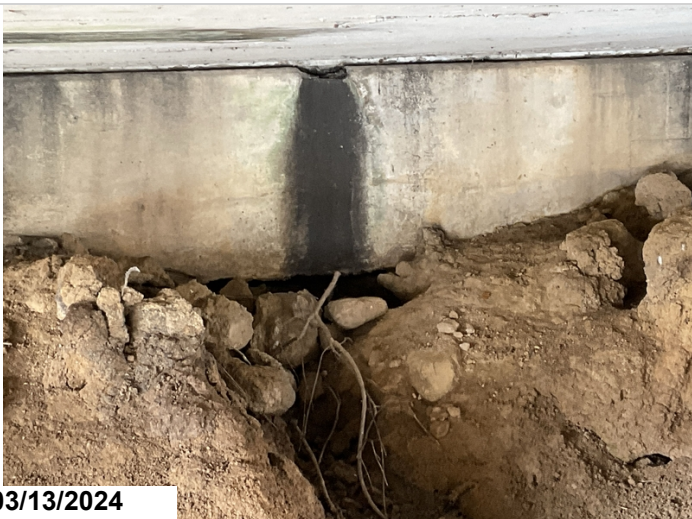
Abutment 1 slope eroded at centerline undermining cap for two feet up to one foot deep.

Abutment slopes have areas of erosion up to two feet deep.

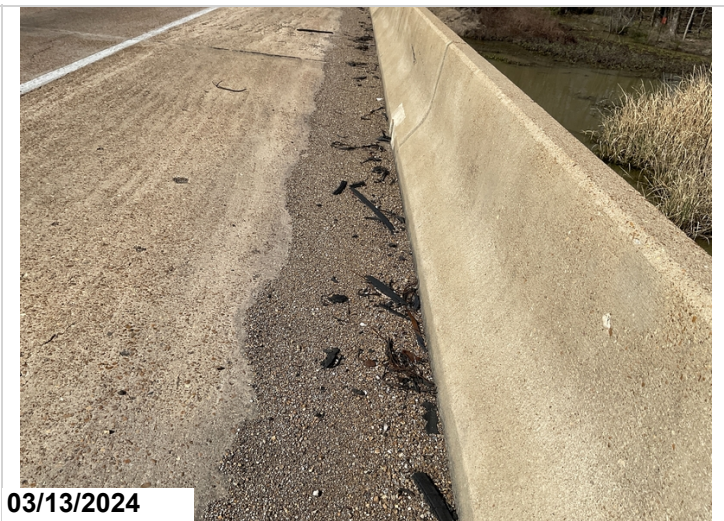
Gutters have dirt and debris.

Dirt and debris in gutters

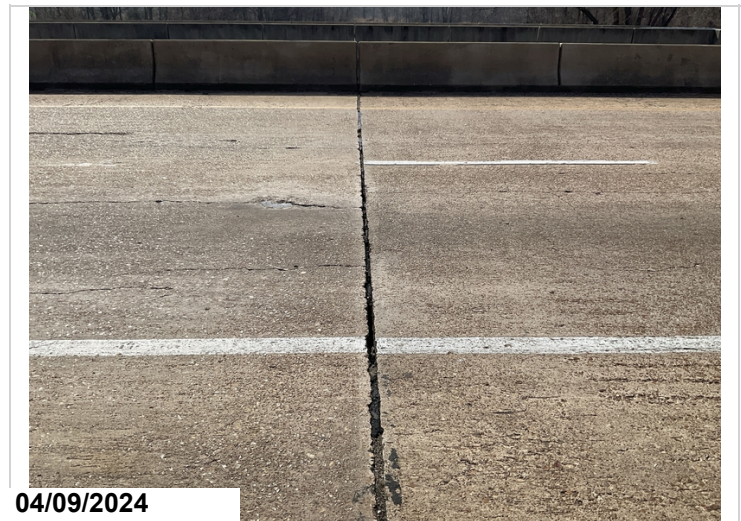
Majority of joint sealer is missing allowing debris into joints.

Bent 3, pourable joint seal: Pourable joint seal missing for 30'.

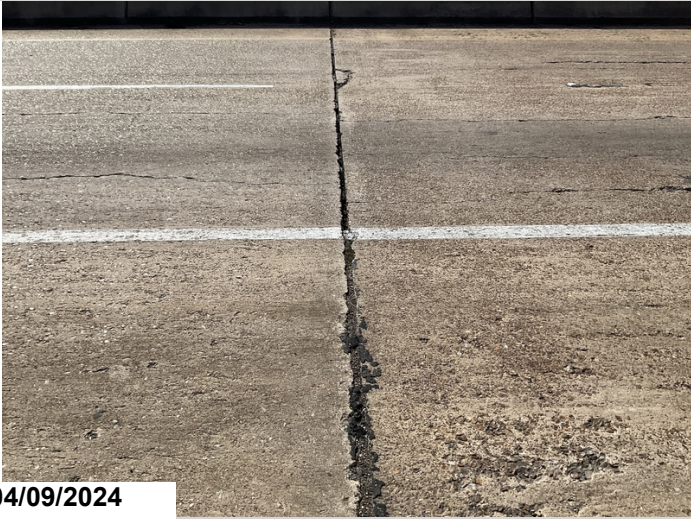
Pourable joint seal, bent 4: pourable joint seal missing across travel lanes.

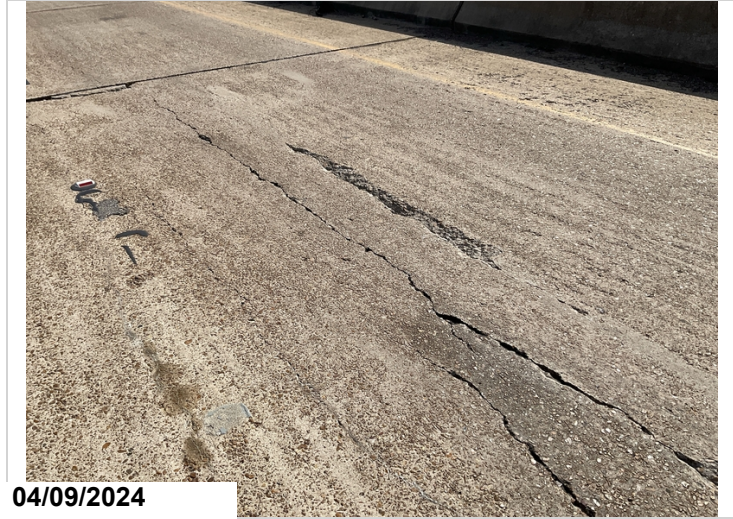
Deck, Span 3, right lane: spalled along crack, typical of left lane.

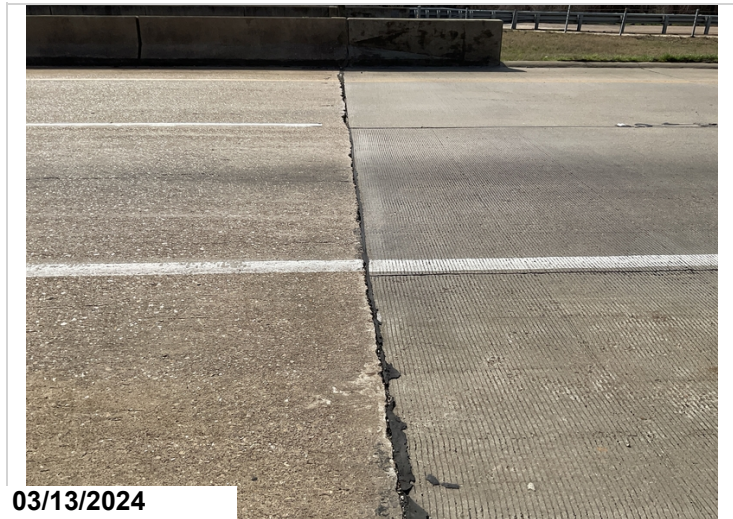
Abutment 1, pourable joint seal, across right travel lane: missing.

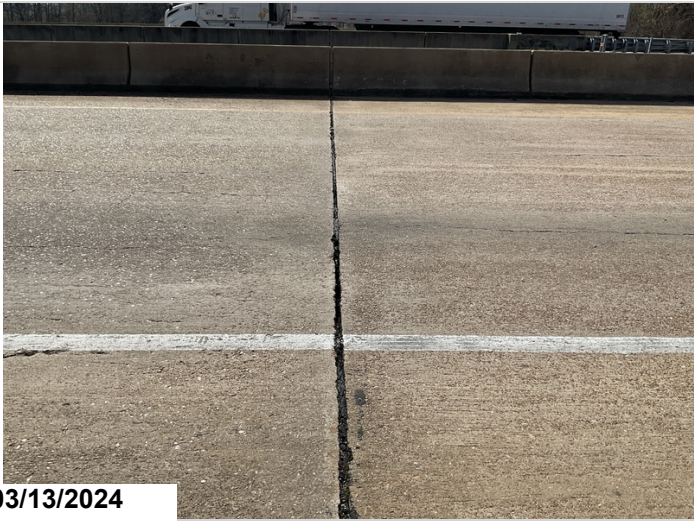
Bent 2, Pourable Joint seal: 15' missing.

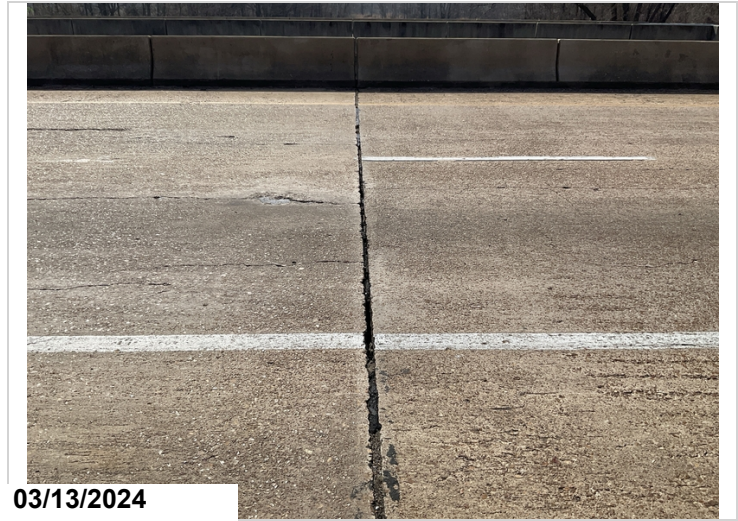
Bent 3, pourable joint seal: Pourable joint seal missing for 30'.

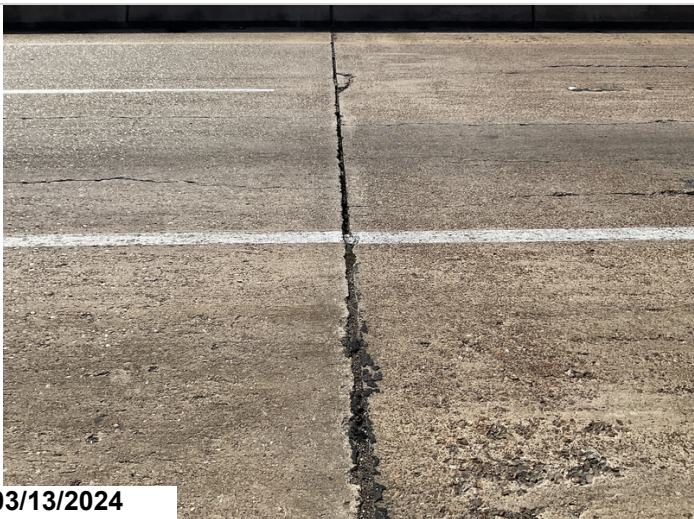
Pourable joint seal, bent 4: pourable joint seal missing across travel lanes.

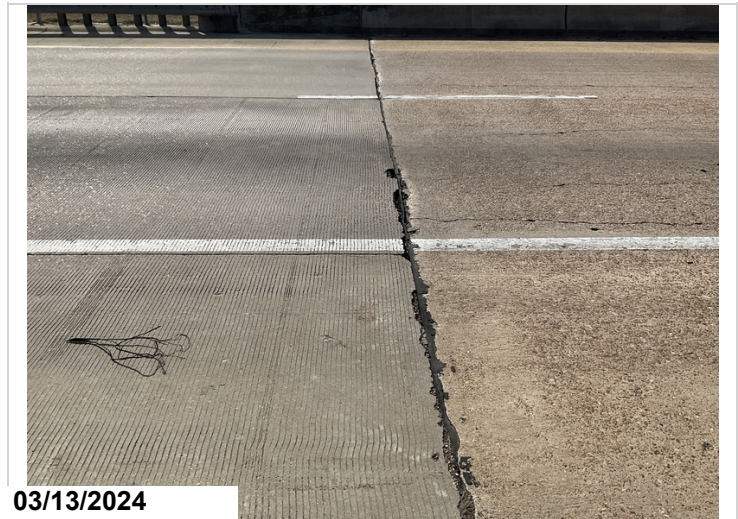
Pourable joint seal, Abutment 2: 16' missing

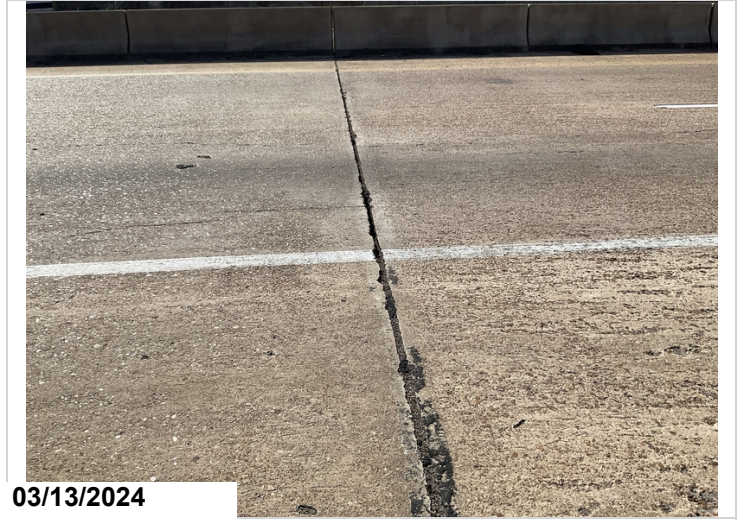
Pourable joint seal, bent 5: pourable joint seal missing across travel lanes.

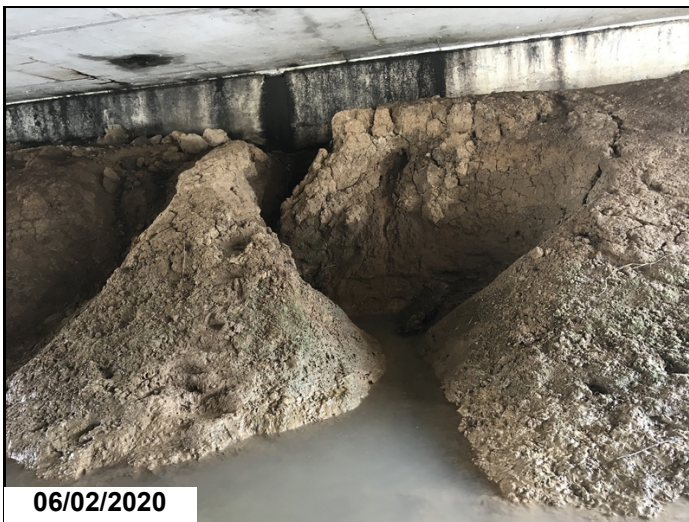
Erosion at abutment 2.

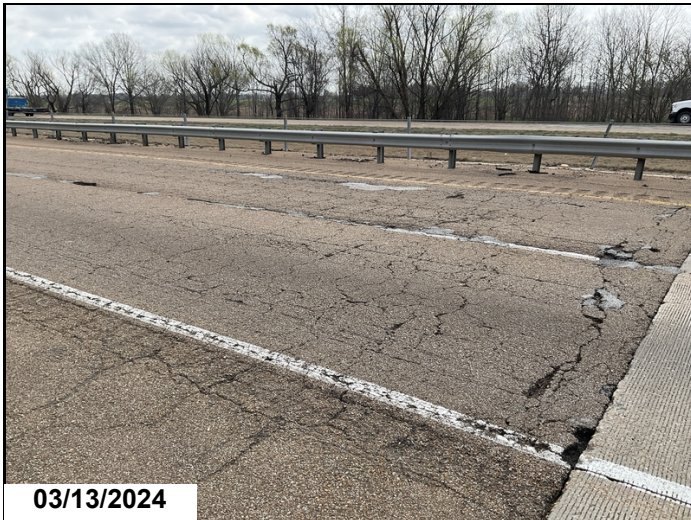
Abutment 2 approach roadway has several one-foot spalls.

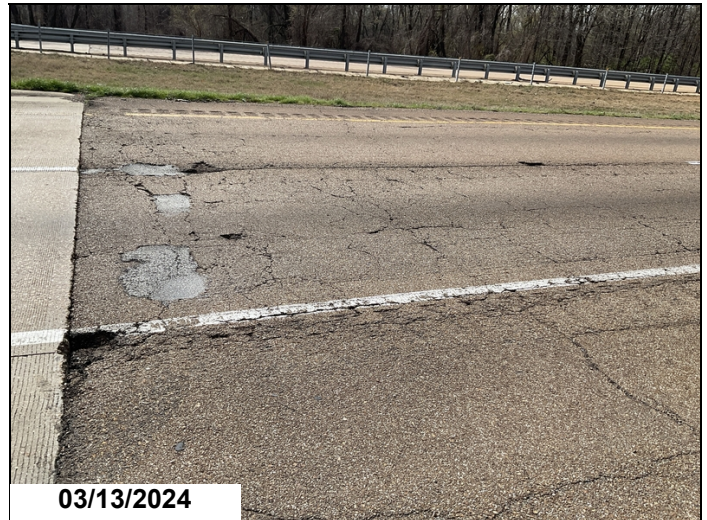
Three one-foot spalls in abutment 1 approach roadway.

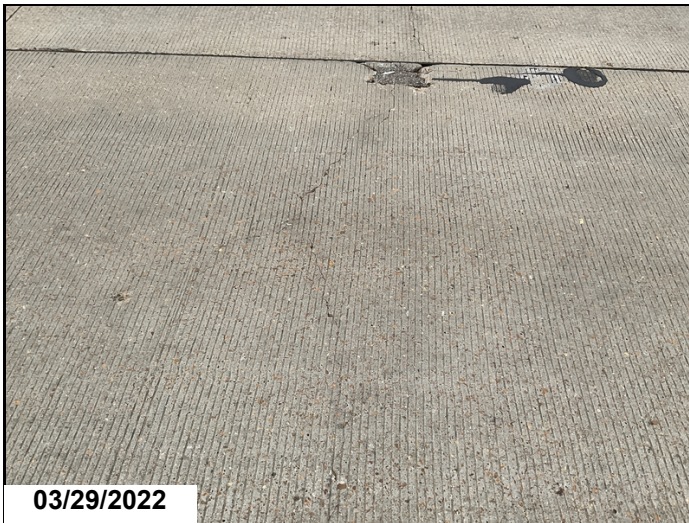
Approach slabs have open cracks.

Typical approach slab crack

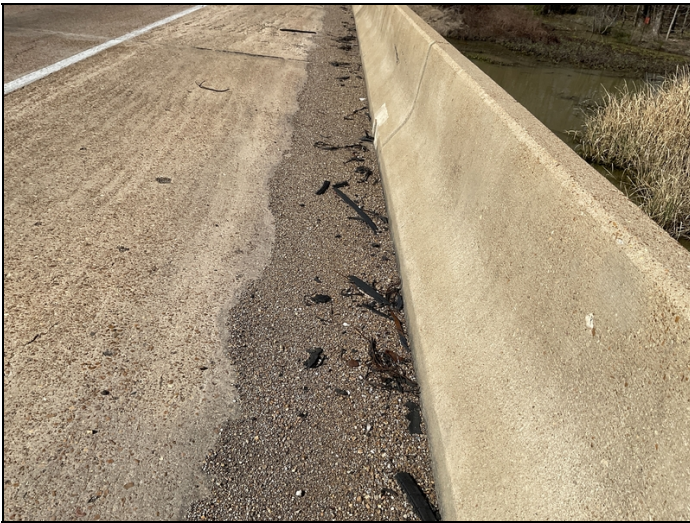
Gutters have dirt and debris.

Dirt and debris in gutters

A-55 - Deck Washing Needed (Yes)

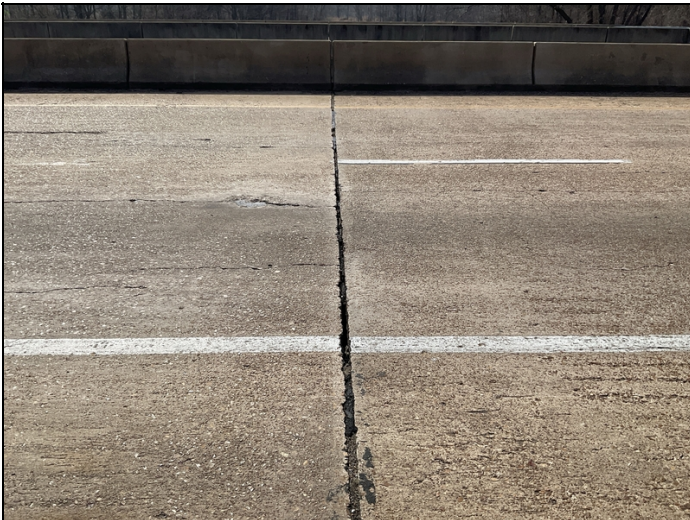
Majority of joint sealer is missing allowing debris into joints.

Bent 3, pourable joint seal: Pourable joint seal missing for 30'.

A-56 - Joint Cleaning/Flushing Needed (Yes)

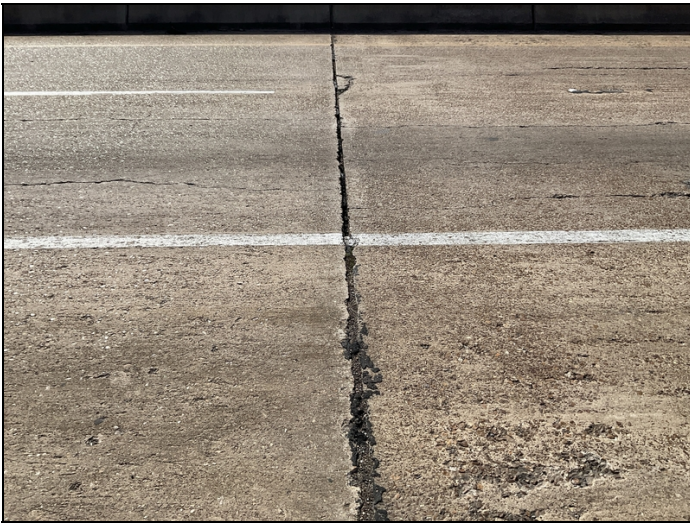
Majority of joint sealer is missing.

Pourable joint seal, bent 4: pourable joint seal missing across travel lanes.

A-59 - Joint Repair Needed (Yes)

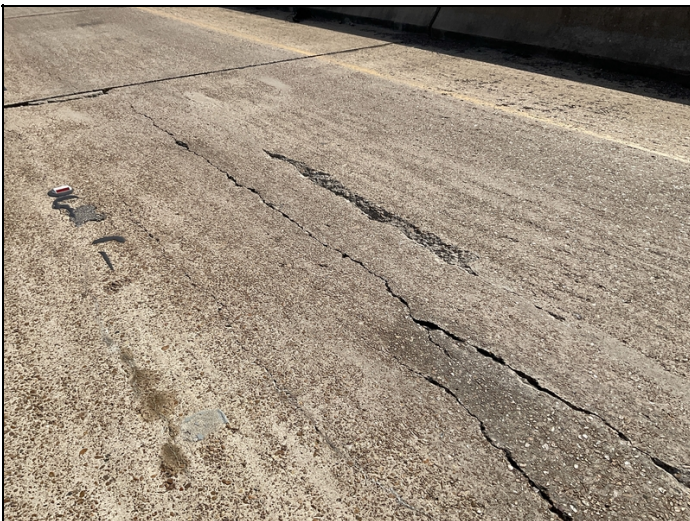
Deck has moderate abrasion full length with areas of heavy scaling and open large unsealed longitudinal deck cracks full length.

Deck, Span 3, right lane: spalled along crack, typical of left lane.

A-62 - Hydro and LMC Advised (Yes)
