Bridge A6518 Inspection Report

National Bridge Inventory Data Sheet

Team Lead: Myron Futrell, Inspection Date: 04/07/2025

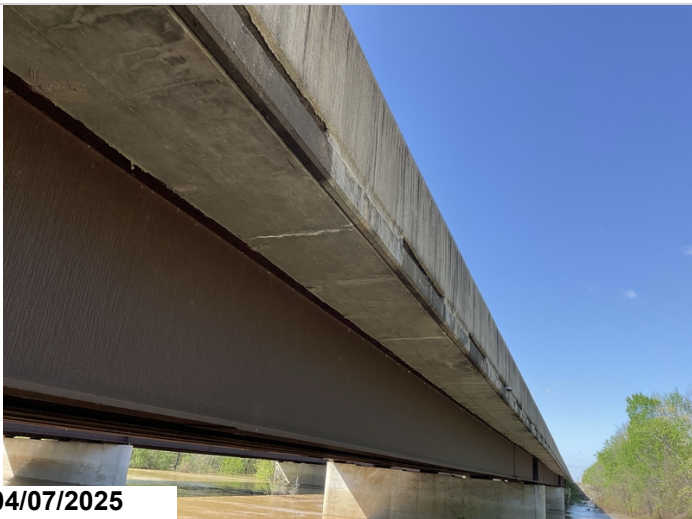
Reinforced concrete deck is in overall good condition. Deck has epoxy overlay and metal stay in place forms. Deck surface cracks have been sealed with epoxy overlay, undersurface of overhangs have transverse cracks with light to moderate efflorescence.

Typical transverse cracking in undersurface of overhang.

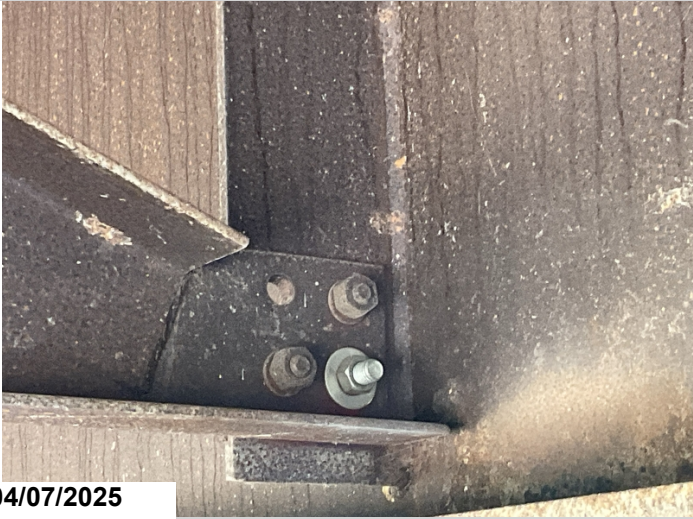
Span 3, bay 2, diaphragm 3: left lower connection bolts loose with one missing and one grade 5 bolt.

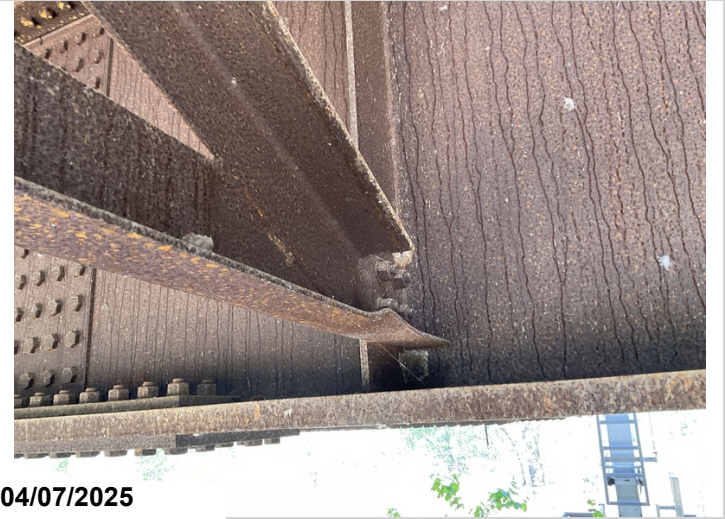
Span 3, right side of girder 3, diaphragm 8 at bottom: dented.

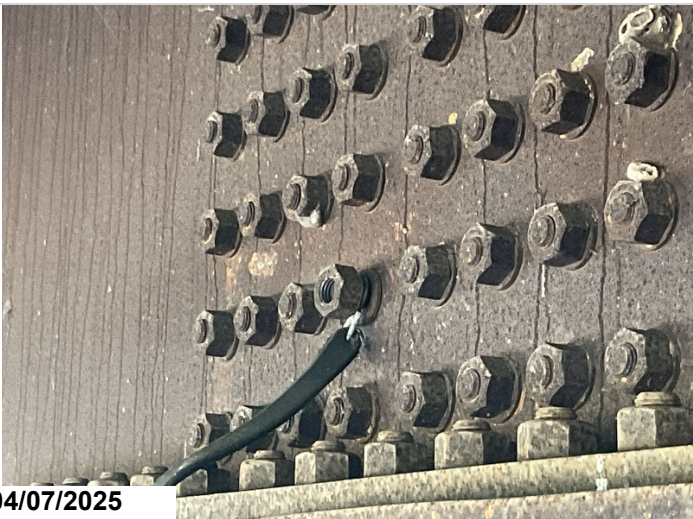
Span 3, girder 1, field splice: one loose nut on second row from bottom in center.

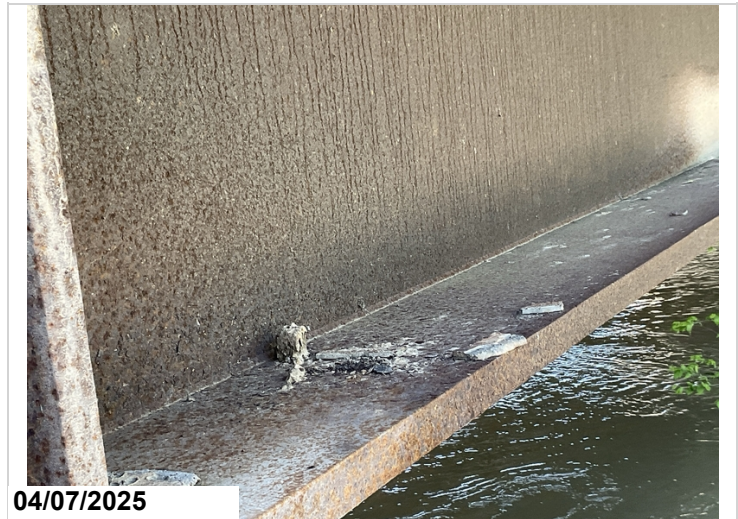
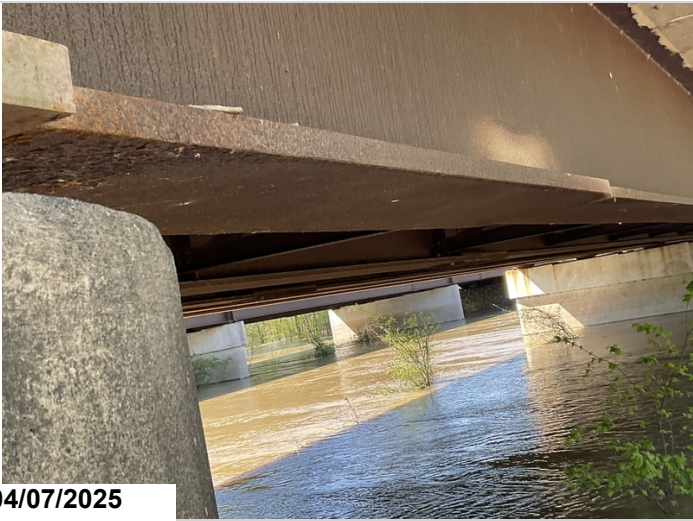
Span 3, girder 1, bent 4, last 10' on bottom of bottom flange and lower web: some scaling rust 1/4" or less flakes.

Corrosion 10LF CS3

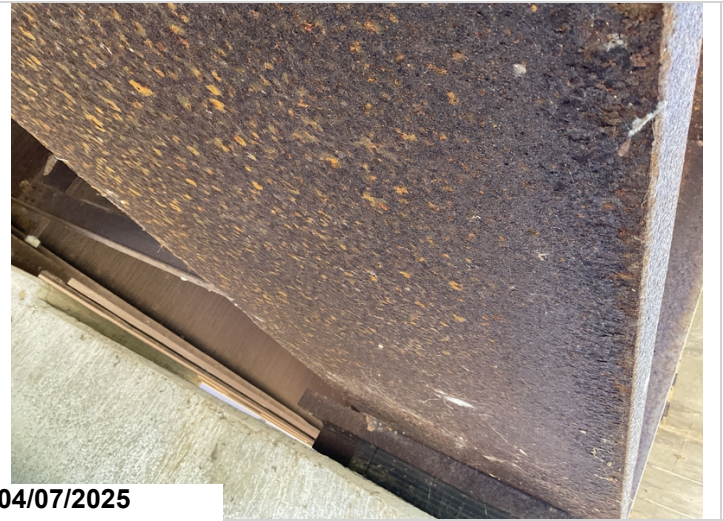
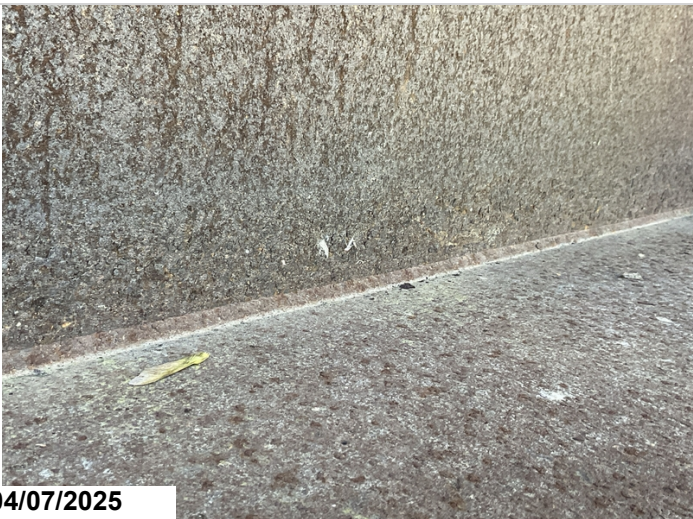
Span 4, girder 1, bent 4, first 10' of bottom flange and lower web has scaly rust 1/4" or less flakes. Corrosion 10LF CS3

Span 4, girder 1, bent 4, first 10' of bottom flange and lower web has scaly rust 1/4" or less flakes.

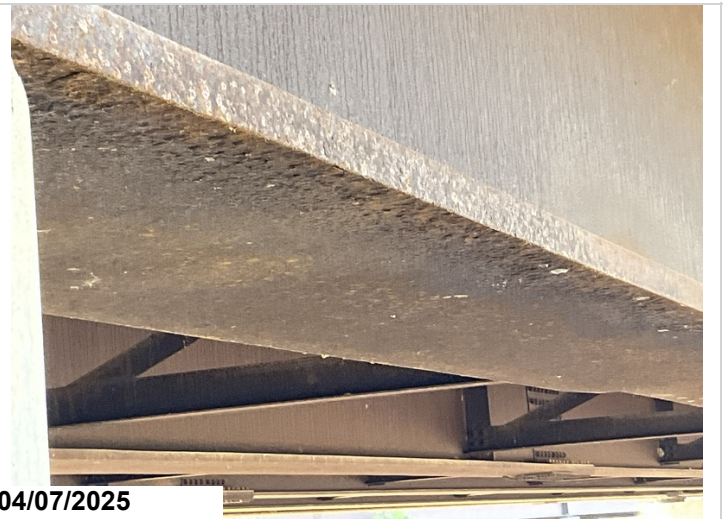
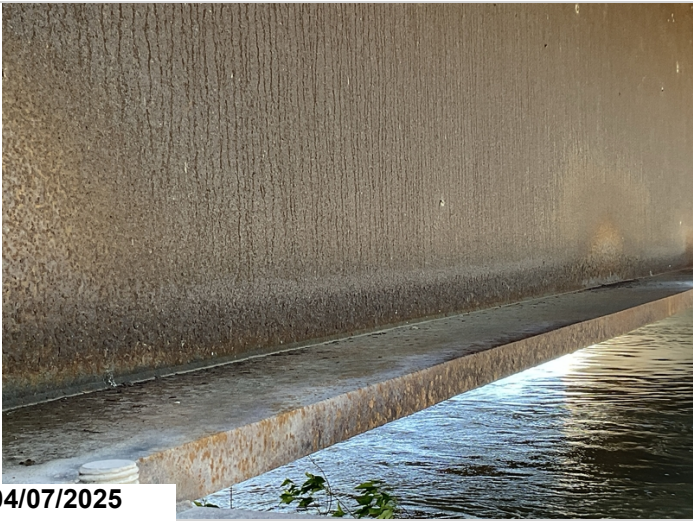
Span 4, girder 1, bent 5 last 10': minor scaling on outside web and bottom flange. Bottom of bottom flange also has minor scaling. Corrosion 10LF CS3

Span 4, girder 1, bent 5 last 10': minor scaling on bottom of bottom flange has minor scaling.

Span 4, girder 1, bent 5 last 10': minor scaling on outside web and bottom flange.

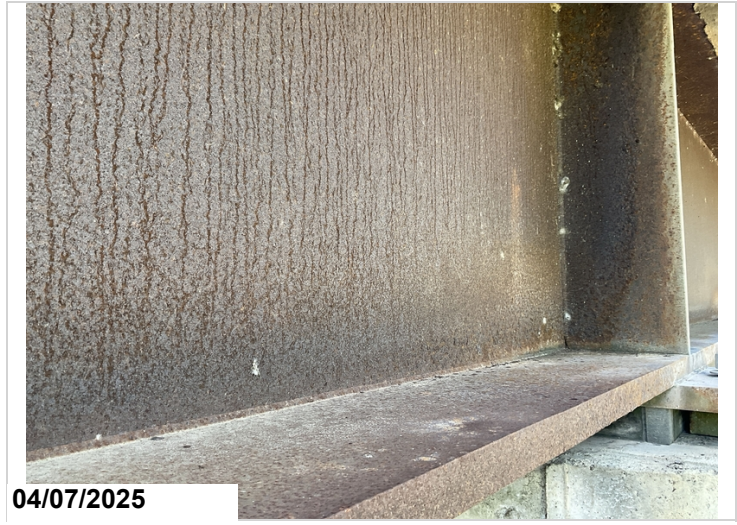
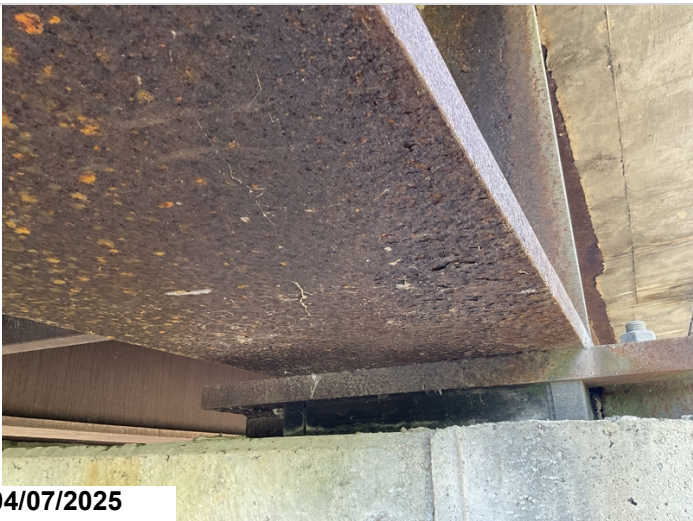
Span 5, girder 1, bent 5, first 3': minor scaling on outside web and bottom flange. Bottom of bottom flange also has minor scaling. Corrosion 3LF CS3

Span 5, girder 1, bent 5, first 3': minor scaling on outside web and bottom flange.

Span 5, girder 1, bent 5, first 3': minor scaling on bottom of bottom flange has minor scaling.

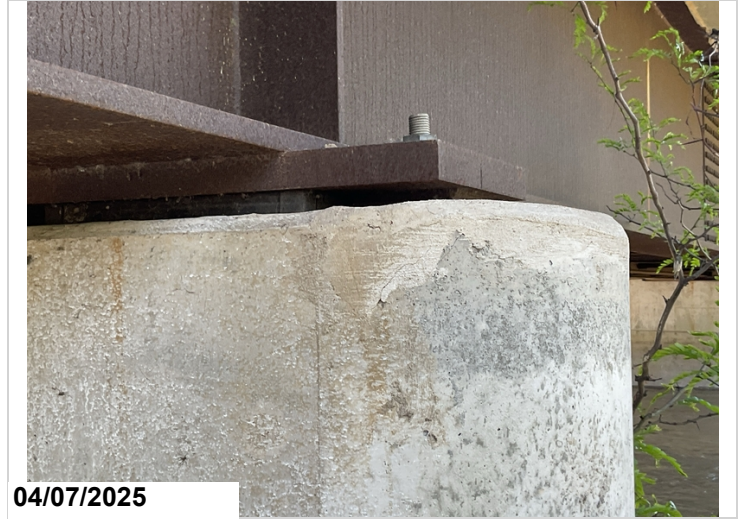
Bent 7, pier wall, left top corner: small area of repair with minor cracks.

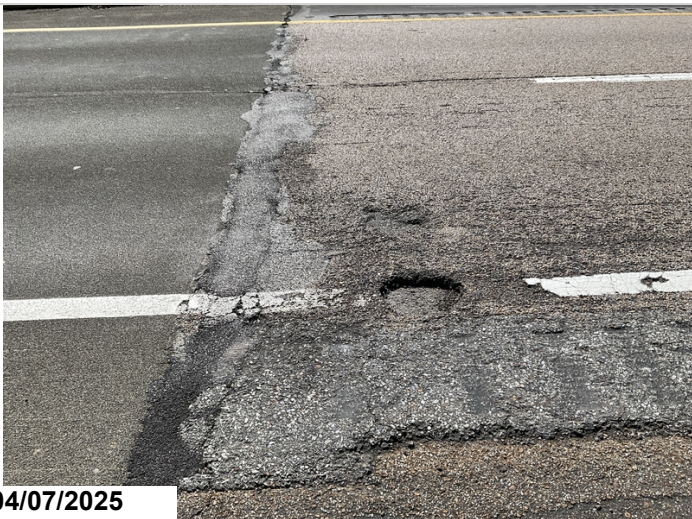
Abutment 1, approach roadway, left lane at white line: 1' spall 2" deep.

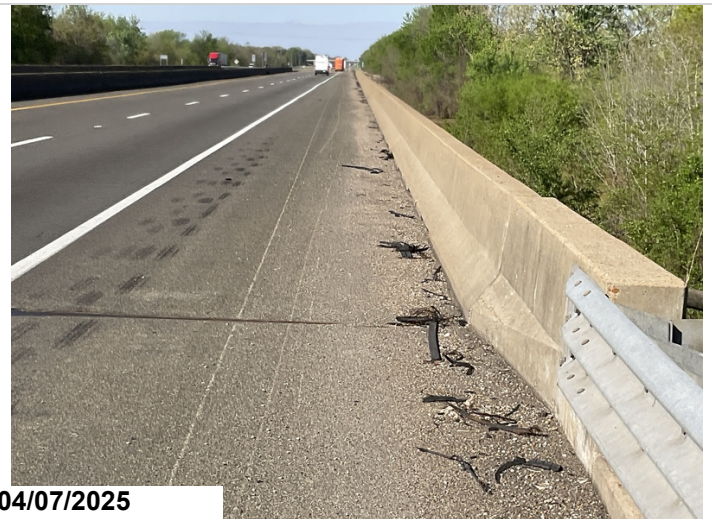
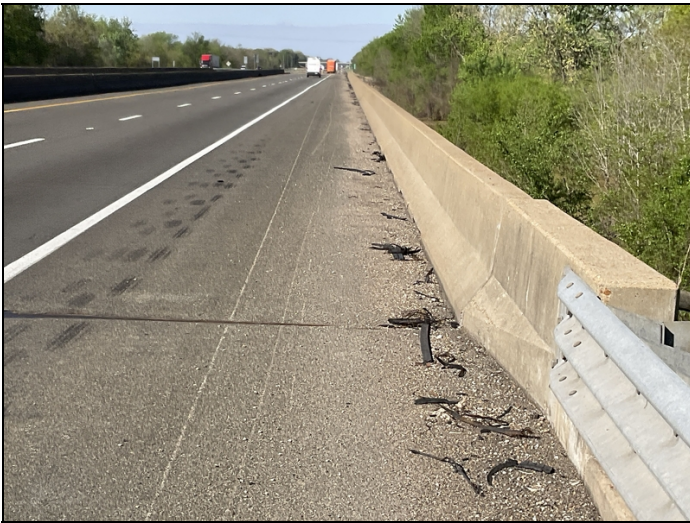
Dirt and debris in gutters.

Gutters have dirt and debris.

A-55 - Deck Washing Needed (Yes)

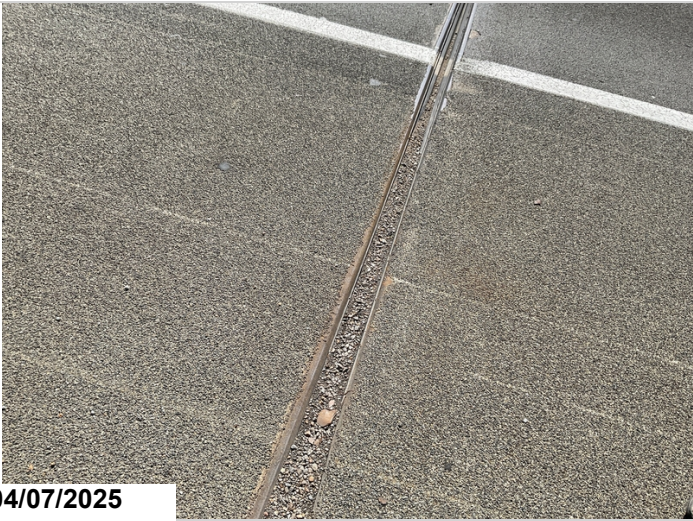
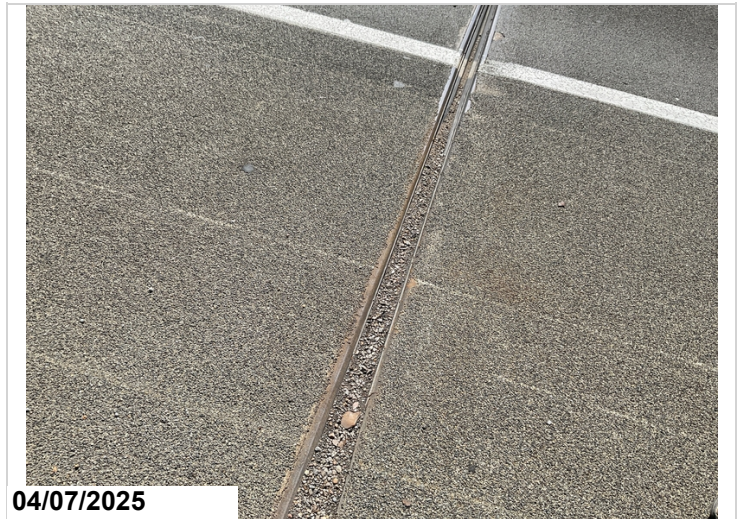
(300) Strip seals: debris in them in gutters. Debris Impaction 32LF CS2							
301	Pourable Joint Seal	LF	80	9	23	48	0
2310	Leakage	LF	48	0	0	48	0
2350	Debris Impaction	LF	3	0	3	0	0
2360	Adjacent Deck or Header	LF	20	0	20	0	0

Typical dirt and debris in joint.

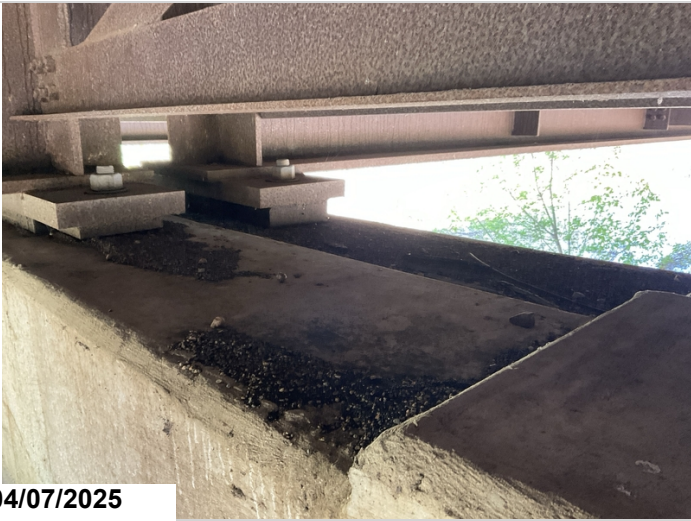
Typical dirt and debris on bent 3 pier cap.

A-58 - Cap Cleaning/Flushing Needed (Yes)

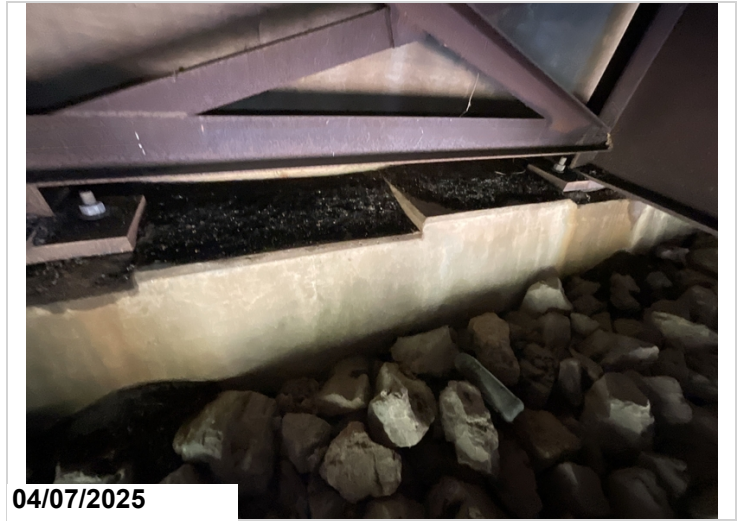
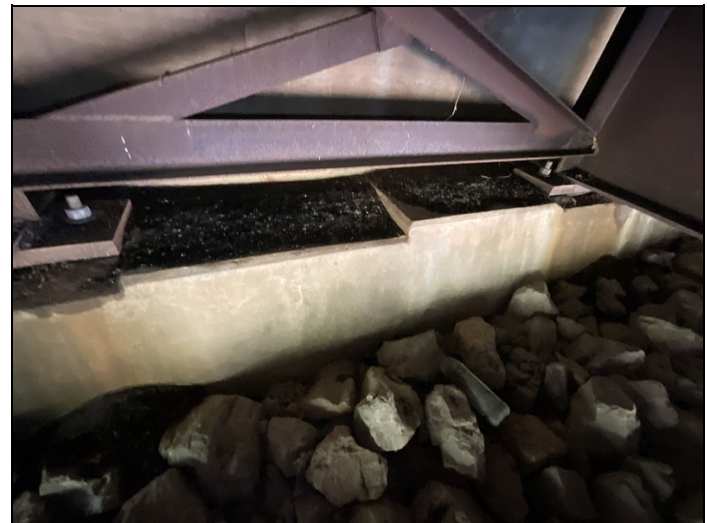
Dirt and debris on abutment caps.

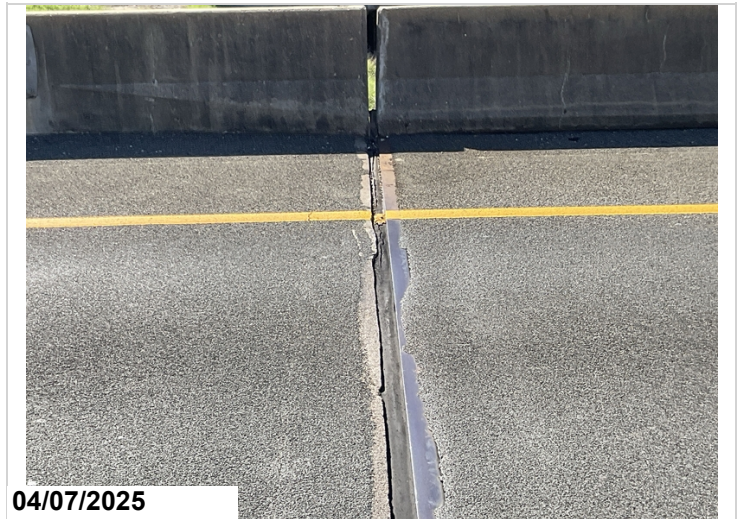
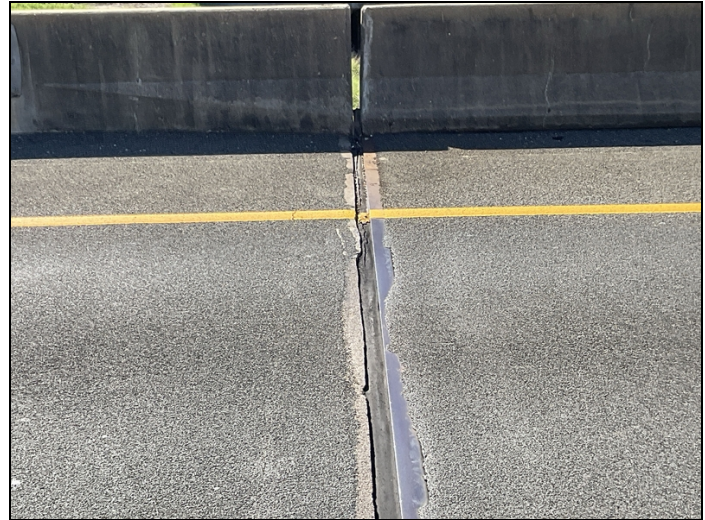
Pourable joint seals at abutments are split causing leakage.

Abutment 2, pourable joint seal, right lane: split.

A-59 - Joint Repair Needed (Yes)

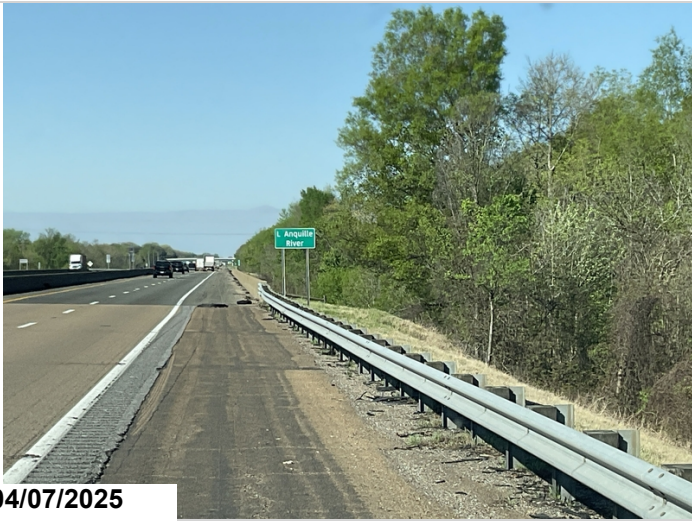
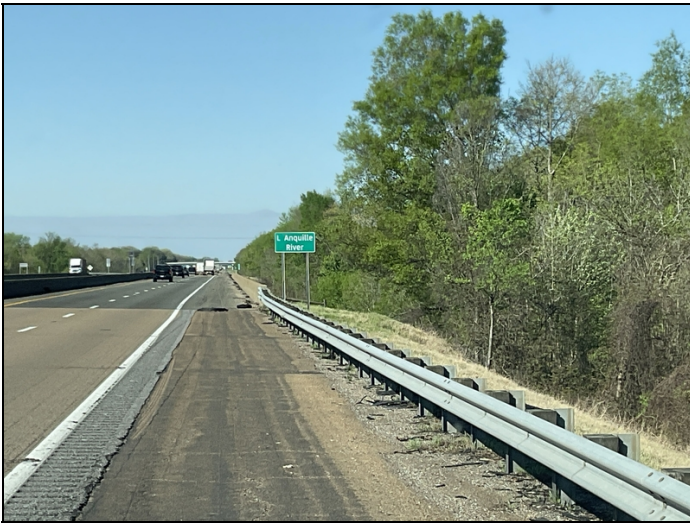
No log mile sign in place.

A-63 - Missing/Incorrect Log Mile Signage (Yes)

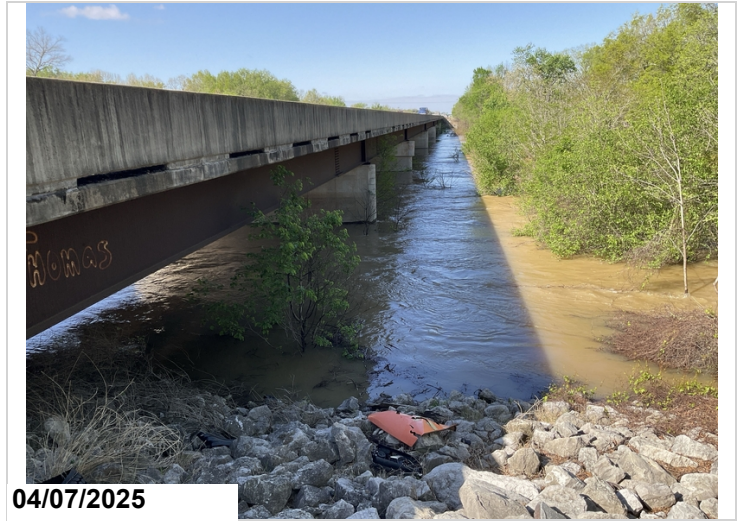
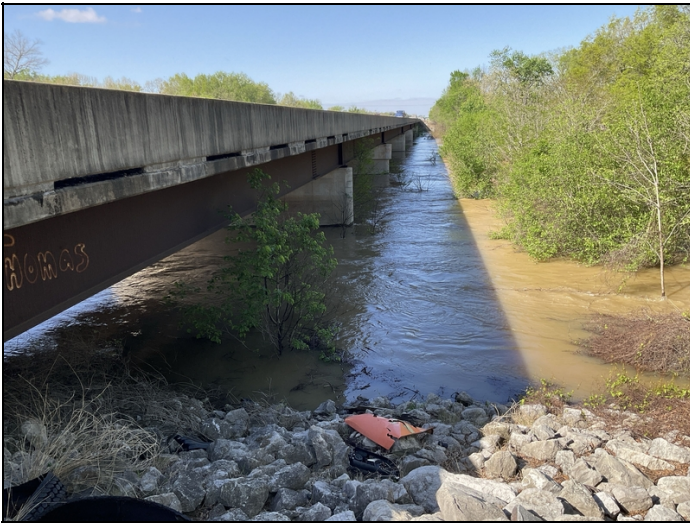
Small trees and vegetation growing under and beside bridge.

A-64 - Vegetation Removal Requested (Yes)

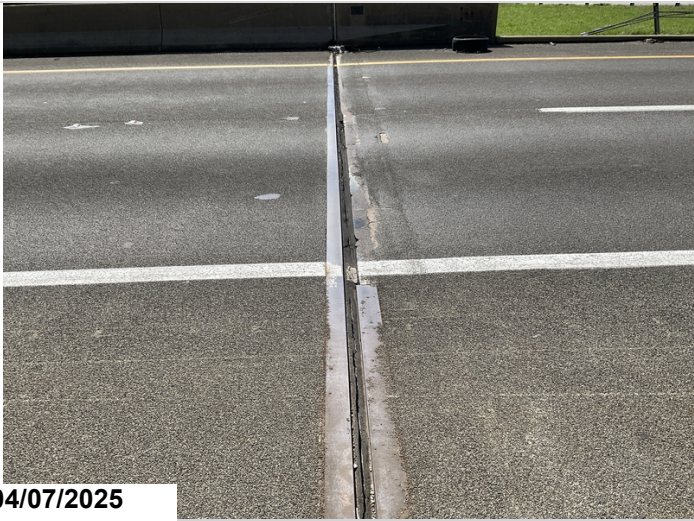
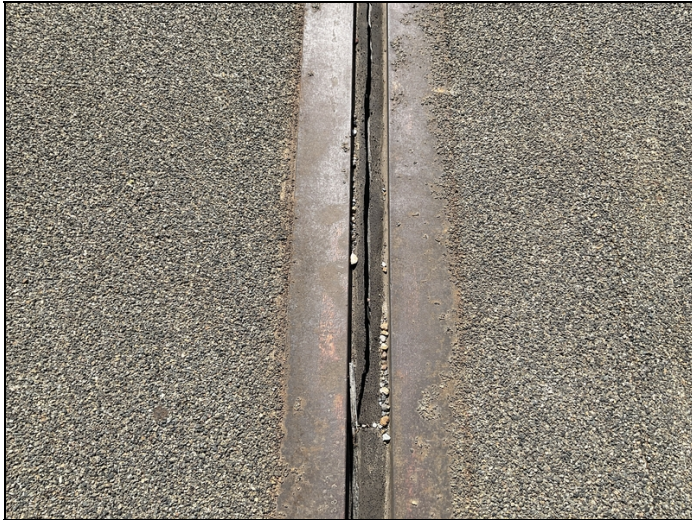
Abutment 1, pourable joint seal: split full width.

Abutment 1, pourable joint seal: split full width, typical split.

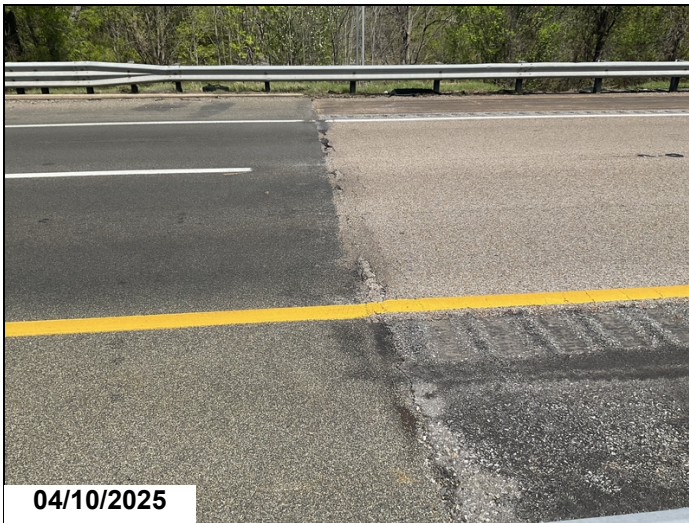
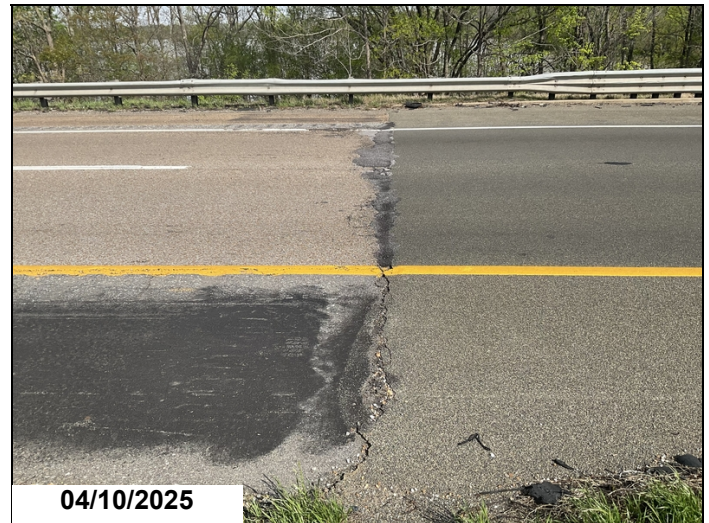
Abutment #1,2 approach roadway overlay are spalled at end of approach slab.

4/7/2025- Repairs have been at time of inspection.

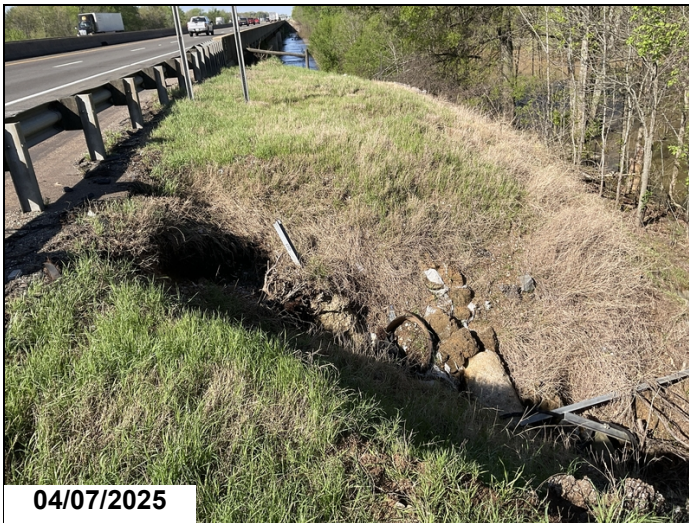
Abutment 2, left approach shoulder slope: eroded up to 20' wide from shoulder pavement down slope.

Type of Work: Repair (General)

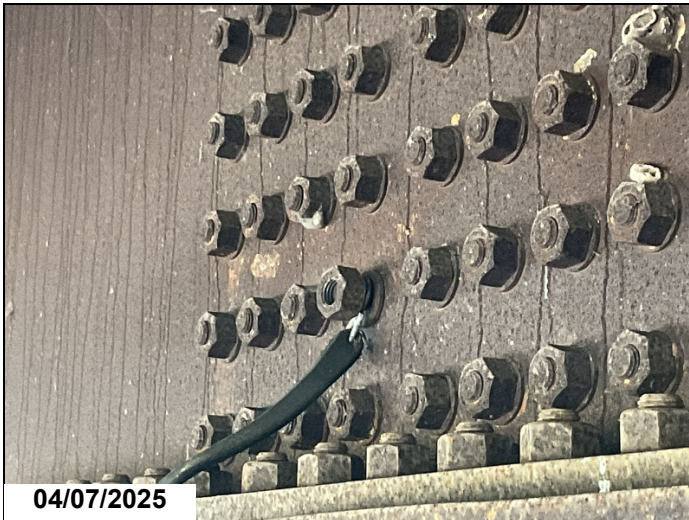
Span 3, girder 1, field splice: one loose nut on second row from bottom in center.

Type of Work: Repair (General)

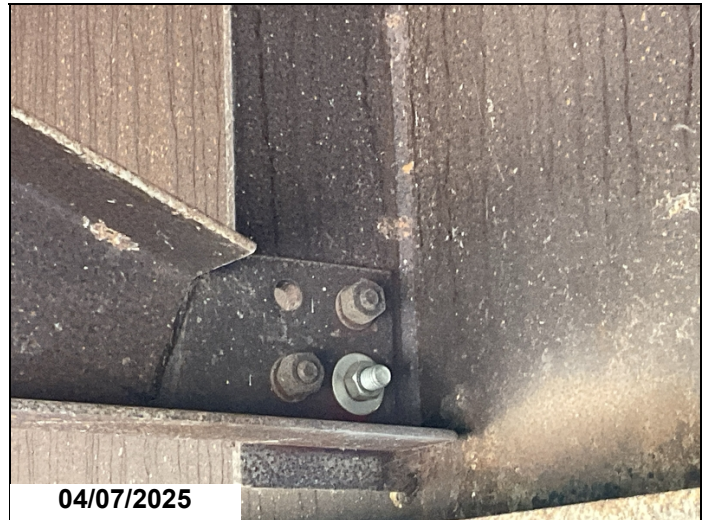
Span 3, bay 2, diaphragm 3: left lower connection bolts loose with one missing and one grade 5 bolt.

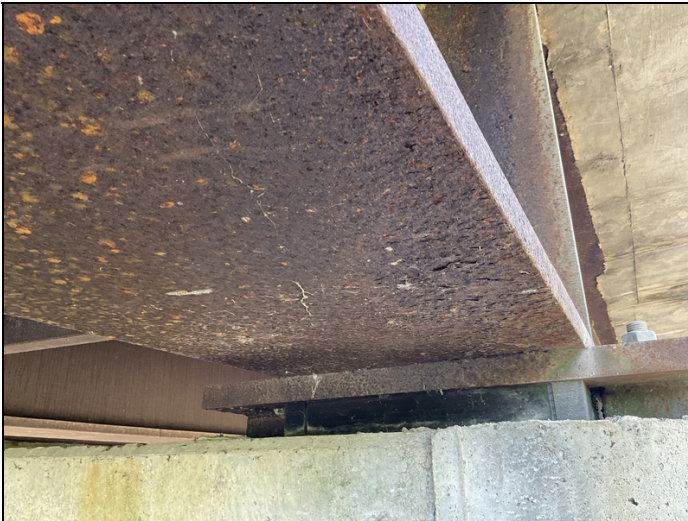
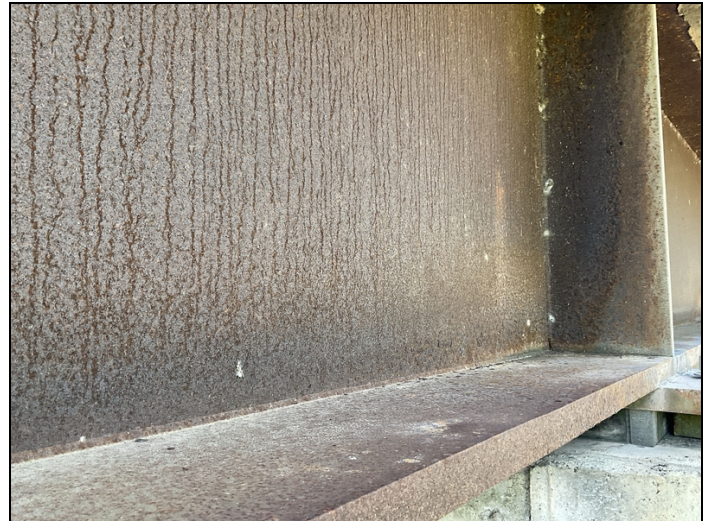
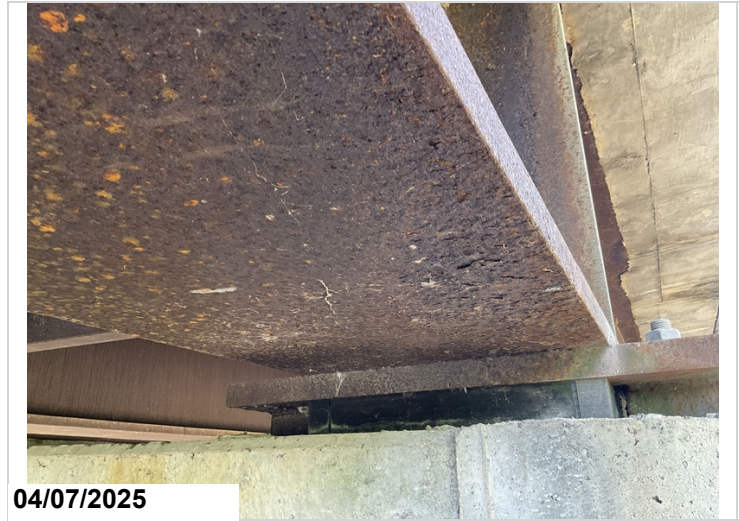
Span 5, girder 1, bent 5, first 3': minor scaling on bottom of bottom flange has minor scaling.

Span 5, girder 1, bent 5, first 3': minor scaling on outside web and bottom flange.

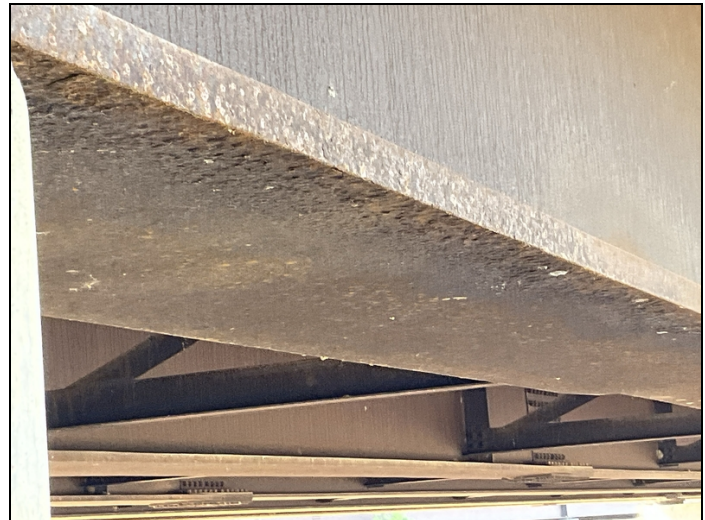
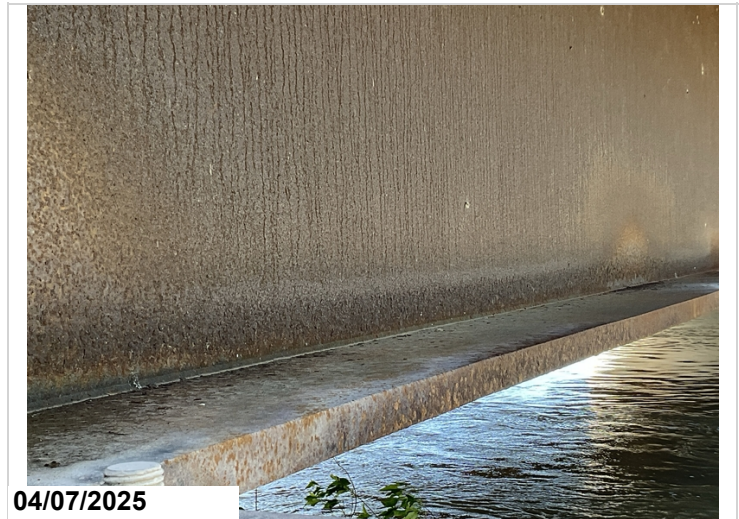
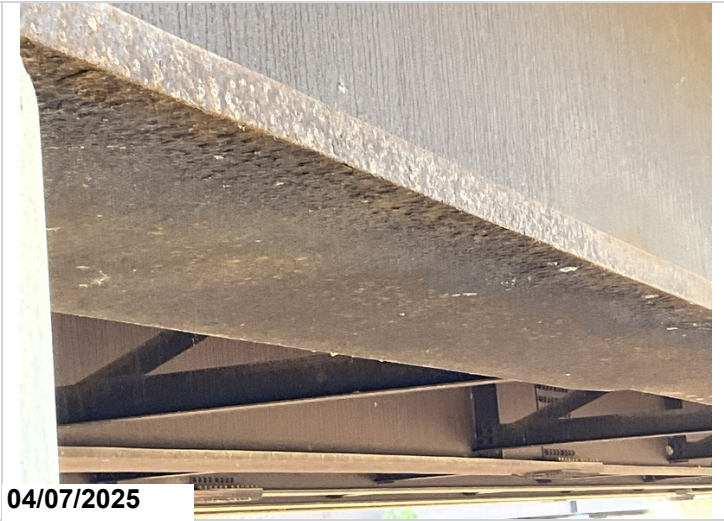
Span 4, girder 1, bent 5 last 10': minor scaling on outside web and bottom flange.

Span 4, girder 1, bent 5 last 10': minor scaling on bottom of bottom flange has minor scaling.

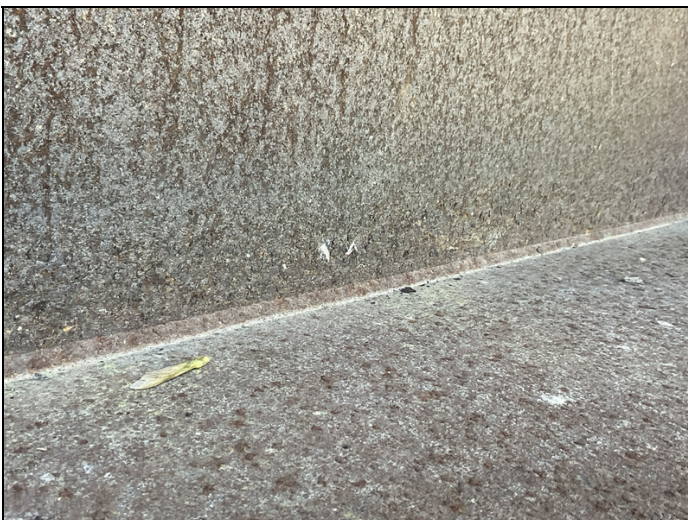
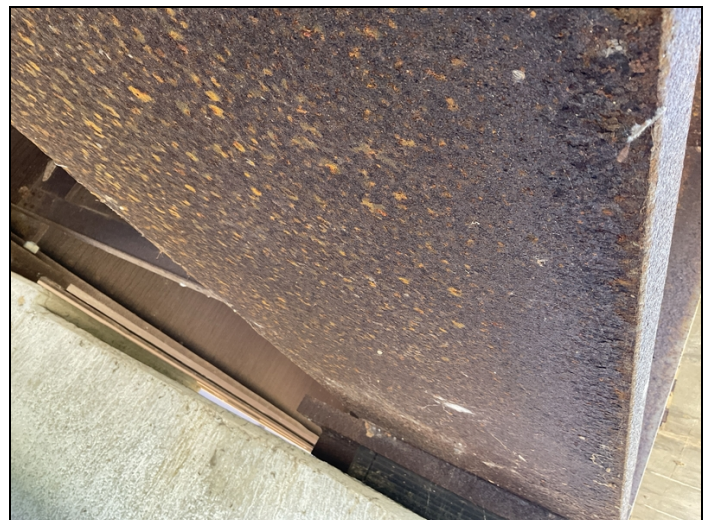
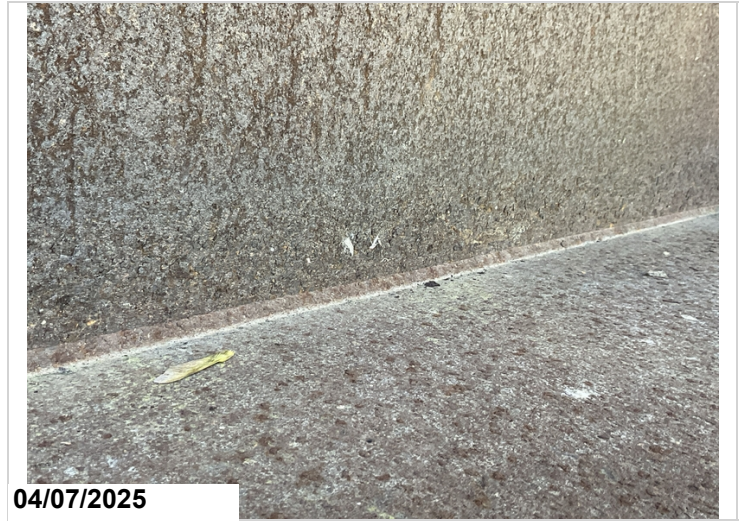
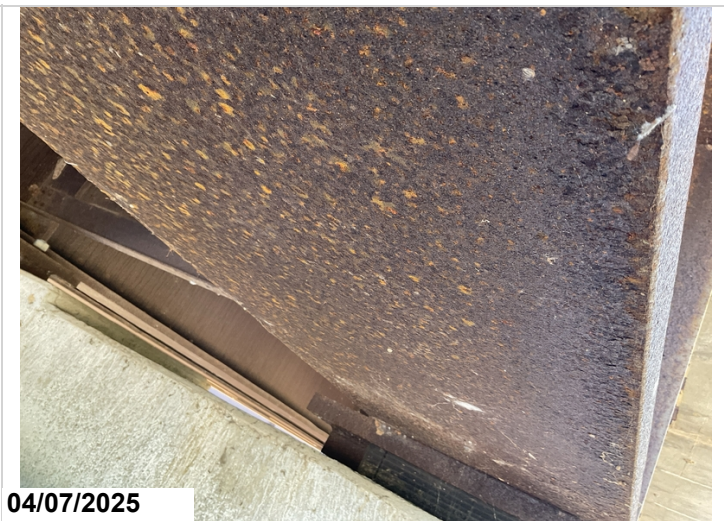
Span 4, girder 1, bent 4, first 10' of bottom flange and lower web has scaly rust 1/4" or less flakes.

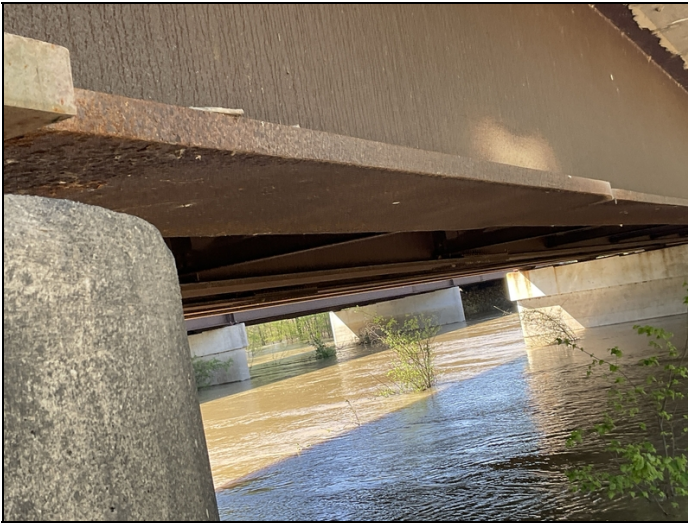
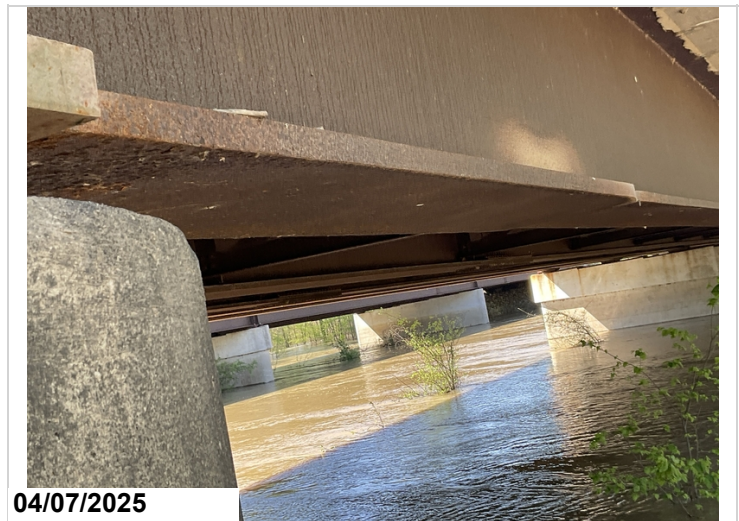
Span 3, girder 1, bent 4, last 10' on bottom of bottom flange and lower web: some scaling rust 1/4" or less flakes.
