Bridge B3732 Inspection Report

Asset #B3732(Routine, Underwater type 2)

I-40EB/Se43/217.76 over Piney Ditch

Team Lead: Myron Futrell Inspection Date: 12/19/2024

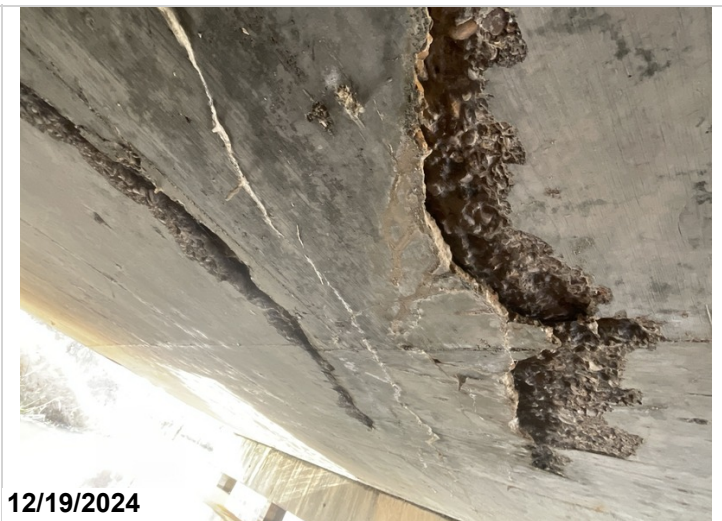
Span 2, undersurface of deck

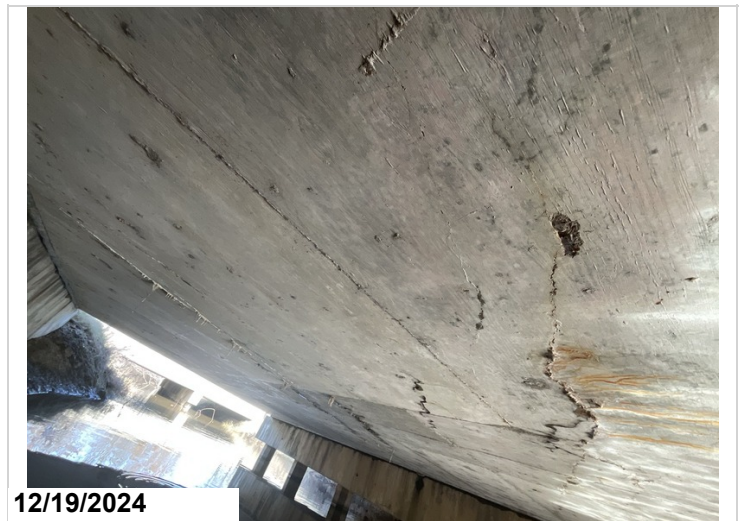
Span 1, undersurface of deck

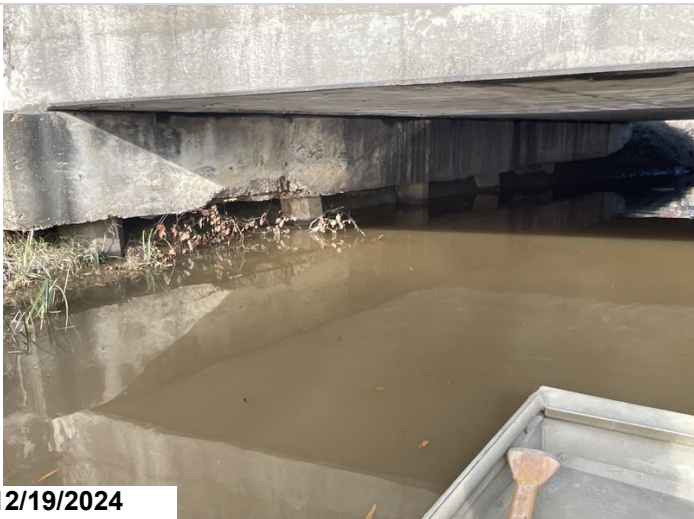
Reinforced concrete substructure is in overall fair condition. Abutment 1 cap is undermined near full length exposing all piles. Abutment 1 pier cap and bent 2 pier caps have several spalls with exposed reinforcing steel and cracking in non-critical areas. Bent 2 pile have light abrasion.

Channel banks are vegetated with some minor slumping, and channel has some minor restrictions. Abutment 1 slope has eroded exposing all piles.

Abutment 1

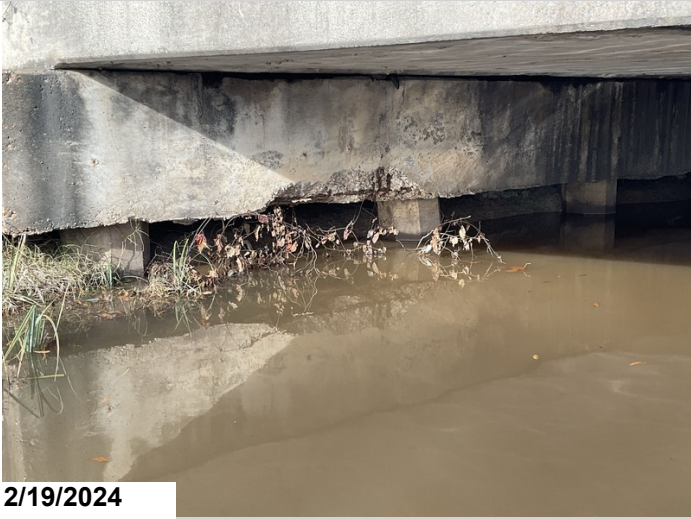
Abutment 1, pier cap, ahead, between piles 6 and 7: 4' spall with exposed reinforcing steel with moderate section loss.

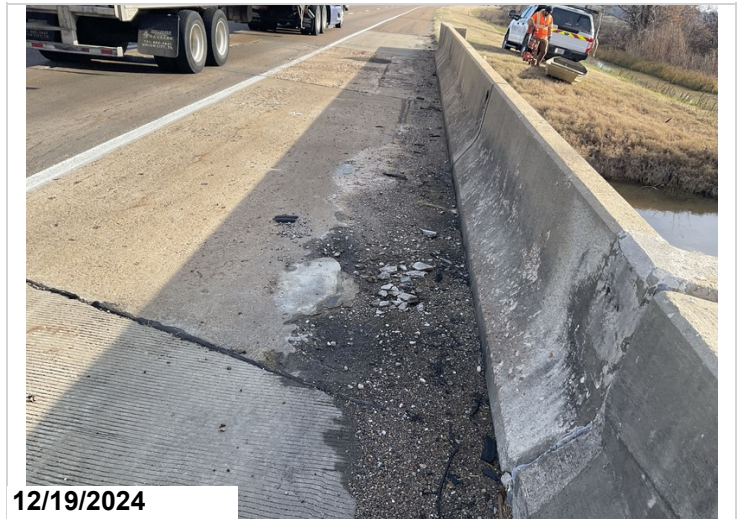
Dirt and debris in gutters

A-55 - Deck Washing Needed (Y)

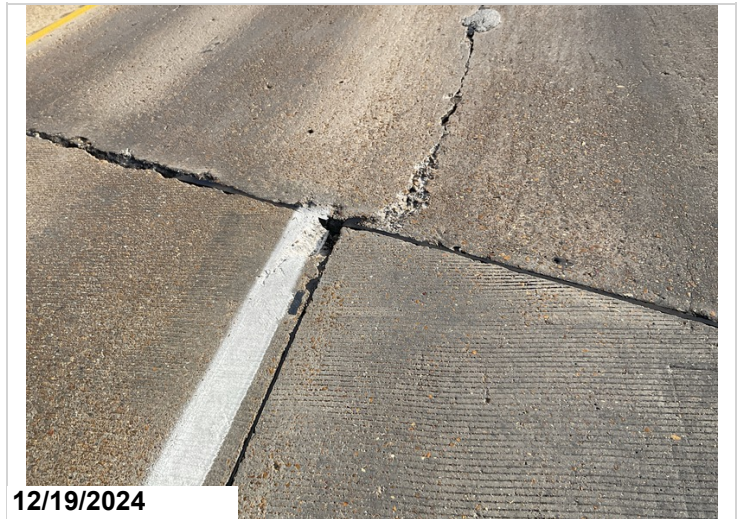
Abutment 1, approach slab, at centerline: small spall

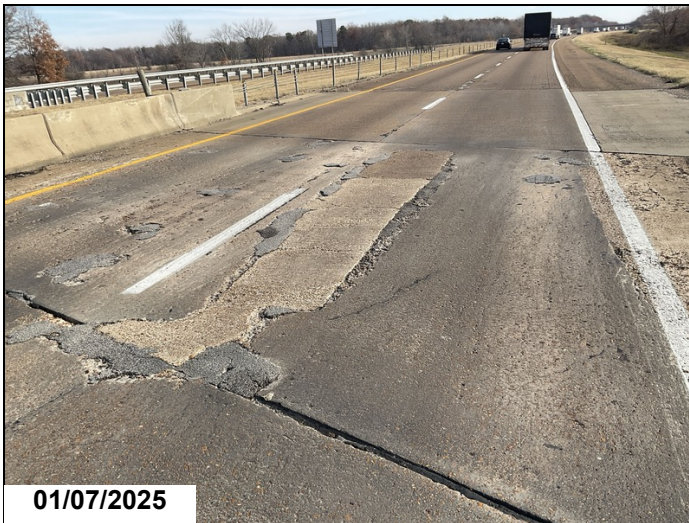
Span 2, deck

Span 2, right lane: 20' long by 2' wide patch failing.

Type of Work: Deck Repair

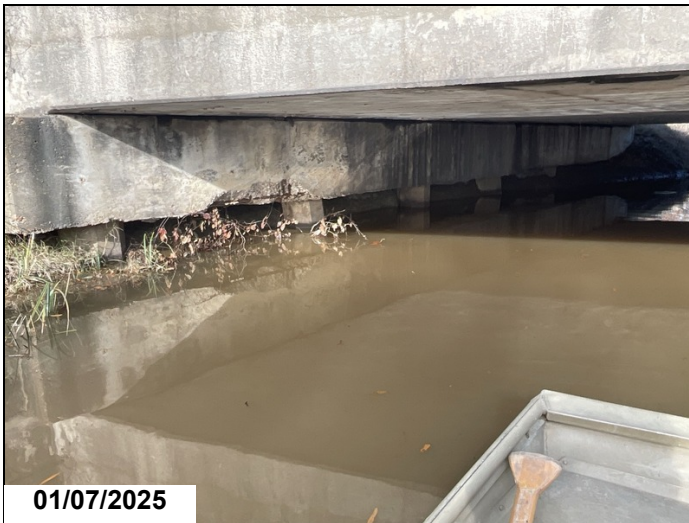
Abutment 1 cap has undermined exposing piles.

12/19/2024-Lowered scour rating from 6 to 5 due to erosion at abutment 1 exposing piles.

Abutment 1 cap: undermined up to 3' exposing all piles.

Type of Work: Channel Work/Drift Removal

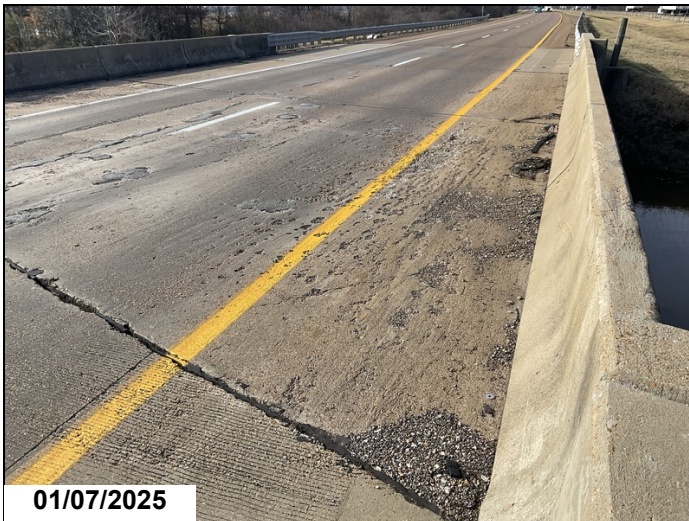
Span 2, left lane

Span 2, deck, left gutter: 8' of moderate scaling with a 2' area of exposed reinforcing steel.

Type of Work: Deck Repair

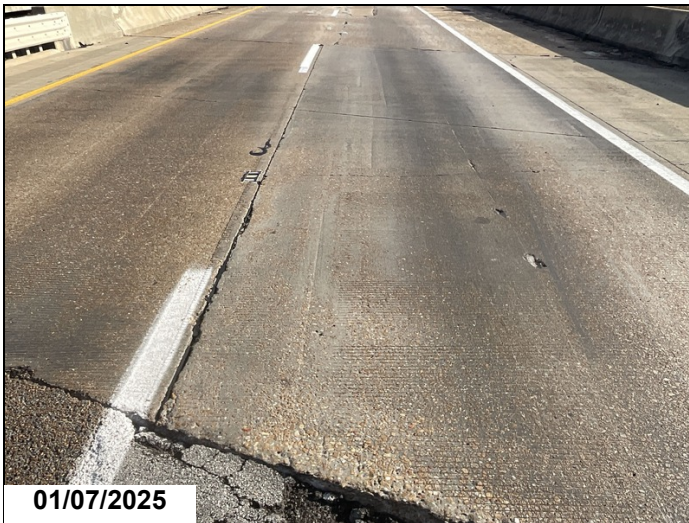
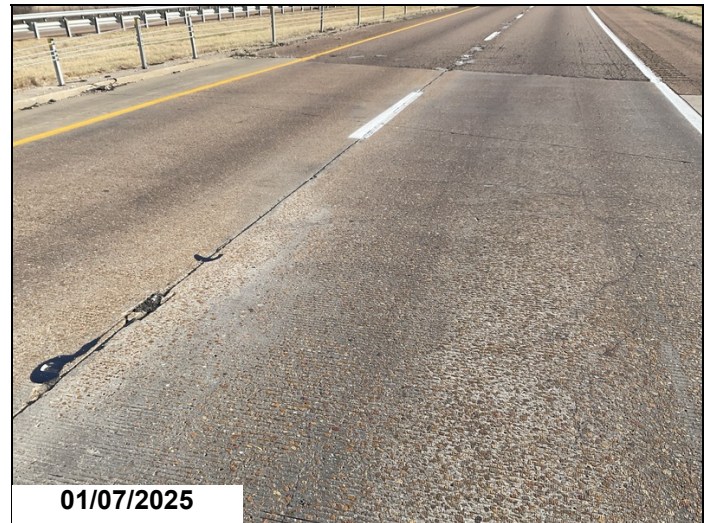
Approach slabs: unsealed cracks.

Type of Work: Approach Leveling/Maintenance

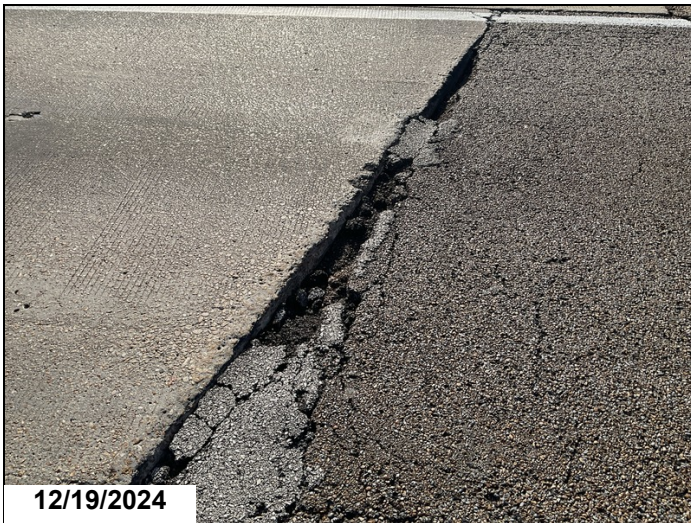
Abutment 1, approach roadway, right lane: spalled at joint with approach slab.

Type of Work: Approach Leveling/Maintenance

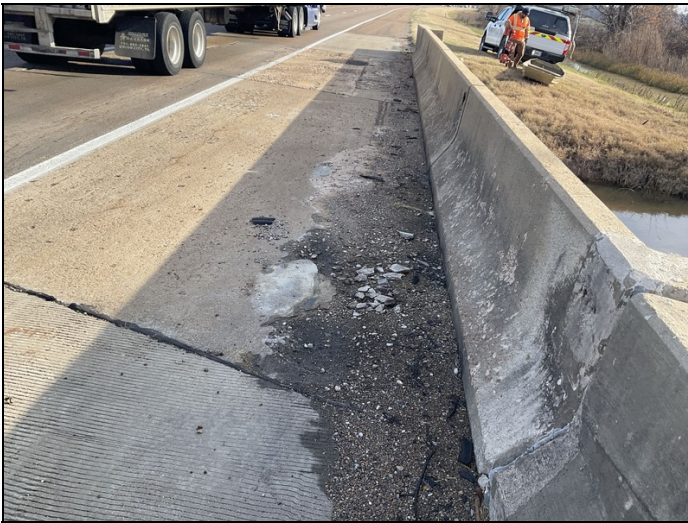
Dirt and debris in gutters

A-55 - Deck Washing Needed (Yes)

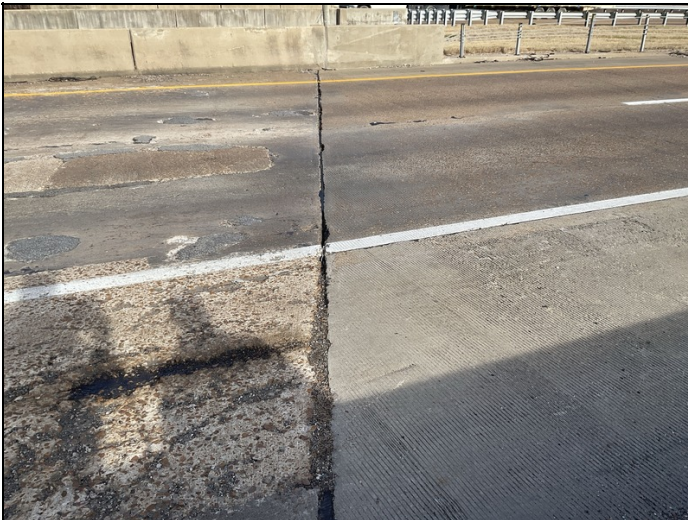
Bent 3, joint

Joint material missing allowing debris impaction.

A-56 - Joint Cleaning/Flushing Needed (Yes)

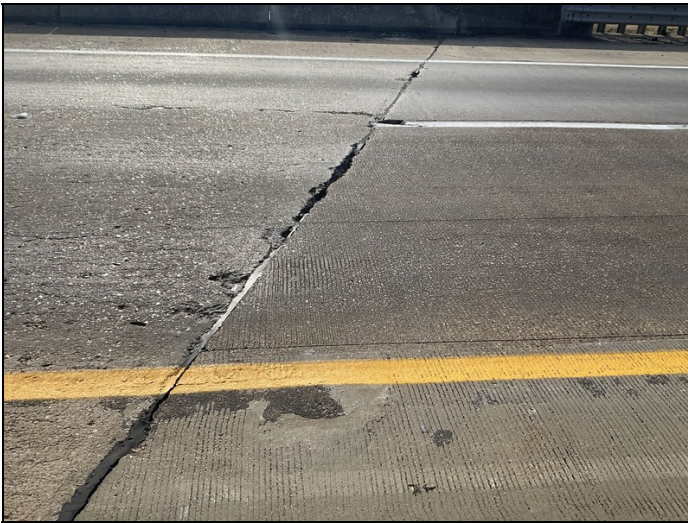
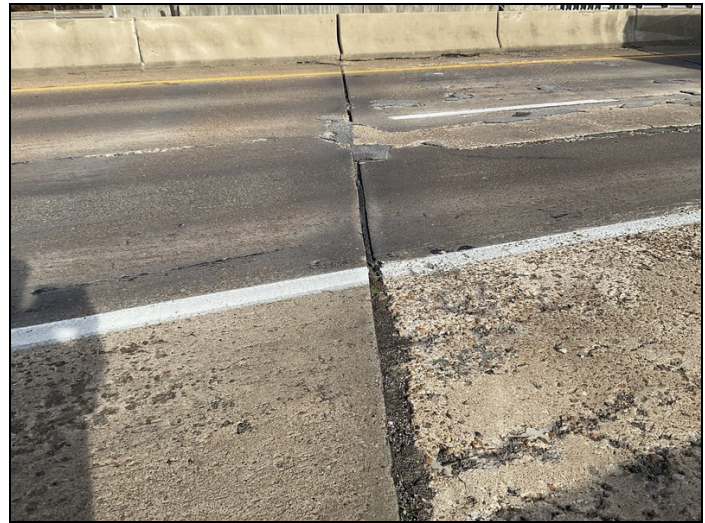
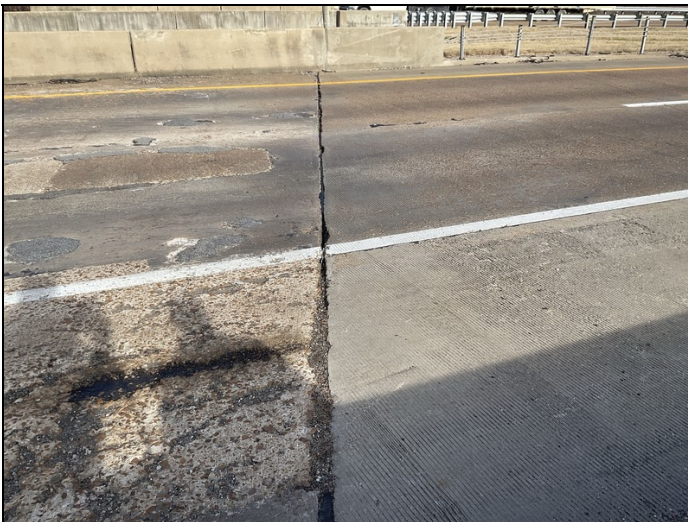
Joint material missing and some spalling at joints.

A-59 - Joint Repair Needed (Yes)

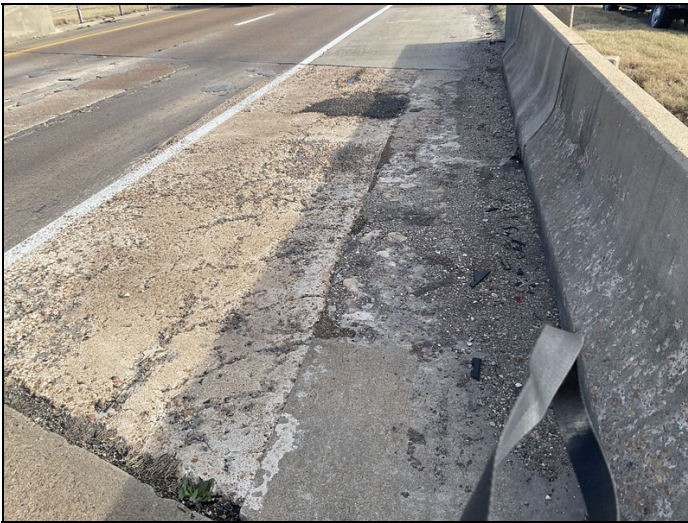
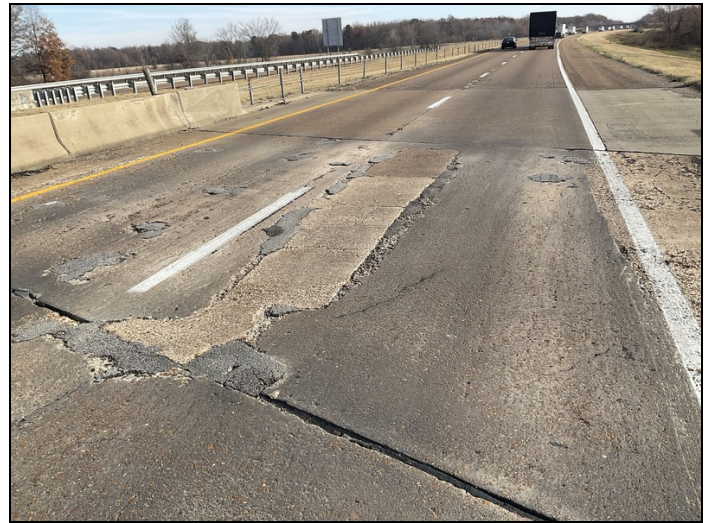
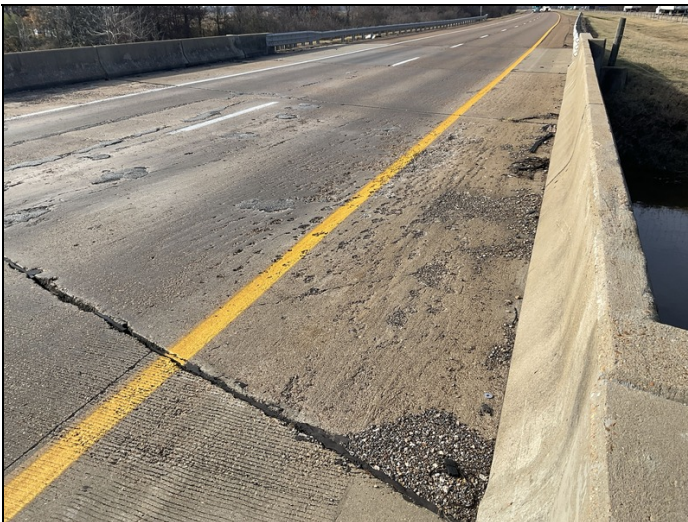
Deck has areas of heavy scaling, open wide cracking and unsound patched areas.

A-62 - Hydro and LMC Advised (Yes)

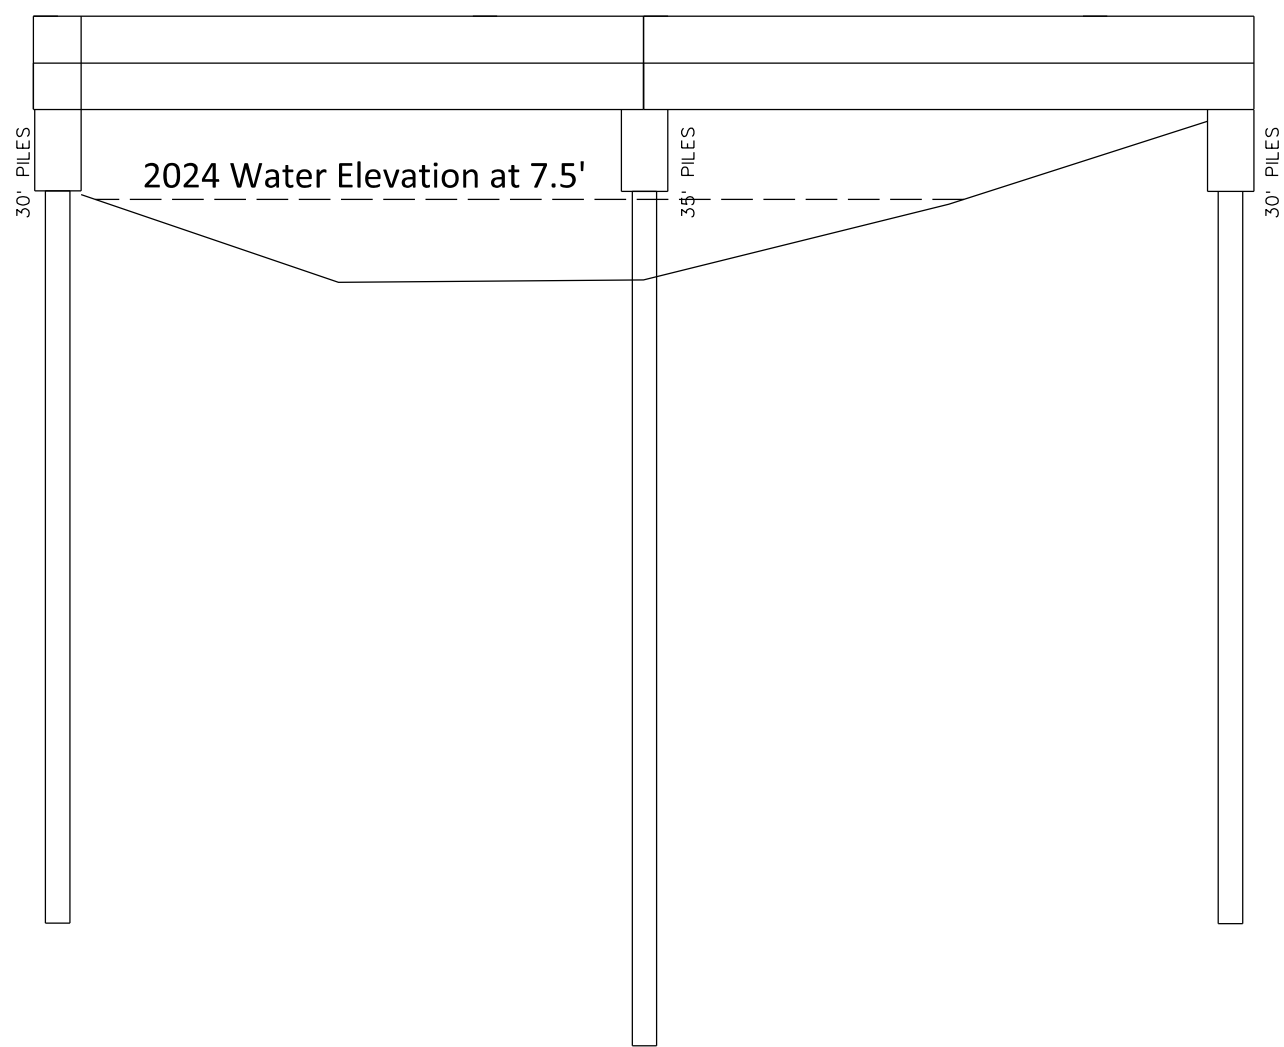
READINGS TAKEN FROM TOP OF PARAPET WALL, RIGHT SIDE OF BRIDGE.

BENT 1	1/2	BENT 2	1/2	BENT 3
12/19/2024	7.3'	10.9'	10.8'	7.7'	4.3'
