Bridge B3766 Inspection Report

Asset #B3766(Routine, Underwater type 2)

I-40EB/Se51/219.89 over Flat Fork Creek

Team Lead: Myron Futrell Inspection Date: 02/06/2024

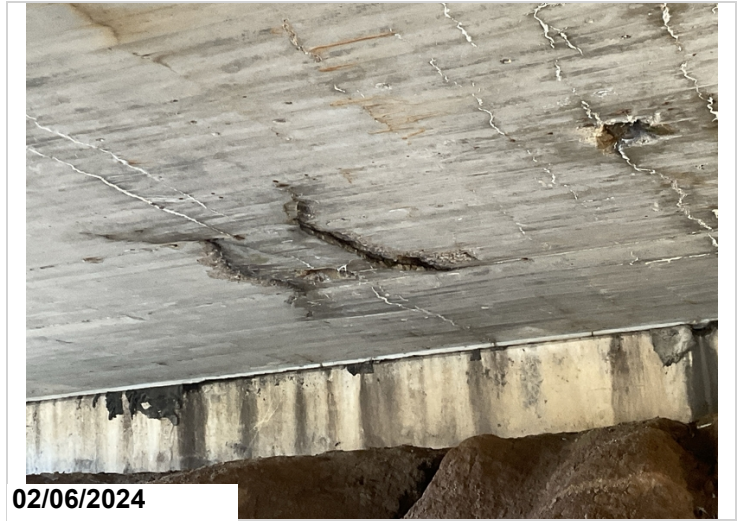
Concrete slab deck is in overall fair condition. Top of deck has several spalls, areas of scaling, open cracks, repaired areas, some of which have been patched with ACHM and some are failing. Soffit / underside of deck has multiple cracks with rust staining and efflorescence and several spalls under sona-tube voids with exposed rebar and a large, delaminated area in span #5.

Large delaminated area span #5 soffit / underside of deck

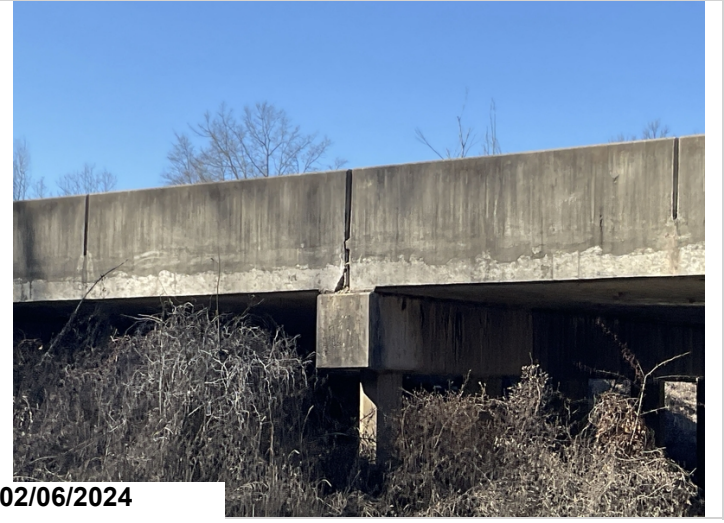
Span #2 right side at bent #2 end of slab spalled

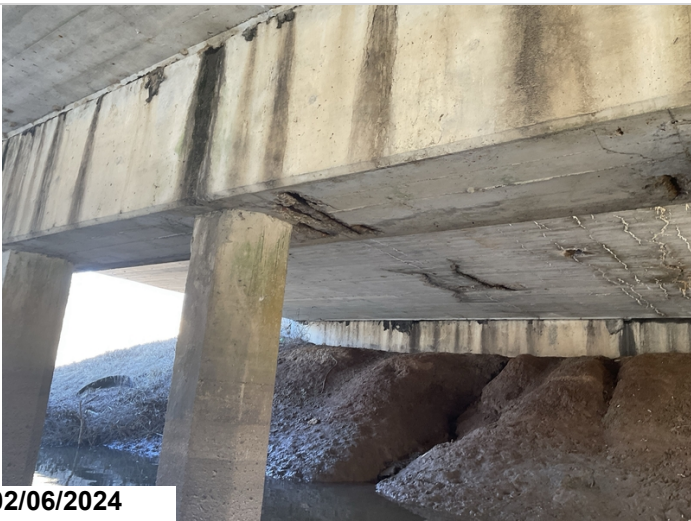
Exposed rebar bent #5 bottom face by pile #5

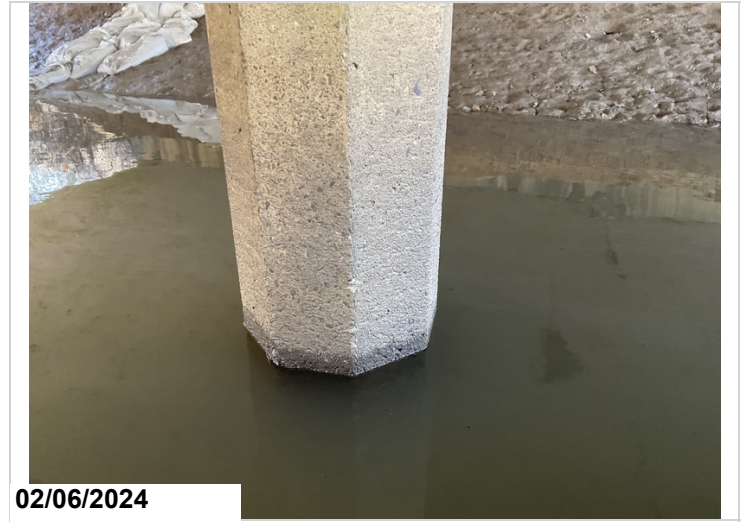
Concrete substructure is in overall satisfactory condition. Piles have very light abrasion with no loose aggregate. Caps have a moderate amount of exposed rebar due to minor spalling and poor concrete coverage with several areas of heavy scaling on ends of caps with loose aggregate.

Typical light abrasion on piles

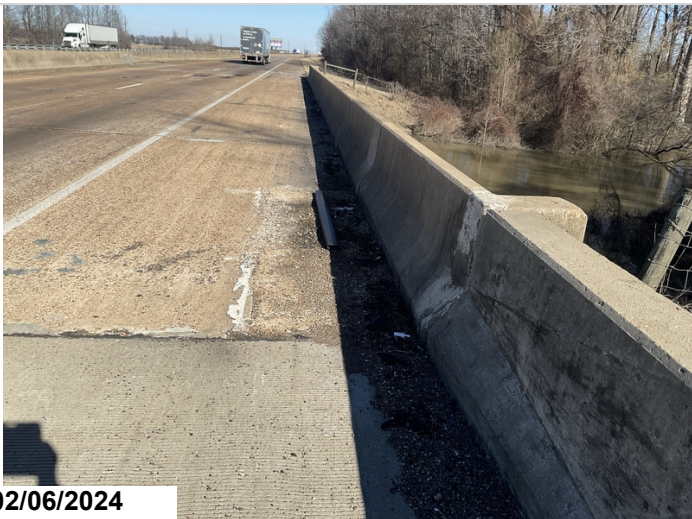
Dirt and debris in gutters.

Dirt and debris in gutters

A-55 - Deck Washing Needed (Y)

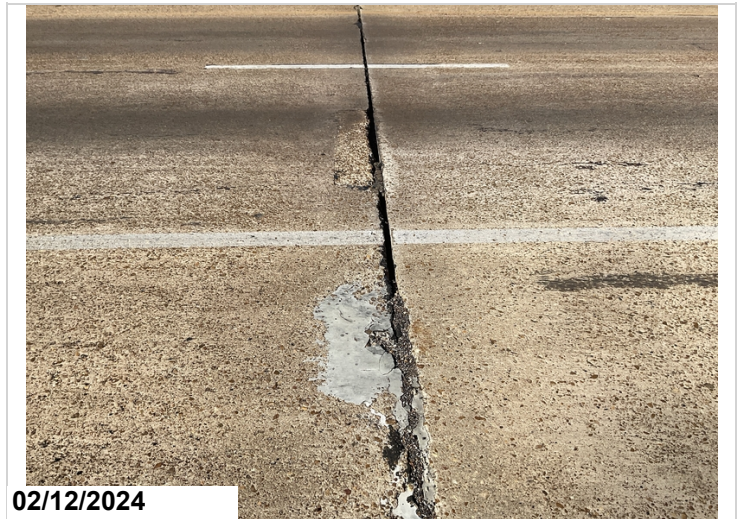
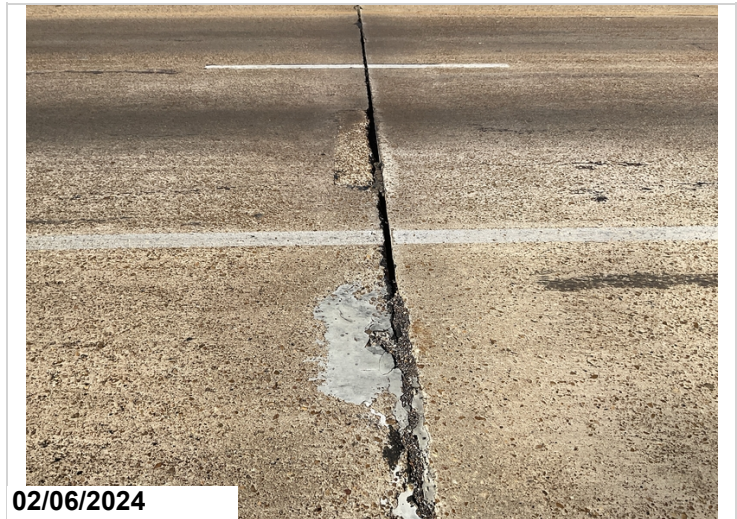
Joints have several areas of missing or damaged joint material.

(301) Joint seals are cracked and leaking with joint material missing and allowing debris to enter.							
321	Reinforced Concrete Approach Slab	SF	1680	1260	0	420	0
1130	Cracking (RC and Other)	SF	420	0	0	420	0

Typical missing joint material

A-59 - Joint Repair Needed (Yes)

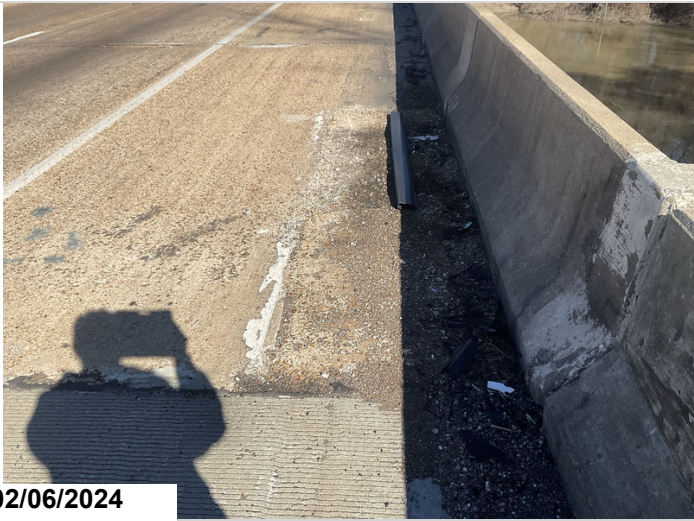
Deck has multiple sealed and unsealed cracks, scaling with loose aggregate and patched areas.

Span #1 right side patch in gutter scaling

A-62 - Hydro and LMC Advised (Y)

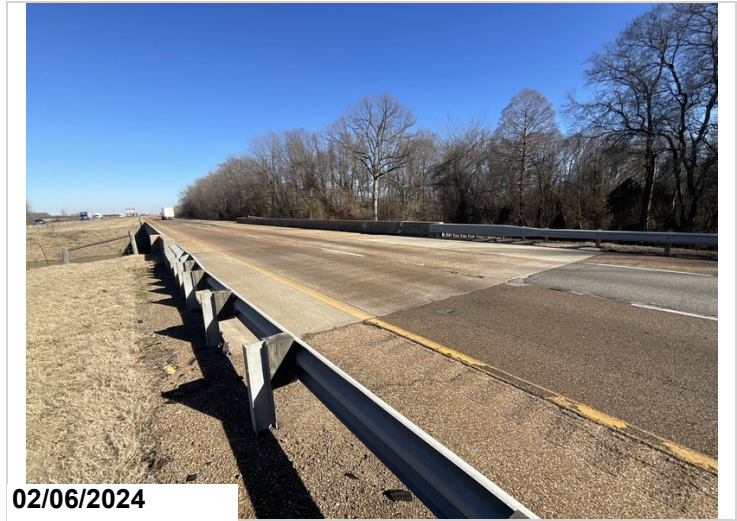
No log mile signs.

No log mile signs

A-63 - Missing/Incorrect Log Mile Signage (Y)

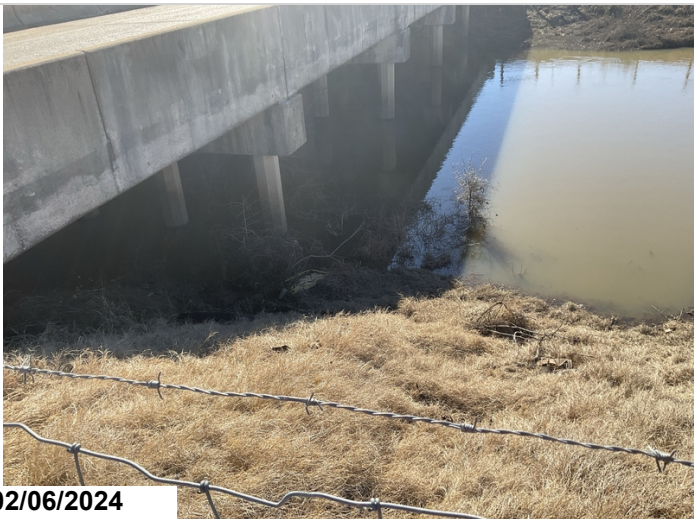
Brush and vegetation growing beside bridge.

Vegetation growth beside bridge

A-64 - Vegetation Removal Requested (Y)

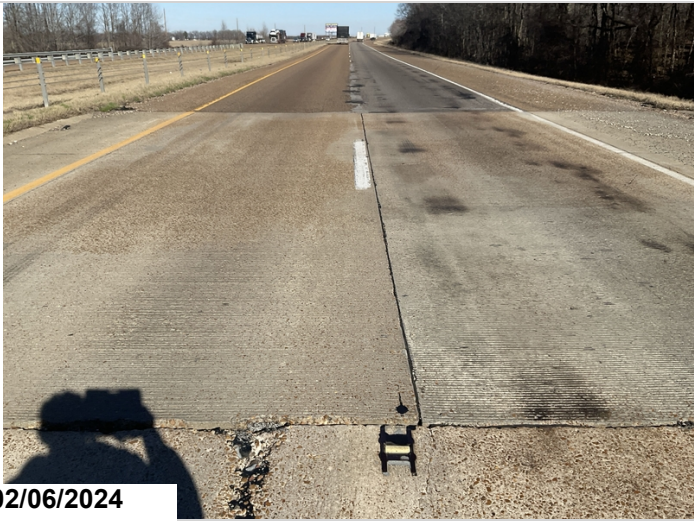
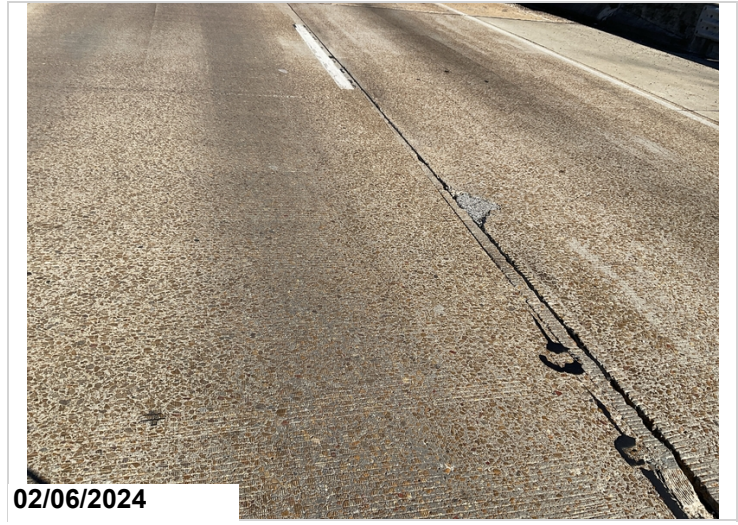
(321) All slabs have longitudinal and transverse cracks.							
331	Reinforced Concrete Bridge Railing	LF	250	250	0	0	0

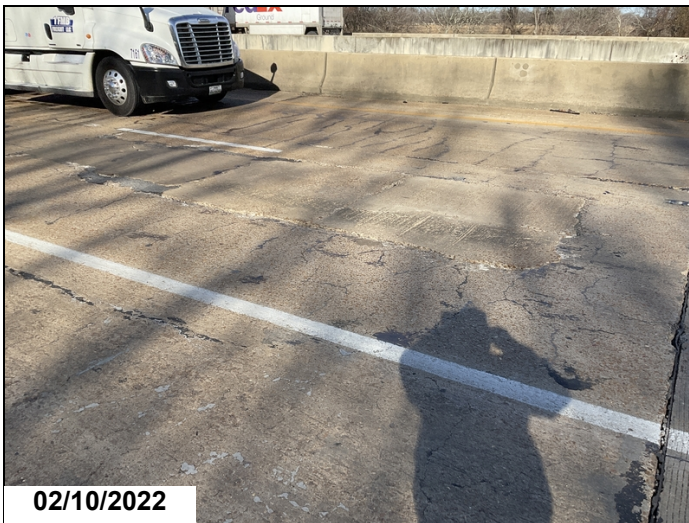
Span #5 deck

Deck span #5 old deck repairs are beginning to fail with multiple ache patches also failing.

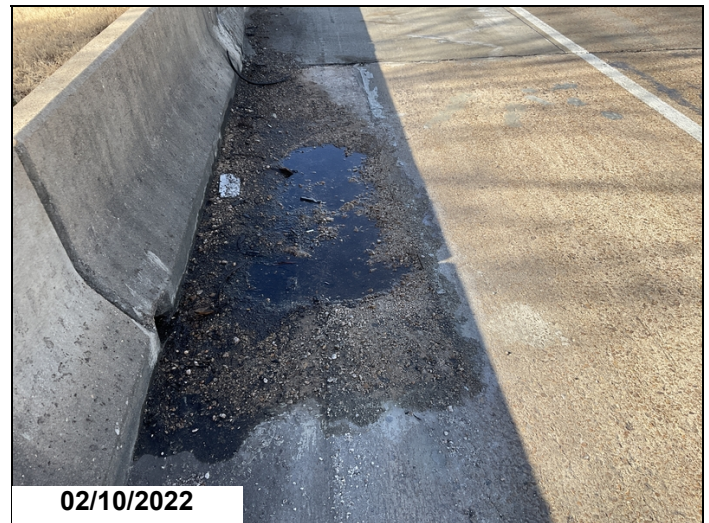
Span #1 has 20' of heavily scaled patches in right gutter.

Span #1 has 15' of heavily scaled patches in right gutter.

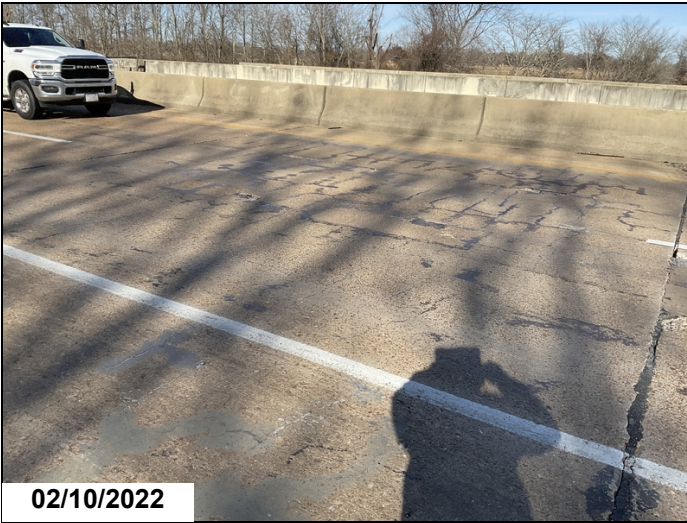
Span #4 deck left lane has full length crack with shallow spalling for 8', right lane has 1' shallow spall, no exposed rebar.

Span #4 deck right lane has two shallow small spalls with achm that is failing.

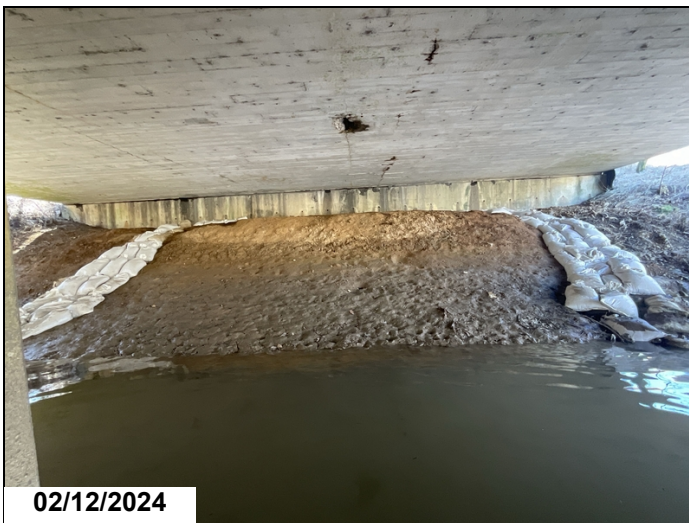
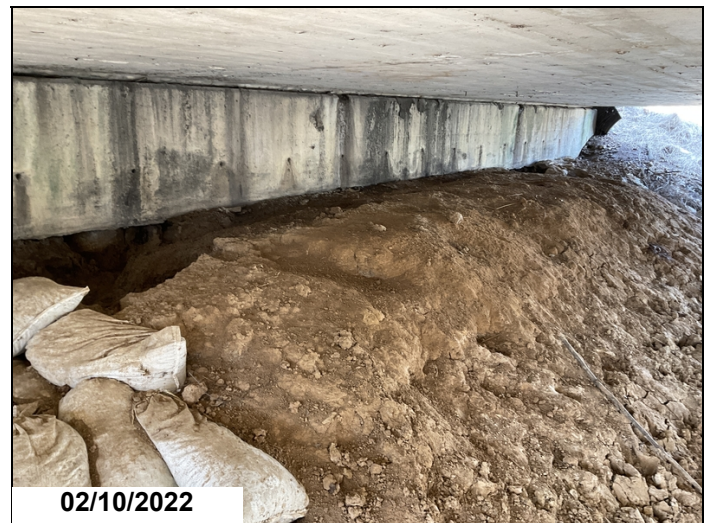
Abutment #1 has some erosion at cap exposing two piles.

2/6/2024-Erosion at abutment #1 has been sandbagged.

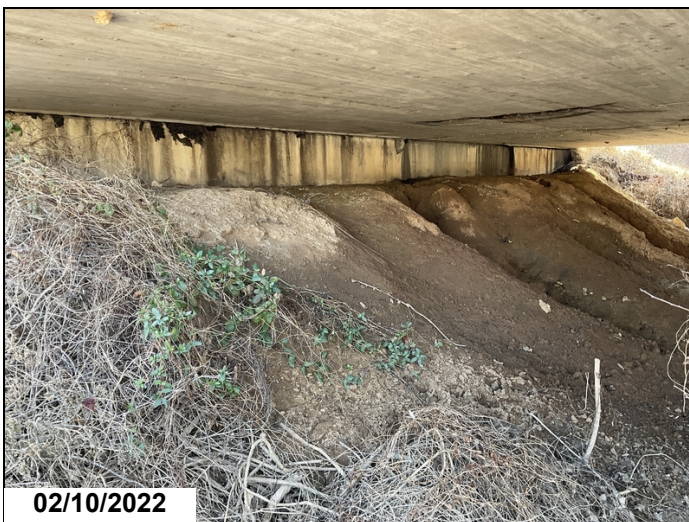
Abutment #2 slope is eroding to near vertical face within four feet of abutment with erosion veins running down slope.

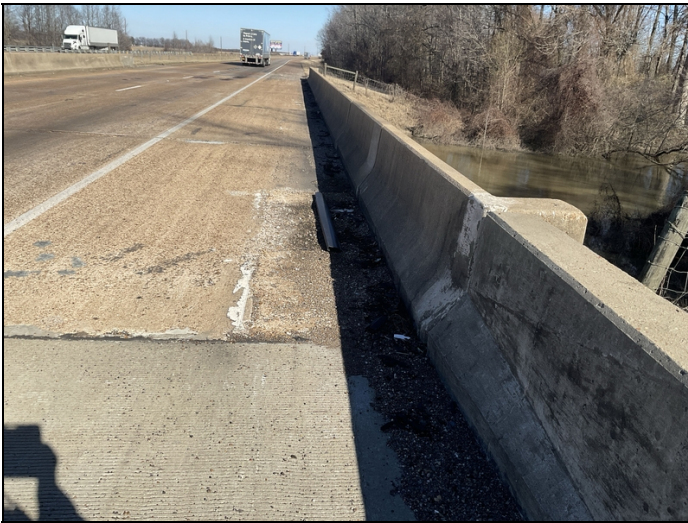
Dirt and debris in gutters.

Dirt and debris in gutters

A-55 - Deck Washing Needed (Yes)

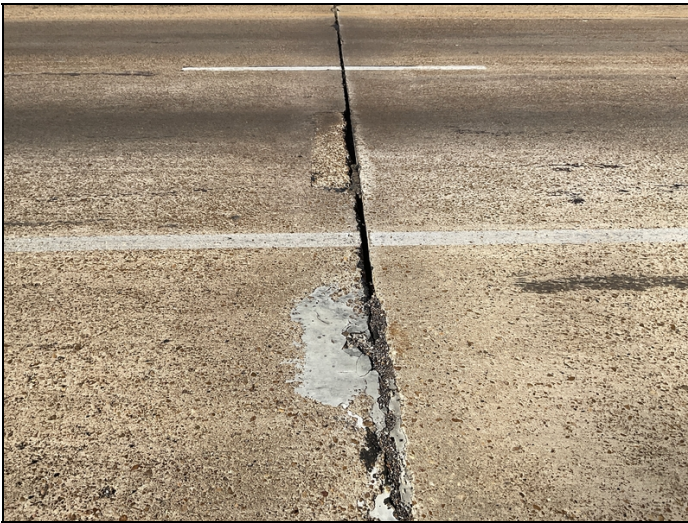
Joints have several areas of missing or damaged joint material.

Typical missing joint material

A-59 - Joint Repair Needed (Yes)

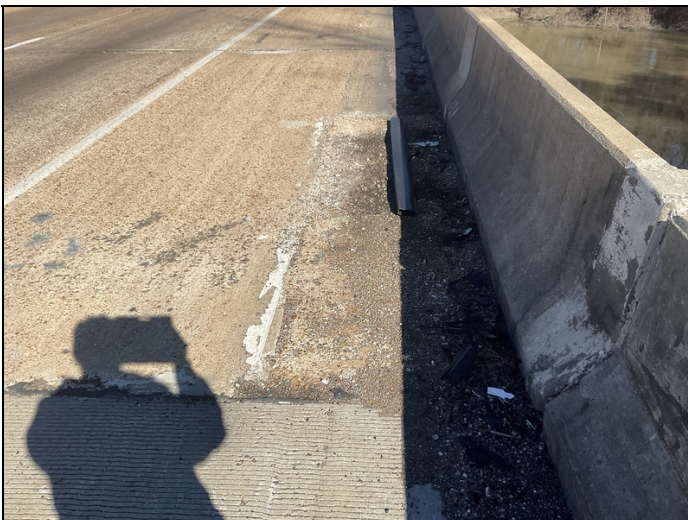
Deck has multiple sealed and unsealed cracks, scaling with loose aggregate and patched areas.

Span #1 right side patch in gutter scaling

A-62 - Hydro and LMC Advised (Yes)

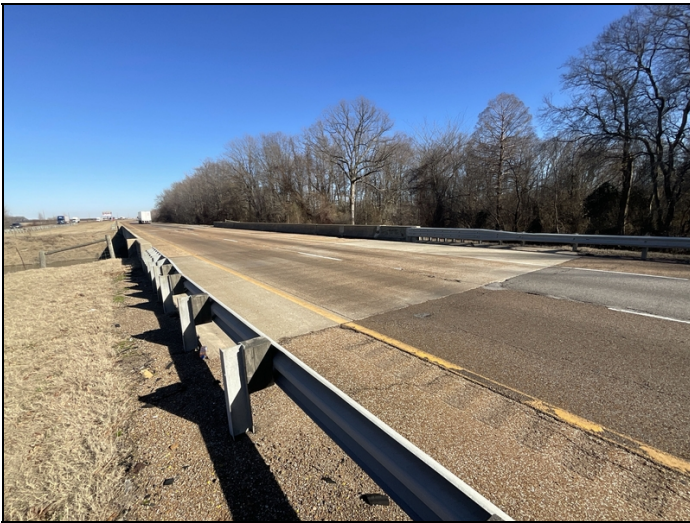
No log mile signs.

No log mile signs

A-63 - Missing/Incorrect Log Mile Signage (Yes)

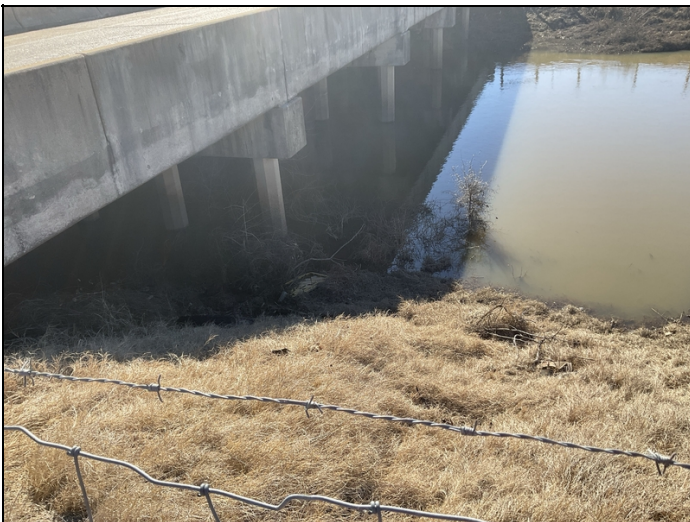
Brush and vegetation growing beside bridge.

Vegetation growth beside bridge

A-64 - Vegetation Removal Requested (Yes)
