Bridge B3769 Inspection Report

Asset #B3769(Routine, Underwater type 2)

I-40EB/Se51/226.19 over Big Creek

Team Lead: Myron Futrell Inspection Date: 03/13/2024

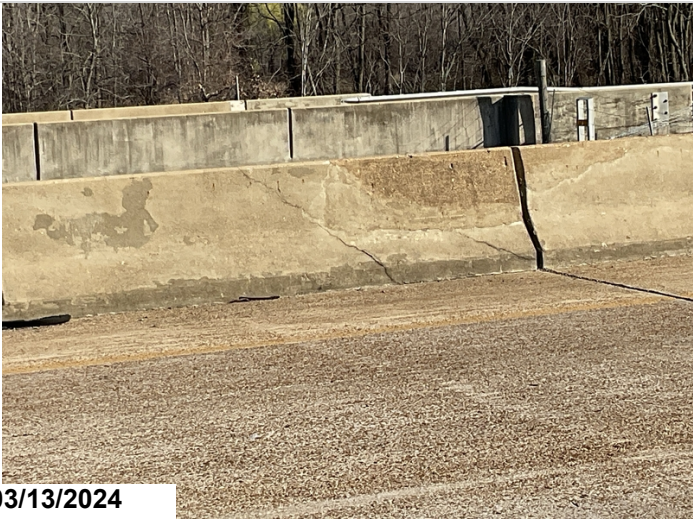
Span 4, bridge rail, left side: two 4' diagonal cracks.4LF CS3

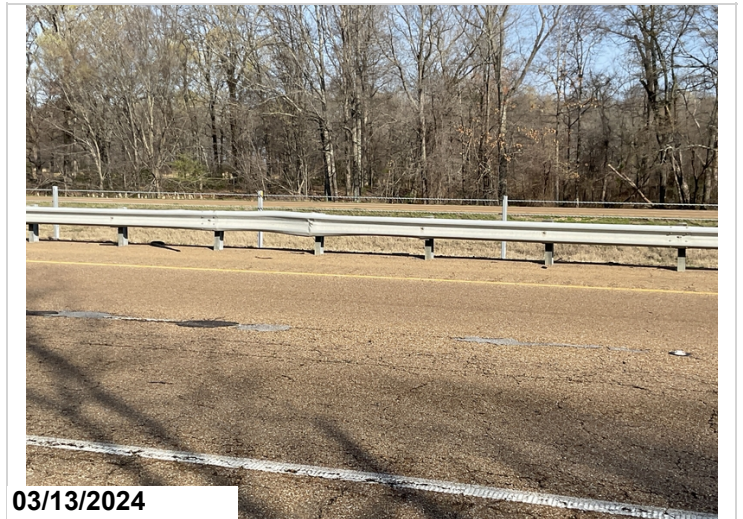
Abutment #1 left approach rail has 6' of moderate collision damage mid span.

Abutment 1 right approach rail has 6' of moderate collision damage mid span.

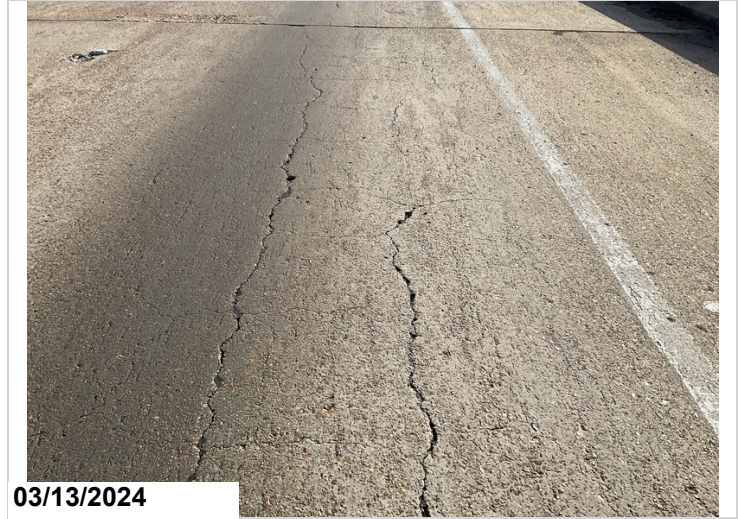
Deck has wide unsealed longitudinal cracking throughout and light to moderate abrasion full length.

Deck cracking span 1 right lane

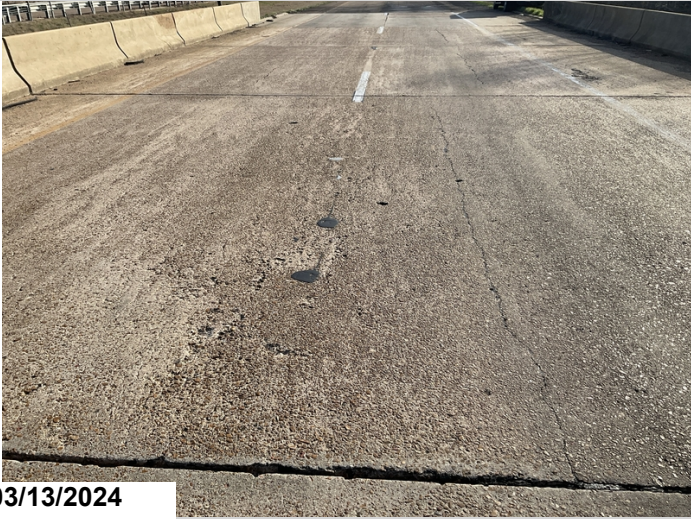
Deck, Span 3, Right Lane, Full Length: Sealed wide crack.

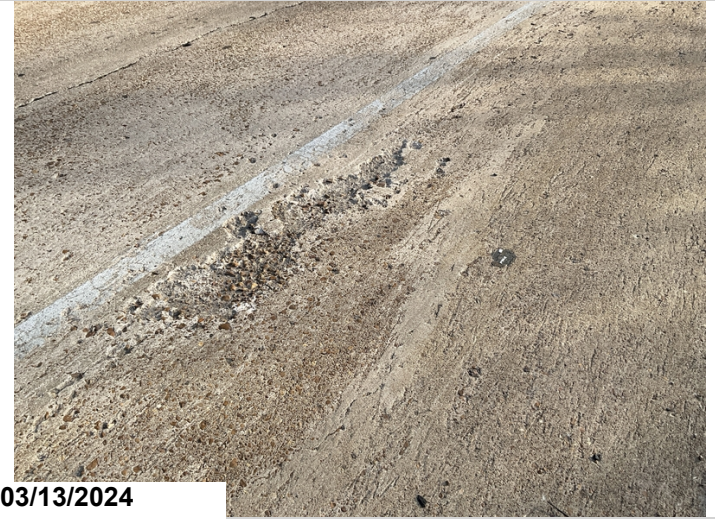
Span 4, deck, right gutter: 1' x 3' of moderate scaling. 3SQF CS3

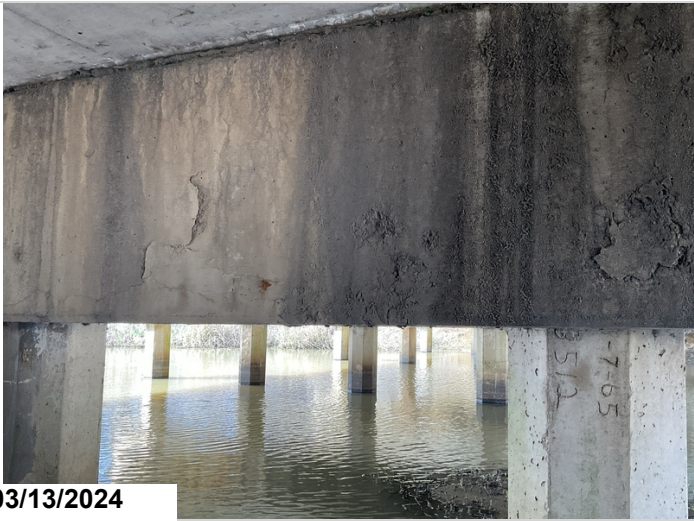
Reinforced concrete substructure is in overall satisfactory condition. Concrete pile caps have several delaminated areas, shallow spalls with exposed reinforcing steel and minor cracking. Abutment slopes have minor erosion.

Bent #5 cap ahead face between piles 3 and 4 has one-foot delaminated area and three feet of longitudinal CS2 cracking.

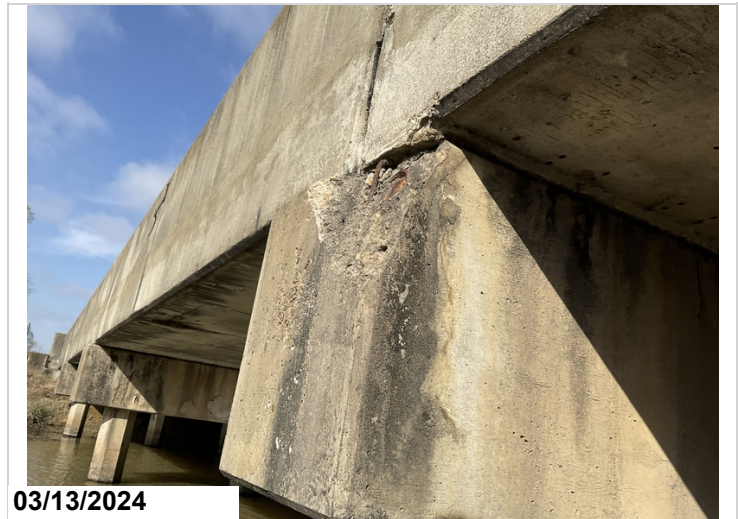
Bent 4 cap right end spalled with exposed rebar

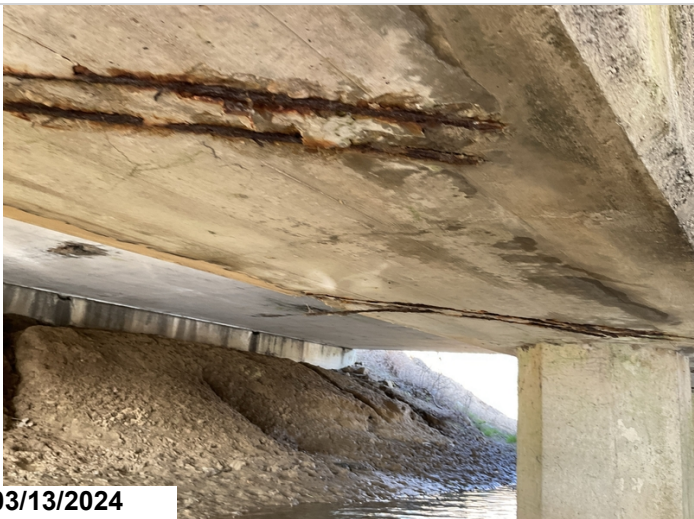
Typical exposed reinforcing steel on bottom face of pile cap

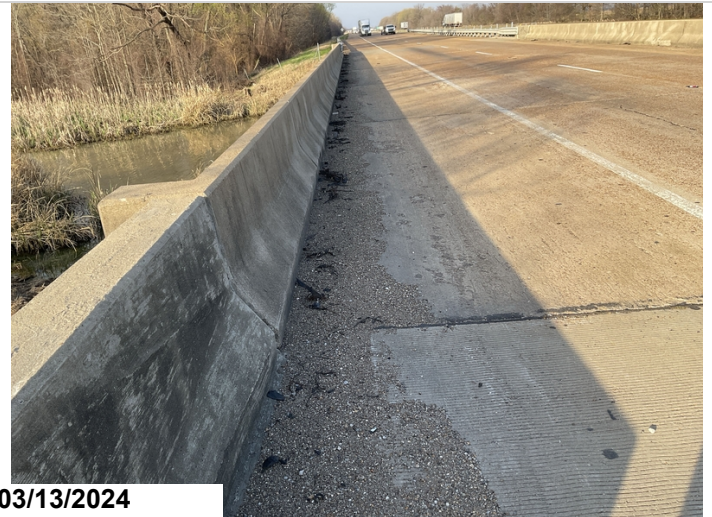
Dirt and debris in gutters.

Dirt and debris in gutters

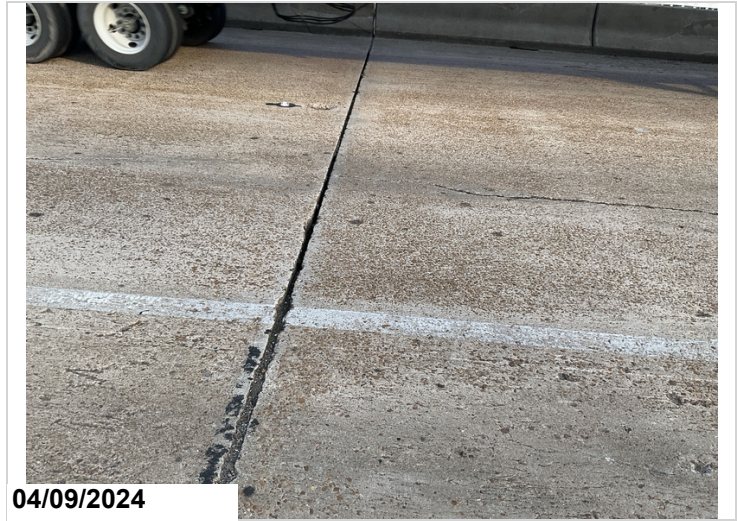
Joint material weathered, cracked or missing allowing debris in joints.

Bent 5 joint seal missing

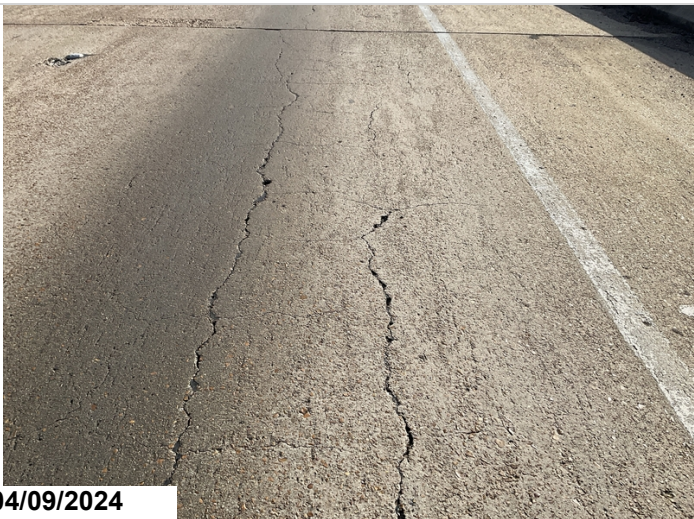
Deck cracking span 1 right lane

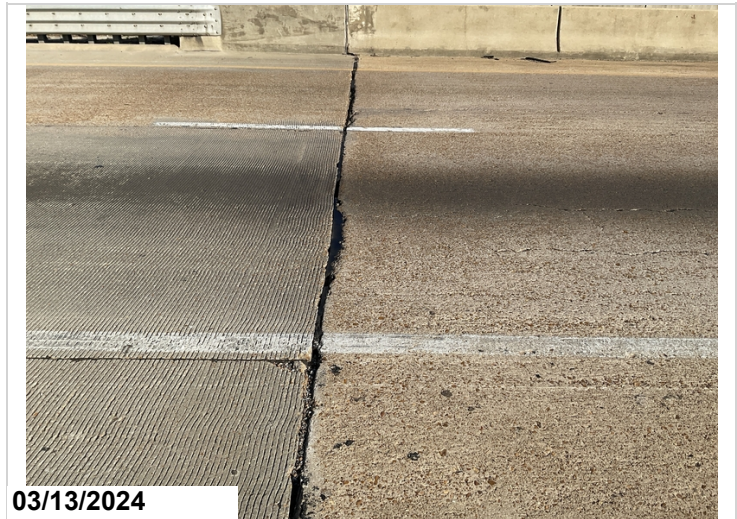
Pourable joint seal, abutment 1: 15' of seal missing

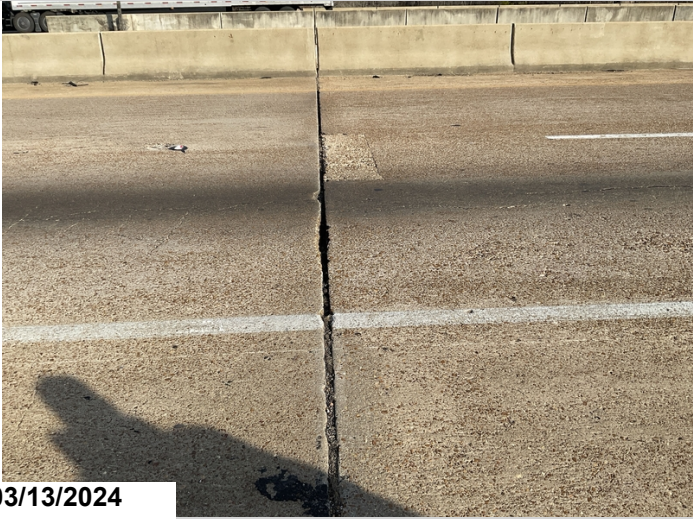
Pourable Joint Seal, Bent 2: Pourable joint seal missing across travel lanes.

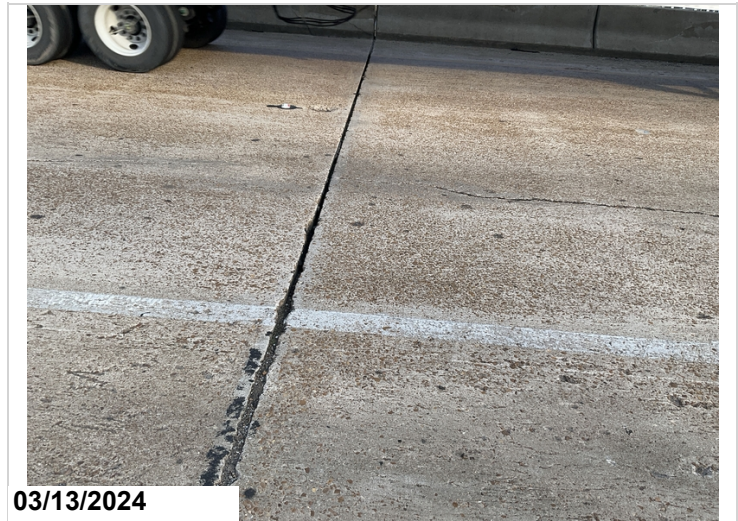
Bent 5 joint seal missing

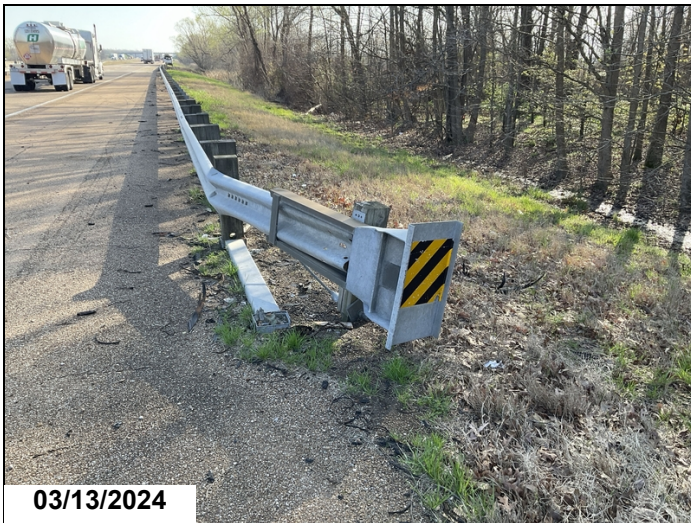
Abutment 1, right approach rail end: first post broken and rail bent, end treatment out of place.

Abutment 1 right approach rail end, first post broken and rail bent, end treatment out of place.

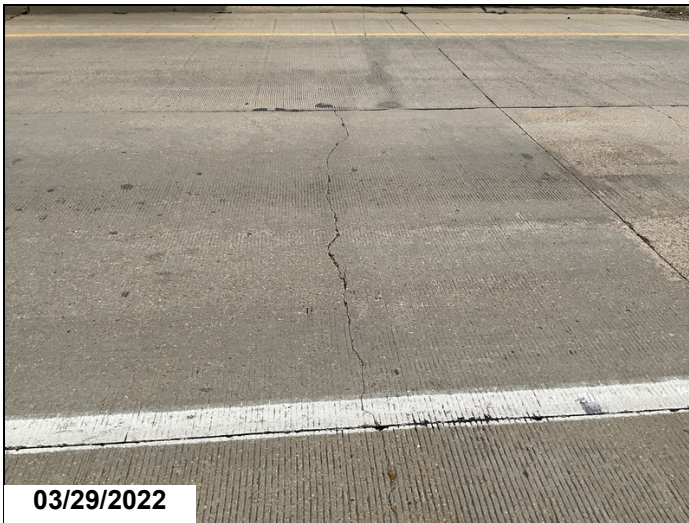
All approach slabs have open transverse cracks.

Typical transverse approach slab crack

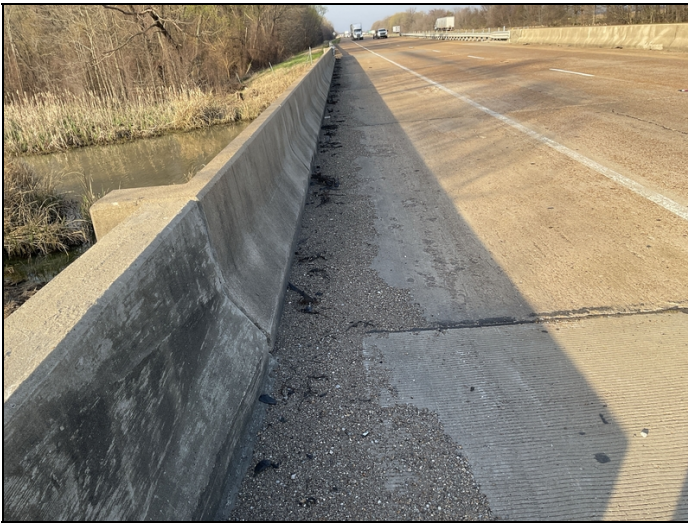
Dirt and debris in gutters.

Dirt and debris in gutters

A-55 - Deck Washing Needed (Yes)

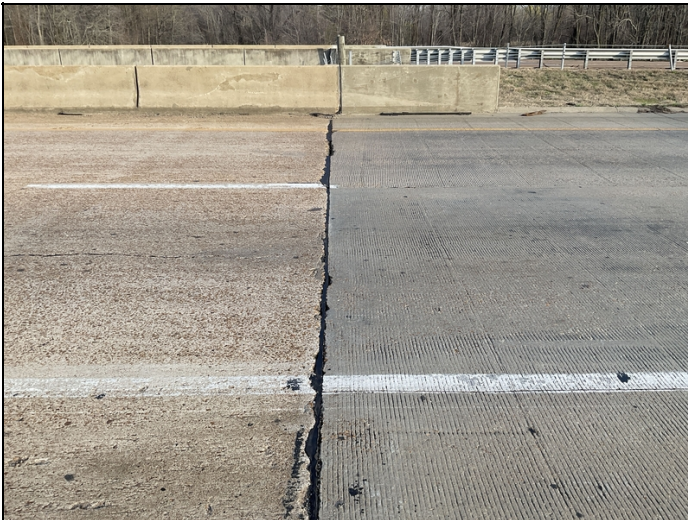
Abutment 2 joint

Joint material weathered, cracked or missing allowing debris in joints.

A-56 - Joint Cleaning/Flushing Needed (Yes)

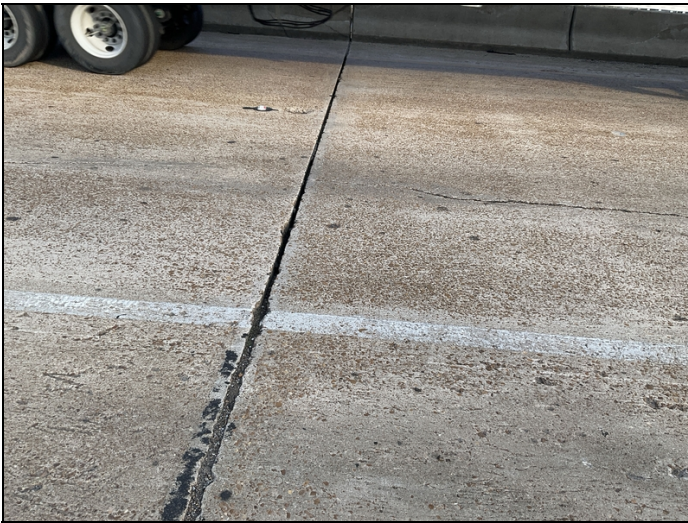
Joint material weathered, cracked or missing allowing debris in joints.

Bent 5 joint seal missing

A-59 - Joint Repair Needed (Yes)

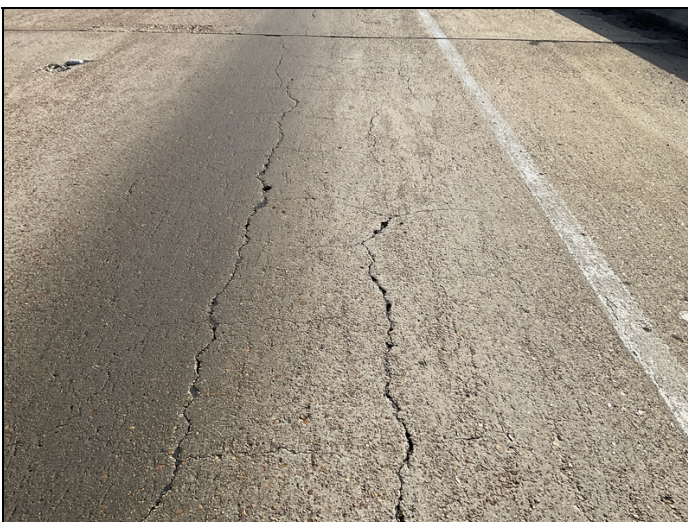
Deck has wide unsealed longitudinal cracking throughout and light to moderate abrasion full length.

Deck cracking span 1 right lane

A-62 - Hydro and LMC Advised (Yes)
