Bridge B6518 Inspection Report

Asset #B6518(Routine, Underwater type 2)

I-40EB/Se51/233.97 over Languille River

Team Lead: Myron Futrell Inspection Date: 04/09/2025

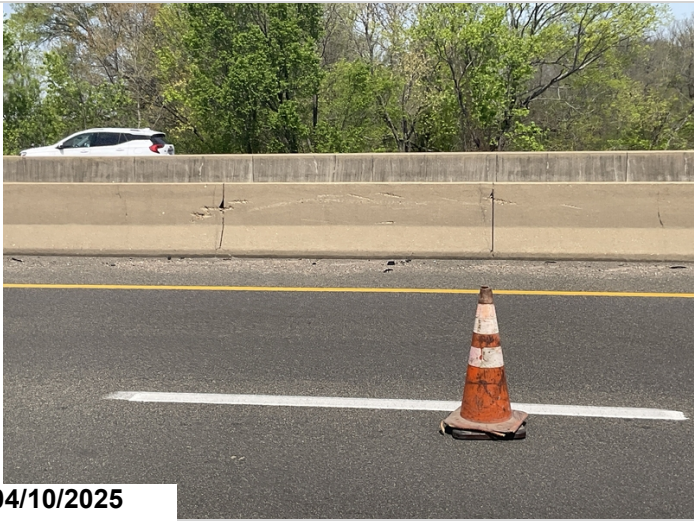
(331) Reinforced concrete bridge rail: several sections have longitudinal cracking with light efflorescence near top, each rail has vertical hairline cracking some with light efflorescence. Efflorescence 317LF CS2 Span 3, bent 4, bridge rail, left side: 10' minor scrapes.

Span 3, bent 4, bridge rail, left side: 10' minor scrapes.

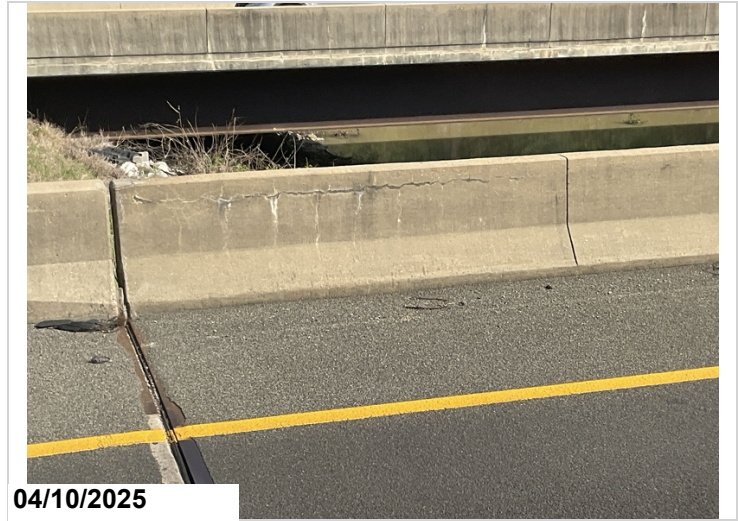
Typical longitudinal cracking in bridge rail

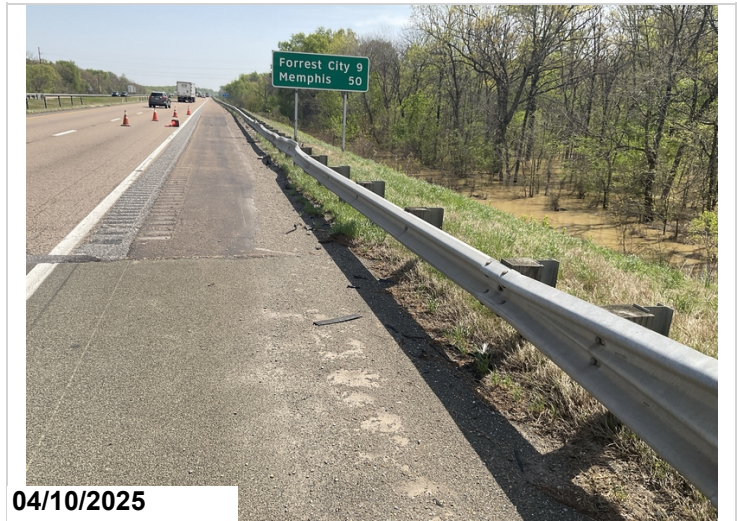
Abutment 2, approach rail, right side: approximately 40' moderate collision damage 60' from bridge end.

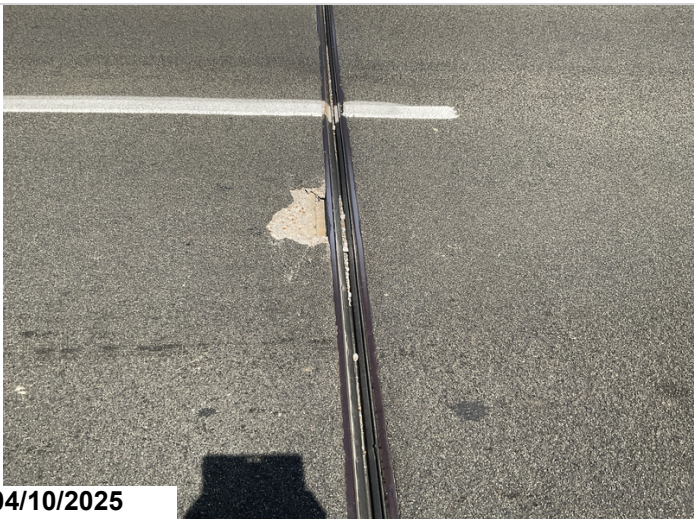
(12) Wearing surface, span 5, at bent 6 joint: 1' spall. Spall 1SF CS3 Undersurface of overhangs: transverse cracks with light efflorescence spaced 3' to 4' apart. Efflorescence 792SF CS2 Deck: cracks have been sealed with epoxy overlay. Cracking 6609SF CS1 Span 5, deck, right lane, at bent 6 joint: 1' spall with no exposed reinforcing steel. Spall 1SF CS3							
107	Steel Open Girder/Beam	LF	3950	3897	1	52	0
1000	Corrosion	LF	52	0	0	52	0
1020	Connection	LF	1	0	1	0	0
515	Steel Protective Coating	SF	31680	0	31528	0	152
3430	Oxide Film Degradation Color/Texture Adherence(Steel Protective Coatings)	SF	31680	0	31528	0	152

Span 5, deck, right lane, at bent 6 joint: 1' spall with no exposed reinforcing steel.

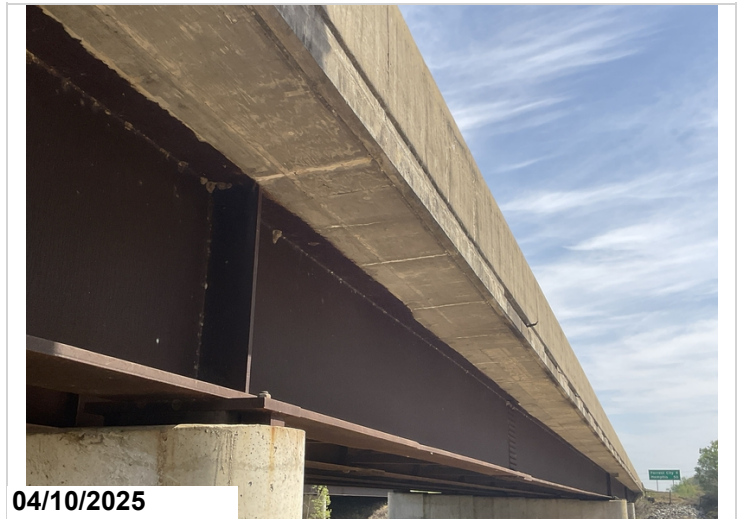
Typical cracking with light efflorescence in undersurface of overhang.

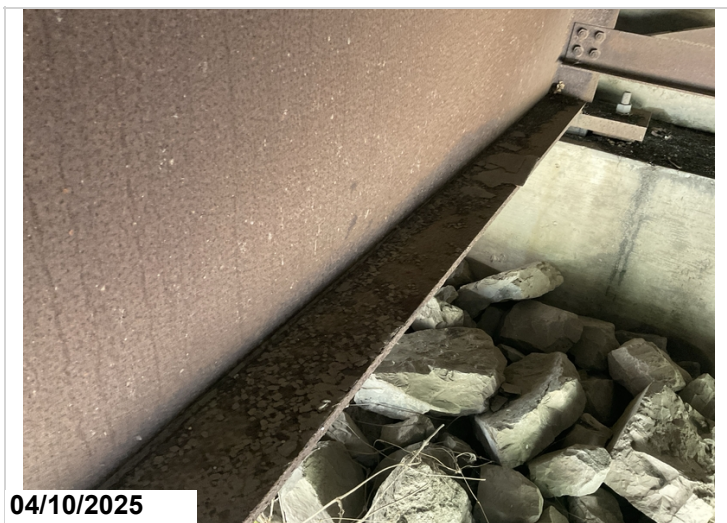
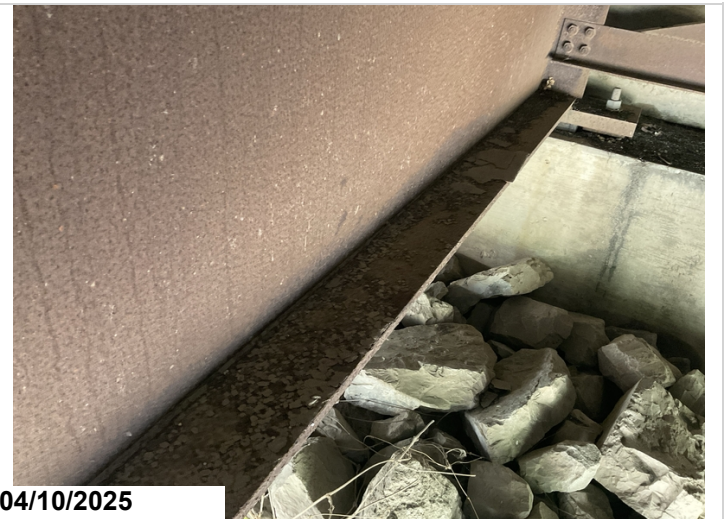
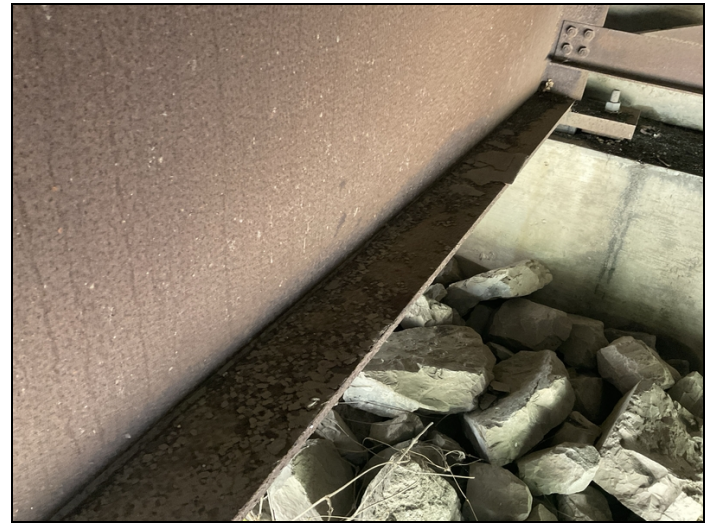
Span 7, girder 3, bottom flange and lower web, last 10':
scaly rust.

Span 7, girder 3, bottom flange and lower web, last 10': scaly rust.

A-57 - Girder End and Bearing Painting Needed (Y)

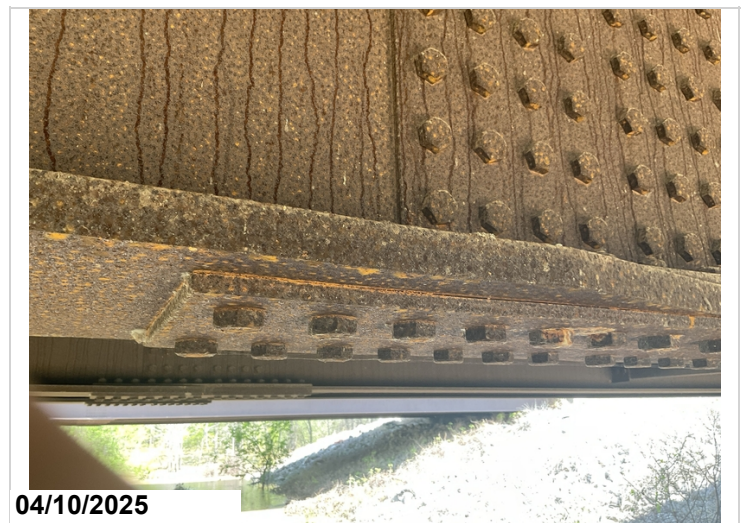
Span 7, girder 3, lower field splice: initial pack rust. Typical of
girder 4.

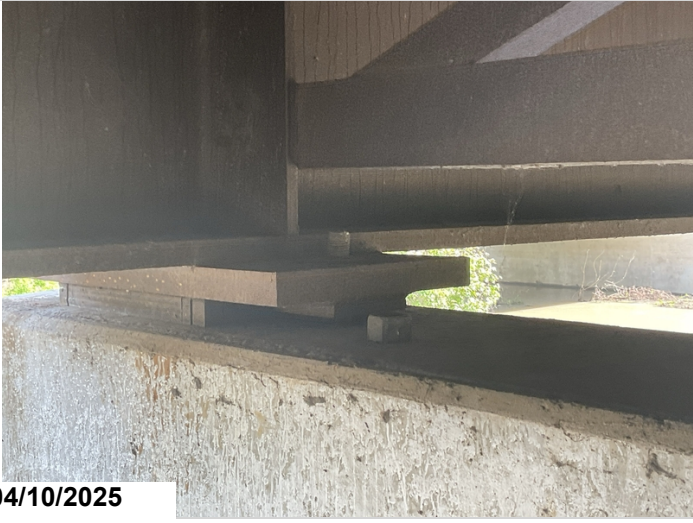
Span 1, girder ,1 bent 2, right bearing nut: sitting on bent.

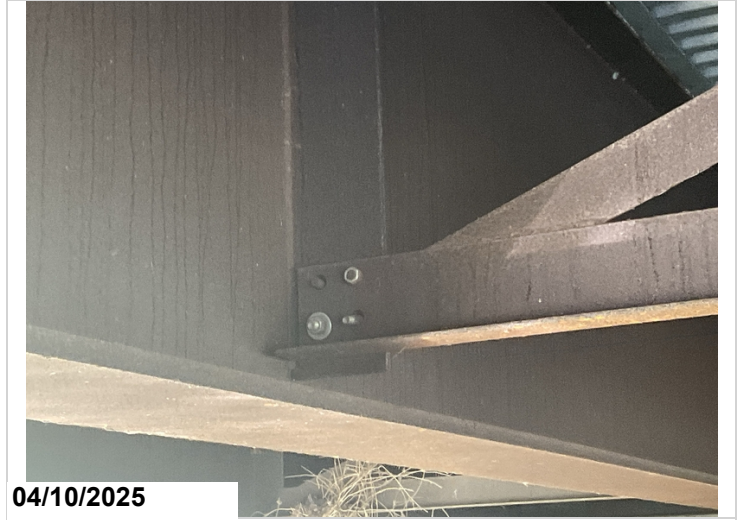
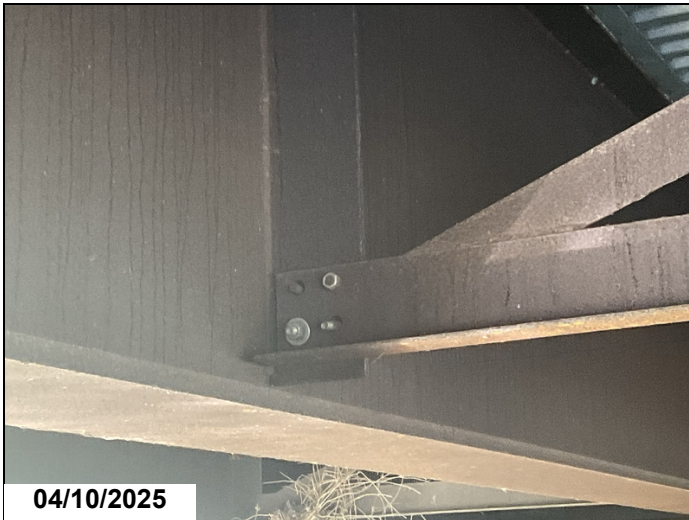
Span 1, girder 4, diaphragm 3, right lower bolts: loose with two missing nuts.

Span 1, girder 4, diaphragm bolts: loose.

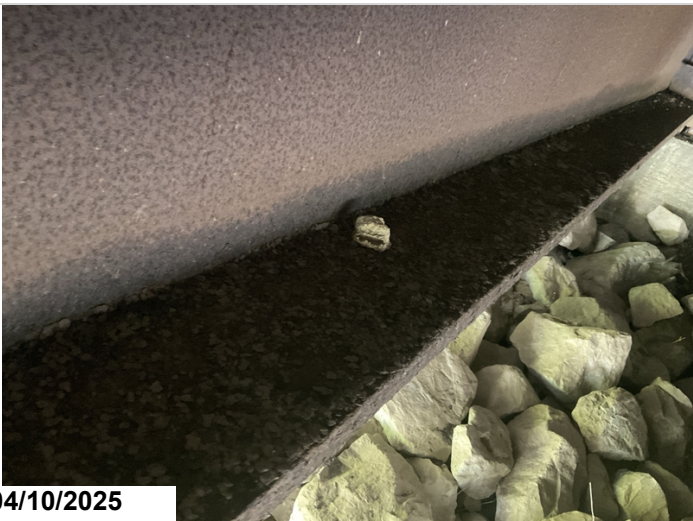
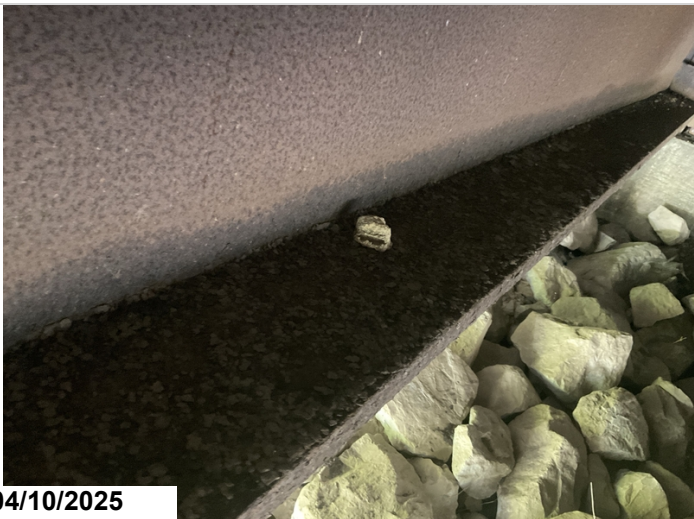
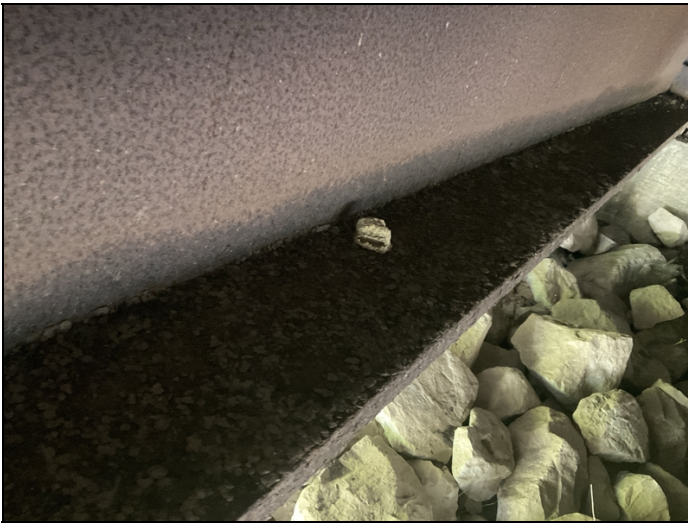
Span 1, girder 4, bottom flange and lower web: first 10' has flaky rust . Typical of girders 2,3,4.

Span 1, girder 4, bottom flange and lower web: first 10' has flaky rust.

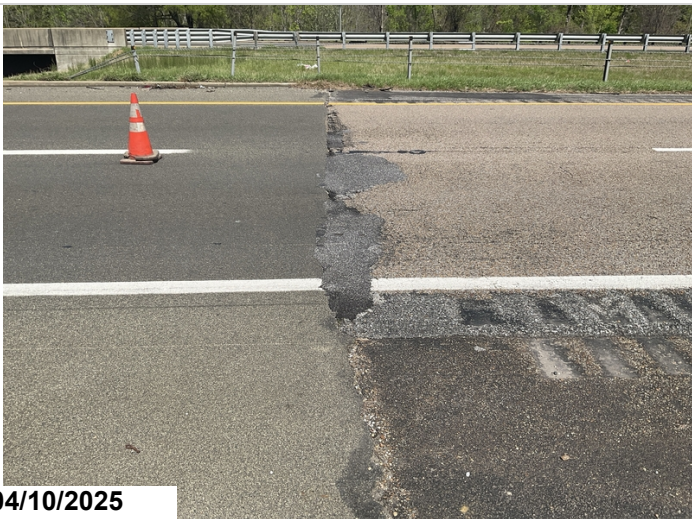
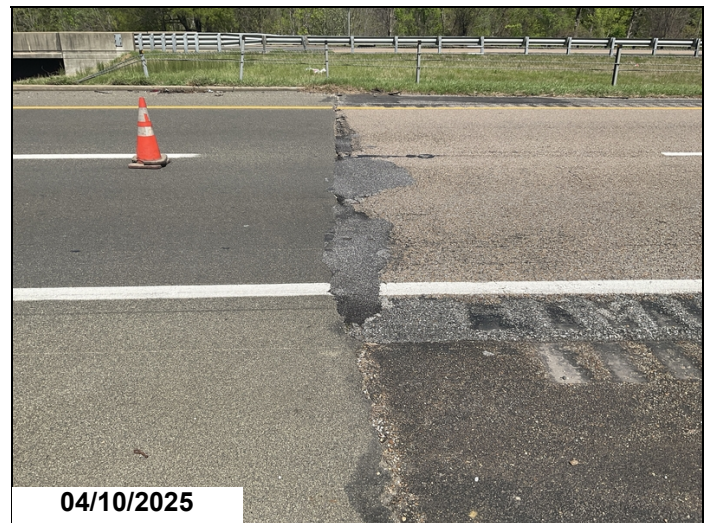
Abutment 2, approach roadway, left lane: asphalt minor spalling.

Type of Work: Approach Leveling/Maintenance

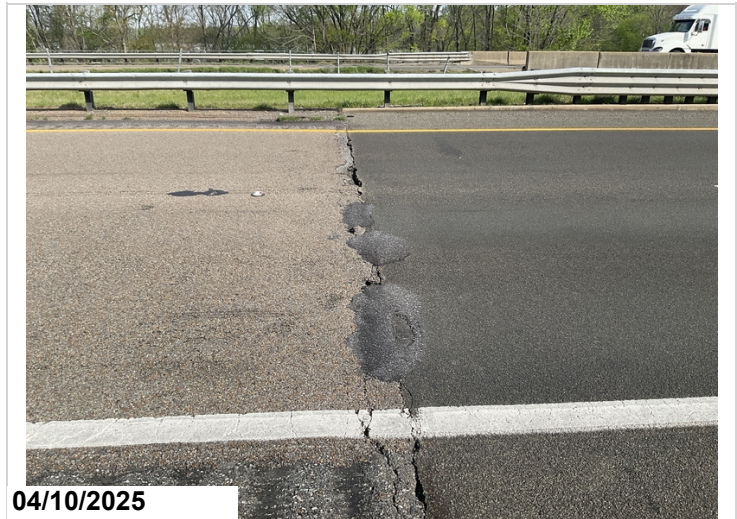
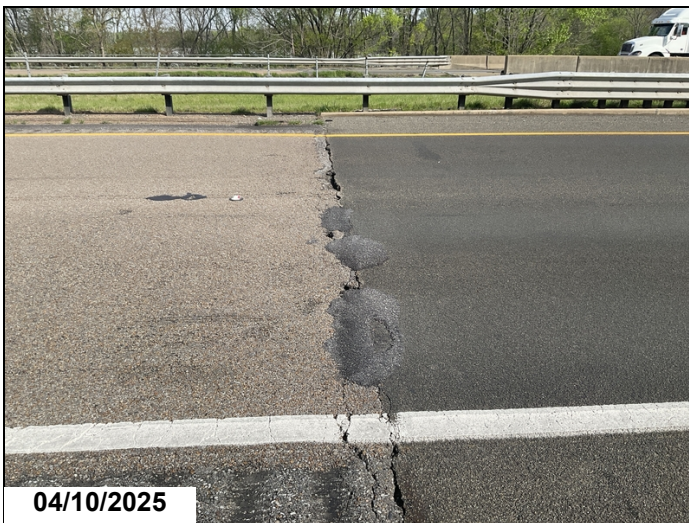
Abutment 1, approach roadway, left lane: asphalt minor spalling.

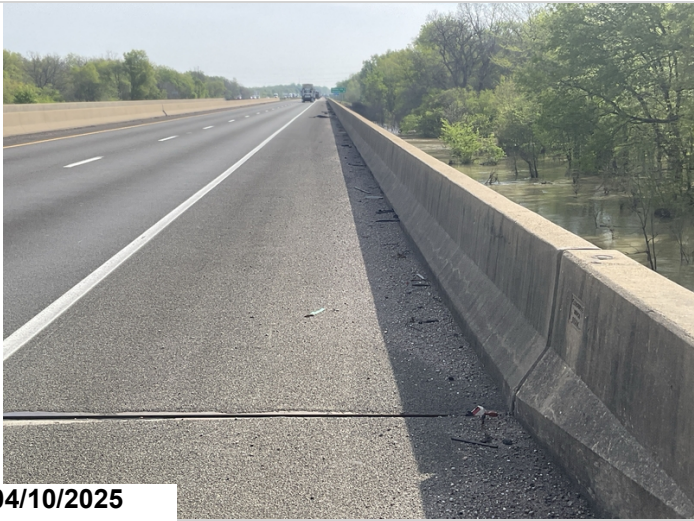
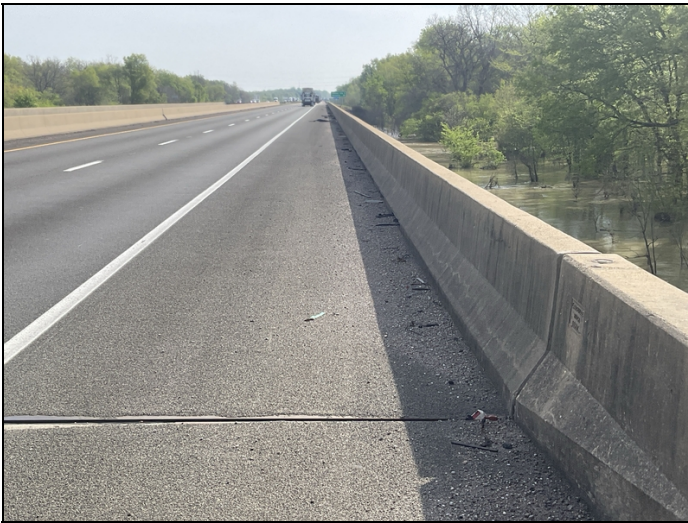
Dirt and debris in gutters.

Dirt and debris in gutters

A-55 - Deck Washing Needed (Y)

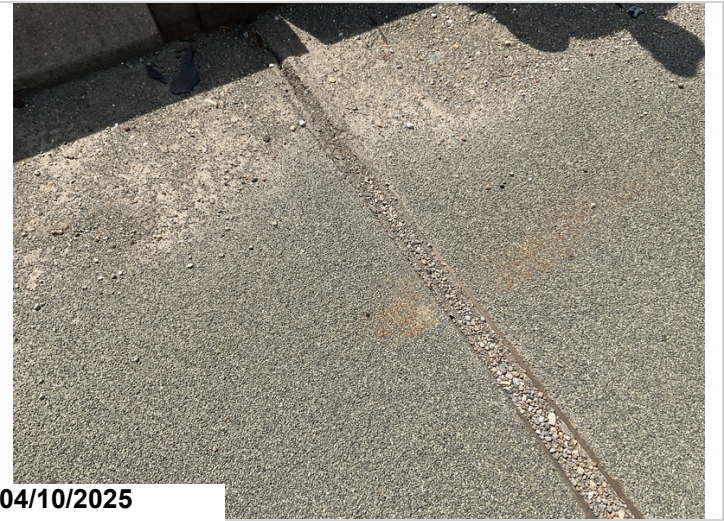
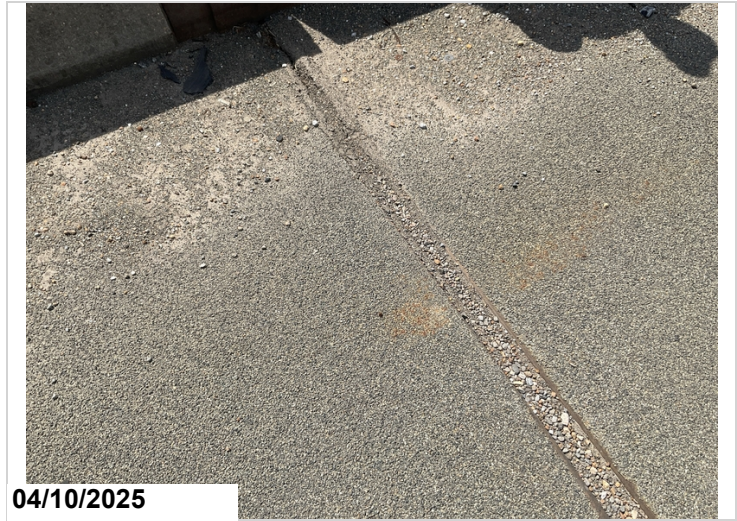
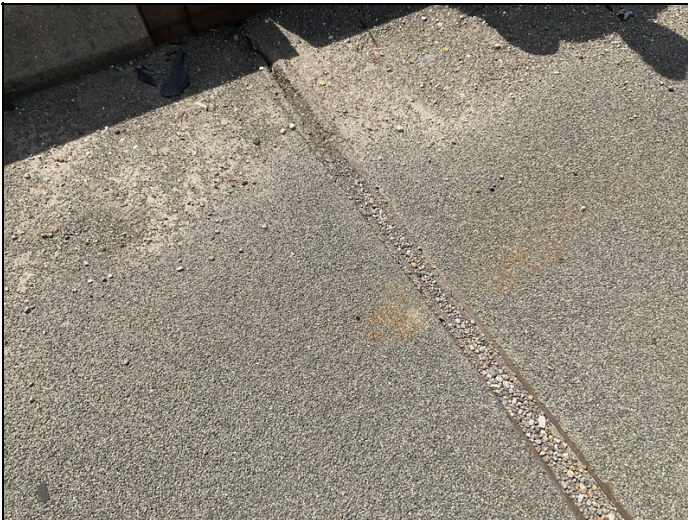
Strip seals in gutters have debris in them.

Typical debris impaction of joints.

A-56 - Joint Cleaning/Flushing Needed (Y)

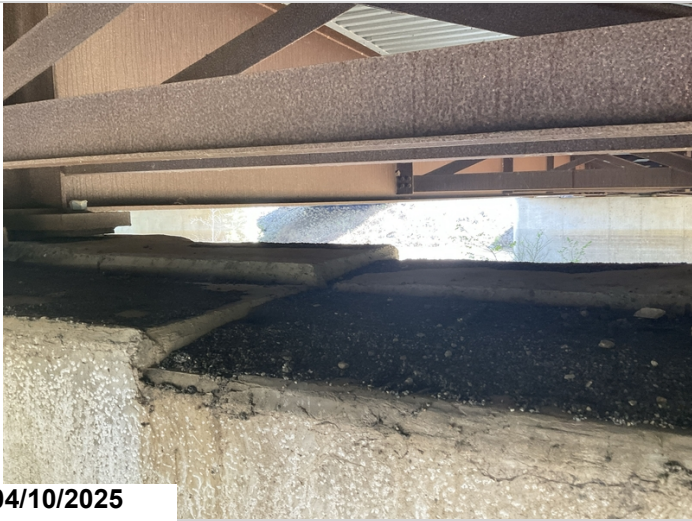
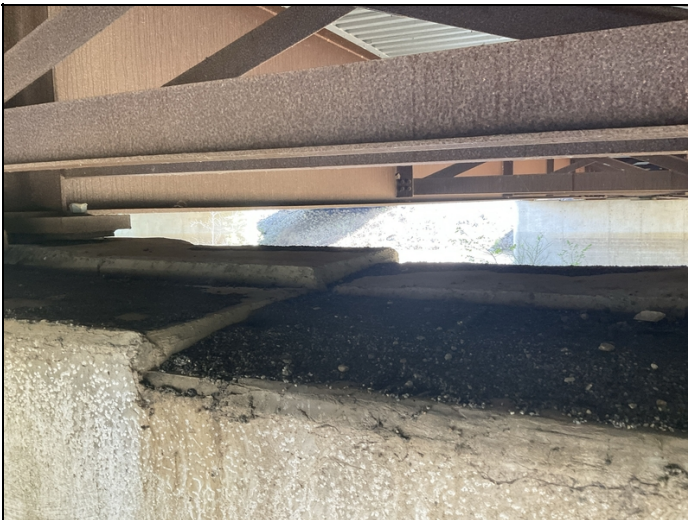
Caps have minor amounts of debris on them.

Dirt and debris on bent 5 pier cap

A-58 - Cap Cleaning/Flushing Needed (Y)

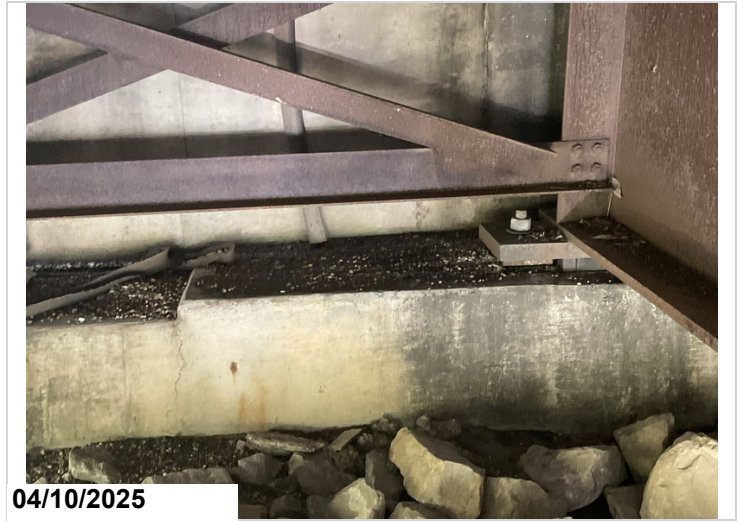
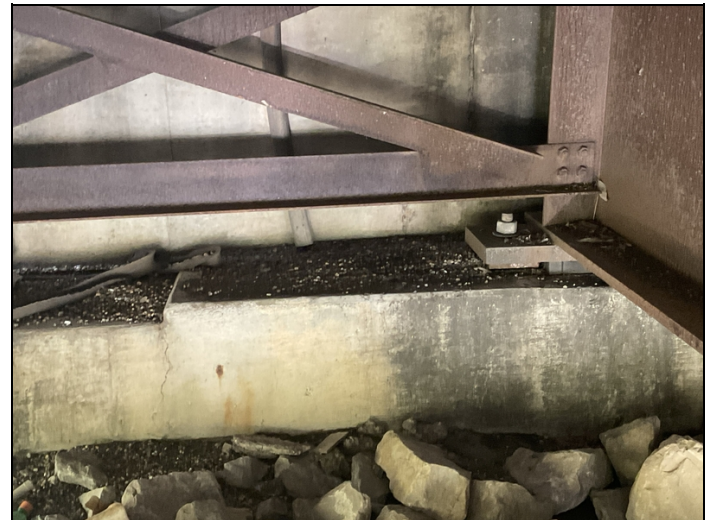
Dirt and debris on abutment caps

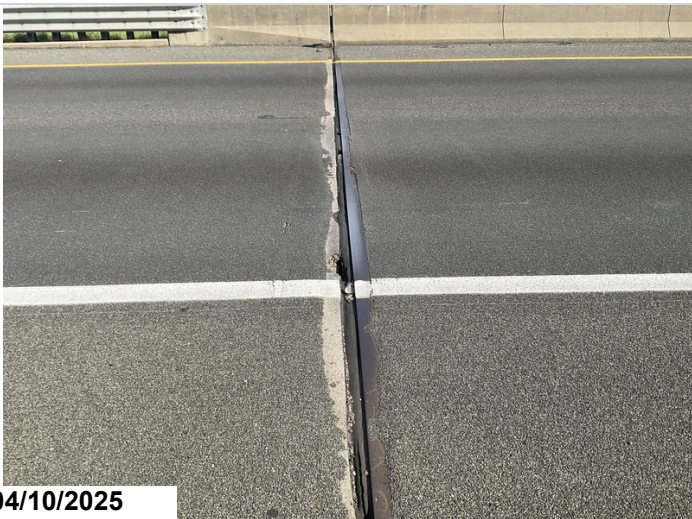
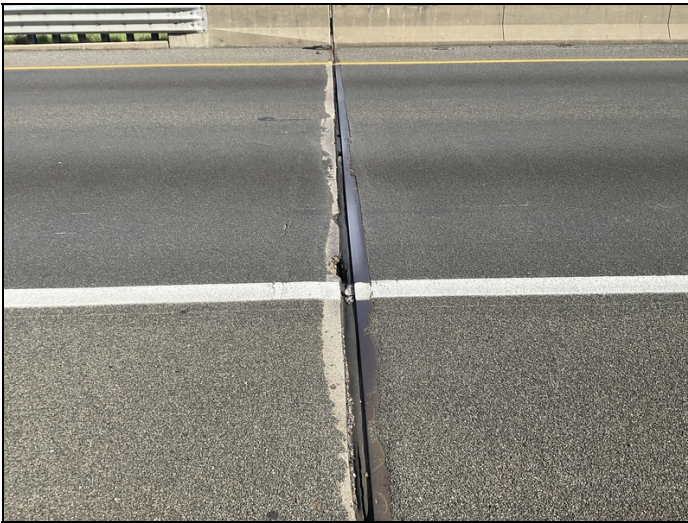
(301) Abutment joints have been rehabbed with the addition of epoxy overlay and changed to pourable joint seal. Abutment 1, pourable joint seal: splits and holes throughout 35LF total. Leakage 35LF CS4							
310	Elastomeric Bearing	EA	50	47	3	0	0
1020	Connection	EA	3	0	3	0	0

Abutment 1, pourable joint seal: splits and holes throughout 35LF total. Leakage 35LF CS4

A-59 - Joint Repair Needed (Y)

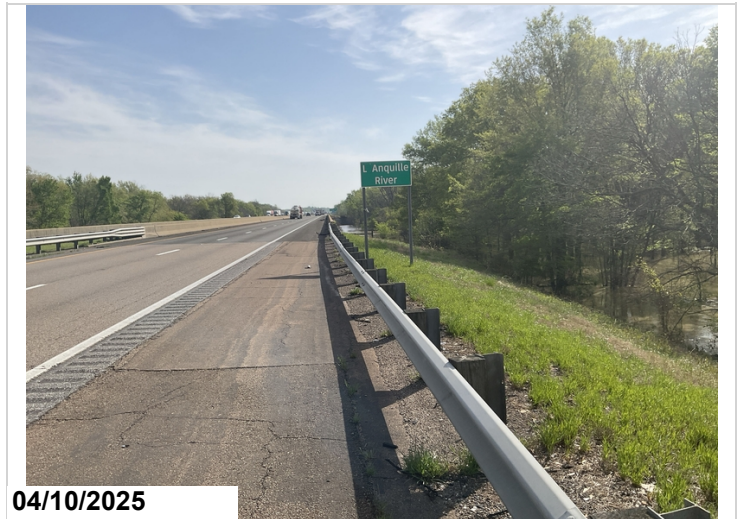
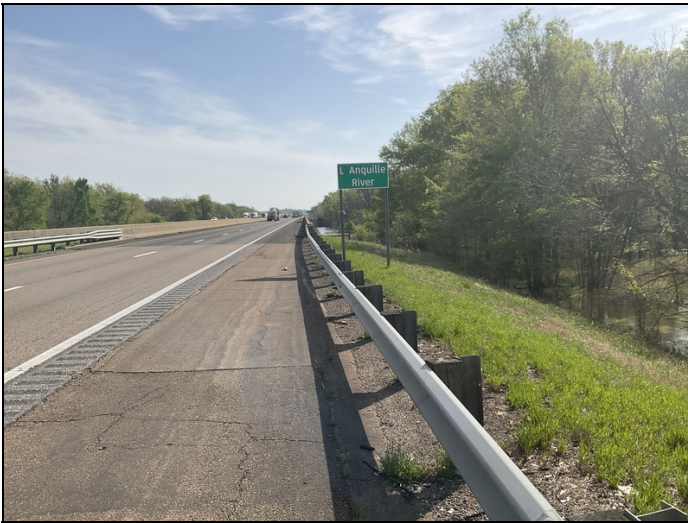
No log mile sign in place.

A-63 - Missing/Incorrect Log Mile Signage (Y)

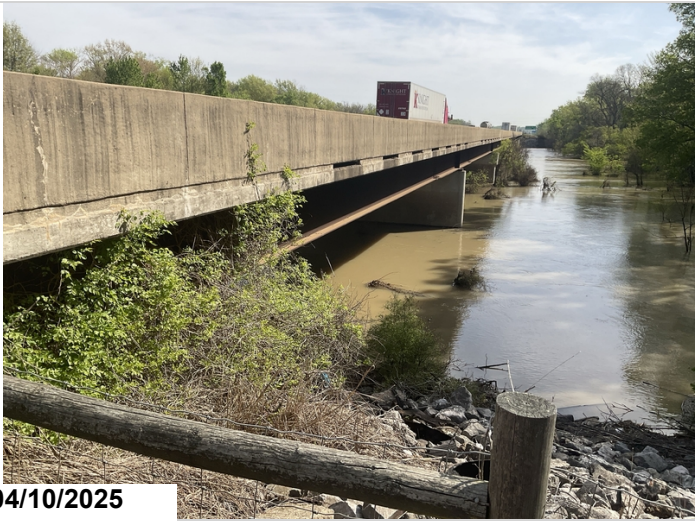
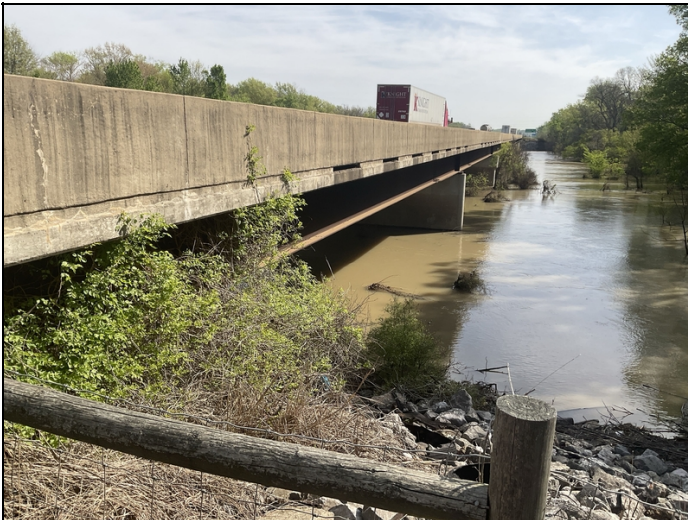
Channel is in overall fair condition. Channel alignment is fair at structure, slopes are well vegetated however, trees and vegetation growing along and into channel restrict flow slightly.

Trees and vegetation growing beside, under and onto bridge

A-64 - Vegetation Removal Requested (Y)

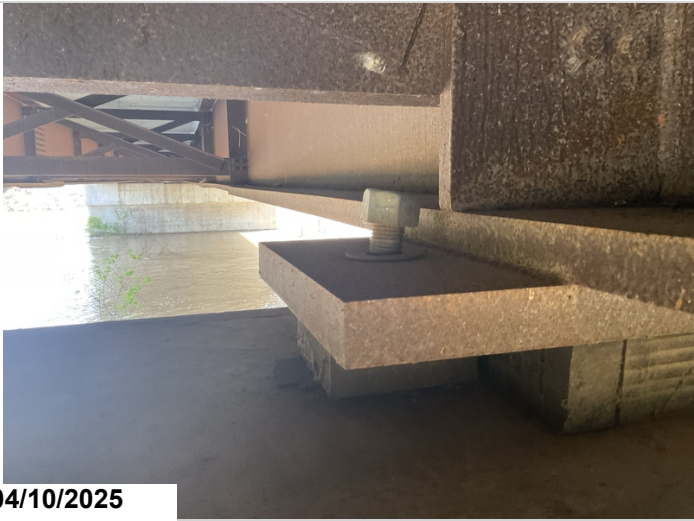
Bent 5, girder 3, left anchor bolt: moves in concrete.

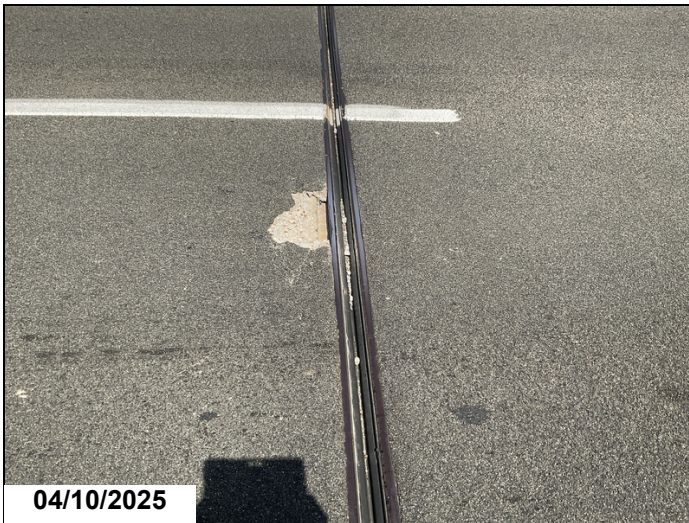
Span 5, deck, right lane, at bent 6 joint: 1' spall with no exposed reinforcing steel.

Type of Work: Deck Repair

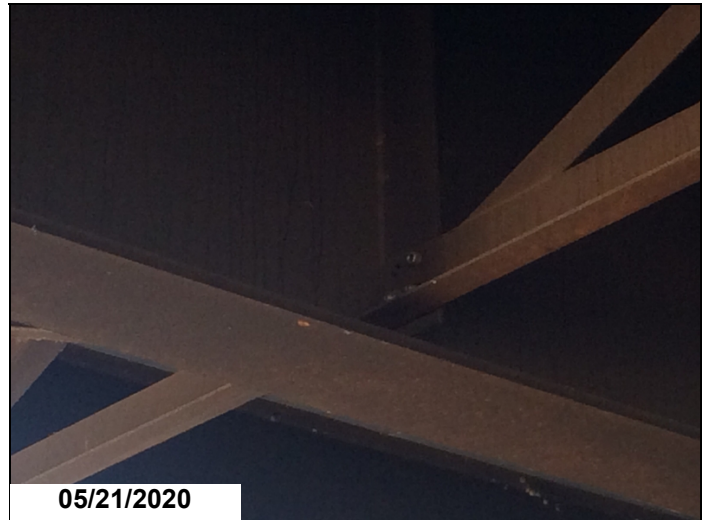
Span 3, bent 4, girder 5, lower diaphragm connection: several loose bolts.

Typical loose diaphragm bolts
