Bridge A3614 Inspection Report

Asset #A3614(Routine, Underwater type 2)

I-40WB/Se51/237.82 over Spring Creek

Team Lead: Myron Futrell Inspection Date: 01/29/2024

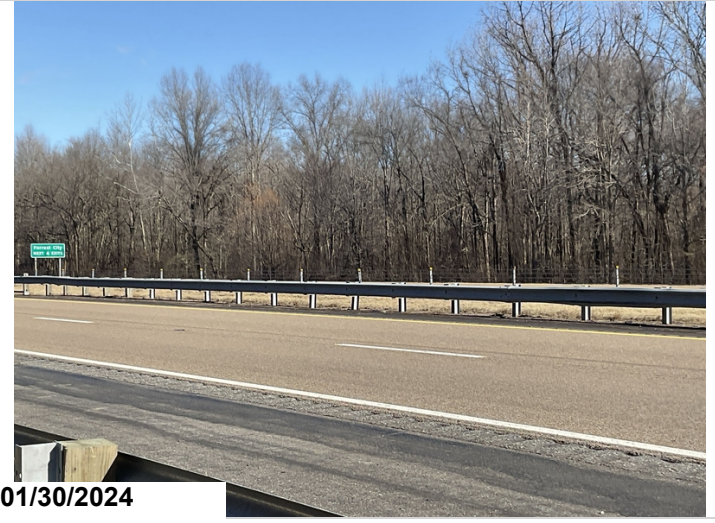
Abutment #2 right approach rail has two areas of minor damage

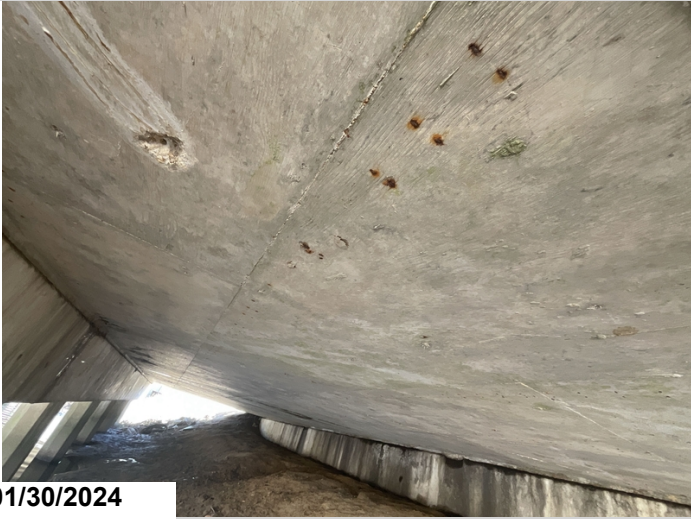
Concrete slab superstructure is in overall fair condition. Soffit / underside of deck has several fairly large spalls with exposed rebar and multiple cracks with rust staining and efflorescence. Top of slab (deck) has an epoxy overlay, spans 1 and 3 have a fairly large spall in the right travel lane.

Span # 1 soffit / underside of deck

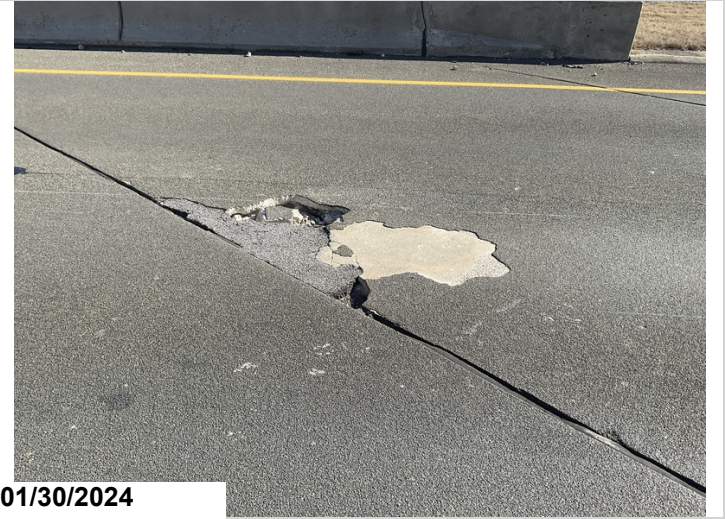
Span #1 right lane at bent #2 has a four foot long by one-foot wide ACHM patch and a two-foot spall up to four inches deep with exposed rebar and four-square feet of missing epoxy overlay.

Span #1 right travel lane at bent #2 has a 3' x 3' spall with ACHM patch reflecting through to soffit-under surface with spall and exposed rebar.

Priority: A - Safety deficiency; requires prompt action

1/31/2024-Reopened as an A priority due to increased severity of spalling.

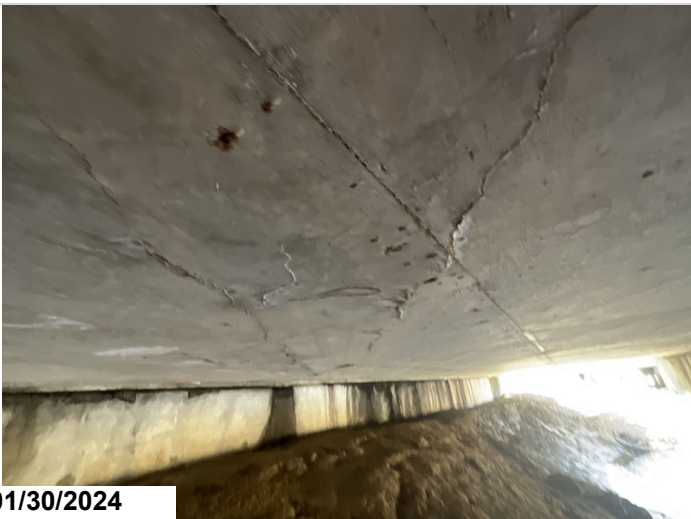
Typical soffit cracks with rust staining and efflorescence

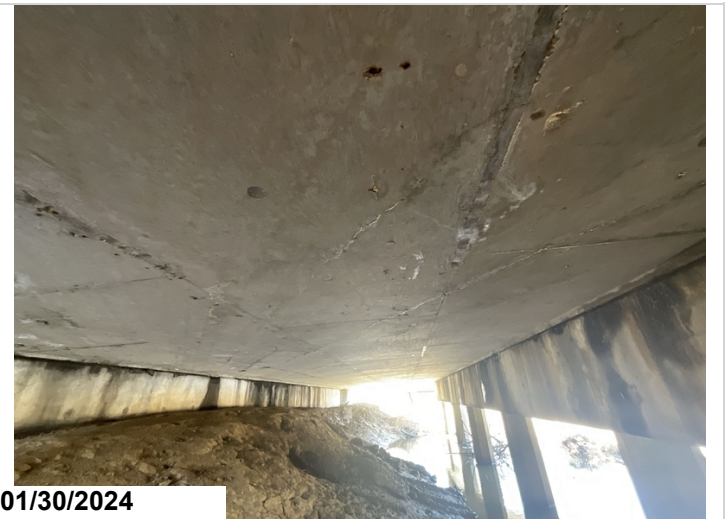
Span #3 soffit / underside of deck

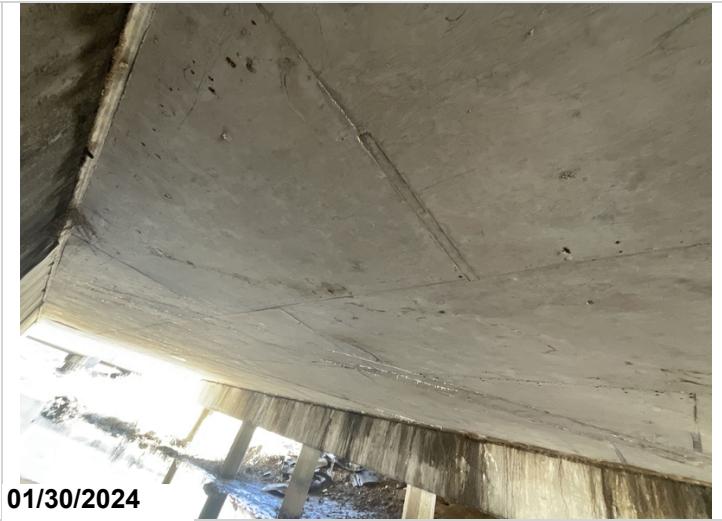
Span #2 soffit / underside of deck

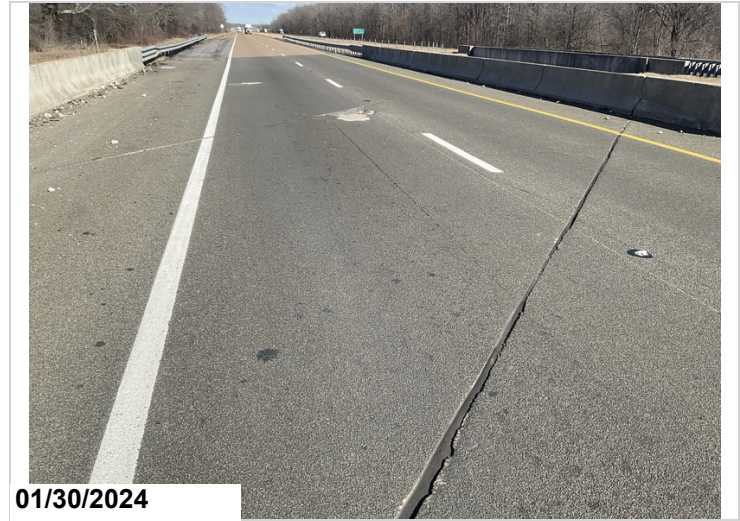
Deck is in overall fair condition. An epoxy wearing surface has been applied to deck. Spans 1 and 3 have a large spall each in the right travel lane, Soffit / underside of deck has several spalls with exposed rebar and multiple cracks with rust staining and efflorescence.

Typical deck

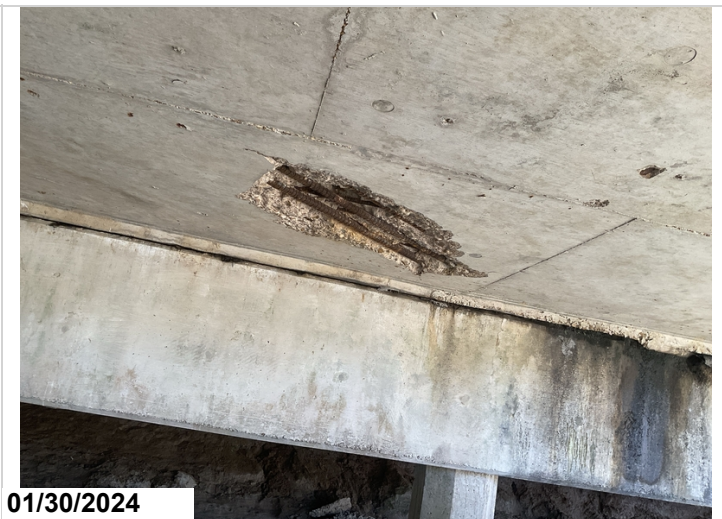
Span #2 soffit has a three foot spall near bent #3 pile #6 with exposed rebar with minor section loss.

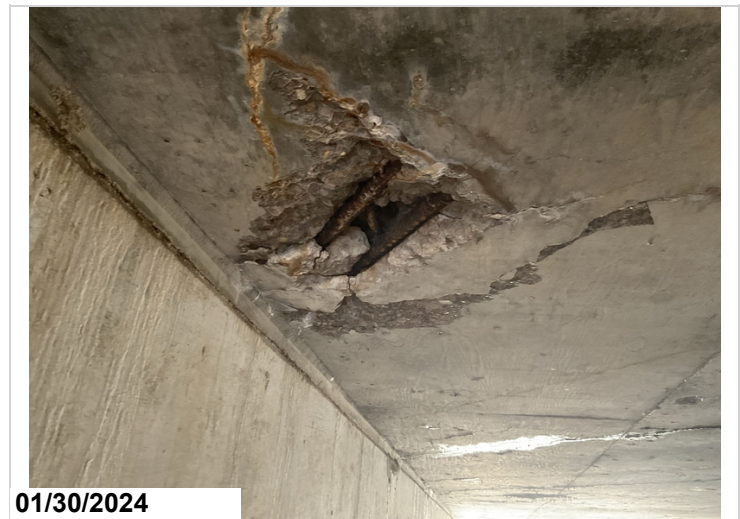
Typical soffit spall with exposed rebar span #1

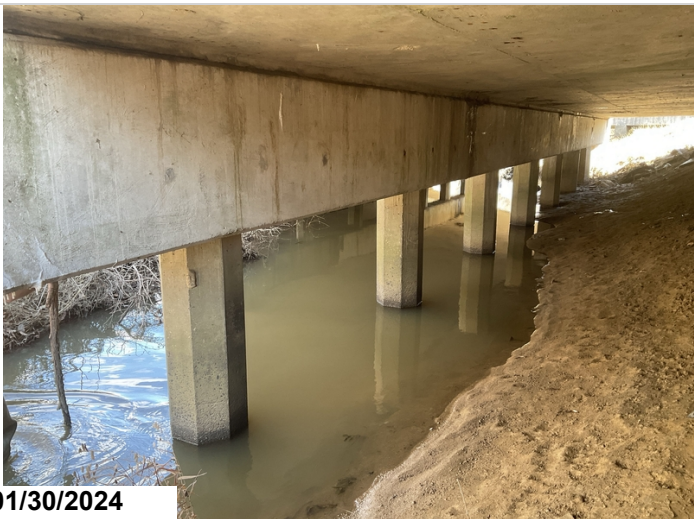
(234) Bent #2 cap left and right ends have multiple cracks with spalling on top with no rebar exposed. Bent #2 cap ahead face has a two-foot spall between piles #2,3 with no rebar exposed. Bent #3 cap back face has a three-foot delamination between piles #2,3. Bent #3 cap back face has a two-foot spall at keyway between piles #6,7 with no rebar exposed. Bent #3 cap bottom chord between piles #4, 5 back face has a two-foot spall with exposed rebar and several one-foot spalls with exposed rebar with minor section loss. Six feet total. Bent #3 cap right end bottom corner has 1' shallow spall with no exposed rebar. All caps have vertical hairline cracks various spacing.							
301	Pourable Joint Seal	LF	296	296	0	0	0
321	Reinforced Concrete Approach Slab	SF	2880	2680	200	0	0
1130	Cracking (RC and Other)	SF	200	0	200	0	0
510	Wearing Surfaces	SF	2880	2880	0	0	0

Bent #2 back face

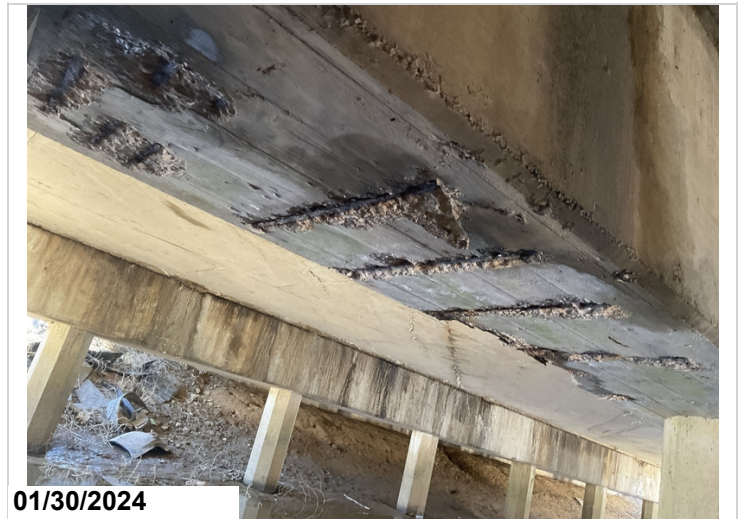
Concrete substructure is in overall satisfactory condition. The caps have some vertical hairline cracking, small to moderate spalling, primarily at keyways and some exposed rebar due to poor concrete coverage.

Spalling on bottom face of bent #3 cap at piles #4 and 5

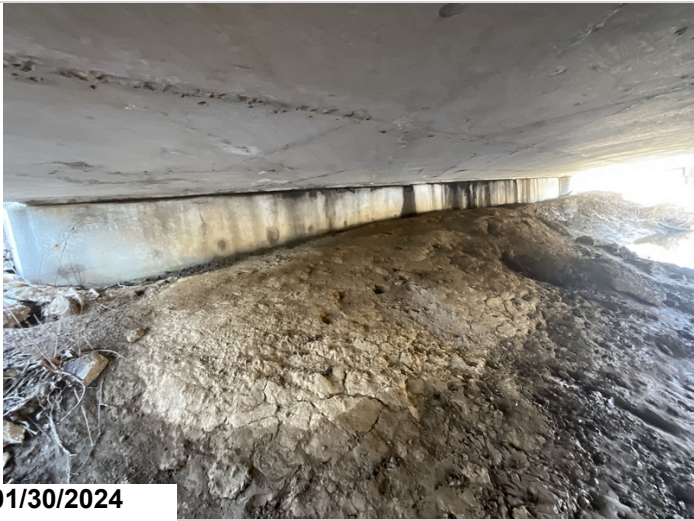
01/27/2022 lowered channel from 8 to 6 due to erosion at abutment #2.

Abutment #2

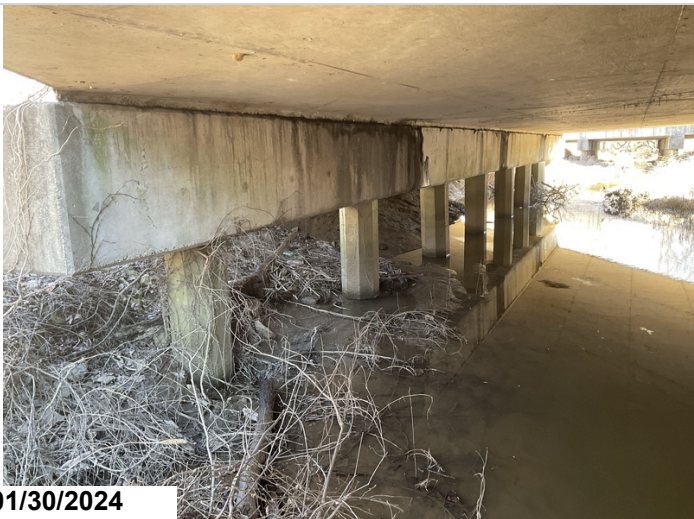
Bent #3 back face

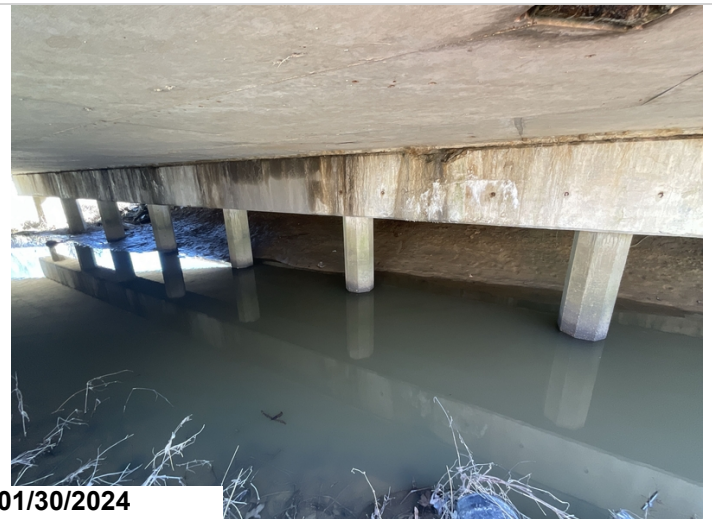
Bent #2 ahead face

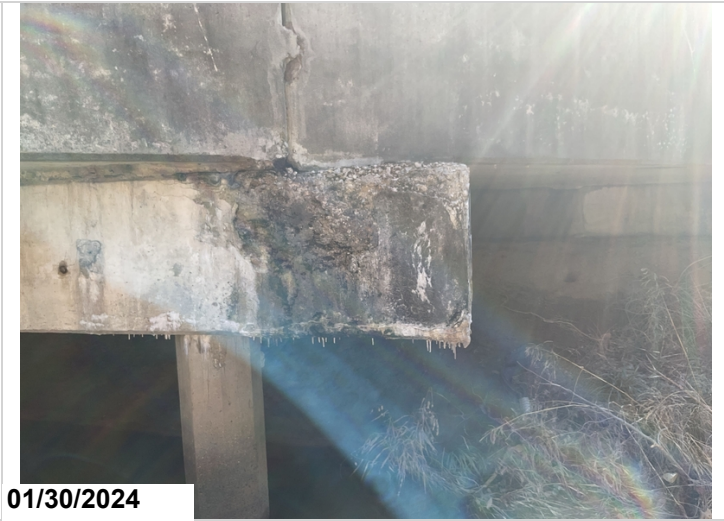
Bent #2 cap left end has heavy scaling with loose aggregate

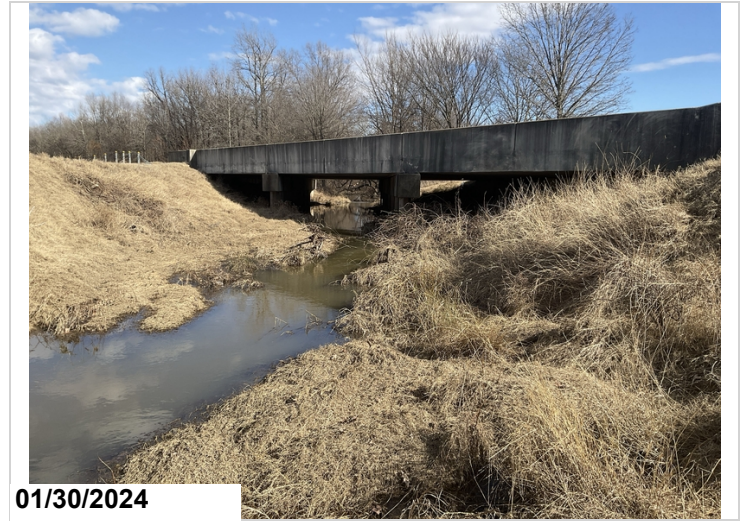
61 - Channel/Channel Protection (6 - Bank is beginning to slump. River control devices and embankment protection have widespread minor damage. There is minor stream bed movement evident. Debris is restricting the channel slightly.) Channel is in overall satisfactory condition. Alignment is fair at structure, slopes under structure have eroded and there is some debris and vegetation growth restricting channel slightly.

Channel right side

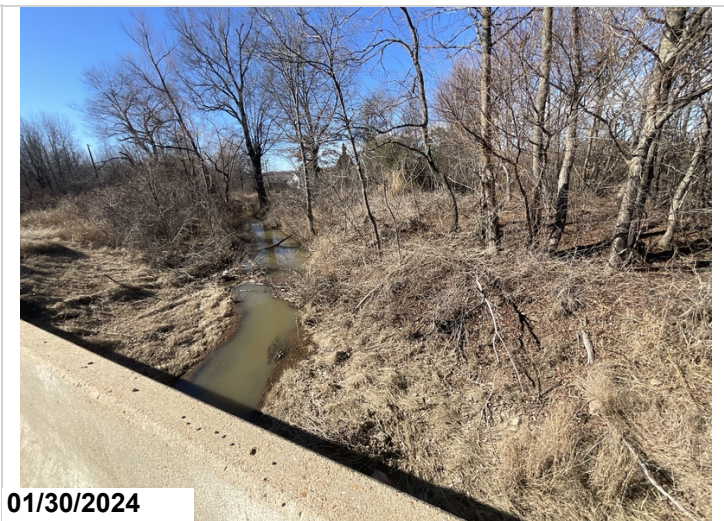
Channel left side

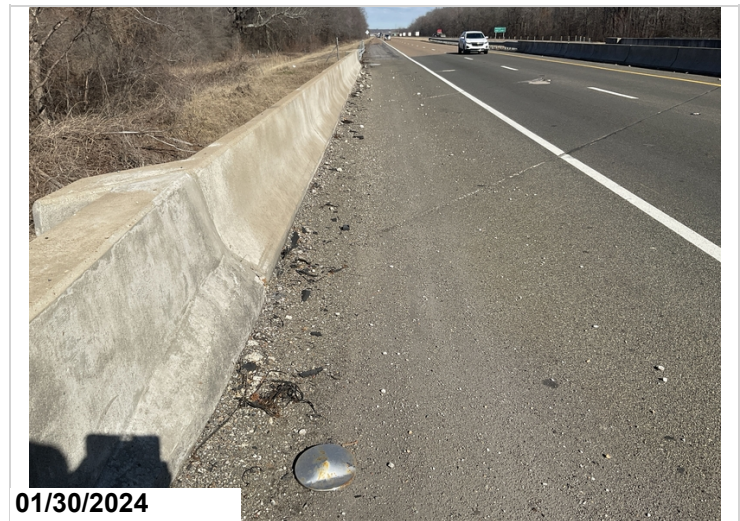
Dirt and debris in gutters.

Dirt and debris in gutters

A-55 - Deck Washing Needed (Y)

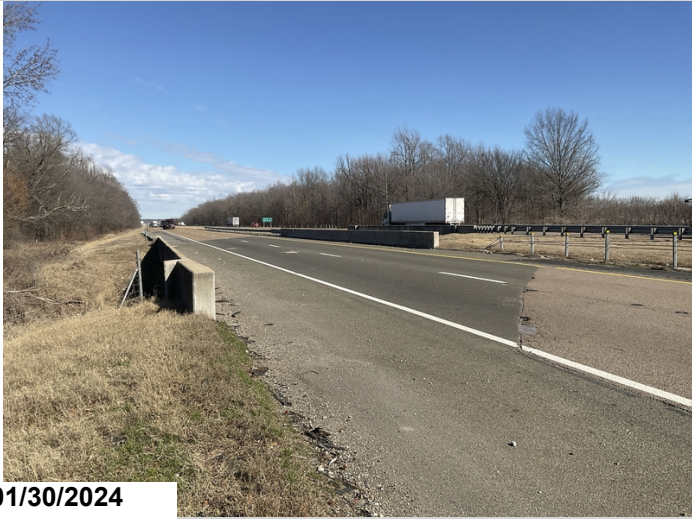
No log mile signs.

No log mile signs

A-63 - Missing/Incorrect Log Mile Signage (Y)

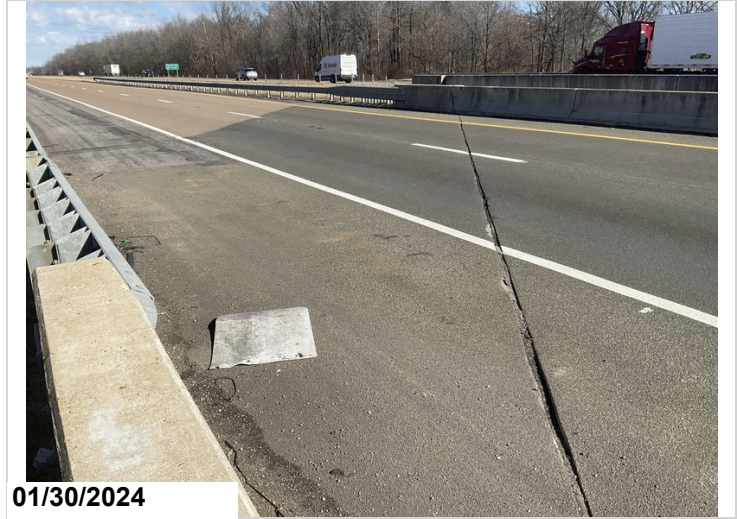
ELEMENTS	DESCRIPTION	UNITS	TOTAL	CS1	CS2	CS3	CS4
(321) Approach slab is covered with an epoxy coated wearing surface. Abutment #2 approach slab wearing surface has six inch wide by two-foot-long area spalled off.							
331	Reinforced Concrete Bridge Railing	LF	180	158	20	2	0
1080	Delamination/Spall/Patched Area	LF	2	0	0	2	0
1130	Cracking (RC and Other)	LF	20	0	20	0	0
(331) Bridge rails have a few vertical cracks Abutment #2 right bridge rail at bridge end has two foot patched area.

Abutment #2 approach slab

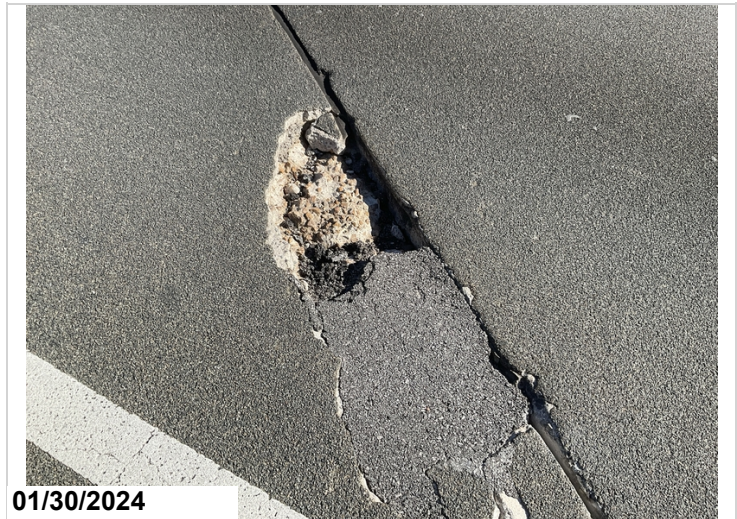
Span #3 at bent #3 right lane

Span #3 right travel lane at bent #3 has one foot by two-foot spall up to four inches deep and one foot by two-foot area patched with ACHM.

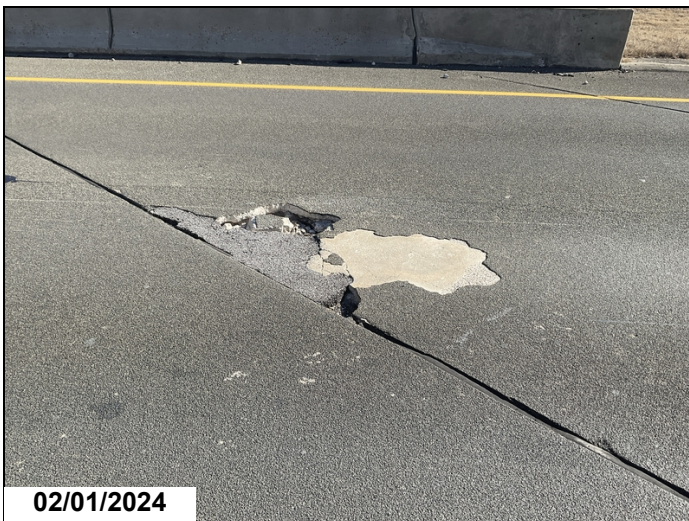
Span #1 right travel lane at bent #2 has a four foot long by one-foot wide ACHM patch and a two-foot spall up to four inches deep with exposed rebar and four-square feet of missing epoxy overlay

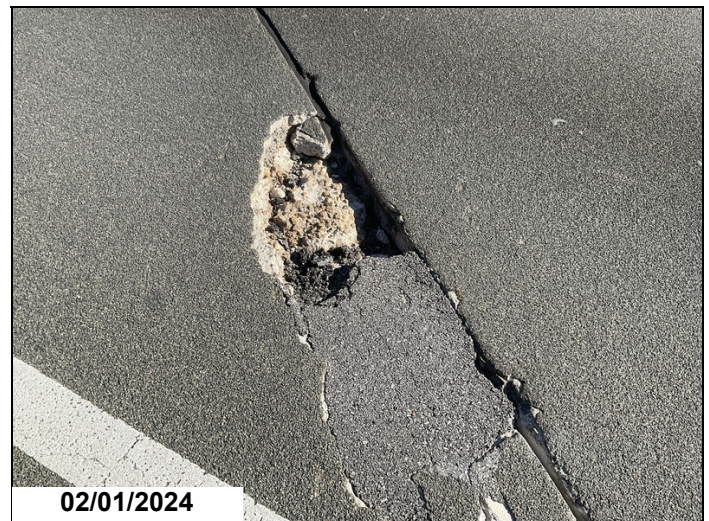
Span #3 at bent #3 right lane

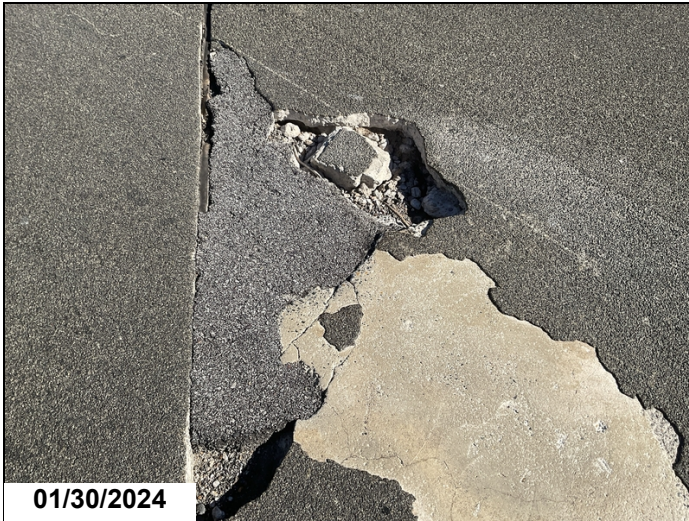
Span #1 at bent #2 right travel lane

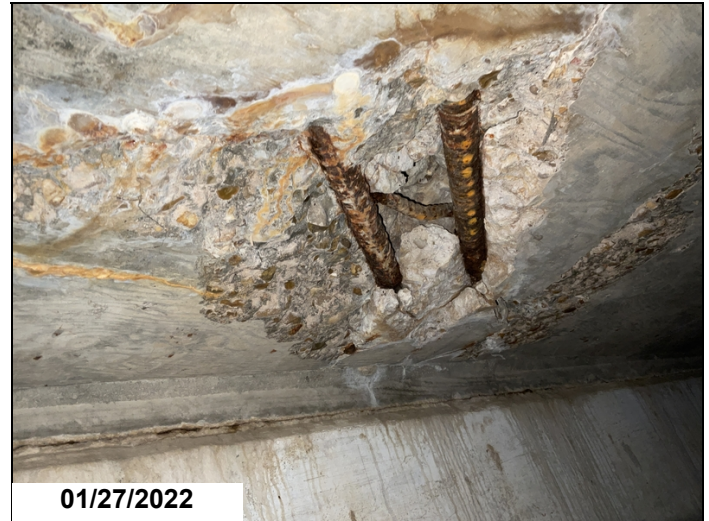
Span #1 right lane at bent #2 has a 3' x 3' spall with ACHM patch reflecting through to soffit-under surface with spall and exposed rebar.

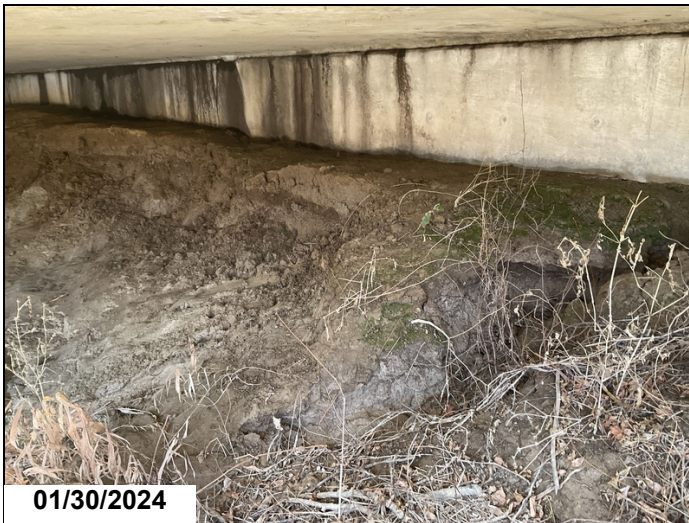
Abutment #2 slope is eroded up to within two feet of abutment.

Abutment #2 slope left side eroded to within two feet of cap with one foot wide erosion vein leading to cap exposing cap one inch for three feet wide

Priority: C - Important

Status: Monitor

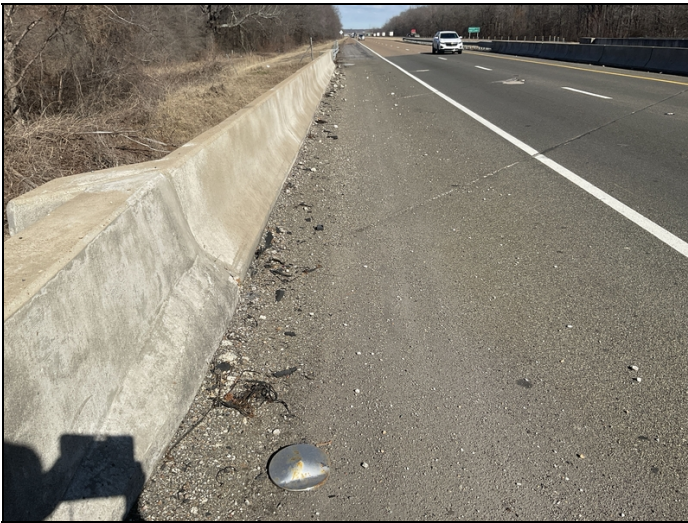
Dirt and debris in gutters.

Dirt and debris in gutters

A-55 - Deck Washing Needed (Yes)

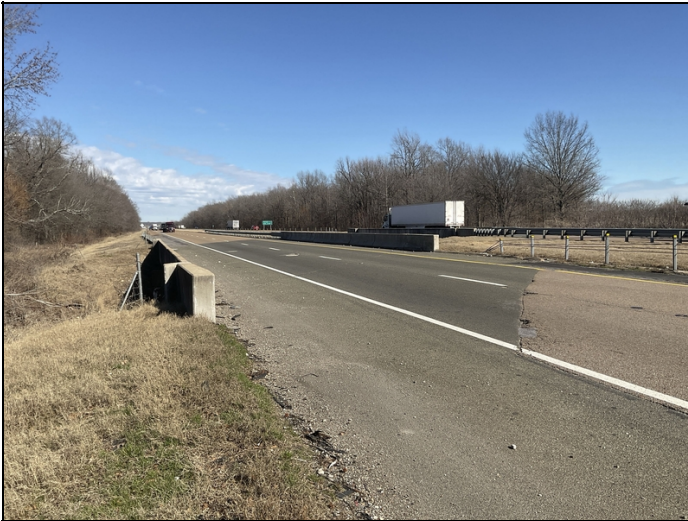
No log mile signs.

No log mile signs

A-63 - Missing/Incorrect Log Mile Signage (Yes)
