Bridge A3617 Inspection Report

I-40WB/Se51/239.44 over Drainage Ditch

Team Lead: Myron Futrell Inspection Date: 04/16/2024

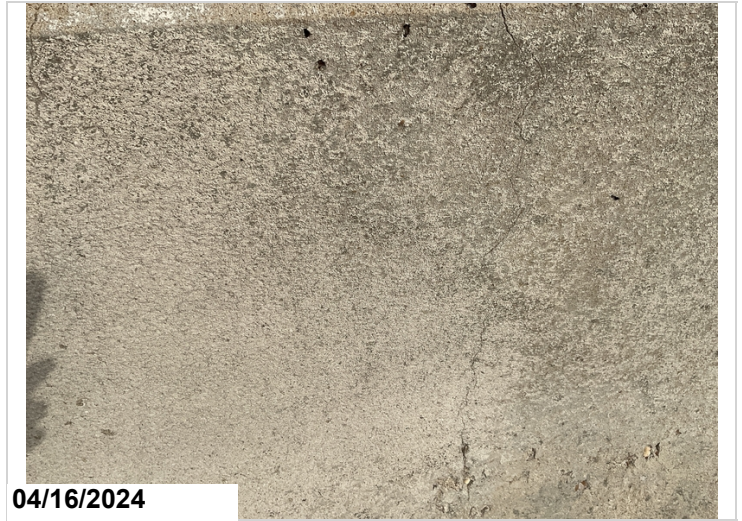
Typical vertical cracking in bridge rail

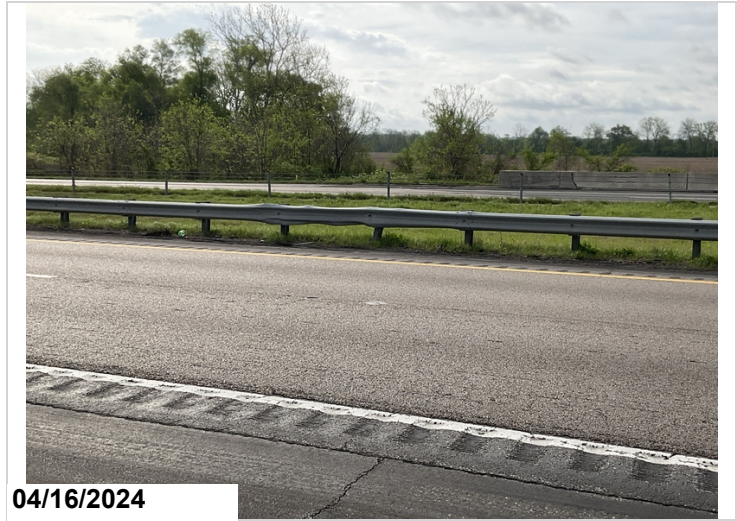
Abutment 2, right approach rail, mid span: approximately 15' moderate collision damage.

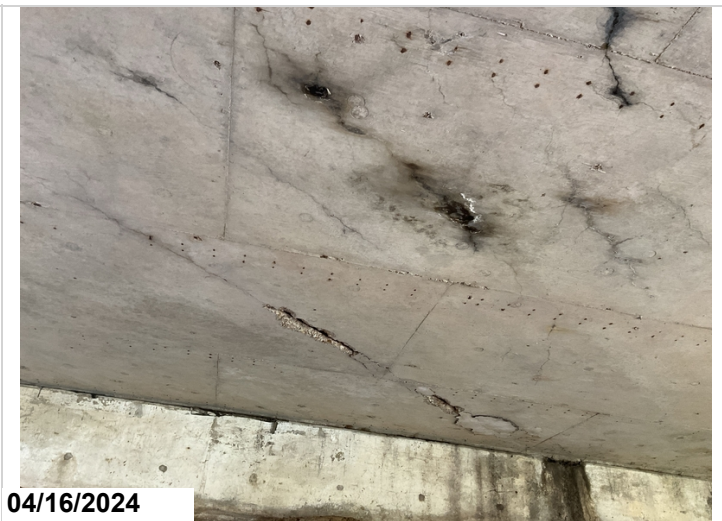
Soffit / undersurface of deck, span 3, near pile 3, at abutment 2: 2' delaminated area with a 3' spall with exposed reinforcing steel having minor section loss. Delam 2SF CS3, Rebar 3SF CS3

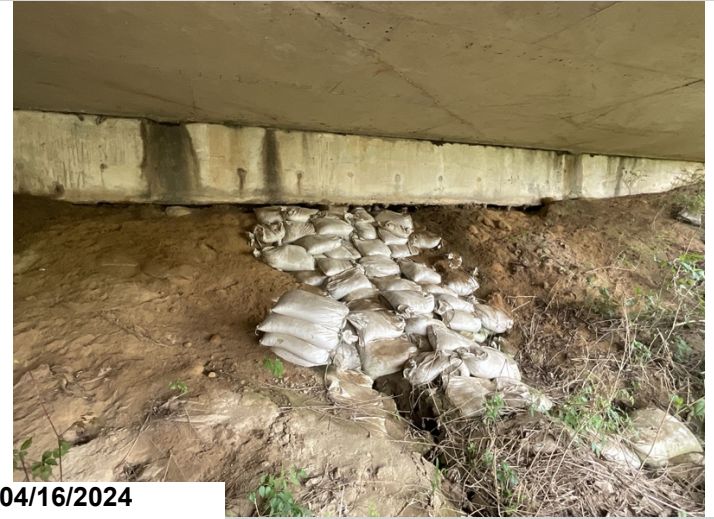
Abutment 1, slope: minor erosion a few inches deep under cap, exposing piles 3 and 4 slightly, area at pile 3 has sandbags placed.

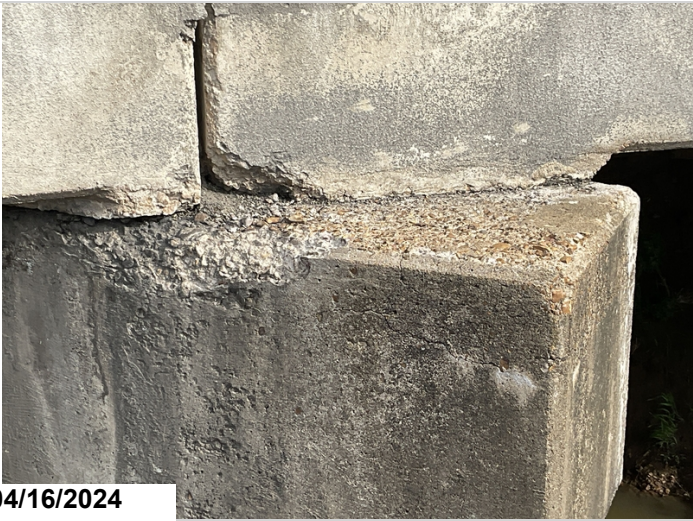
Bent 2, pile cap, right end, top: is scaling with one foot spall back face top edge no exposed rebar.

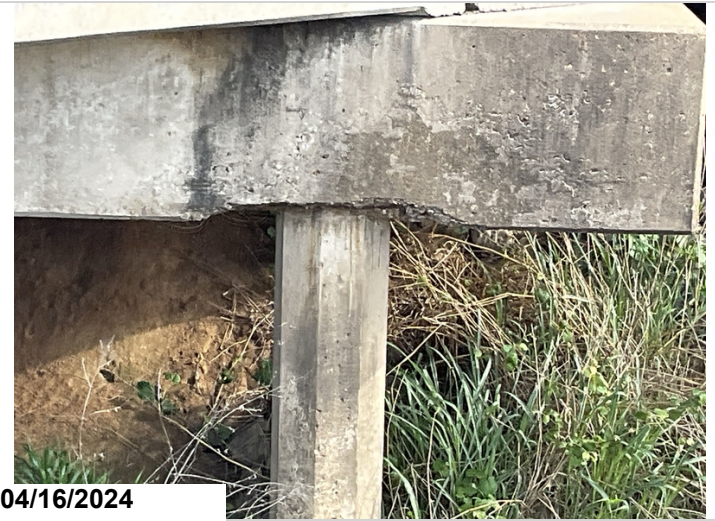
Bent 3, pile cap, back face, at bottom: 3' spall with exposed reinforcing steel with minor section loss on bottom edge at pile 8.

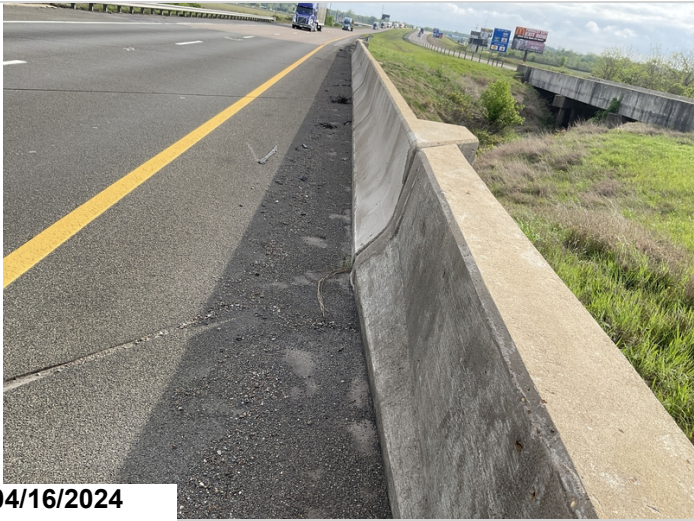
Dirt and debris in gutters.

Dirt and debris in gutters

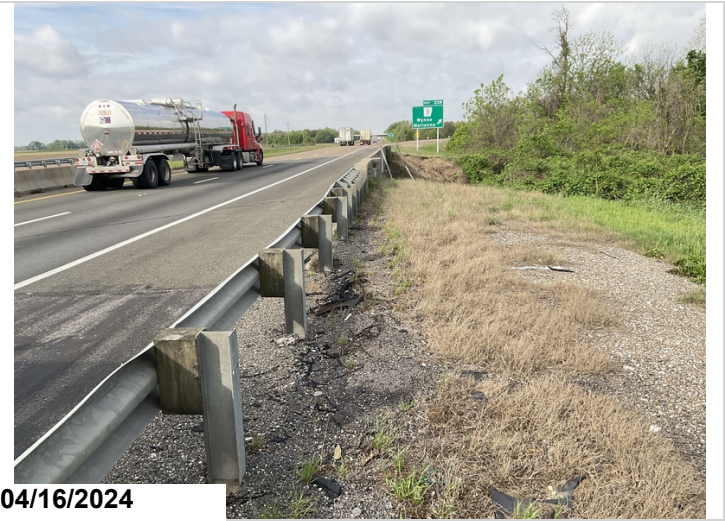
No log mile sign.

No log mile sign

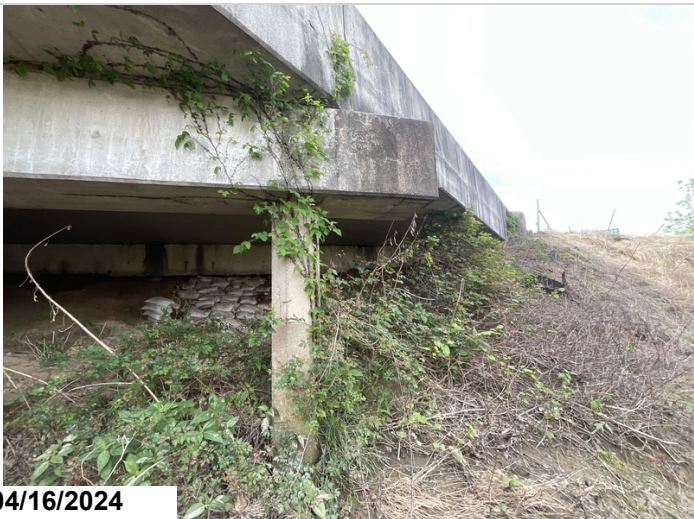
Vegetation growing beside, under and onto bridge.

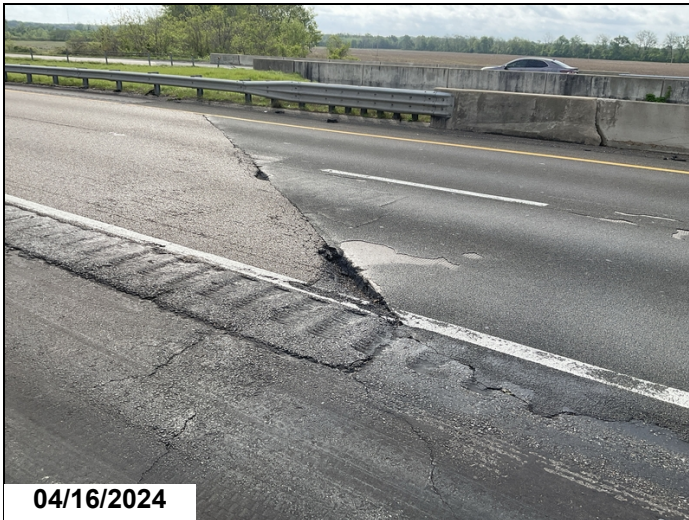
5/1/2024-Reopened as a B priority due to increased spalling of approach roadway at abutment 2 approach slab.

Abutment 2, approach roadway, left lane, at end of approach slab: 1' x 6" spall and a 3' long x 10" wide x 6" deep spall.

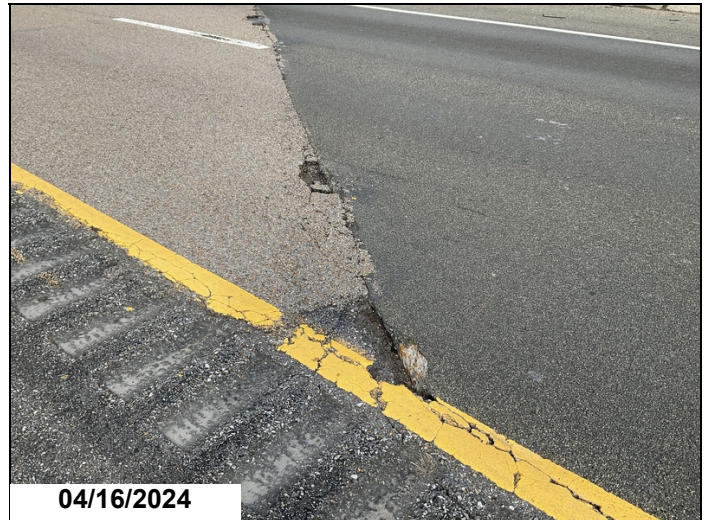
Abutment 1, approach roadway, right lane, at edge of approach slab: two 1' x 6" spalls in overlay.

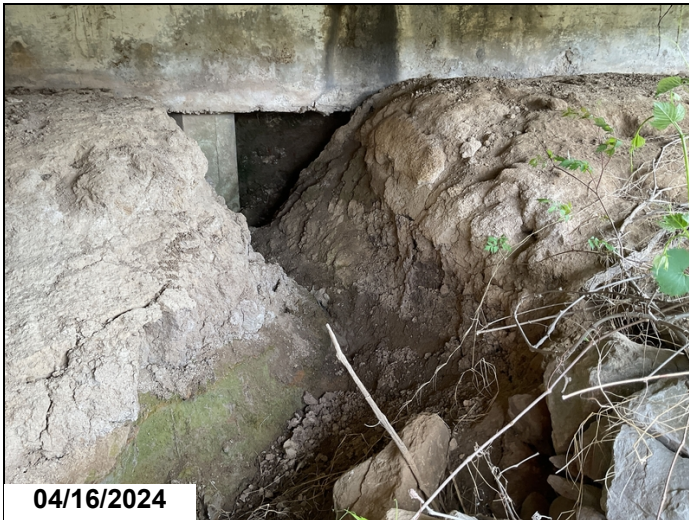
Abutment 2, cap, at pile 7: undermined for 4' up to 2 1/2' deep exposing pile.

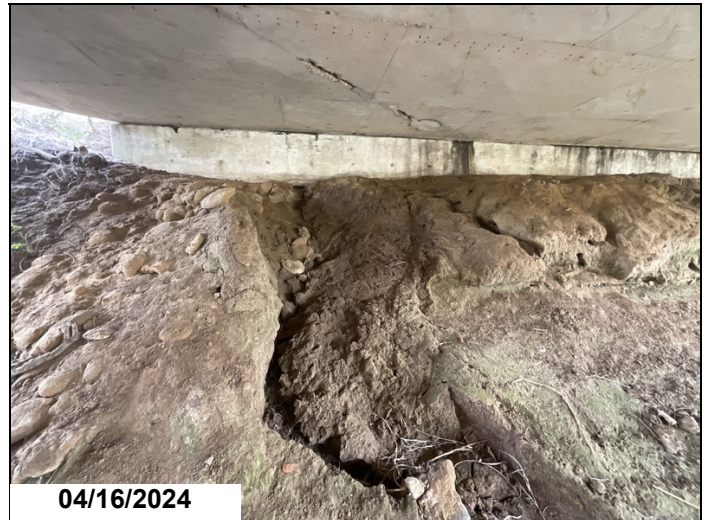
Abutment 2, slope, left side: eroded to cap, four feet from left end of cap, with erosion veins extending down slope.

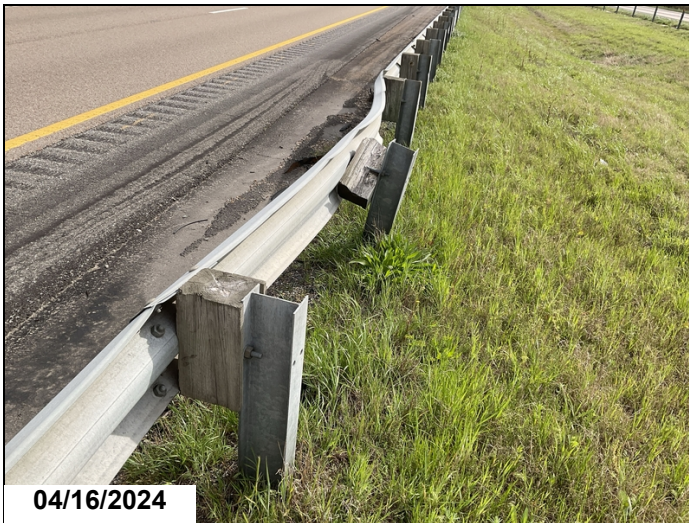
Abutment 2, approach rail, right side, mid span:
approximately 15' moderate collision damage.

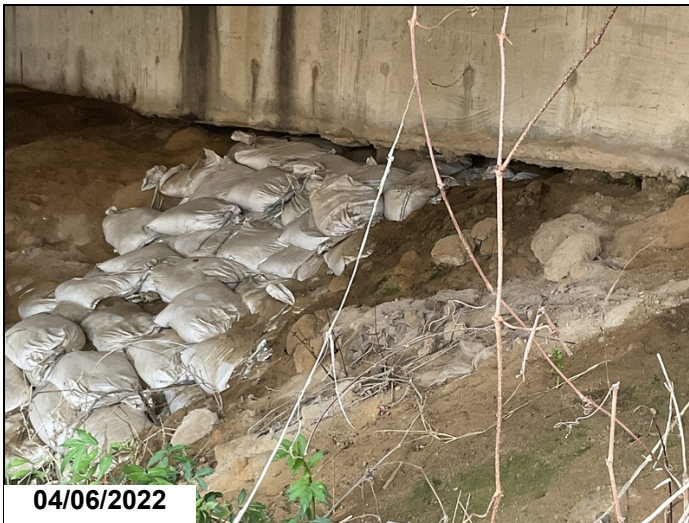
Abutment 1, slope: minor erosion a few inches deep under cap.

Abutment #1 has minor erosion a few inches deep under cap.

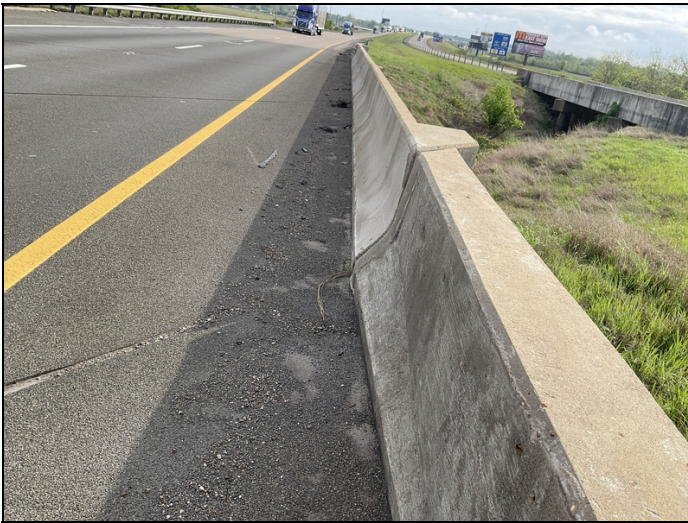
Dirt and debris in gutters.

Dirt and debris in gutters

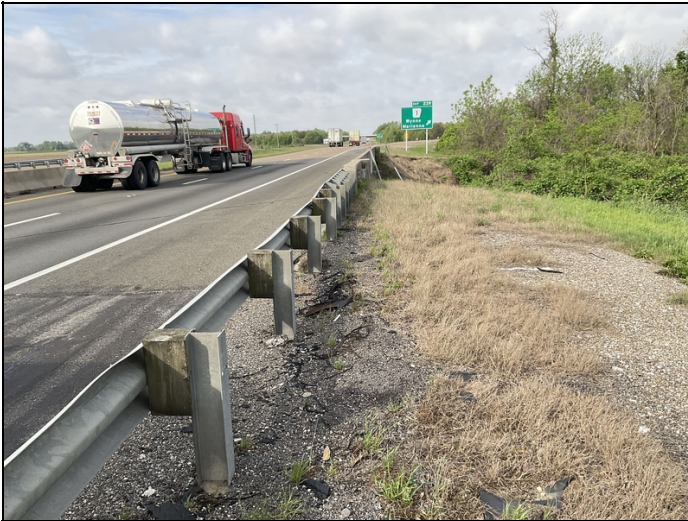
No log mile sign.

No log mile sign

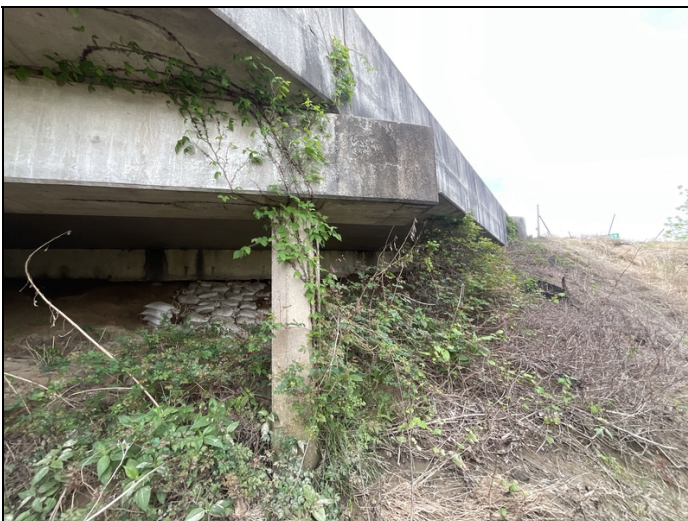
Vegetation growing beside, under and onto bridge.
