Bridge A3724 Inspection Report

I-40WB/Se43/209.29 over Bayou Deview

Location: 6.37 Miles West Of Us 49

Team Lead: Drew Melton **Inspection Date:** 06/04/2025

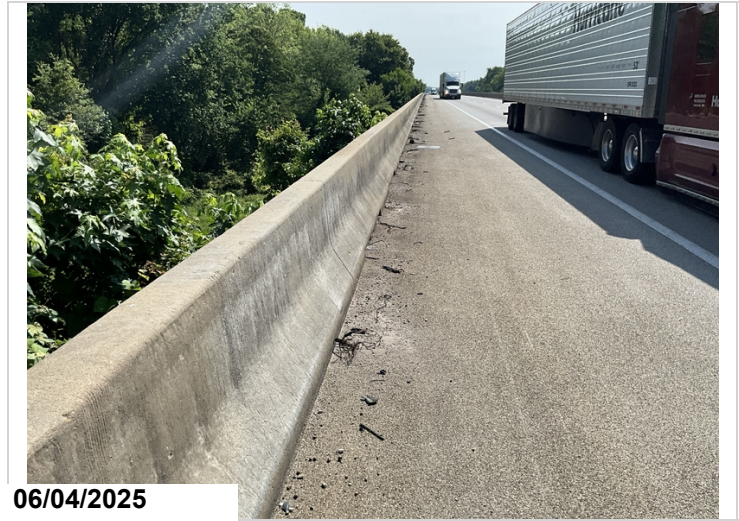
Deck Gutters, Full Length: Dirt and debris.

A-55 - Deck Washing Needed (Y)

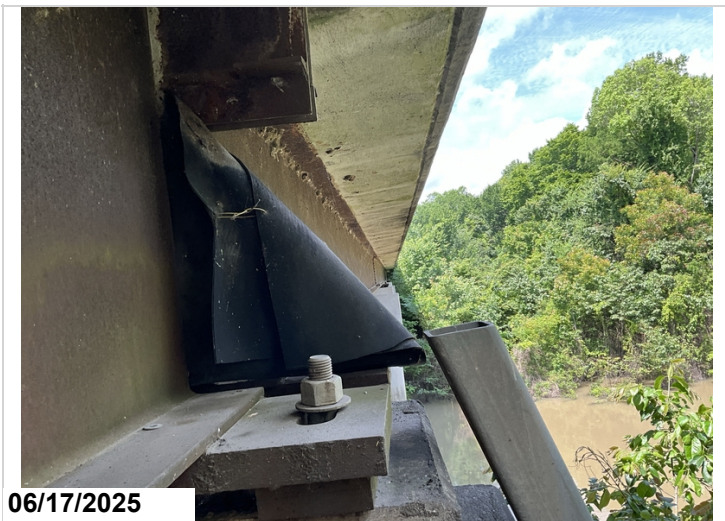
Bent 8 & 16, Joint Drain, Under Bridge: Disconnected not working.

A-59 - Joint Repair Needed (Y)

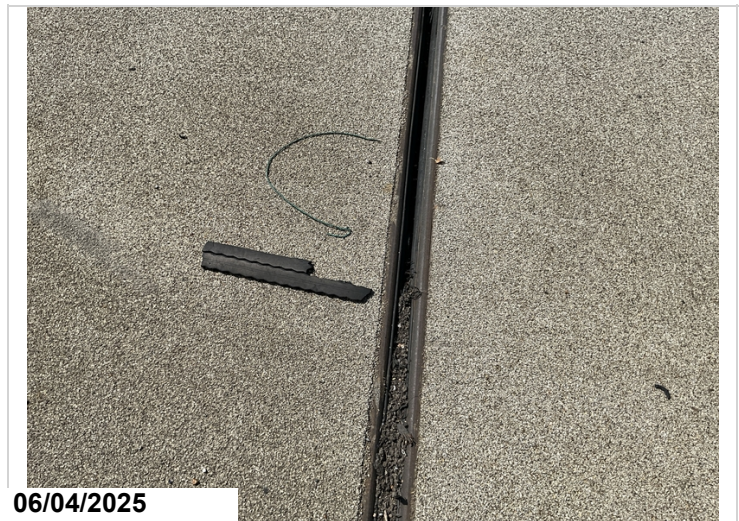
Joints, In Gutters: Debris impaction.

Joints, In Gutters: Debris impactation.

A-56 - Joint Cleaning/Flushing Needed (Y)

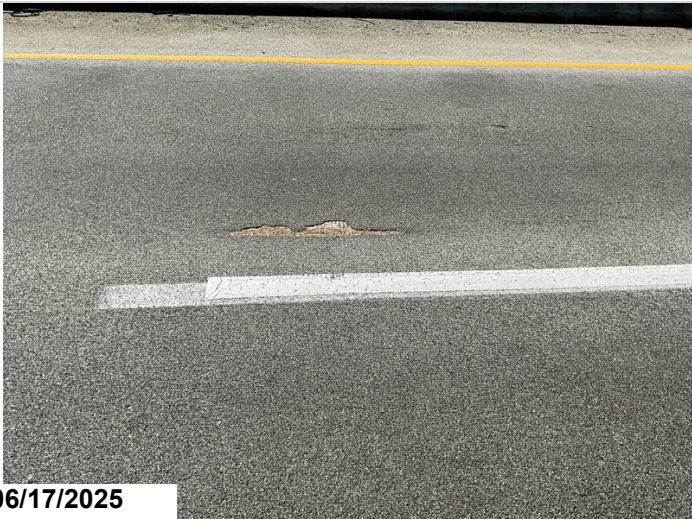
Wearing Surface, Span 22: 3" wide by 2' long wearing surface missing.

A-61 - Polymer Overlay Advised (Y)

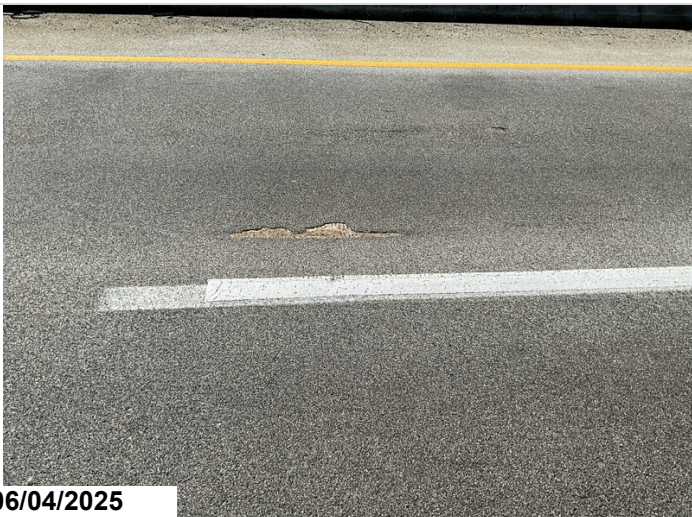
Wearing Surface, Span 22: 3" wide by 2' long wearing surface missing.

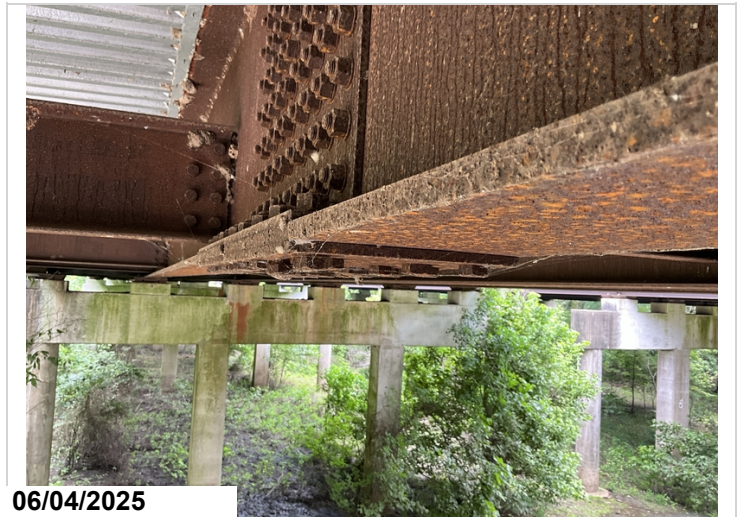
Span 7, Girder 2, Field Splice, Bottom, Left: Bolt Loose.

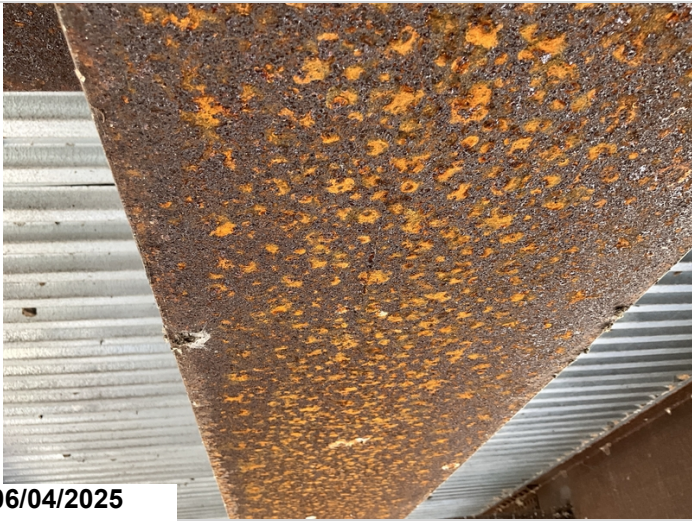
Typical minor delamination on bottom of girder.

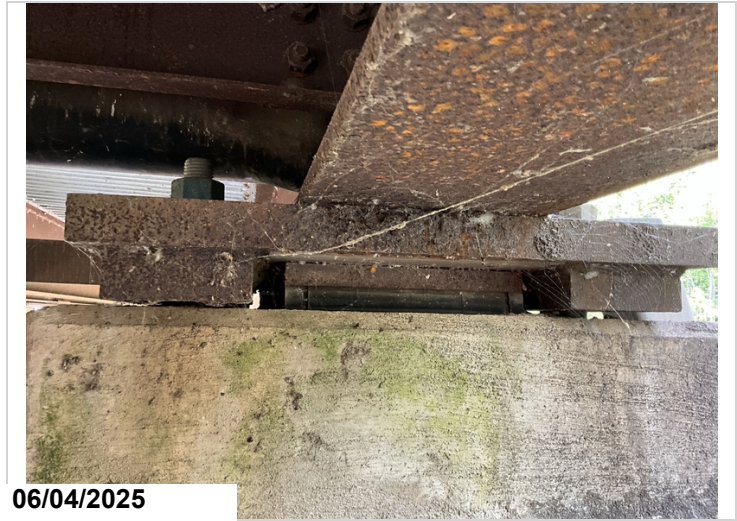
Span 16, Girder 1, At Bent 16, Bottom Of Bottom Flange:
Active corrosion with laminations at bearing little to no
section loss.

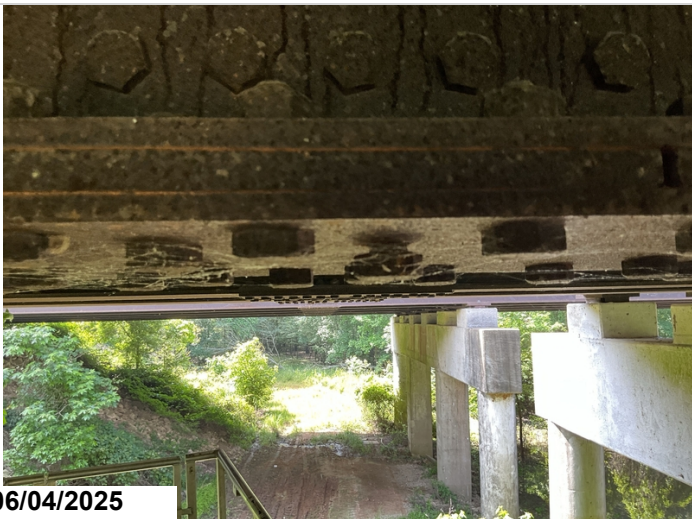
Span 22, Girder 3, Field splice, Bottom, Left: Bolt loose.

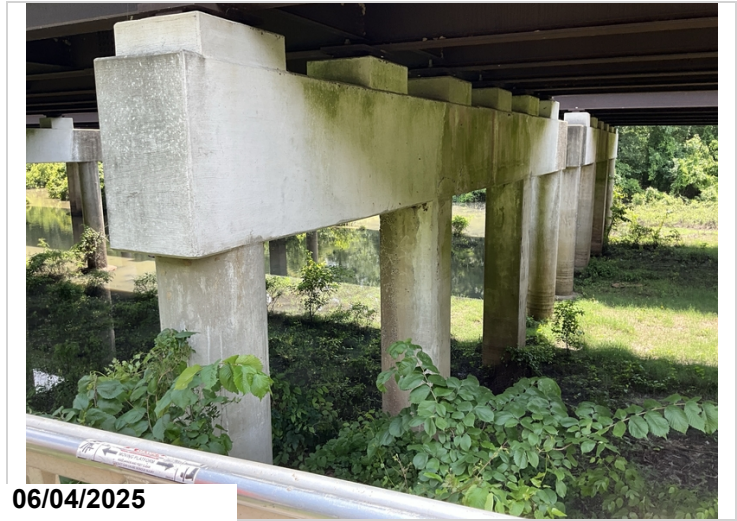
Cap, Bent 3, Back, Bottom, At Column 2: 2' cracks with delaminations.

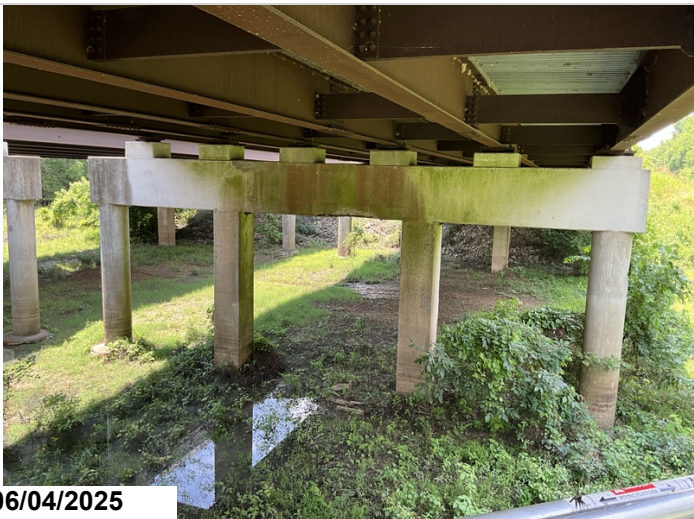
Cap, Bent 3, Ahead, Bottom, Between Columns 2 & 3: 8' of cracks with delaminations. 4' spalled with exposed reinforcing steel with moderate section loss.

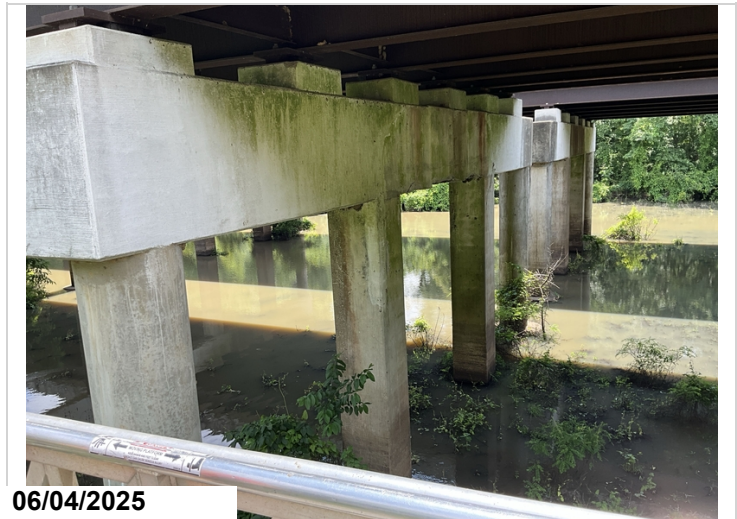
Cap, Bent 4, Back, Bottom, Between Columns 2 & 3: 6' spall with exposed reinforcing steel moderate section loss. 2' cracks with delaminations.

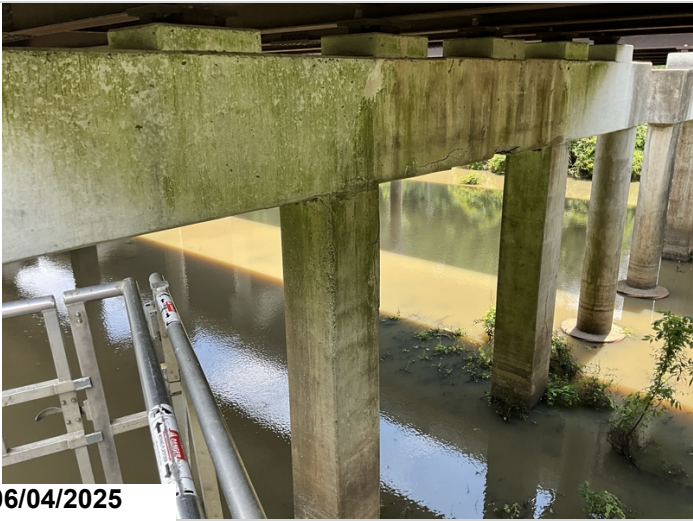
Cap, Bent 5, Back, Bottom, Between Columns 2 & 3: 1' spall with exposed reinforcing steel moderate section loss. 2' cracks with delaminations.

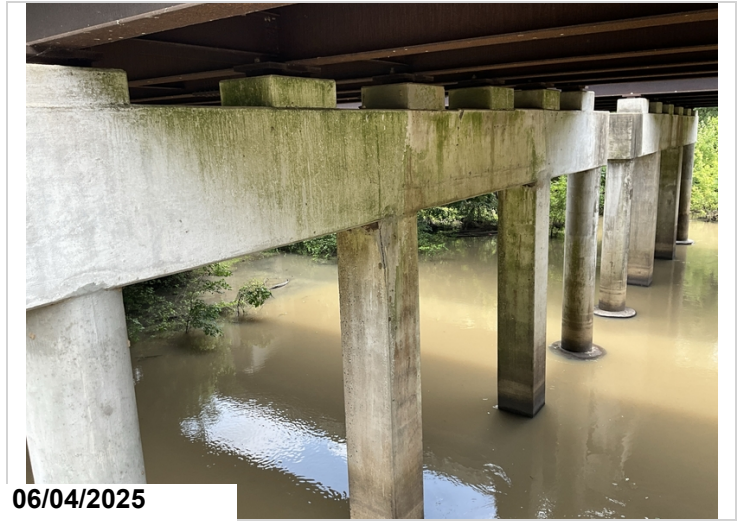
Cap, Bent 7, Back, Between Girders 4 & 5, Top: 2' cracks with delamination.
Cap, Bent 7, Bottom, Between Columns 2 & 3: Two 1' cracks with delaminations.

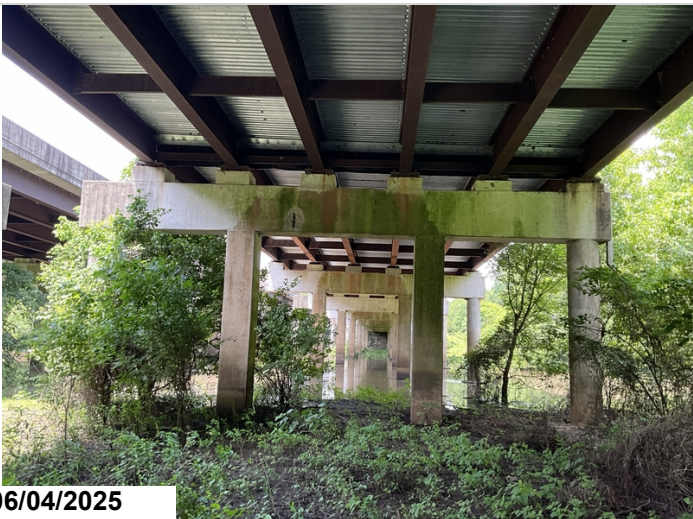
Cap, Bent 8, Ahead, Between Columns 2 & 3: 2' spall with exposed reinforcing steel with moderate section loss.

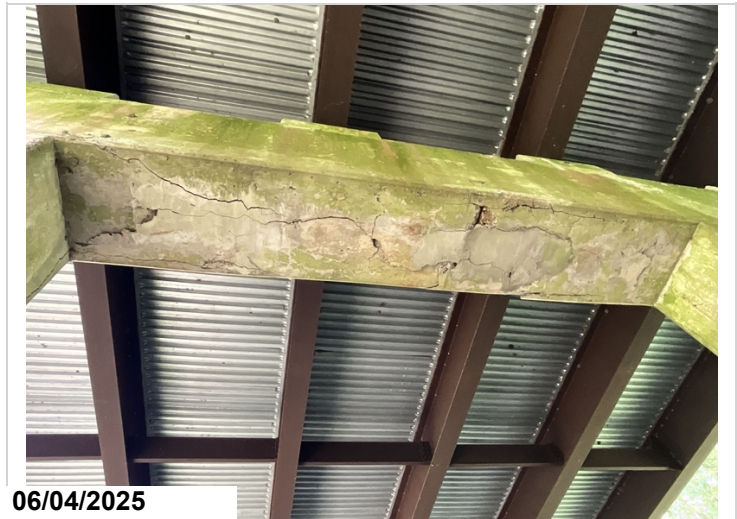
Cap, Bent 9, Ahead, Bottom, Back, Between Columns 2 & 3: 12' cracks with delaminations. 6" piece of exposed reinforcing steel moderate section loss..

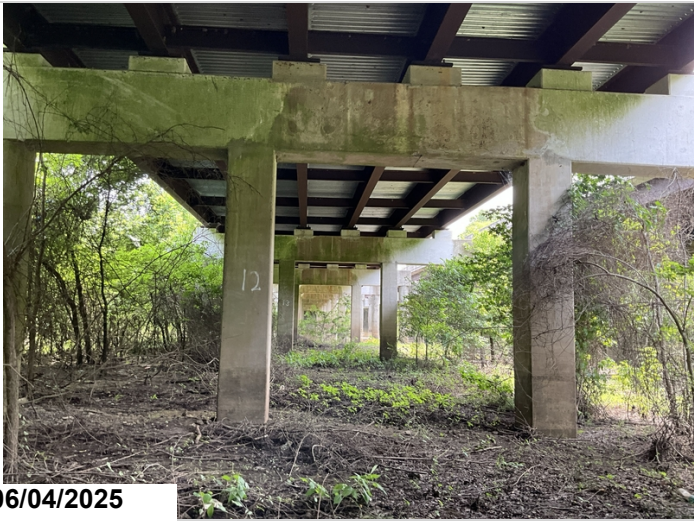
Cap, Bent 12, Ahead, Back, Bottom, Between Columns 2 & 3: 5' cracks with delaminations.

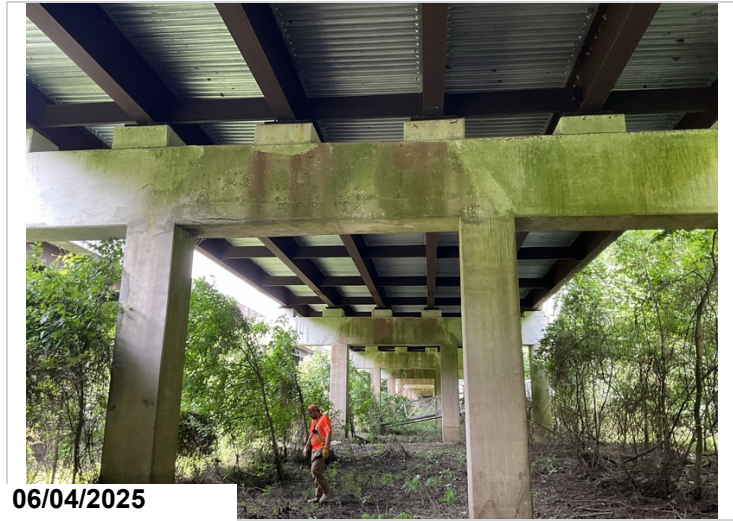
Cap, Bent 11, Ahead, Back, Lower Corner, Starting At Column 3: 4' cracks with delaminations.
Cap, Bent 11, Bottom, Between, Columns 2 & 3: 6' cracks with delaminations.

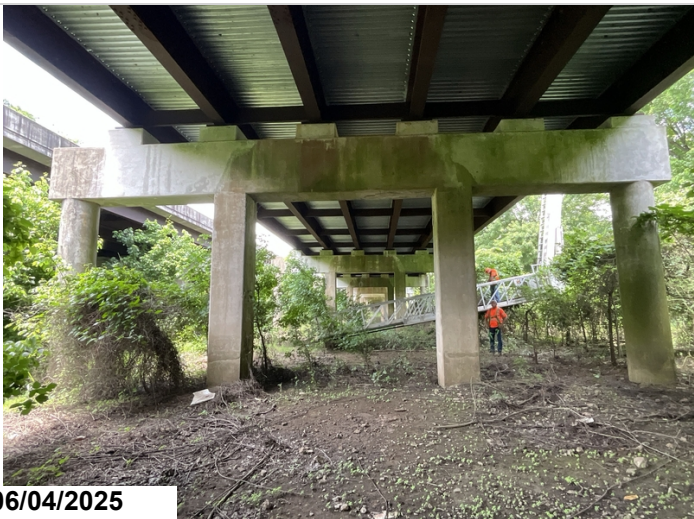
Cap, Bent 10, Back, Lower Corner Into Bottom, Starting At Column 2: 3' cracks with delaminations.

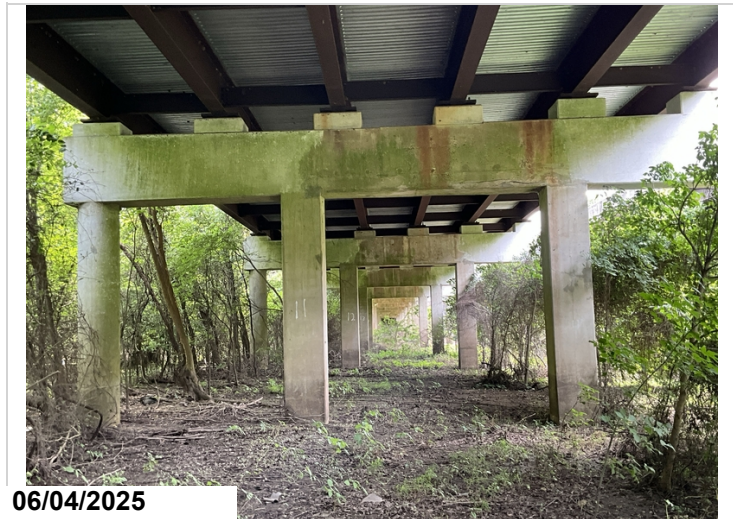
Cap, Bent 11, Ahead, Back, Lower Corner, Starting At Column 3: 4' cracks with delaminations.
Cap, Bent 11, Bottom, Between, Columns 2 & 3: 6' cracks with delaminations.

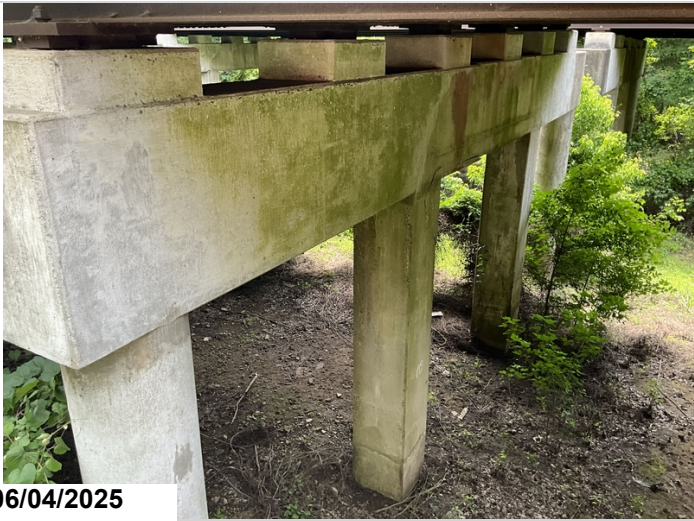
Cap, Bent 10, Back, Lower Corner, Starting At Column 2: 3' cracks with delaminations.

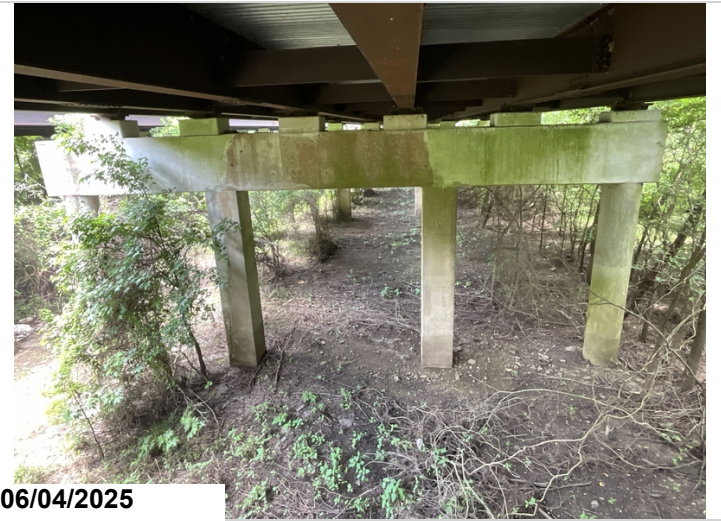
Cap, Bent 12, Ahead, Back, Bottom, Between Columns 2 & 3: 5' cracks with delaminations.

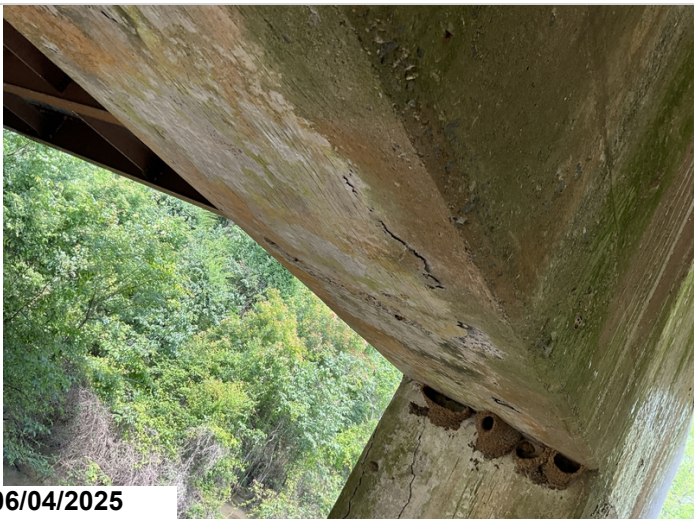
Cap, Bent 15, Bottom, Between Columns 2 & 3: 3' cracks and delaminations, and one small spall no exposed reinforcing steel.

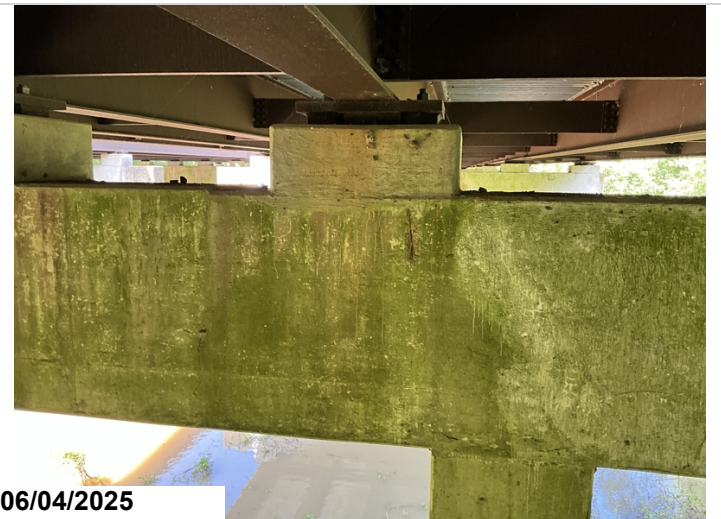
Cap, Bent 22, Ahead, Under Girder 3: 1' exposed reinforcing steel minor section loss.

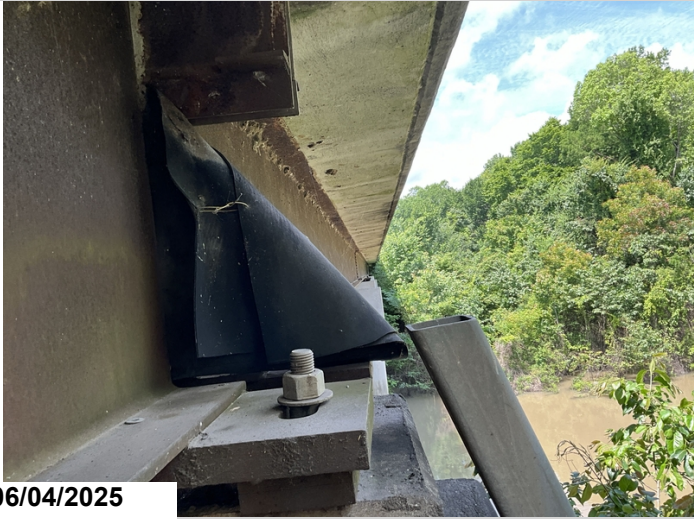
Bent 8 & 16, Joint Drain, Under Bridge: Disconnected not working.

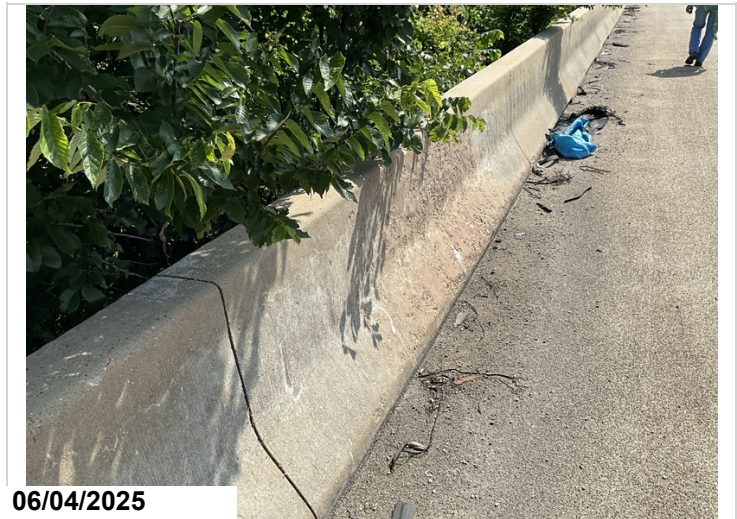
Span 12, Bridge Rail, Left: 5' of collision fire damage.

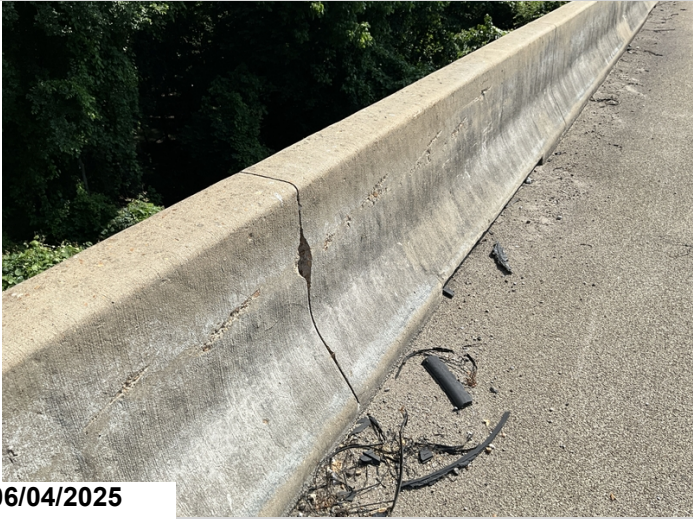
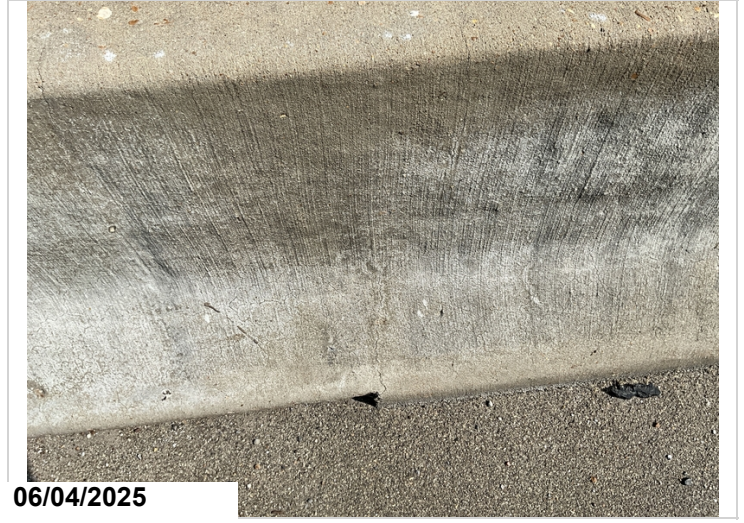
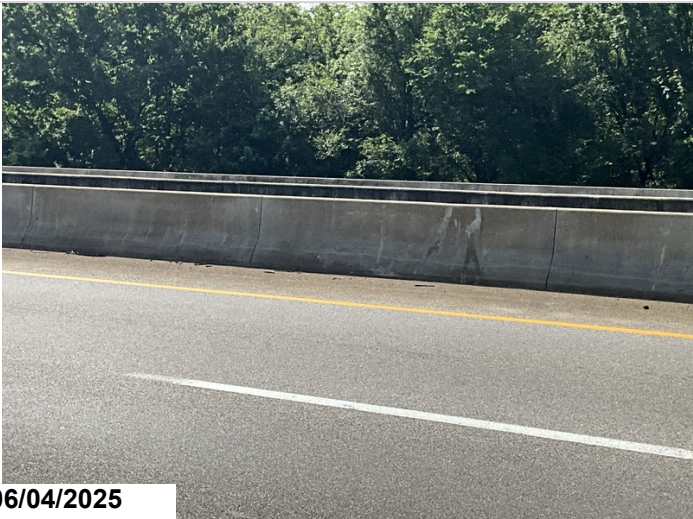
Bridge railing is in good condition with cracks and some minor collision damage.

Bridge Rails, Full Length: Minor collision damage.

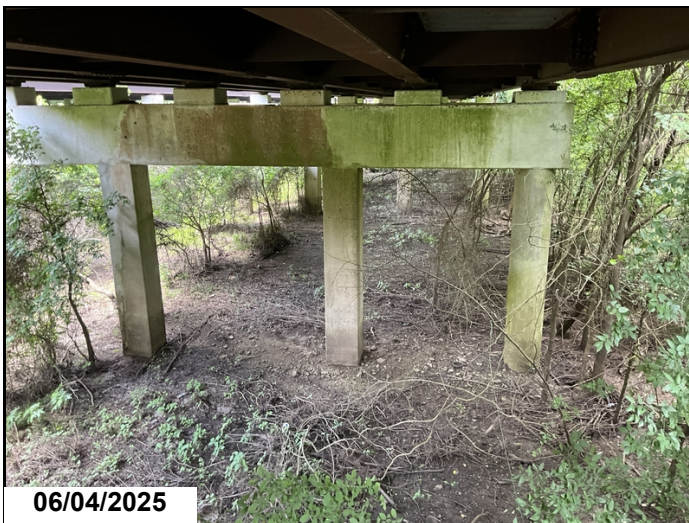
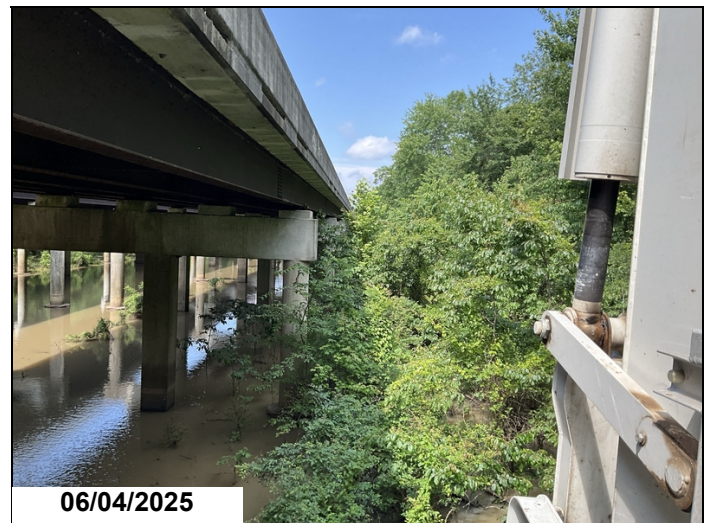
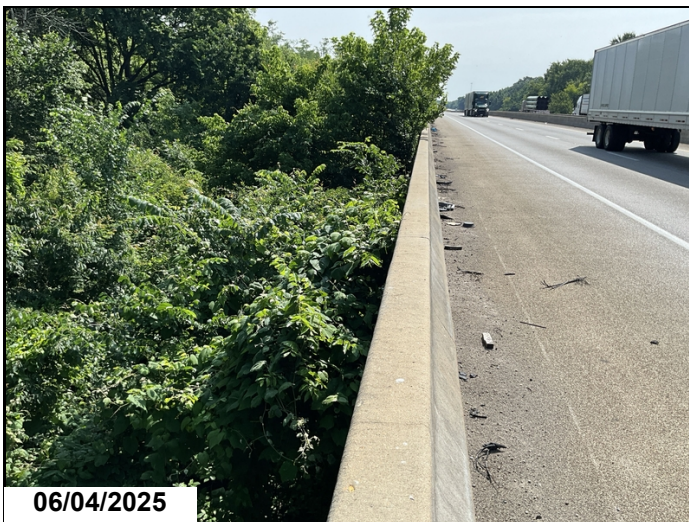
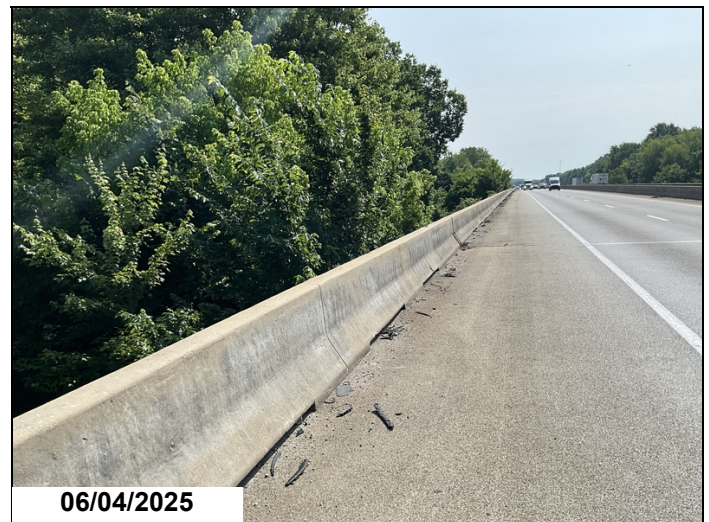
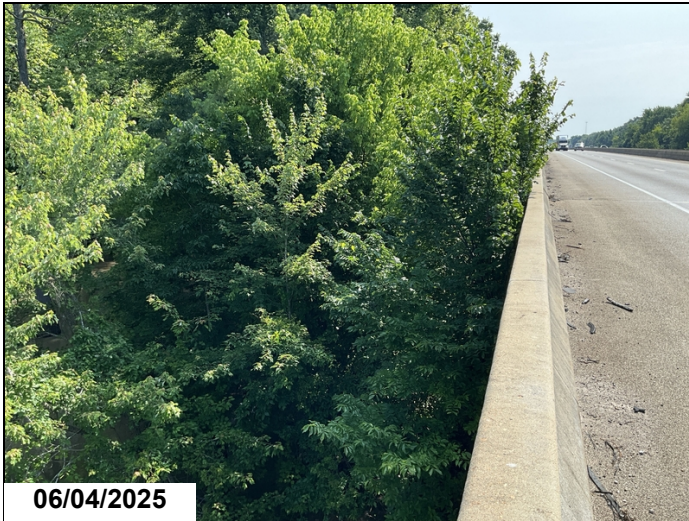
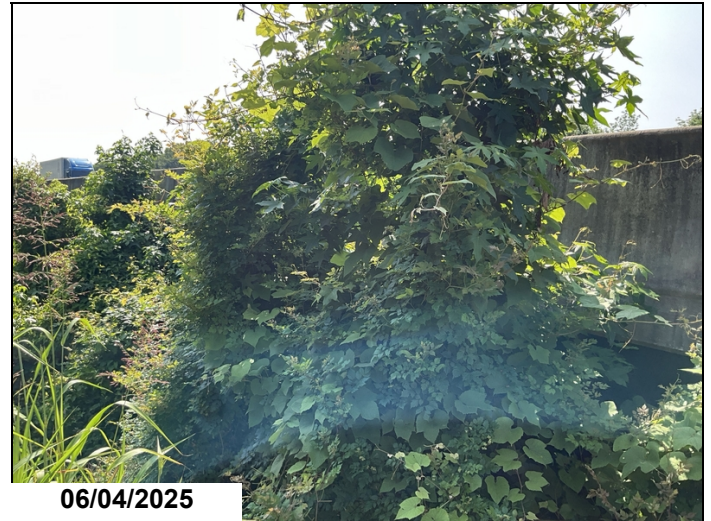
Channel has good alignment and is in fair condition. An over abundance of trees and vegetation growing under and beside bridge restriction channel flow rate.

Over abundance of trees and vegetation is growing under and beside bridge hindering access for bridge inspection. Spans 11, 12, 13 have no access with snooper, ground access only.

Typical vegetation

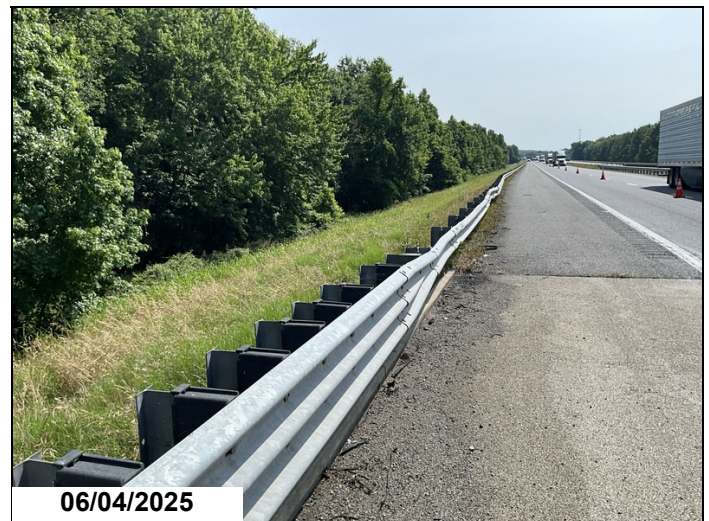
Abutment 2, Approach Rail, Left: Collision damage.

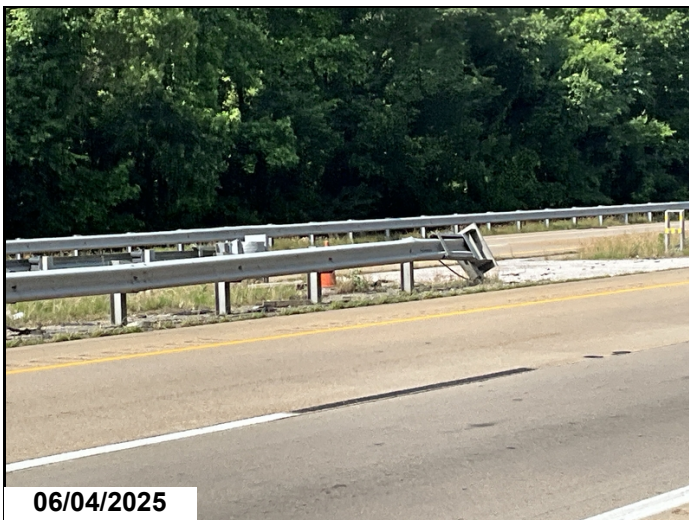
Abutment 1, Approach Rail, Right, Terminal End: Collision damage.

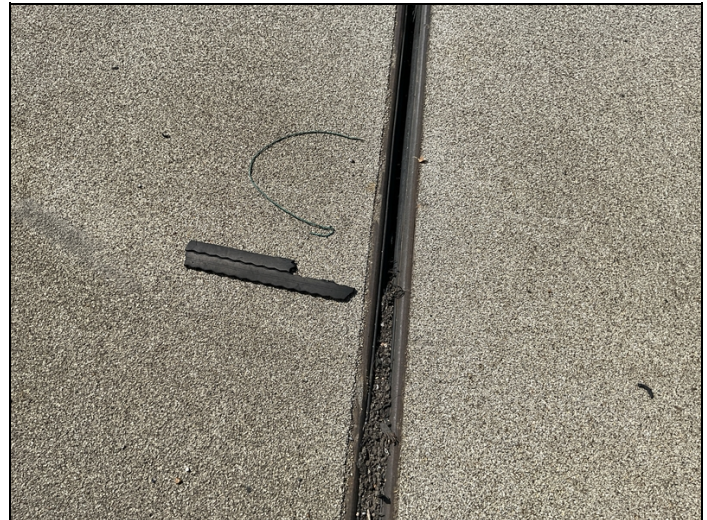
Joints, In Gutters: Debris impaction.

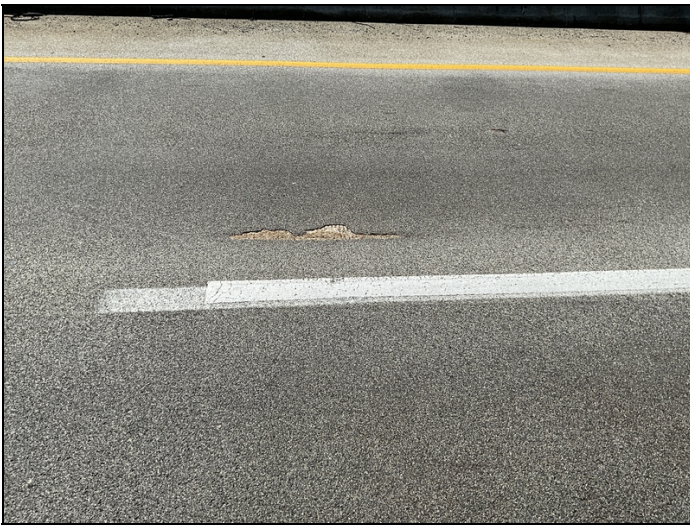
Wearing Surface, Span 22: 3" wide by 2' long wearing surface missing.

A-61 - Polymer Overlay Advised (Yes)
