Bridge A3727 Inspection Report

Asset #A3727(Routine, Underwater type 2)

I-40WB/Se43/211.61 over Creek

Location: 4.06 Miles West Of Sh 17

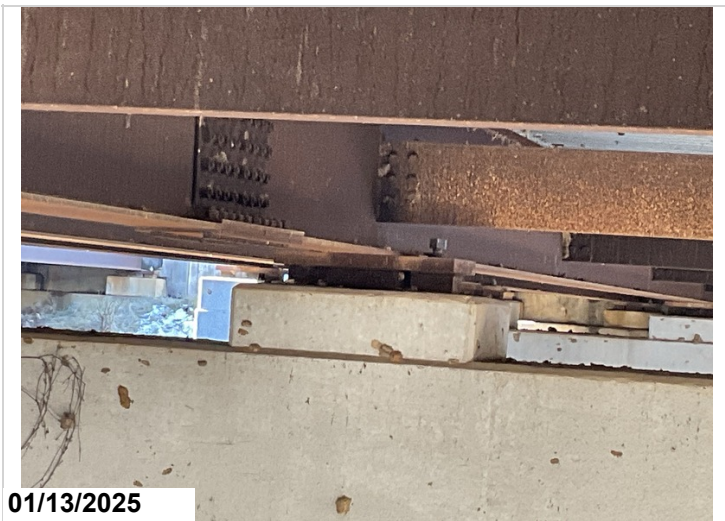
(310) Bent 2, Girder 1, both anchor bolts: nuts backed off. Connection 1EA CS2 Bent 3, Girder 4, anchor bolt: loose nut. Connection 1EA CS2							
321	Reinforced Concrete Approach Slab	SF	1757	1717	0	40	0
1130	Cracking (RC and Other)	SF	40	0	0	40	0
521	Concrete Protective Coating	SF	1757	1712	0	0	45
3540	Effectiveness (Concrete Protective Coatings)	SF	45	0	0	0	45

Bent 3, Girder 4, anchor bolt: loose nut.

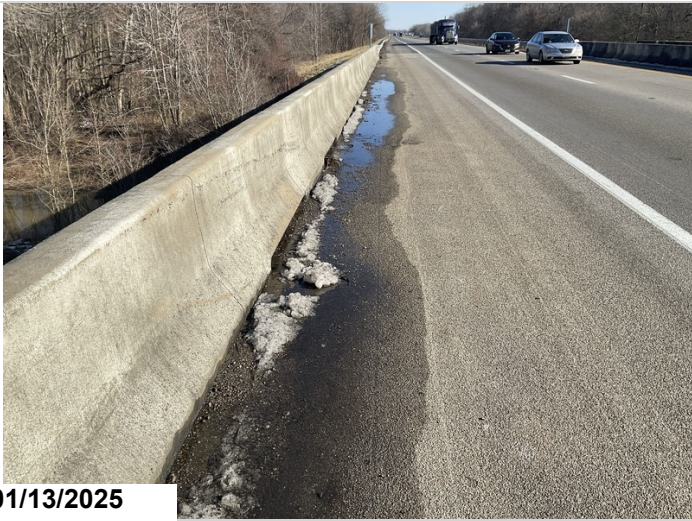
Deck has dirt and debris in gutters

Dirt and debris in gutters.

A-55 - Deck Washing Needed (Y)

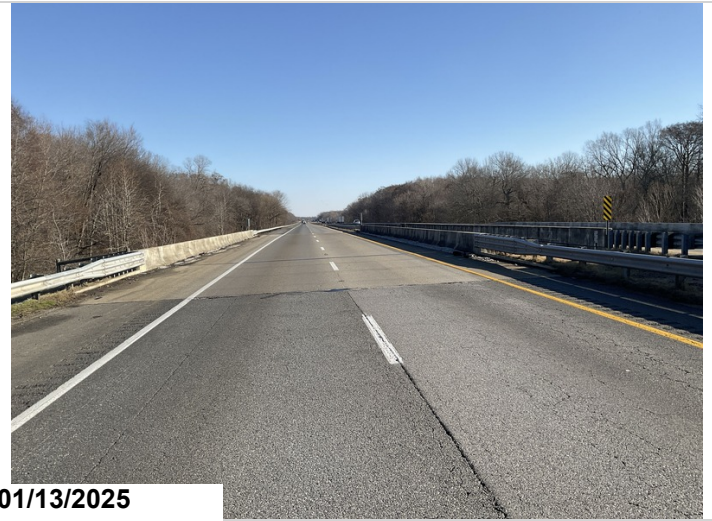
No log mile signs present

No log mile sign in place.

A-63 - Missing/Incorrect Log Mile Signage (Y)

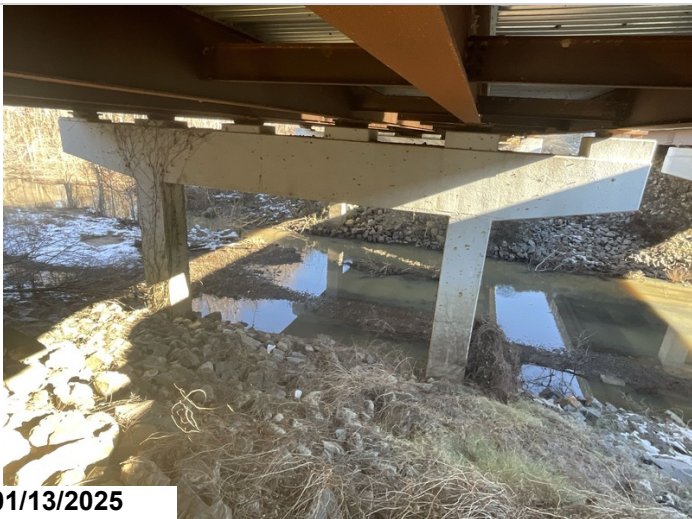
Vines and vegetation growing onto bents 2 and 3 and beside and under bridge.

Vegetation growing on bent 2 and beside and under bridge.

A-64 - Vegetation Removal Requested (Y)

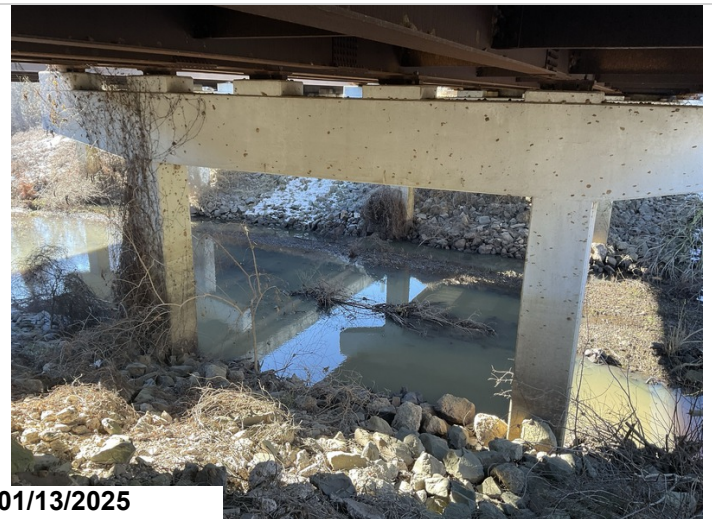
Vegetation growing on bent 3 and beside and under bridge.

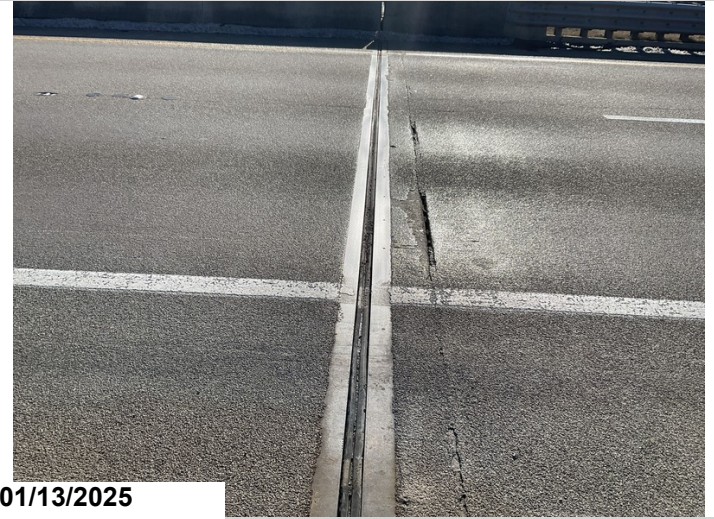
(302) Abutment 1, compression joint sea: 10' of lost adhesion with minor sagging.							
310	Elastomeric Bearing	EA	24	22	2	0	0
1020	Connection	EA	2	0	2	0	0

Abutment 1, joint: seal has lost adhesion for 10' with minor sagging.

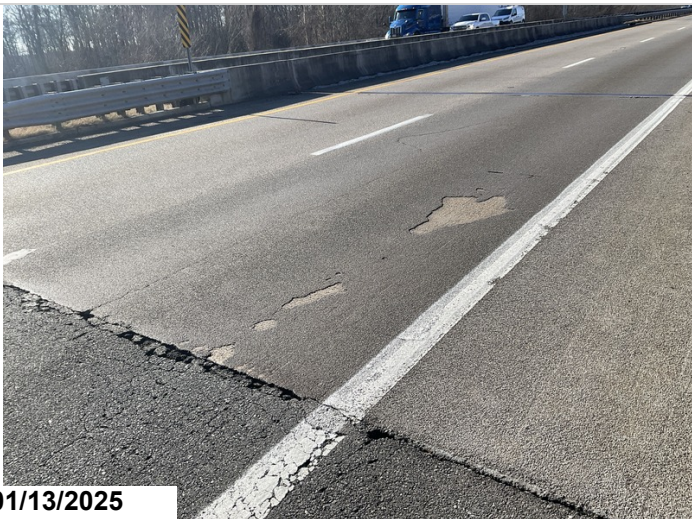
Abutment 2, approach slab

(321) Abutment 1, approach slab: longitudinal CS3 crack at center line. Cracking 40SF CS3 Abutment 1, approach slab, concrete protective coating: longitudinal CS3 crack at center line. Effectiveness 40SF CS3 Abutment 2, concrete protective coating, approach slab: 5 square feet of epoxy overlay failed in left lane. Effectiveness 5SF CS4 Approach slabs have been covered with epoxy overlay.							
331	Reinforced Concrete Bridge Railing	LF	268	268	0	0	0

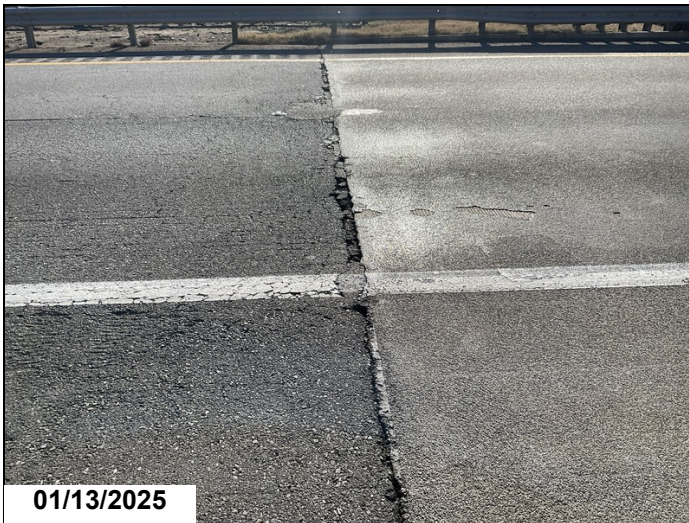
Abutment 2, approach roadway

Abutment 1 and 2 approach roadways: overlay raveling at approach slabs.

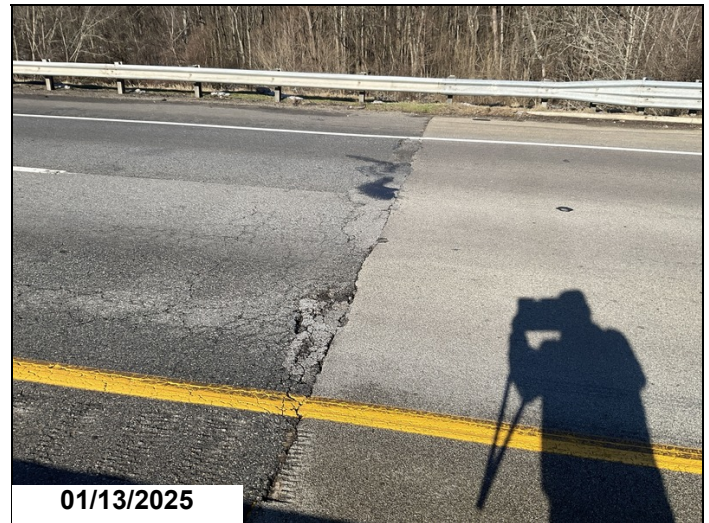
Abutment 1, approach roadway

1/13/2025-Abutment 1 approach roadway has been patched at time of inspection.

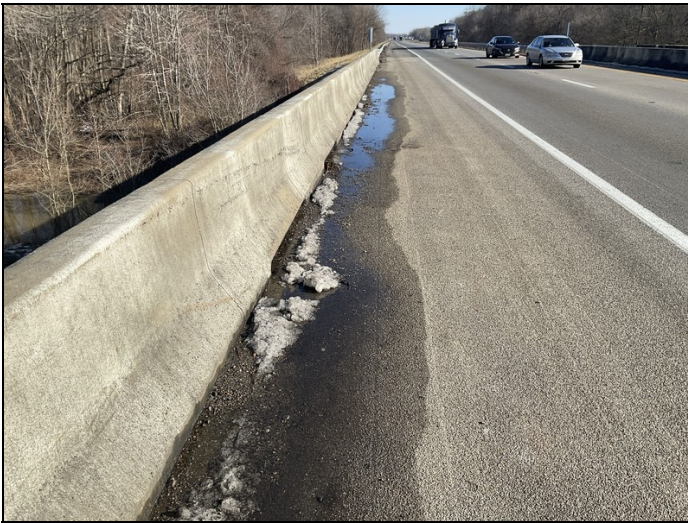
Deck has dirt and debris in gutters

Dirt and debris in gutters.

A-55 - Deck Washing Needed (Yes)

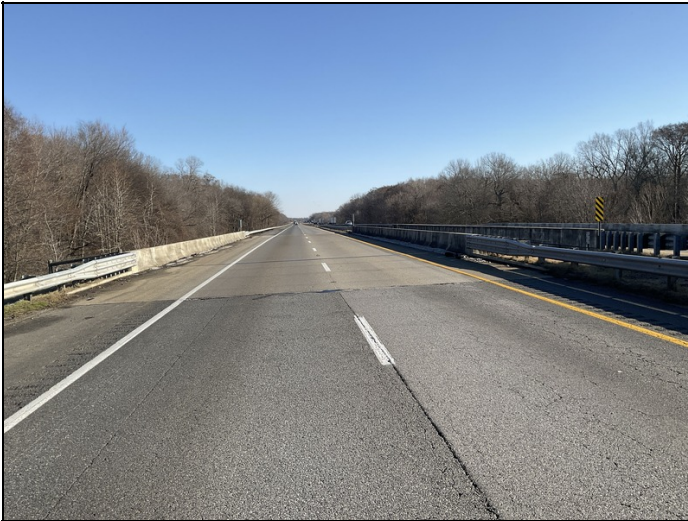
No log mile signs present

No log mile sign in place.

A-63 - Missing/Incorrect Log Mile Signage (Yes)

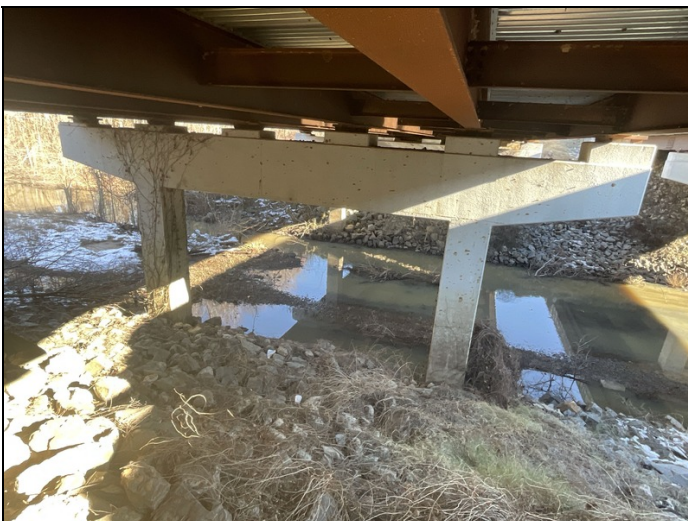
Vines and vegetation growing onto bents 2 and 3 and beside and under bridge.

Vegetation growing on bent 2 and beside and under bridge.

A-64 - Vegetation Removal Requested (Yes)

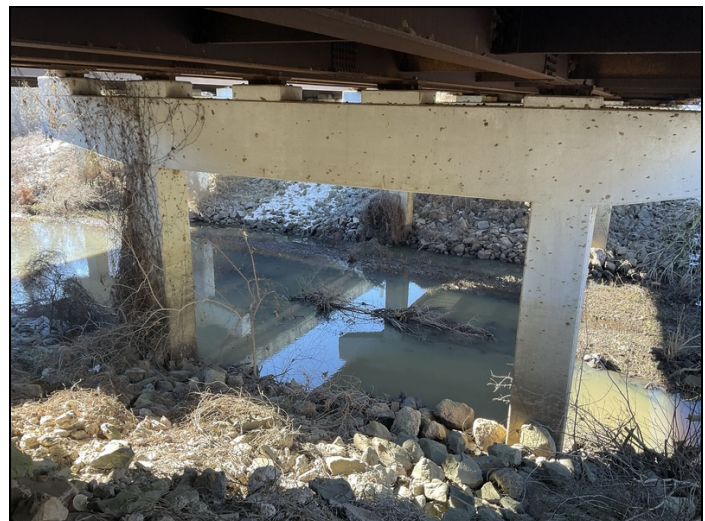
Vegetation growing on bent 3 and beside and under bridge.
