Bridge A3731 Inspection Report

Team Lead: Jonathan Gonzalez, Inspection Date: 09/05/2025

I-40WB/Se43/215.99 over Cr-179/Z-D/L-1.72

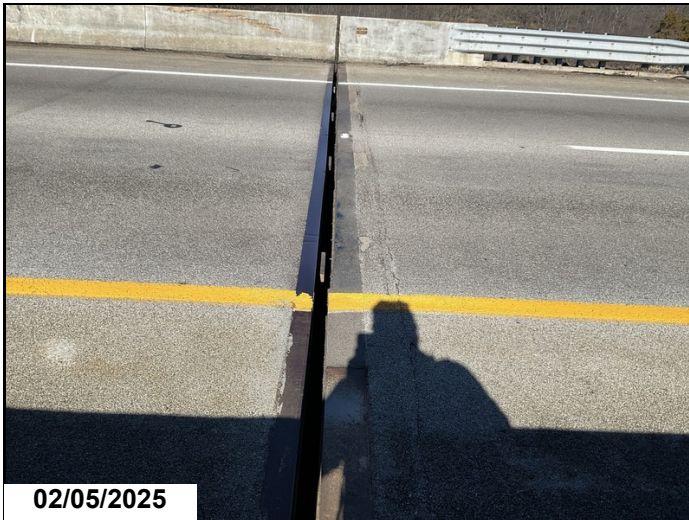
Abutment 2, compression joint seal, full width: joint seal has fallen out and drain has failed.

Abutment 2, joint seal: missing, full width, drain has failed.

Abutment 2, compression joint, full width: joint seal has fallen out and drain has failed.

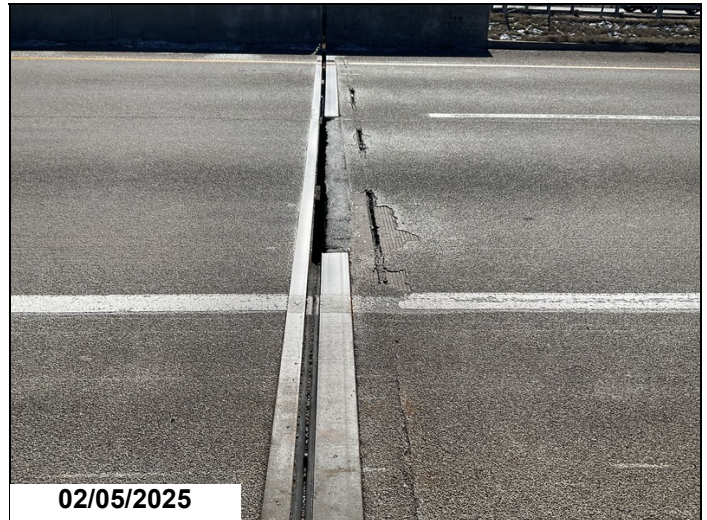
Abutment 1, compression joint seal, left lane: 30' of joint seal missing and 10' of road iron has been removed.

Abutment 1, left lane, road iron: 10 feet removed and 30' of joint seal missing.

Abutment 1, compression joint seal, left lane: 10' of joint steel has been removed and 30' of joint seal missing.

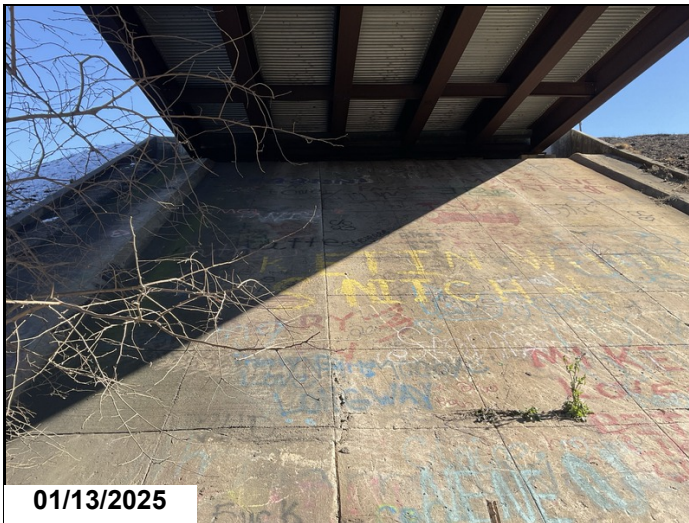
Graffiti on bent 3 pier wall and abutment 2 slope pavement.

Graffiti, abutment 2 slope pavement.

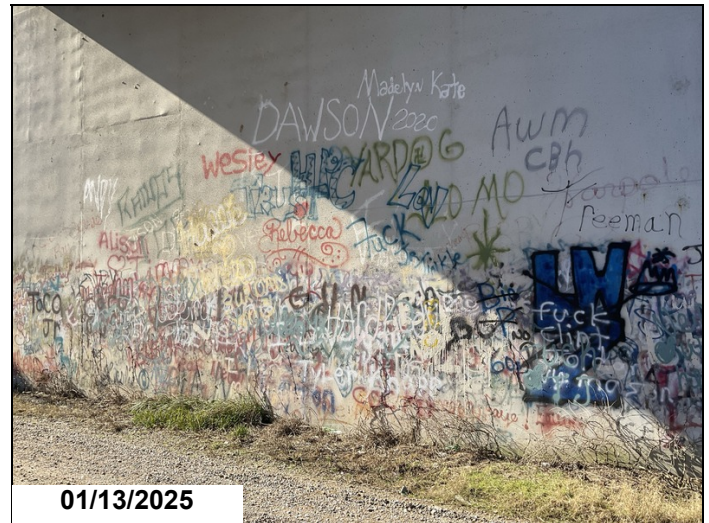
Graffiti, bent 3
