Bridge B3614 Inspection Report

Asset #B3614(Routine, Underwater type 2)

I-40EB/Se51/237.82 over Spring Creek

Team Lead: Myron Futrell Inspection Date: 01/29/2024

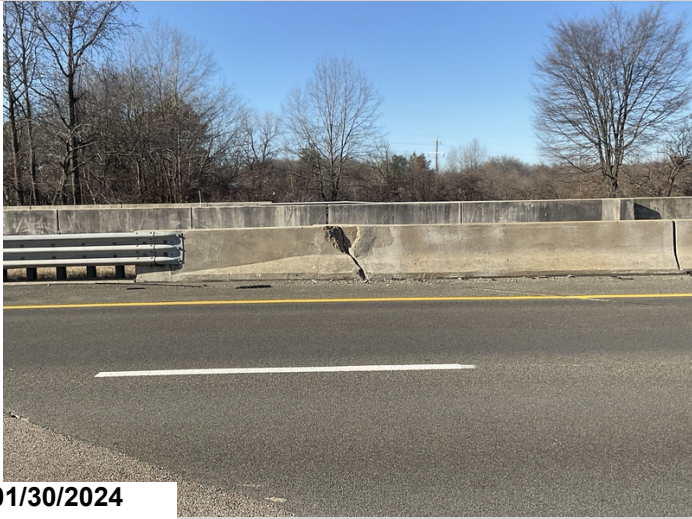
(331) Abutment #1 left transition rail has 2' X 2' spall with exposed rebar no section loss. Bridge rails have vertical cracks spaced three feet apart. Bent #2 right side rail at bottom span #1 has six-inch spall no rebar. Span #2 left side outside at bent #3 has three-inch spall with exposed rebar.

Abutment #1 left bridge rail

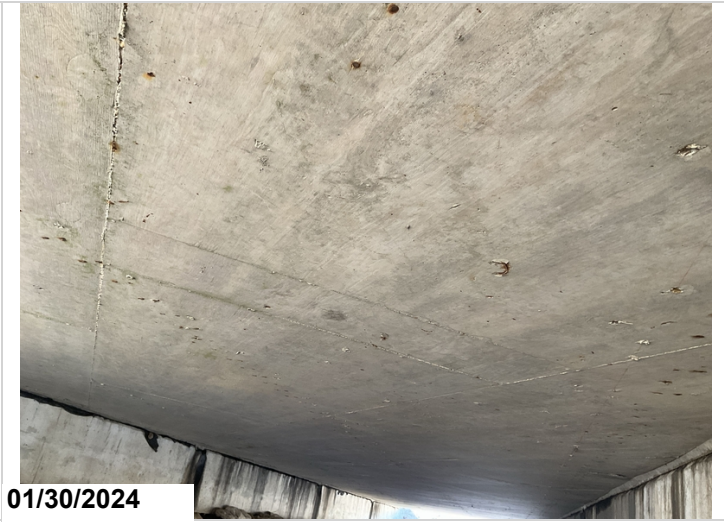
Deck is in overall satisfactory condition. Deck has an epoxy coated wearing surface. Soffit / underside of deck has a few spalled areas with exposed rebar, some cracking with rust staining and efflorescence.

Span #1 soffit / underside of deck

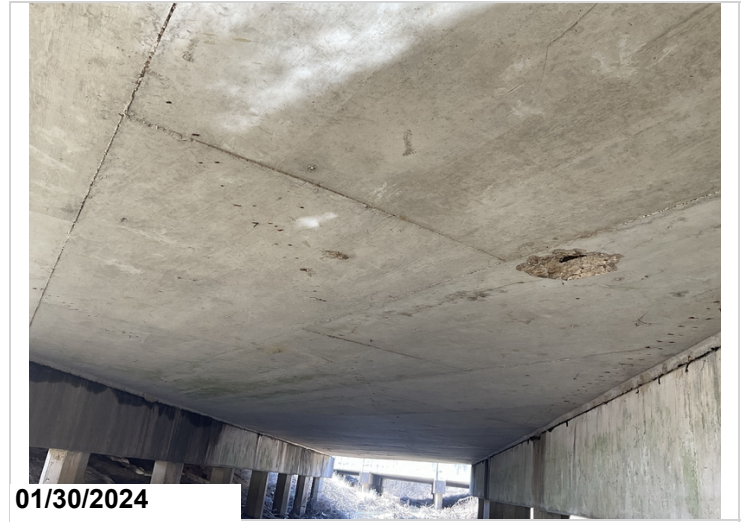
Span #2 soffit / underside of deck

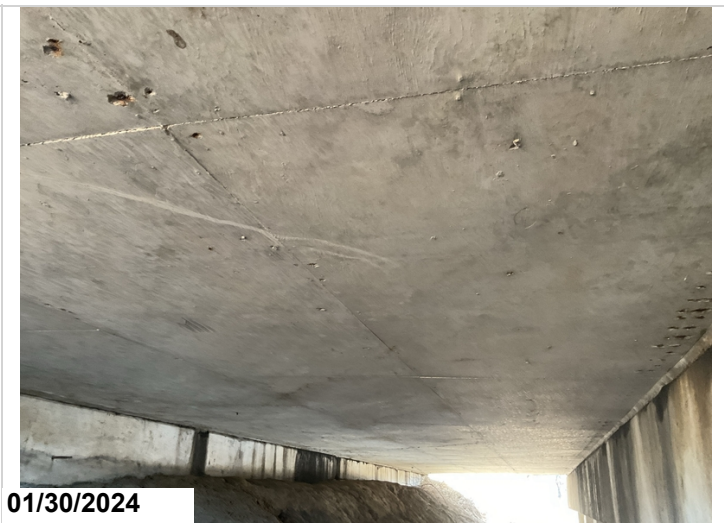
Span #3 soffit / underside of deck

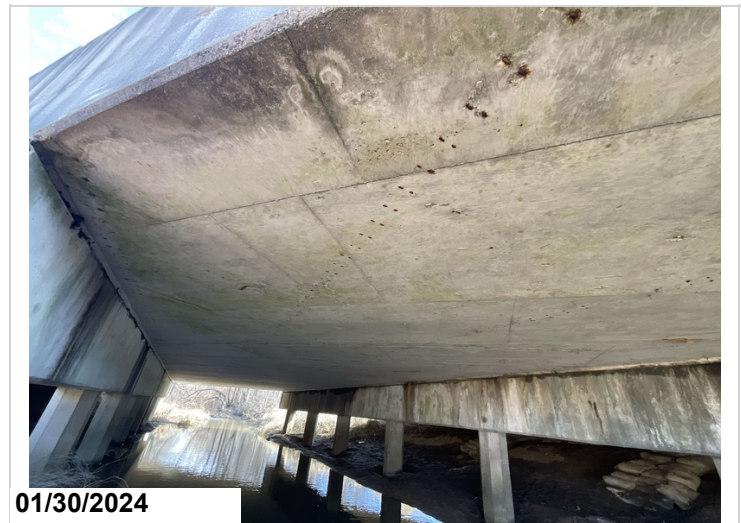
Span #2 soffit / underside of deck

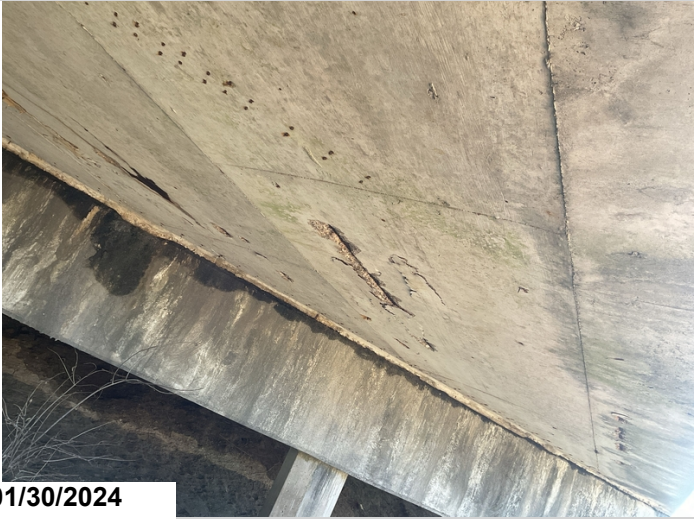
(38) Deck soffit-under surface has open longitudinal cracks with areas of light efflorescence and small rust stains all spans. Span #2 soffit-under surface has 1' spall with exposed rebar with minor section loss, 2' from bent #3 and 10' from right side of bridge, and left side has two 3' spills near bent #2 with exposed rebar with minor section loss and one 1' spall with exposed rebar with minor section loss near bent #3. Soffit-under surface span #3 right side at bent #3 has one-foot delaminated area. Deck has epoxy coated wearing surface.							
215	Reinforced Concrete Abutment	LF	144	144	0	0	0
227	Reinforced Concrete Pile	EA	18	18	0	0	0
234	Reinforced Concrete Pier Cap	LF	144	142	0	2	0
1090	Exposed Rebar	LF	2	0	0	2	0

Span #2 soffit left side spalled with exposed rebar

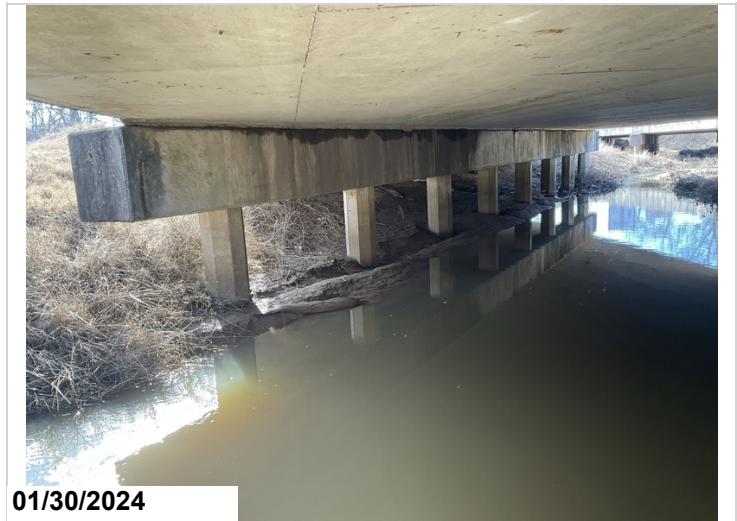
(234) All caps both faces have several hairline vertical cracks various spacing. Bent #2 cap ahead face above pile #4 has six-inch spall with exposed rebar with 5% section loss. Bent #2 cap right end has six-inch spall with exposed rebar with 5% section loss. Bent #3 cap right end has moderate scaling with no loose aggregate. Bent #3 cap ahead face above pile #7 has six-inch spall with rebar exposed with 5% section loss. Bent #3 cap back face between piles 2,3 and 6,7 has 1' delamination at keyway.							
301	Pourable Joint Seal	LF	296	296	0	0	0

Bent #2 cap ahead face

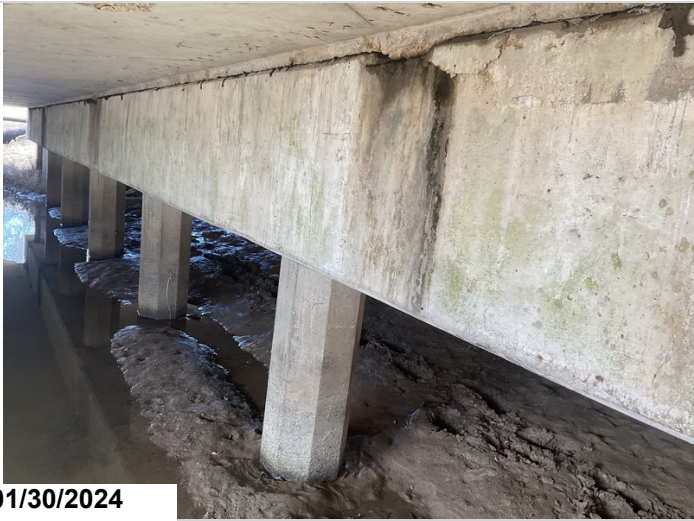
Bent #3 cap back face

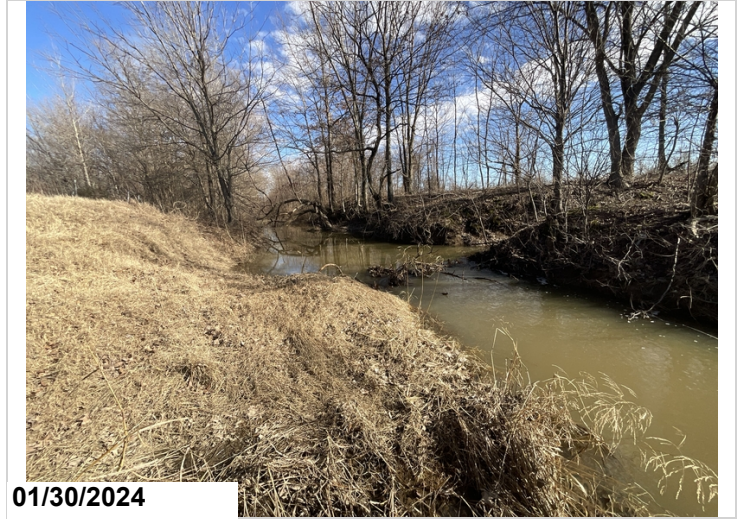
61 - Channel/Channel Protection (6 - Bank is beginning to slump. River control devices and embankment protection have widespread minor damage. There is minor stream bed movement evident. Debris is restricting the channel slightly.)
Channel is in overall satisfactory condition. Channel alignment is fair at structure, slopes underneath bridge have moderate erosion. Debris and vegetation restrict channel slightly.

Channel right side

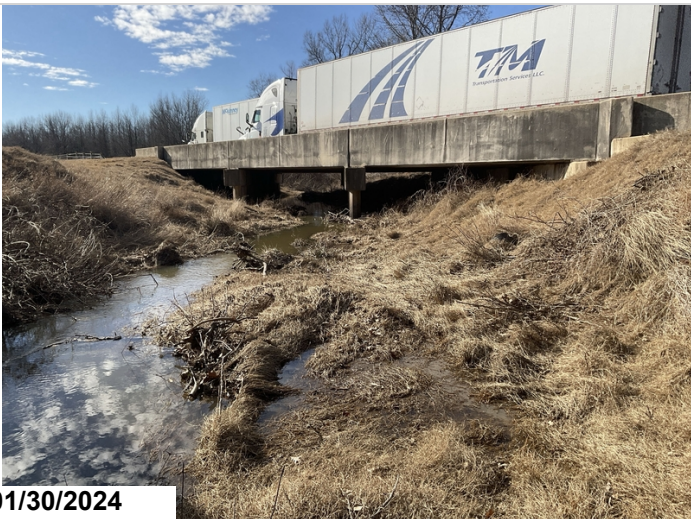
Channel left side

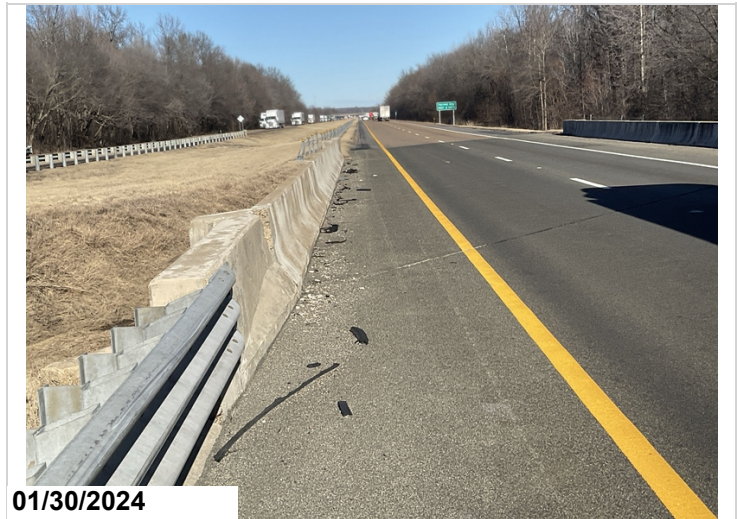
Dirt and debris in gutters.

Dirt and debris in gutters

A-55 - Deck Washing Needed (Y)

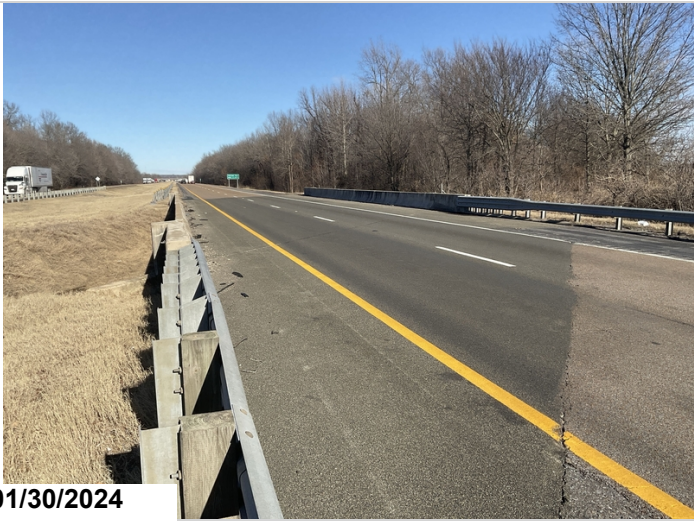
No log mile signs in place.

No log mile signs

A-63 - Missing/Incorrect Log Mile Signage (Y)

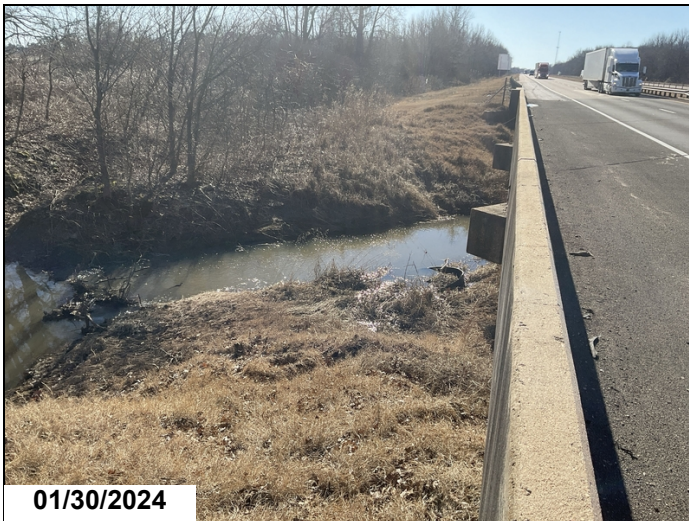
Small trees and vegetation are growing under and beside bridge.

Trees and vegetation have been cleared

1/30/2024-Vegetation has been cut at time of inspection.

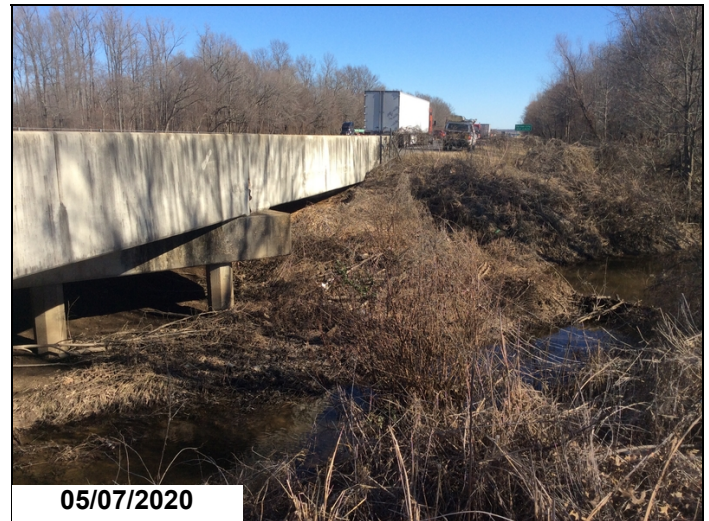
Typical vegetation

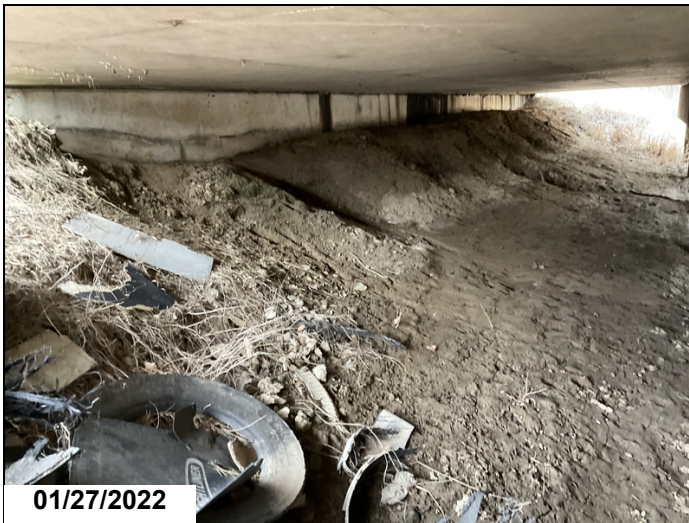
Abutment #2 slope has areas of erosion up to the abutment.

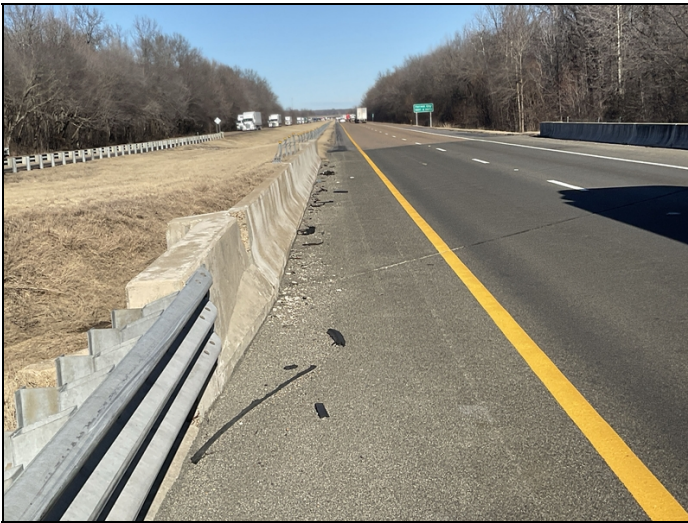
Dirt and debris in gutters.

Dirt and debris in gutters

A-55 - Deck Washing Needed (Yes)

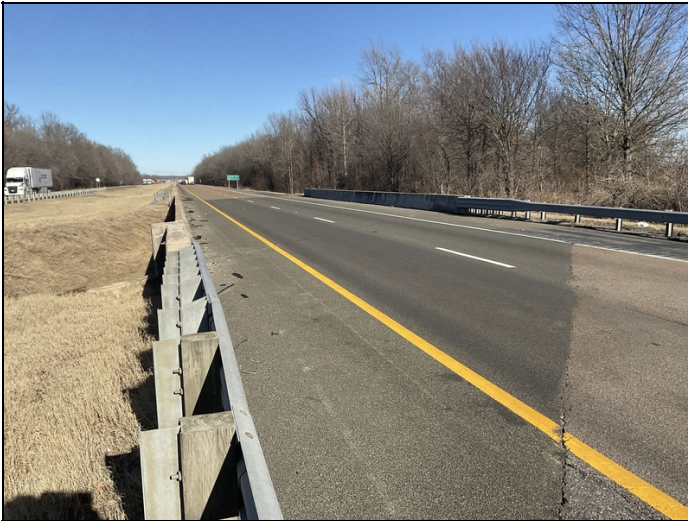
No log mile signs in place.

No log mile signs

A-63 - Missing/Incorrect Log Mile Signage (Yes)
