Bridge B3617 Inspection Report

Asset #B3617(Routine, Underwater type 2)

I-40EB/Se51/239.44 over Drainage Ditch

Team Lead: Myron Futrell Inspection Date: 04/16/2024

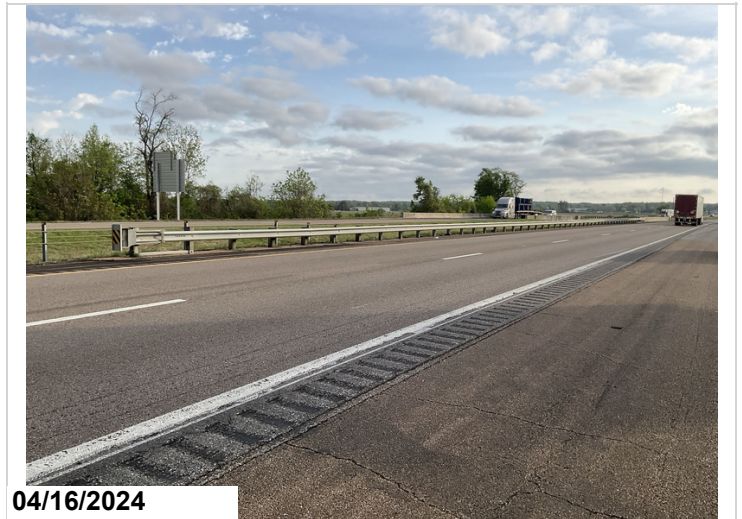
Abutment 1, approach rail, left side, mid span: approximately 20' minor collision damage.

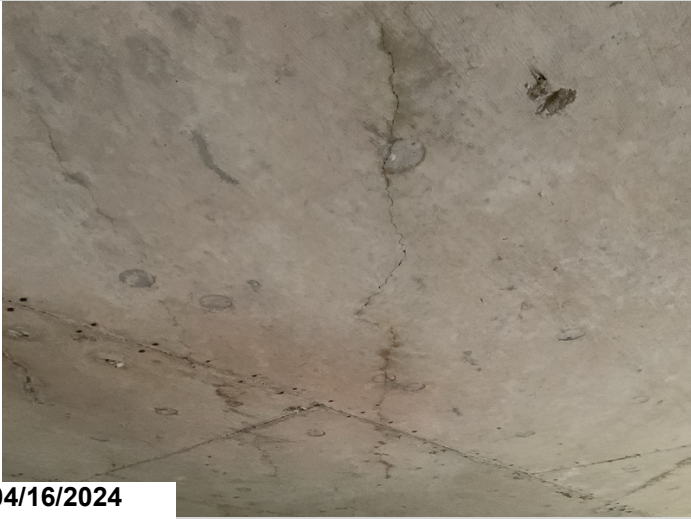
Voided slab superstructure is in overall satisfactory condition. Soffit / undersurface has longitudinal cracking, some with rust staining and efflorescence. Top of slab has epoxy wearing surface. Ends of slabs have minor spalling at bents.

Typical soffit / undersurface of deck crack with rust stains

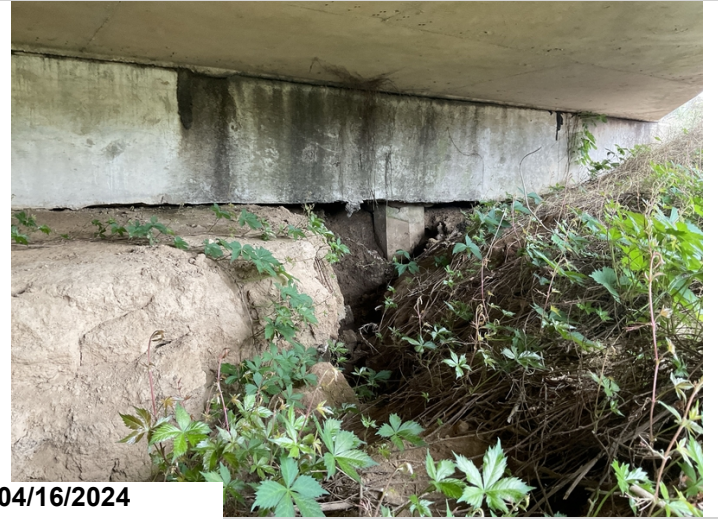
(215) Abutment 1, cap: slope eroded at pile 2 for 4' up to 2' deep, exposing pile 2. 4LF CS2 Abutment 2, slope, 6' to right of centerline: cap undermined for 3' up to 1' deep exposing 1 pile. 3LF CS2 Abutment 2, cap, 6' to right of centerline: cap has 1' delaminated area. 1LF CS3							
227	Reinforced Concrete Pile	EA	18	18	0	0	0

Abutment 1, cap: slope eroded at pile 2 for 4' up to 2' deep, exposing pile 2.

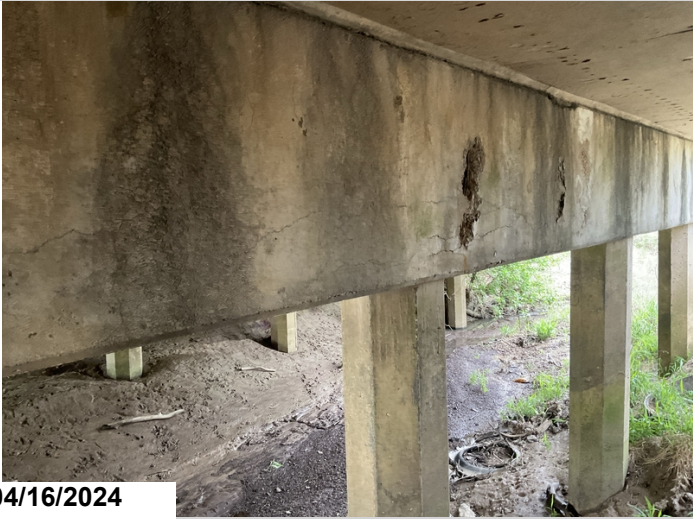
Bent 3, pile cap, ahead face, between piles 2 and 3: two 1' spalls with exposed reinforcing steel with moderate section loss and 6' of cracking.

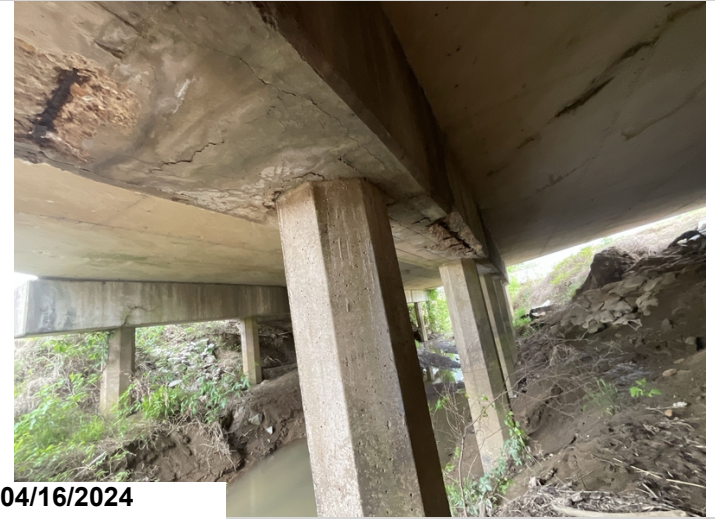
Bent 3, pile cap, bottom face, between piles 5 and 6: spalled with exposed reinforcing steel with moderate section loss.
6LF CS3

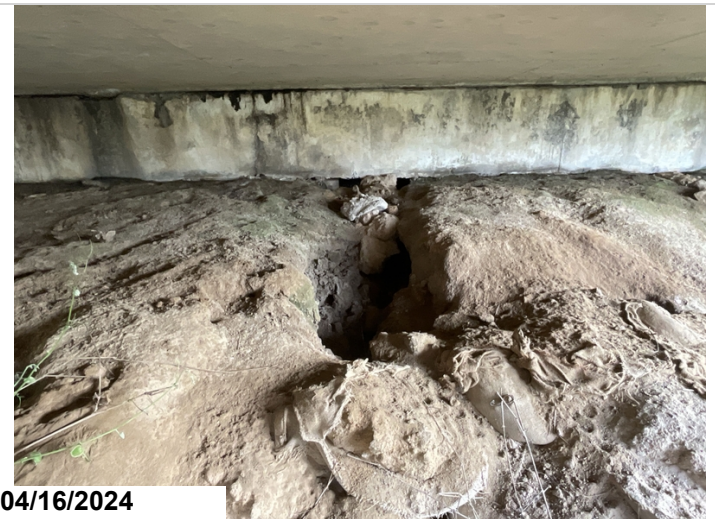
Abutment 2: erosion exposing 1 pile

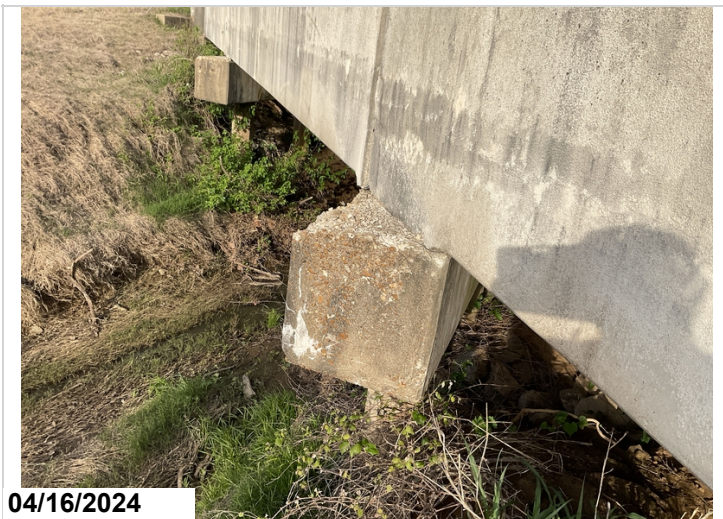
Bent 3, pile cap, right end heavily scaled with loose aggregate

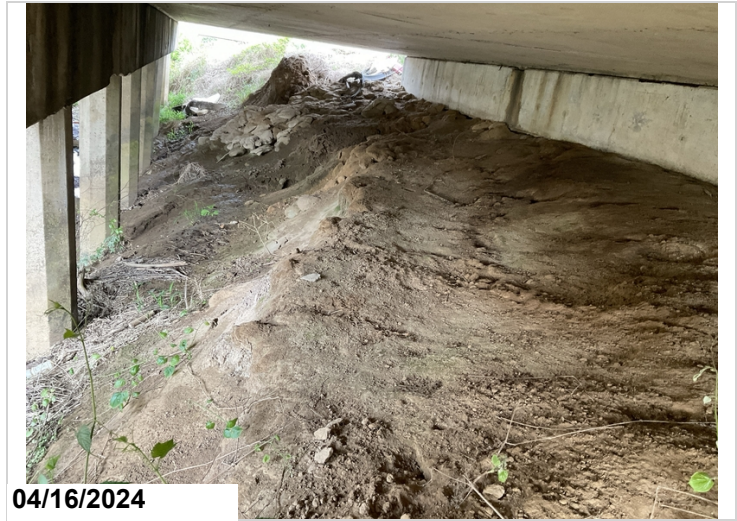
Channel is in fair overall condition. Channel alignment is fair, bridge has 52 degree skew. Abutment slopes have minor to moderate erosion exposing several piles, otherwise slopes are well vegetated with the exception of a small area right side of bridge that is steep and eroded. Channel, both sides, has vegetation growth restricting flow.

Abutment 2, slope: erosion.

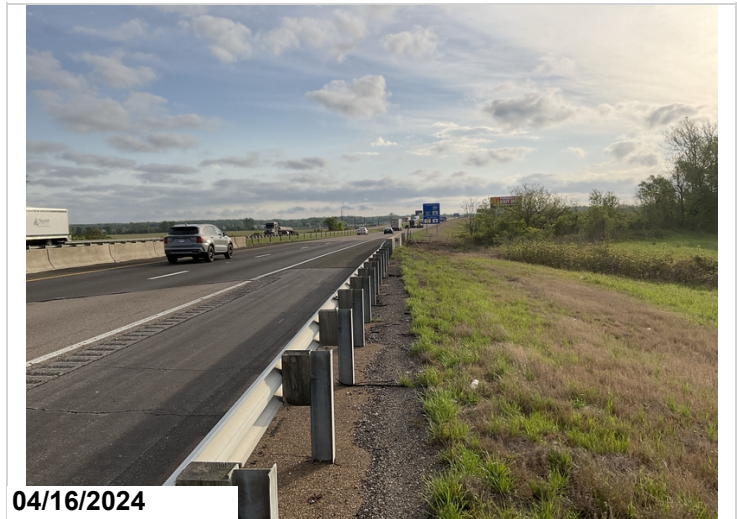
No log mile sign in place.

No log mile sign

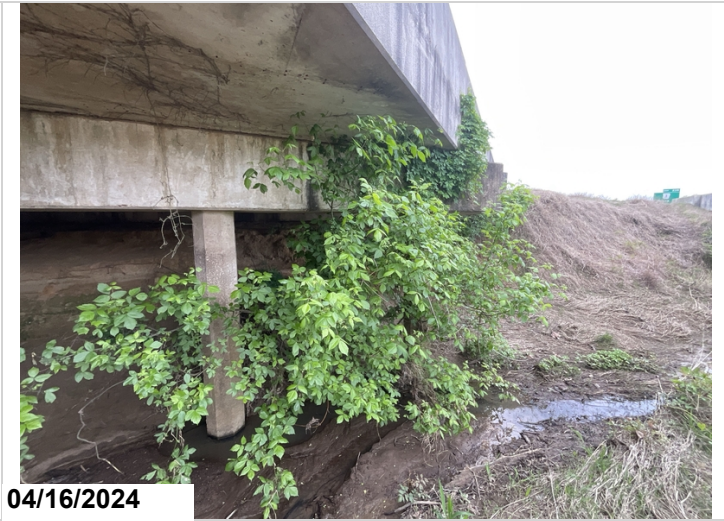
Small trees and vegetation growing beside and under bridge.

Vegetation growing beside, under and onto bridge

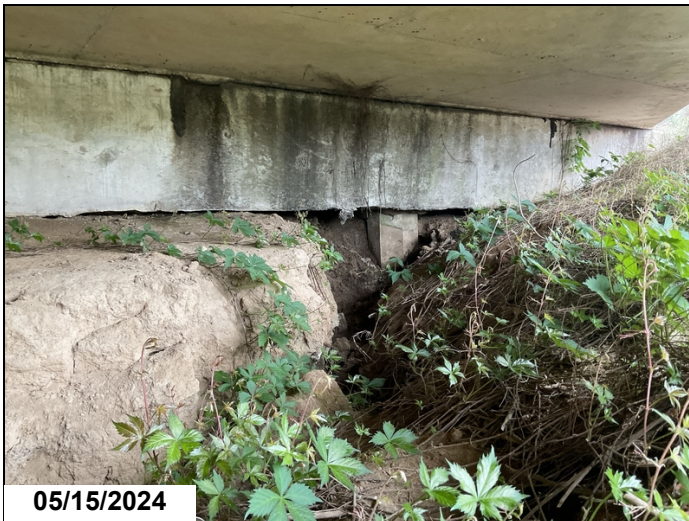
Abutment 1, slope: eroded undermining cap and exposing pile 2.

Abutment 1, cap: slope eroded at pile 2 for 4' up to 2' deep, exposing pile 2.

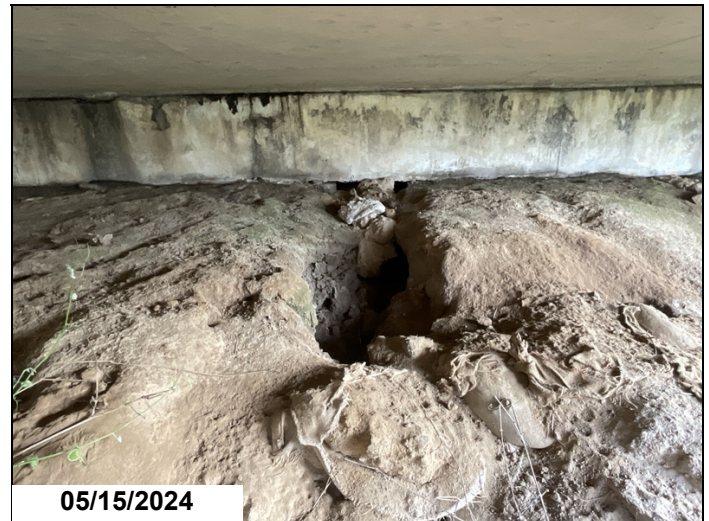
Abutment 2, slope: eroded to a vertical face within four feet of abutment, with erosion vein exposing one pile slightly.

Abutment 2: erosion exposing 1 pile

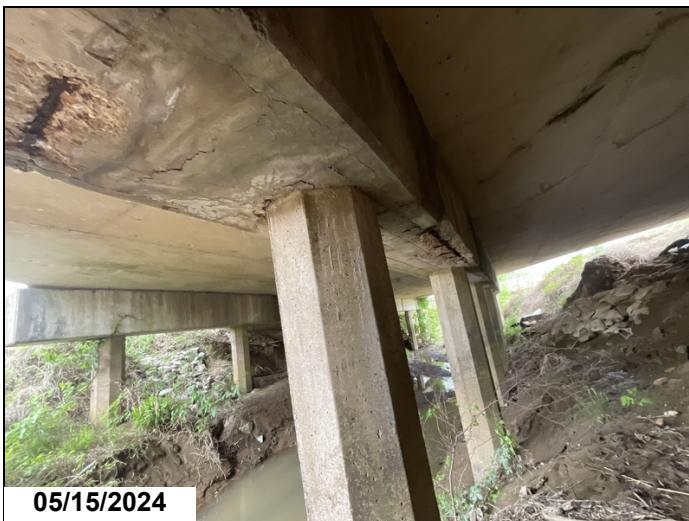
Bent #3 cap bottom face between piles #3,6 has 30' of longitudinal cracking and a 3' x 1' spall with exposed rebar with moderate section loss between piles #5,6.

Bent 3, pile cap, bottom face, between piles 5 and 6:
spalled with exposed reinforcing steel with moderate
section loss. 6LF CS3

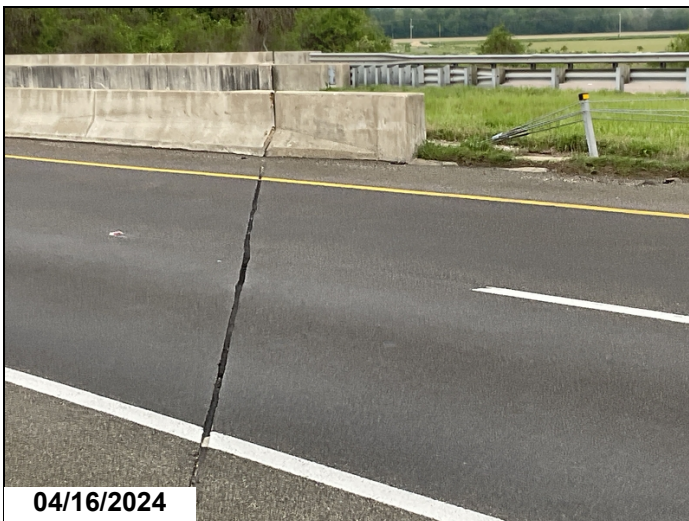
Abutment 2, approach slab: small spall has been repaired.

Approach slabs have had an epoxy overlay since last inspection.
4/16/2024-Spall has been repaired at time of inspection.

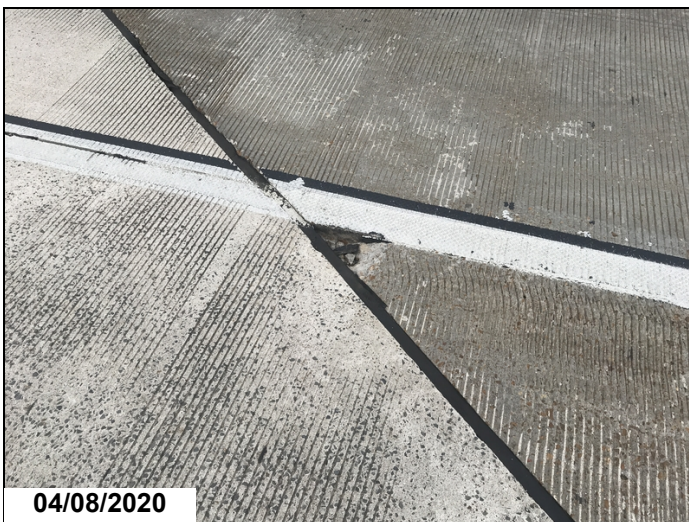
Small spall in abutment 2 approach slab at center line at bridge end.

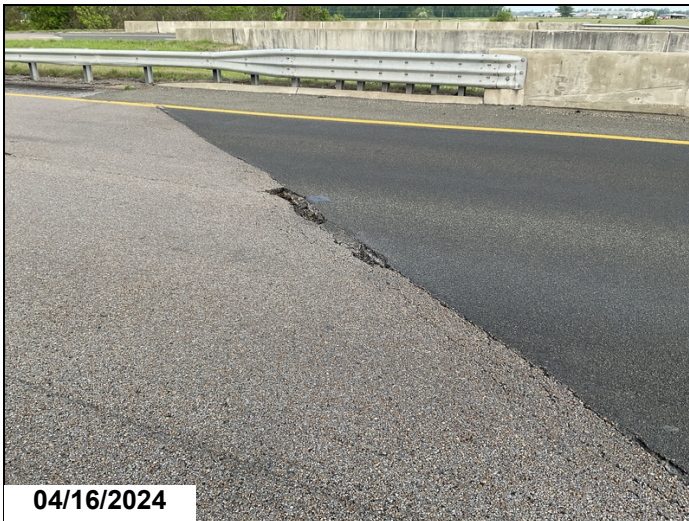
Abutment 1, approach roadway, at centerline and right lane: spalled for 1' x 6" and 2' x 6".

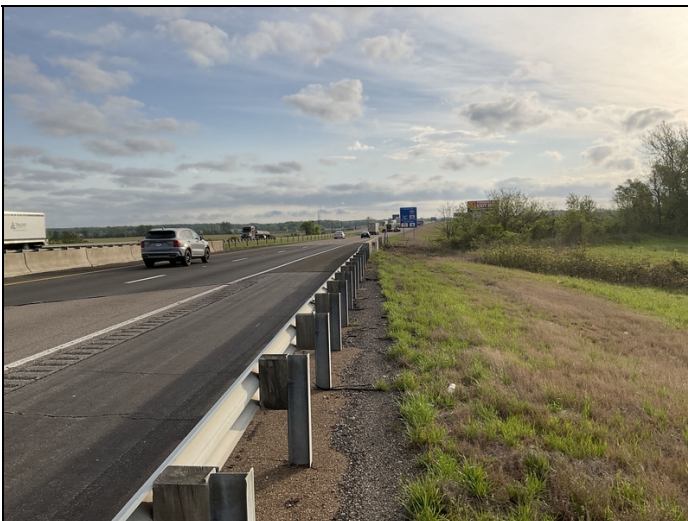
No log mile sign in place.

No log mile sign

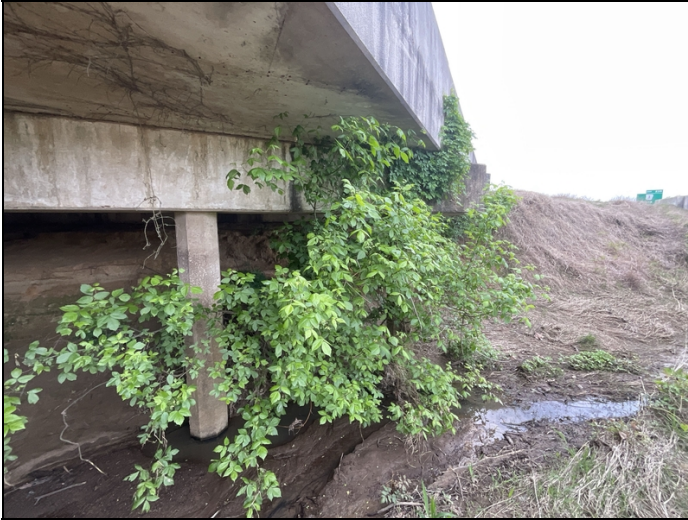
Small trees and vegetation growing beside and under bridge.

Vegetation growing beside, under and onto bridge
