## Bridge B3724 Inspection Report

| IDENTIFICATION | |
|---|---|
| (7) Facility Carried | I-40EB/Se43/209.29 |

| INSPECTIONS * | | | |
|---|---|---|---|
| (90) Inspection Date | 06/05/2025 | | |

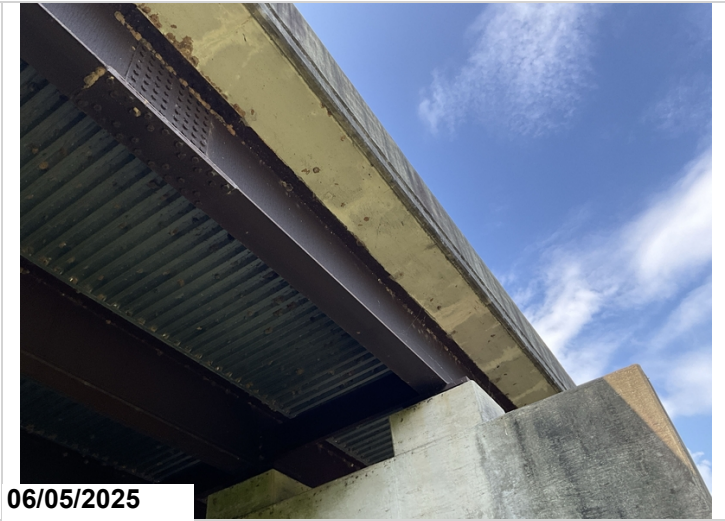
| ELEMENTS | DESCRIPTION | UNITS | TOTAL | CS1 | CS2 | CS3 | CS4 |
|---|--|---|---|---|---|---|---|
| Undersurface Overhangs, Full Length: Transverse cracks spaced 3' apart some with light efflorescence. 1000SF CS2 (Cracking), 325SF CS2 (Efflorescence/Rust Staining) | | | | | | | |

Typical undersurface overhang

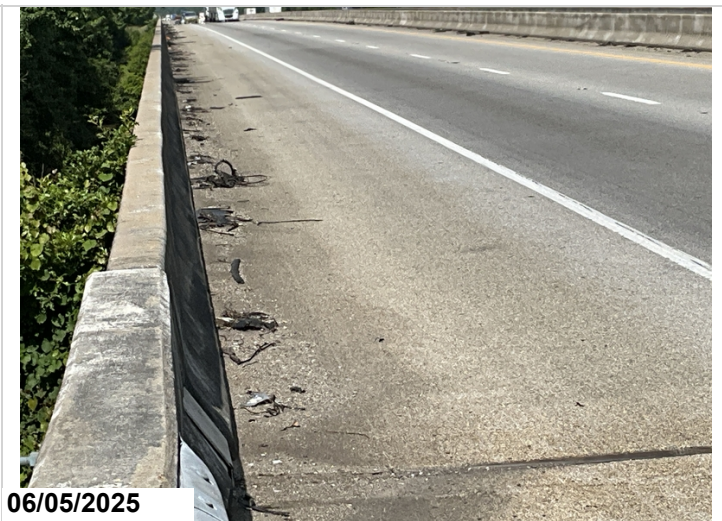
Typical debris in gutters

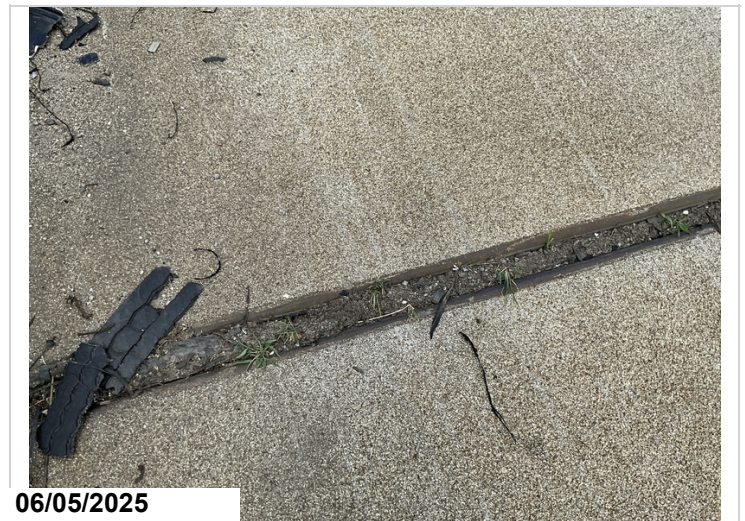
Typical debris in joints

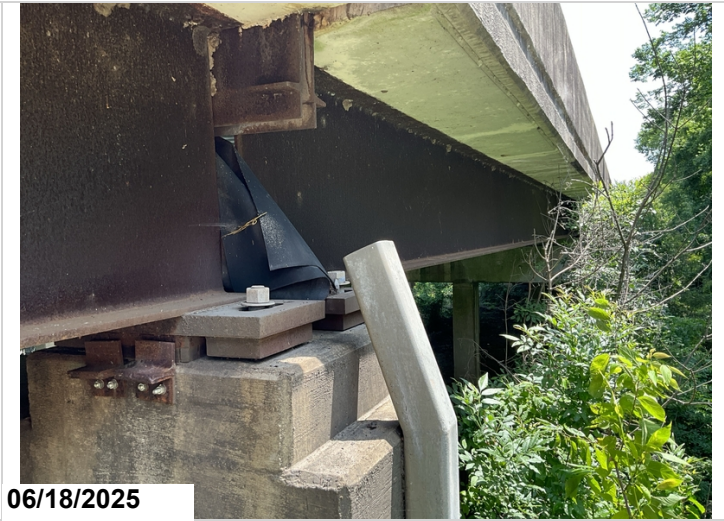
Bridge joints are in satisfactory condition with a few small holes, debris impaction, small area failed, and a couple of drain troughs not hooked up to drains.

Joint Trough, Bent 8, Right: Last 3' failed.

Joint Trough, Bent 8, Right: Last 3' failed.

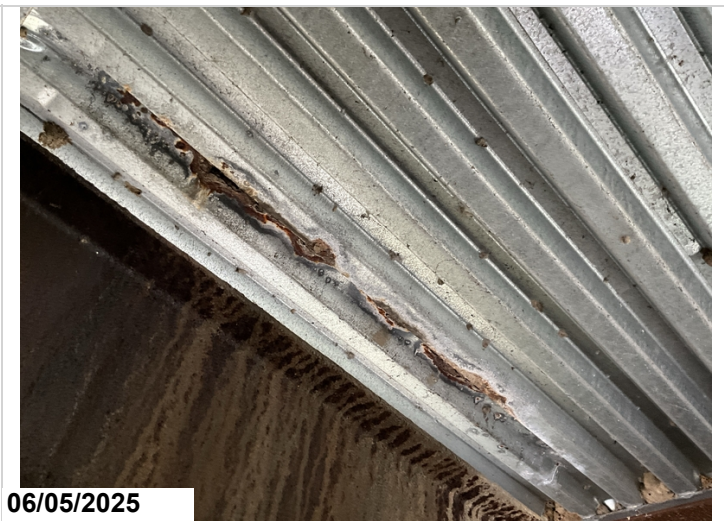
| ELEMENTS | DESCRIPTION | UNITS | TOTAL | CS1 | CS2 | CS3 | CS4 |
|---|--|---|---|---|---|---|---|
| Span 18, Undersurface, Center Span, Bay 3, Stay In Place Form: Rusted through. | | | | | | | |

Typical stay in place form corrosion

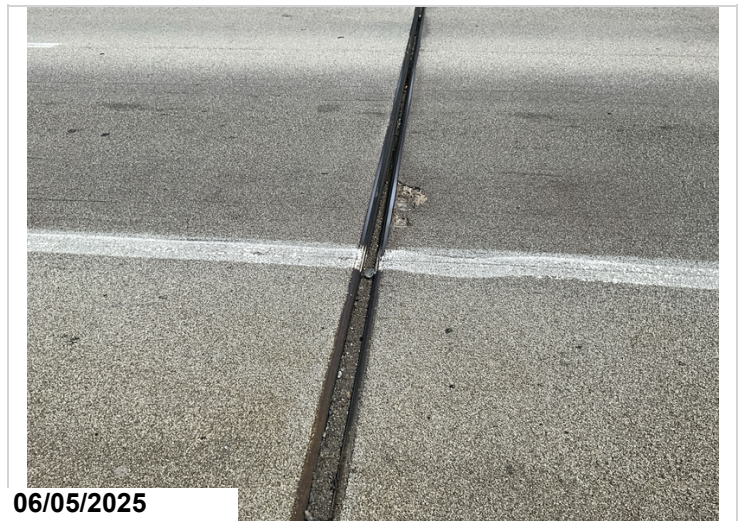
| ELEMENTS | DESCRIPTION | UNITS | TOTAL | CS1 | CS2 | CS3 | CS4 |
|---|--|---|---|---|---|---|---|
| (12) Deck, Span 9, Ahead Of Bent 8 joint: 1' wide spall no exposed reinforcing steel. 1SF CS3 (Delamination/Spall/Patched Area), 1SF CS3 (Effectiveness) | | | | | | | |

Deck, Span 9, Ahead Of Bent 8 joint: 1' wide spall no exposed reinforcing steel.

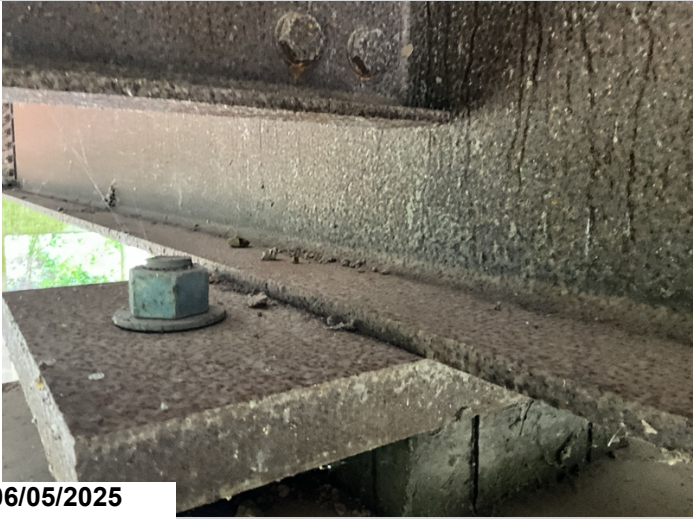
Bent 20, Girder 4, Girder To Soul Plate Weld: Not welded.  
Bent 20, Girder 5, Girder To Soul Plate Weld: Not welded.

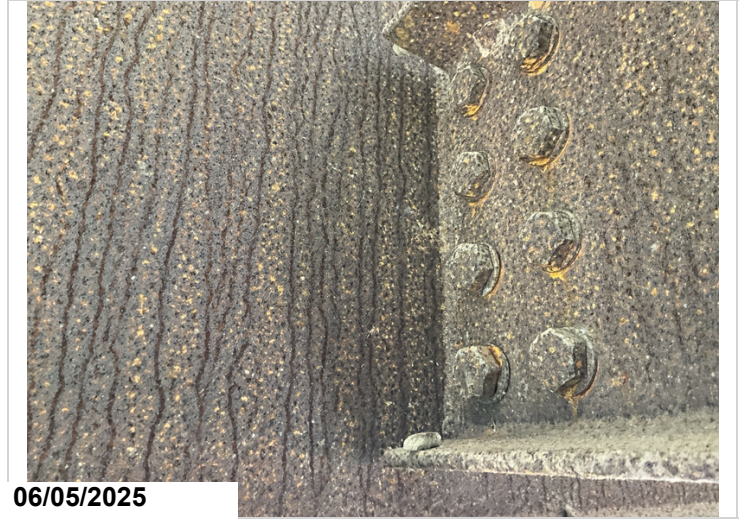
Typical diaphragm bolt loose.

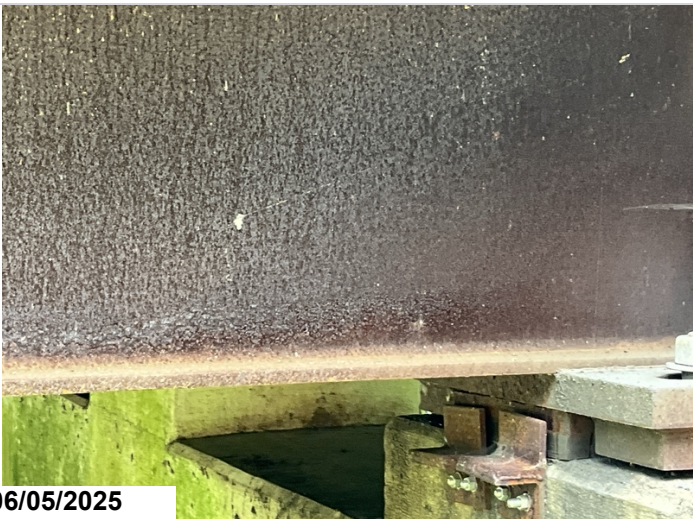
Typical active corrosion on girders.

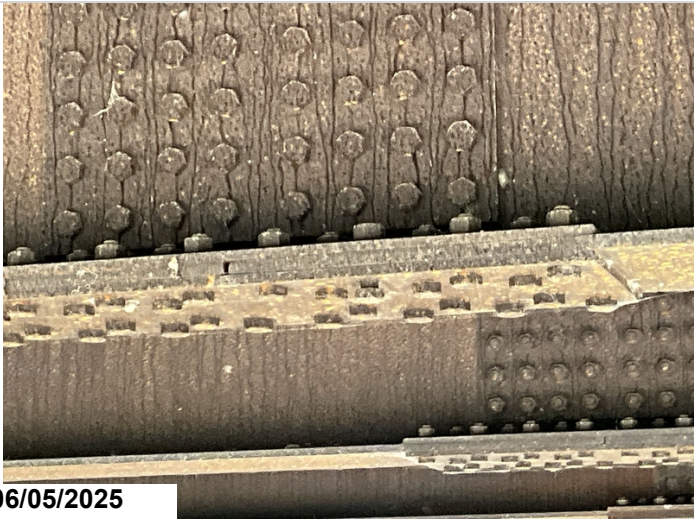
| ELEMENTS | DESCRIPTION | UNITS | TOTAL | CS1 | CS2 | CS3 | CS4 |
|---|--|---|---|---|---|---|---|
| Span 4, Girder 4, Field Splice, Bottom, Left: Bolt Loose. 1LF CS2 (Connection) | | | | | | | |

Span 4, Girder 4, Field Splice, Bottom, Left: Bolt Loose.

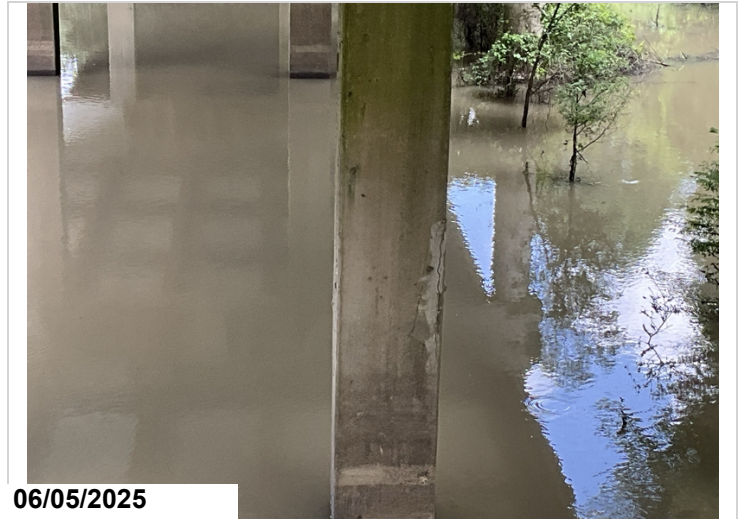
Bent 20, Column 3, Back, Right, Corner: Cracked for 3'.

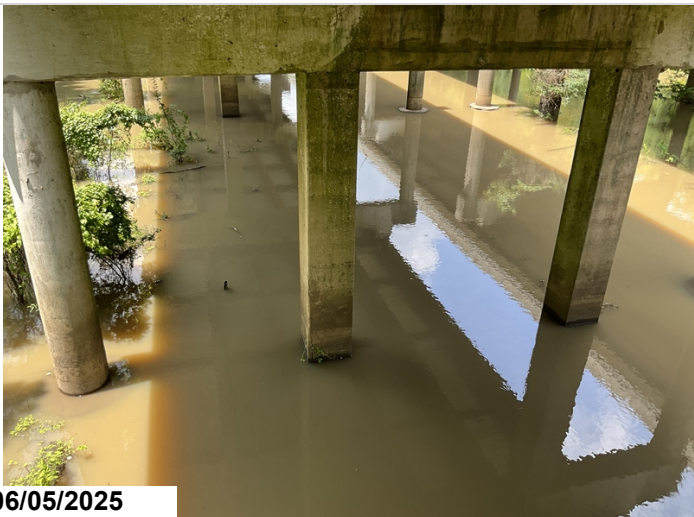
Bent 17, Column 3: Cracks and delaminations.

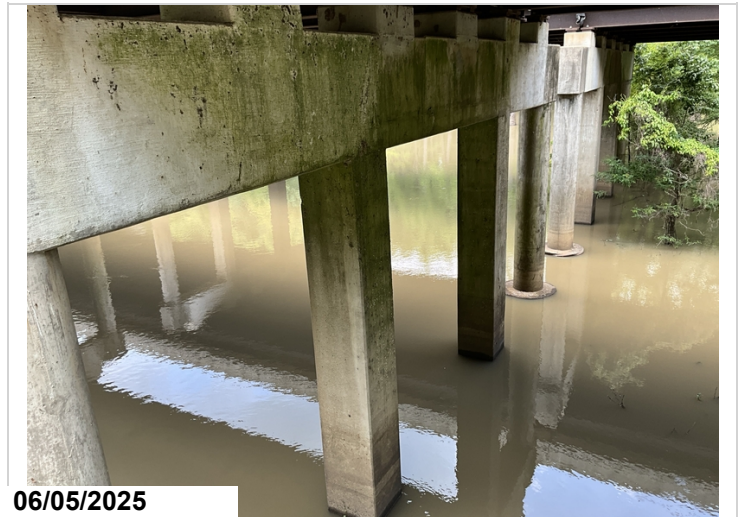
Bent 16, Column 2: Cracks and delaminations.

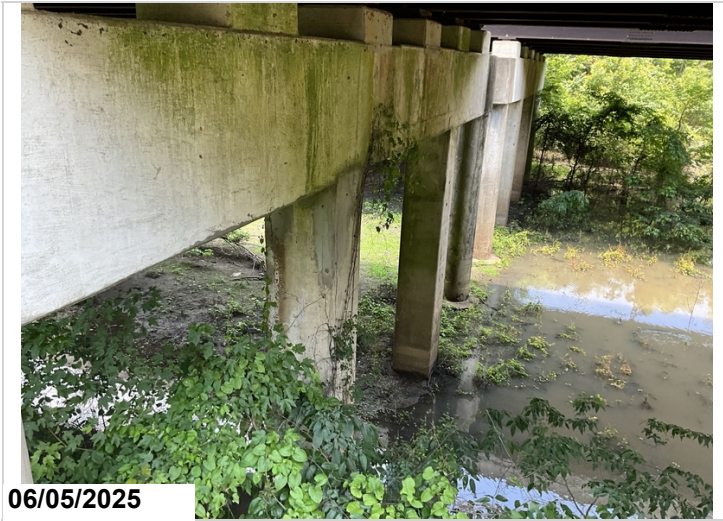
Bent 14, Column 2 & 3: Cracks and delaminations.

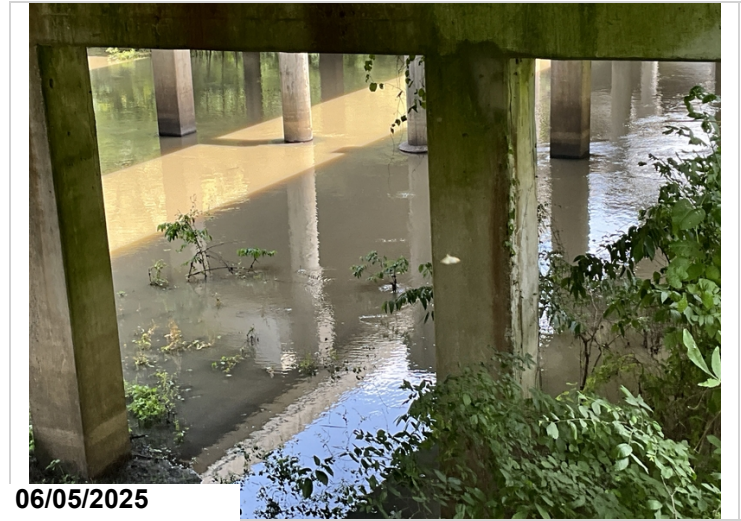
Bent 14, Column 3: Cracks and delaminations.

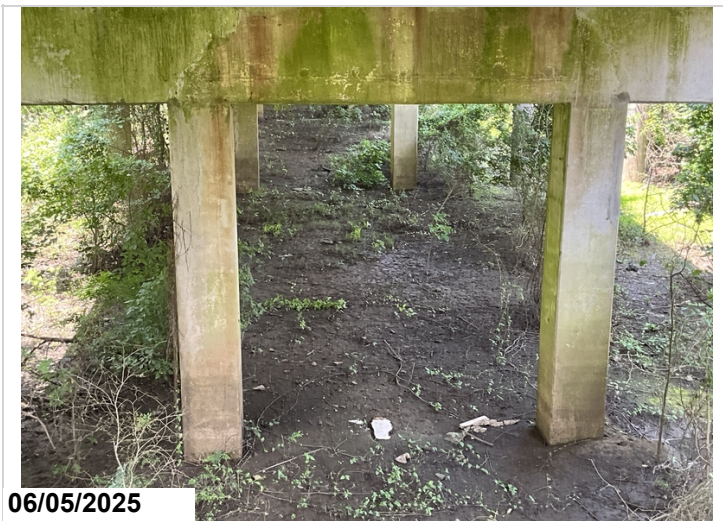
Bent 12, Column 1 & 2: Cracks and delaminations.

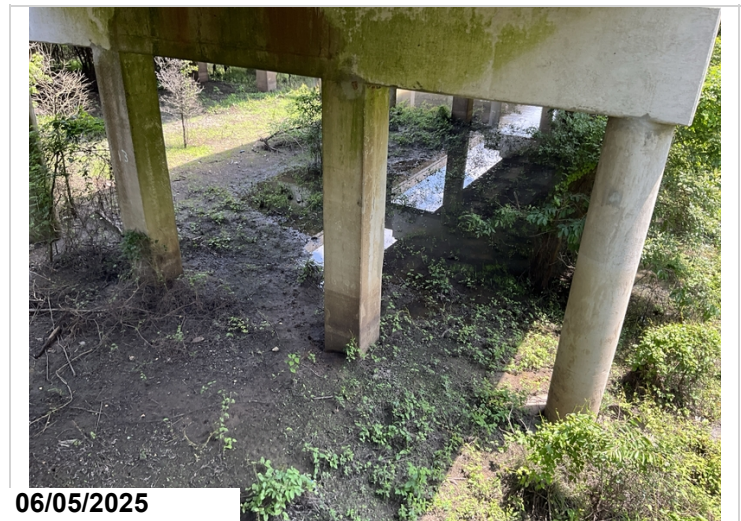
Bent 13, Column 3: Cracks and delaminations.

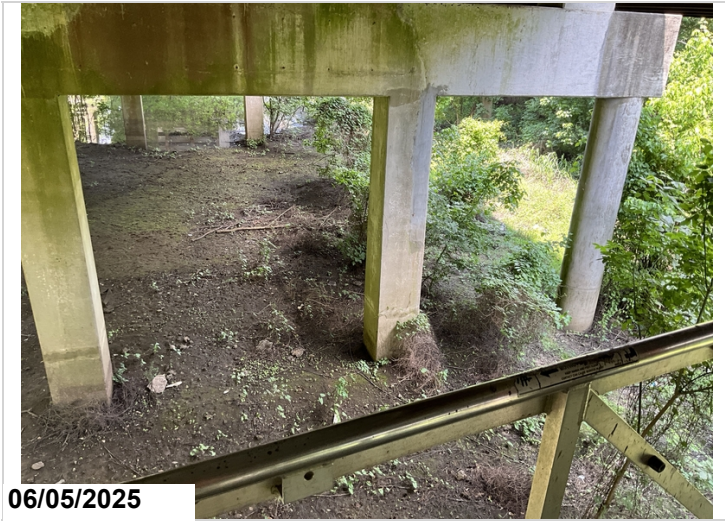
Bent 10, Column 2: Cracks and delaminations.

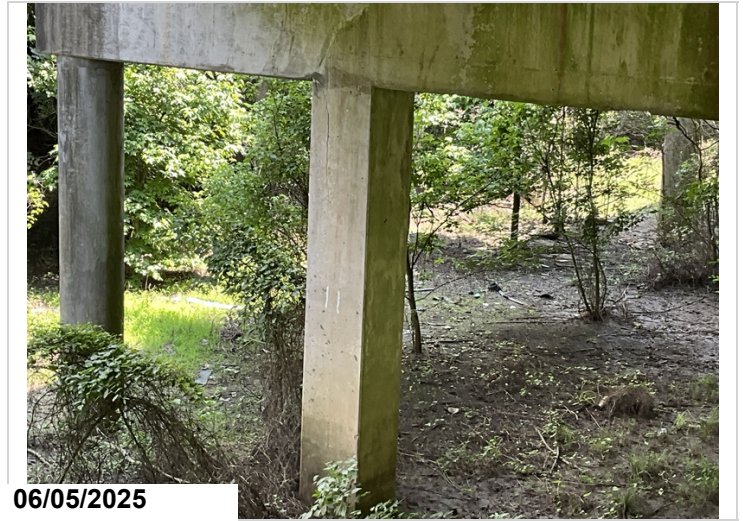
Bent 11, Column 2: Cracks and delaminations.

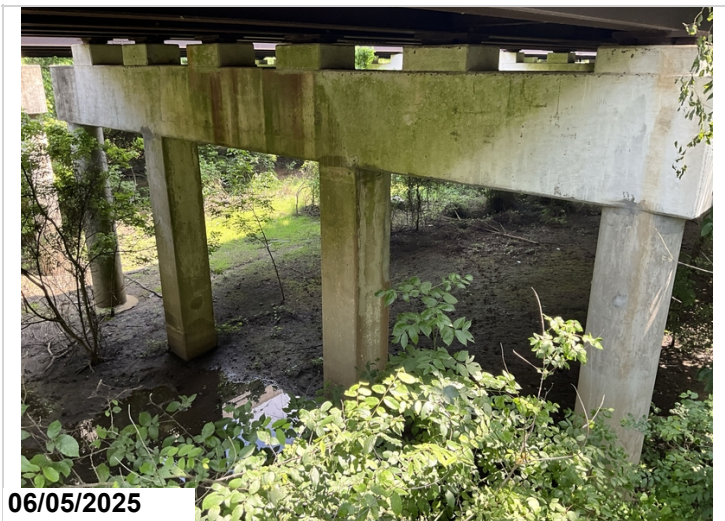
Bent 9, Column 3: Cracks and delaminations.

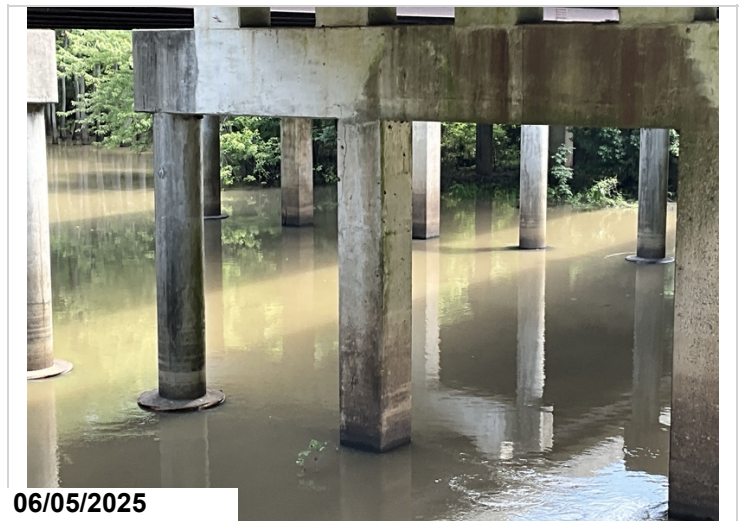
Bent 6, Column 2: Cracks and delaminations.

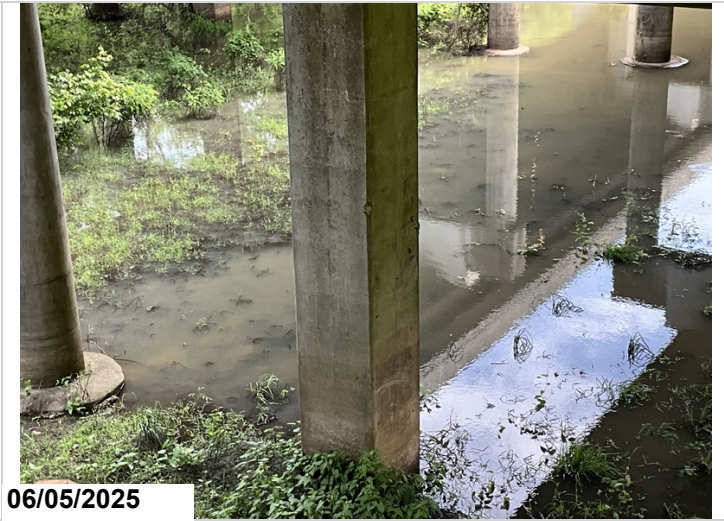
Bent 3, Column 2: Cracks and delaminations.

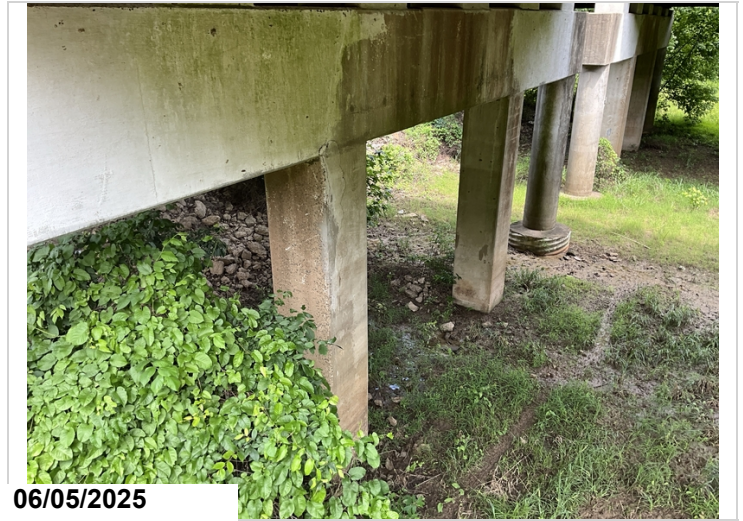
Bent 2, Column 3: Cracks and delaminations.

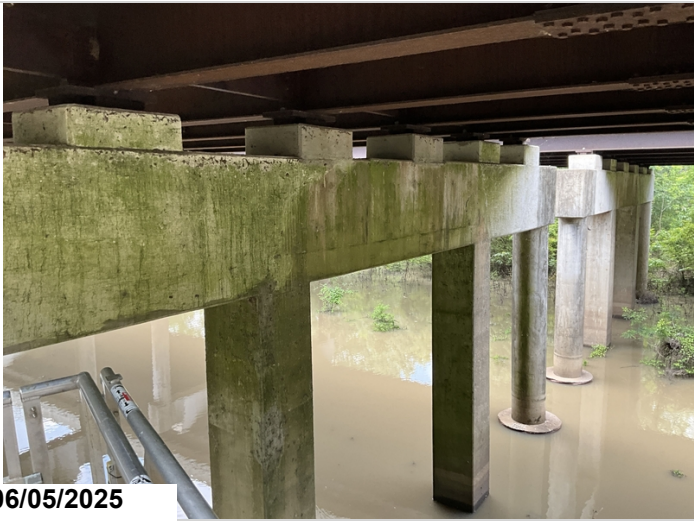
Cap, Bent 19, Ahead, Above Column 2: 1' cracks with delamination.

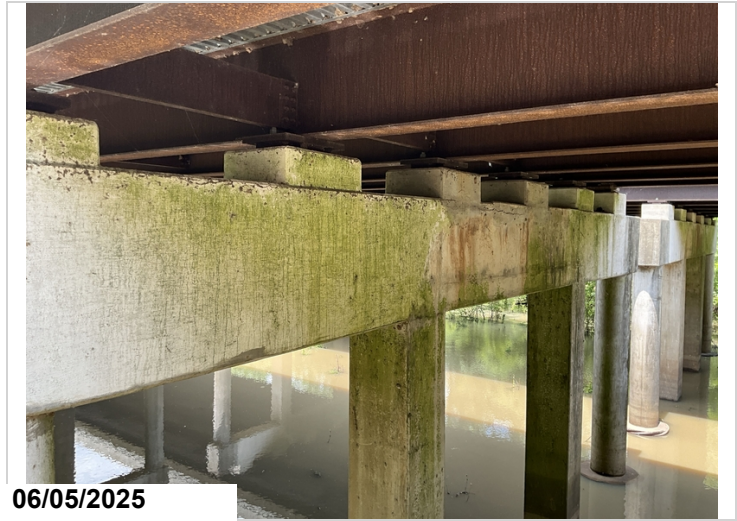
Cap, Bent 18, Ahead, Top, Between Girders 3 & 4: 4' cracks with delamination, and a 5' long crack.

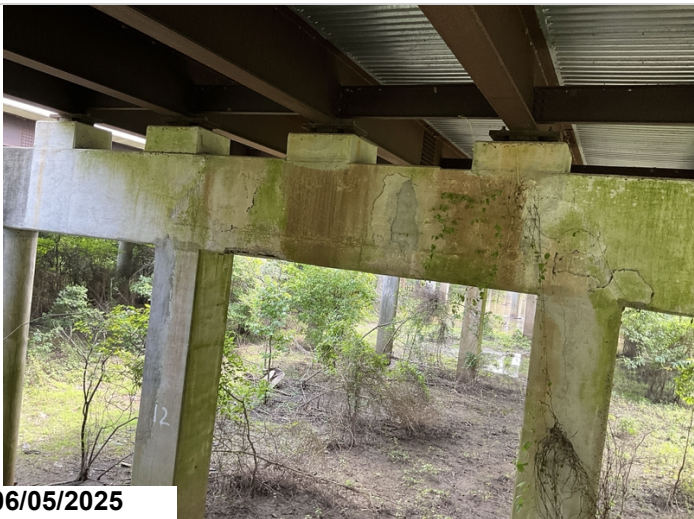
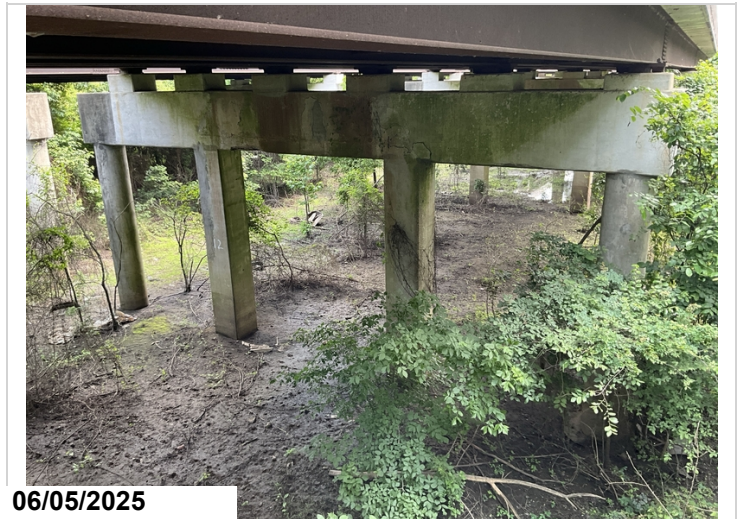
Cap, Bent 12, Bottom, Between Columns 2 & 3: 2' Cracks with delaminations.

Cap, Bent 12, Back, Between Columns 2 & 3: Three 3' cracks with delaminations.

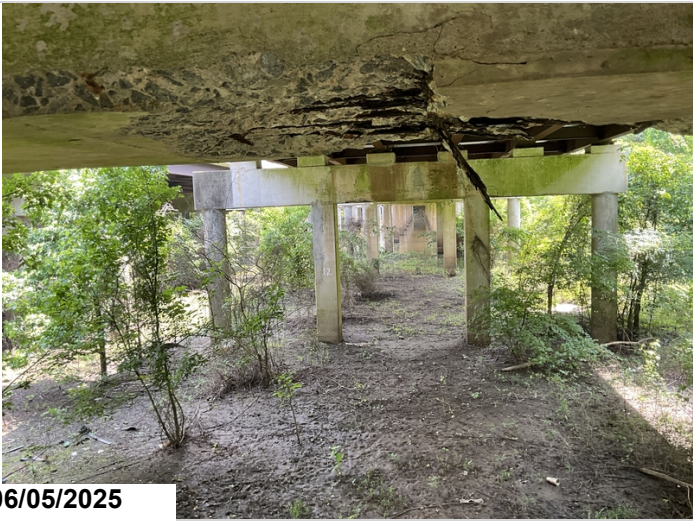
Cap, Bent 11, Bottom, Between Columns 2 & 3: 5' of spalls exposed reinforcing steel with moderate to heavy section loss.

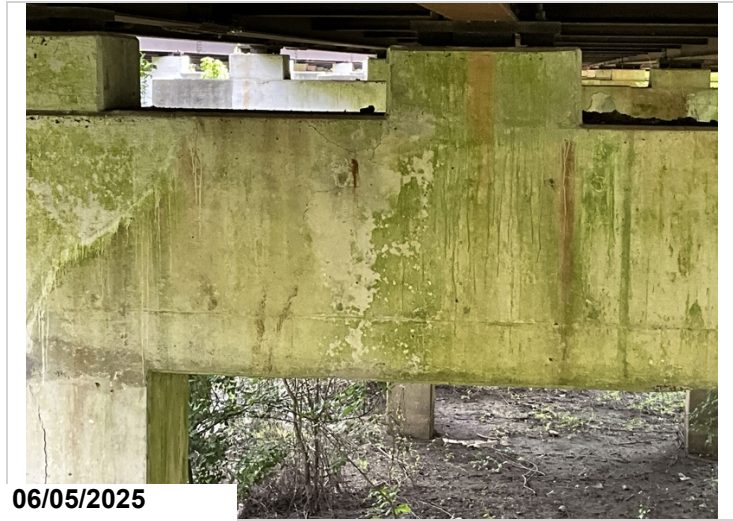
Cap, Bent 11, Back, Under & To Left Of Girder 3: 3' cracks with delaminations.

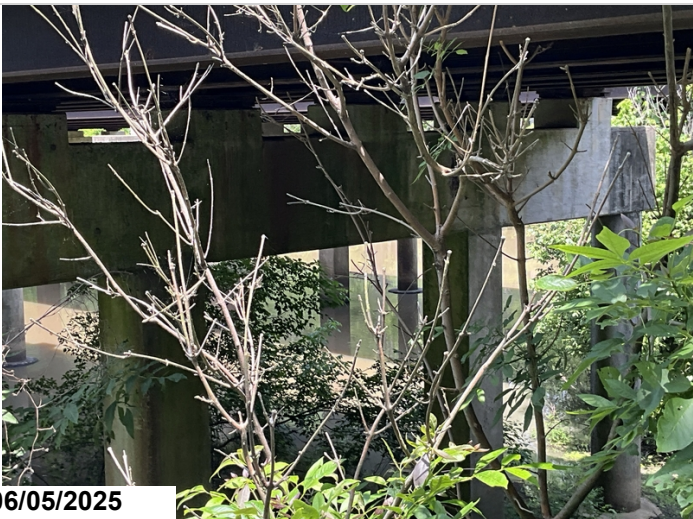
Cap, Bent 8, Ahead, Column 2: 1' spall with exposed reinforcing steel, and a 1' cracks with delaminations.

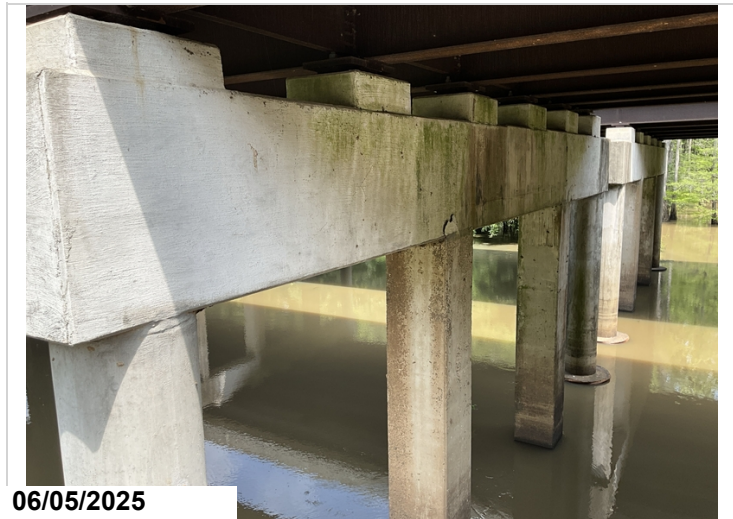
Cap, Bent 6, Ahead, Above Columns 2 & 3: 1' cracks with delaminations each location.

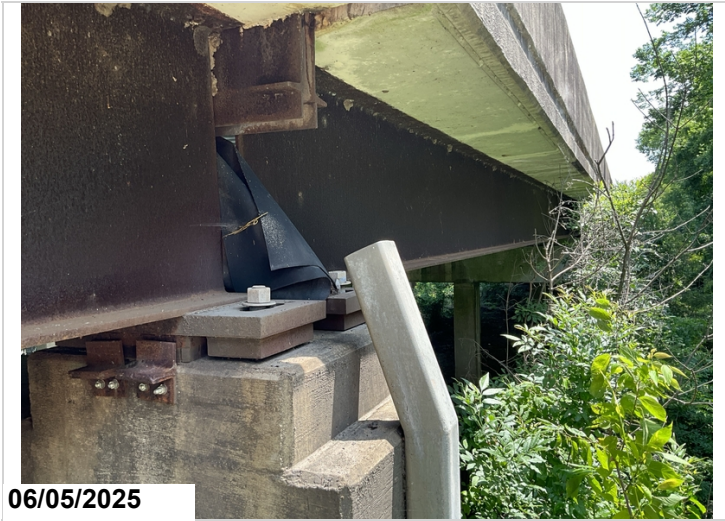
Joint Trough, Bent 8, Right: Last 3' failed.

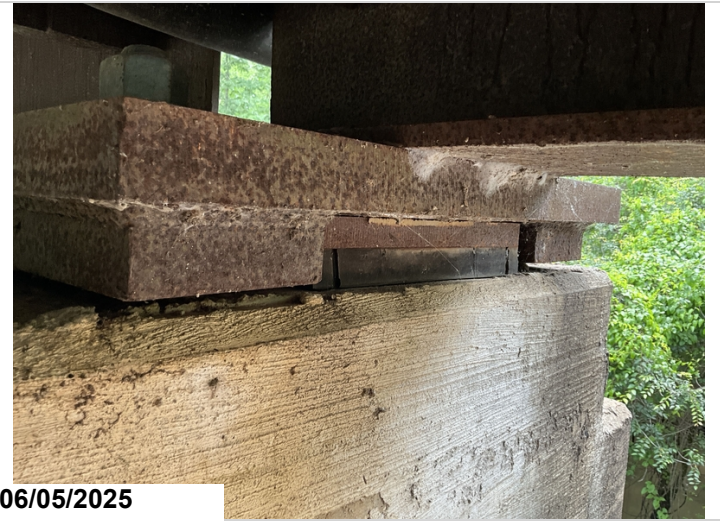
Span 14, Bent 15, Bearing 4: Bearing has twisted and moved back but still under girder plate.

Span 15, Bent 16, Bearing 6: Bearing has twisted and moved back but still under girder plate.

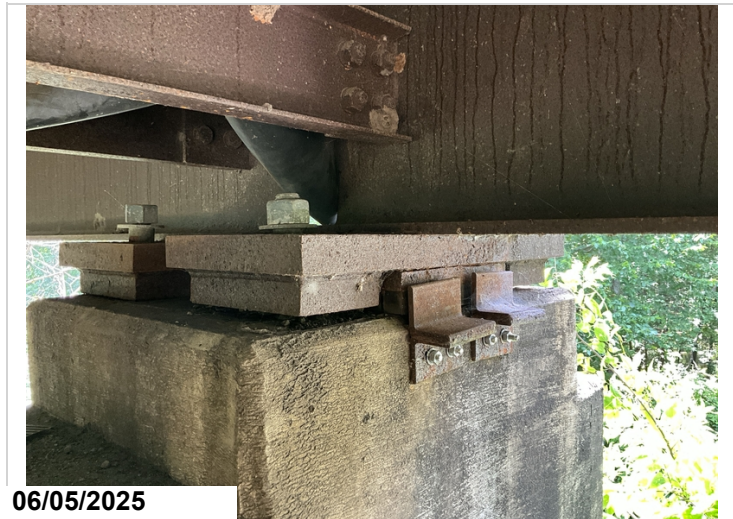
Span 7, Bent 8, Bearing 6: Bearing pad has been repositioned and a restrainer added.

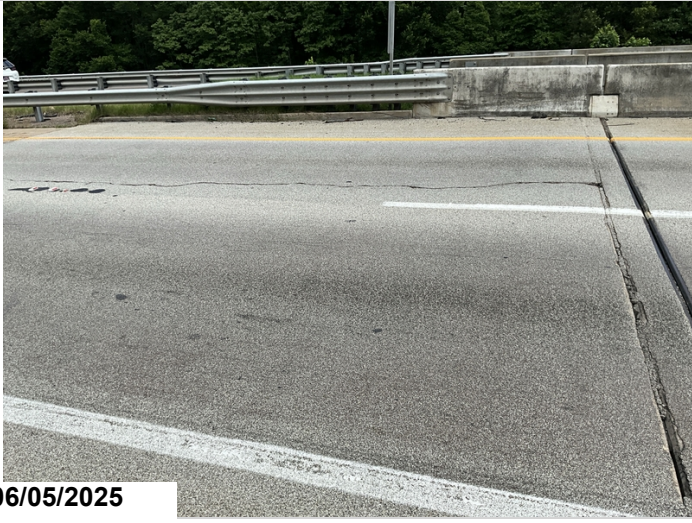
Abutment 1, Approach Slab, Left Lane: Full length longitudinal crack reflecting through overlay.

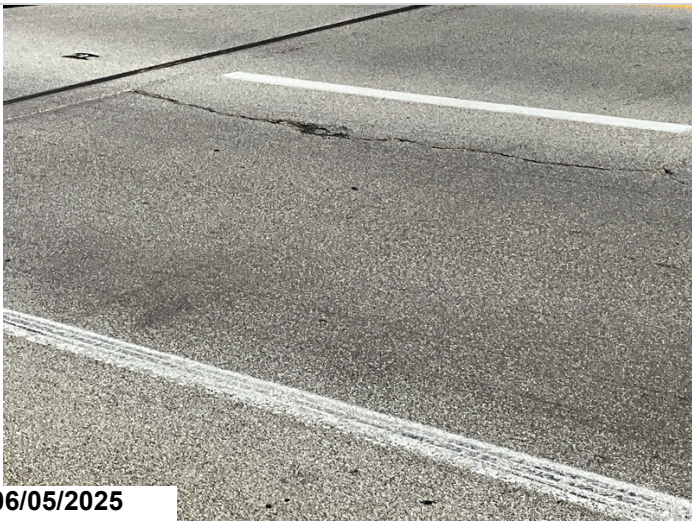
Abutment 2, Approach Slab: Several cracks reflecting through the epoxy coating.

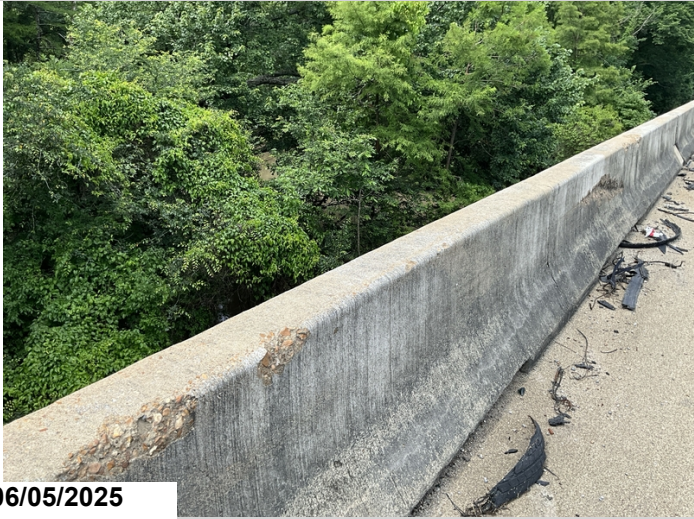
Span 18, Bridge Rail, Right: 4' gouging due to collision damage.

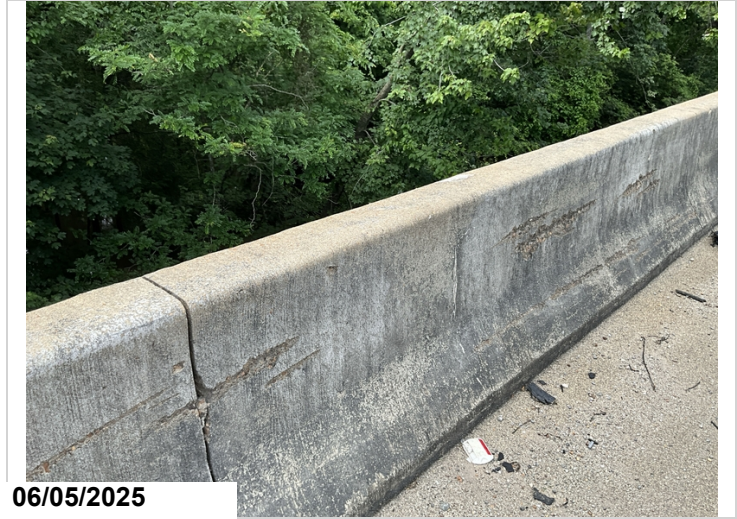
Span 16, Bridge Rail, Right: 10' long area of impact damage.

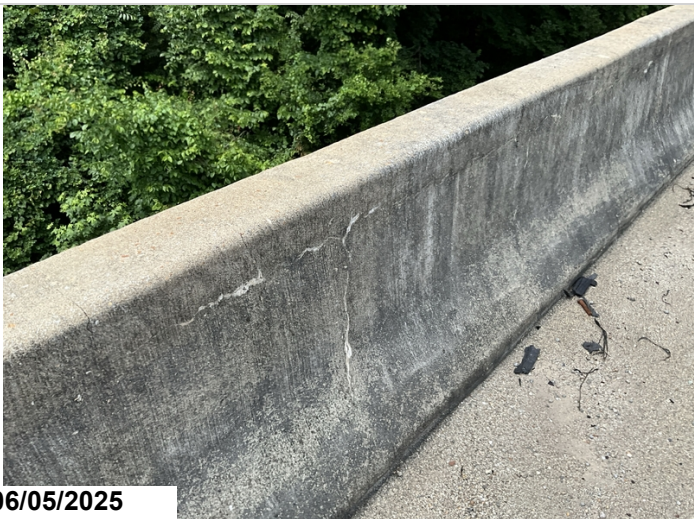
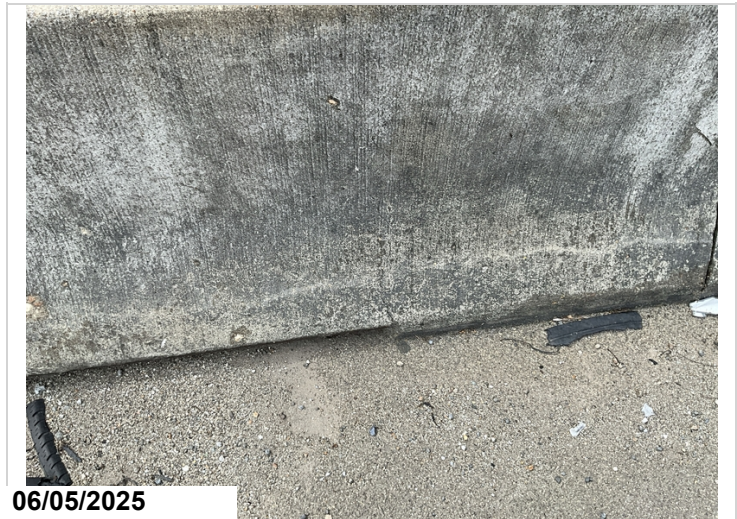
Bridge Rails, Full Length: Vertical cracks spaced 2' apart half with efflorescence and one longitudinal crack full length 3" down from top.

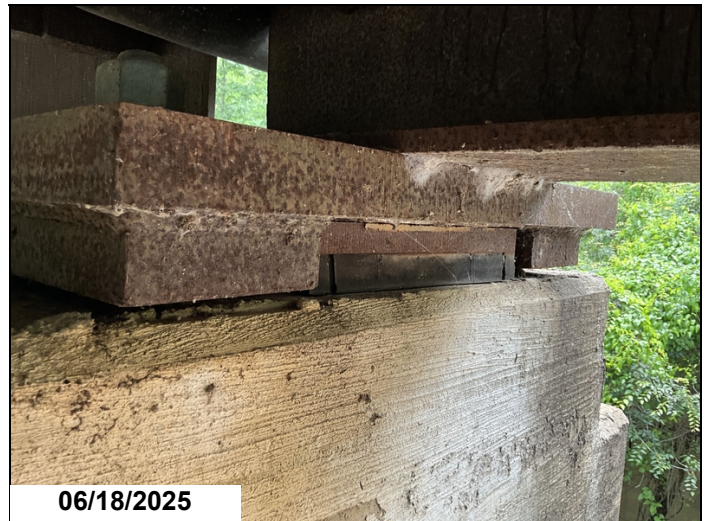
Span 14, Bent 15, Bearing 4: Bearing has twisted and moved back but still under girder plate.  
Span 15, Bent 16, Bearing 6: Bearing has twisted and moved back but still under girder plate.  
Span 16, Bent 17, Bearing 4: Bearing has twisted and moved back but still under girder plate.

Type of Work: Bearing Repair/Replacement

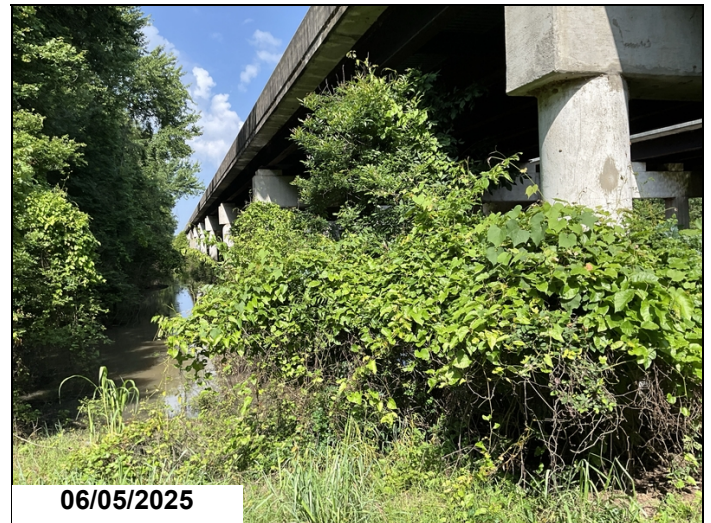
Channel has good alignment and is in fair condition. An over abundance of trees and vegetation growing under and beside bridge restriction channel flow rate.

Typical vegetation

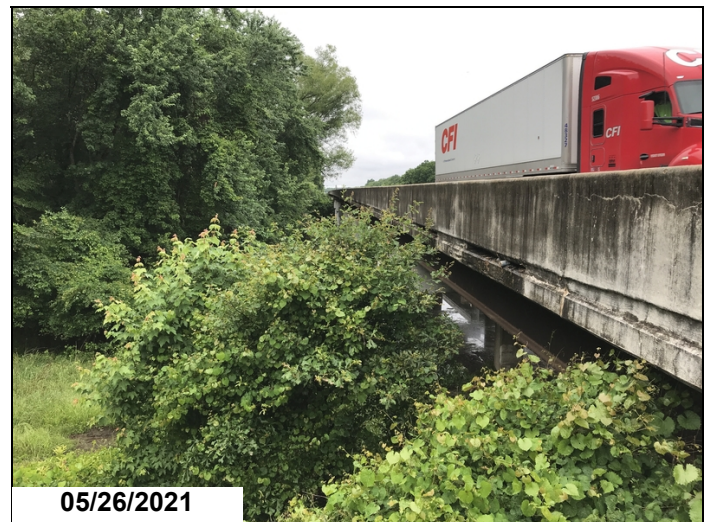
Typical vegetation beside bridge

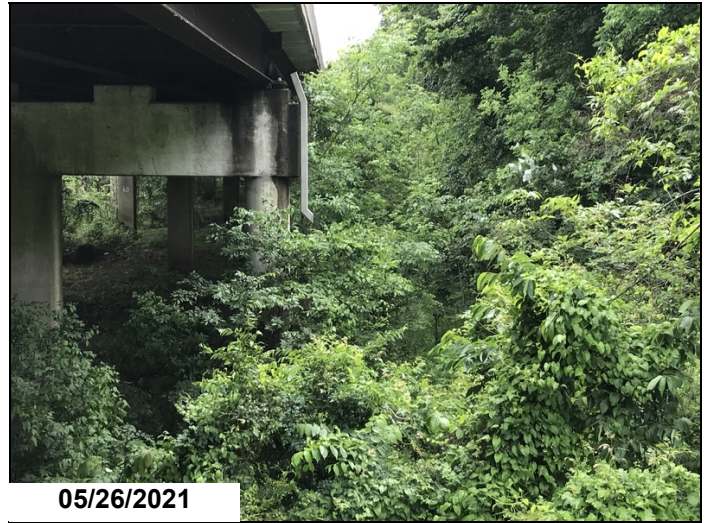
Typical vegetation hindering inspection access.

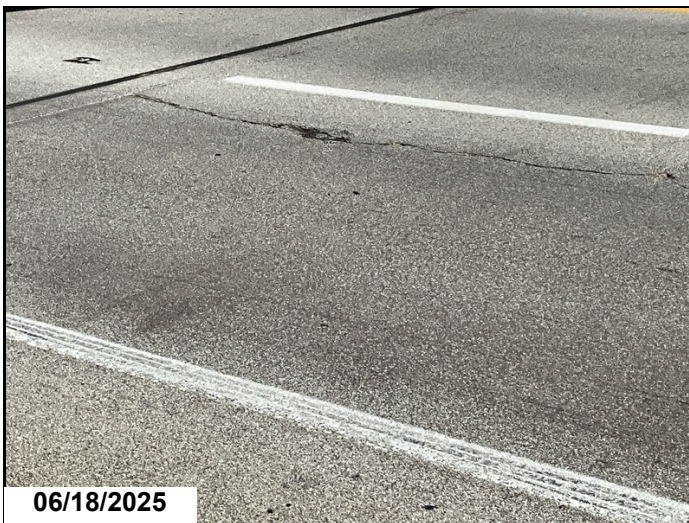
Abutment 2, Approach Slab: Several cracks reflecting through the epoxy coating.

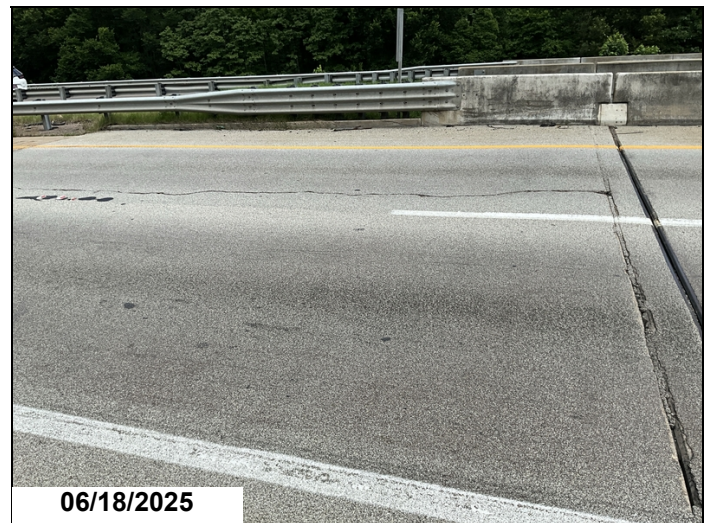
Abutment 1, Approach Slab, Left Lane: Full length longitudinal crack reflecting through overlay.

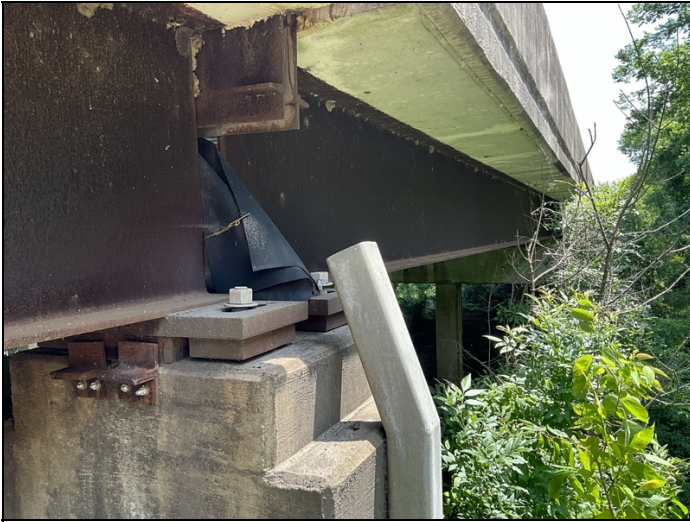
Joint Trough, Bent 8, Right: Last 3' failed.
