Bridge B3727 Inspection Report

Asset #B3727(Routine, Underwater type 2)

I-40EB/Se43/211.61 over Creek

Team Lead: Myron Futrell Inspection Date: 01/13/2025

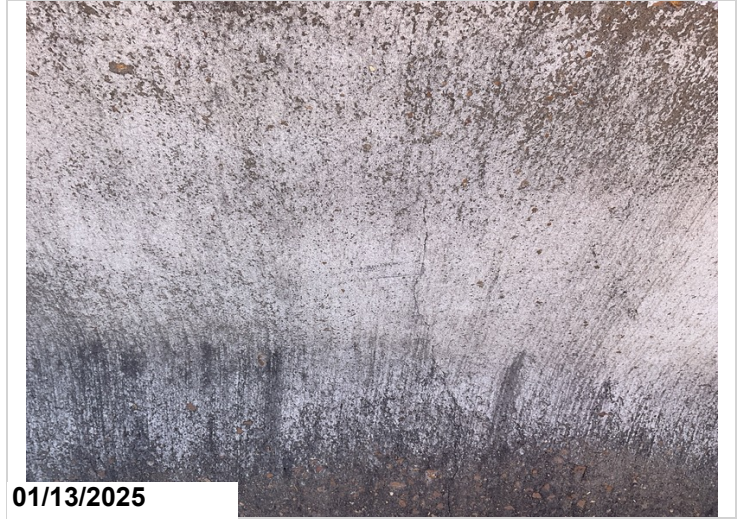
(331) Reinforced concrete bridge rails, scattered throughout: longitudinal and vertical cracking, some with light efflorescence. Cracking 40LF CS2, Efflorescence 40LF CS2

Typical vertical cracking in bridge rail

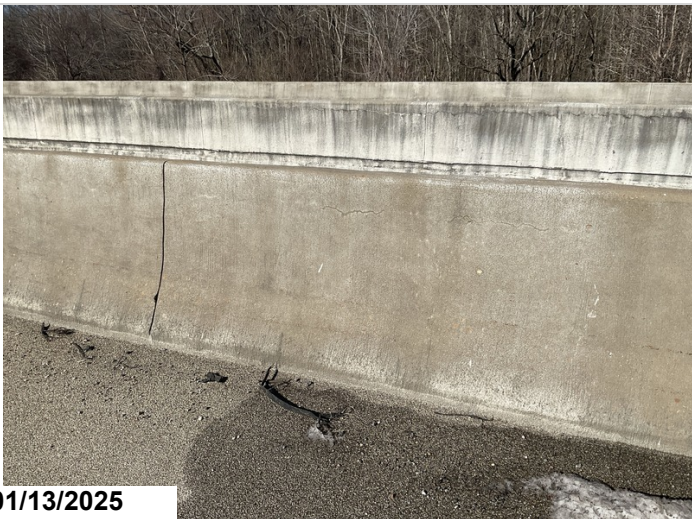
Cracks and efflorescence in bridge rails.

Reinforced concrete bridge rail: typical longitudinal cracking with light efflorescence.

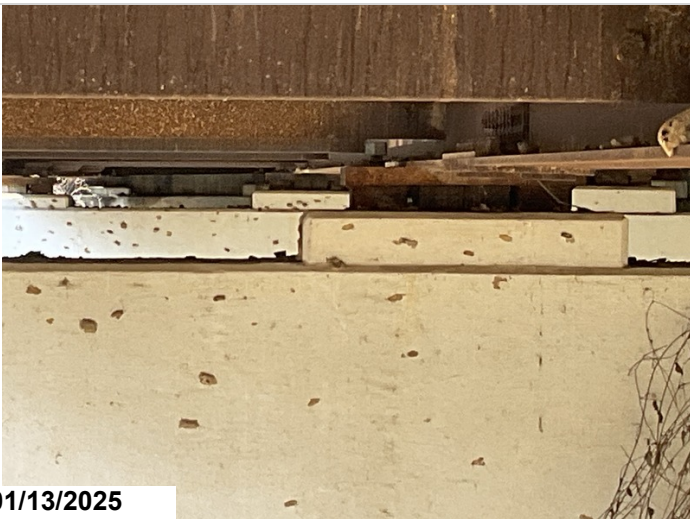
(310) Bent 1 bearing 2: crack in weld to bottom flange Bent 3, girder 5, right anchor bolt: nut backed off. Connection 1EA CS2							
321	Reinforced Concrete Approach Slab	SF	1757	1757	0	0	0
521	Concrete Protective Coating	SF	1757	1757	0	0	0

Bent 3, girder 5, right anchor bolt: nut backed off.

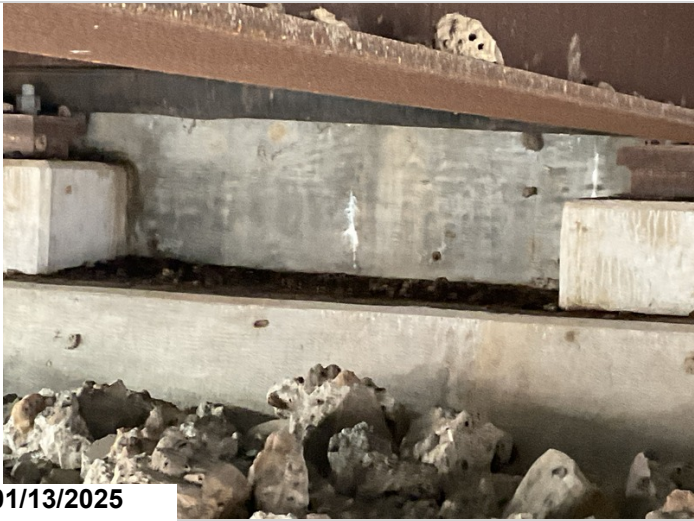
Reinforced concrete substructure is in overall good condition. Pier caps and columns have no noted deficiencies, abutment backwalls have a few vertical cracks with light efflorescence.

Lowered Substructure from 8 to 7 due to cracks with efflorescence in back walls.

(205) No noted deficiencies.							
215	Reinforced Concrete Abutment	LF	120	112	8	0	0
1120	Efflorescence/Rust Staining	LF	8	0	8	0	0
(215) Reinforced concrete abutments, backwalls: several vertical hairline cracks with light efflorescence. Efflorescence 85LF CS2							
234	Reinforced Concrete Pier Cap	LF	82	82	0	0	0

Typical vertical hairline crack in abutment back wall with light efflorescence

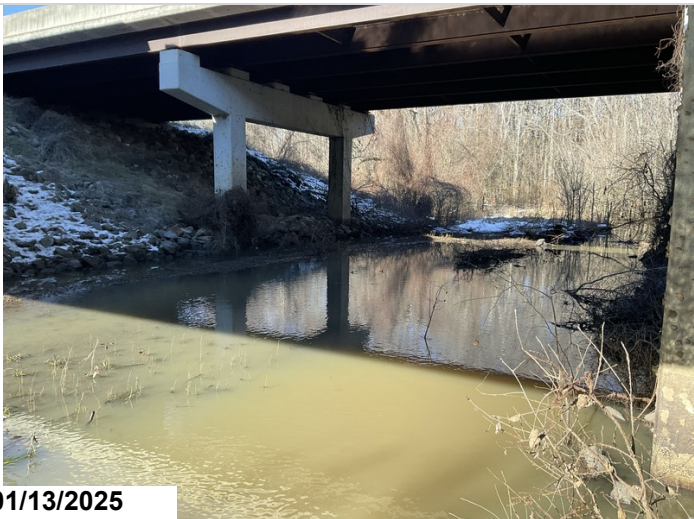
Channel is in overall fair condition. Slopes have minor erosion, trees and brush growing in channel restrict channel slightly.

12/12/2022 lowered channel from 8 to 5 due to large amounts of debris restrictions.

Channel, left side

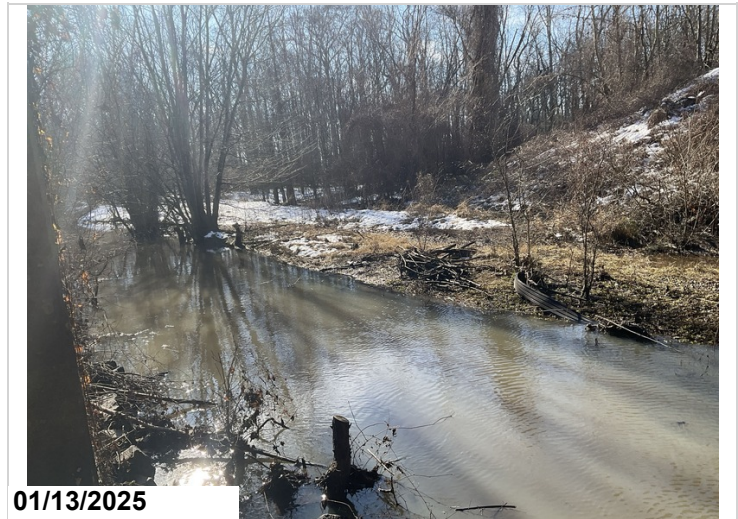
Channel, right side

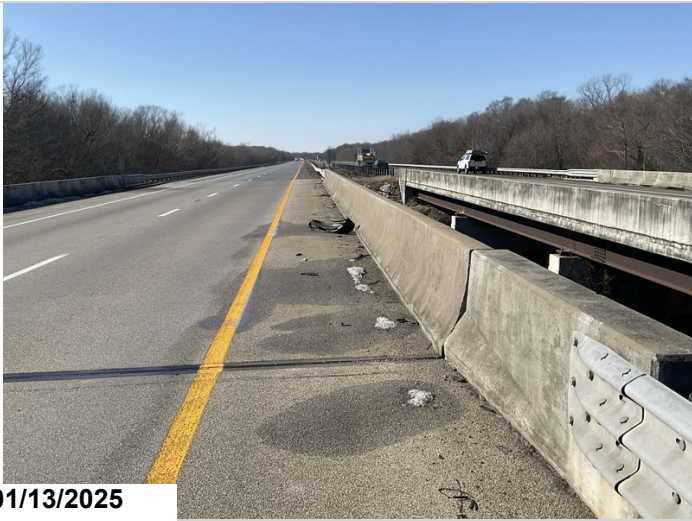
Deck has dirt and debris in gutters.

Dirt and debris in gutters

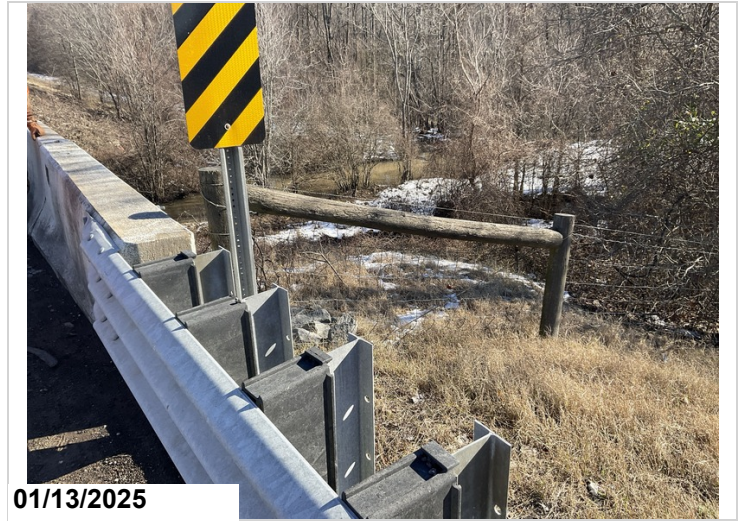
No log mile signs in place

No log mile sign in place

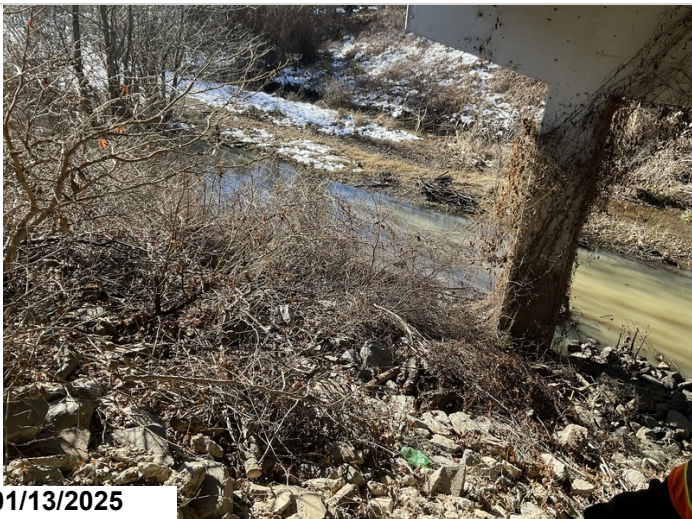
Trees and vegetation growing beside and onto bridge.

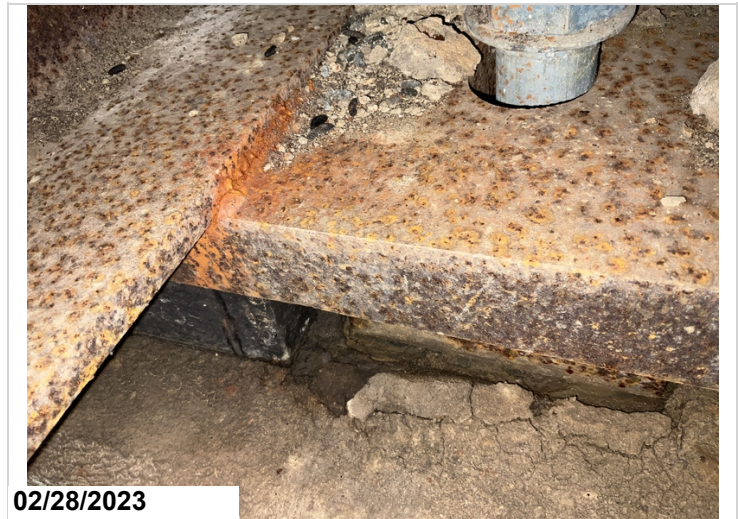
Bent 1 bearing 2, crack in weld to bottom flange
All bearings in good condition, minor surface rust.

Bent 1 bearing 2, crack in weld to bottom flange.

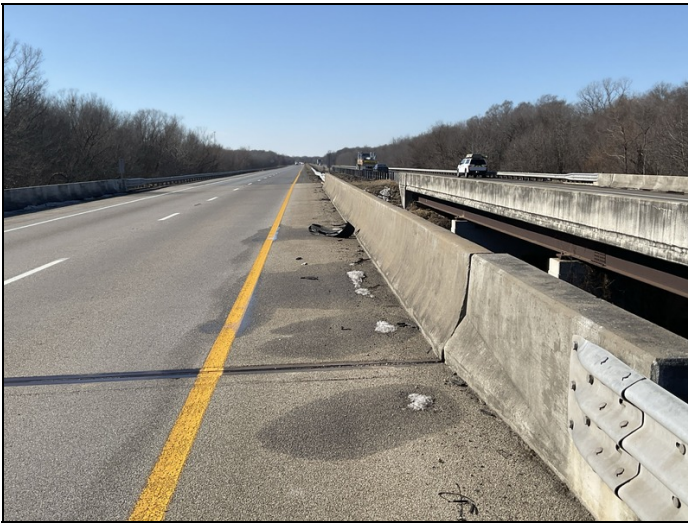
Deck has dirt and debris in gutters.

Dirt and debris in gutters

A-55 - Deck Washing Needed (Yes)

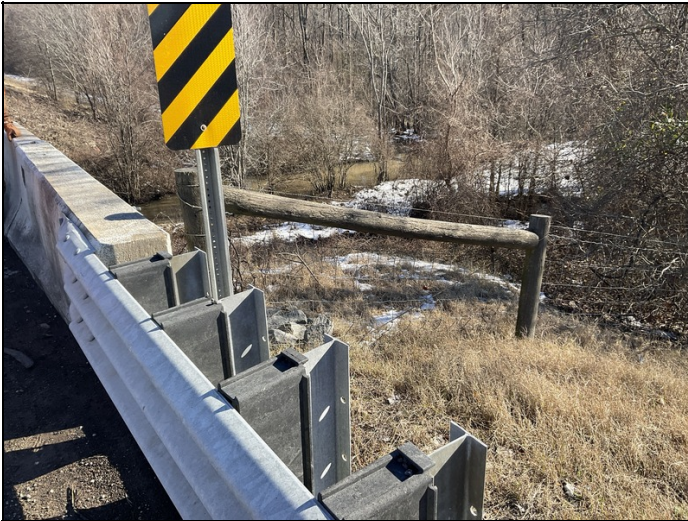
No log mile signs in place

No log mile sign in place

A-63 - Missing/Incorrect Log Mile Signage (Yes)

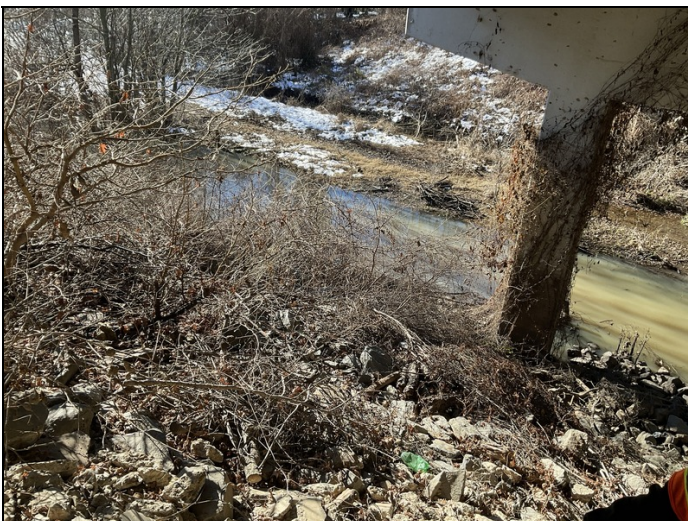
Trees and vegetation growing beside and onto bridge.

A-64 - Vegetation Removal Requested (Yes)
