Bridge B3731 Inspection Report

National Bridge Inventory Data Sheet

Team Lead: Jonathan Gonzalez, Inspection Date: 09/05/2025

Asset #B3731 (Record Change)
I-40EB/Se43/215.99 over Cr-179/Z-D/L-1.73

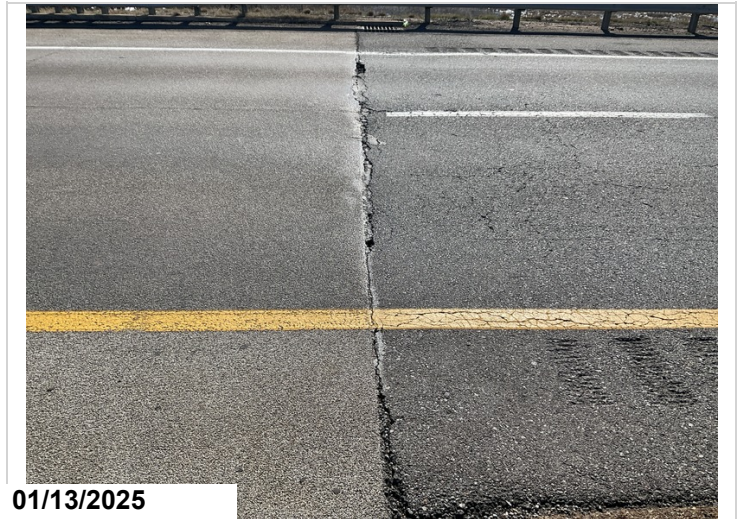
Abutment 1, approach roadway: pavement raveling at joint with approach slab.

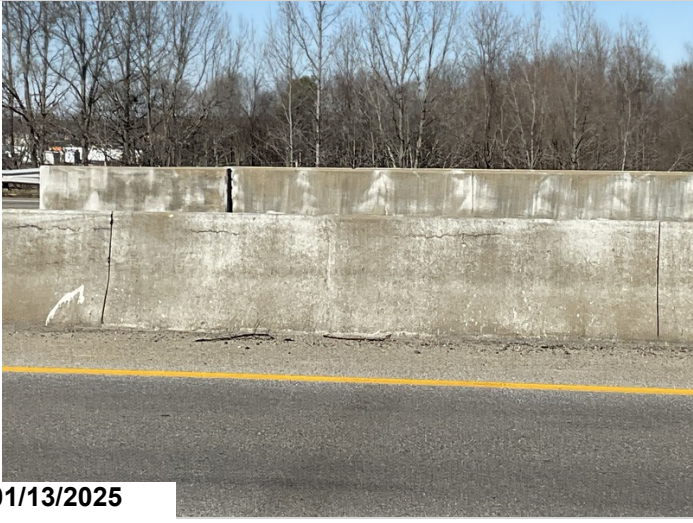
Reinforced concrete bridge rail has vertical cracking, some with light efflorescence scattered throughout.

Typical longitudinal cracking in left bridge rail.

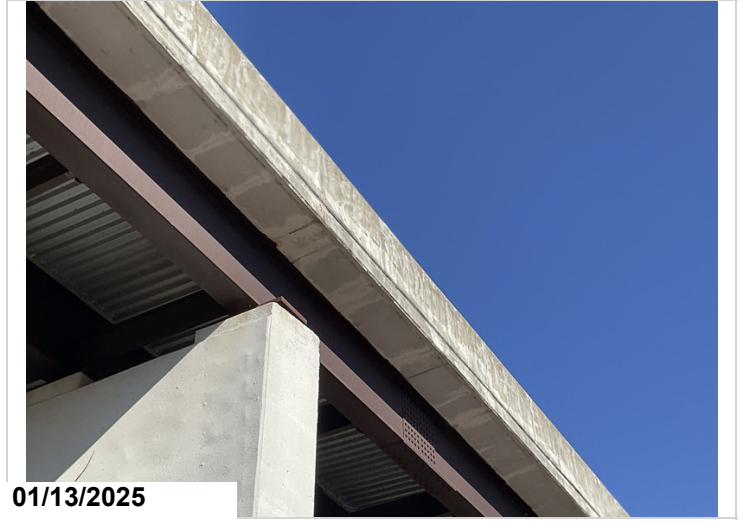
Deck is cast in place concrete with an epoxy overlay. The deck in span 2 center deck has 1' area of epoxy overlay missing with shallow spall, and the undersurface of overhangs have cracks with efflorescence.

Typical cracking in overhang.

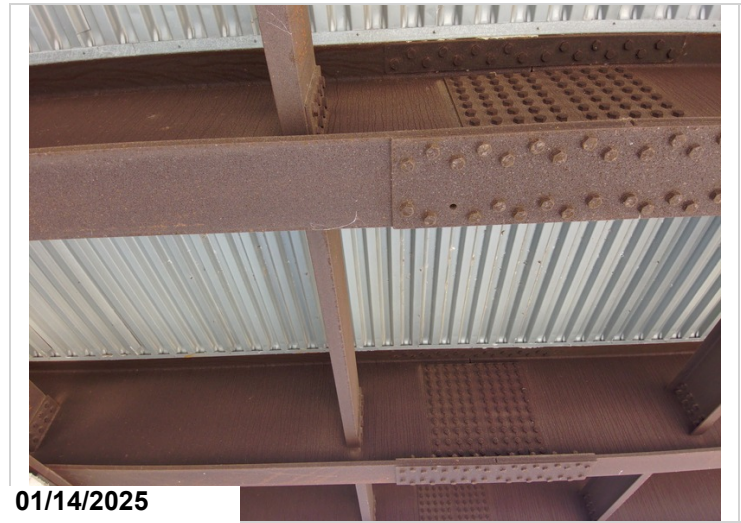
Superstructure is steel A588 girders. Girders are in good condition with span 2 girder 4 at first bottom splice plate there is one bolt missing.

01/04/2023 lowered superstructure from 9 to 8 due to span 2 girder 4 at first bottom splice plate there is one bolt missing.

Span 2, girder 4, first bottom splice plate: one bolt missing.

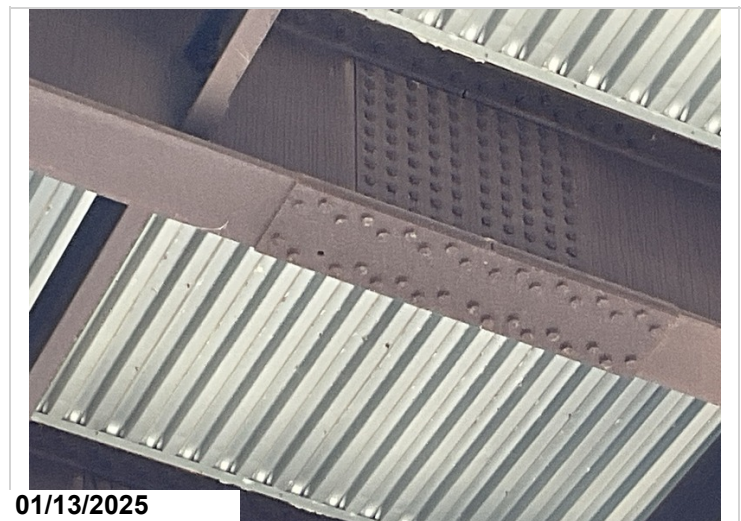
Span 2, girder 4, first splice: missing bolt in bottom flange.

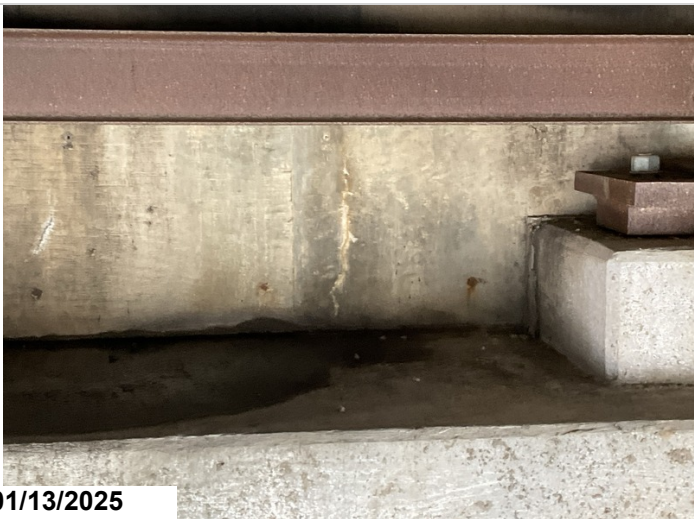
Reinforced concrete substructure is in overall good condition with the only thing noted on pier walls is graffiti, abutment back walls have a few hairline cracks with light efflorescence.

1/14/2025-Lowered substructure from 8 to 7 due to minor cracking in abutment backwalls with light efflorescence.

Typical vertical crack in abutment back wall with light efflorescence.

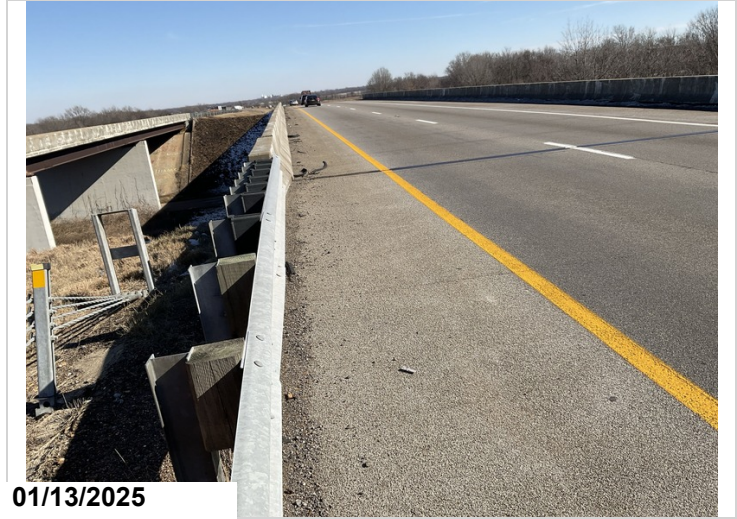
Deck has small amount of dirt and debris in gutters.

Dirt and debris in gutters.

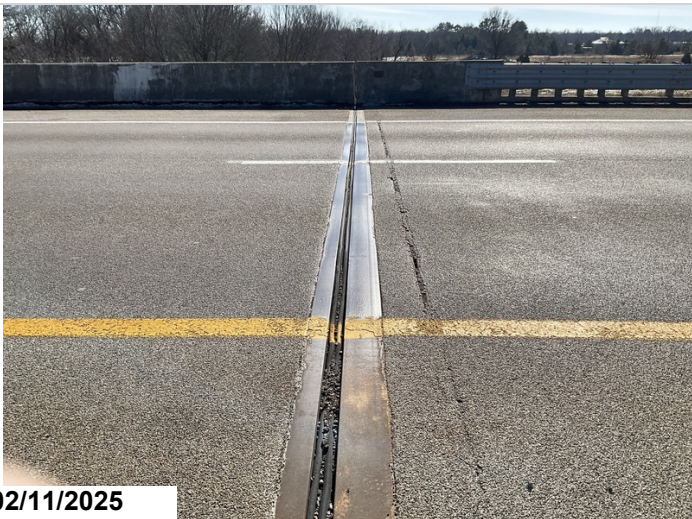
Moderate debris impaction in joints.

Moderate debris impact in joints along shoulders.

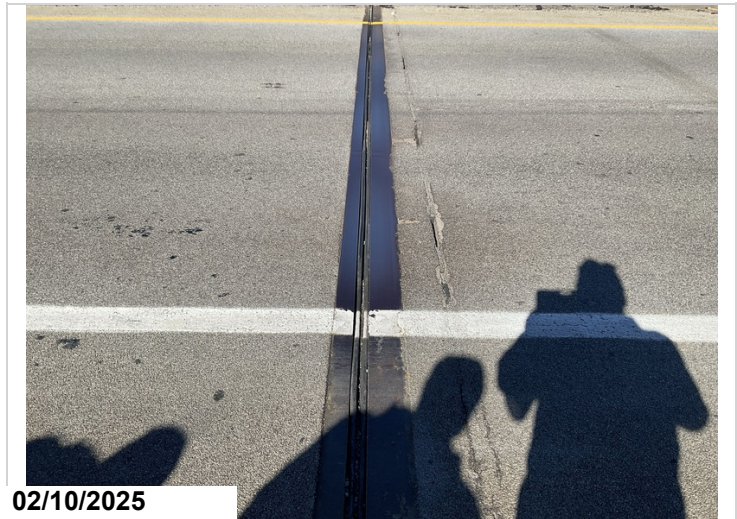
Abutment 2, joint seal: 10' of lost adhesion with minor sagging.

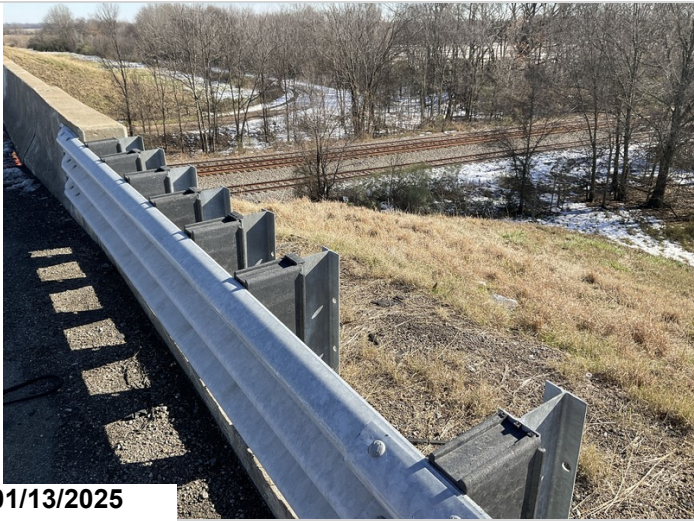
No log mile signs in place.

No log mile sign in place.

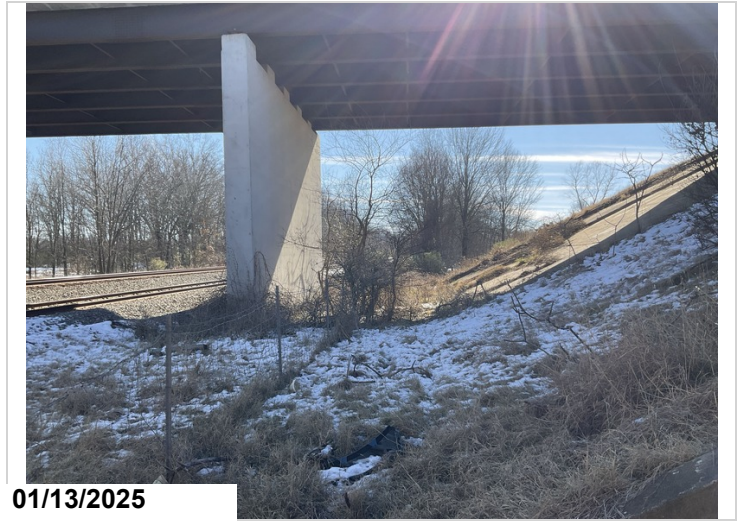
Small trees and vegetation growing under bridge and in slope pavement joints.

Trees and vegetation growing under bridge.

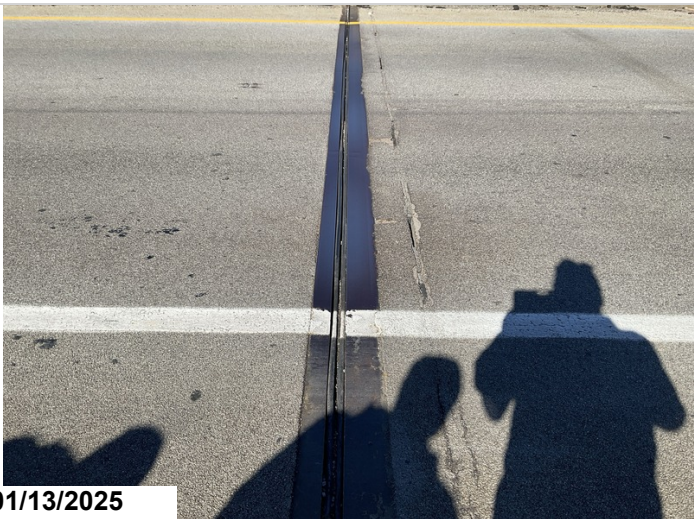
Abutment 2, joint seal: 10' of lost adhesion with minor sagging.

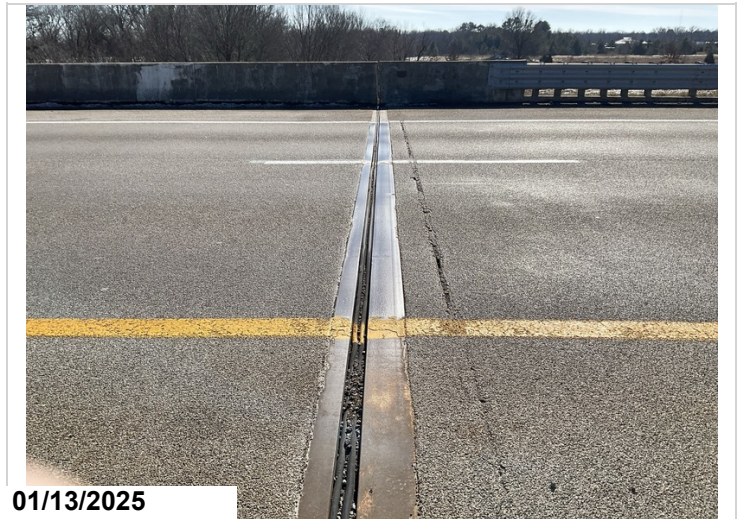
Abutment 1, compression joint seal: lost adhesion and sagging 1" for 10' in center.
Abutment 2, compression joint seal: lost adhesion with 15' total of sagging up to 1".

Abutment 1, joint seal: 15' lost adhesion and sagging.

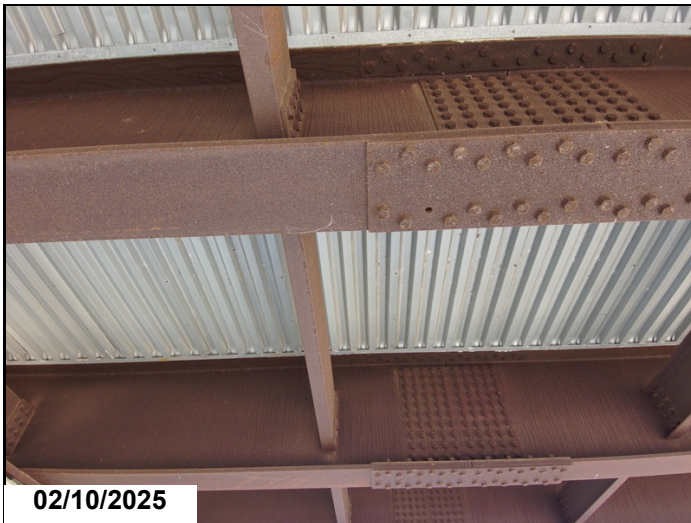
Span 2, girder 4 at first bottom splice plate there is one bolt missing.

Span 2, girder 4, first bottom splice plate: one bolt missing.

Type of Work: Superstructure Repair

Status: Monitor

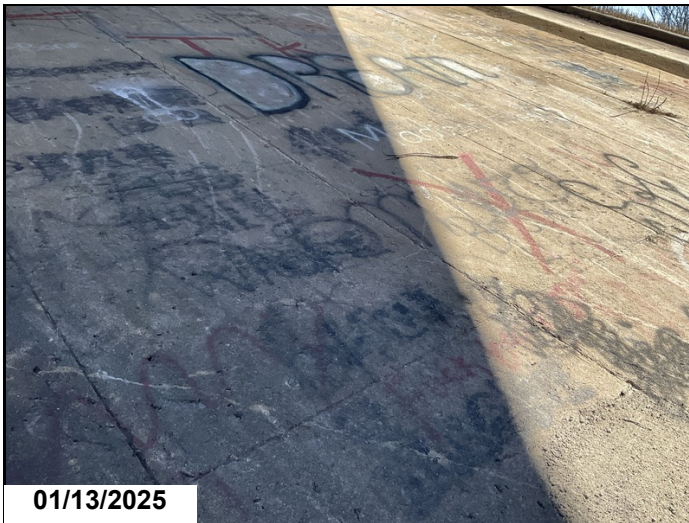
Abutment 2, slope pavement and bent 3 pier wall: graffiti painted on them.

Abutment 2, slope pavement: graffiti.

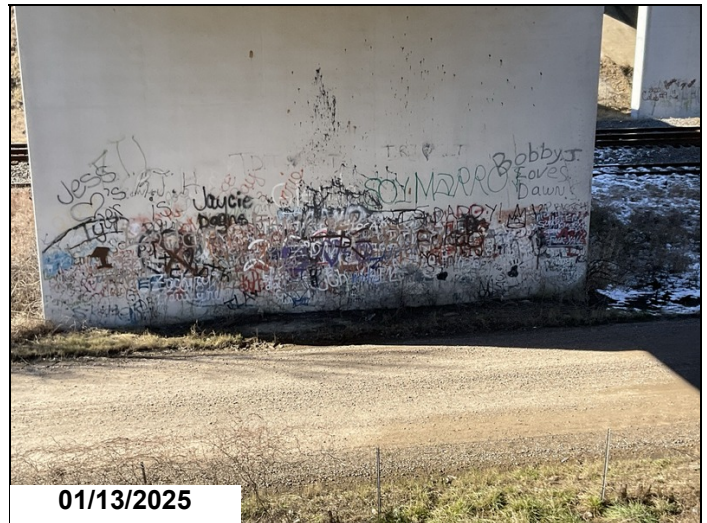
Bent 3, pier wall, ahead face, graffiti.

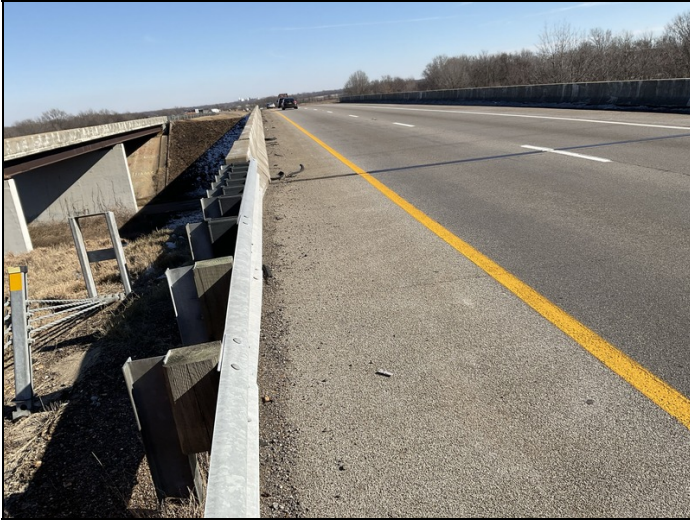
Deck has small amount of dirt and debris in gutters.

Dirt and debris in gutters.

A-55 - Deck Washing Needed (Yes)

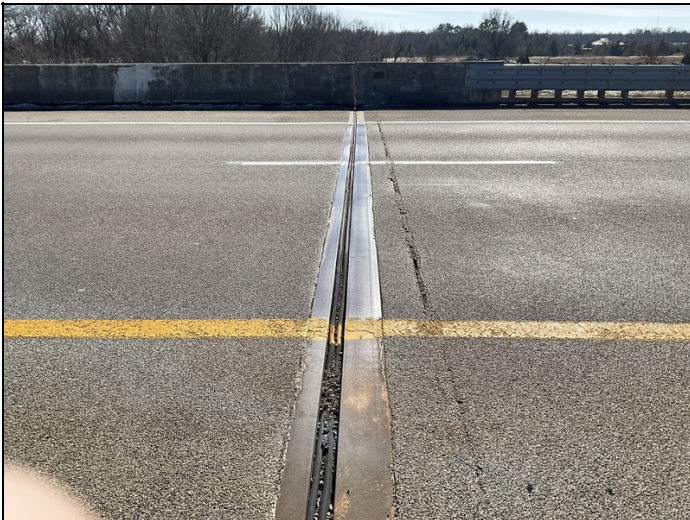
Moderate debris impactation in joints.

Moderate debris impactation in joints along shoulders.

A-56 - Joint Cleaning/Flushing Needed (Yes)

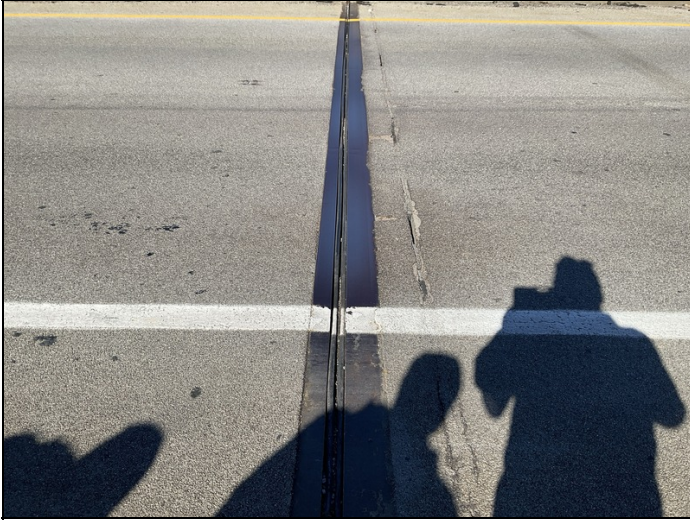
Abutment 1, compression joint seal: lost adhesion and sagging 1" for 10' in center.

Abutment 2, compression joint seal: lost adhesion with 15' total of sagging up to 1".

Abutment 2, joint seal: 10' of lost adhesion with minor sagging.

A-59 - Joint Repair Needed (Yes)

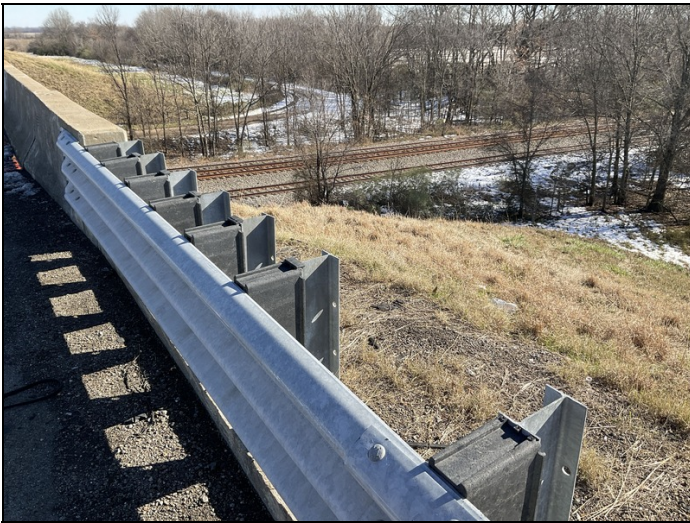
No log mile signs in place.

No log mile sign in place.

A-63 - Missing/Incorrect Log Mile Signage (Yes)

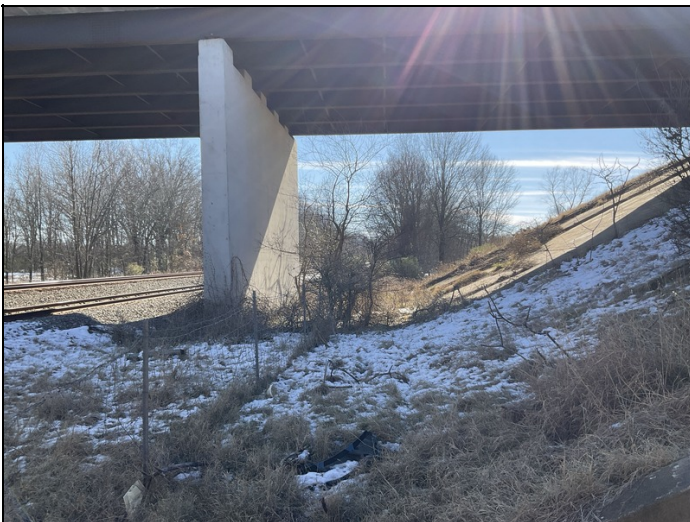
Small trees and vegetation growing under bridge and in slope pavement joints.

Trees and vegetation growing under bridge.

A-64 - Vegetation Removal Requested (Yes)
