Bridge #03211(Routine)

Gillmore/Z-D CR28 over I-55/Sec-11/L-26.74

Team Lead: Drew Melton Inspection Date: July 08, 2020

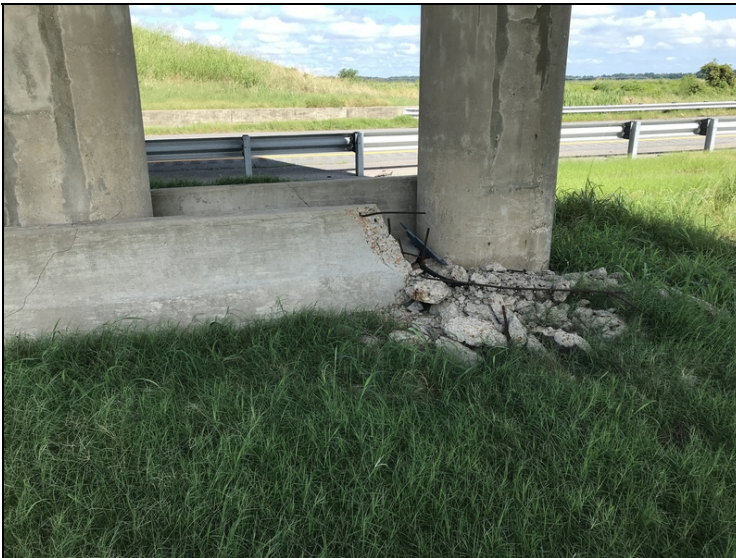
Bent #3 right side pier protection is broken/destroyed left side has cs3 crack.

Bent #3 right side pier protection is broken/destroyed left side has cs3 crack.

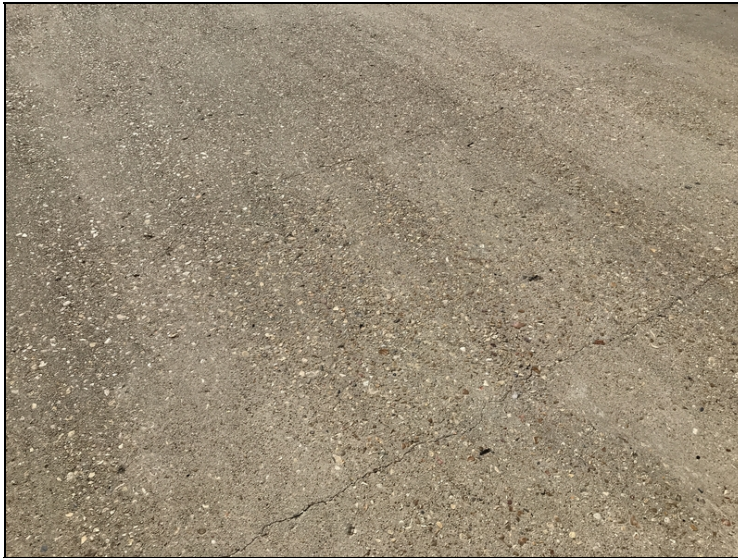
Deck has open transverse cracks spaced one and a half feet apart.
Span #2 deck right lane three quarter span has eight inch shallow spall no exposed rebar.
07/08/2020 Deck cracks are growing bigger and more of them.

Typical deck cracks.

07/08/2020 lowered deck from 7 to 6 due to the number of cs2,cs3 deck cracks.

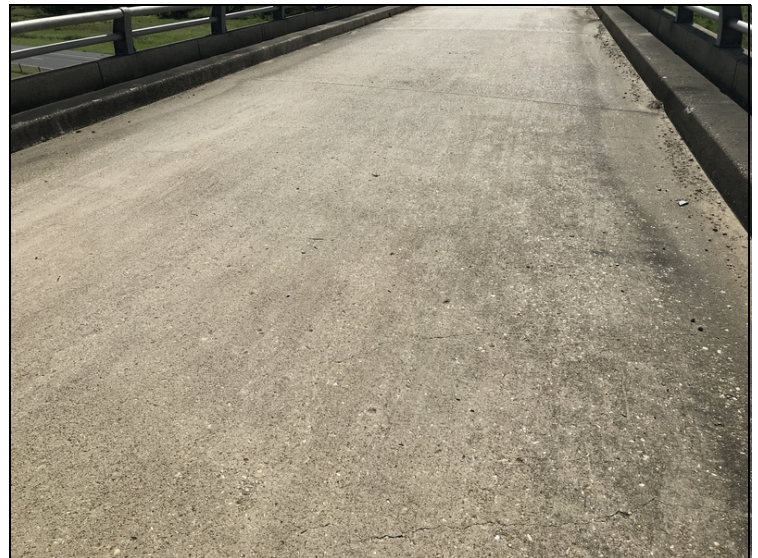
Typical deck

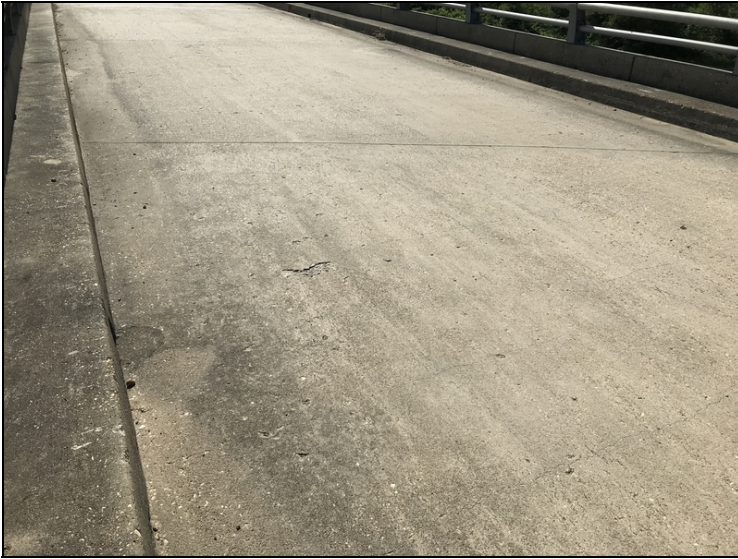
Span #2 deck right lane three quarter span has
eight inch shallow spall no exposed rebar.

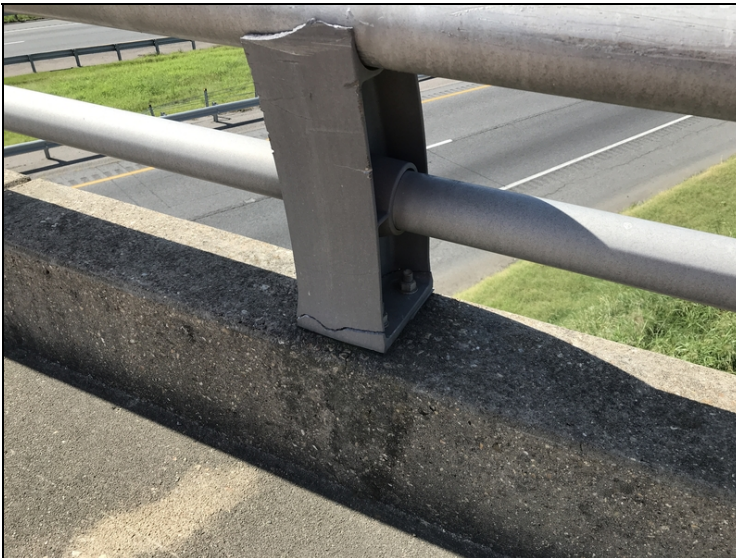
Span #4 left side third metal post is cracked at base.

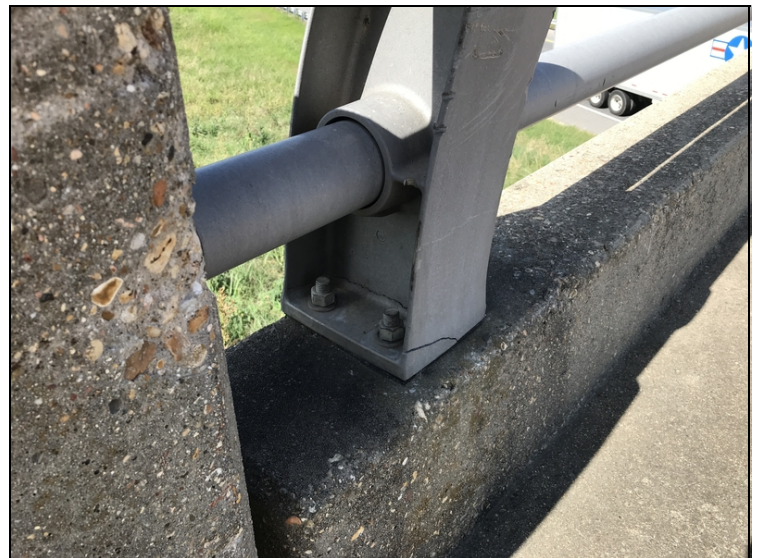
Span #1 left metal first post is cracked at base.

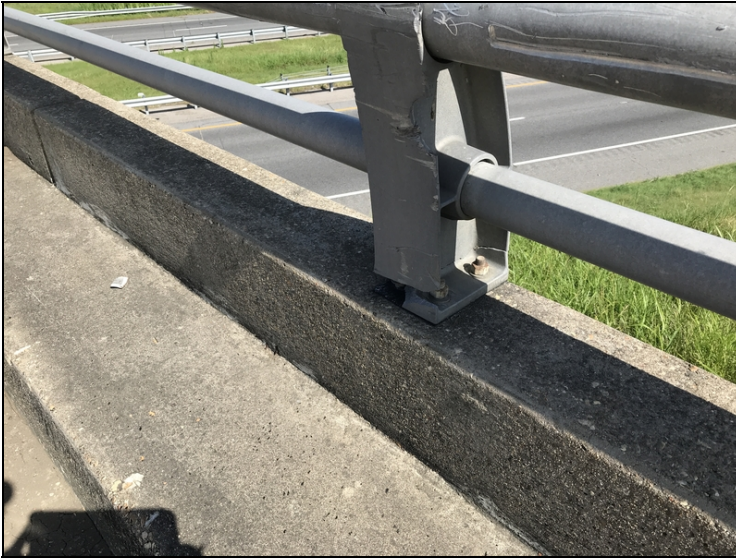
Span #1 right metal second rail post is broken at base.

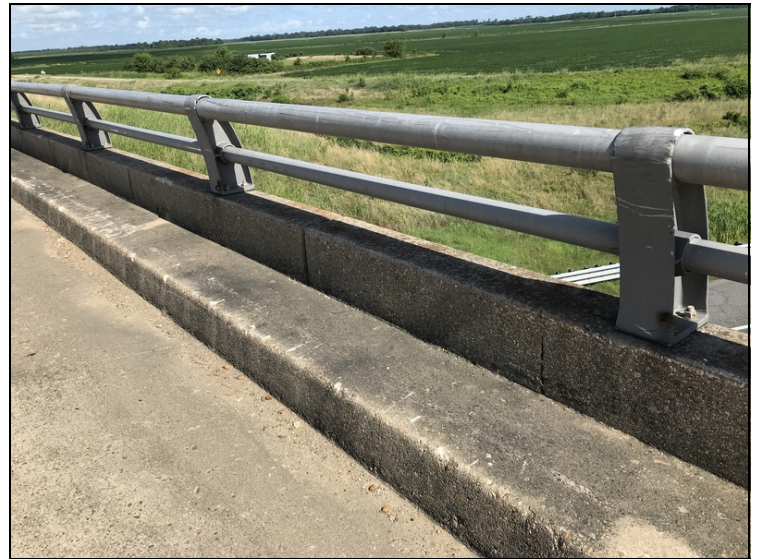
Span #3 right bridge rail metal post #3,4,5 are cracked at base.

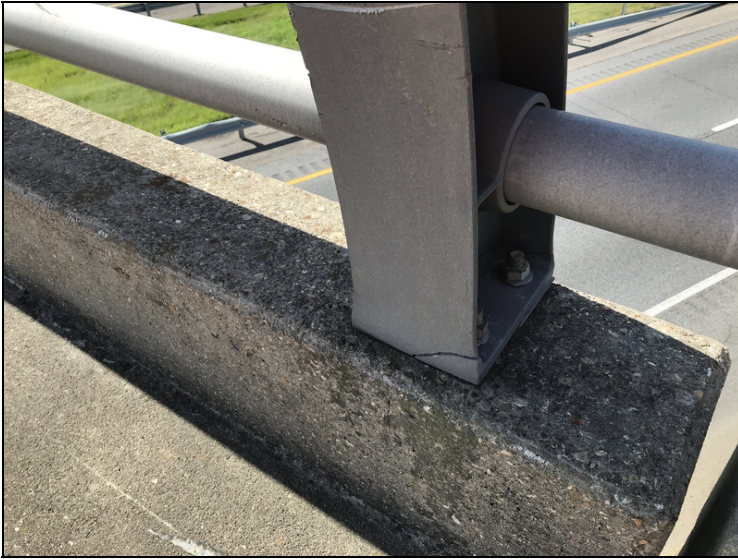
Span #3 left bridge rail ninth metal post is cracked at base.

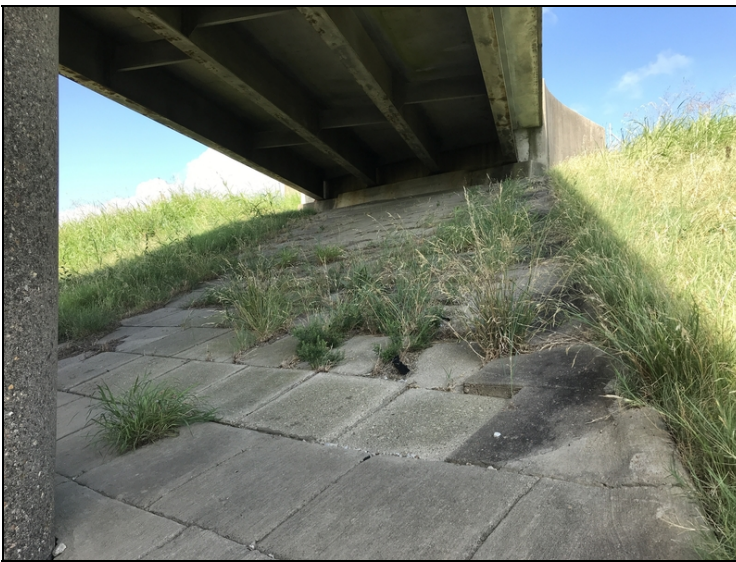
Abutment #2 slope

Vegetation is growing through cracks and onto slope pavement both abutments.

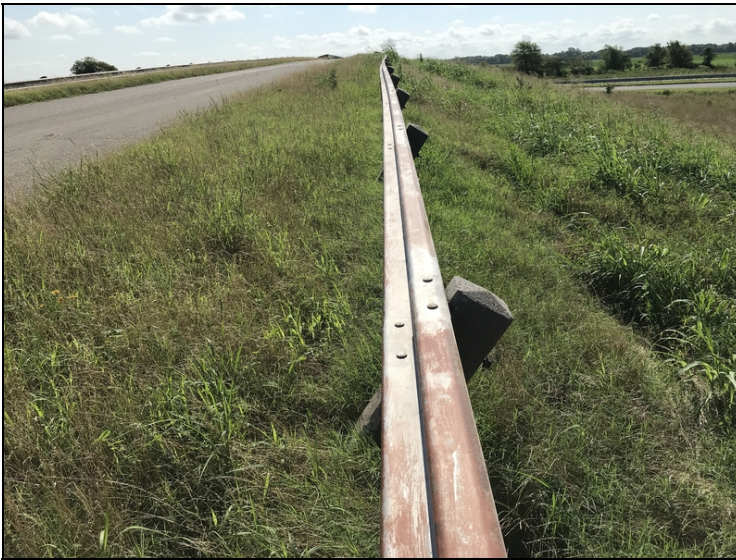
Abutment #2 left approach rail is leaning out.

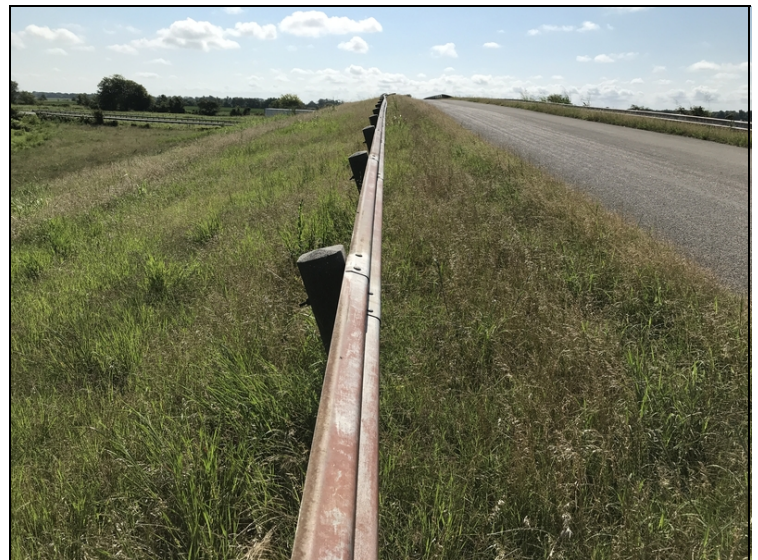
Abutment #2 right approach rail is leaning out.

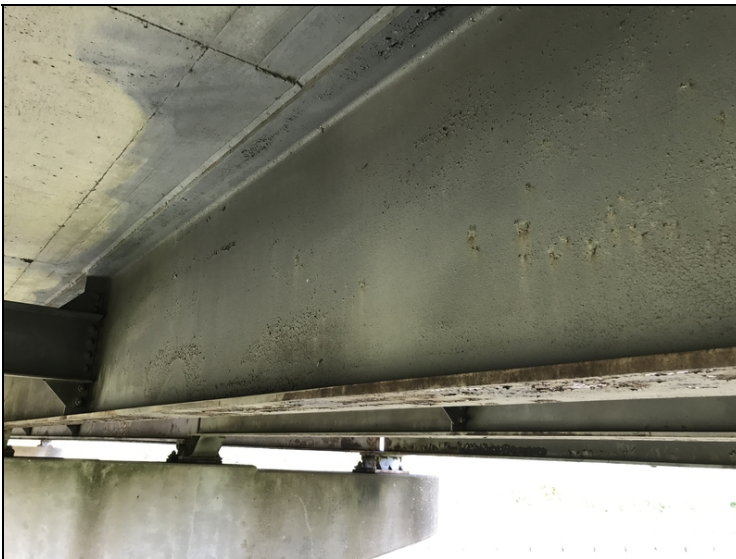
Both outside girders have surface rust entire length 35% bare steel.
Interior girders have surface rust full length with 15% bare steel.
Bottom of bottom flange of all girders have surface rust full length.
50% of paint has areas of light peeling.

Typical paint interior girders.

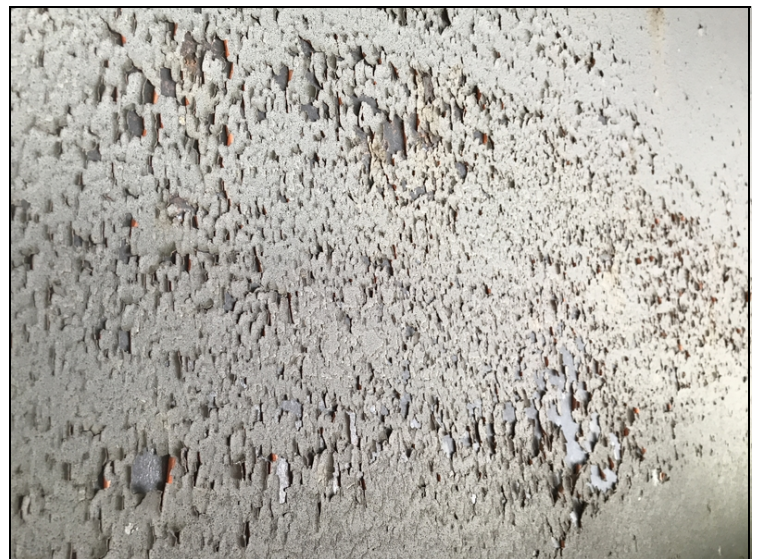
Typical peeling paint on girders.

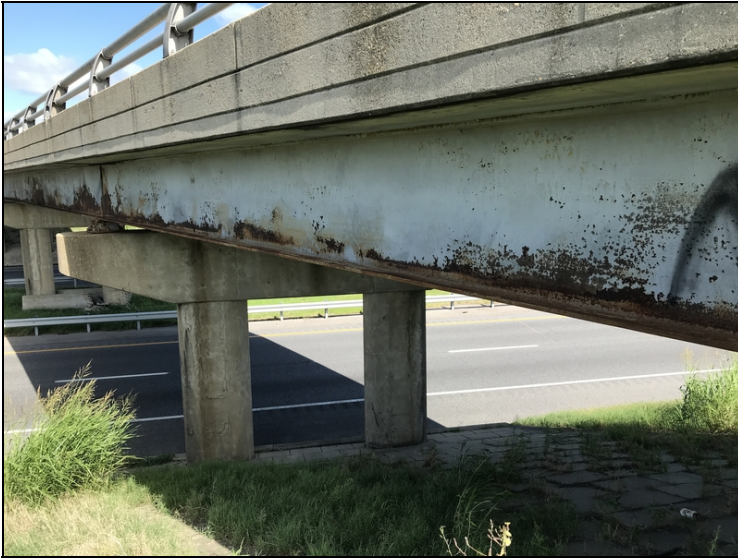
Typical paint condition outside girders.
