Bridge #06998(Routine)

I-555/Sec-1/L-0.22 over I-55/Sec-11/L-23.47

Team Lead: Drew Melton Inspection Date: September 09, 2020

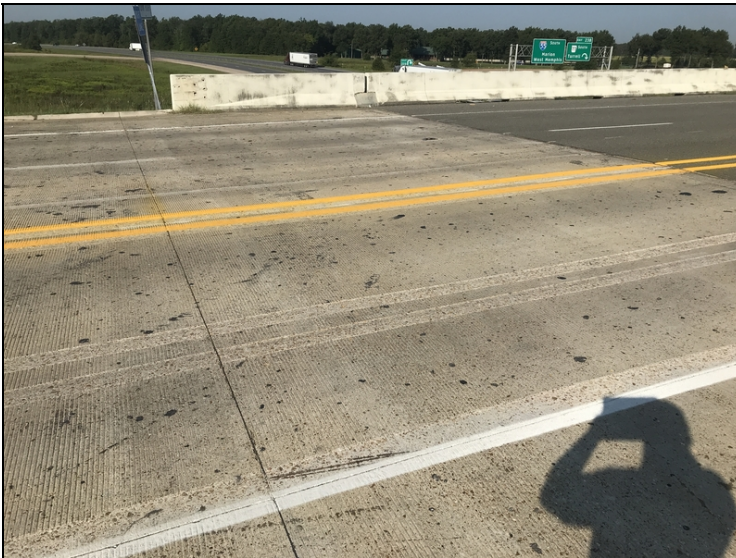
Abutment #1 approach slab

(321)	Both approach slabs have diagonal cracking at corners near bridge end 40 square feet.						
331	Reinforced Concrete Bridge Railing	LF	564	423	141	0	0
1130	Cracking (RC and Other)	LF	141	0	141	0	0

Both approach slabs have diagonal cracking at corners near bridge end 40 square feet.

**Date Reported:** 11/02/2012  
**Priority:** D- Routine  
**Type of Work:** Repair  
**Status:** Monitor  
**Component:** 321 - Reinforced Concrete Approach Slab
