Bridge 05222 Inspection Report

Asset #05222(Routine, Underwater type 2)

Sh-42/Sec-3/L-8.10 over St Francis River Relief

Team Lead: Myron Futrell Inspection Date: 01/06/2026

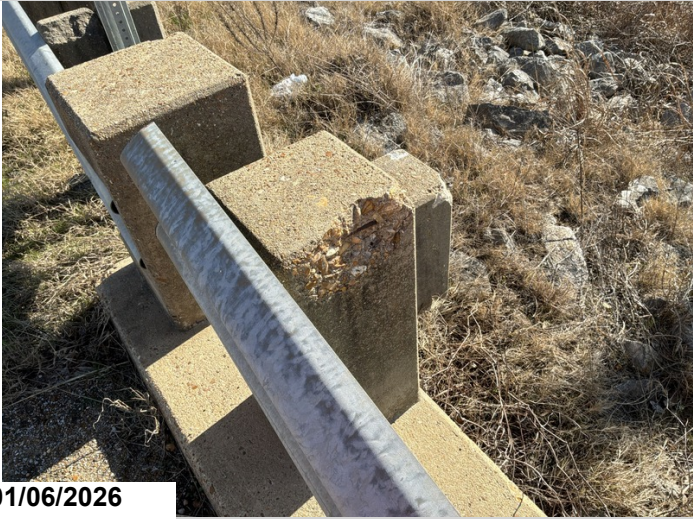
Span 4, right side, rail post 4: 1' spall with exposed reinforcing steel at top.

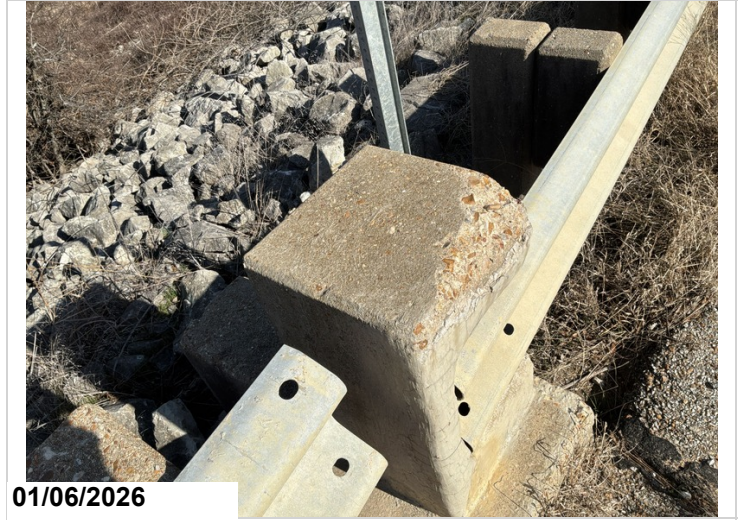
Bridge rail, monument post, abutment 2, left side: spall for 1'.

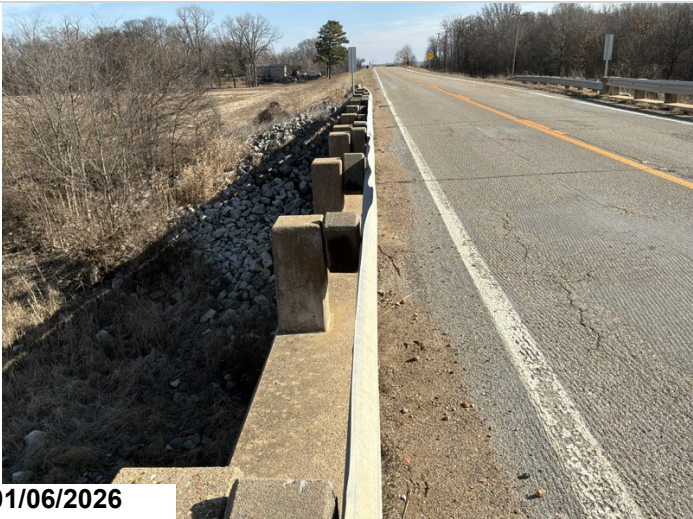
Bridge rails are in overall good condition. Left bridge rail has some minor collision damage and right bridge rail has a spacer missing.

Typical bridge rail, left side: collision damage.

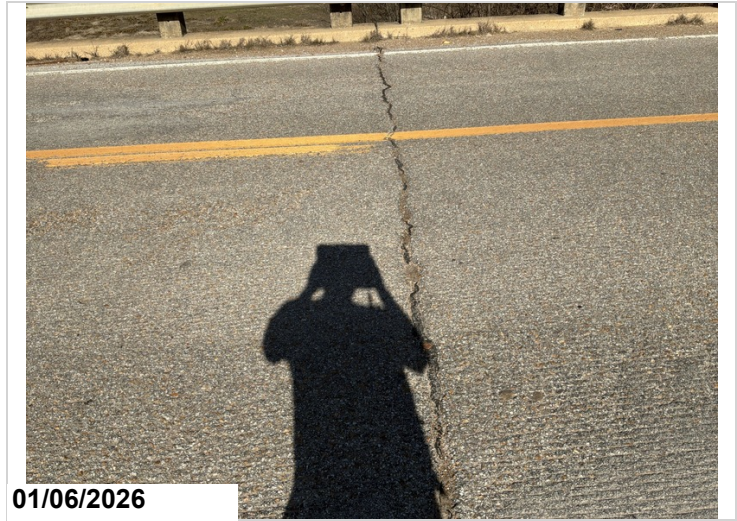
Typical joint, bent 4.

Bridge joints are in overall satisfactory condition. Joints have been overlaid with ACHM allowing non-compressible materials to enter.

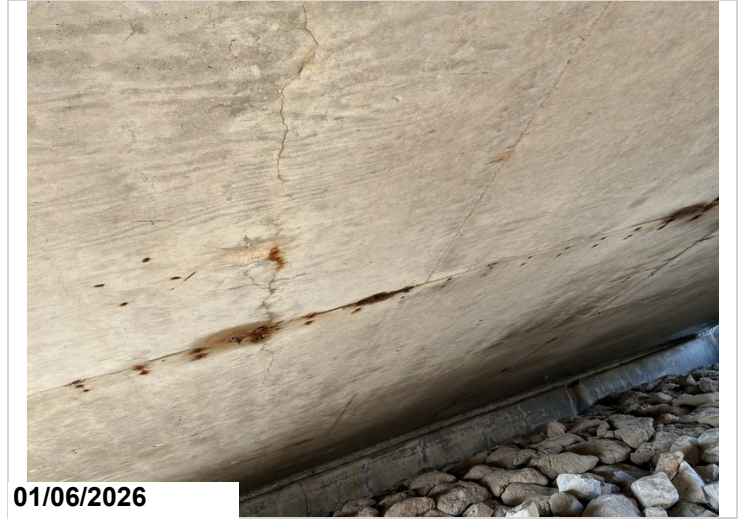
Deck is reinforced concrete voided slab, so deck and superstructure are rated the same. Deck is in good condition with asphalt overlay on deck surface. Under surface has minor cracks, one with rust stains.

Span 1, near center: typical cracking with rust stains.

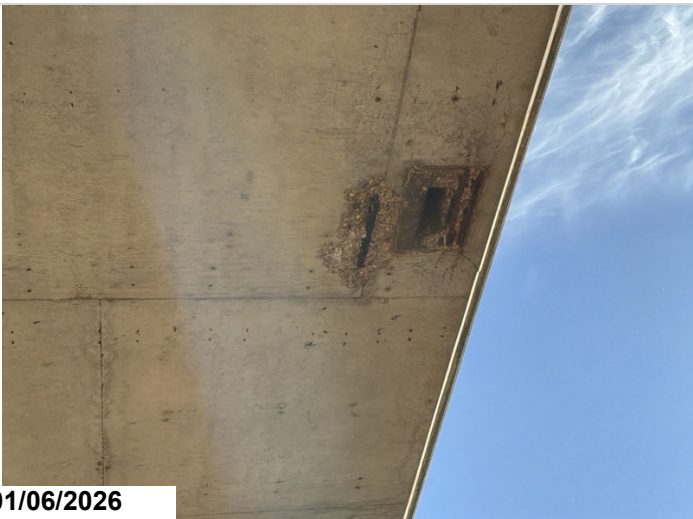
Span 3, right side, by drain: 1' spall with exposed reinforcing steel.

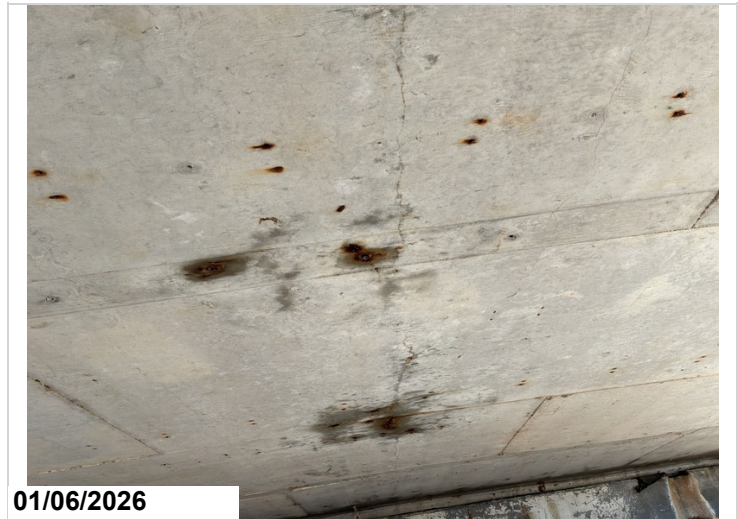
Span 4, center span: typical longitudinal cracks with rust stains.

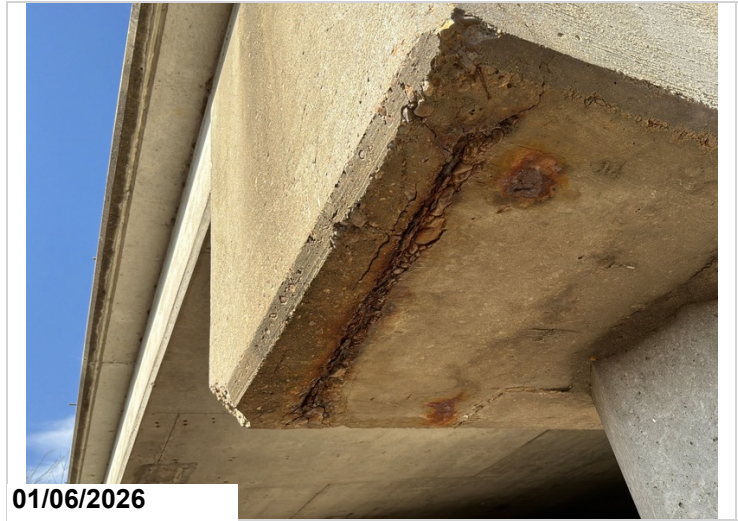
Substructure is in good condition with minor spalls, and cracks some with exposed reinforcing steel. Substructure is reinforced concrete piles and caps.

Bent 2, cap, bottom face, right side: 2' spall with exposed reinforcing steel.

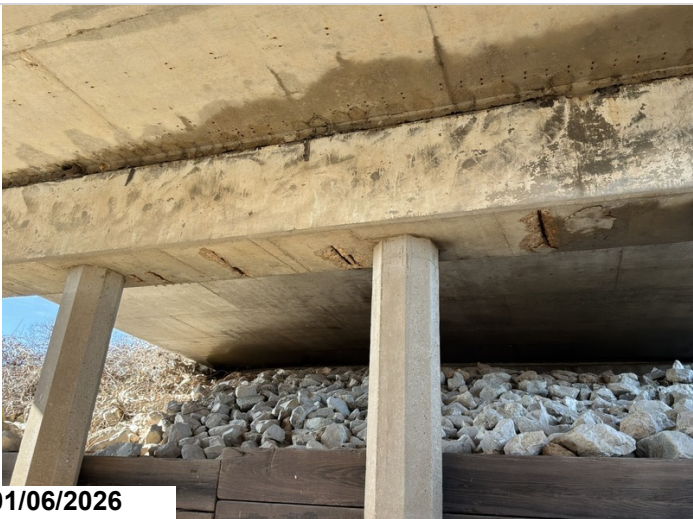
Bent 2, cap, bottom face, between piles 2 and 3: six 1' spalls with exposed reinforcing steel.

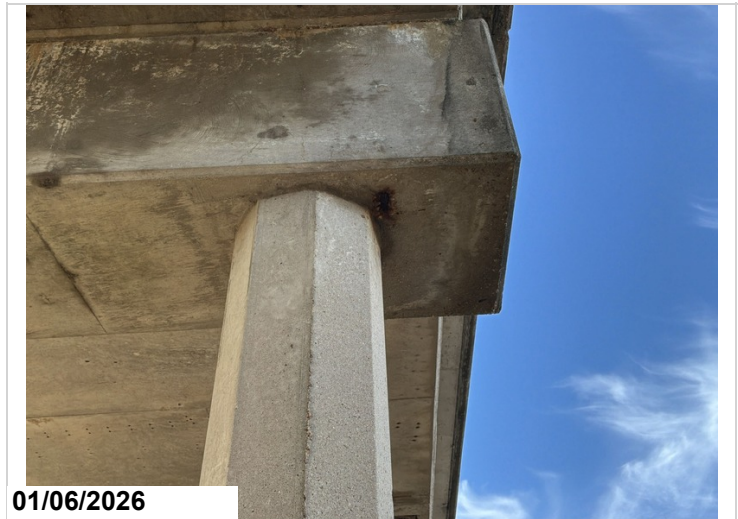
Bent 3, cap, bottom face, left side of pile 1: 6" spall with exposed reinforcing steel.

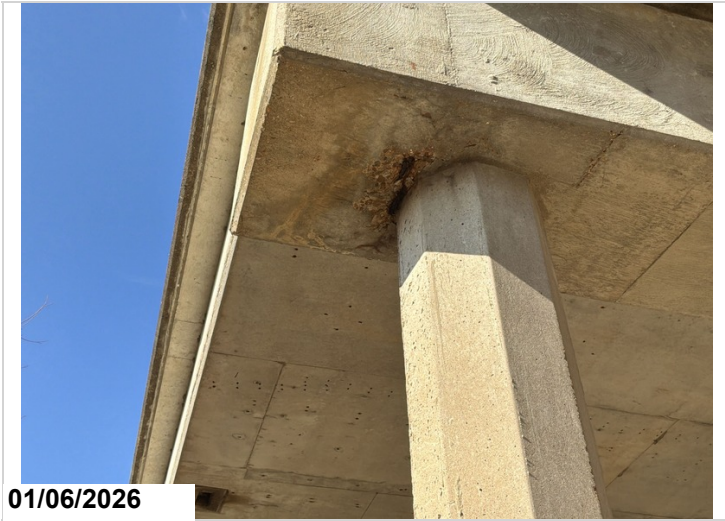
Bent 3, cap, on bottom face, right of pile 4: 1' spall with exposed reinforcing steel.

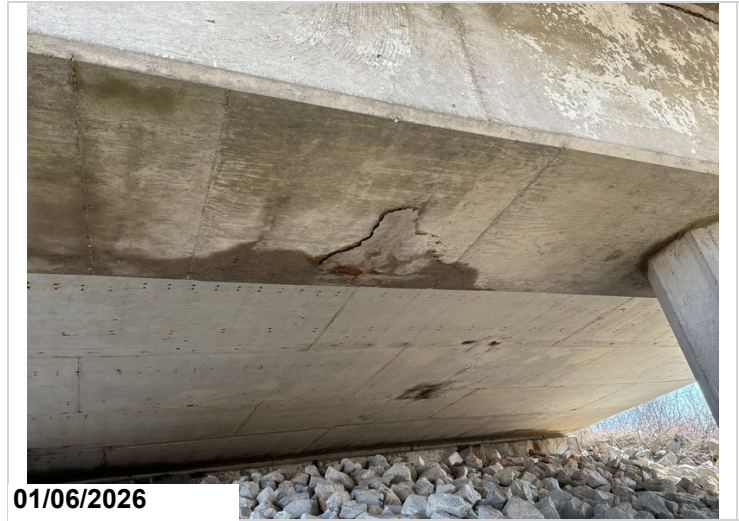
Bent 4, between piles 1 and 2, bottom face: cracked and delaminated for 2'.

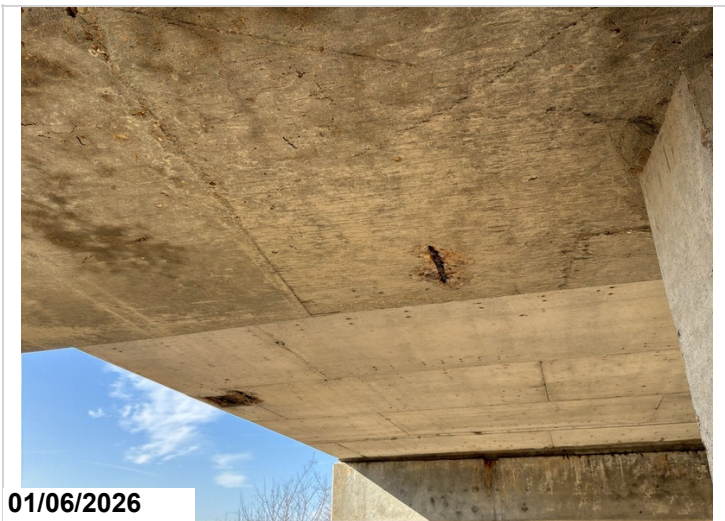
Bent 4, cap, bottom face, on each side of pile 3: delaminated for 6".

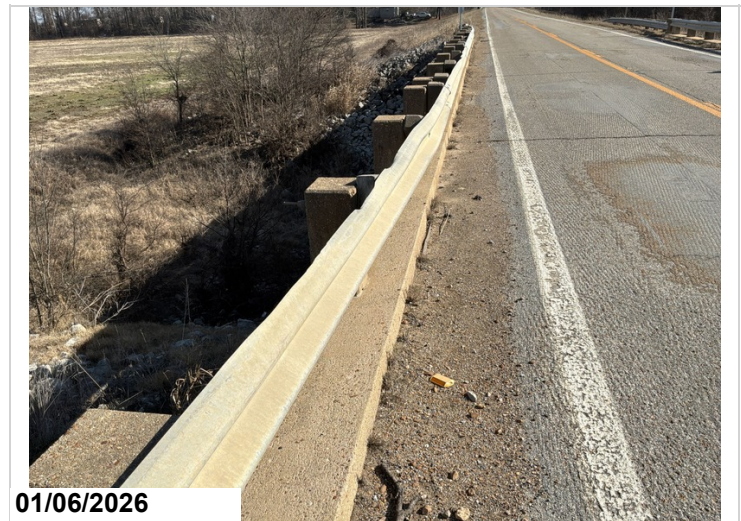
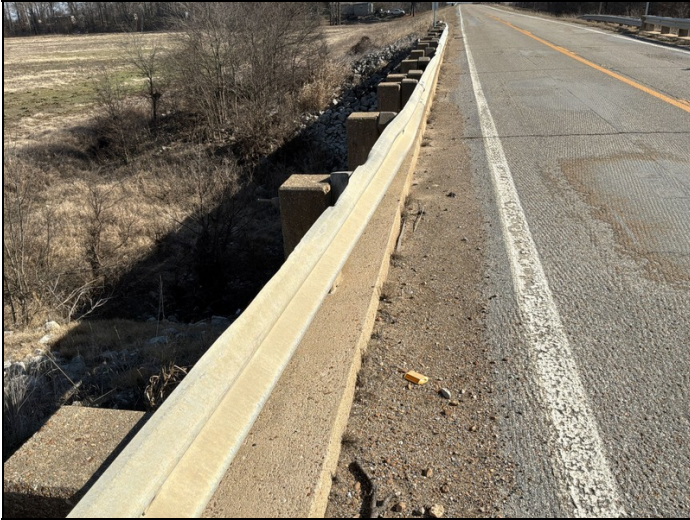
Gutters have dirt and debris in them.

Dirt and debris in gutters.

A-55 - Deck Washing Needed (Yes)

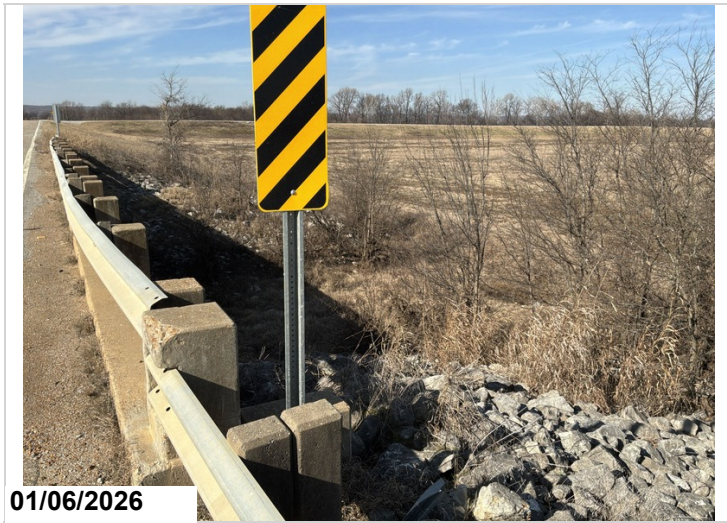
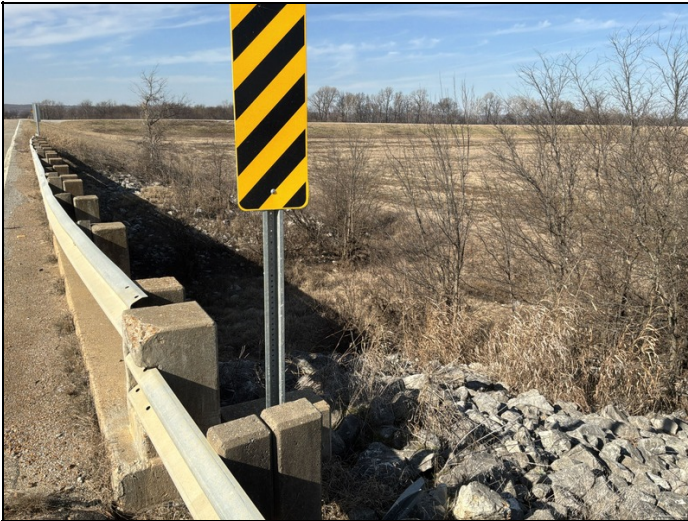
Log mile incorrect should read Sh-42, Section-3, Log mile-8.10. Abutment 2 log mile sign missing.

Abutment 2: log mile sign missing.

A-63 - Missing/Incorrect Log Mile Signage (Yes)

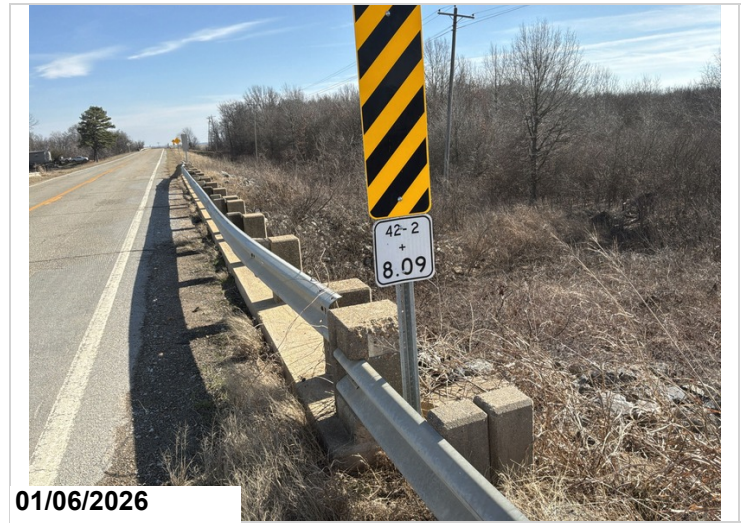
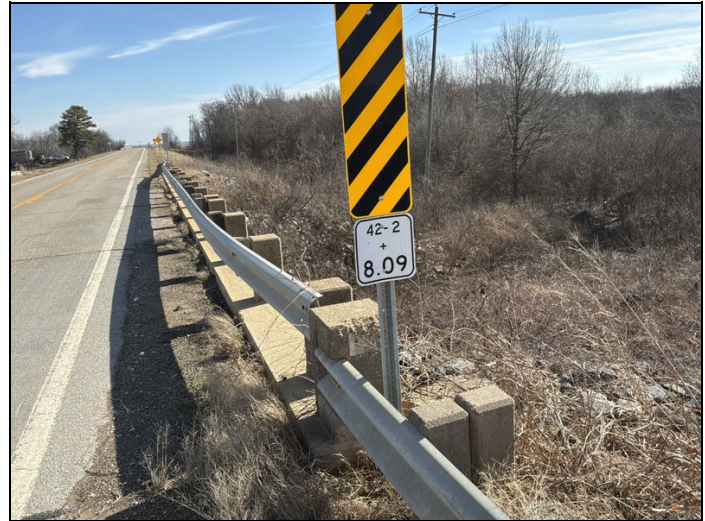
Abutment 1, log mile sign.

Log mile incorrect should read Sh-42, Section-3, Log mile-8.10. Abutment 2 log mile sign missing.

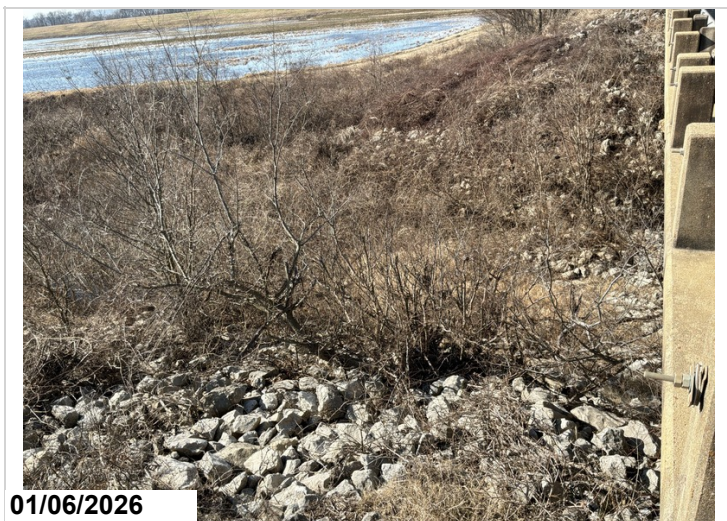
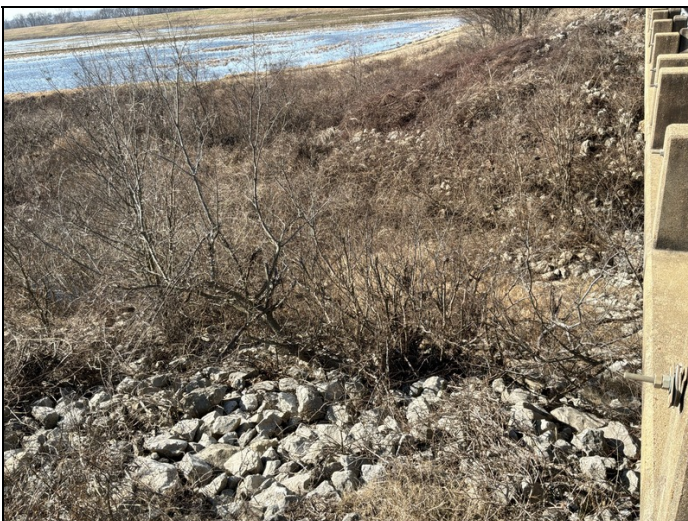
Trees and brush are growing beside and under bridge.

Trees and vegetation growing onto and beside bridge.

A-64 - Vegetation Removal Requested (Yes)

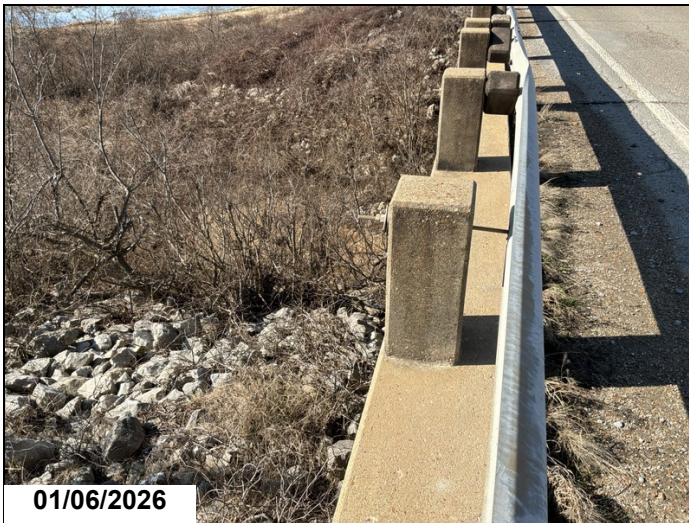
Bridge rail, span 4, post 3: spacer is missing.
