Bridge 05223 Inspection Report

Route:42 Section:03 Log:8.25

Team Lead: Drew Melton, Inspection Date: 10/07/2024

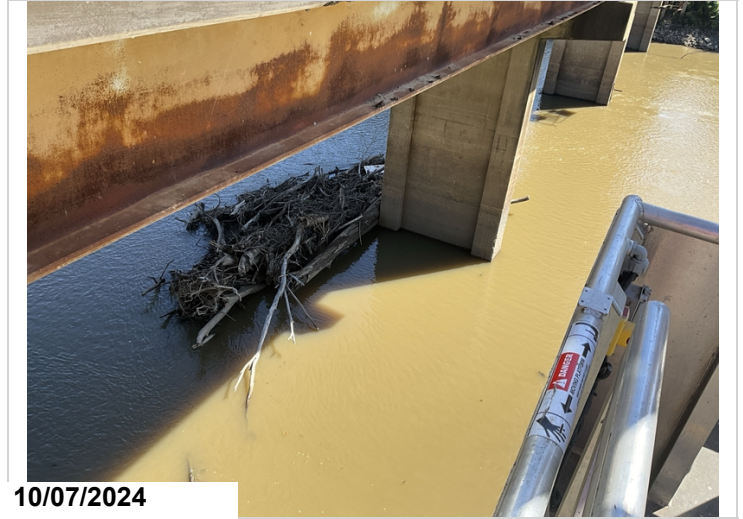
Channel, Bent 4, Left Side: Moderate drift.

Bent 4 drift

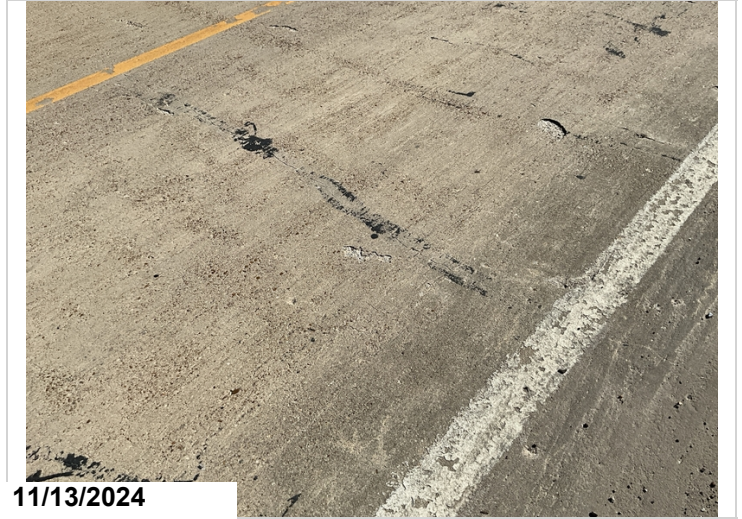
Deck Surface, Full Length: Transverse cracks some are sealed and spaced 2' apart.

Typical deck crack

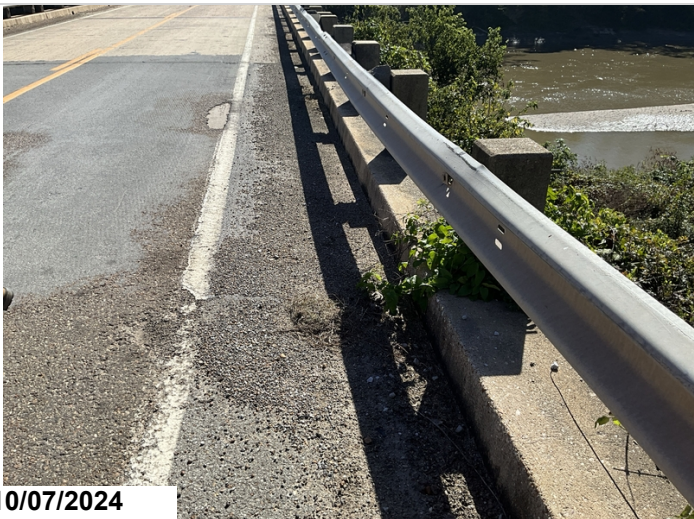
Deck Gutters: Dirt and debris.

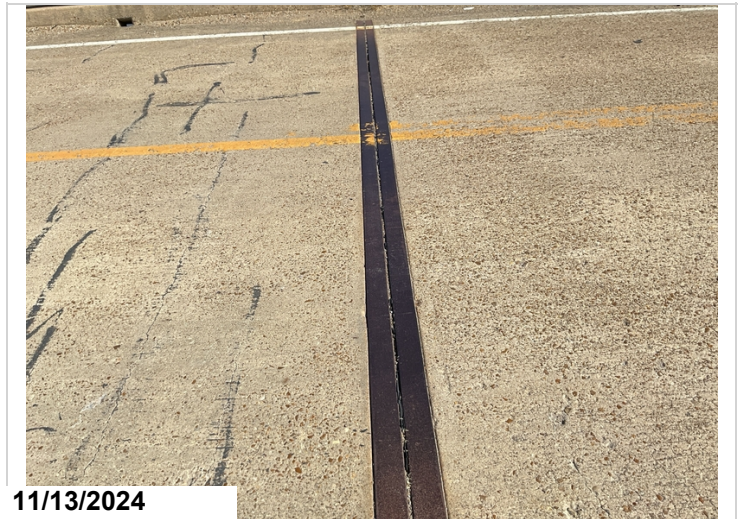
All Joint Seals: Cracked, broken and deteriorated.

Typical joint

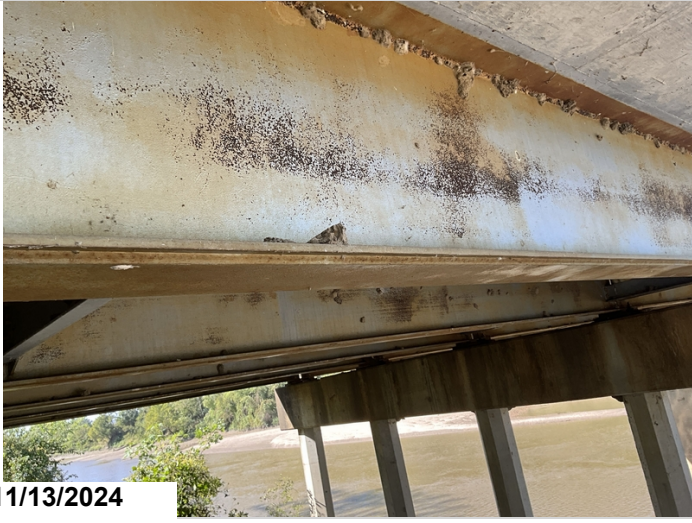
Girders, All Spans, Full Length: Rusty with 25% bare steel 50% rust bleeding through paint. Rest of paint is chalky and has loss of color pigment.

Typical girder condition

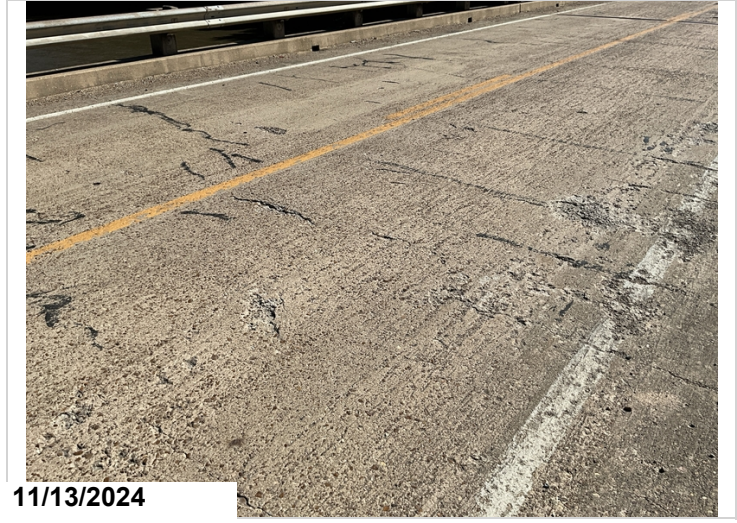
Typical deck spalls

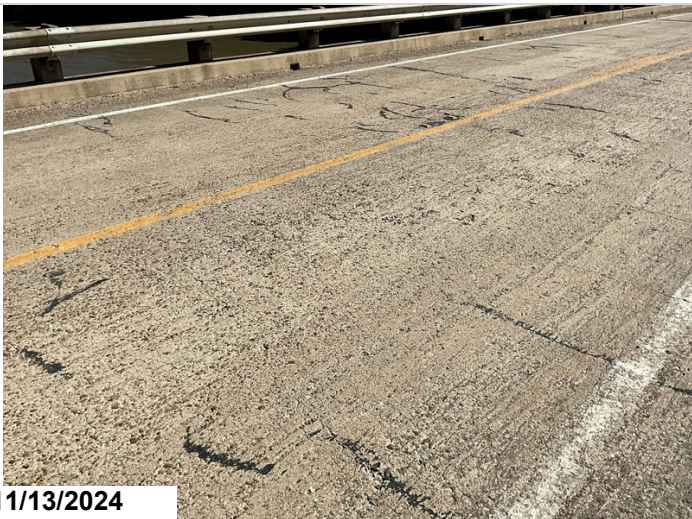
Typical deck abrasion

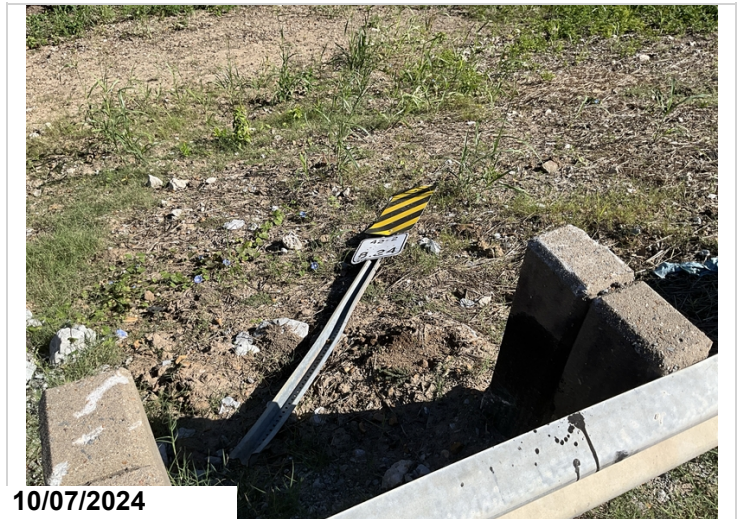
Abutment 2 log mile sign laying down

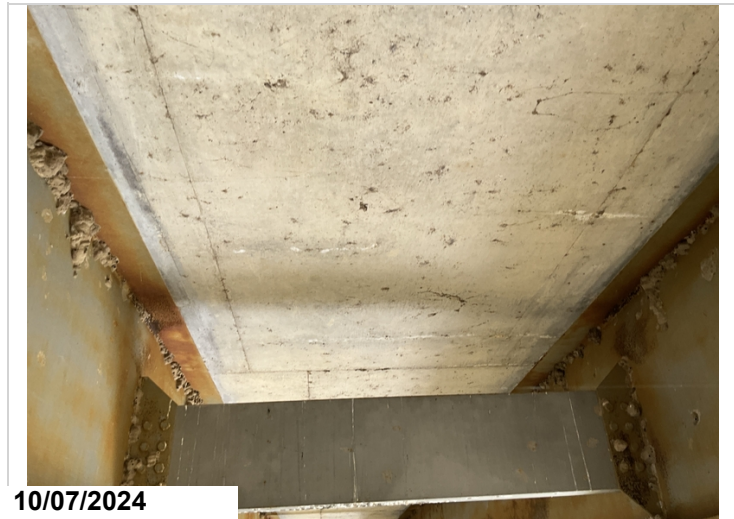
Span 5, Deck Undersurface, Bay 3, 1/4 Span: 1' delamination.

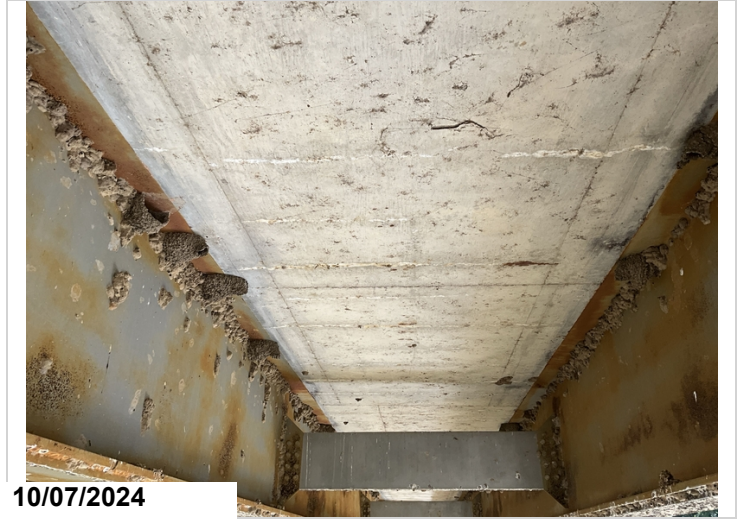
Typical crack with efflorescence span 5

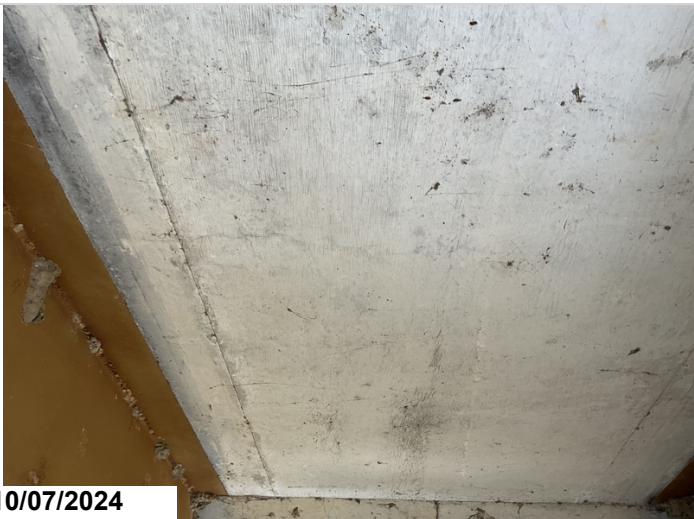
Typical deck undersurface crack

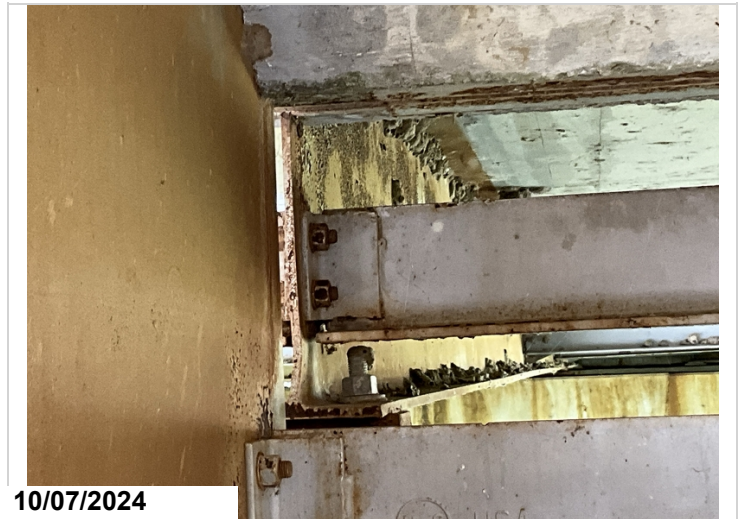
Span 2, Girder 3, Bent 3: Web is bent on end.

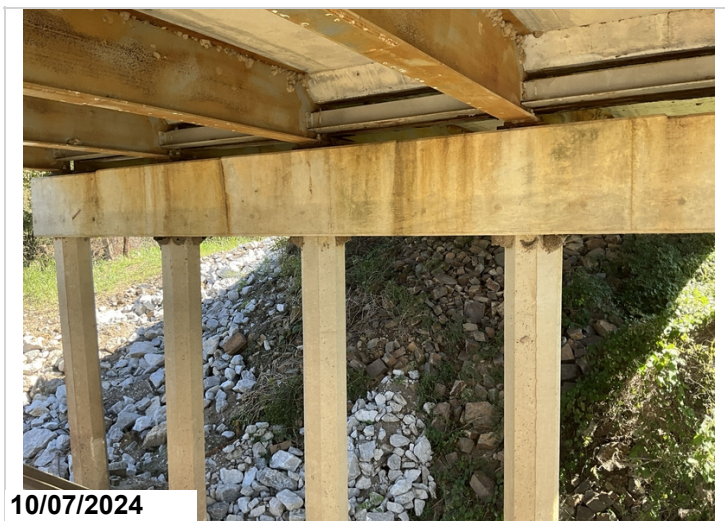
Bent 7, Cap, Back: 1' of exposed reinforcing steel due to poor concrete coverage. Reinforcing steel has moderate section loss.

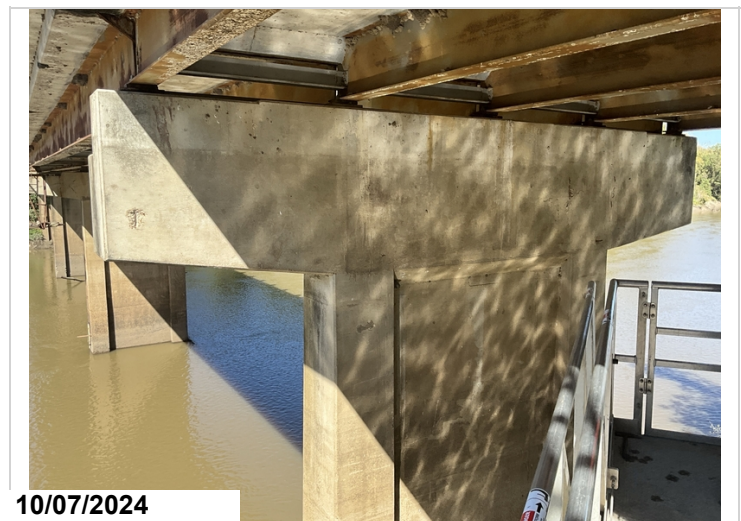
Bent 6, Cap, Ahead: 3' of exposed reinforcing steel due to poor concrete coverage. Reinforcing steel has moderate section loss.

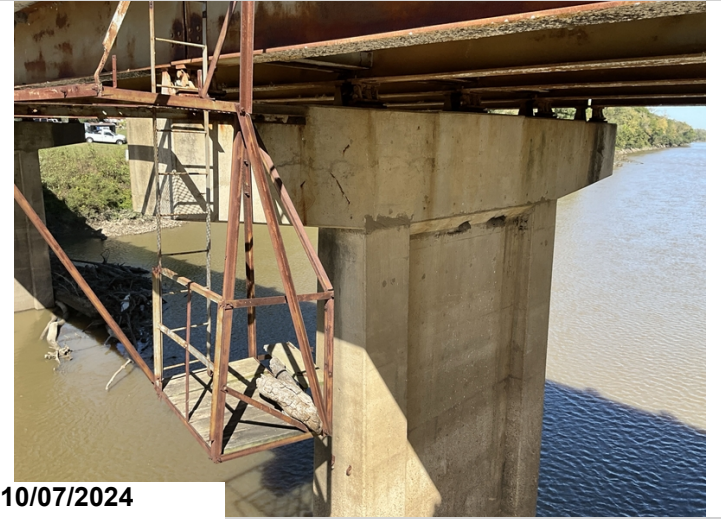
Bent 5, Cap, Ahead: 2' of exposed reinforcing steel due to poor concrete coverage. Reinforcing steel has moderate section loss.

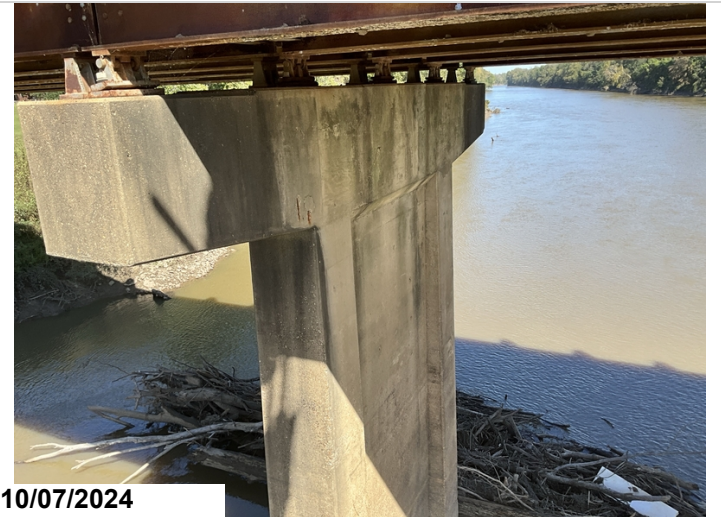
Bent 4, Cap, Ahead: 3' of exposed reinforcing steel due to poor concrete coverage. Reinforcing steel has moderate section loss.

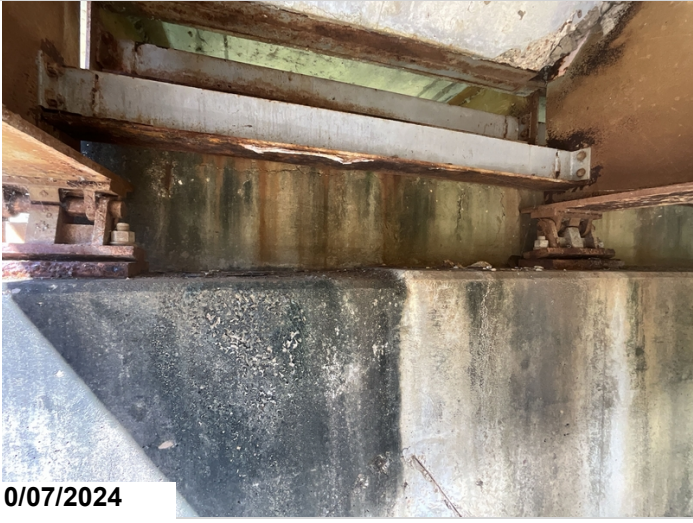
Bent 3, Cap, Ahead: 3' exposed reinforcing steel due to poor concrete coverage. Reinforcing steel has minor section loss.
Bent 3, Cap, Ahead: 8' of longitudinal cracking.

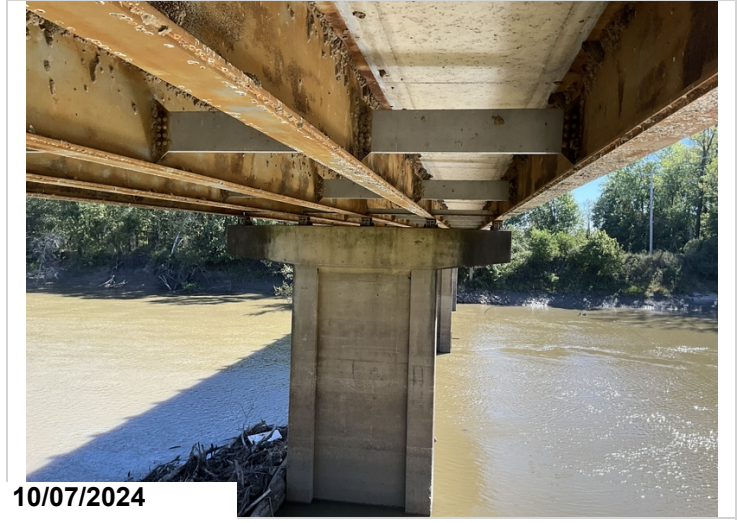
Bent 4, Cap, Back, Under Girder 4: 1' spall with reinforcing steel exposed. Reinforcing steel has minor section loss.

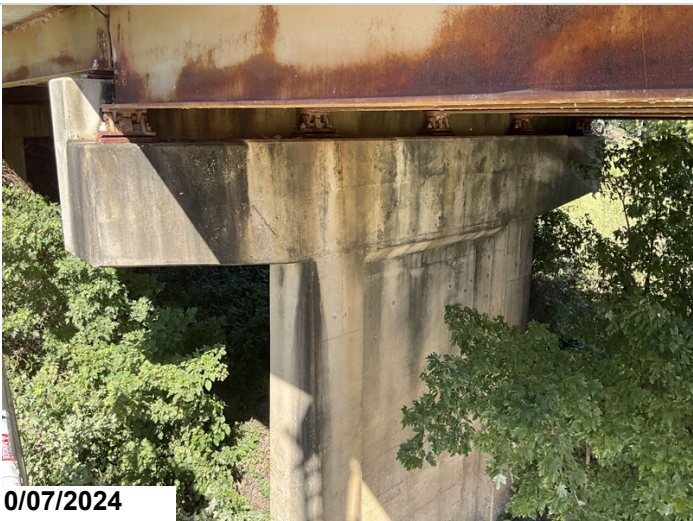
Bent 3, Cap, Ahead: 3' exposed reinforcing steel due to poor concrete coverage. Reinforcing steel has minor section loss.
Bent 3, Cap, Ahead: 8' of longitudinal cracking.

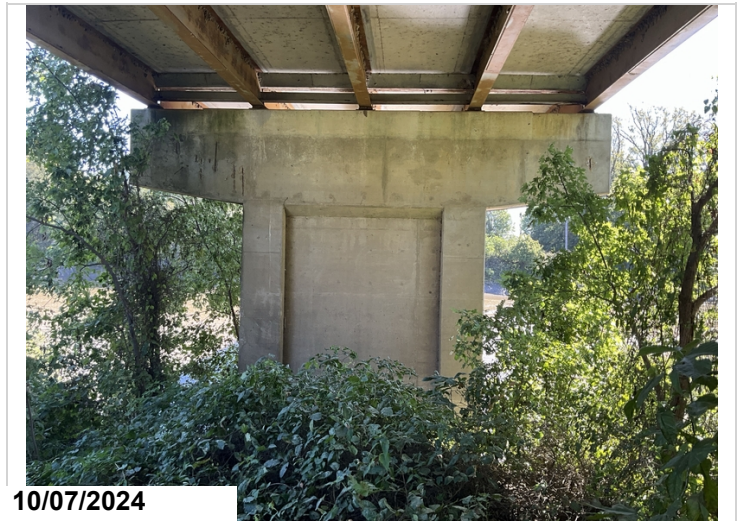
Bent 3, Cap, Back: Six 1' spalls with reinforcing steel exposed above left column and a 1' spall with exposed reinforcing steel on right side. Reinforcing steel has no section loss.

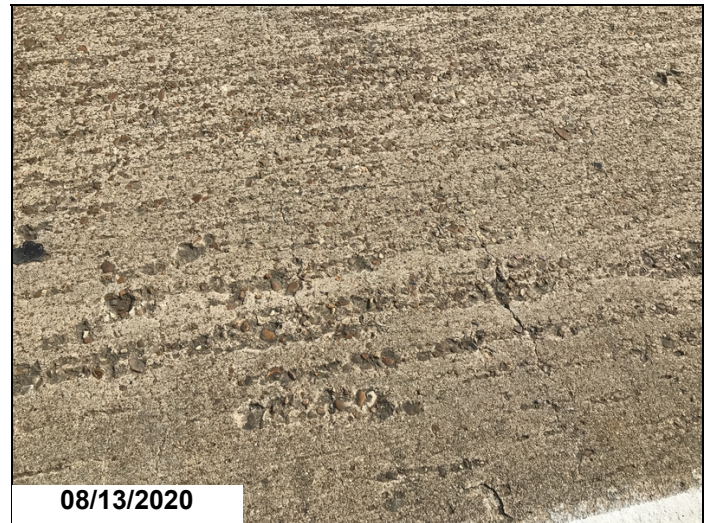
Deck spans #3,4 have moderate areas of scaling with depths up to ½".

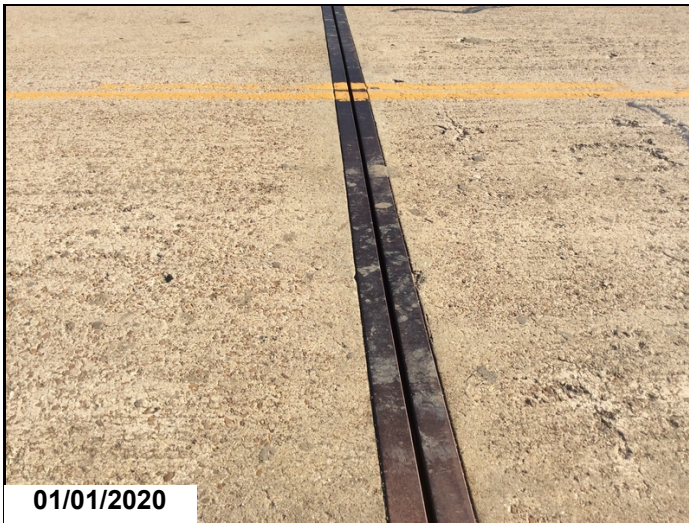
Bent 3, Joint seal: Missing.

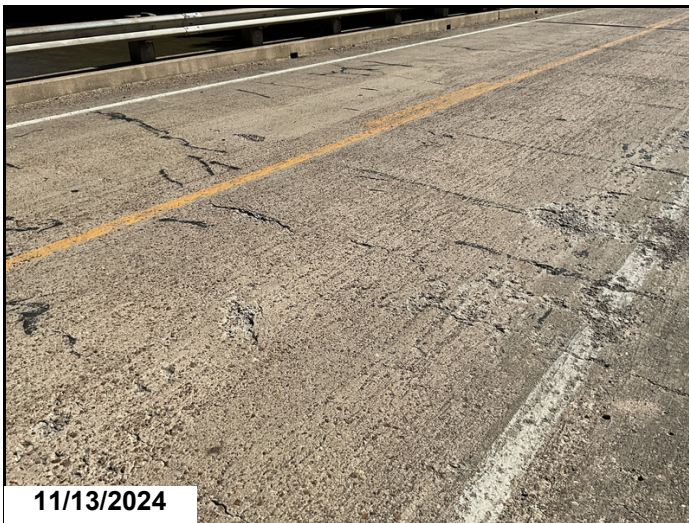
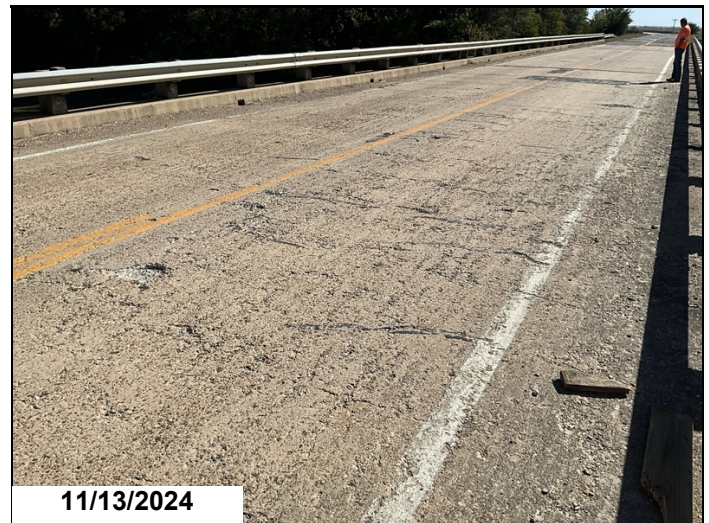
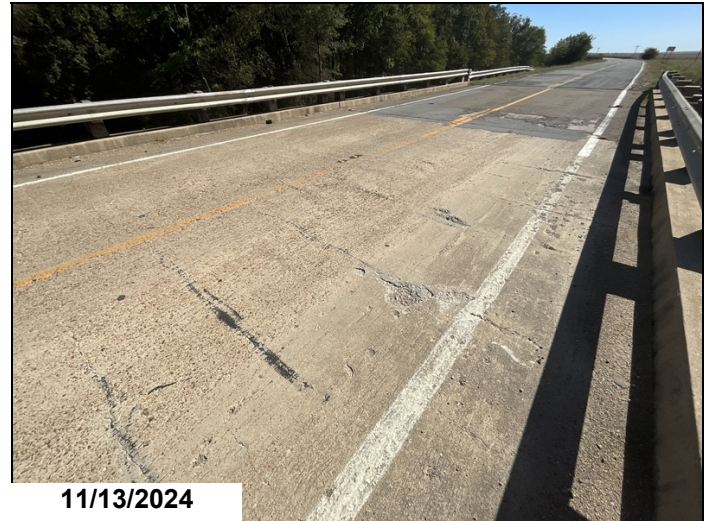
Span 3, Deck Surface, Right Lane: 6" spall, and 1' spall.

Span 4, Deck Surface, Right Lane, 15' From Bent 5: 1' spall with no exposed reinforcing steel.

Span 4, Deck Surface, Right Lane: 1' spall no exposed reinforcing steel.

Span 5, Deck Surface, Left Lane: Two 1' shallow spalls and one 2' by 1' spall no exposed reinforcing steel.

Span 6, Deck Surface, Right Lane: Three shallow spalls with no exposed reinforcing steel.

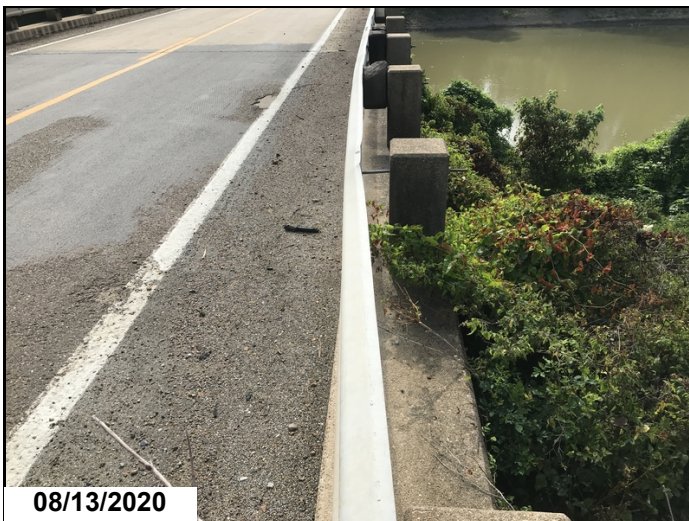
Span 1 right side bridge rail

Bridge Rails: Spacers on each side are turned and not square with bridge.
Span 1, Bridge Rail, Right: 2nd post missing spacer and posts 3 & 5 have broken spacers.

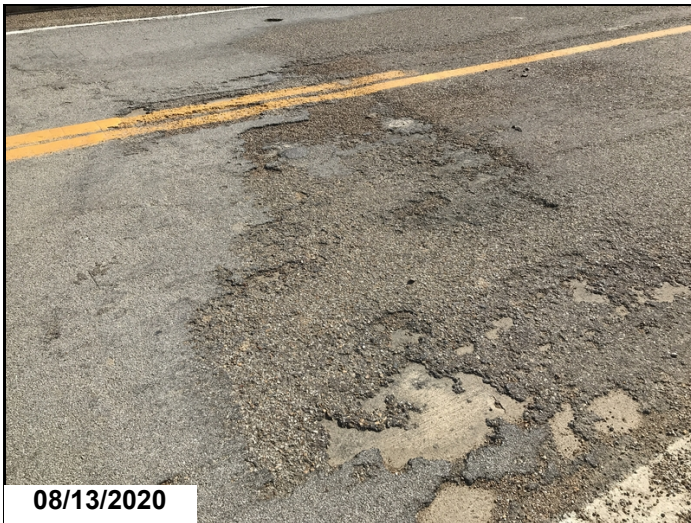
Wearing Surface, Span 7, Near Bent 7: 40 square feet of rough area.

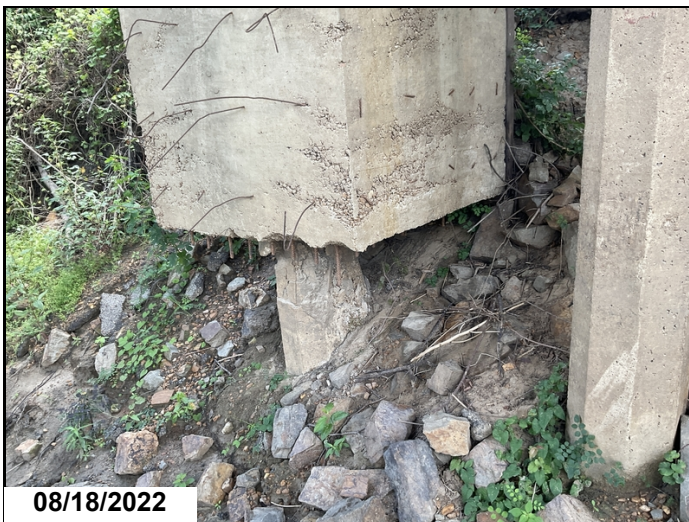
Bent #7 pile #1 repair is undermined up to four feet due to erosion.

Bent #7 pile #1 repair undermined

Undermining has been repaired since last inspection.

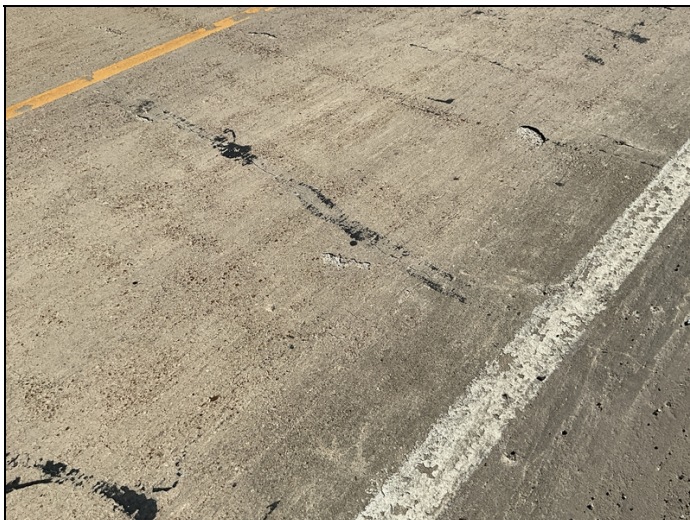
Deck Surface, Full Length: Transverse cracks some are sealed and spaced 2' apart.

Typical deck crack

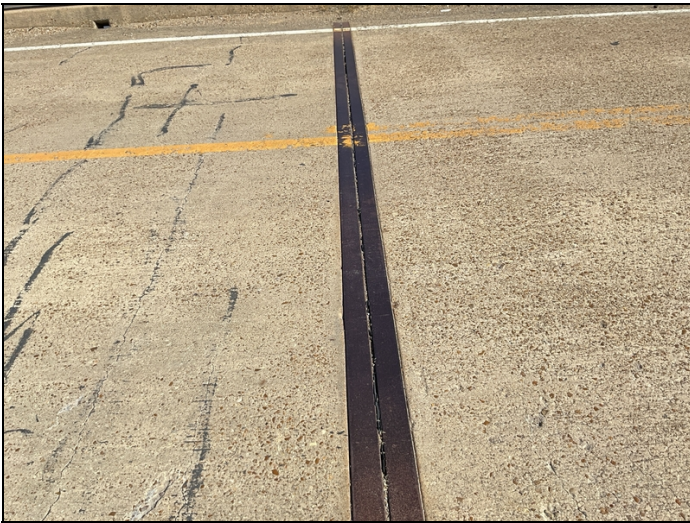
All Joint Seals: Cracked, broken and deteriorated.

Typical joint

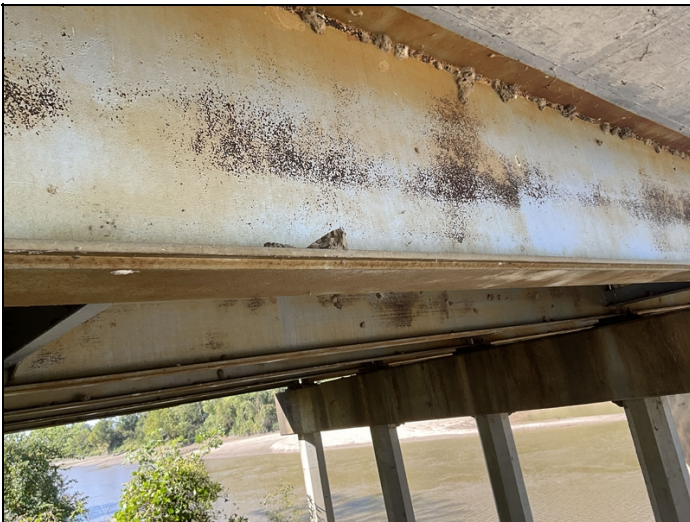
Girders, All Spans, Full Length: Rustied with 25% bare steel 50% rust bleeding through paint. Rest of paint is chalky and has loss of color pigment.

Typical girder condition

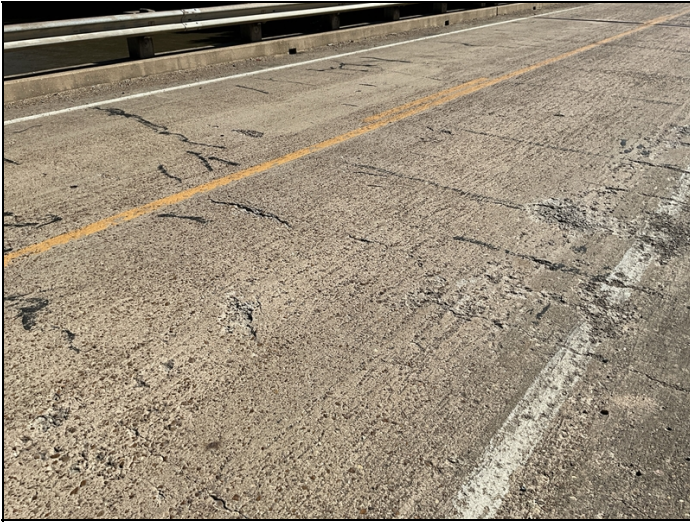
Deck Surface, Full Length: Transverse cracks some are sealed spaced 2' apart.
Each span has shallow spalls and moderate abrasion.

Typical deck spalls

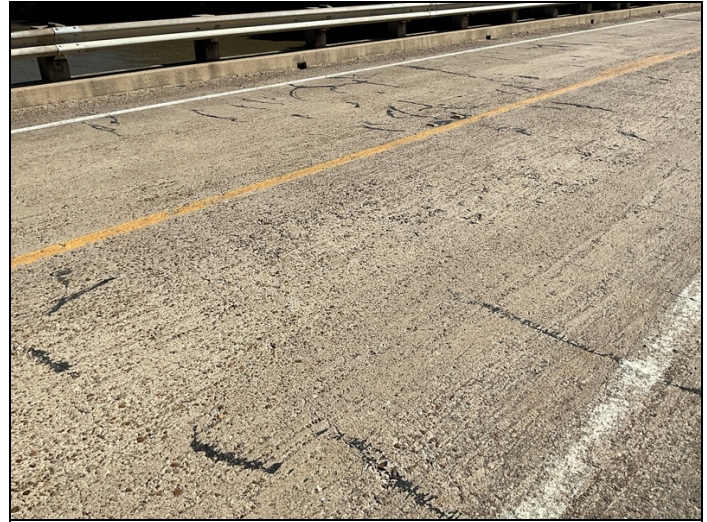
Typical deck abrasion

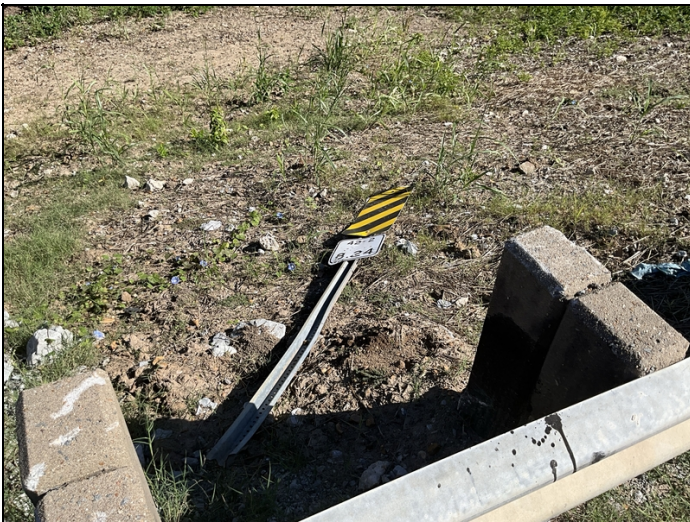
Log mile signs are laying down and are incorrect. They should read Sh-42, Section 3, Log Mile 8.25.

Abutment 2 log mile sign laying down

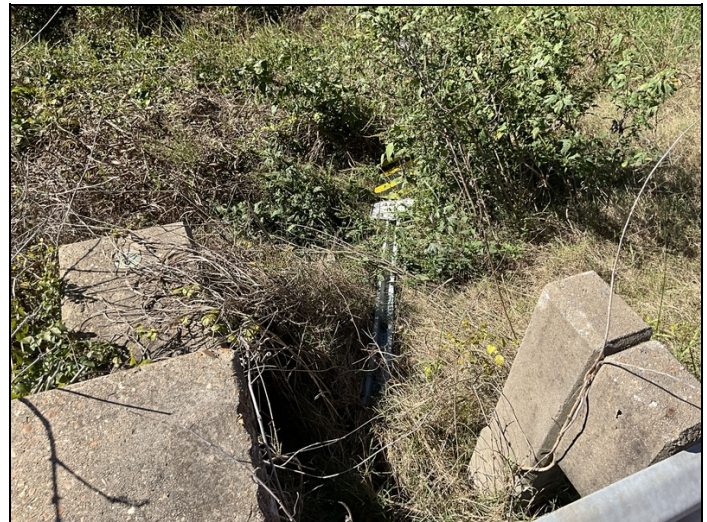
Abutment 1 log mile sign laying down
