## Bridge 05224 Inspection Report

Asset #05224(Routine, Underwater type 2)

Sh-42/Sec-3/L8.419 over Relief Ditch

Team Lead: Drew Melton Inspection Date: 05/20/2024

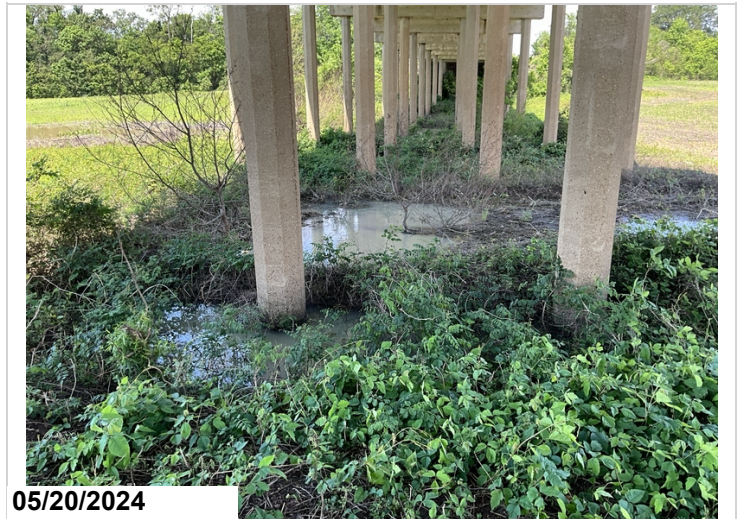
Minor scour exists under the structure at and around interior bents. Scour is minor with a small amount of standing water when everything else is dry.

Typical scour around interior bents.

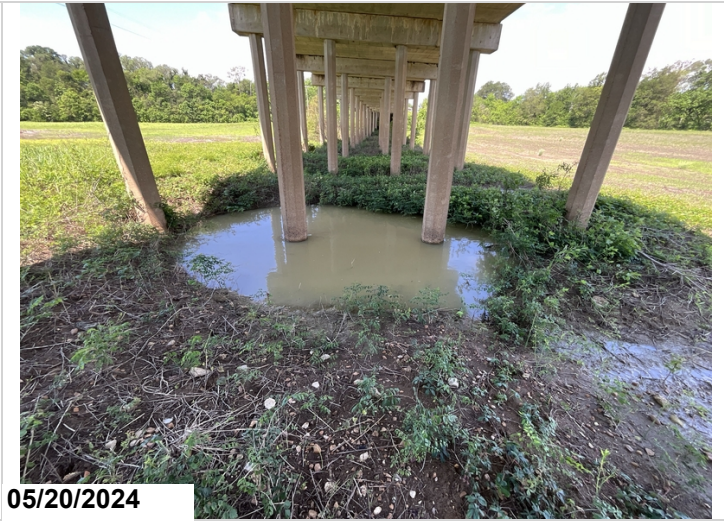
Bent 13 area of minor scour

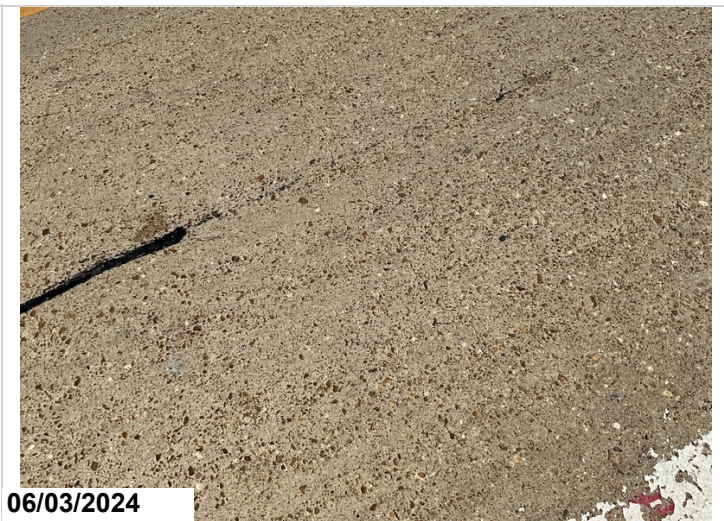
All Spans, Deck Surface: Transverse and longitudinal cracks. 1800SF CS2 (Cracking)

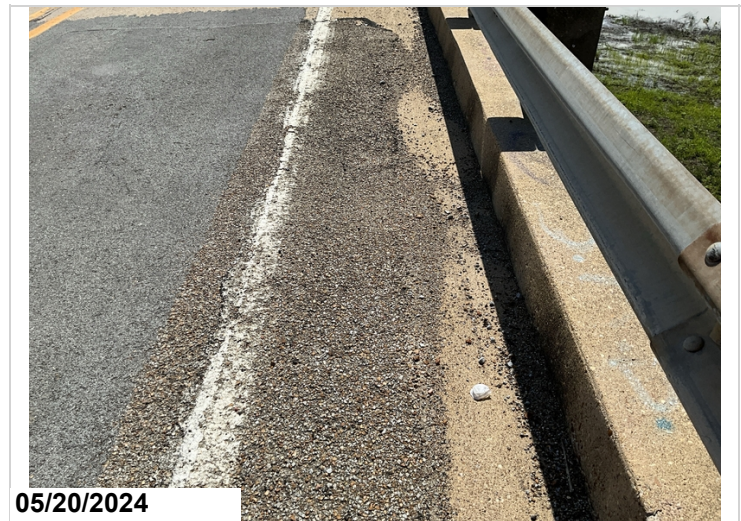
All Spans, Gutters, Full Length: Dirt and debris.

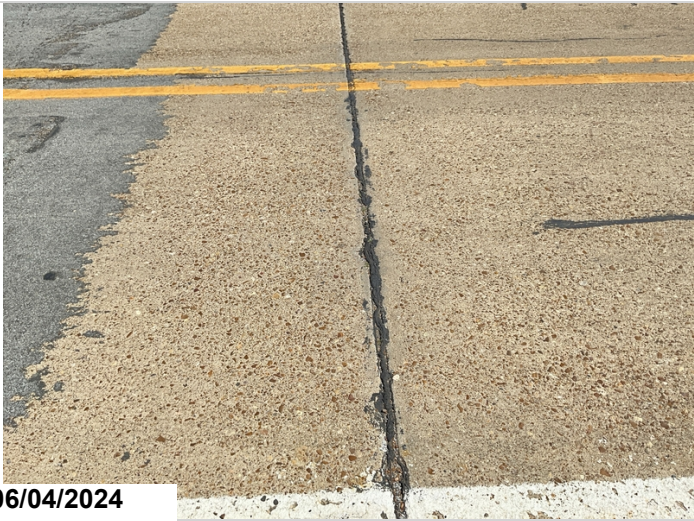
All Bents, Joints, Full Length: Areas of debris impacting them.

Typical joint

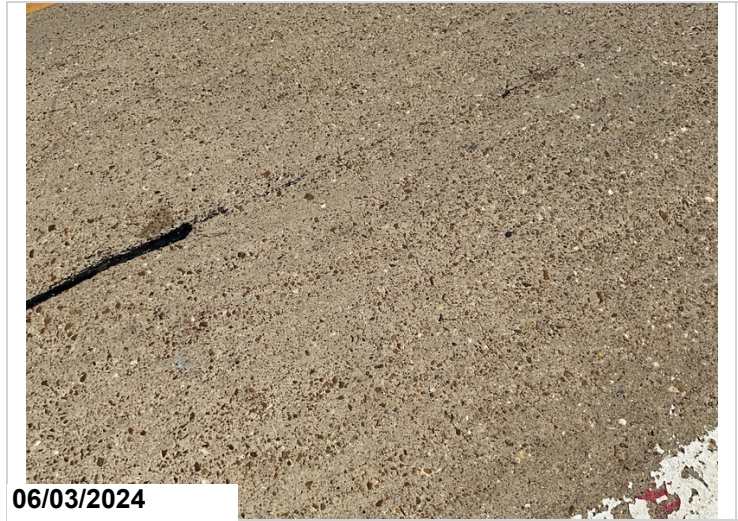
All Spans, Deck Surface: Transverse and longitudinal cracks. 1800SF CS2 (Cracking)

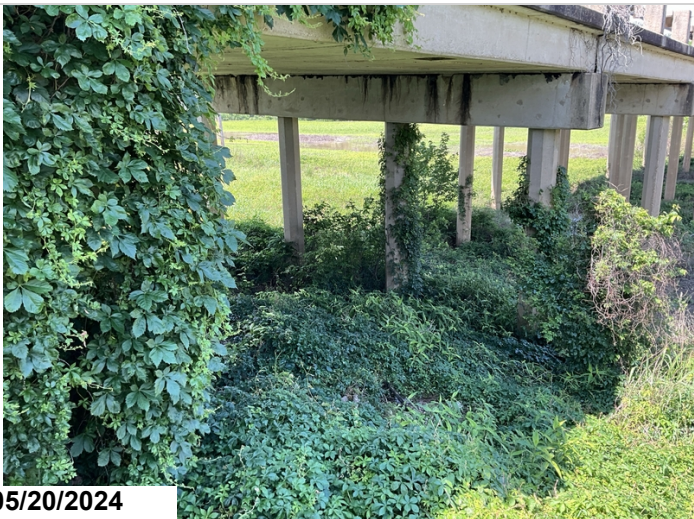
Vegetation is growing under, beside and on to bridge.

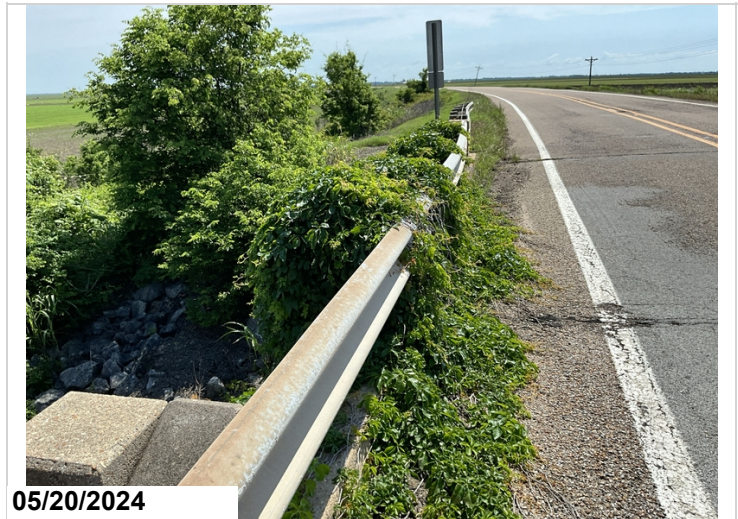
Vegetation growing onto roadway

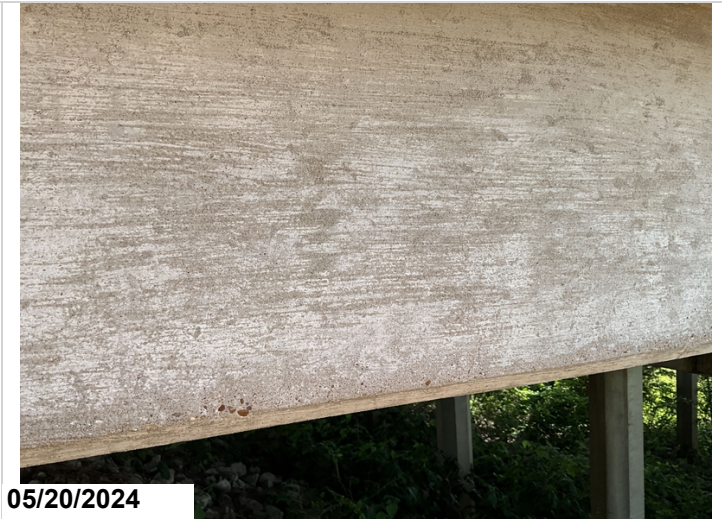
Superstructure is in good condition with vertical cracks on side of slab.

All Spans, Slab, Both Sides: Vertical hairline cracks.

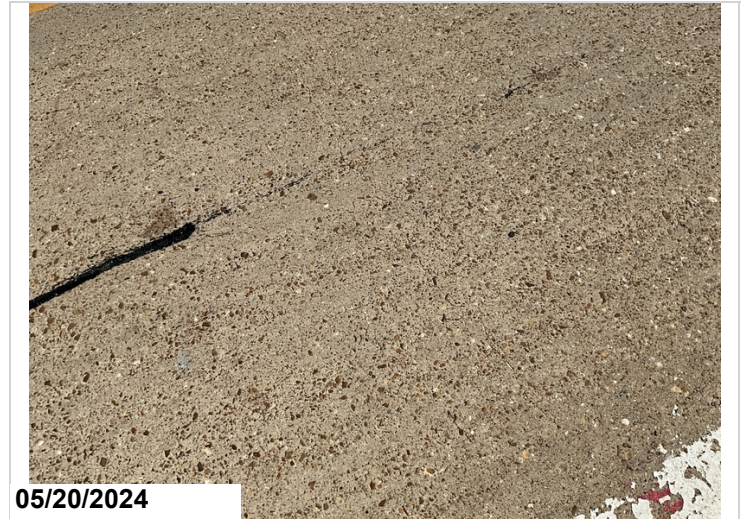
All Spans, Deck Surface: Transverse and longitudinal cracks. 1800SF CS2 (Cracking)

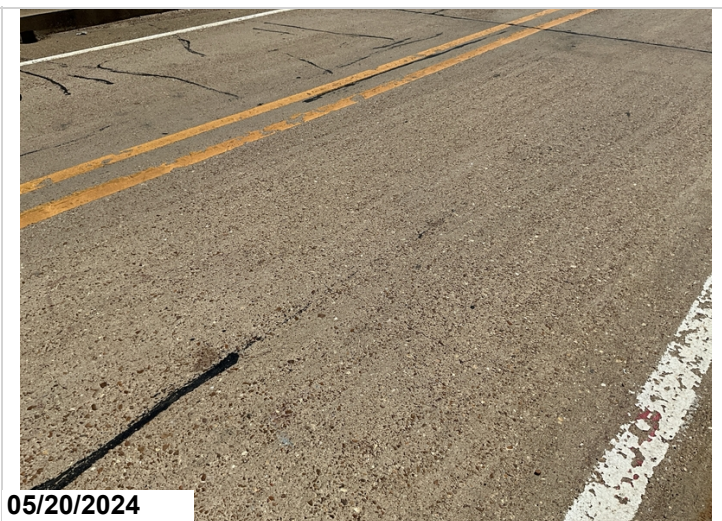
All Spans, Deck Surface, Full Length: Light abrasion. 4000SF CS2 (Abrasion/Wear)

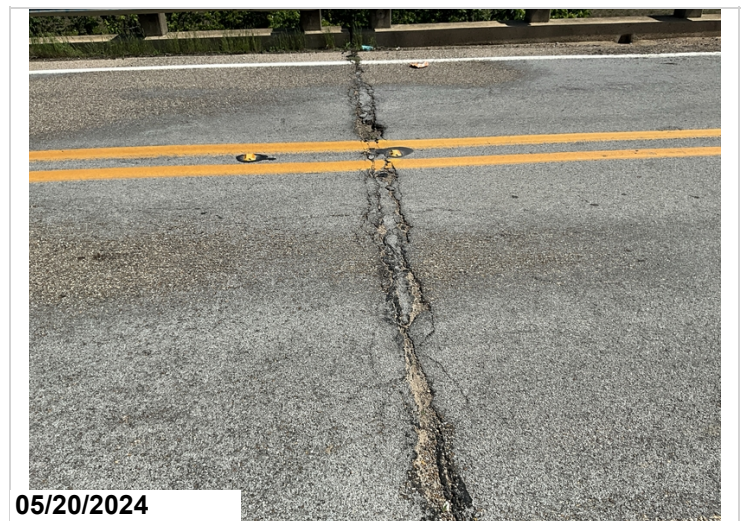
Span 1, Wearing Surface, Bent 2 Joint: Shallow spalls in left lane. 28SF CS2 (Delam/Spall/Patched Area/Pothole)

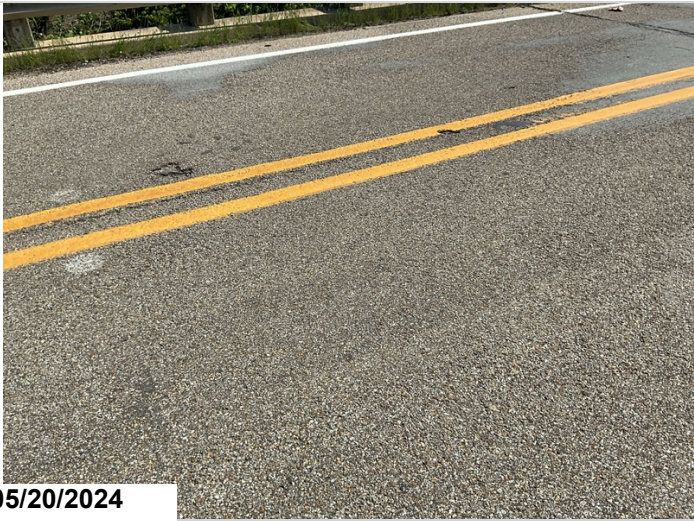
Span 1, Wearing Surface: Two small shallow spalls. 2SF CS2 (Delam/Spall/Patched Area/Pothole)

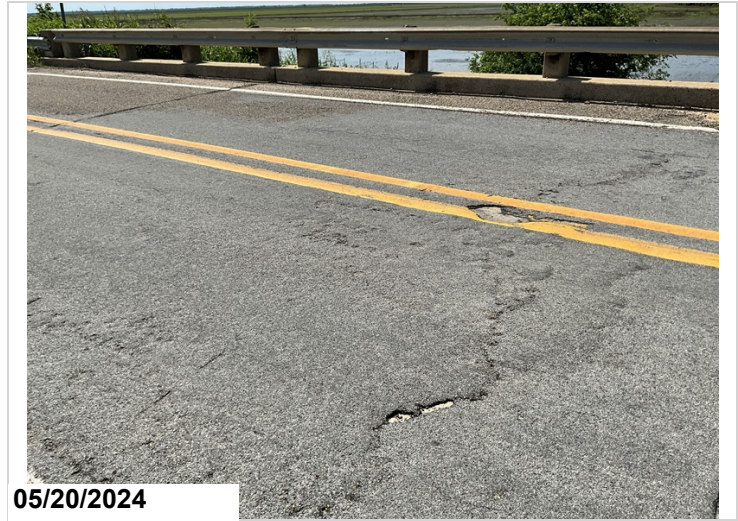
Span 15, Wearing Surface: Two small shallow spalls. 2SF CS2(Delam/Spall/Patched Area/Pothole)

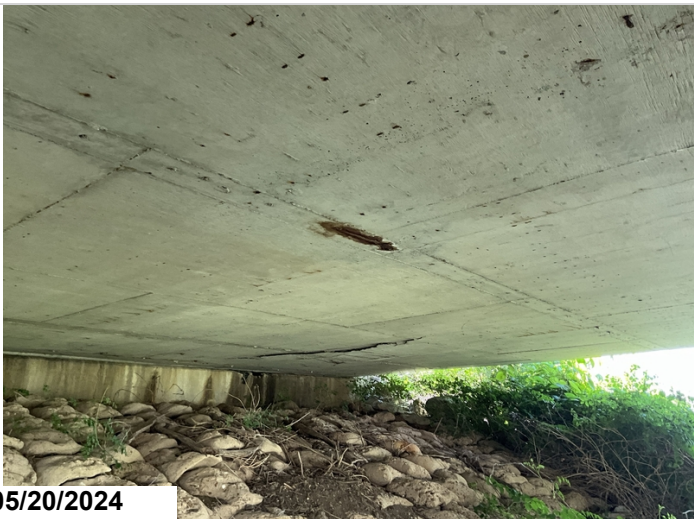
Span 16, Deck Undersurface, Right, Near Abutment 2:  
4' (Length) X 2' (Width) delaminated area. 8SF CS2  
(Delamination/Spall/Patched Area)

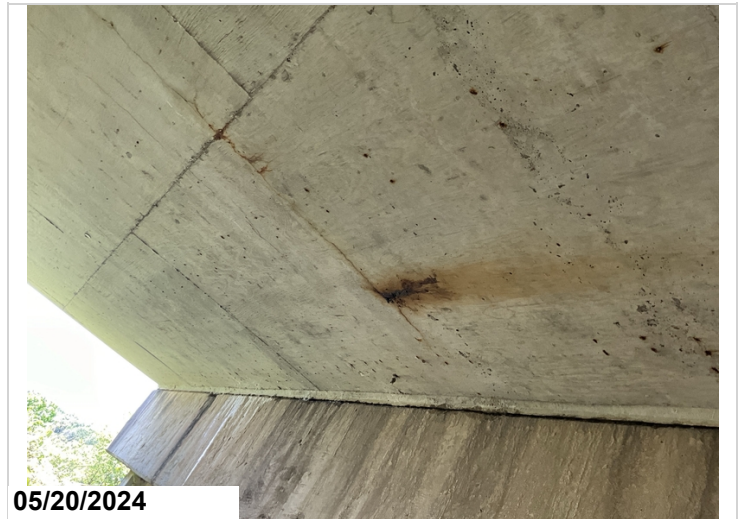
All Spans, Deck Undersurface, Full Length: Hairline cracks  
with rust staining. 400SF CS3 (Efflorescence/Rust Staining)

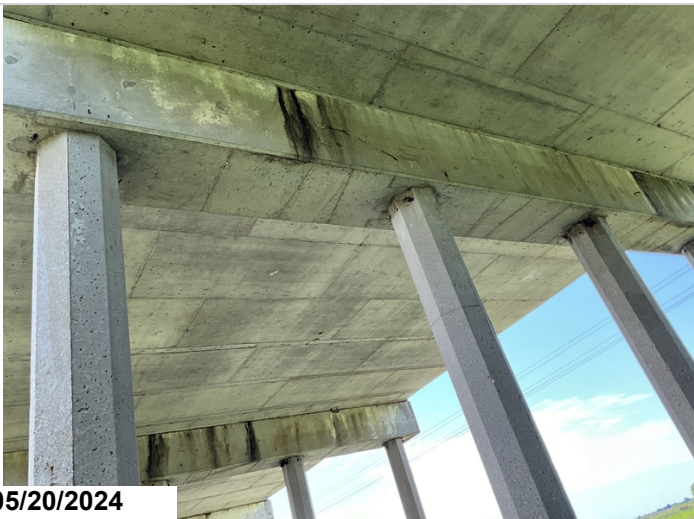
Bent 4, Pile Cap, Back, Near Center: 2; (length) cage steel exposed. Cage steel has minor section loss. 2LF CS3 (Exposed Rebar)

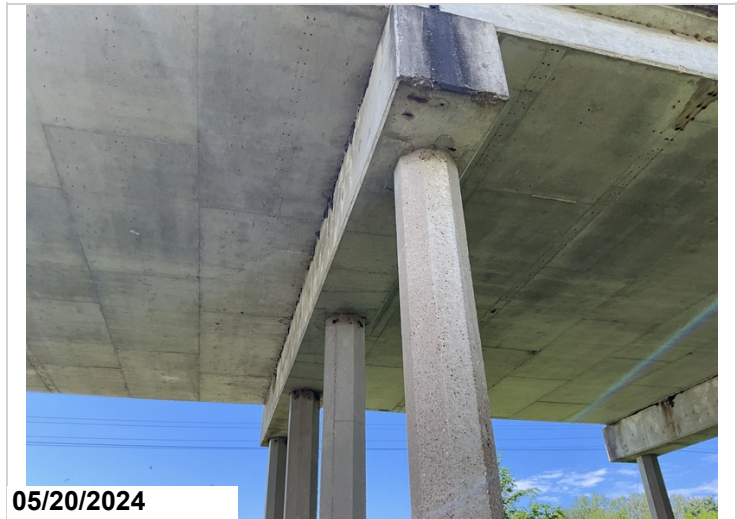
Bent 4, Pile Cap, Bottom, Left End: Three small pieces of exposed reinforcing steel. Reinforcing steel has minor section loss. 2LF CS3 (Exposed Rebar)

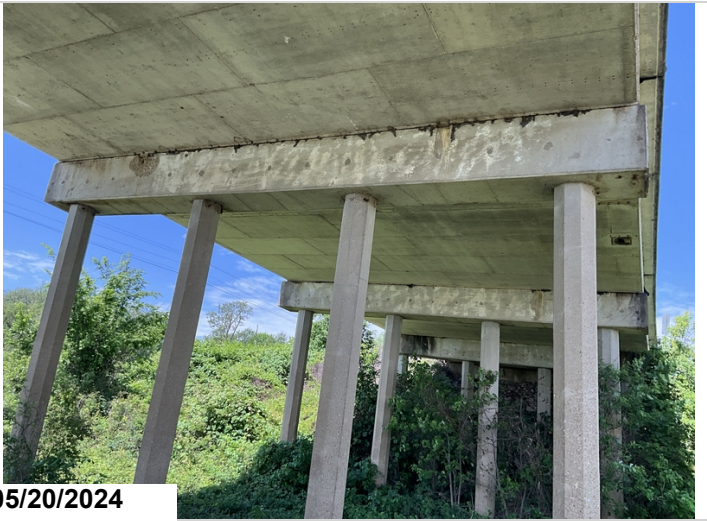
Bent 4, Pile Cap, Ahead, Top, Between Piles 3 & 4: 1' (Width) x 1 1/2' (Length) spall no exposed reinforcing steel. 2LF CS3 (Delamination/Spall/Patched Area)

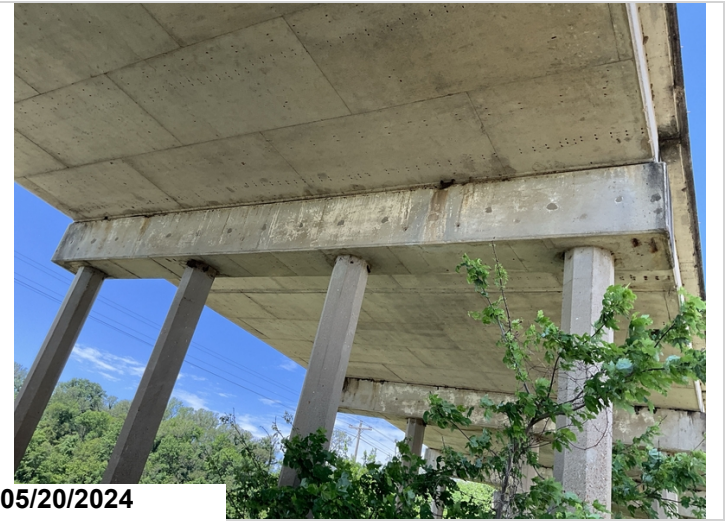
Bent 6, Pile Cap, Bottom, Left End: Two small pieces of exposed reinforcing steel. Reinforcing steel has minor section loss. 1LF CS3 (Exposed Rebar)

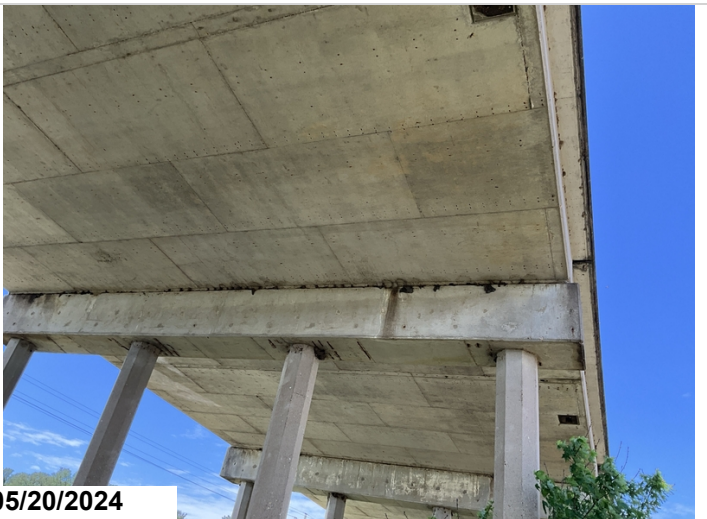
Bent 7, Pile Cap, Bottom, Full Length: Twelve small pieces of exposed reinforcing steel. Reinforcing steel has minor section loss. 9LF CS3 (Exposed Rebar)

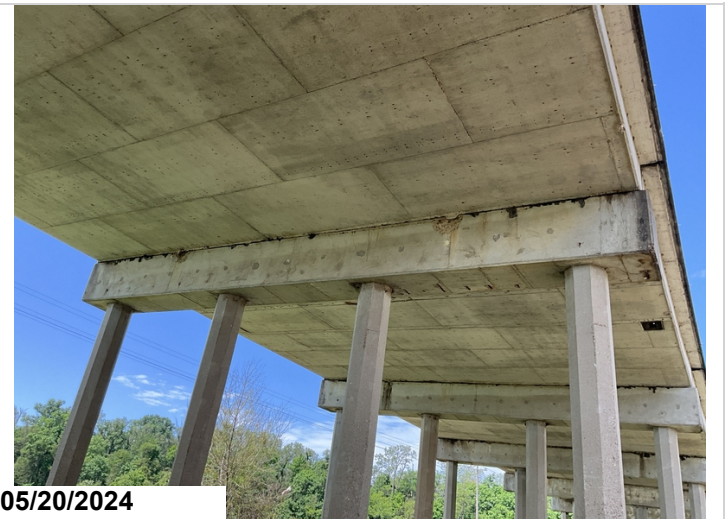
Bent 9, Pile Cap, Ahead, Top, At Keyways: 1' (Width) x 1 1/2' (Length) spalls no exposed reinforcing steel. 4LF CS3 (Delamination/Spall/Patched Area)  
Bent 9, Pile Cap, Bottom, Left Half: Nine small pieces of exposed reinforcing steel. Reinforcing steel has minor section loss. 5LF CS3 (Exposed Rebar)

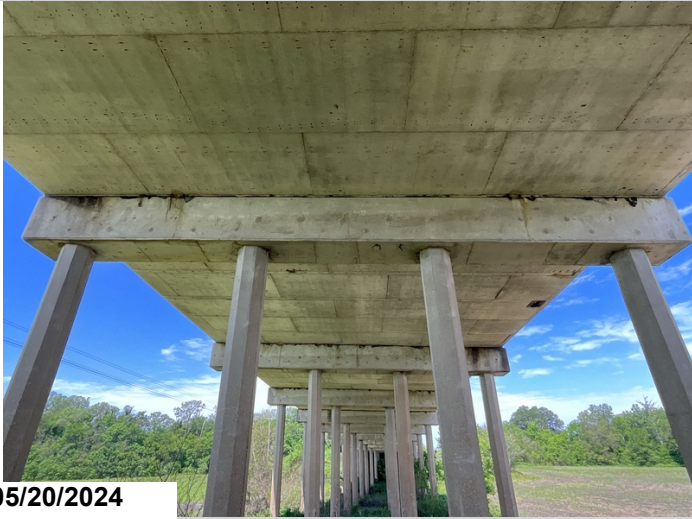
Bent 11, Pile Cap, Bottom, Near Center: Two small pieces of exposed reinforcing steel. Reinforcing steel has minor section loss. 2LF CS3 (Exposed Rebar)

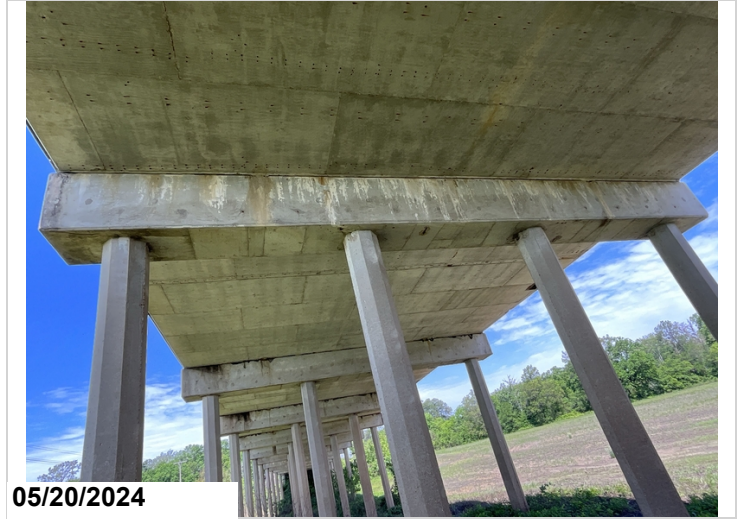
Bent 12, Pile Cap, Bottom: Three small pieces of exposed reinforcing steel. Reinforcing steel has minor section loss. 3LF CS3 (Exposed Rebar)

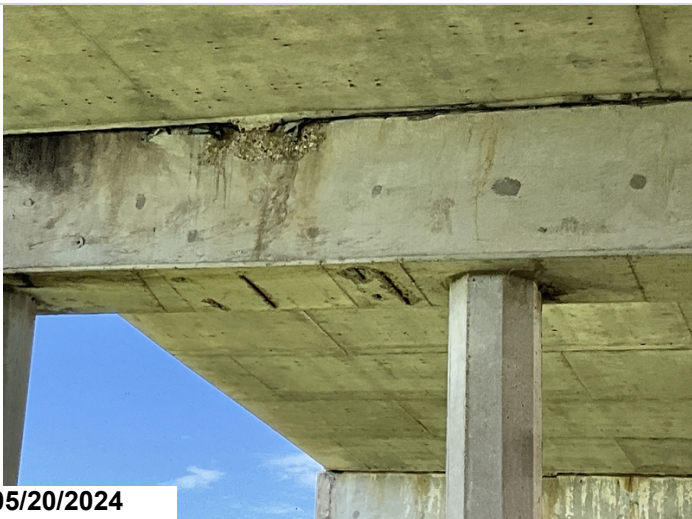
Bent 13, Pile Cap, Ahead, Top, Between Piles 3 & 4: 1' (Width) x 1 1/2' (Length) spall no exposed reinforcing steel. 2LF CS3 (Delamination/Spall/Patched Area)  
Bent 13, Pile Cap, Bottom, Right: Six small pieces of exposed reinforcing steel. Reinforcing steel has minor section loss. 2LF CS3 (Exposed Rebar)

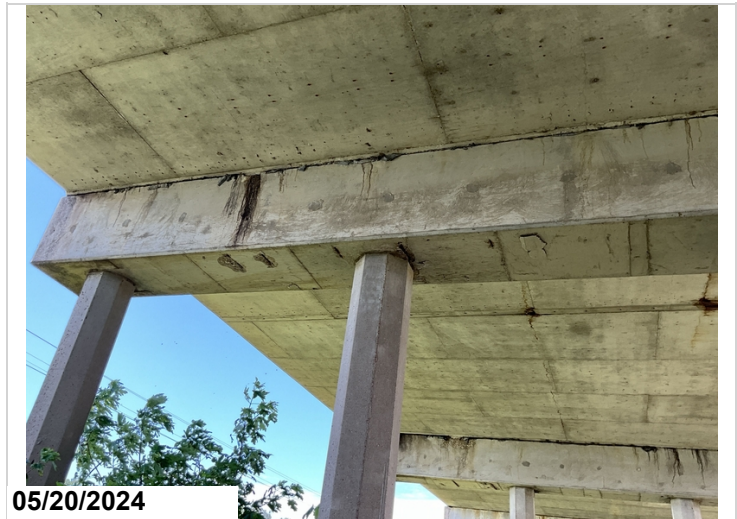
Bent 14, Pile Cap, Bottom: Five small pieces of exposed reinforcing steel. Reinforcing steel has minor section loss. 5LF CS3 (Exposed Rebar)

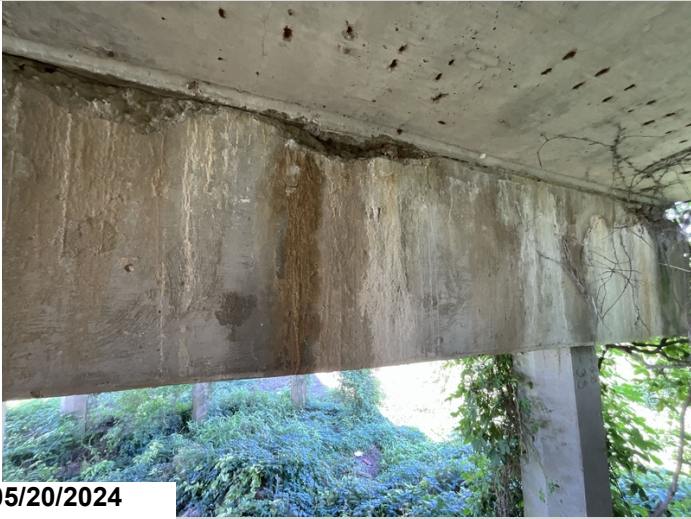
Bent 16, Pile Cap, Ahead, Left End, Between Piles 1 & 2:  
Three 1' (Length) x 6" (Height) spalls no exposed reinforcing  
steel. 3LF CS3 (Delamination/Spall/Patched Area)

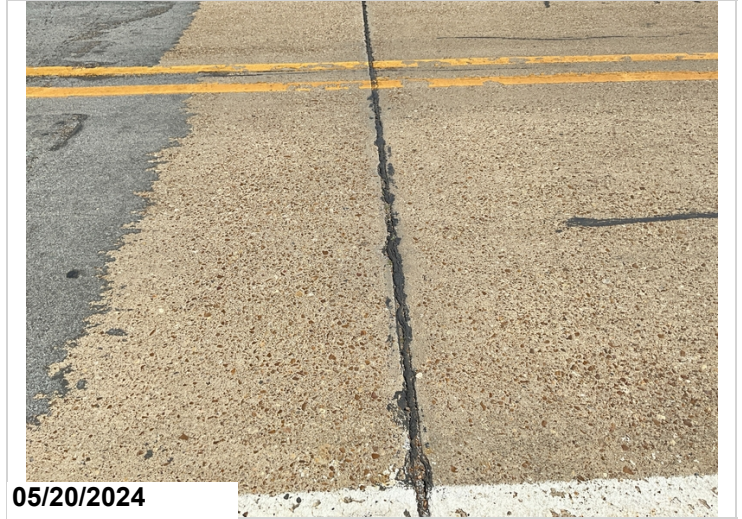
Typical joint

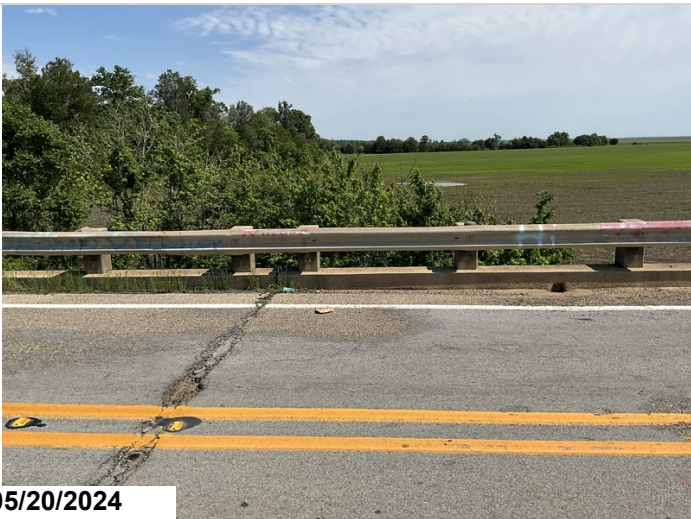
Metal Bridge Railing, Both Sides: Areas of graffiti.

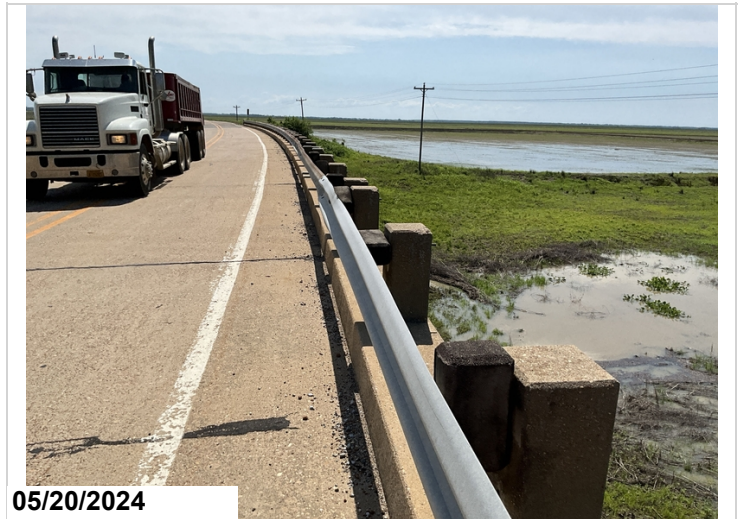
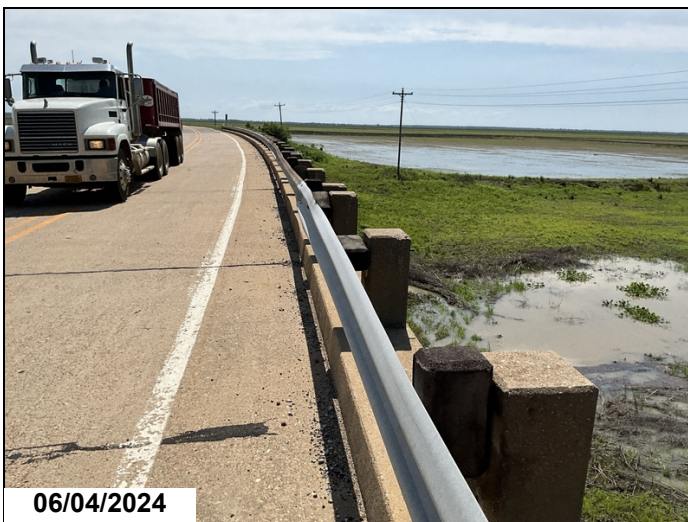
Span 4, 5 & 6, Metal Bridge Railing, Right Side: 30' of minor  
collision damage. 30LF CS2 (Distortion)

Span 4, 5 & 6, Metal Bridge Railing, Right Side: 30' of minor collision damage. 30LF CS2 (Distortion)

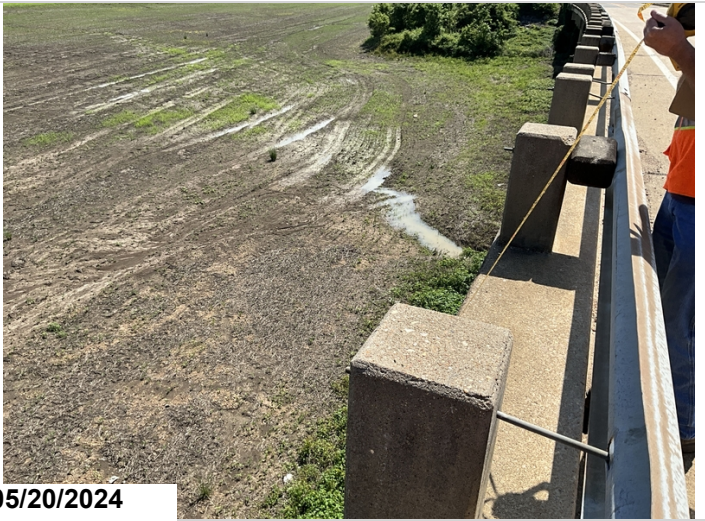
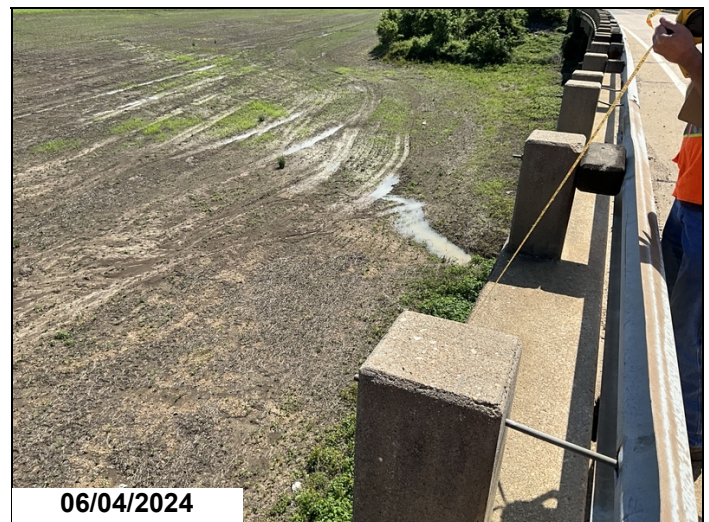
Span 6, Metal Bridge Railing, Left Side: Two missing rail post spacers. 2LF CS3 (Connection)

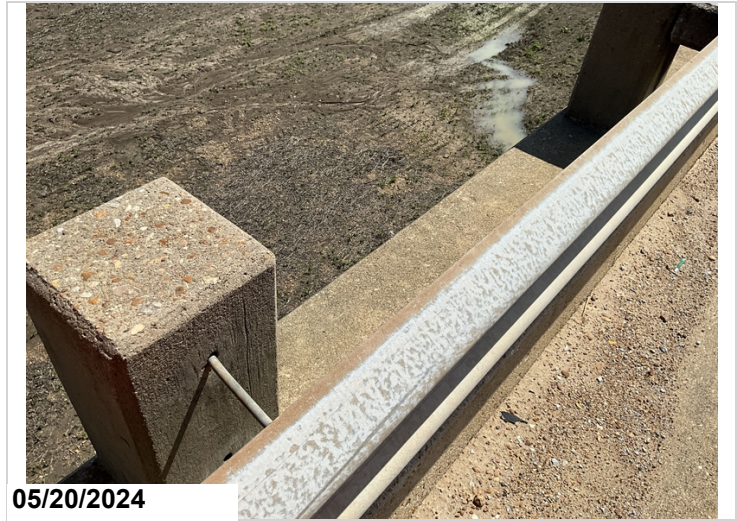
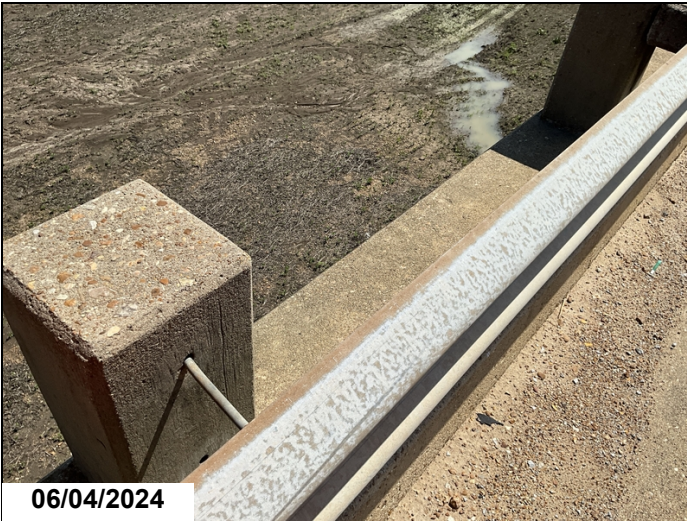
Span 7, Metal Bridge Railing, Left Side: One missing rail post spacer. 1LF CS3 (Connection)

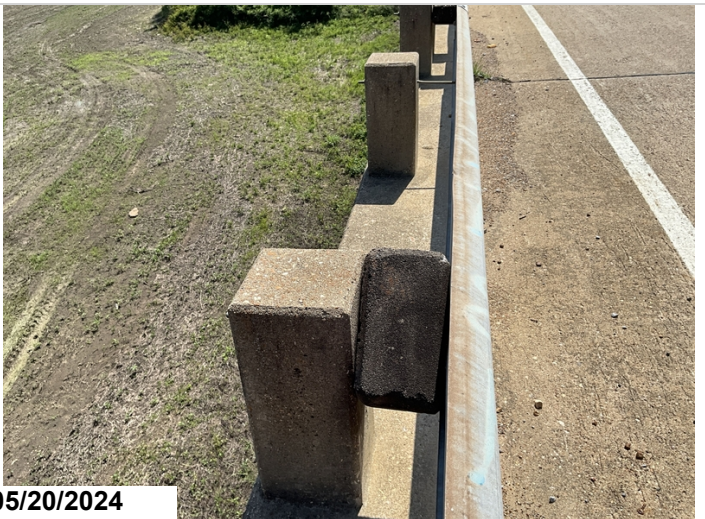
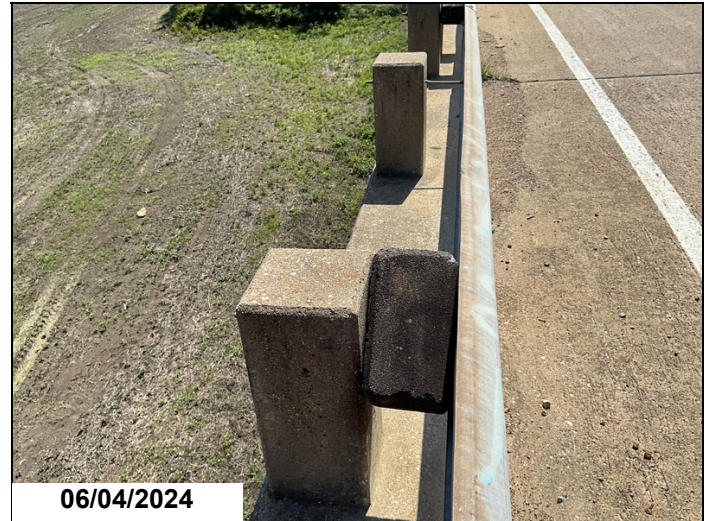
Span 9, Metal Bridge Railing, Left Side: One missing rail post spacer. 1LF CS3 (Connection)

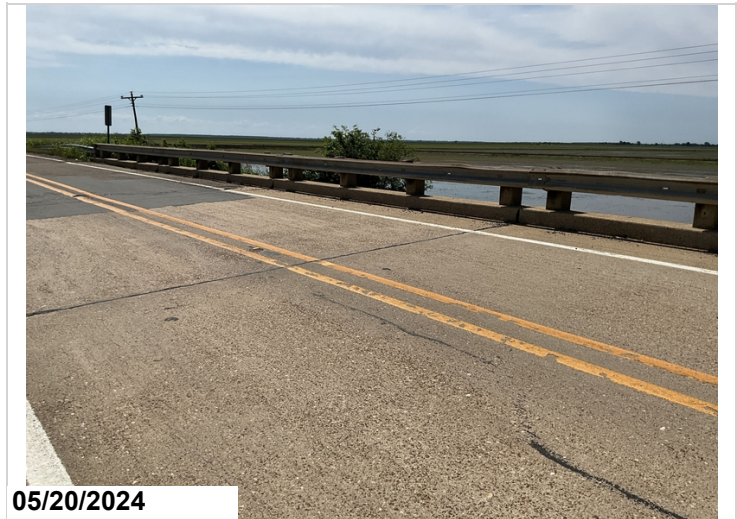
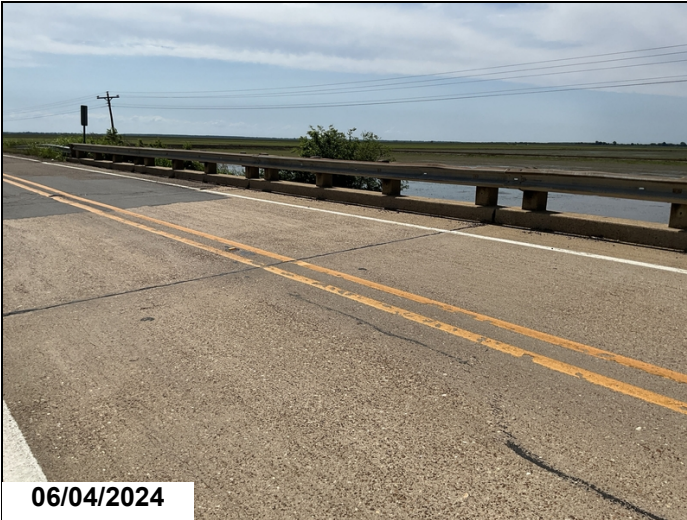
Span 14, Metal Bridge Railing, Right Side: 10' of minor collision damage. 10LF CS2 (Distortion)

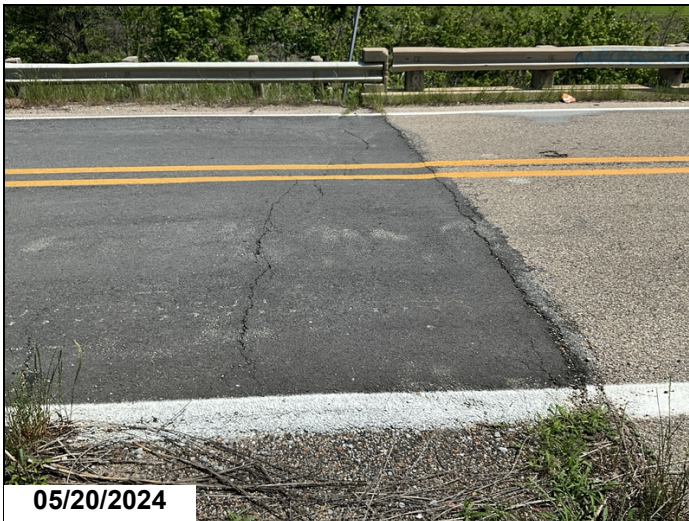
Abutment #1 approach roadway has settled up to 1".

05/20/2024 Approach 1 roadway has been repaired since last inspection.

05/20/2024 Approach 1 roadway has been repaired since last inspection.

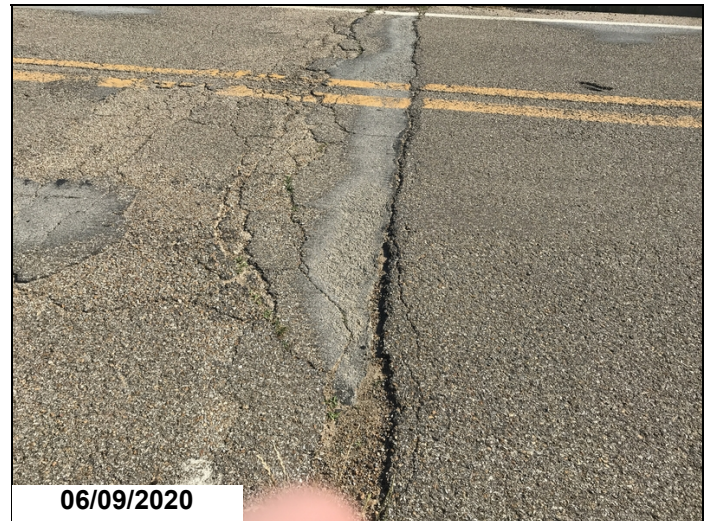
Abutment #1 approach roadway.

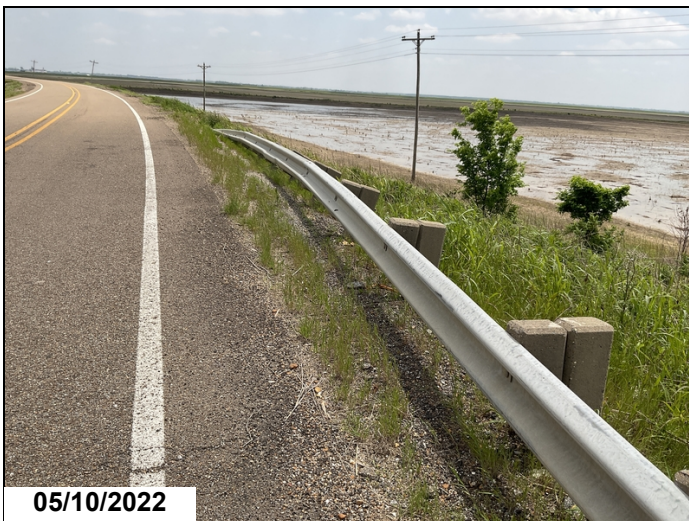
Abutment 2, Approach Rail, Right Side: Leaning out.

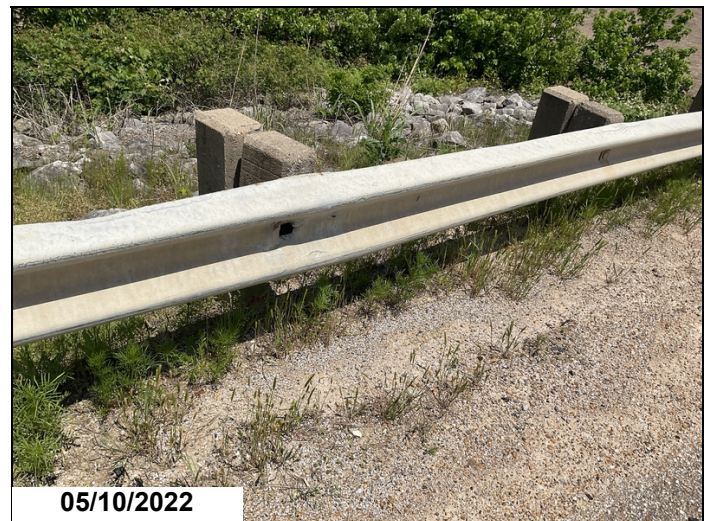
Abutment 1, Approach Rail, Left Side: Seventh post is not connected.

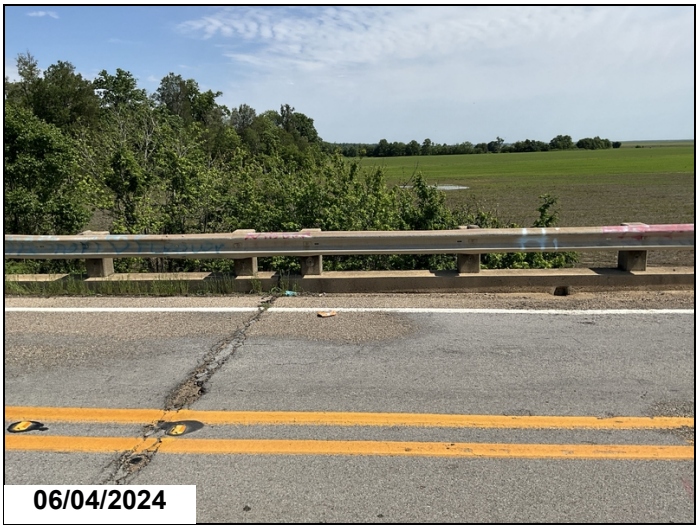
Metal Bridge Railing, Both Sides: Areas of graffiti.

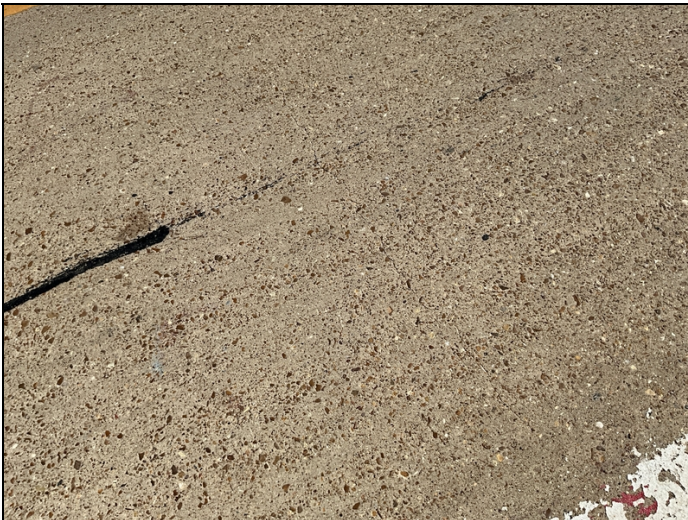
All Spans, Deck Surface: Transverse and longitudinal cracks. 1800SF CS2 (Cracking)

### A-54 - Sealable Deck Cracks (Yes)

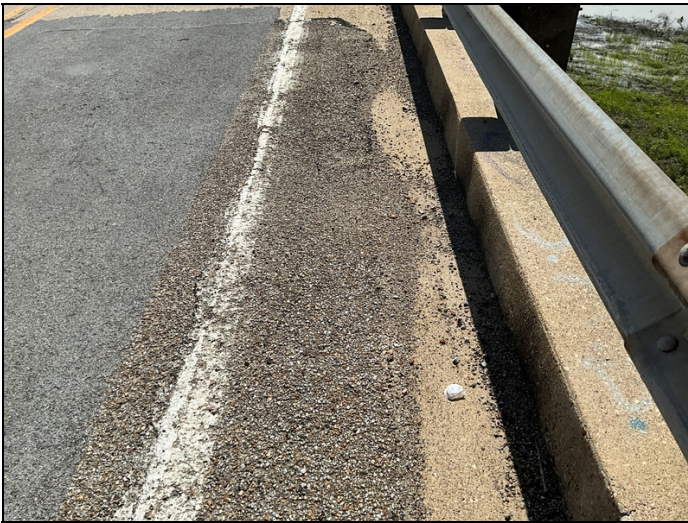
All Spans, Gutters, Full Length: Dirt and debris.

**A-55 - Deck Washing Needed (Yes)**

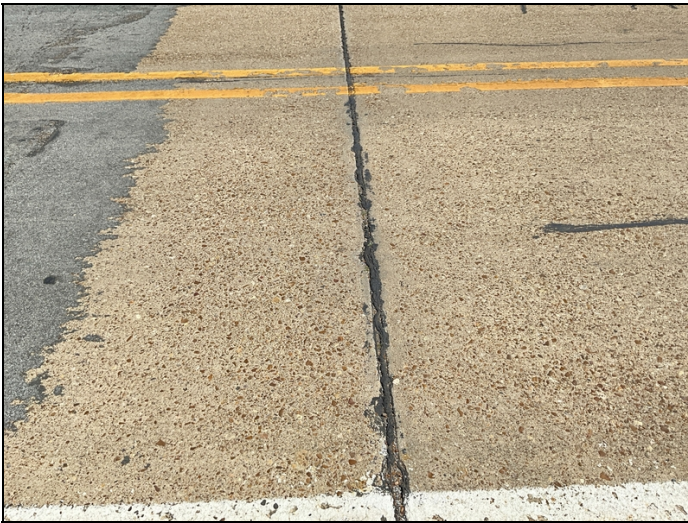
All Bents, Joints, Full Length: Areas of debris impacting them.

Typical joint

**A-59 - Joint Repair Needed (Yes)**

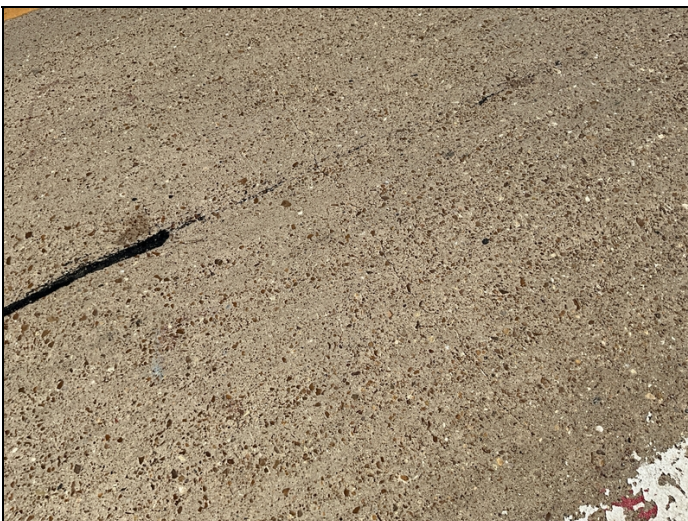
All Spans, Deck Surface: Transverse and longitudinal cracks. 1800SF CS2 (Cracking)

**A-61 - Polymer Overlay Advised (Yes)**

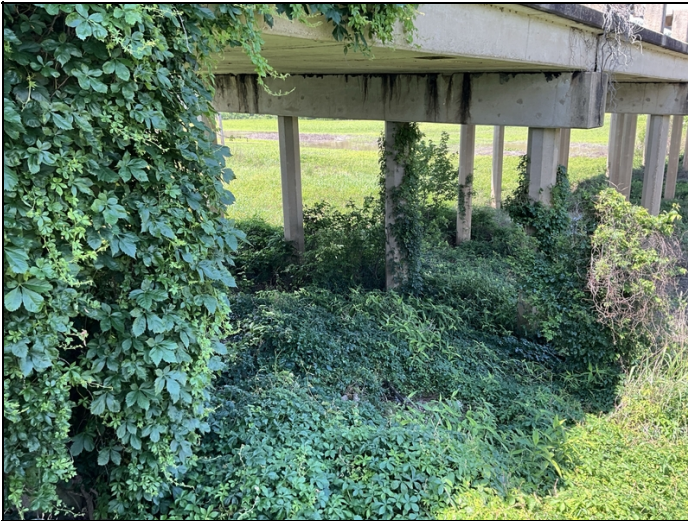
Vegetation is growing under, beside and on to bridge.

**A-64 - Vegetation Removal Requested (Yes)**

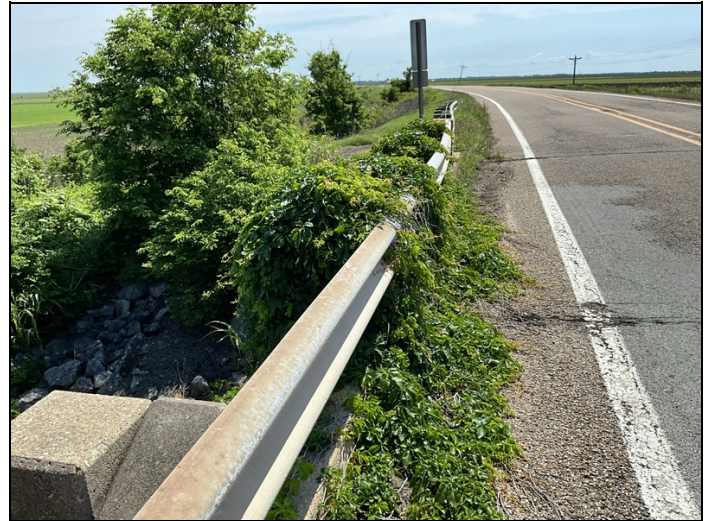
Vegetation growing onto roadway
