Bridge 02673 Inspection Report

Asset #02673(Routine, Underwater type 2)

I-40W/Sec52/278.83 over Ten Mile Bayou

Team Lead: Myron Futrell Inspection Date: 04/26/2022

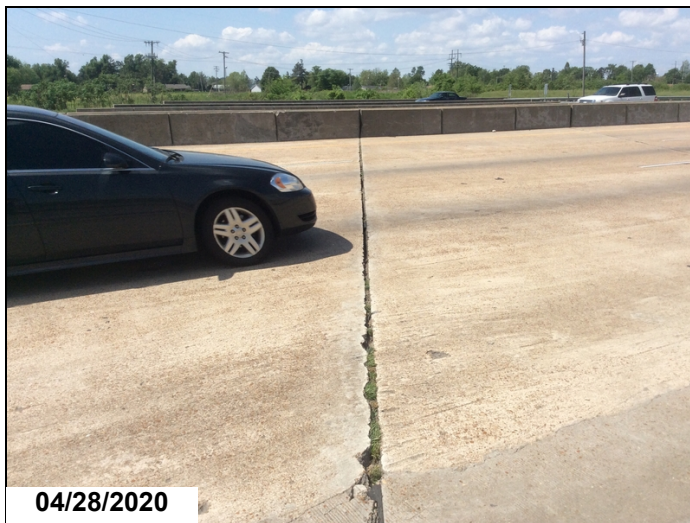
All deck joints are missing material.

Type of Work: Repair (General)

Status: Monitor

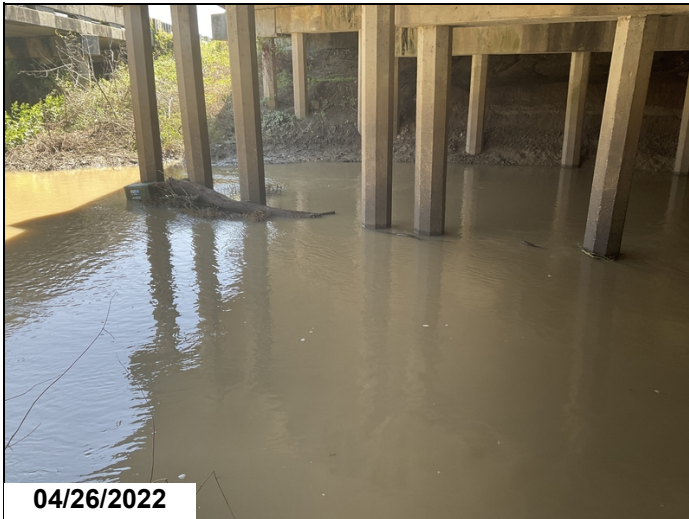
CHANNEL SMALL DRIFT AT BENT #3 LEFT SIDE.

4/26/2022-Large drift gone small drift remains.

Small drift in channel, bent #3 left side

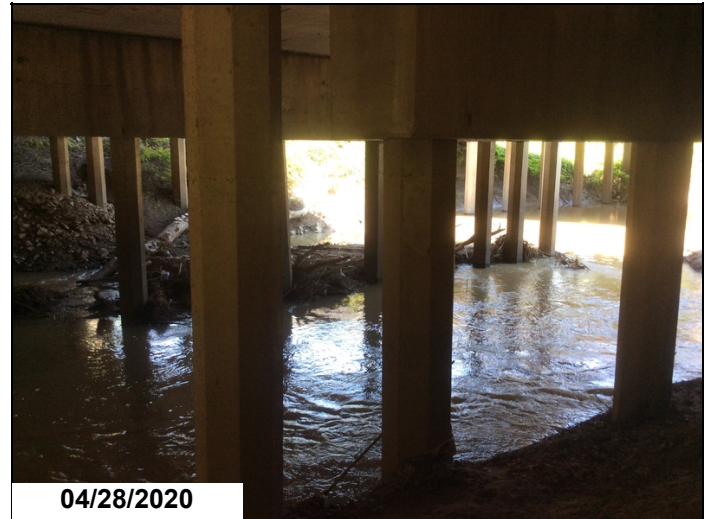
Large drift left side of bridge.

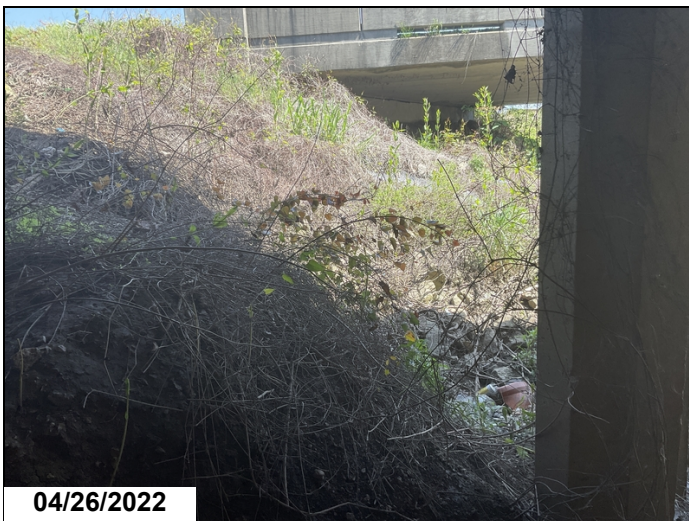
Abutment #1 left, right side slope is eroded with depths up to 3' extending down slope to bent #2.
Scouring of slope at bent #4 exposing (+/-)3' of piles from original slope line.

Erosion abutment #1 left side

Type of Work: Repair (General)

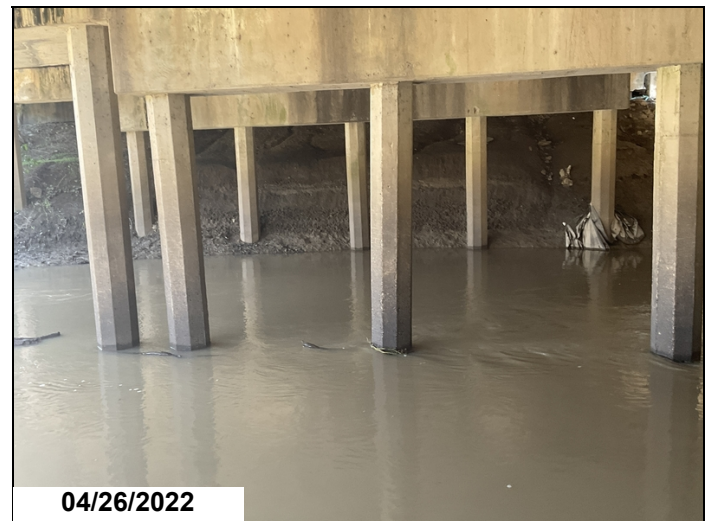
Scouring of slope at bent #4 exposing (+/-)3' of piles from original slope line.

Erosion at bent #4

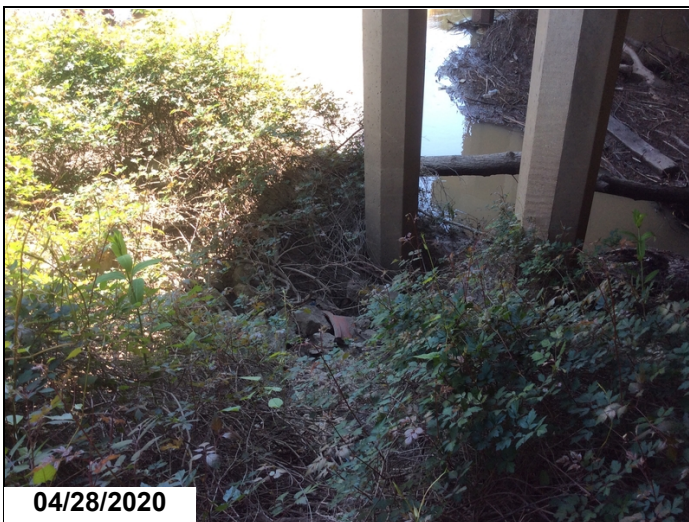
Abutment 1 left side slope.

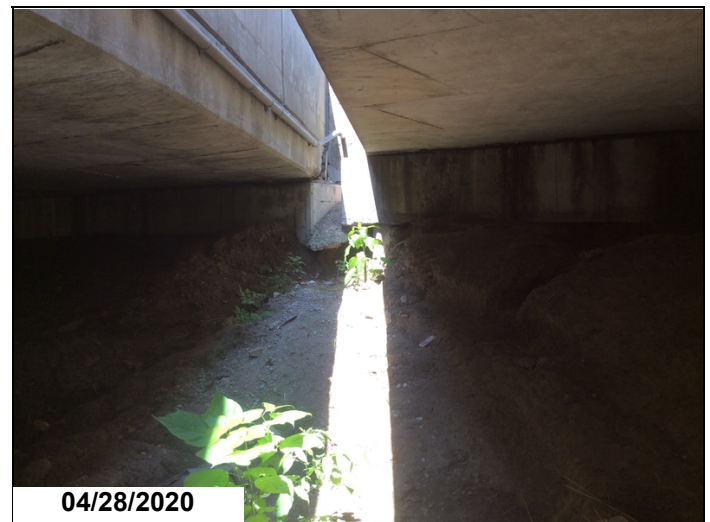
Abutment 1 right side slope.

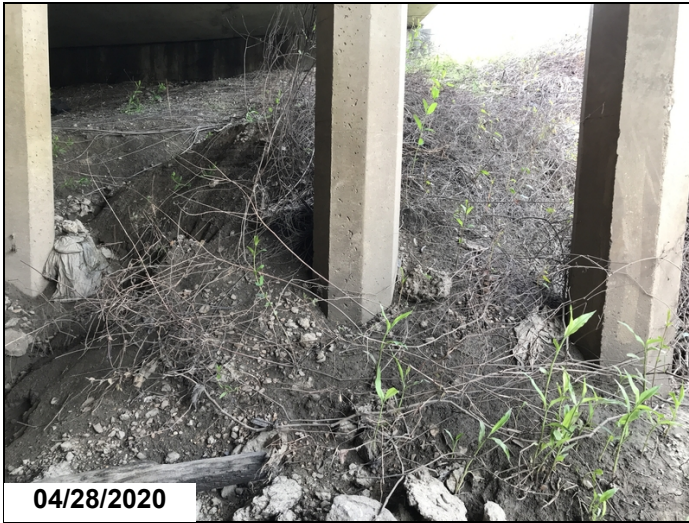
Abutment #1 left, right side slope is eroded with depths up to 3' extending down slope to bent #2.

Abutment #1 slope erosion.

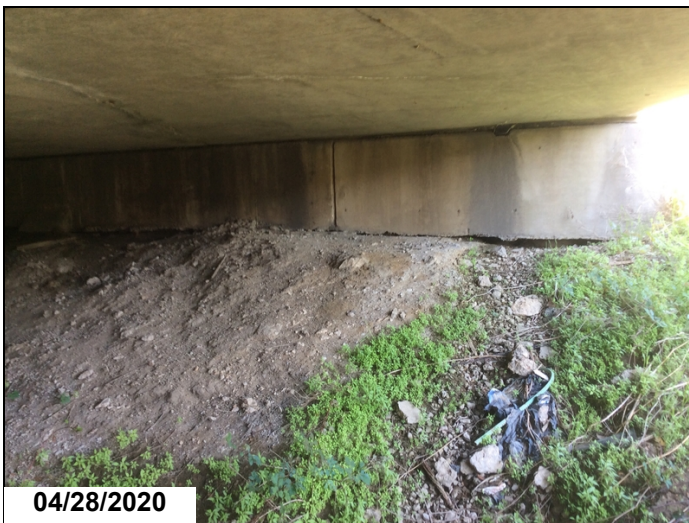
Abutment #1 cap left end is undermined 6" for a length of 6' exposing pile #1.

Abutment 1 cap undermined left end.

Type of Work: Repair (General)

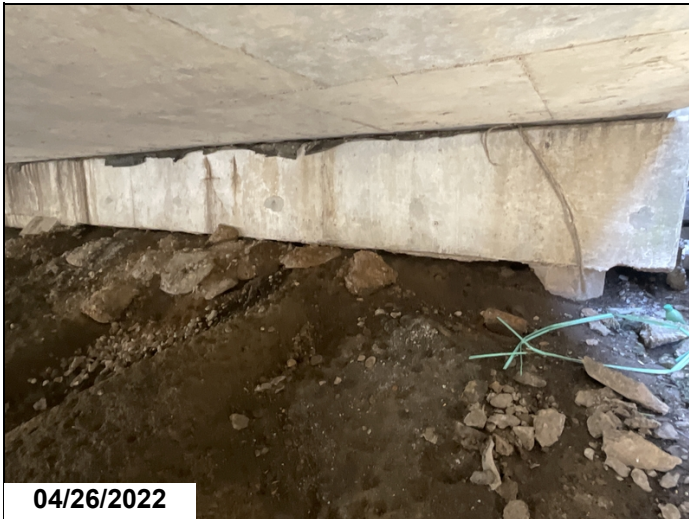
Abutment cap 2 right end is undermined up to 1' for 15'.

4-26-2022 added more erosion.

Abutment 2 right end is undermined up to 1' for 15'.

Type of Work: Repair (General)

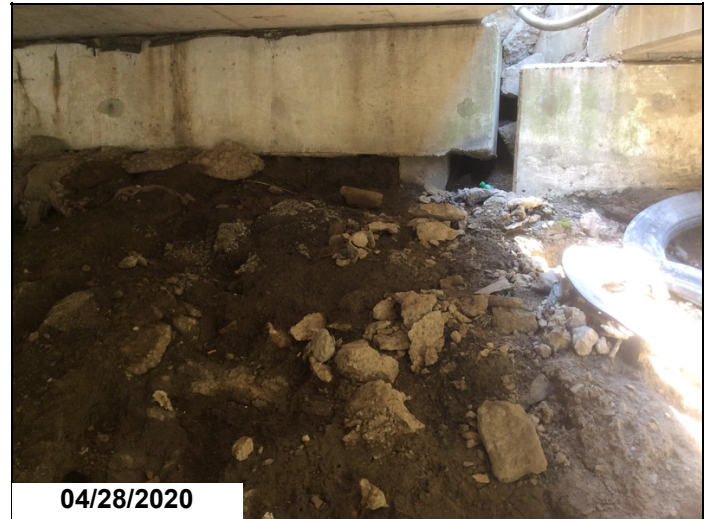
Abutment 2 right end is undermined 1' for 3'.

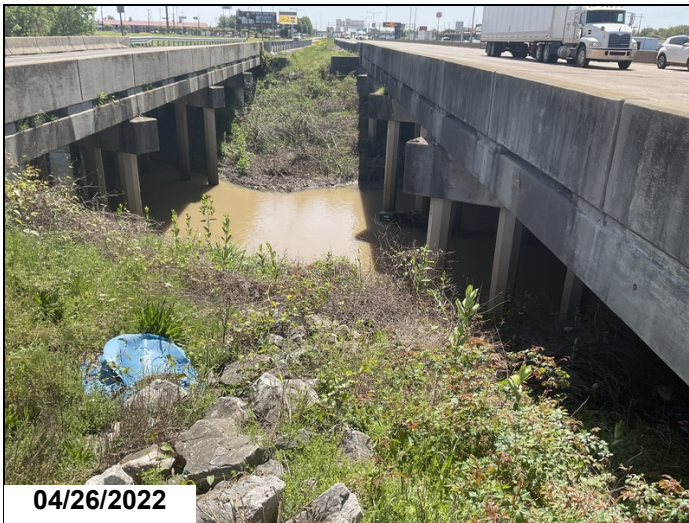
Vegetation growing beside and under bridge

Type of Work: (Inactive) (Inactive) 1 - Clean

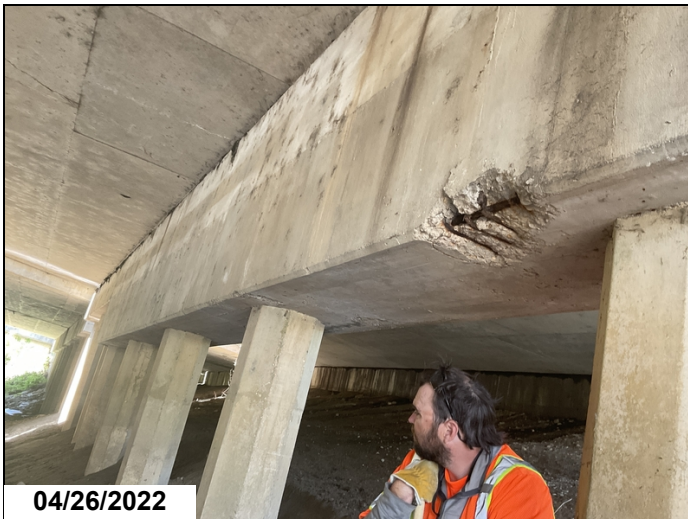
04/26/2022

Bent #2 ahead face

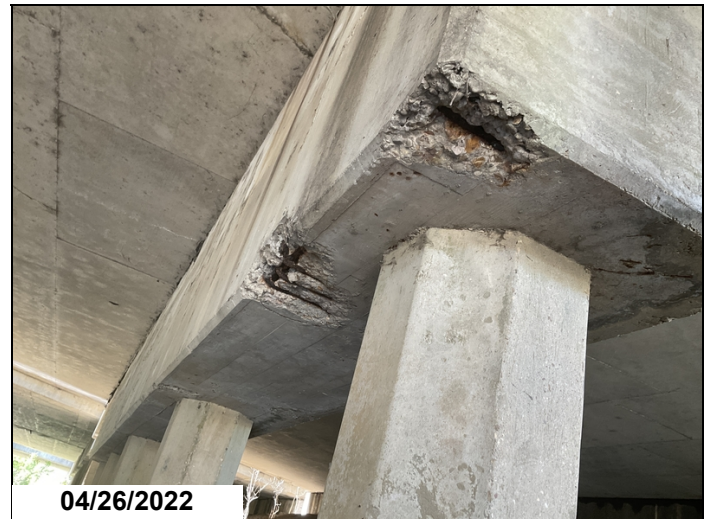
04/26/2022

Bent #2 cap ahead, bottom face has two one foot spalls with exposed rebar by pile #5.

Type of Work: Repair (General)

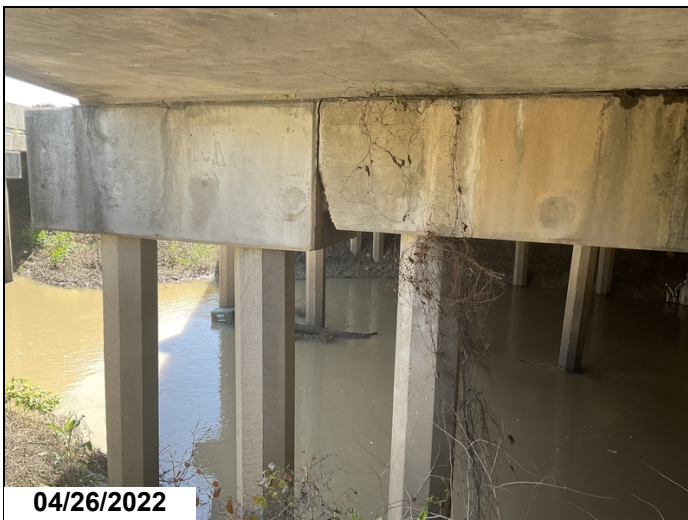
04/26/2022

Bent #2,3 cap left side at construction joint has 1' spall with no exposed rebar.

Bent #2 cap back face, left side spalled at construction joint

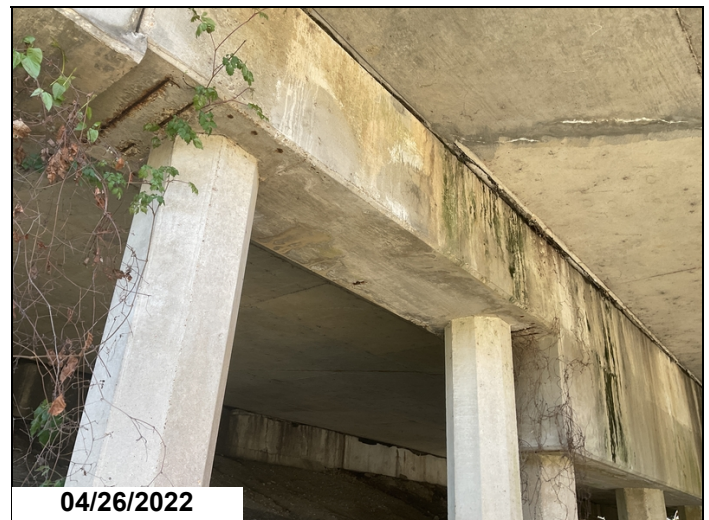
04/26/2022

Bents 3&4 small spalls on bottom of cap at bent #3 piles (8 & 11) and bent #4 (3,4 & 11).

Exposed rebar, bent #4 cap bottom face left side by piles #3 and 4.

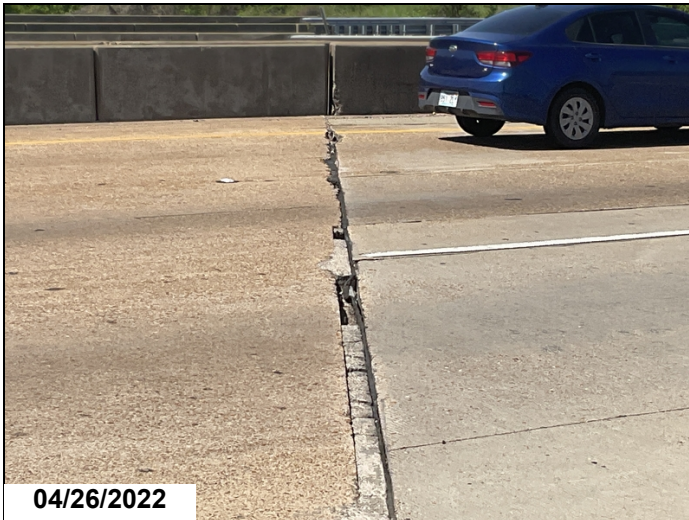
Abutment #1 joint left side adjacent header spalled for six feet

Type of Work: Repair (General)

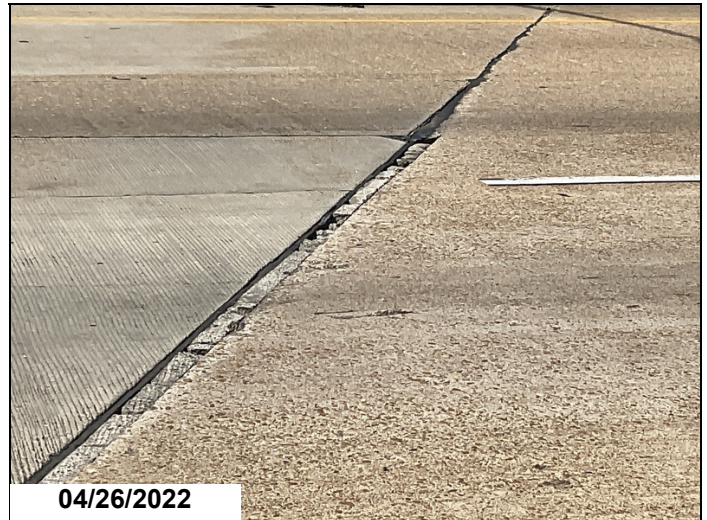
Abutment #2 joint left side adjacent header has twenty feet of cracking and spalling

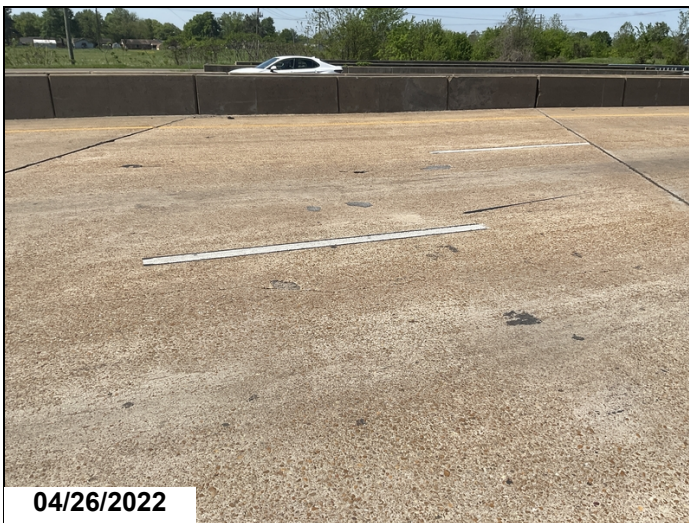
04/26/2022

Span #3 center and right lanes have one foot shallow spall each.
Span #4 deck has one foot long narrow spall at centerline

Span #3 center and right lanes have one foot shallow spall each.

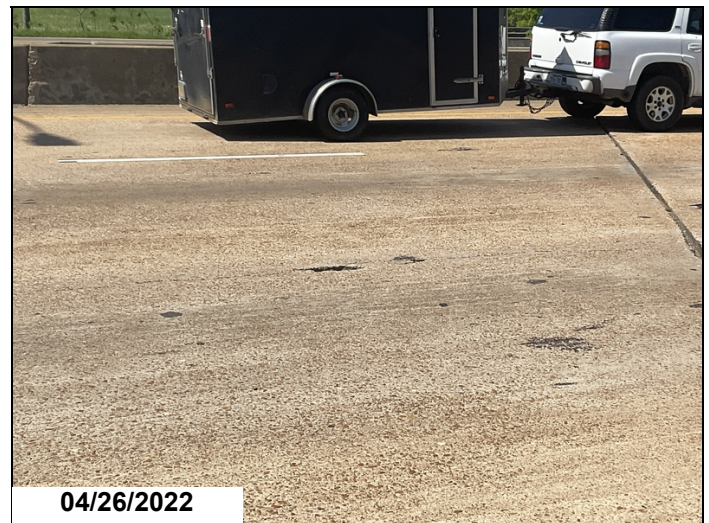
04/26/2022

Span #4 deck has one foot long narrow spall at centerline

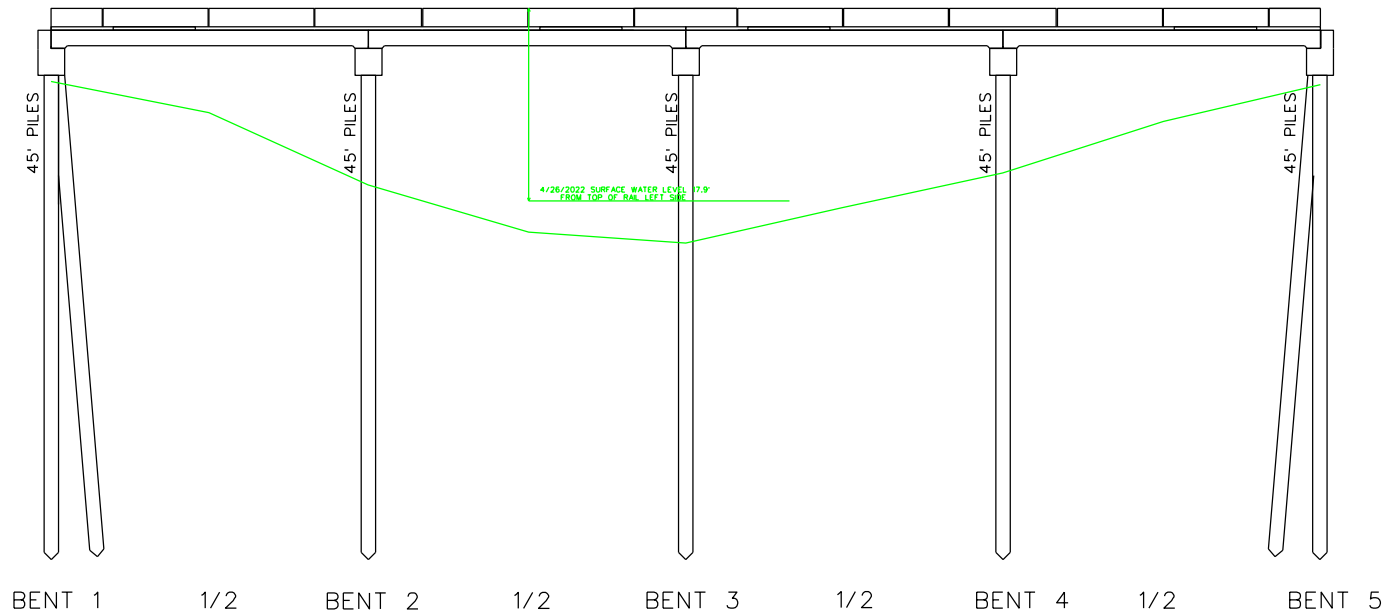
BRIDGE #02673
CHANNEL PROFILE
LEFT SIDE

04/26/2022 6.8' 9.8' 16.4' 20.8' 21.8' 18.5' 15.3' 10.5' 7.1'
