## **Bridge A2673 Inspection Report**

I-40EB/Se52/278.83 over Ten Mile Bayou

Location: West Memphis By-Pass

Team Lead: Myron Futrell Inspection Date: 09/21/2022

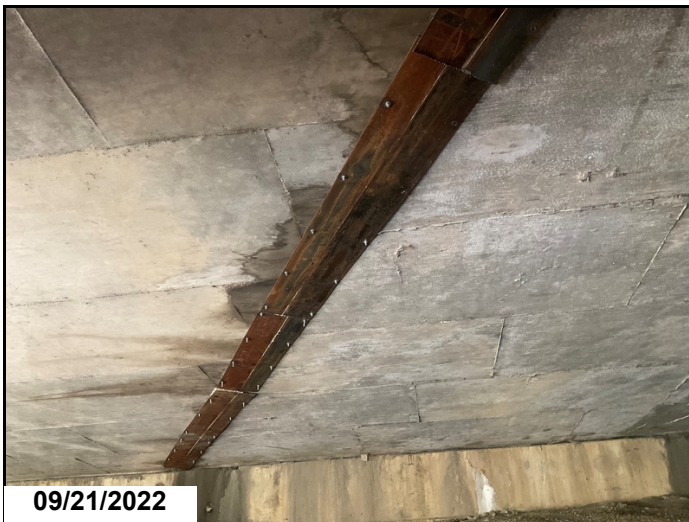
Slabs have up to four inch+ gap between left and right slabs in span #1 at abutment #1 and up to two inches in span #2, tapering to closed at bent #3. Right half of slab has rotated to the south at abutment #1 to bent #3.

Span #1 soffit / underside of deck at slab separation repair

9/21/2022-Four inch gap between left and right slabs in span #1 at abutment #1 has been patched with concrete with steel plates underneath. The two inch gap between slab sections in span #2, tapering to closed at bent #3, still remains.

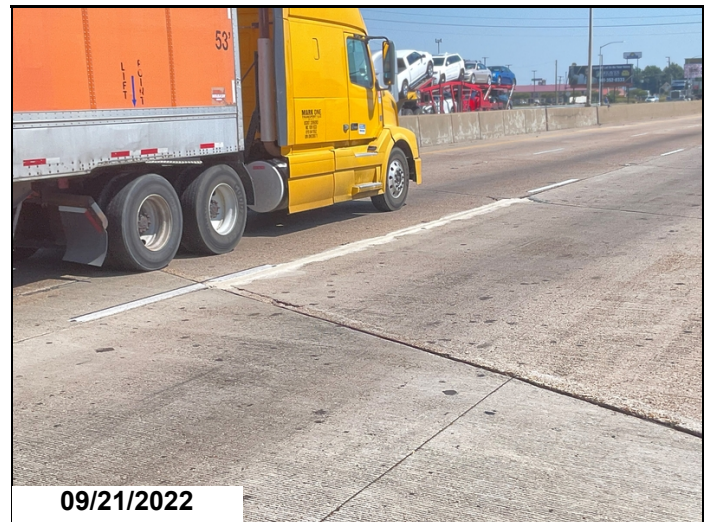
Span #1 slab repair.

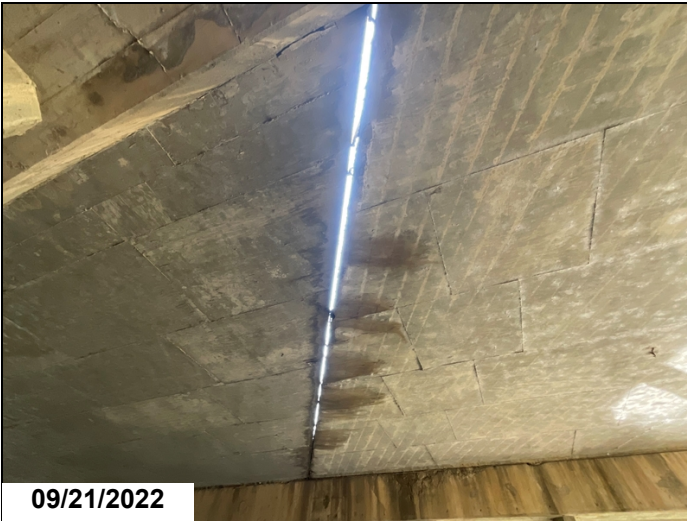
Span #2 soffit between slabs approximately 2" gap at bent #2

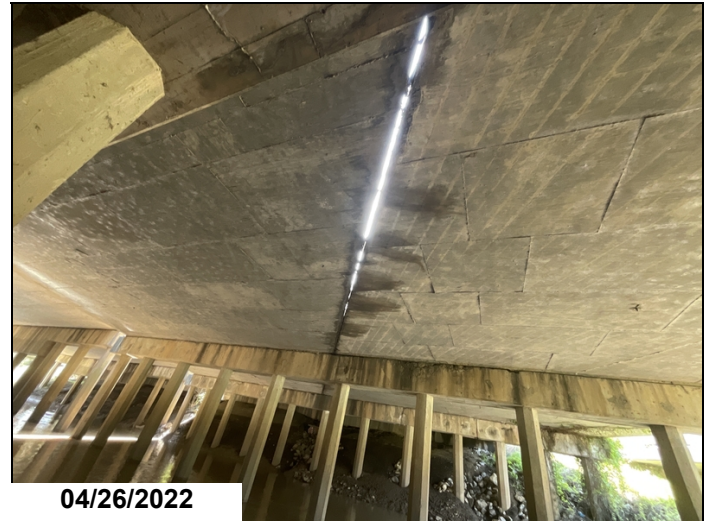
Span #2 soffit / underside of deck

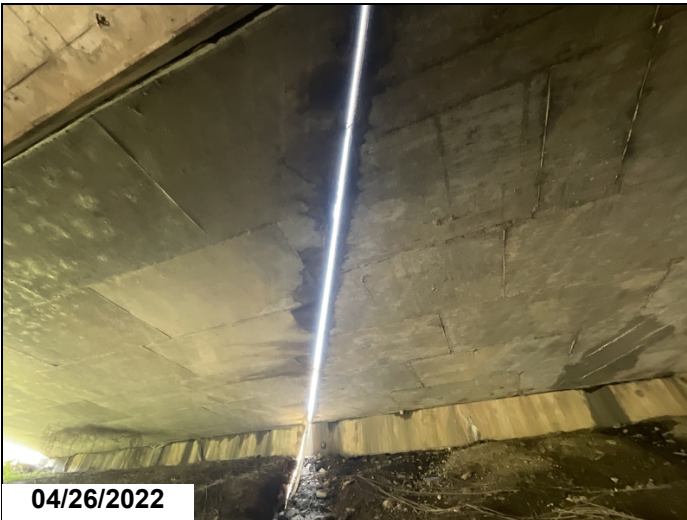
Slabs have up to four inch+ gap between left and right slabs in span #1 and up to two inches in span #2.

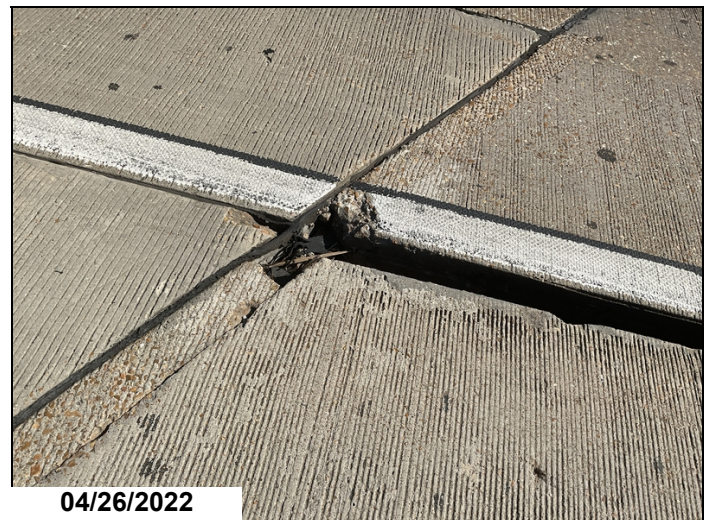
Span #1 deck right lane at abutment #1

Span #1 right lane has two, one foot spalls at joint.

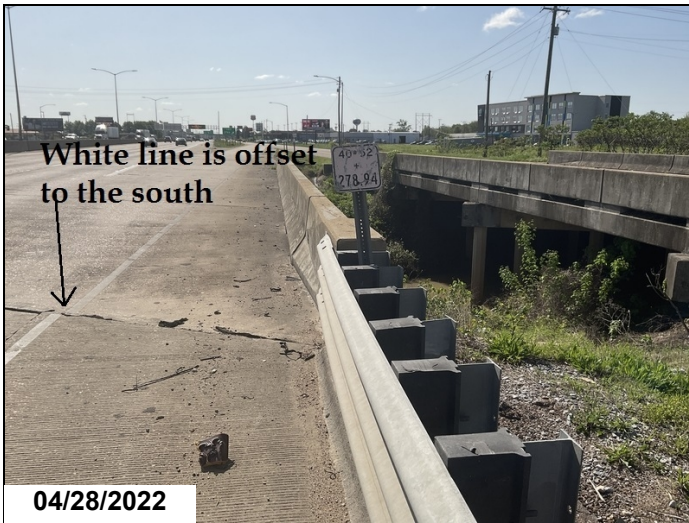
Abutment #1 right white line offset due to right half of slab rotating to the south.

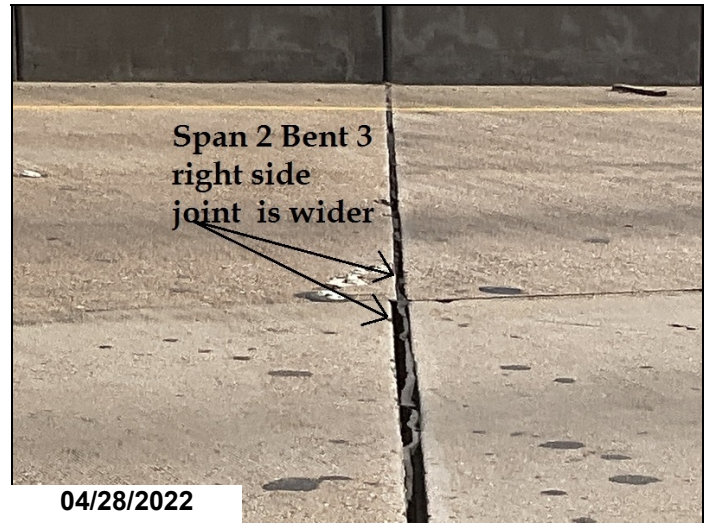
Difference between joint widths bent #3, spans #2 and 3, right side.

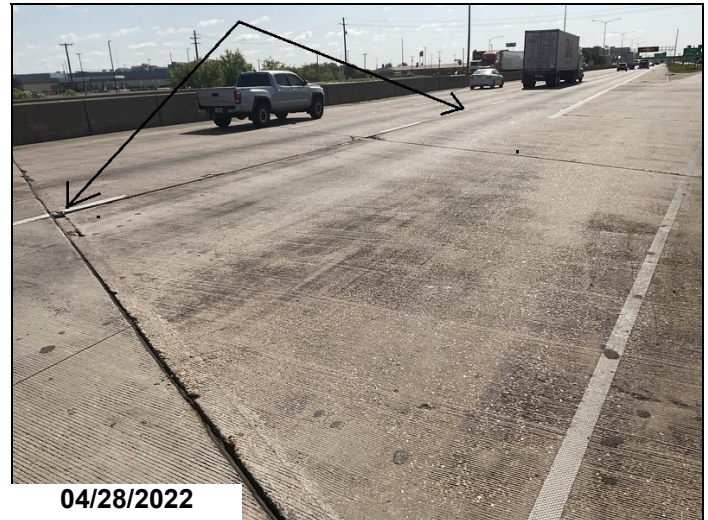
Length of gap between spans

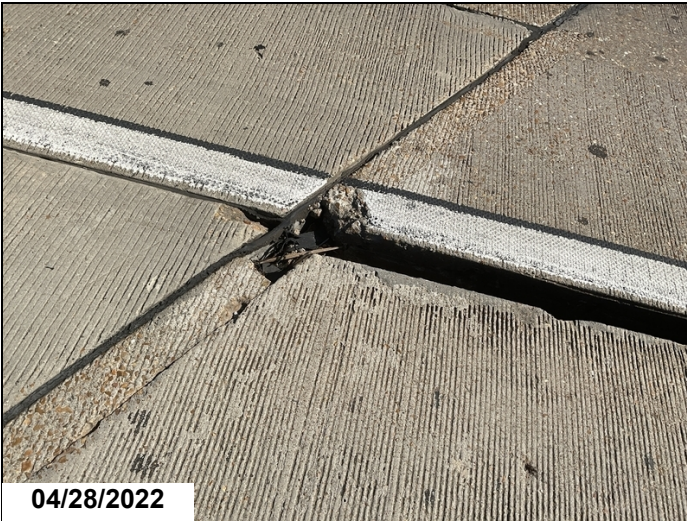
Joint between right and left slabs at abutment #1

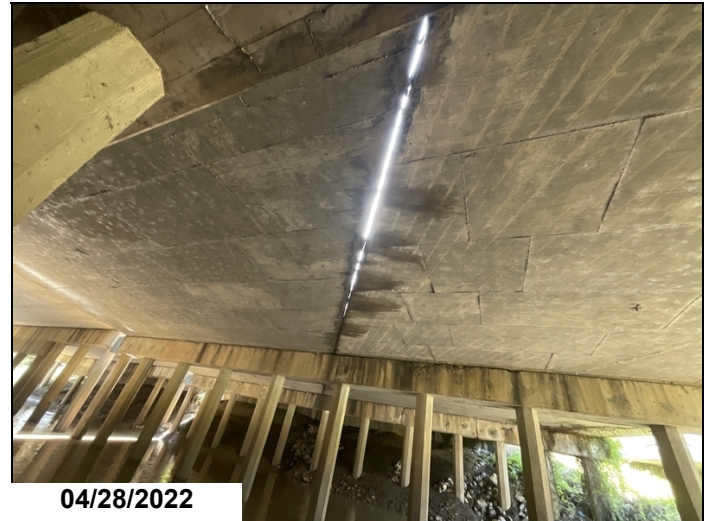
Span #2 under side of deck at joint between right and left slabs.

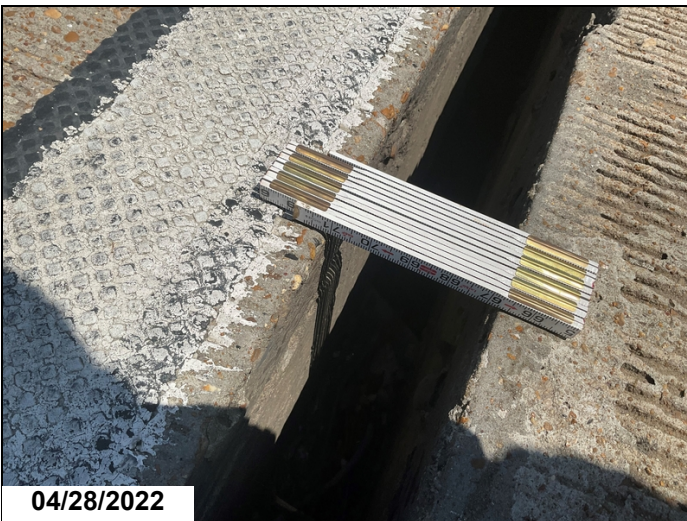
Width of gap between right and left slabs near abutment #1.

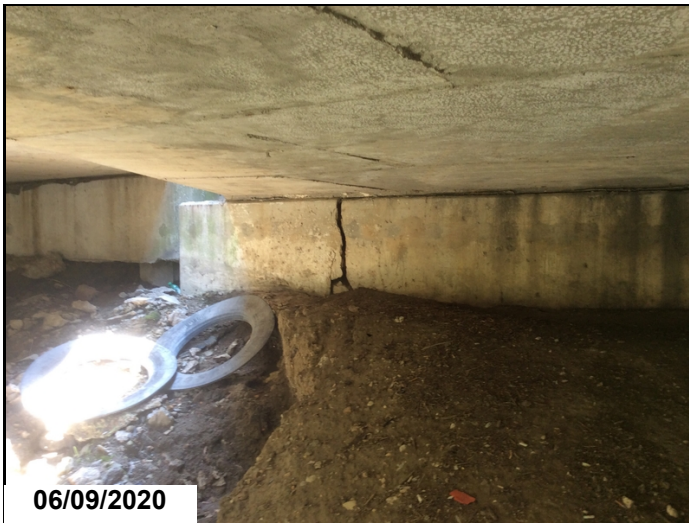
Abutment #2 cap has 1 ½" wide vertical crack 6' right of left end of cap.

Abutment 2 left end crack.

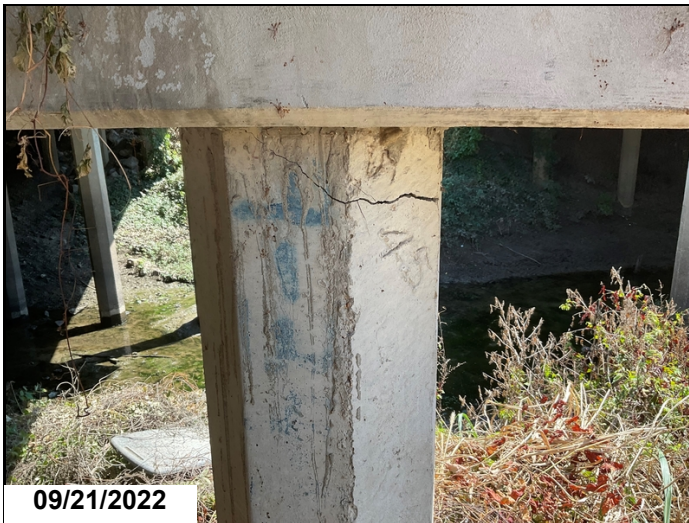
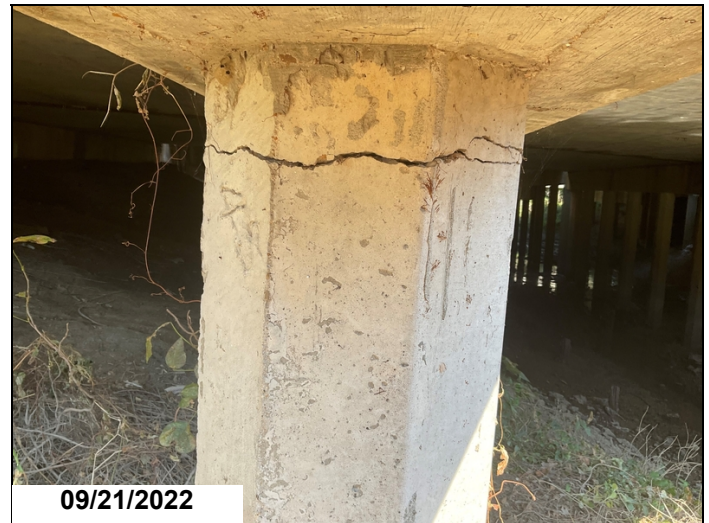
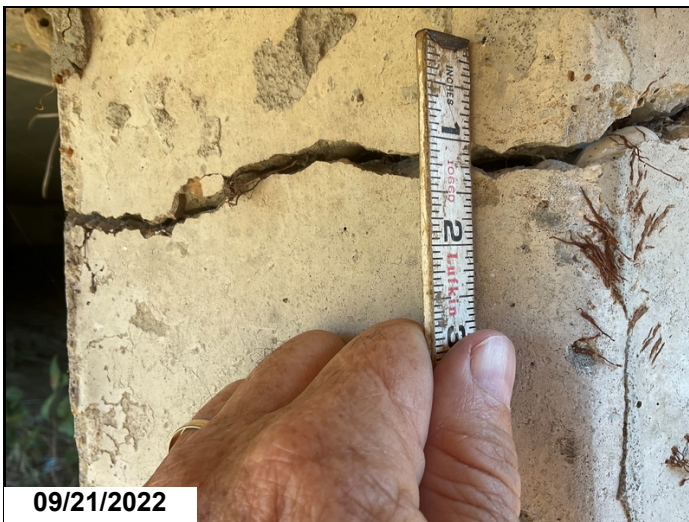
(227) Bent #2 pile #12 has 1/4" wide horizontal crack approximately 4" below cap.							
234	Reinforced Concrete Pier Cap	LF	385	357	15	13	0
1080	Delamination/Spall/Patched Area	LF	15	0	2	13	0
1090	Exposed Rebar	LF	1	0	1	0	0
1120	Efflorescence/Rust Staining	LF	12	0	12	0	0

Bent #2 pile #12 has 1/4" horizontal crack approximately 4" below cap.

1/4" crack in bent #2 pile #12

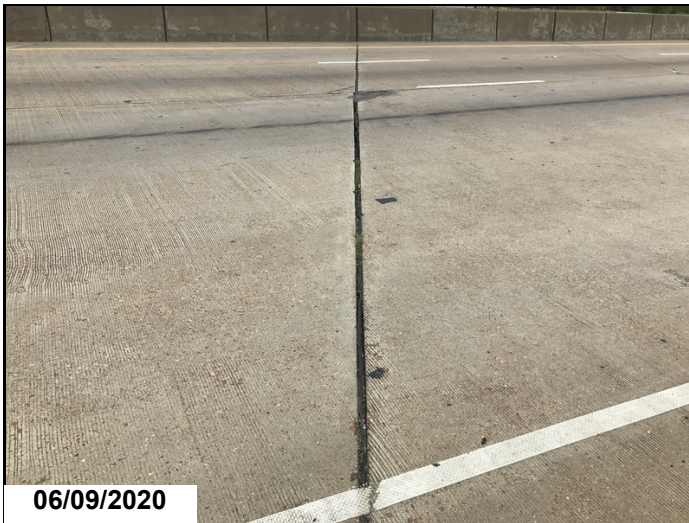
Joint material is weathered and cracked with areas of loss of adhesion.

Typical joint

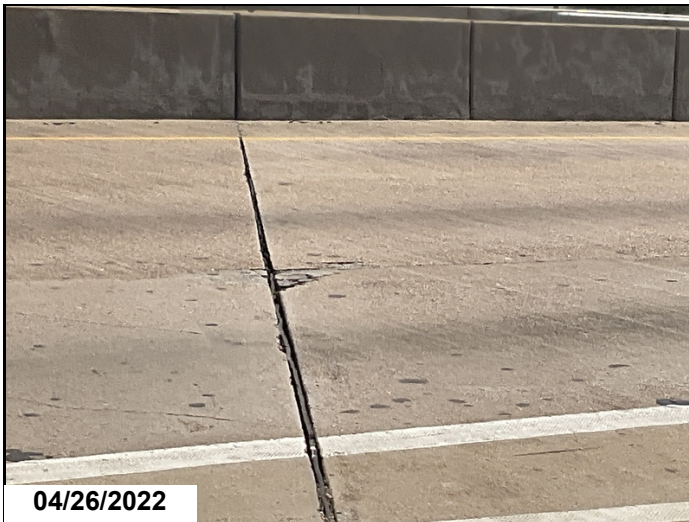
Span #4 bent #4 at center line has two foot patched area

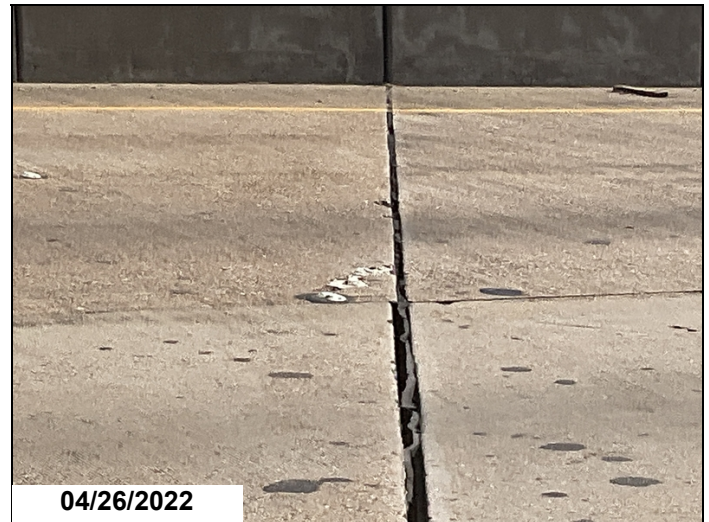
Bent #3 span #2 at center line has two foot cracked / delaminated area.

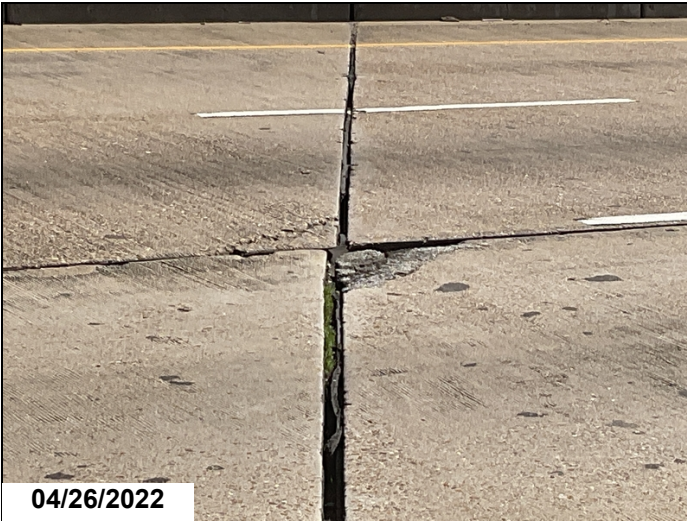
Bent #2 span #2 at center line has two foot cracked / delaminated area, span #3 has patched area

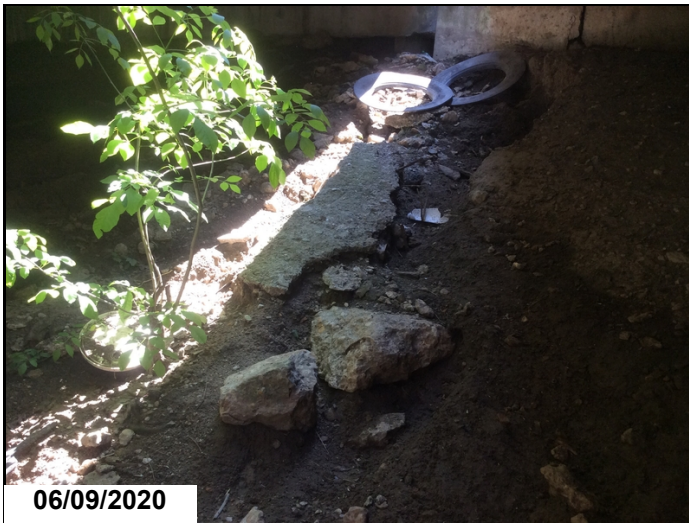
Abutment 2 left side has erosion up to 2' deep.

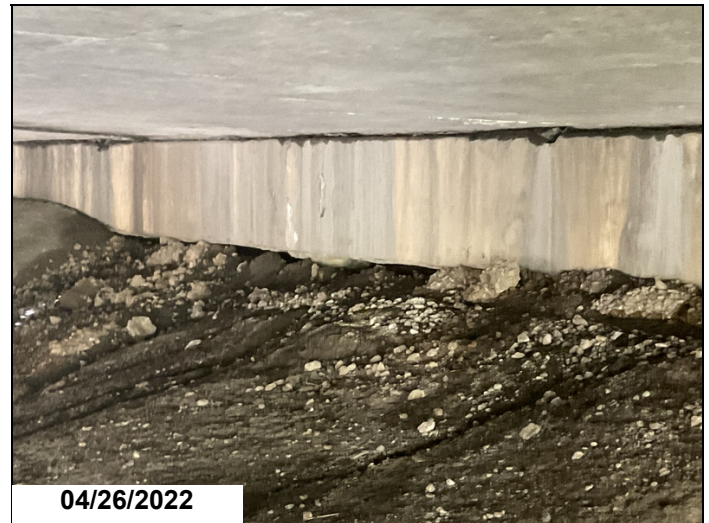
Abutment #2 cap undermined for fifteen feet at center line up to one foot exposing two piles.

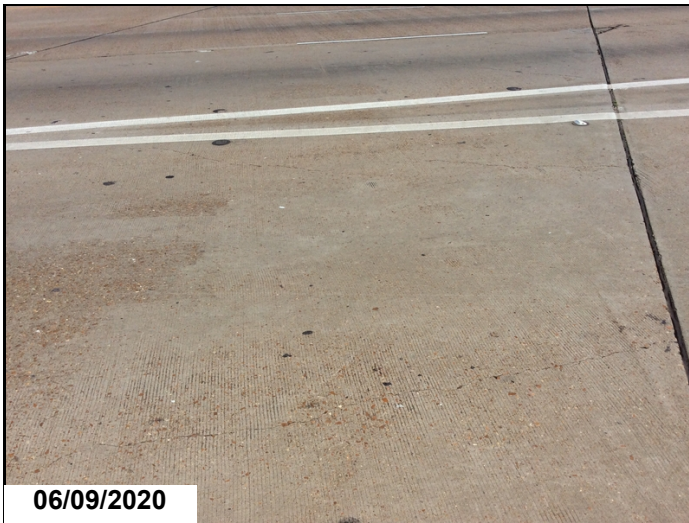
Deck has open transverse and longitudinal cracks.

Typical deck crack.

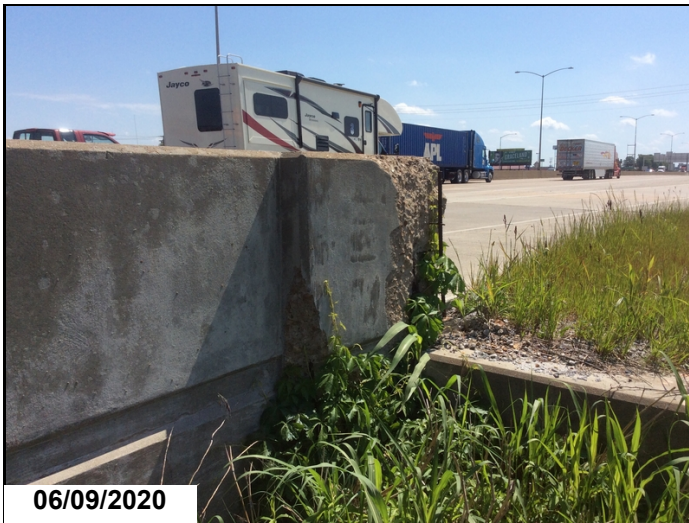
Abutment #2 right side bridge rail as a three foot spall with exposed rebar on back side.

Abutment 2 right side bridge rail.

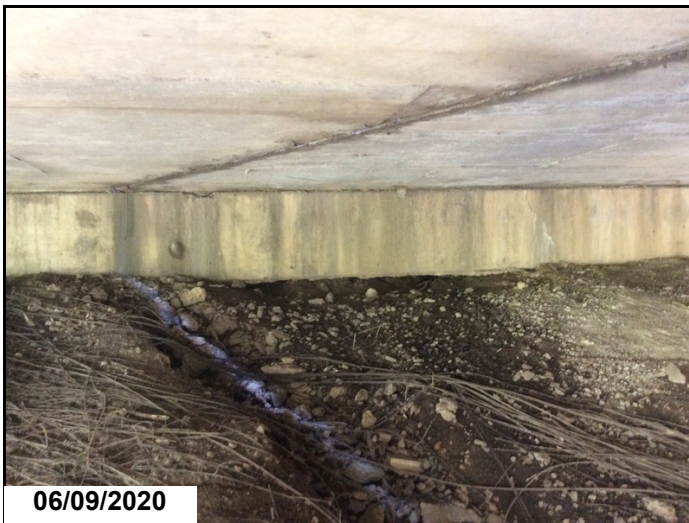
Abutment #1 cap is undermined 1' deep for 10' length at center line.

Abutment 1 cap undermined.

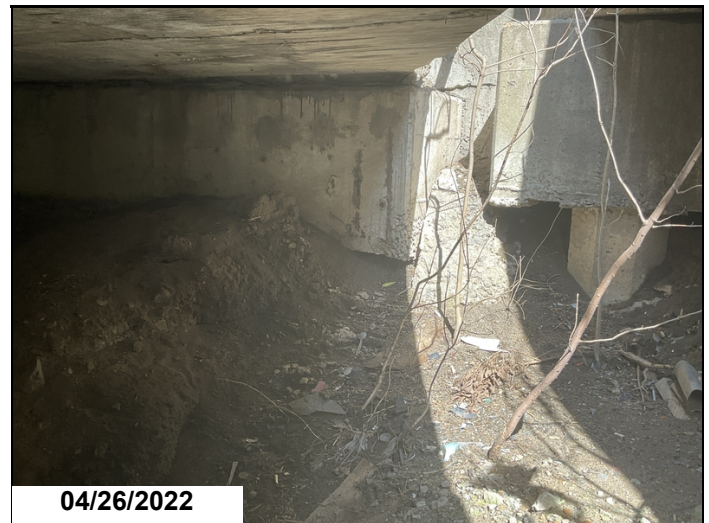
Abutment #1 cap left end undermined up to six inches for one foot.

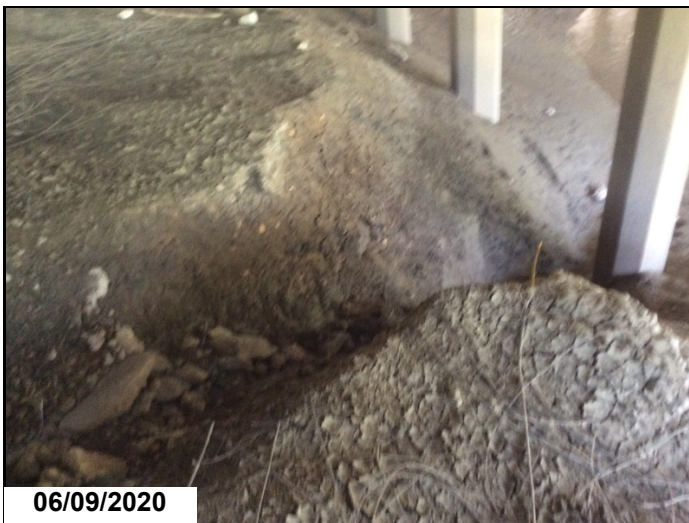
Abutment #1 slope is eroded at center line with depths up to 5' extending down slope.

Span 1 slope in center.

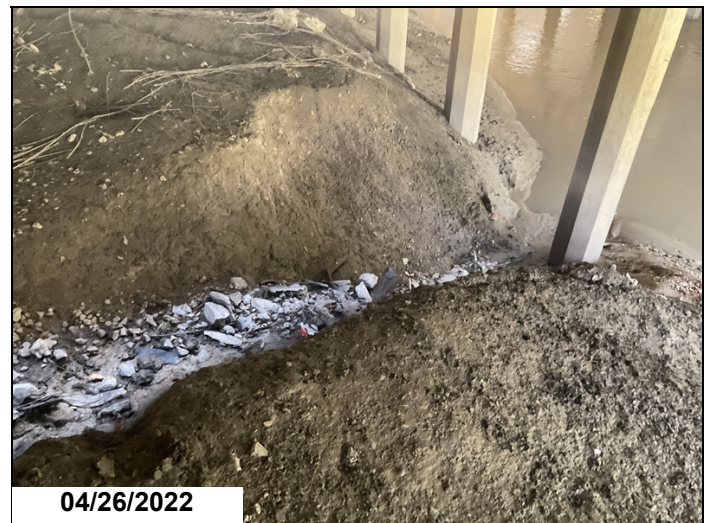
Abutment #1 slope erosion between piles #6 and 7.

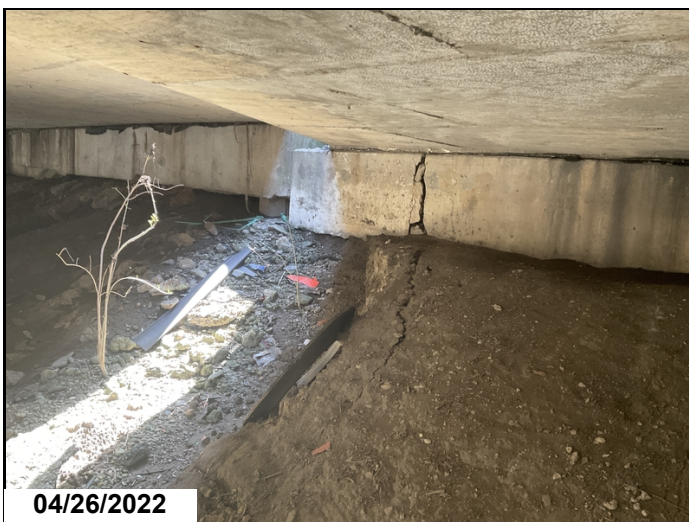
Abutment #2 cap left side cracked and slope eroded.

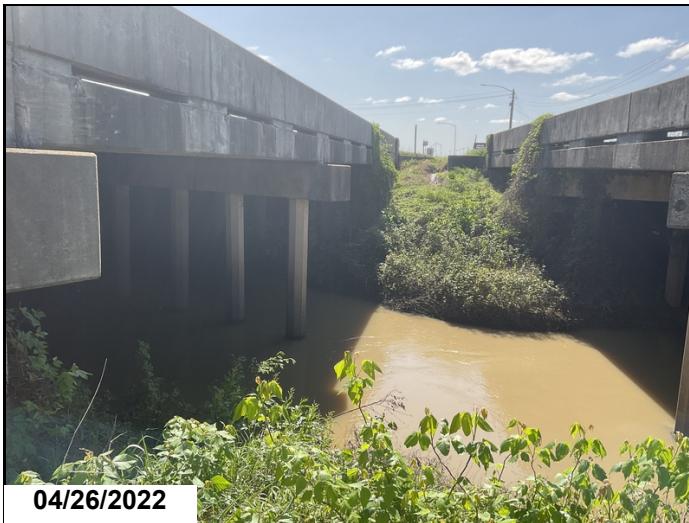
Vegetation growing beside, under and onto bridge.

Vegetation growing beside, under and onto bridge, right side.

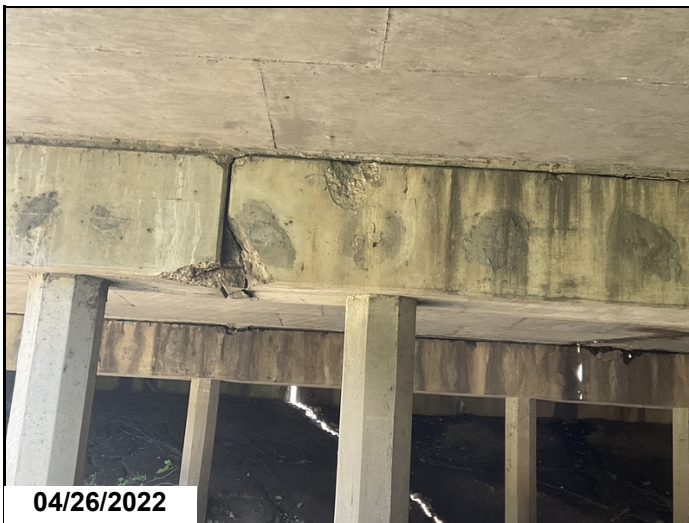
Bent #3 cap between piles 9,10 has a spall with exposed rebar on ahead face and one foot shallow spall with no exposed rebar.

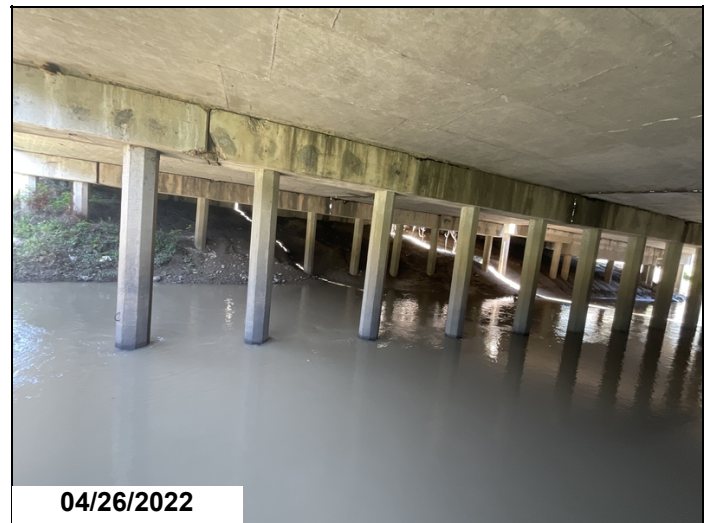
Bent #3 ahead face

Bent #2 cap back face above pile #1 has a two-foot delaminated area.  
Bent #2 cap back face above pile #11 has two, six-inch delaminated areas.  
Bent #2 cap ahead face between pile #5 and #6 has a one-foot delaminated area.  
Bent #3 cap back face above pile #7 has a four-foot delaminated area.  
Bent #3 cap back face between pile #10 and #11 has a two-foot delaminated area.  
Bent #3 cap between piles #9 and #10 has a spall with exposed rebar on ahead face.  
Bent #4 cap ahead face has a one-foot delaminated area between piles #5 and #6 and a two-foot delaminated area above pile #3.  
Bent #4 has a one-foot spall at key way on ahead face above pile #8 with no exposed rebar.  
Bent #4 cap ahead face between piles #9 and 10 has vertical crack at joint.  
Bent #4 cap ahead face between piles #1 and #3 has a one-foot delaminated area.  
Caps have vertical cracks some with light efflorescence.

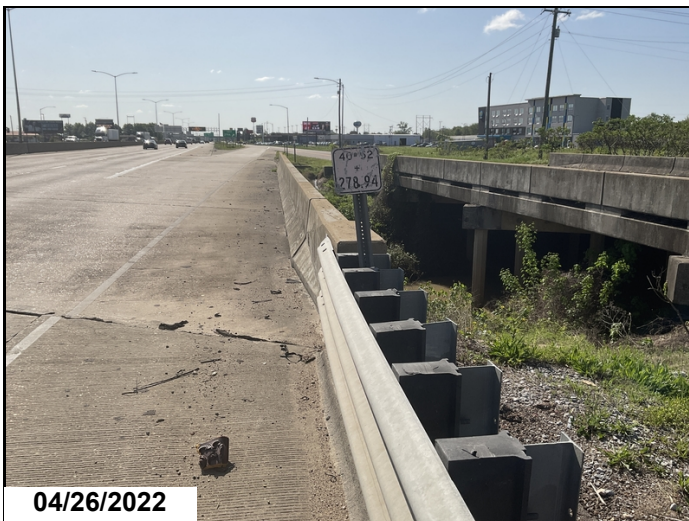
Abutment #1 log mile sign

Log mile sign should be 278.83.
