Bridge Inspection Report

03290
SH 119-02- LM 4.79
over
I 55-SEC 12

Structure Number: 03290

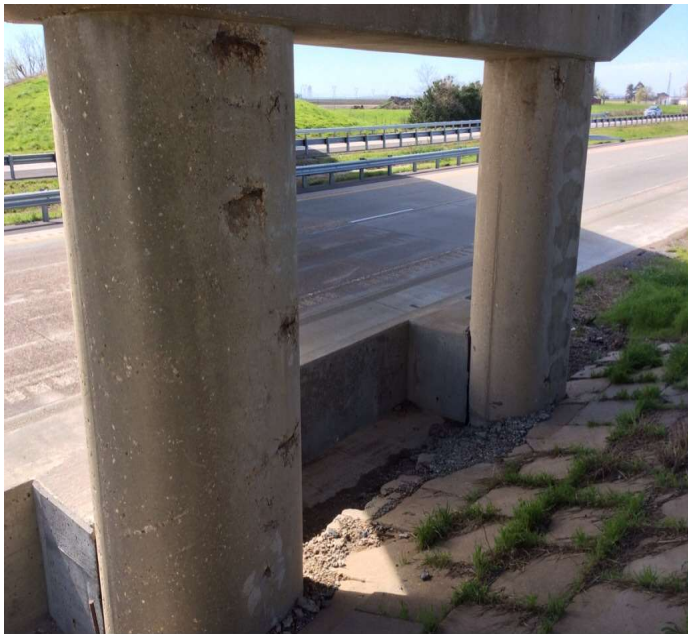
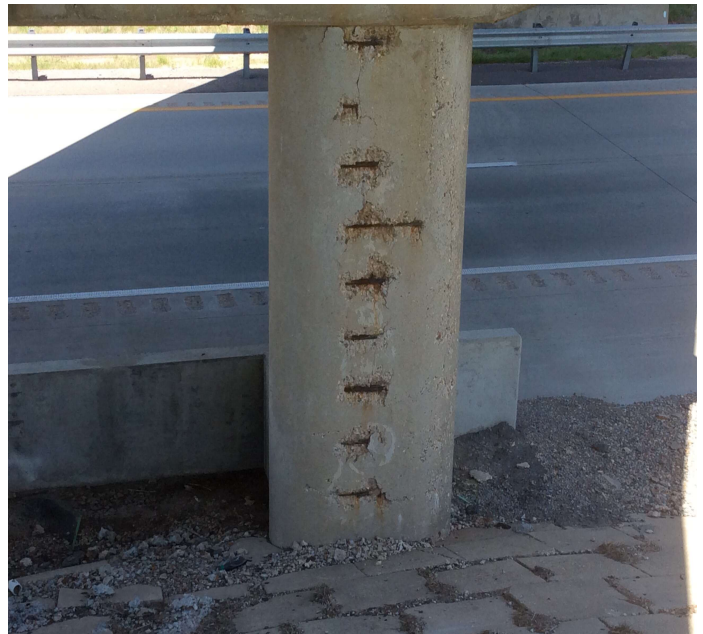
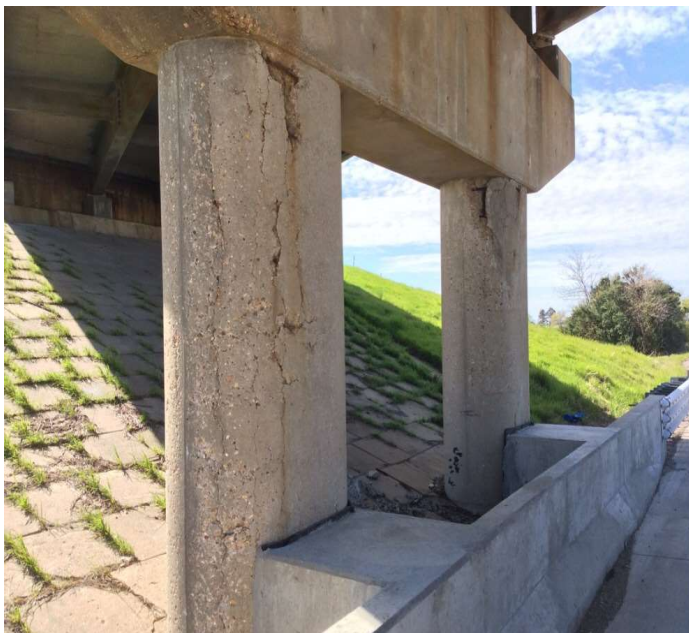
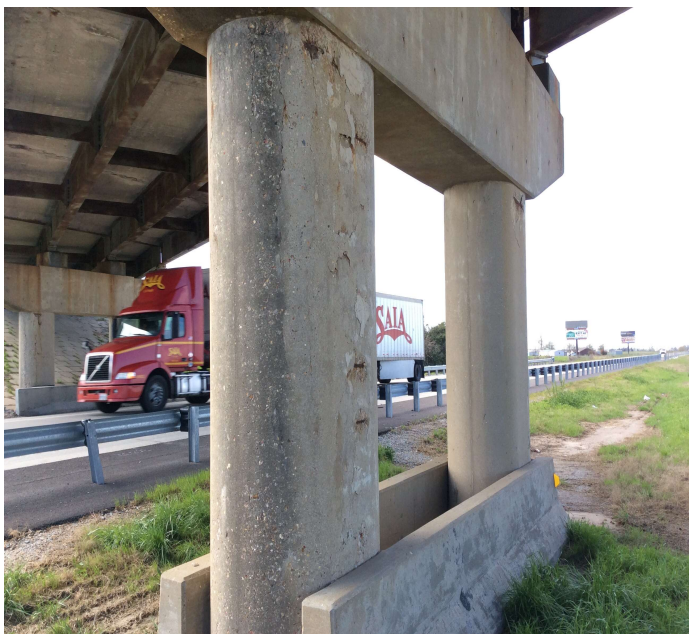
Columns 1 & 2 bents 2,3 & 4 have several spalled and/or impending spalls with some exposed rebar, some have been patched previously, but patches are cracking and shelling off.

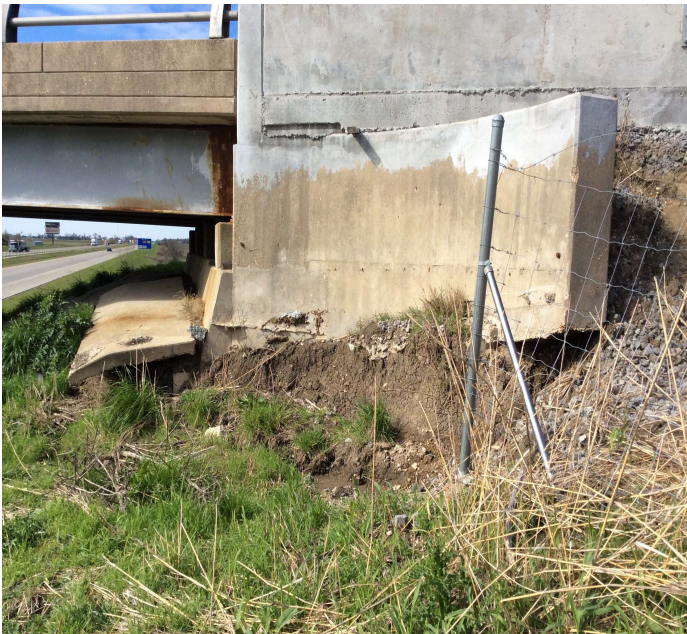
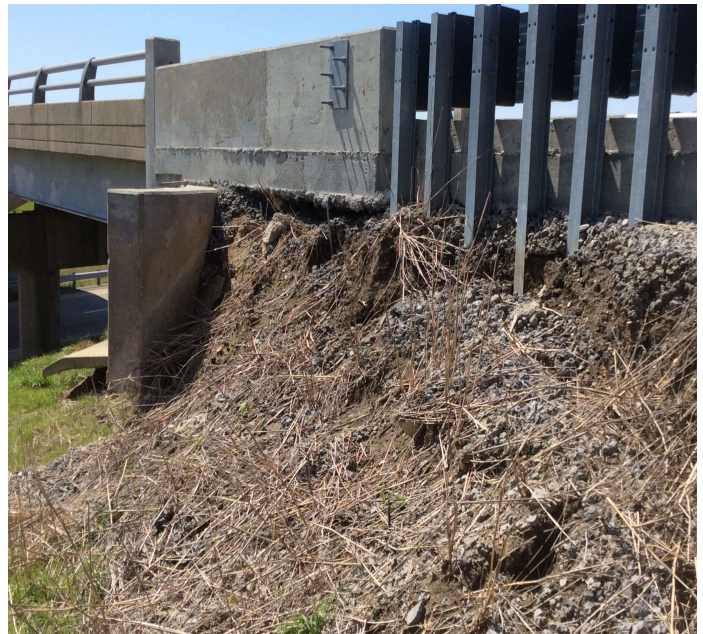
Spans 1&4 Concrete Slope Protection is cracked, settling and separating from Abutments up to 3 inches. Slide and Erosion on the right side of Bent 5 with displacement to Slope Protection exposing the right corner of Abutment, see 2016 photo.

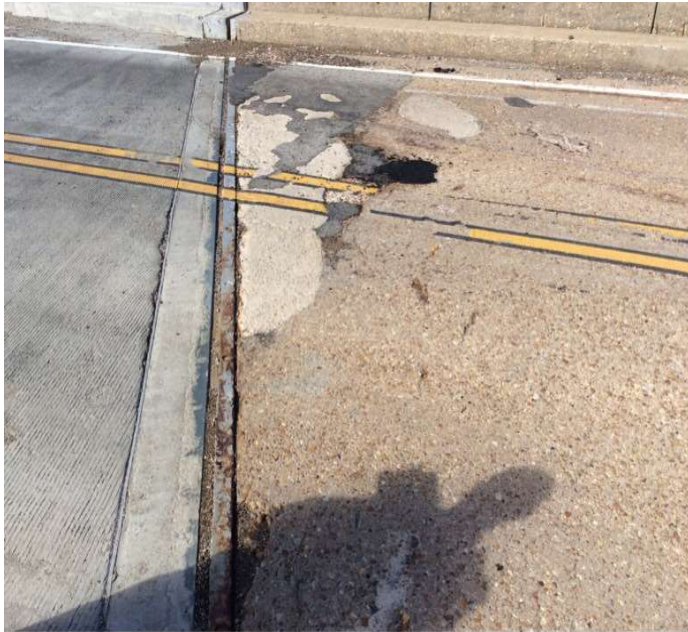
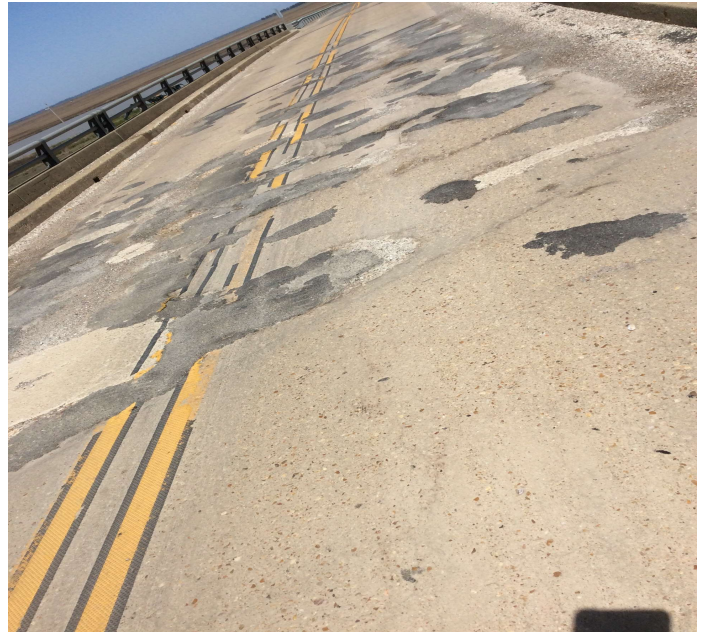
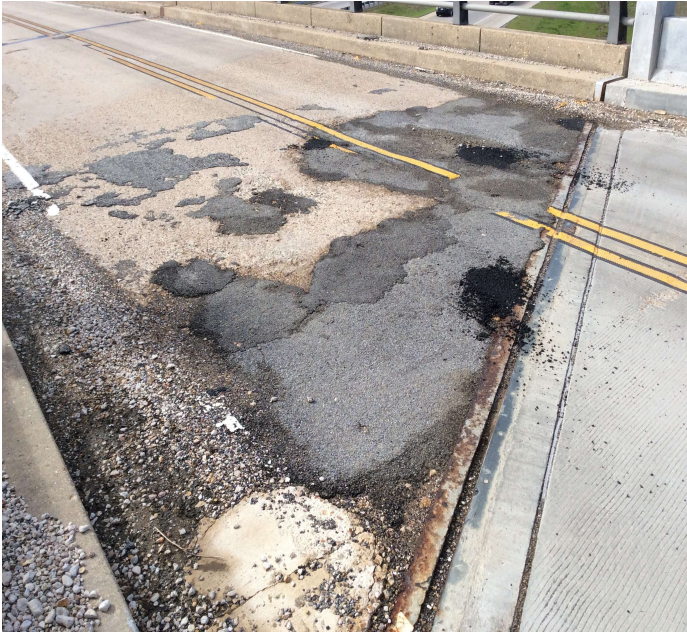
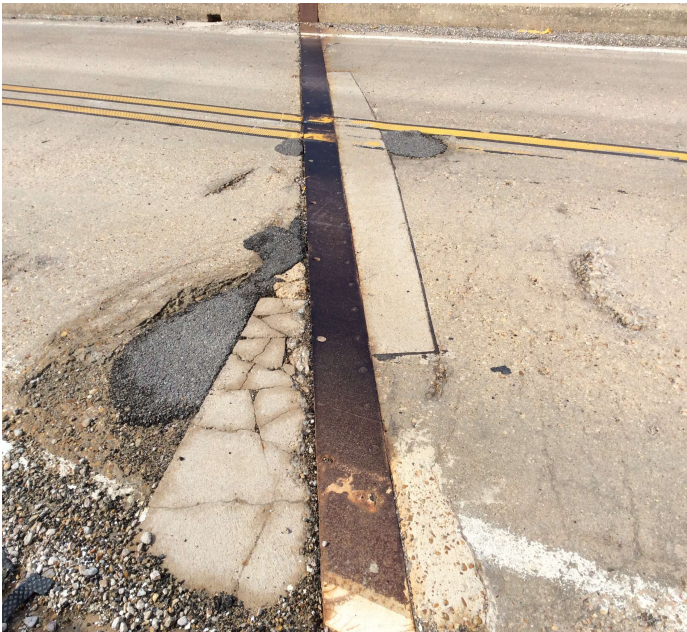
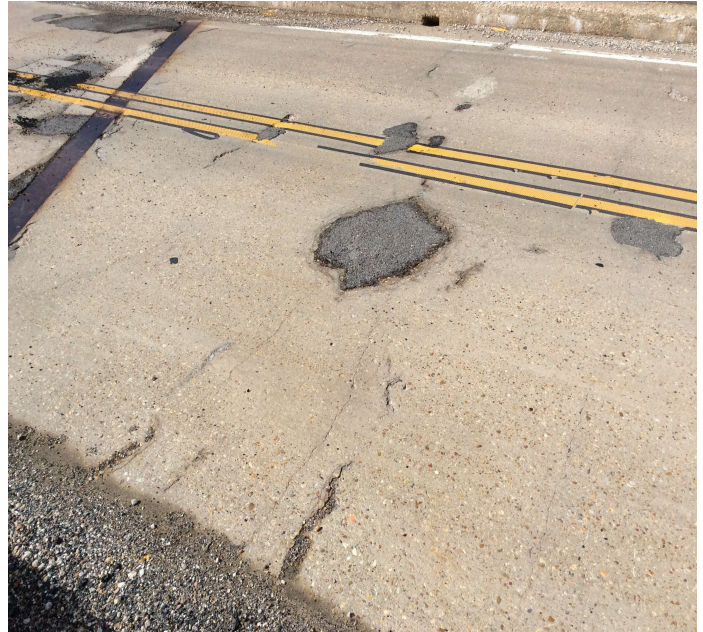
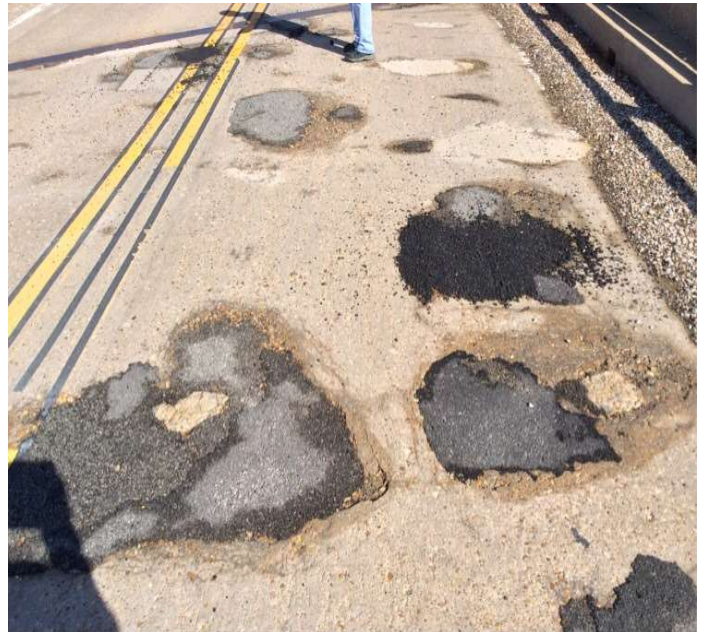
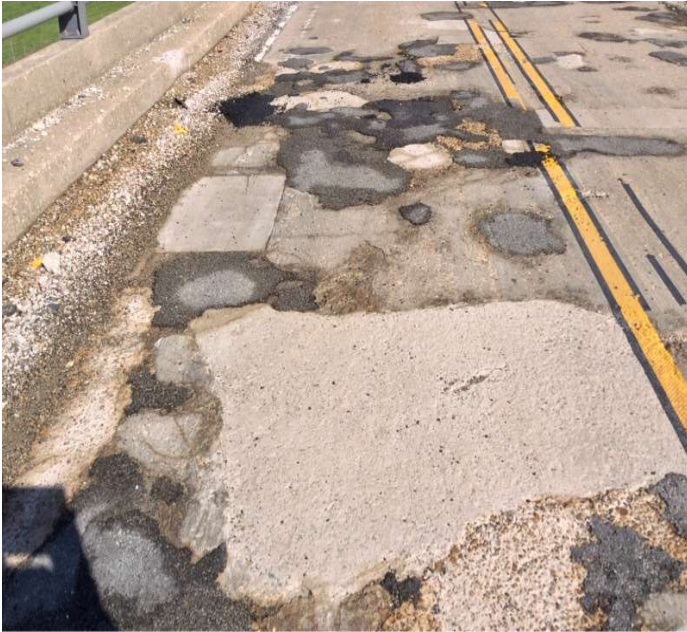
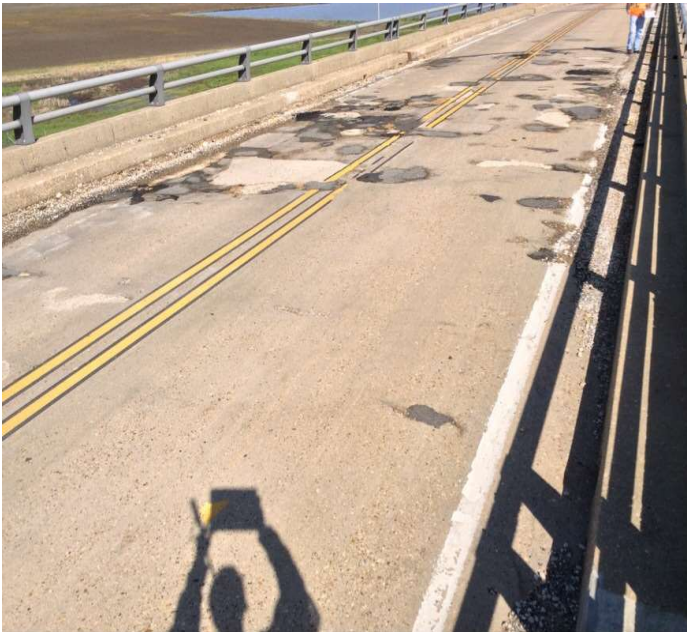
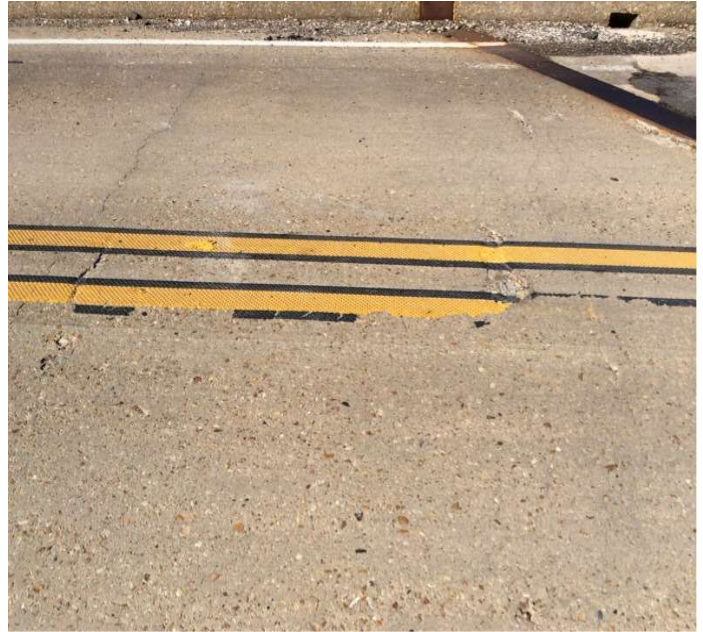
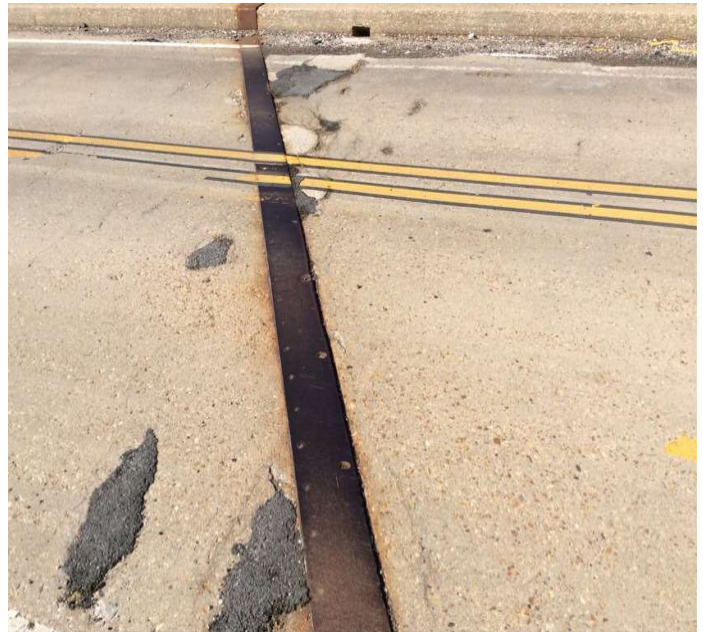
Top of Deck

has several areas patched and some delamination, 30% - 35% distress area and has several sealable cracks with light to medium scale and several small shelled out areas, see 2016 photo & 2018 span 3 photo.

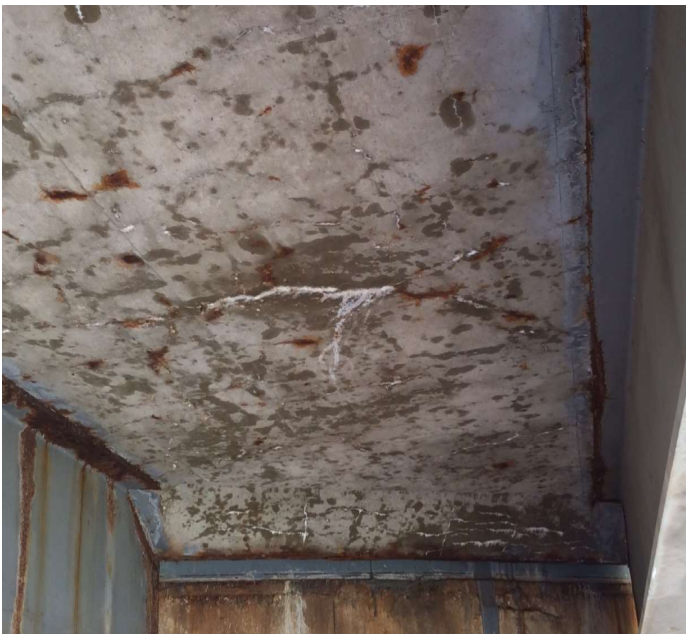
Bottom of Deck has several cracks with light efflorescence and rust stains, especially Span 4 Bays 1&2 near Bent 5. Bottom of Deck Span 4 Bay 1 has a 2 each 4ft. x 1ft. of delamination/ impending spall and 5 each 1ft. x 1ft. spall with rebar exposed.

Bottom of Deck Span 4 Bay 2 has a 4ft. x 1ft. of delamination/ impending spall.

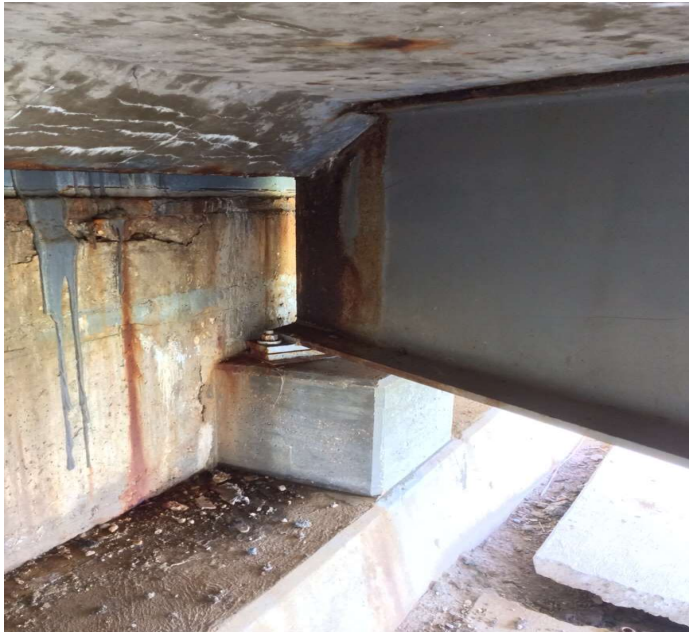
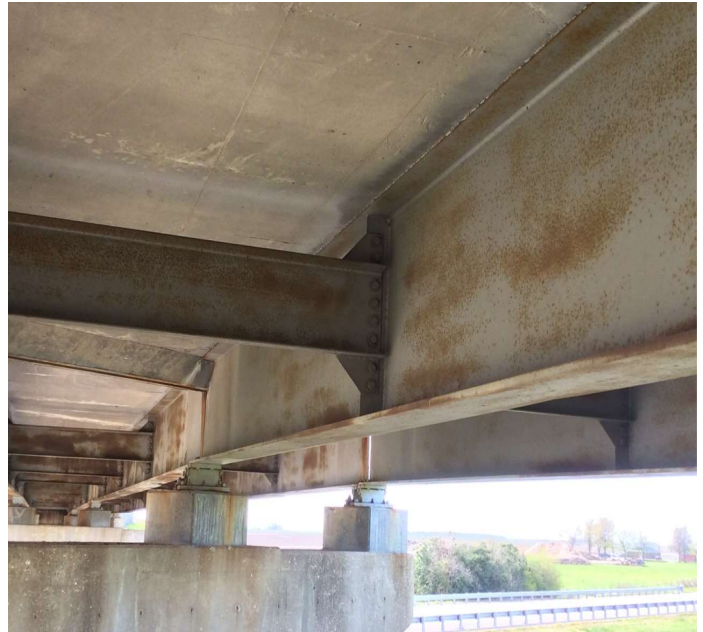
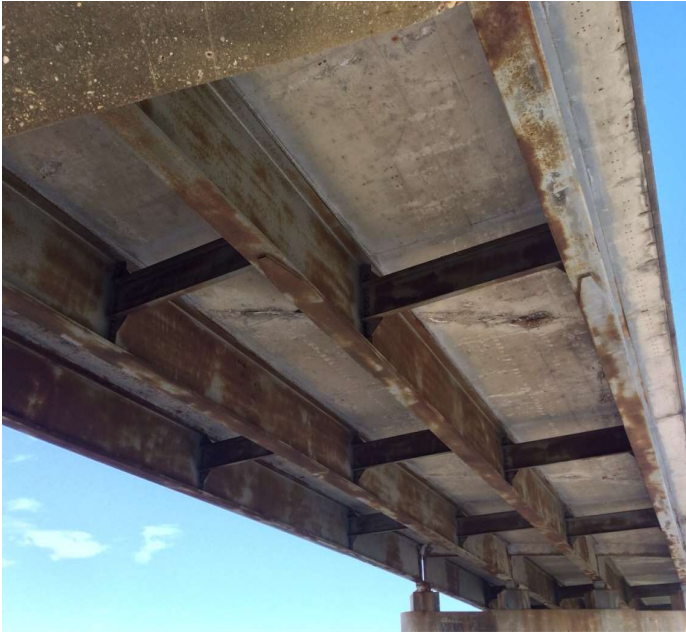
Majority of Steel Girders are rusted with pitting.

Up to 3ft. on end of Steel Girders are rusted with some minor measurable section loss, up to 1/8 inch, especially on ends and to web at concrete haunches over Bents 2, 3, & 5.

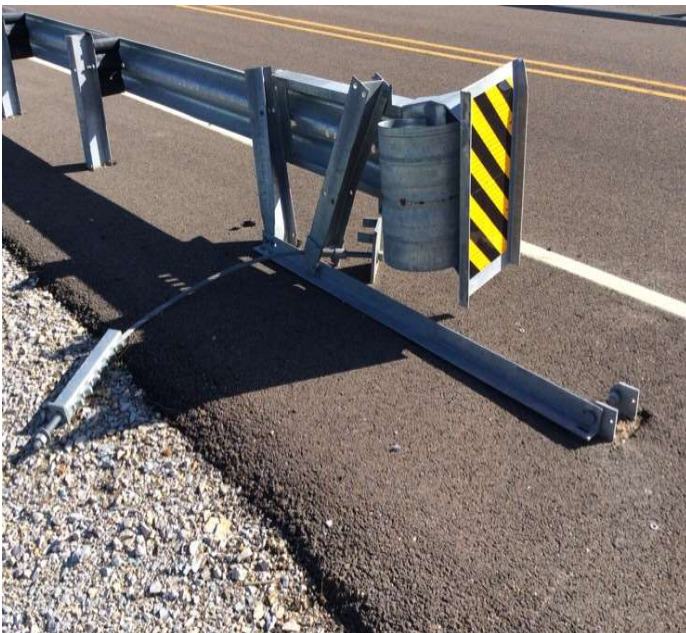
Left Approach Guard Rail and Anchor System has some collision damage, see 2016 photo.

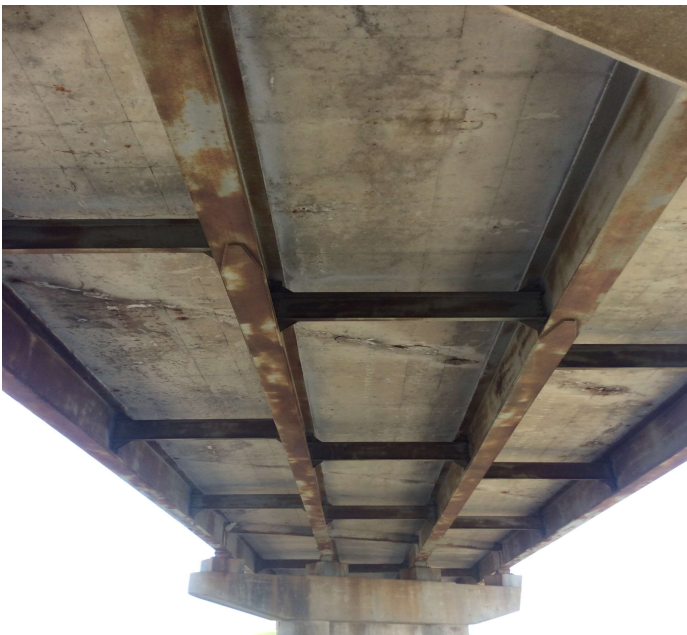
Bottom of deck spans 2 & 3 over interstate traffic has delaminated areas/impending spalls.
