Bridge Inspection Report

M1832
SH 119-02- LM 6.71
over
DITCH NO. 41

Structure Number: M1832

Facility Carried: SH 119-02- LM 6.71

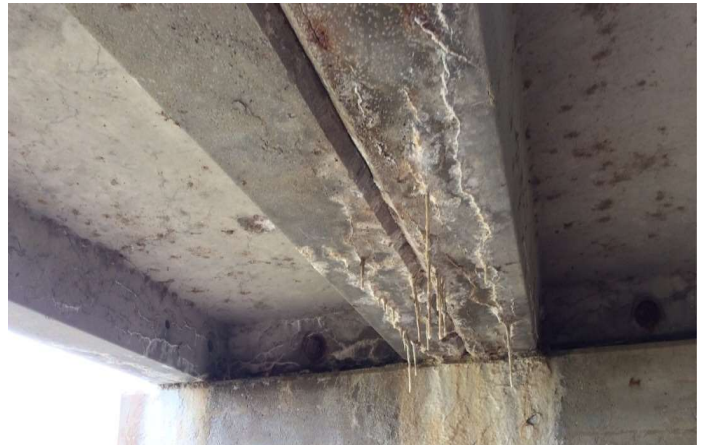
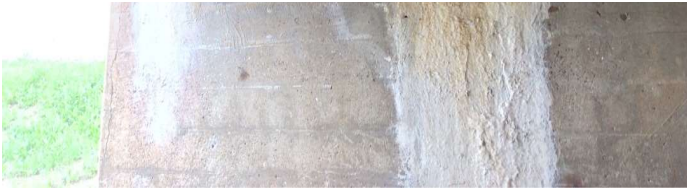
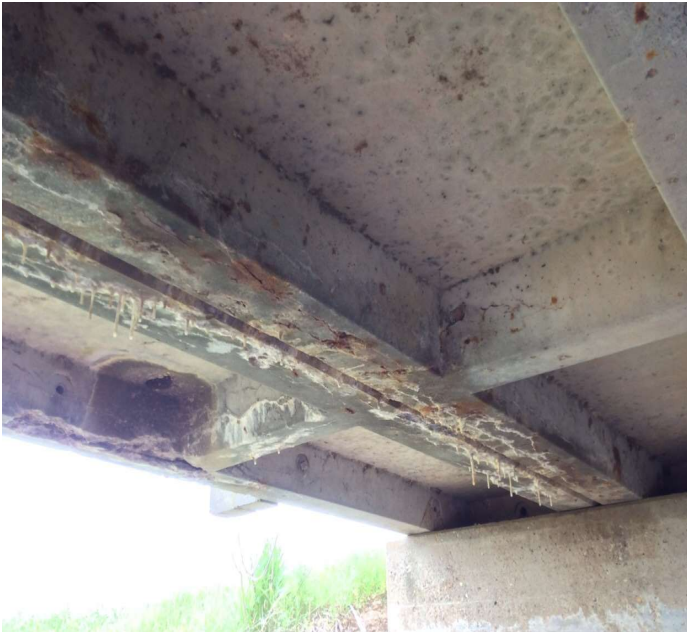
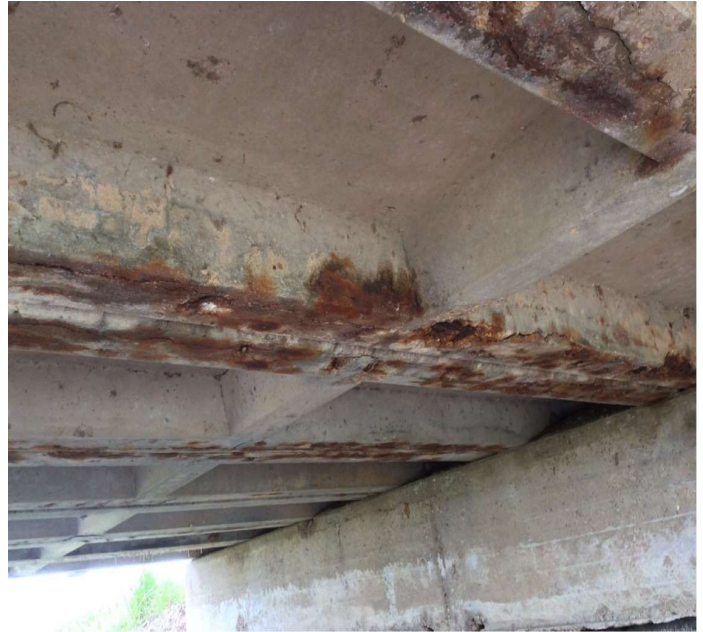
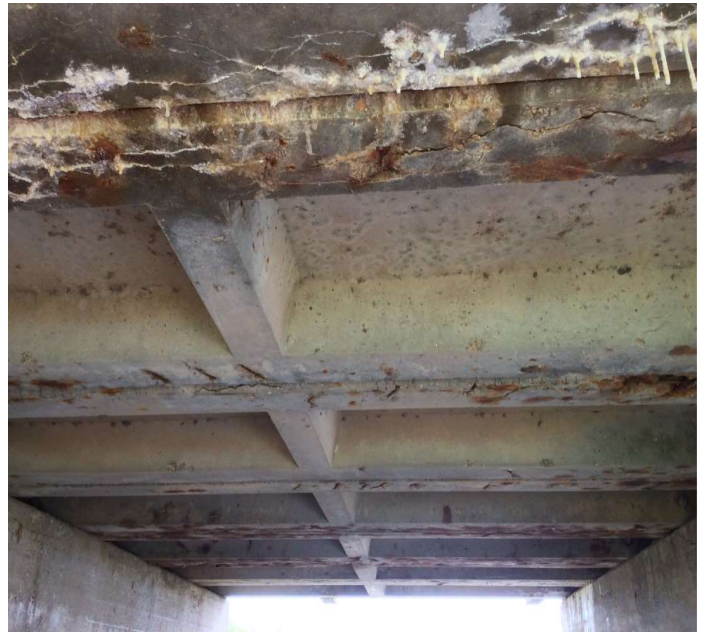
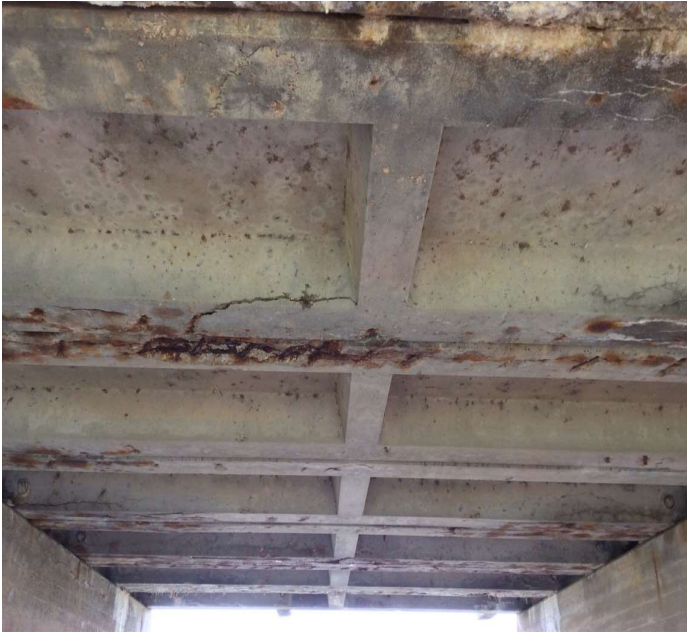
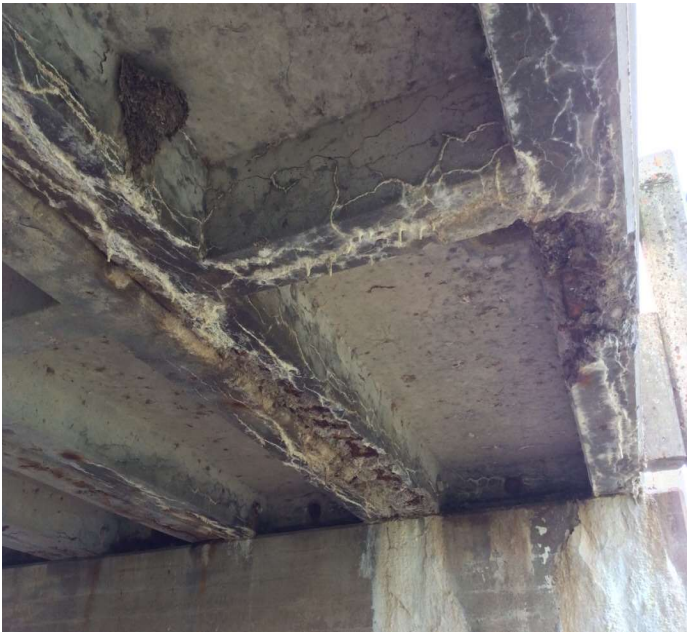
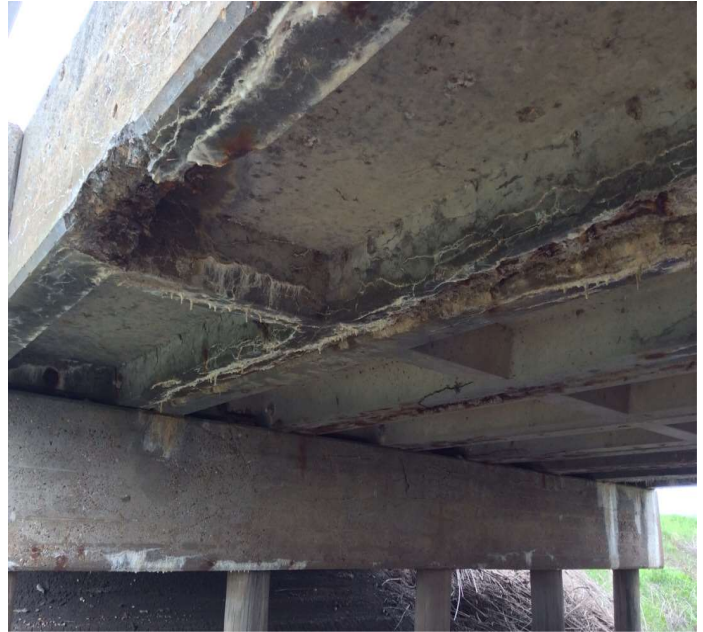
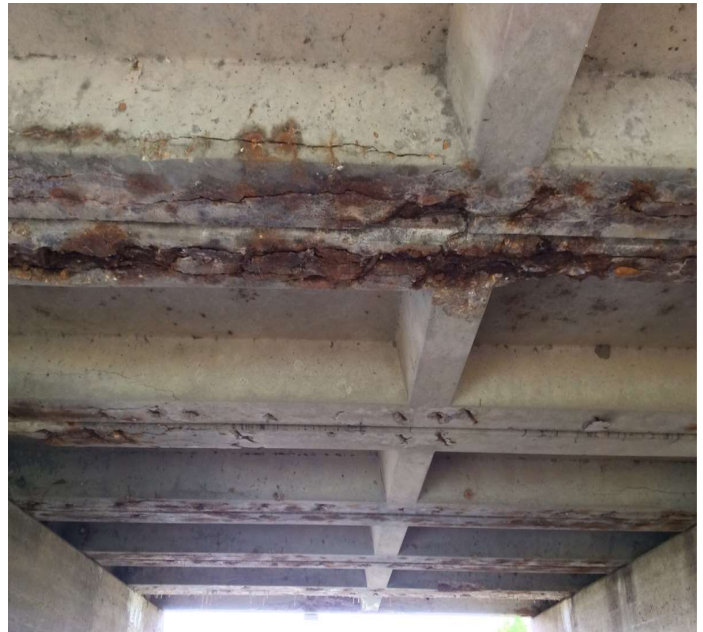
Channel Beams have numerous open longitudinal cracks with heavy rust stains and efflorescence and spalls with rebar exposed in bottom of Girders, see 2016 photos:

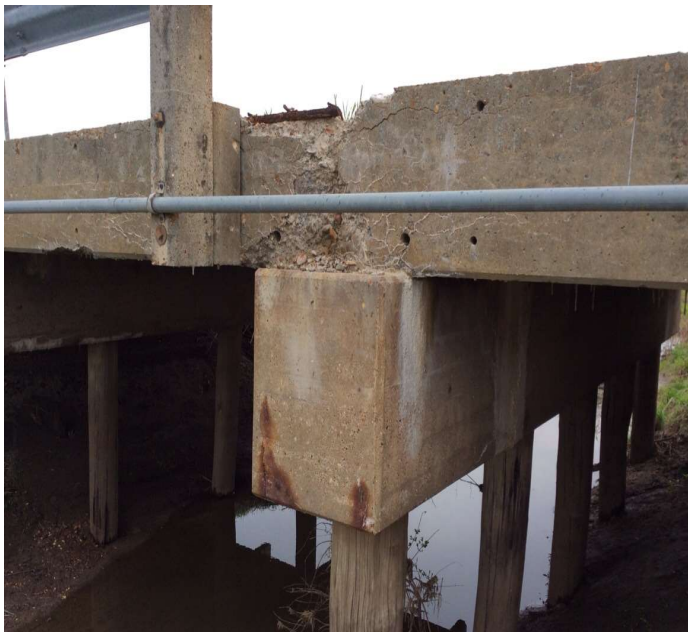
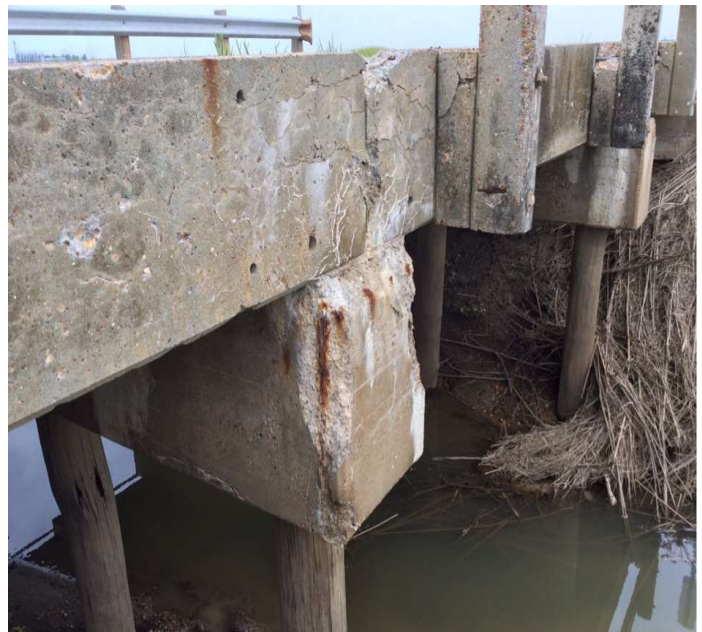
4LF on the left end of Bent 2 Concrete Cap has moderate deterioration, cracking with efflorescence, and rust stains, see 2016 photo.

Right end of Bent 2 Concrete Cap has a 1LF minor spall with exposed rebar and the bottom of cap between Piles 4&5 is spalled with rebar exposed, see 2016 photo.

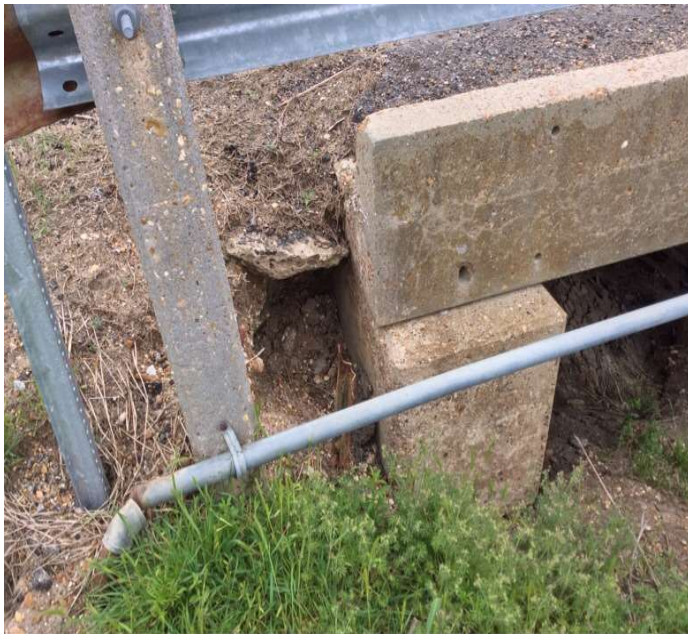
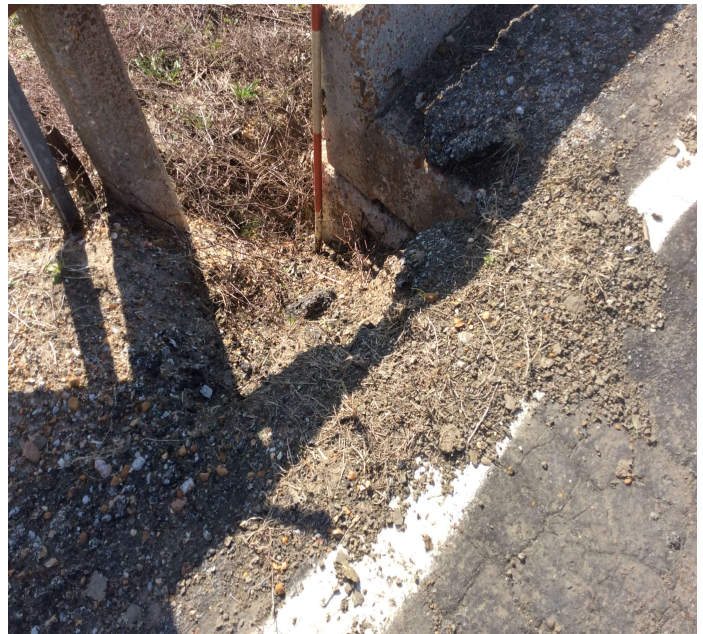
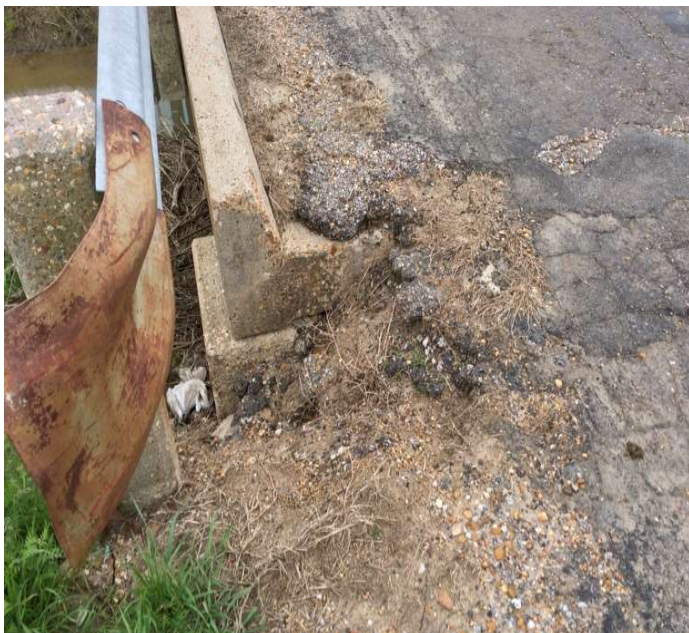
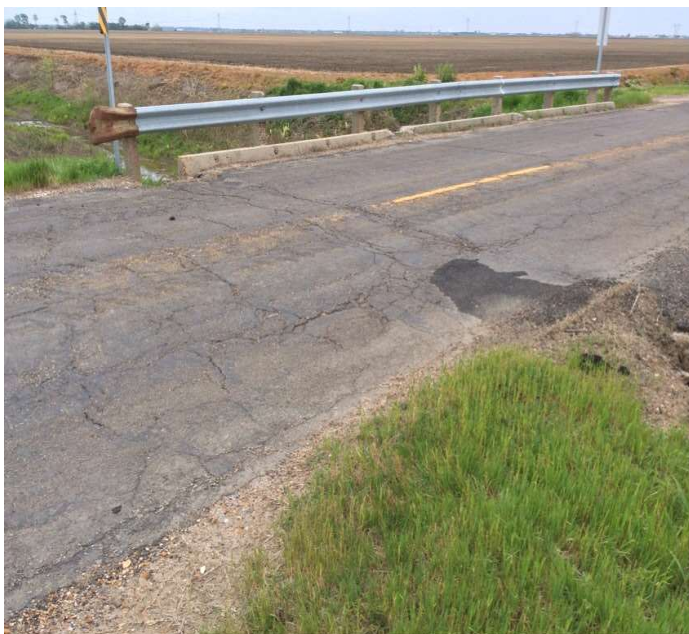
Approach Roadway has 1 1/2 in. settlement at each end of bridge and has asphalt cracking, see 2016 photo. Left & right shoulders of Approach Roadway is washing out exposing 2.5LF on the left end and 1.5LF of the right end of Abutment Bent 4.

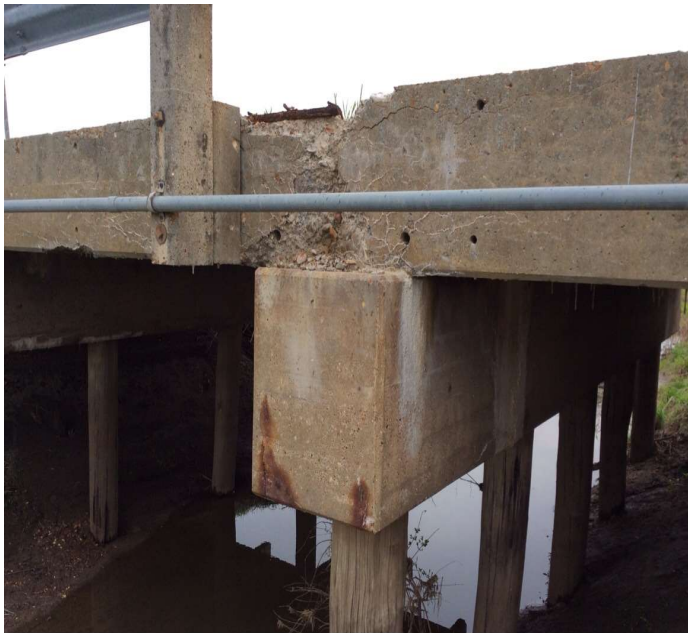
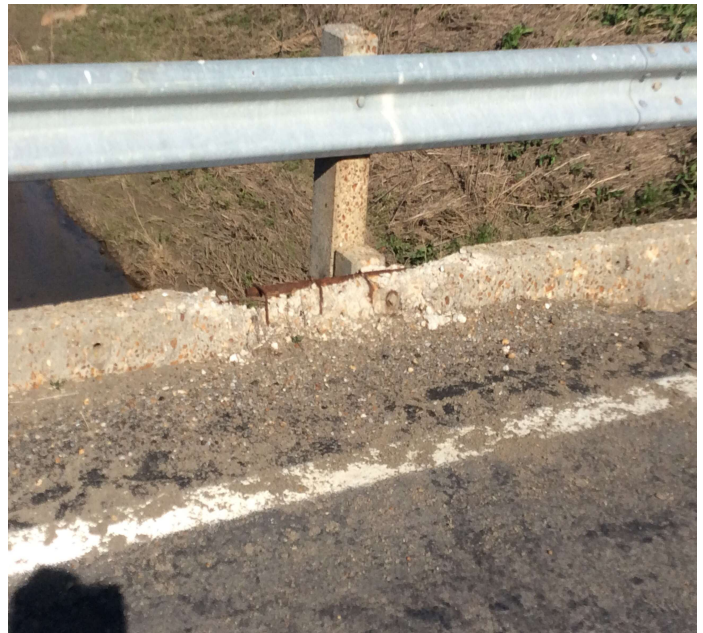
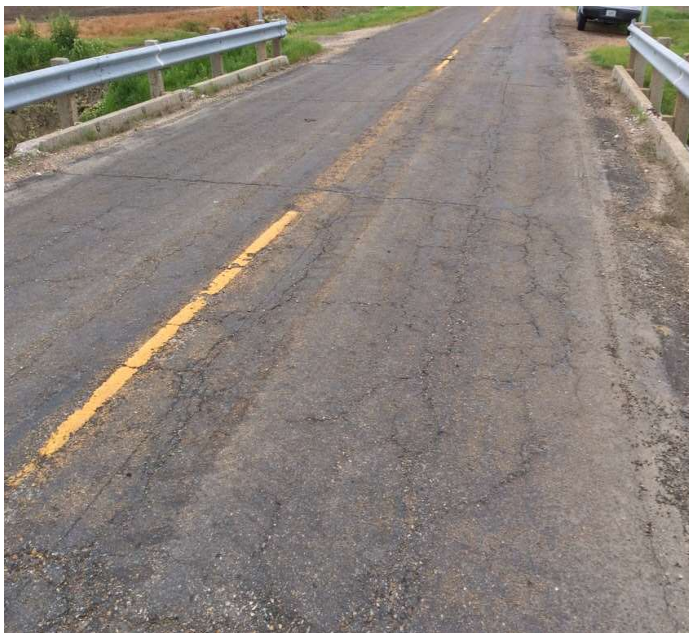
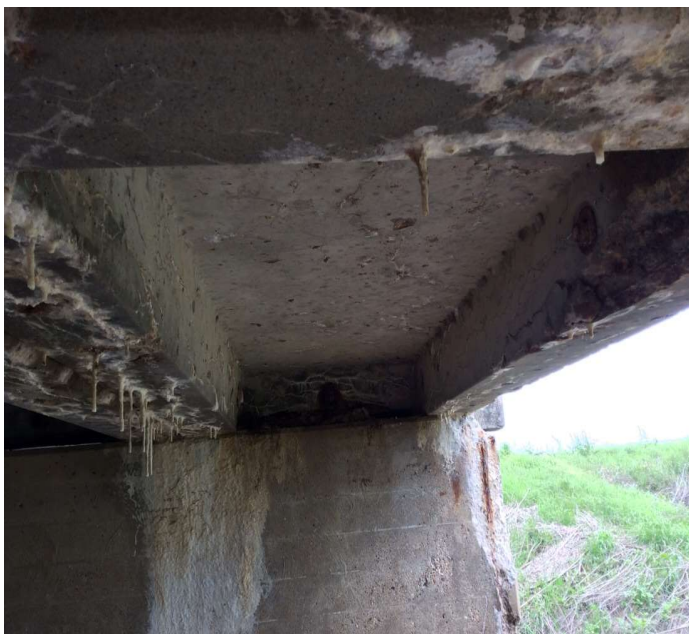
Left & right Concrete Curbs has some cracking and deterioration with 6ft. of rebar exposed, see 2016 & 2018 photo of Span 2.

Deck with asphalt overlay has transverse cracks over joints and longitudinal and map cracking between Units, see 2016 photo.

Bottom of some Deck Units has some map cracking with efflorescence, especially Spans 1,2&3 Units 1&7 and Span 2 Unit 2, see 2016 photo.

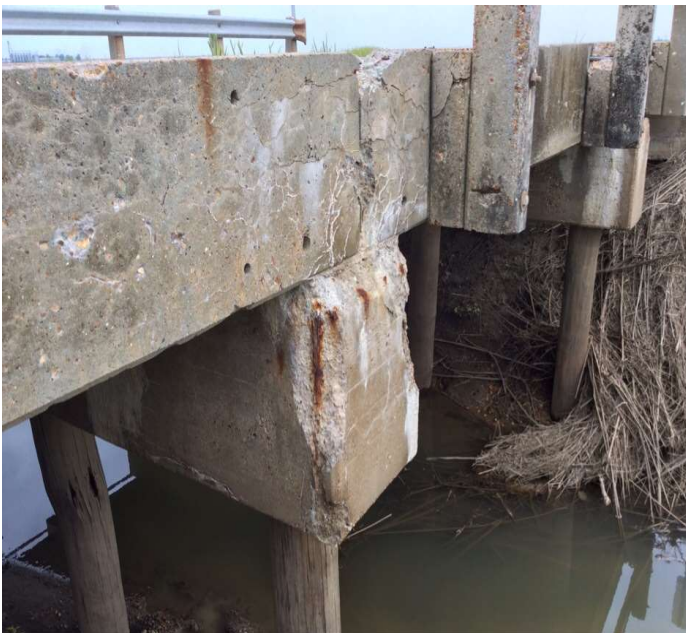
PHOTO 1 Description

Right Rail Concrete Spacer Blocks are cracked & broke, see 2016 photo of Bent 2 right side.

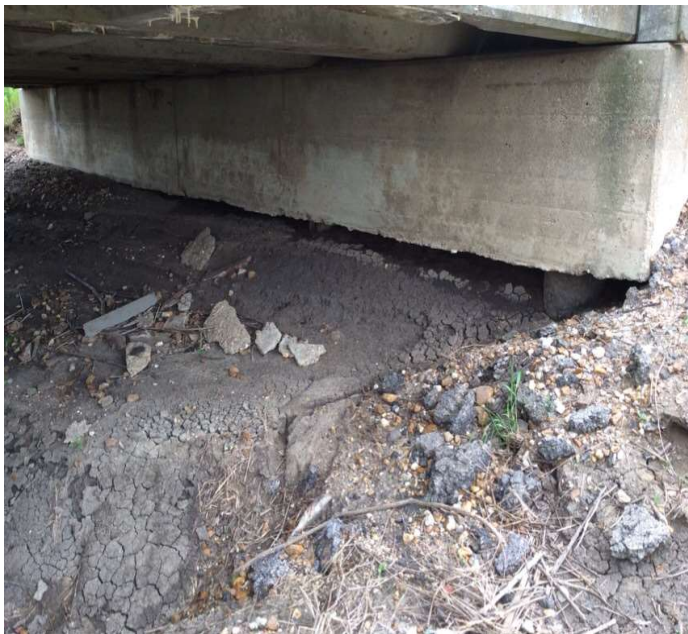
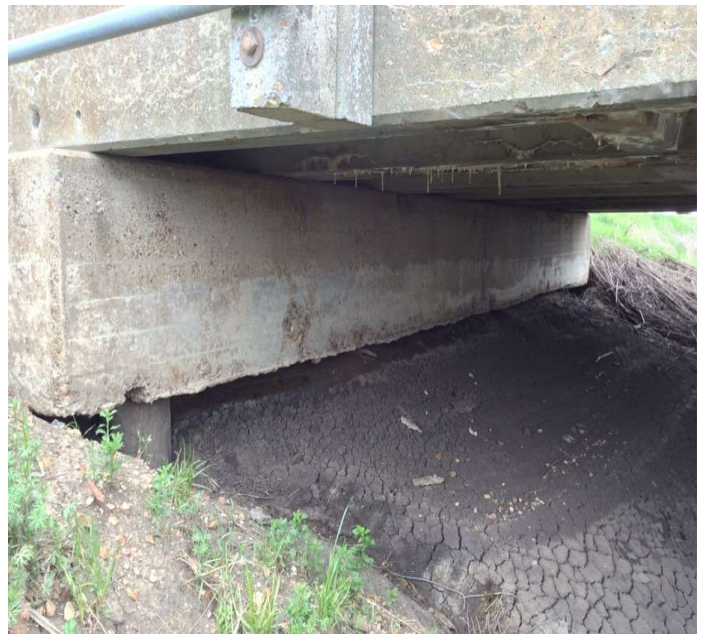
Bent 1 Abutment has 17LF of the left end having some undermining of cap, up to 1ft. deep and 1ft. under cap, see 2016 photo.

Bent 4 Abutment has the left & right end having some undermining of cap, up to 1.5LF deep and 2ft. under cap exposing Piles 1&5, see 2016 photo.

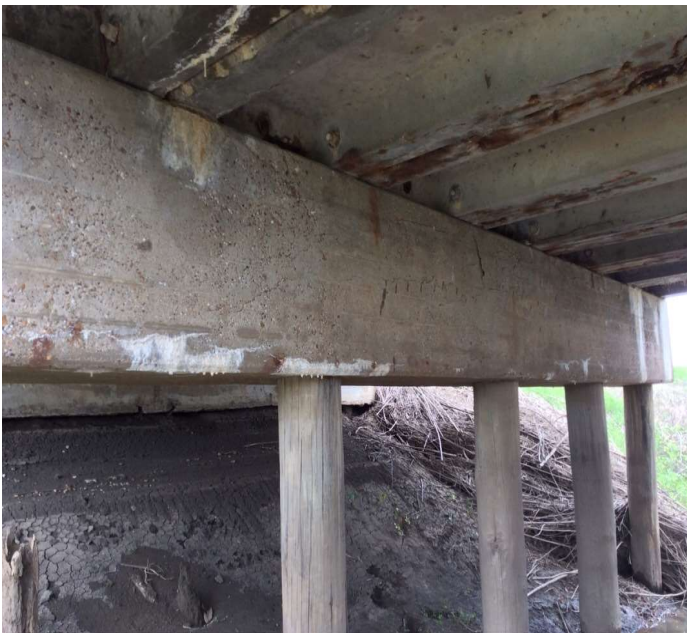
PHOTO 1 Description

Bent 3 Concrete Cap has delamination, map cracking, and cracks with efflorescence, see 2016 photo.

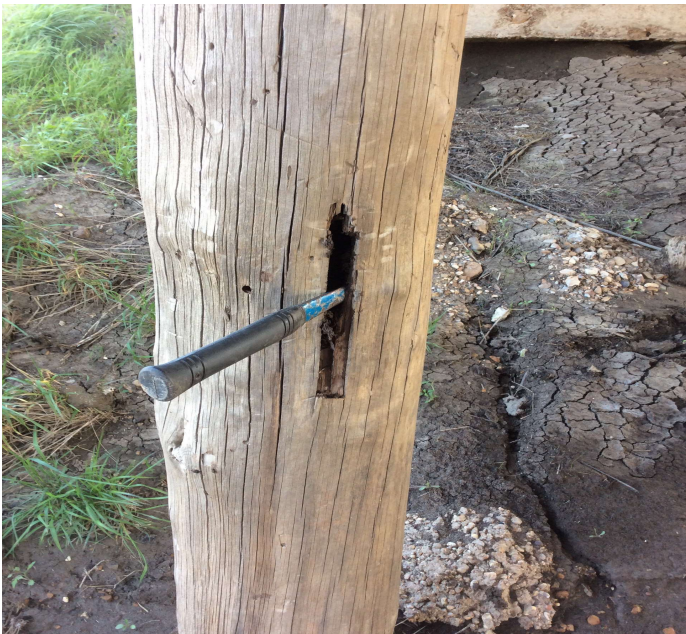
PHOTO 1 Description

Bent 3 Timber Pile 1 is decayed and partially hollow with a 1 in. shell on span 2 side, see 2018 photo.
