Bridge #07161(Routine, Underwater type 2)

US 63 -03-LM20.34 over Big Running Water

Team Lead: James Adams Inspection Date: April 13, 2020

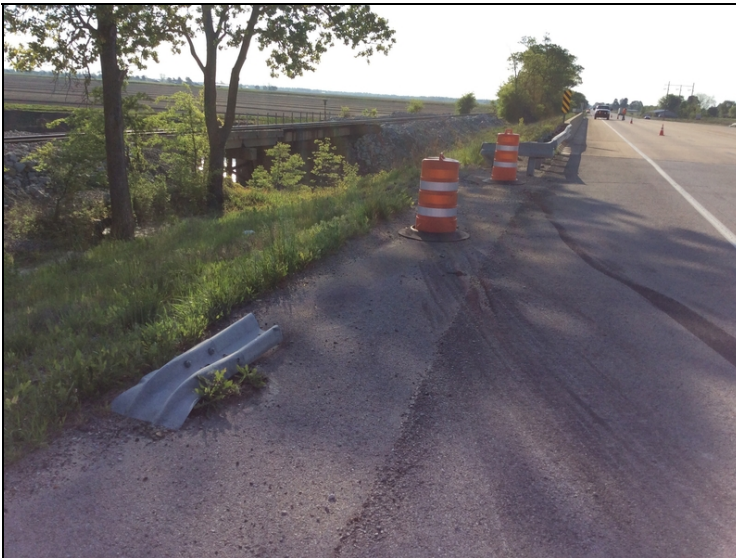
Lt approach rail at bent 1 has collision damage.

Left approach rail at bent 1 collision damage has been repaired.
Left and right bridge rails have several vertical cracks.
Approach slabs have several transverse and longitudinal cracks. Some have been sealed in the past.
Joints at bents 1 and 4 beginning to lose adhesion.
Deck has several unsealed longitudinal and transverse cracks.
Soffit has several transverse cracks with light efflorescence near center line.
Overhangs have several transverse cracks with efflorescence.
