Bridge #A0650 (Routine)
US 63-03- LM 7.17 over HARDING CREEK
Location: 7.17 MI SE SHARP CO LINE

Team Lead: Tim Myrick Inspection Date: August 31, 2021

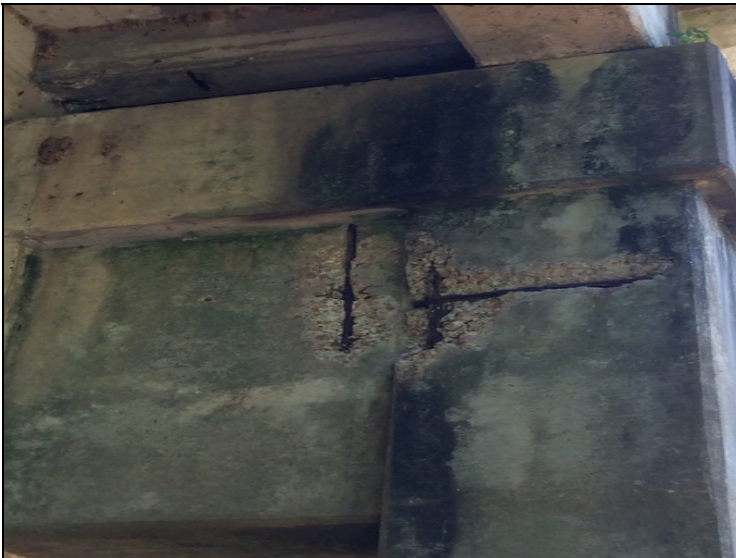
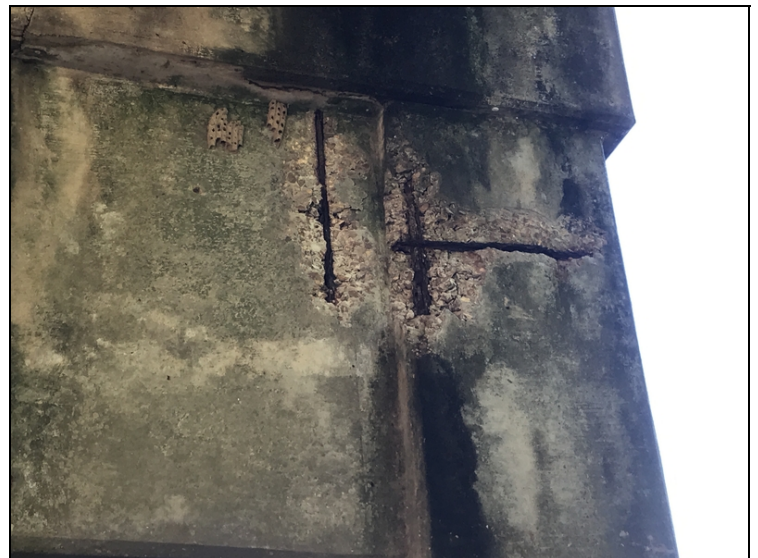
Span 1 side Bent 2 column 4 2019

Bent 2 column 4 has a 2' x 2' spall with rebar exposed. Exposed rebar has approximately 40% loss of section.

Bent 2 cap has 3' of cracks.
Bent 2 cap has a 2' spall under girder 1 on span 2 side.
Bent 2 column 4 has a 2' x 2' spall with exposed rebar, rebar has approximately 40% section loss.
Bent 1 abutment has vertical cracks with efflorescence under girders 1 & 5.
Bent 3 abutment has diagonal cracks with efflorescence build up.
Bents 1 and 3 abutments have horizontal cracks along cold joint with some efflorescence and honeycombed areas.

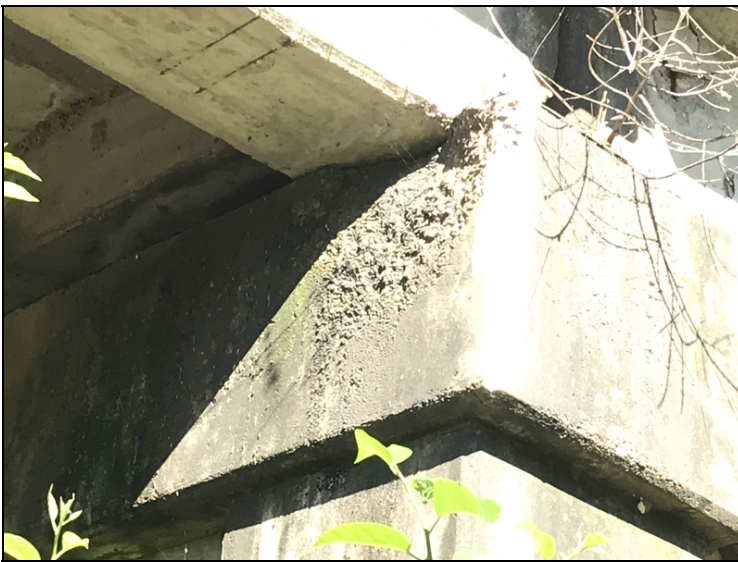
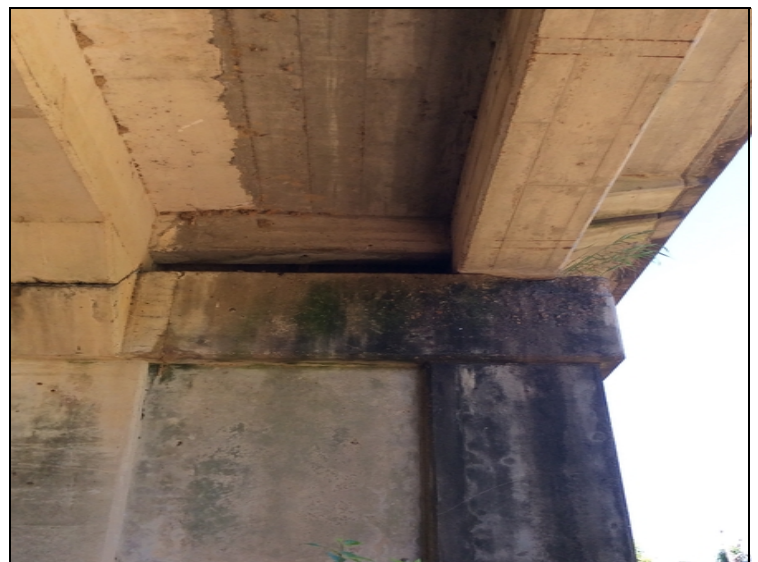
Span 2 bent 2 at girder 1 cap 2019

Bent 2 cap has a 2' spall under girder 1 on ahead side.

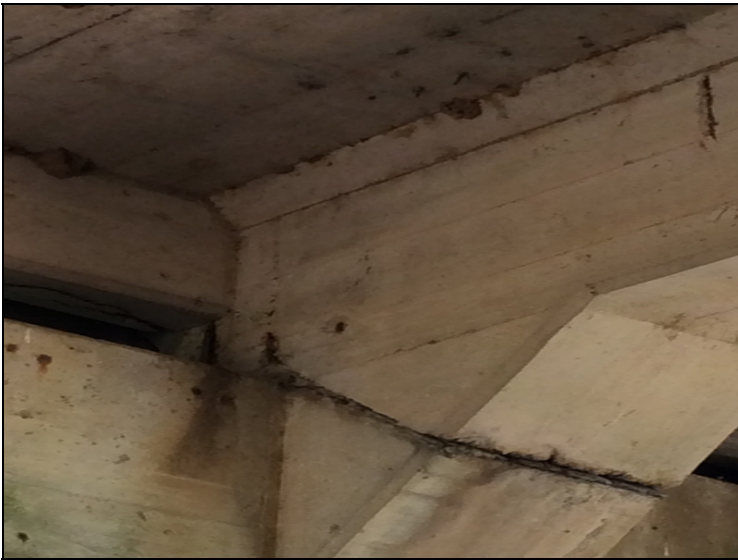
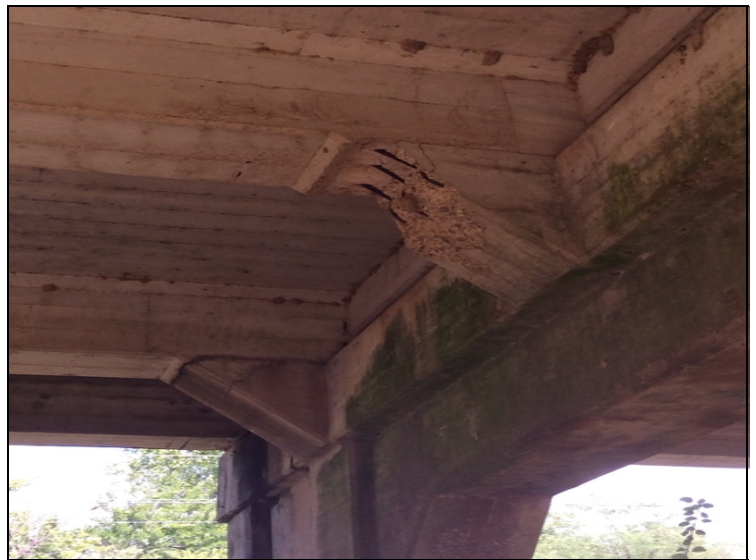
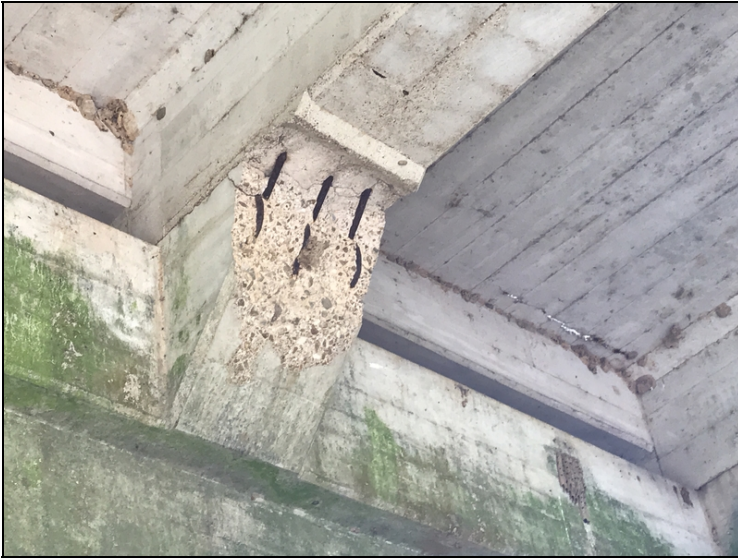
Span 1 Bent 2 girder 3 haunch 2019

Span 1 bent 2 girder 3 concrete haunch is spalled under girder with some rebar exposed.
Span 2 bent 2 girder 2 concrete haunch is spalled under girder with some rebar exposed.
Span 2 bent 2 girders 2 and 5 have rebar exposed.
Span 2 bent 2 girder 4 haunch portion is cracked with rust stains.
Span 2 girder 4 near bent 3 has some exposed rebar.

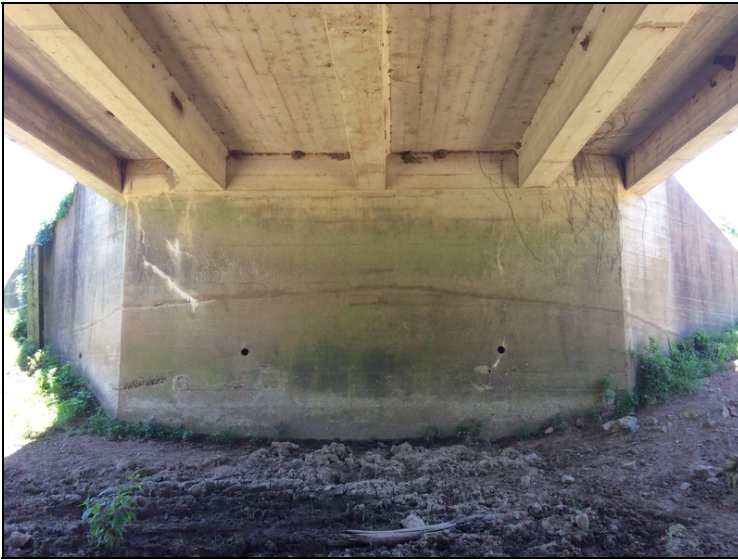
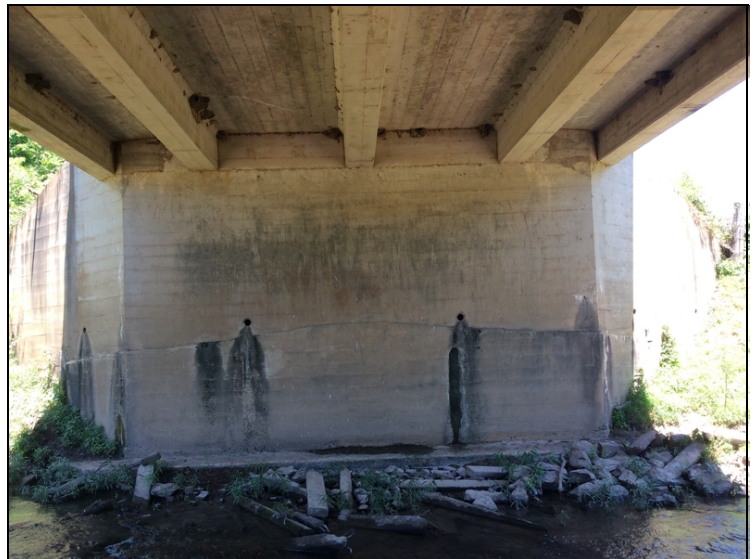
Bents 1 and 3 abutments have horizontal cracks along cold joint with some efflorescence and honeycombed areas. Abutments have vertical & diagonal cracks with efflorescence build up.

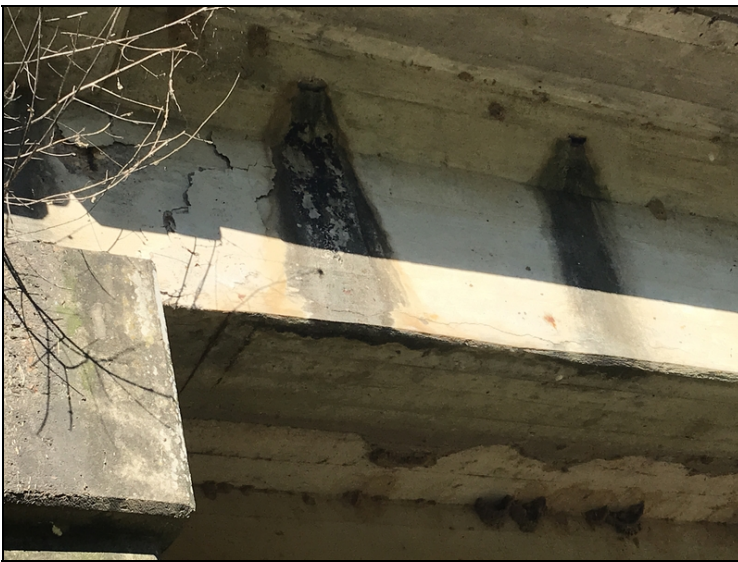
Span 1 girder 1 at bent 2 2019

Span 1 girder 1 at bent 2 has 1' of exposed rebar, 2' of delamination & 3' of cracking on left side of girder.

Span 1 girder 1 at bent 2 has 1' of exposed rebar, 2' of delamination & 3' of cracking on left side of girder.
Span 1 girder 2 over bent 2 is spalled with exposed rebar.
Span 1 bay 1 over bent 2 concrete diaphragm is spalled with exposed rebar.
Span 1 bent 2 girder 3 concrete haunch is spalled under girder with some exposed rebar.
Span 2 bent 2 girder 2 concrete haunch is spalled under girder with some exposed rebar.
Span 2 bent 2 girders 2 and 5 have some exposed rebar.
Span 2 bent 2 girder 4 haunch portion is cracked with rust stains.
Span 2 girder 4 near bent 3 has some exposed rebar.
