Bridge #A0652(Underwater type 2, Routine)

US 63-03- LM 9.11 over Clear/Chaplin Crk

Team Lead: Tim Myrick **Inspection Date:** August 31, 2021

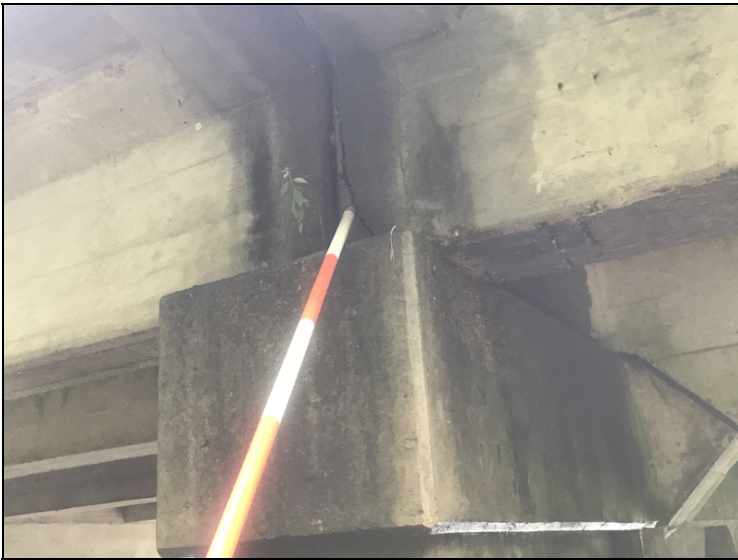
Span 2 girder 5 at bent 2

Span 2 under Girder 5 Bent 2 has a small shelled out area face of cap (1 ft. x 2 ft.) no exposed rebar.

Bent 2 cap span 2 side under girder 5 has a small spalled area (1' x 2') with no exposed rebar.

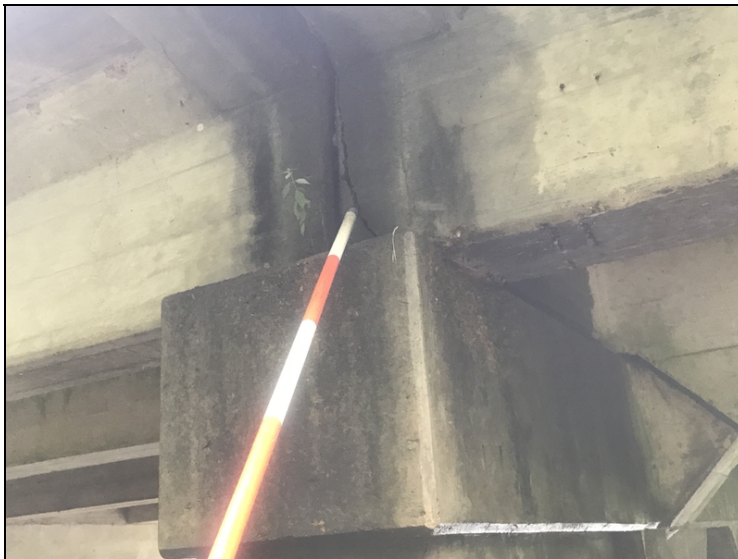
Span 2 girder 5 at bent 2

Span 1 Girder 4 Bent 2 girder haunch is shelled out (6in. x 12in.) with rebar exposed, see 2013 photo.
Span 2 Girder 5 Bent 2 has an open crack on end of girder. See 2019 photo.

Span 2 girder 5 bent 2 has an open crack on end of girder.
