**Bridge #A0653**(Routine)  
**US 63-03- LM 11.06 over BRUSHY CREEK**  
**Location: 11.06 MI SE SHARP CO LINE**

**Team Lead:** Tim Myrick **Inspection Date:** August 11, 2021

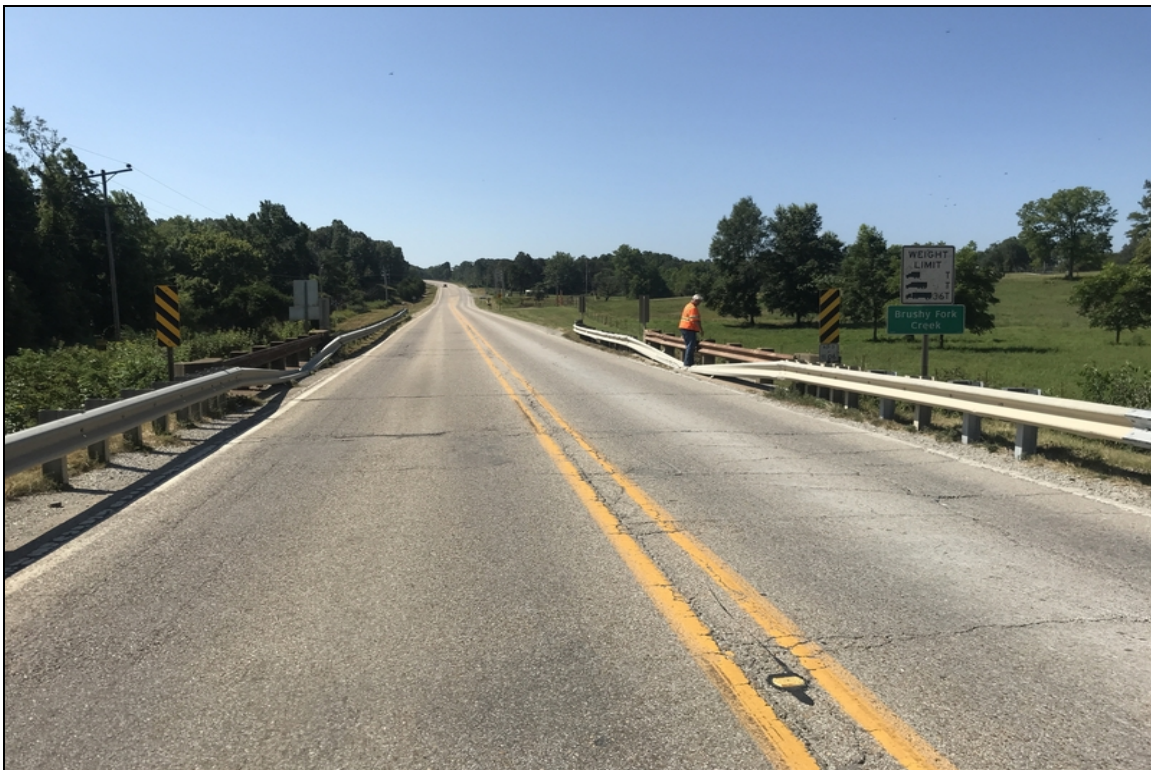
Beginning offroad

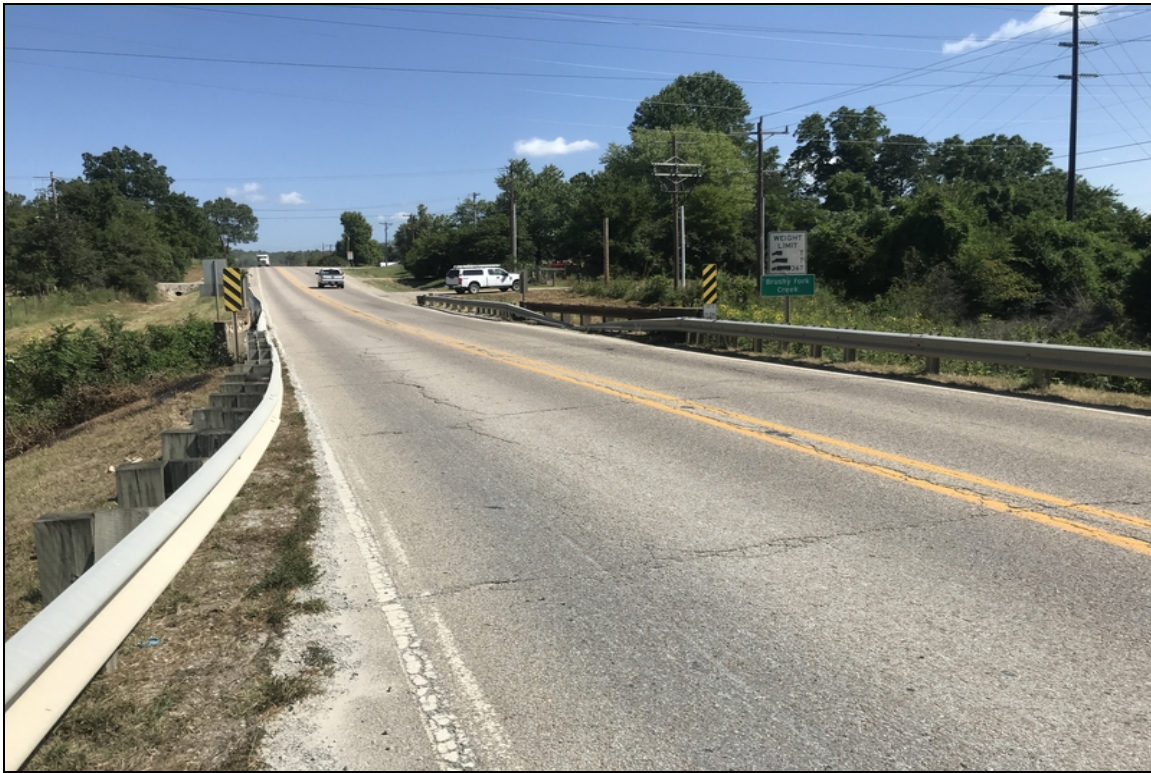
Ending end

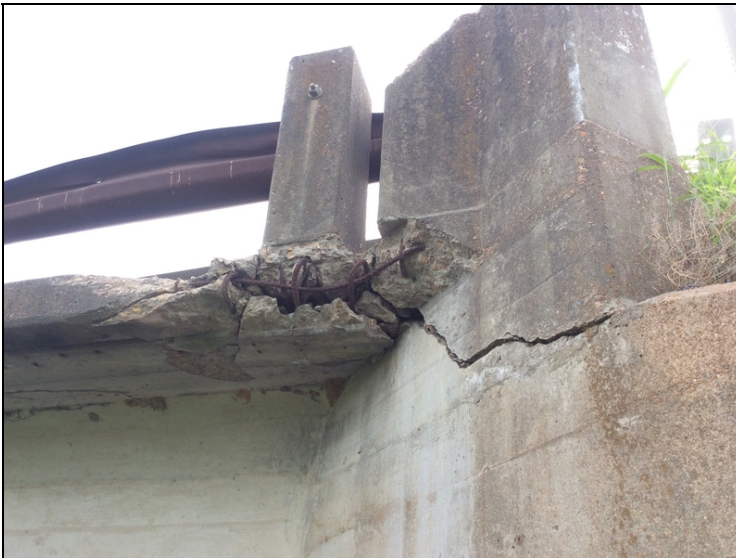
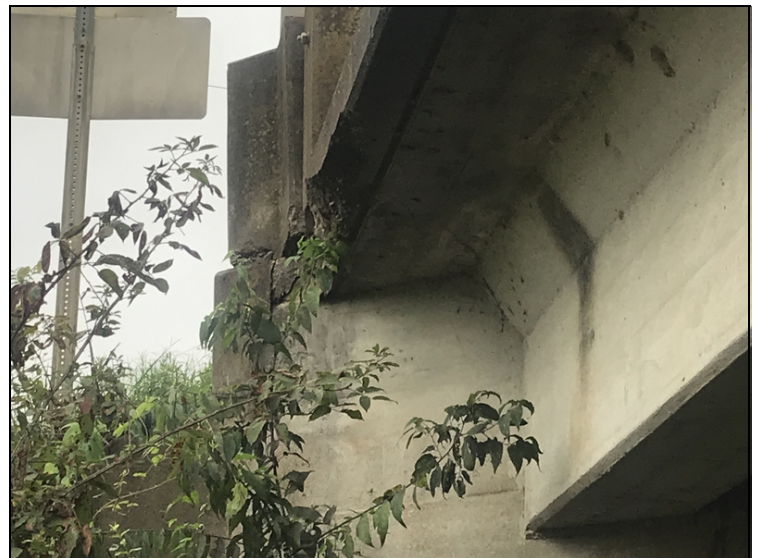
Rt bridge rail corner posts and overhangs are spalled with rebar exposed.

Span 1 right side at bent 1 guard rail & post  
2019

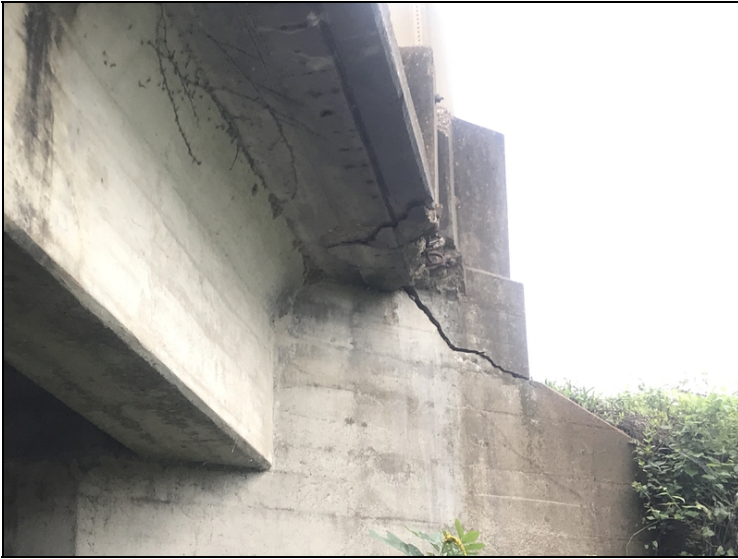
Span 1 right side bent 2 rail & soffit 2019

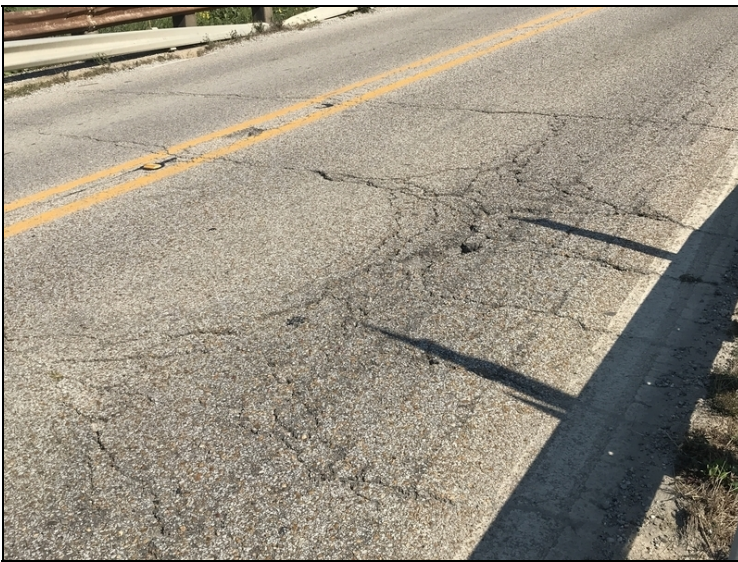
Wheel path in northbound lane has map cracking.  
Asphalt overlay has a 1' spall near bent 2.

Deck located near Bent 2
