District 10, Mississippi County

**Bridge #01268(Routine)**  
**US 61-02- LM 2.53 over FRENCHMANS BAYOU**  
**Location: 2.53 MI N CRITTENDEN CO**

**Team Lead:** Richard Jones **Inspection Date:** November 01, 2021

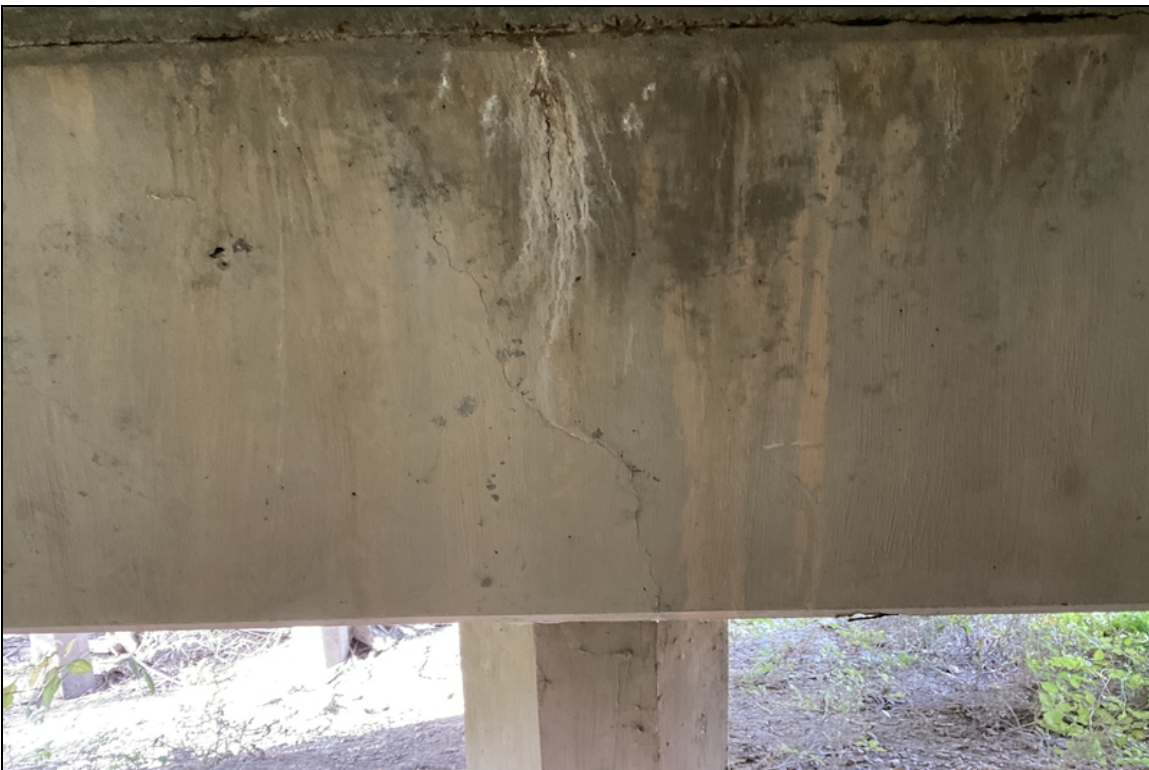
Bent 6 ahead at pile 4

Bent 6 cap has a possible settlement crack on ahead side over pile 4.

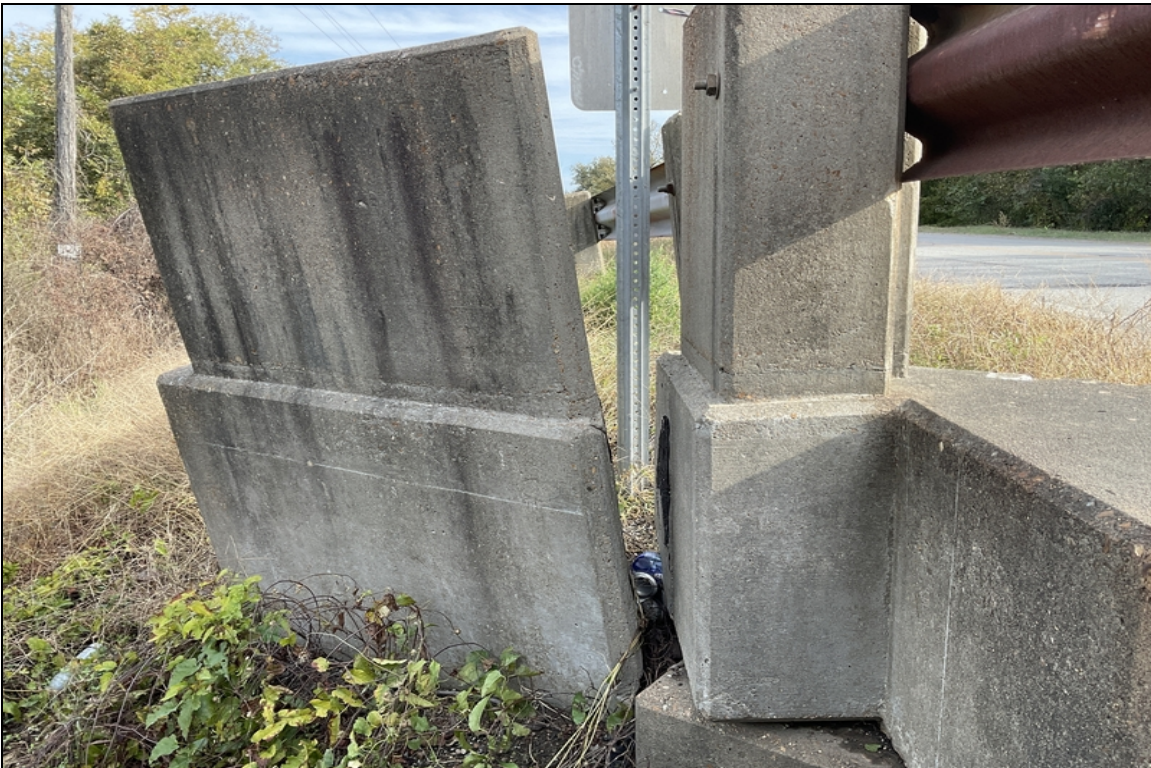
Bent 7 Lt wing/endpost is rotated toward the channel.

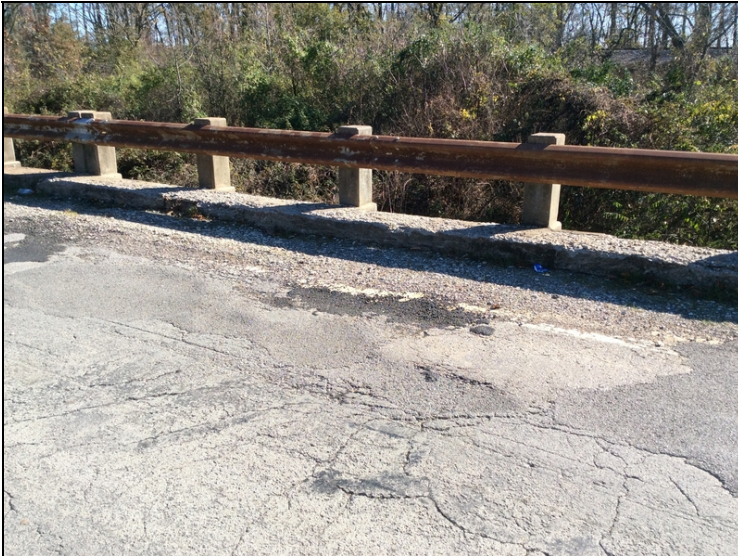
Span 4 right curb & deck.

Wearing surface has several longitudinal cracks, map cracks and delaminated areas or patches in wheel paths. Wearing surface is mostly delaminated or spalled/raveling out along gutters and over joints.

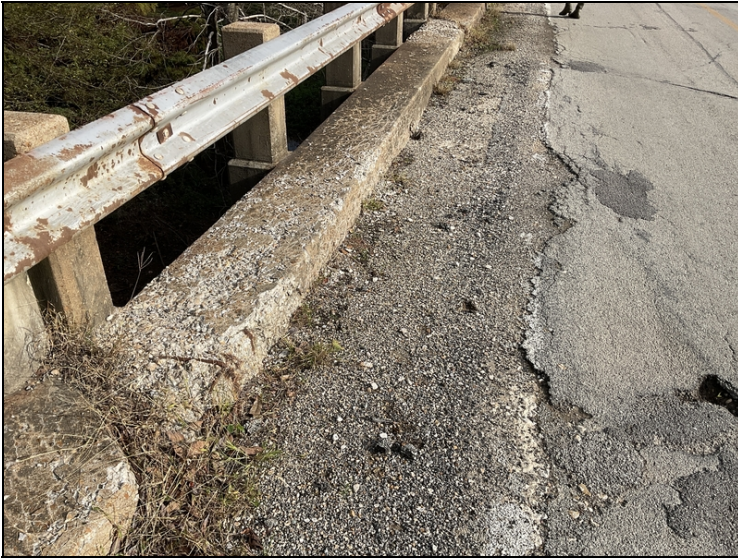
Span 2 Lt curb

Gutters have several delaminated or spalled areas and a few patched areas. Patches are in fair to poor condition.

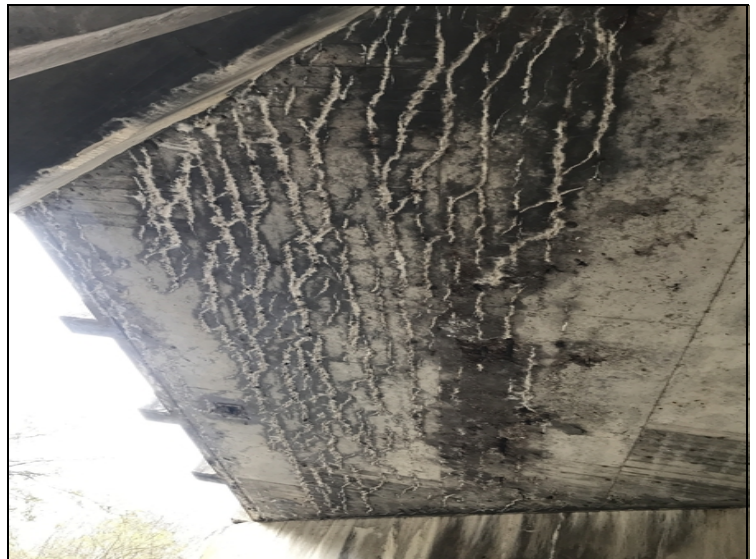
Span 4 soffit RT side

Slab soffit has several longitudinal cracks with heavy efflorescence or rust stains under gutters and outside wheel path. Soffit has several spalls with exposed rebar, mostly near centerline or outside edges at drain openings.

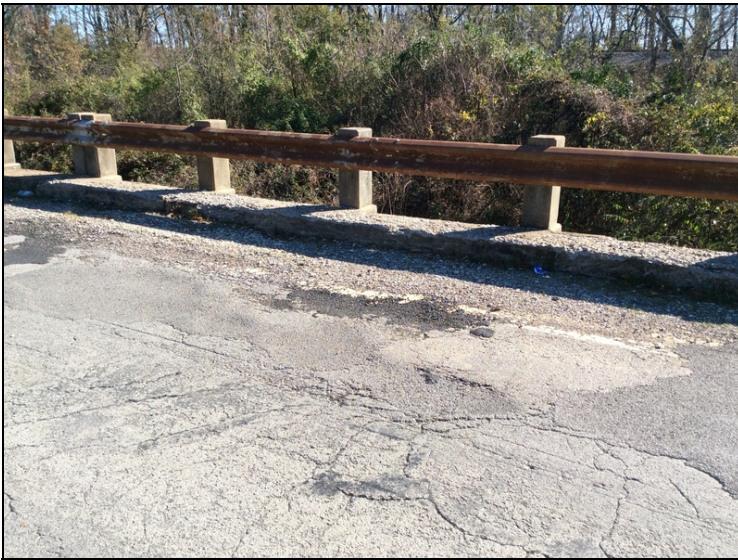
Span 4 right curb & deck.

Lt and Rt curbs have areas of concrete disintegration some exposed rebar.

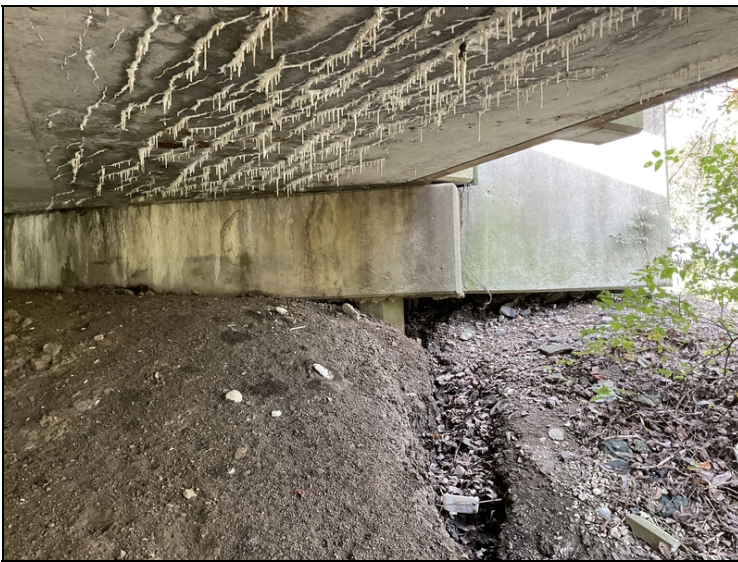
Bent 1 Lt

Bent 1 abutment is undermined on Lt end up to 1' below and 2' back under.

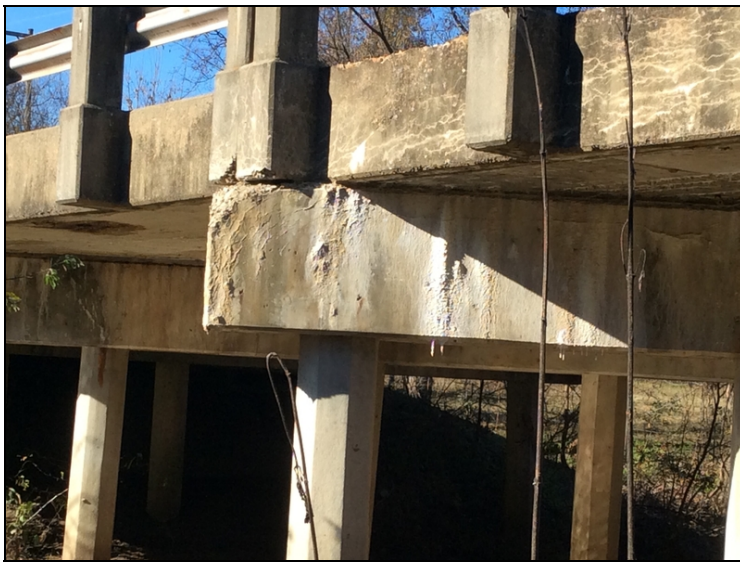
Right end bent 4 cap span 4 side.

Caps have several cracks with efflorescence. Caps have some deterioration near ends.  
Caps have a few spalls with rebar exposed.

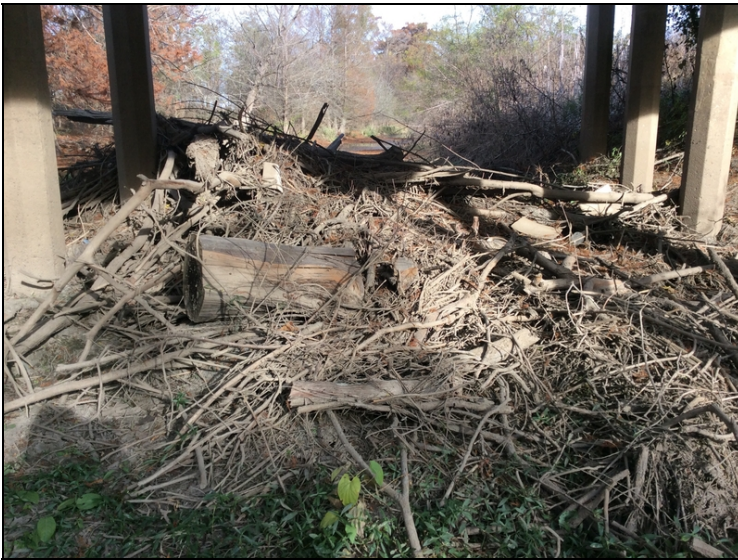
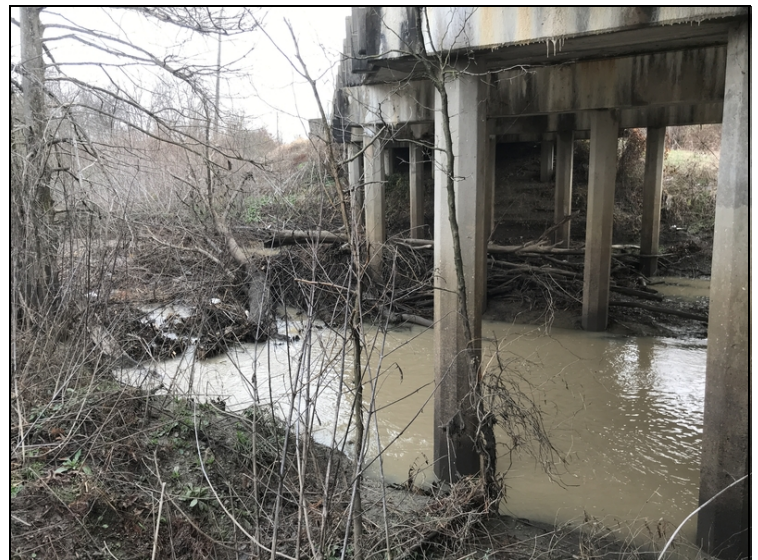
Moderate drift on bents 4 & 5 and under span 4.

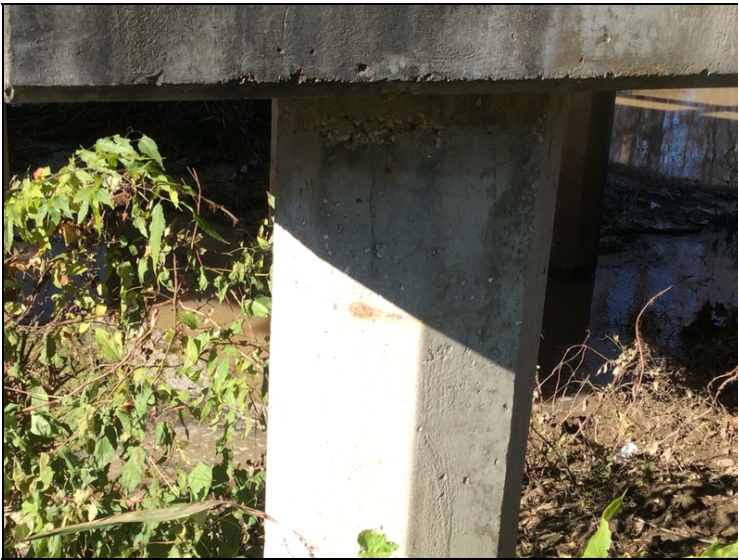
Bent 6 pile 6.

Several piles have vertical cracks near top. Some have efflorescence or rust stains.
