Bridge #06289(Routine)

US 412-08-LM 17.71 over EIGHT MILE CREEK

Team Lead: James Adams Inspection Date: September 28, 2020

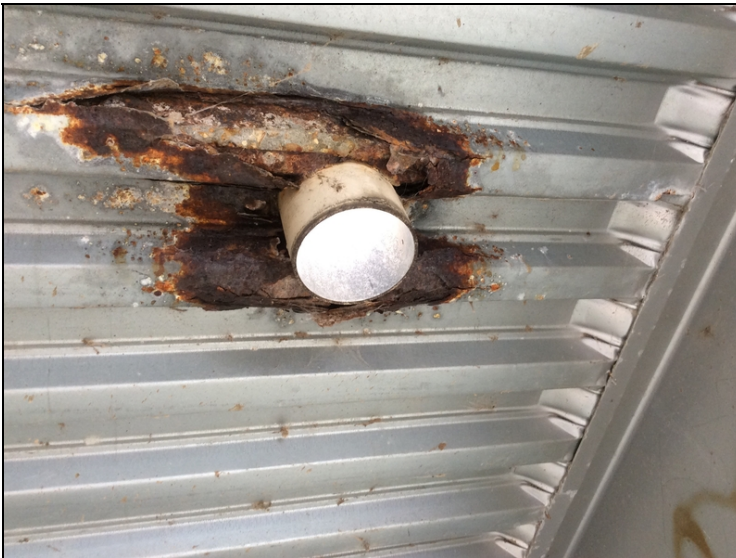
Span 3 drain 3 right side

SIP forms around drain openings have rust and leakage through deck.

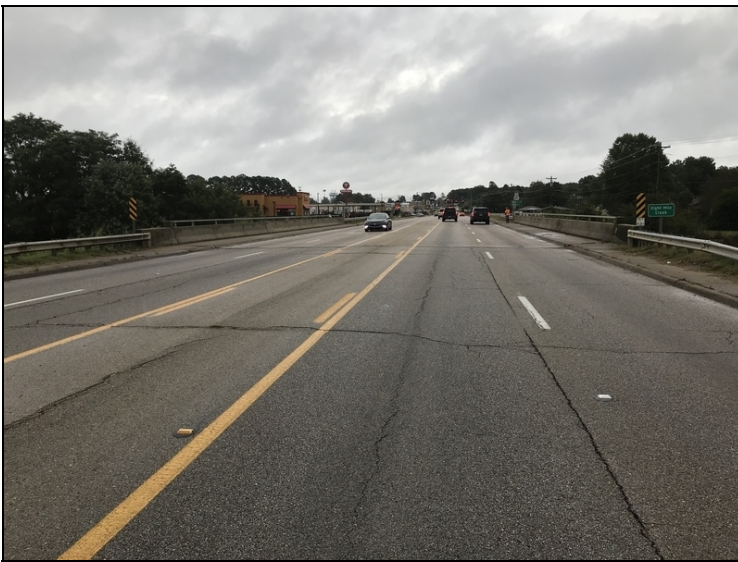
Approach roadways have some settlement at each end of bridge. Sidewalks have settlement at each end of bridge.
* Approach on bent 1 end has a 3' x 1' pot hole at end of bridge.

* Pothole repaired, but asphalt remains cracked with a few delaminations. Observed at inspection, 09-28-2020 JFA/CWS
