**Bridge #06540(Routine)**  
**US 63-03- LM 24.33 over SH 367, Front St**  
**Location: 2.5 MI S JCT 412&367**

**Team Lead: Tim Myrick Inspection Date: July 14, 2021**

IDENTIFICATION	
(1) State Names	Arkansas
(8) Structure Number	06540
(5) Inventory Route	63
(2) Highway Agency District	10
(3) County Code	75-Lawrence County, Arkansas

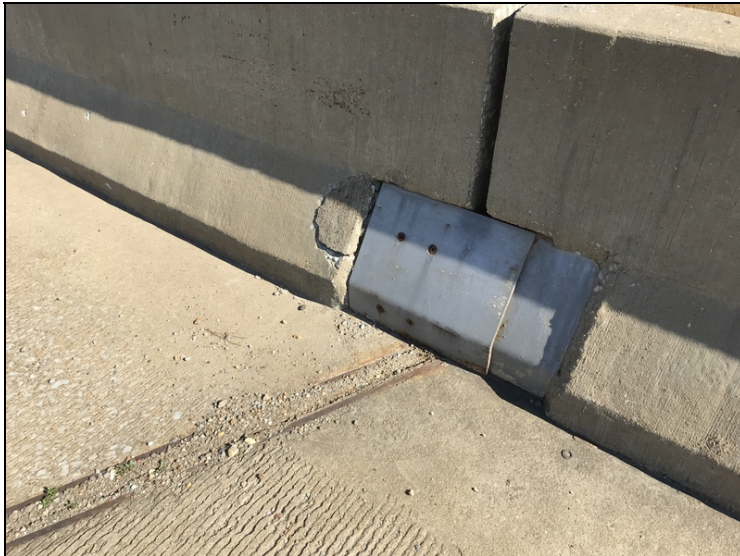
Span 2 Rt rail has a small spall with 1' of rebar exposed on outside of rail near end of span.  
Span 3 Rt rail has a small spall on top of rail near beginning of span.  
Concrete rail at bent 4 has a small delamination at joint.

Delamination in rail at bent 4 2019

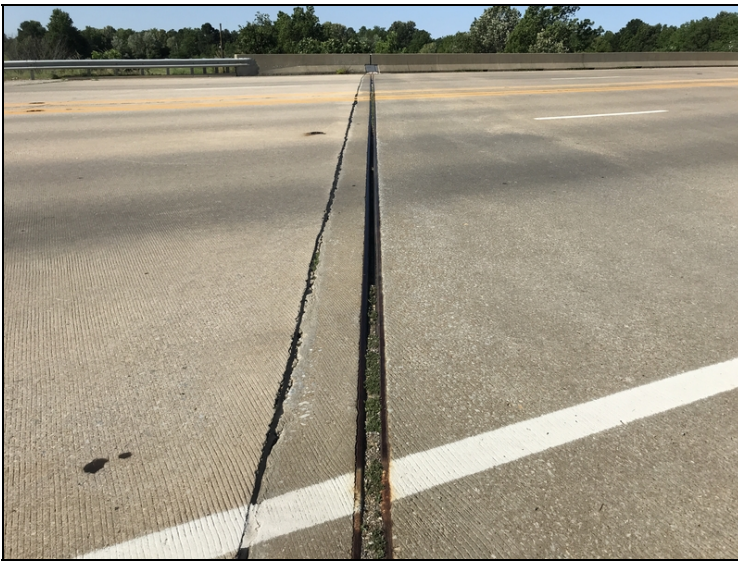
Expansion joints are partially filled with dirt.

Bent 1 joint 2019&#10;

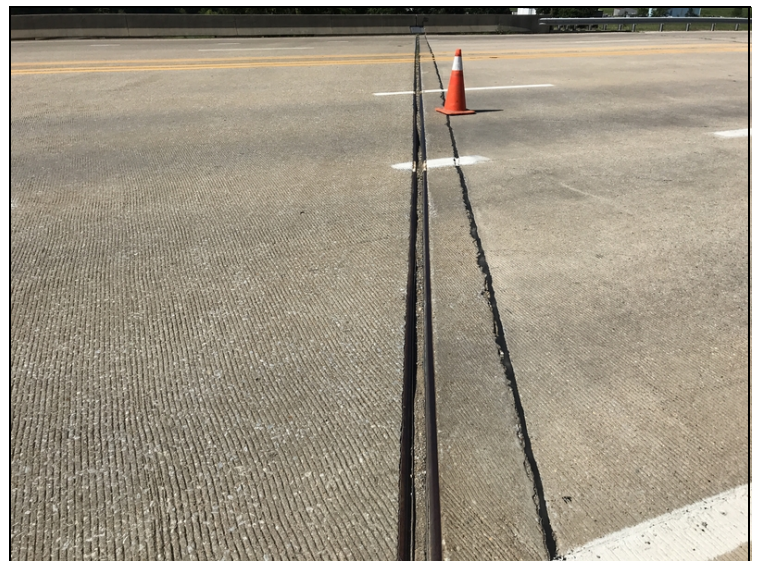
Bent 1 joint 2019

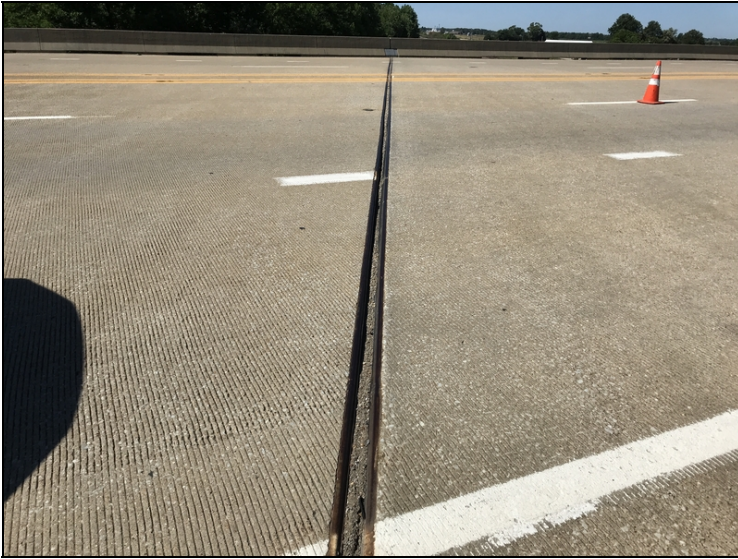
Bent 6 joint 2019
