Bridge #03662(Routine)
SH 90- 01- LM 5.14 over DITCH NO. 11

Location: 5.0 MI E OF RECTOR

Team Lead: Tim Myrick Inspection Date: November 11, 2020

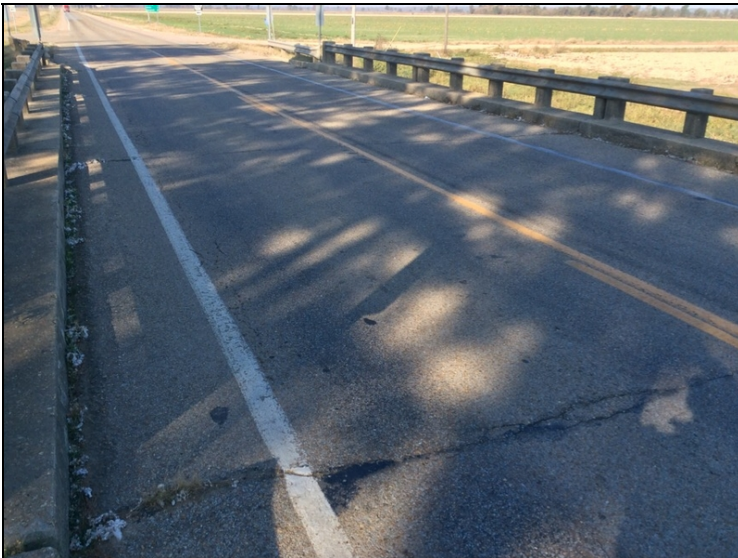
Top of Concrete Deck with an Asphalt Overlay has minor size and insignificant density sealable cracks.

Top of concrete deck with an asphalt overlay has moderate width & open cracks with some delamination between asphalt & concrete detected by sounding.

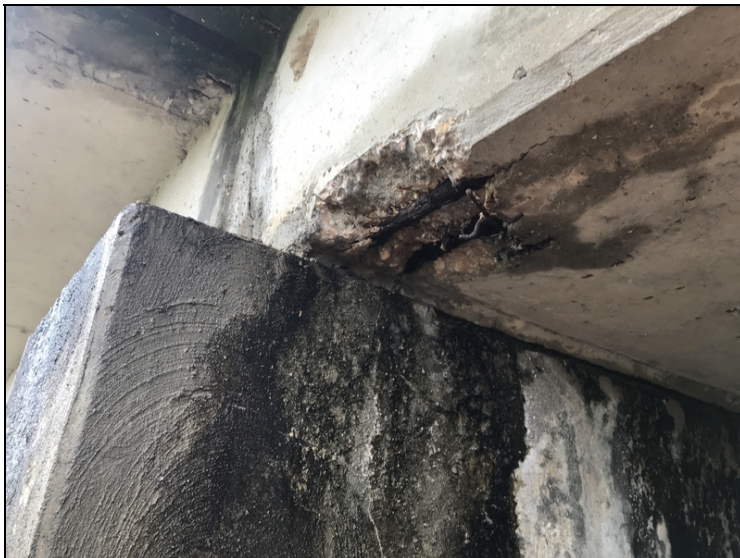
Span 3 soffit RT edge near bent 3

Bottom of Deck Span 3 near Bent 3 has 2 each 8in. x 8in. shelled out area with rebar exposed, see 2014 & 2018 photo. Bottom of slab Span 3 near bent 3 has 2 spalled areas, (1) 10 in. x 12 in. x 1 in. deep, (1) 24 in. x 12 in x 2 in. deep with exposed rebar with section loss, see 2018 photo.

Bottom of slab Span 3 near bent 3 has 2 spalled areas, (1) 10 in. x 12 in. x 1 in. deep, (1) 24 in. x 12 in x 2 in. deep with exposed rebar with section loss.

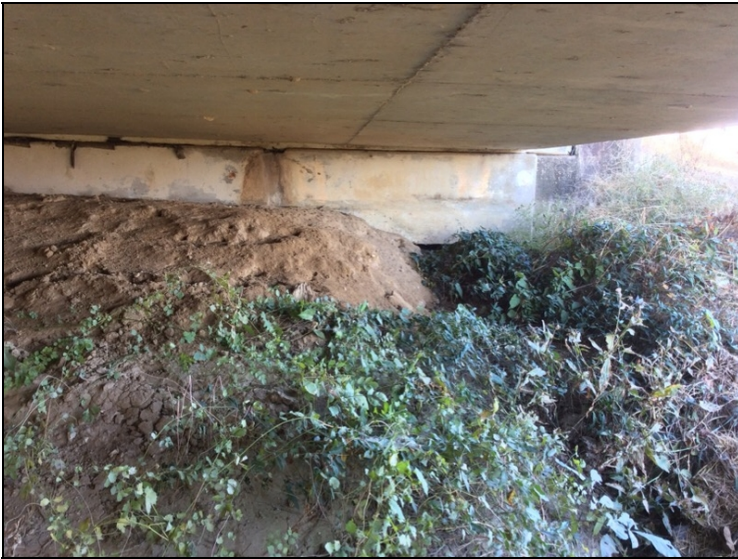
Right side of Abutment Bent 4 is starting to undermine from roadway runoff, see 2016 photo.

Right side of bent 4 abutment has minor undermining from roadway runoff.

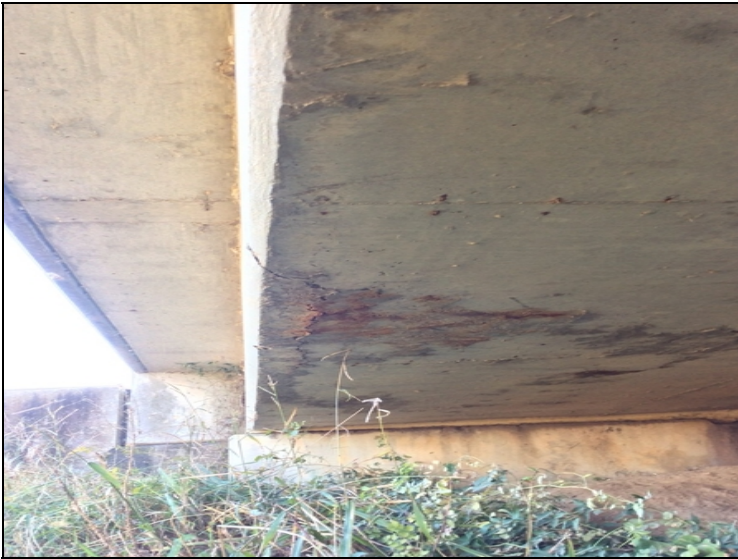
Bottom of Deck Span 1, near mid span, has cracking & delamination, see 2016 photo.
Ends of Spans 2&3 Slabs over Bent 3 has some diagonal cracking and spalled areas on side of deck.

Bottom of slab span 1, near mid span, has vertical cracking on both sides.
