Bridge #03663(Routine)
SH 90-01- LM 4.17 over DITCH NO. 10
Location: 6.1 MI E OF RECTOR, ARK.

Team Lead: Tim Myrick **Inspection Date:** November 11, 2020

Maintenance Needs

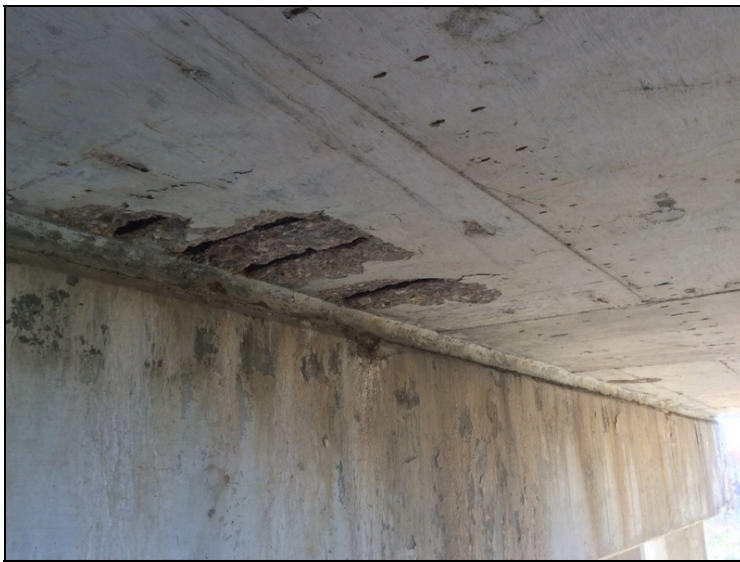
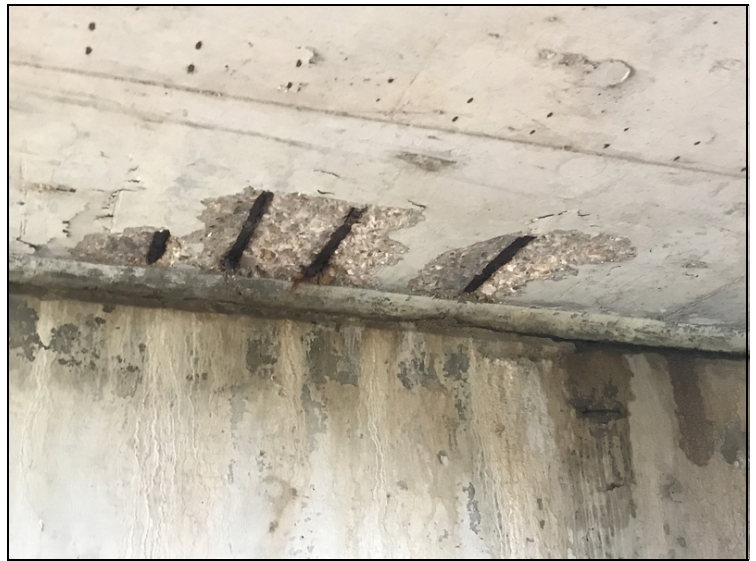
Span 3 soffit near bent 3

Bottom of Concrete Slab Span 3 near Bent 3 Cap has a 1.5 ft. x 5 ft. x 1 in. deep area and a 6 in. x 4 in. x 1 in. deep area shelled out with exposed rebar.

Bottom of slab span 1 has two spall near bent 1 and span 3 near bent 3 cap has a 1.5 ft. x 5 ft. x 1 in. deep area and a 6 in. x 4 in. x 1 in. deep area spalled with exposed rebar.

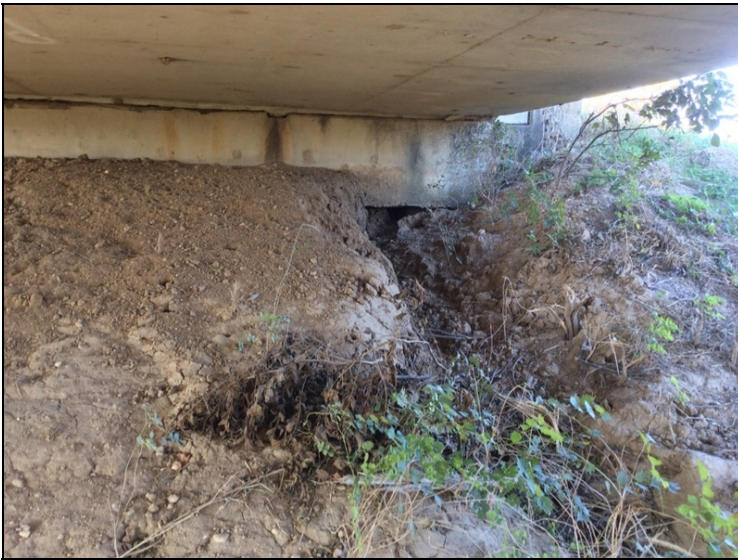
5ft. right end of Abutment Bent 4 Cap is beginning to undermine from roadway runoff.

5 ft. right end of Bent 4 Cap is beginning to undermine from roadway runoff, 1 ft. below & 2.5 ft. back under abutment.

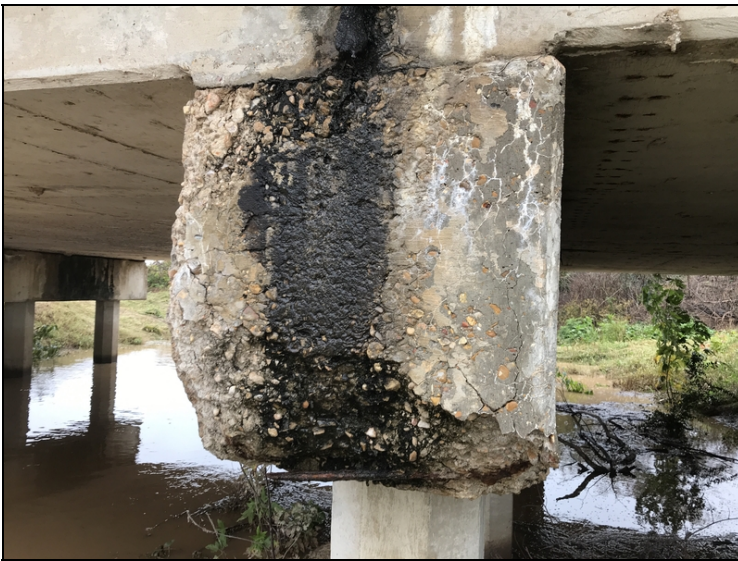
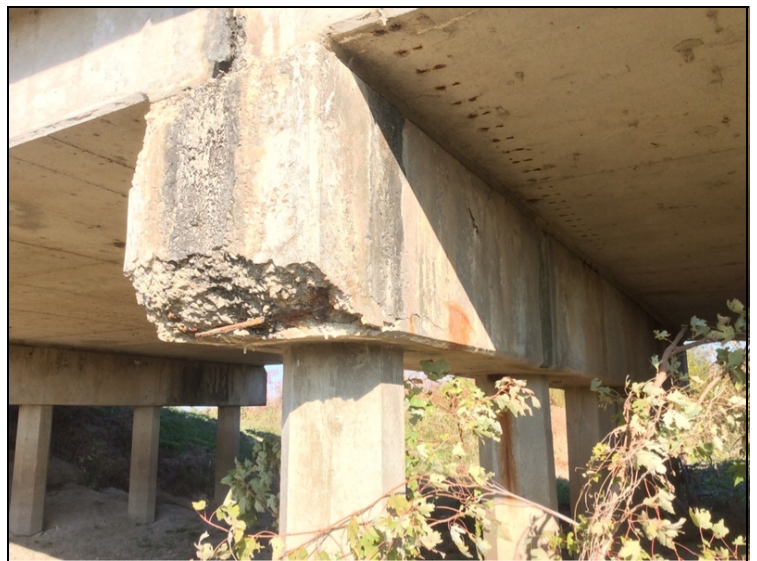
Bent 2 LT end

Ends of Caps Bents 2&3 have some deterioration & cracking with rebar exposed, no loss of bearing area at this time. Face and Bottom of Caps Bents 2&3 have several very small popouts with rebar exposed, due to inadequate coverage of steel placement. Face of Caps Bents 2&3 have some areas of cracking with impending spalls.

Ends of bents 2&3 caps have some deterioration & cracking with exposed rebar, no loss of bearing area at this time.

Face and bottom of caps bents 2 & 3 have several very small pop outs with exposed rebar, due to inadequate coverage of steel placement.

Face of caps bents 2 & 3 have some areas of cracking with impending spalls.

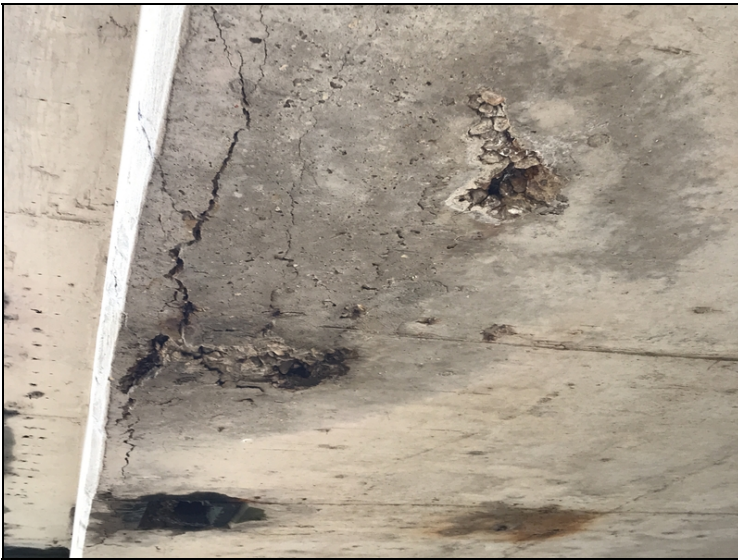
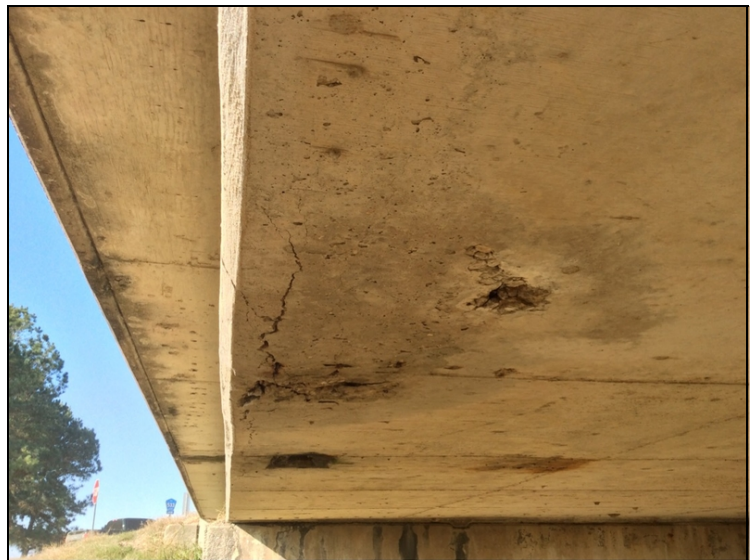
LT edge span 2

Left side and bottom of Concrete Deck Span 2 has several cracks in concrete with some rebar exposed, see 2018 photo.

Span 2 left edge and bottom of deck has a 6 ft. area of cracks and some exposed rebar.
