**Bridge #03664(Routine)**  
**SH 90- 01- LM 2.22 over MAYO DITCH**  
**Location: 2.22 MI NW ST. FRANCES RI**

**Team Lead: Tim Myrick Inspection Date: November 11, 2020**

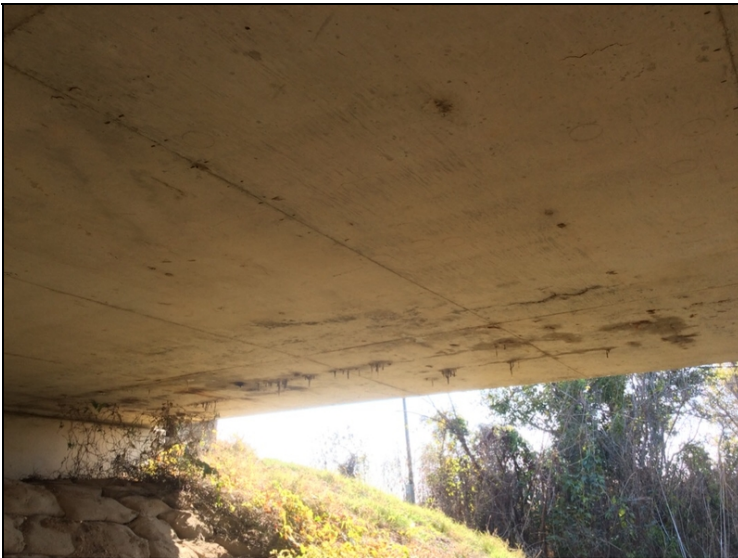
4ft. left and right side of Bottom of Slab Span 1 has several longitudinal cracks with efflorescence, rust stains, and salt cycles.

4ft. left and right side of Bottom of Slab Span 1 has several longitudinal cracks with efflorescence, rust stains.

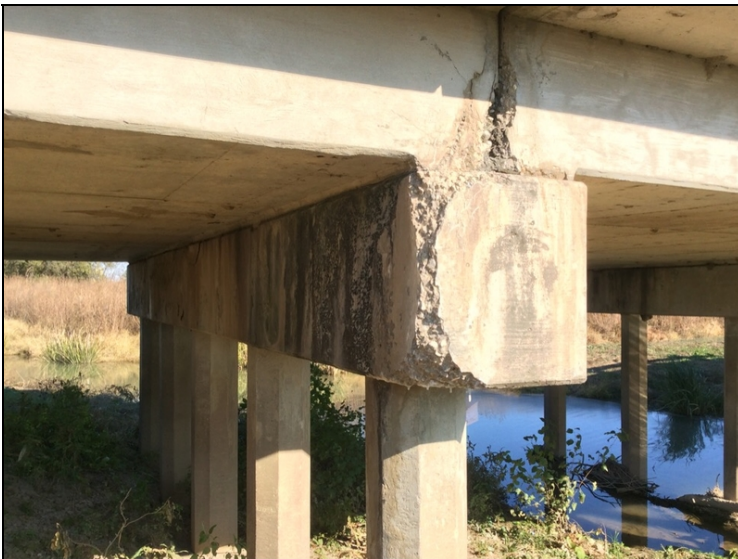
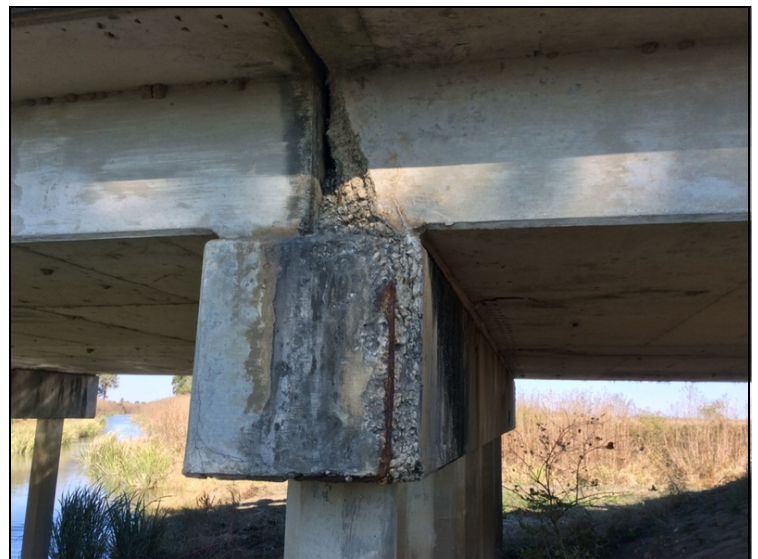
Ends of Concrete Slabs over Bents 2, 3, 4, & 5 has some diagonal cracking, efflorescence, deterioration, and some rebar exposed, see 2016 of Bent 2 for typical.

Bottom of Slabs has some cracking with efflorescence, some delaminated areas and some spalled areas with rebar exposed.

Ends of Concrete Slabs over Bents 2, 3, 4, & 5 have some diagonal cracking, efflorescence, deterioration, and some exposed rebar.

Bottom of Slabs have some cracking with efflorescence, some delaminated areas and some spalled areas with exposed rebar.

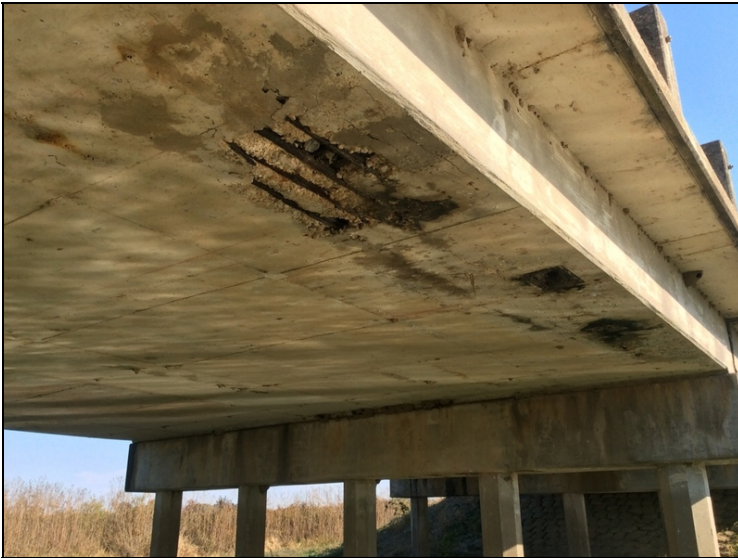
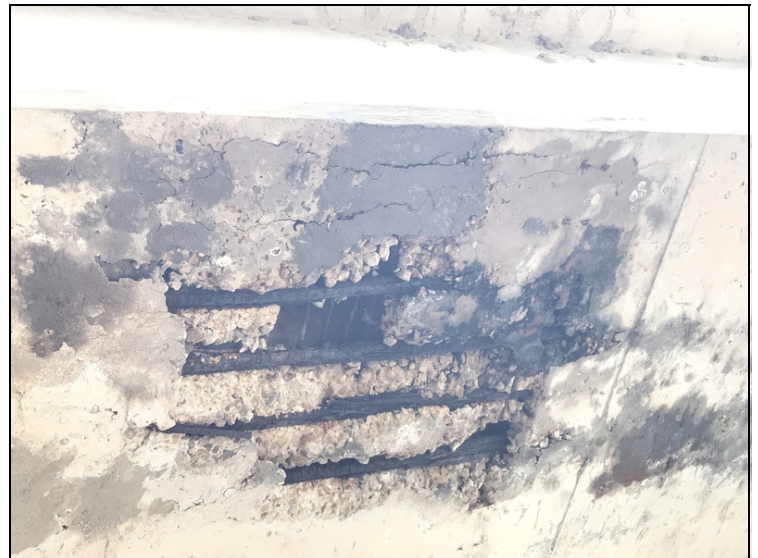
Span 3 LT Side soffit

Left side of Bottom of Concrete Slab Span 3 has a 3ft. x 4ft. honeycomb area with rebar exposed, some section loss to rebar, sonovoid is open.

Spall on bottom of deck is below patch on deck.

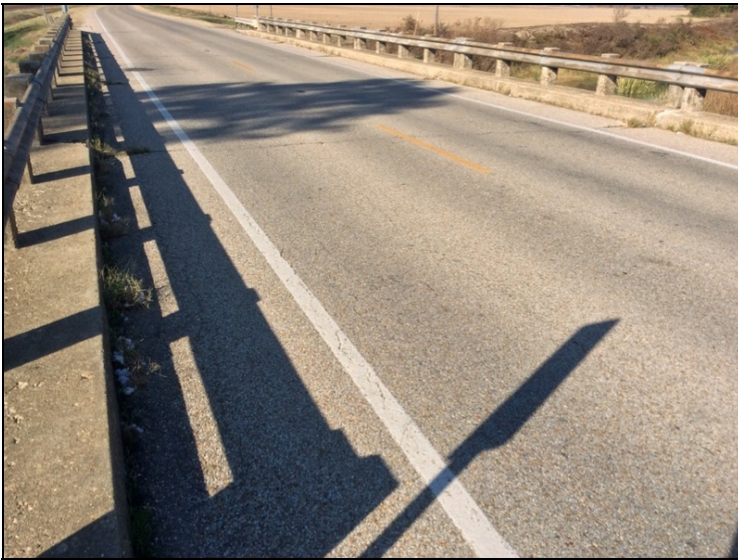
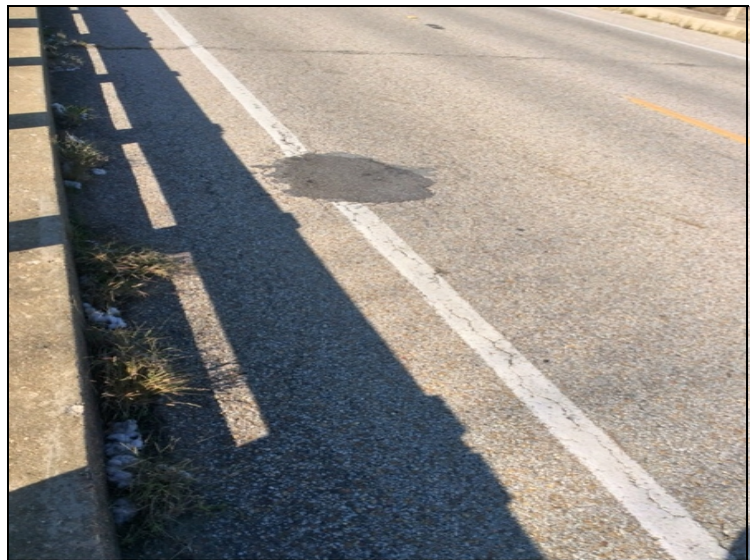
Deck/wearing surface

Top of Concrete Slab with Asphalt Overlay has several seal able cracks and Span 3 has a 4sqft. asphalt patch.

Top of Concrete Slab with Asphalt Overlay has several moderate width cracks.

Span 3 has a 4 sqft. asphalt patch with partial failure.

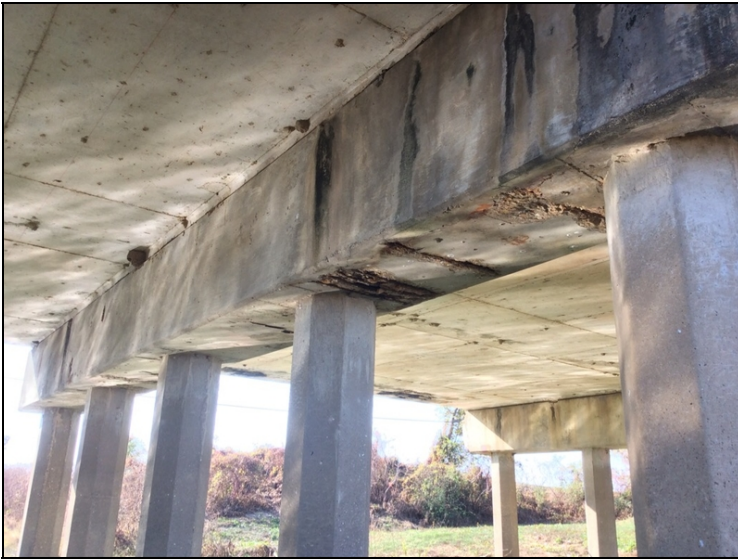
Bottom of Cap Bent 3 has several small shelled out areas with rebar exposed, inadequate coverage due to steel placement.

Bottom of Bent 3 cap has several small spalled areas with exposed rebar, inadequate coverage due to steel placement.

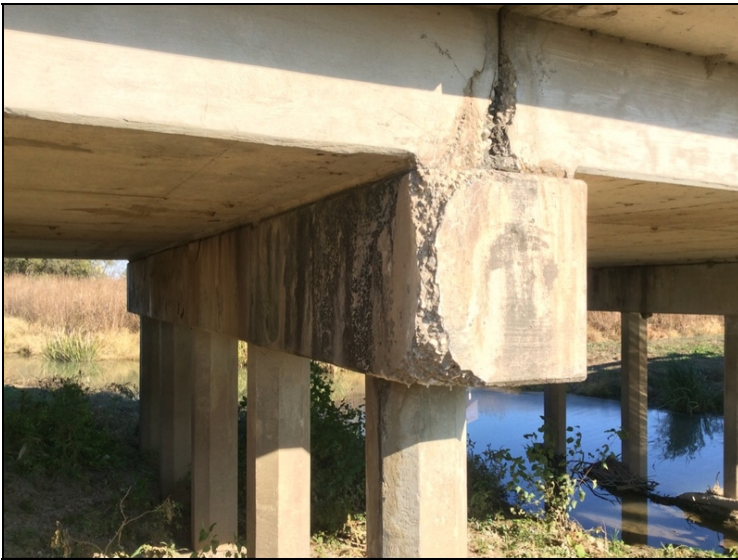
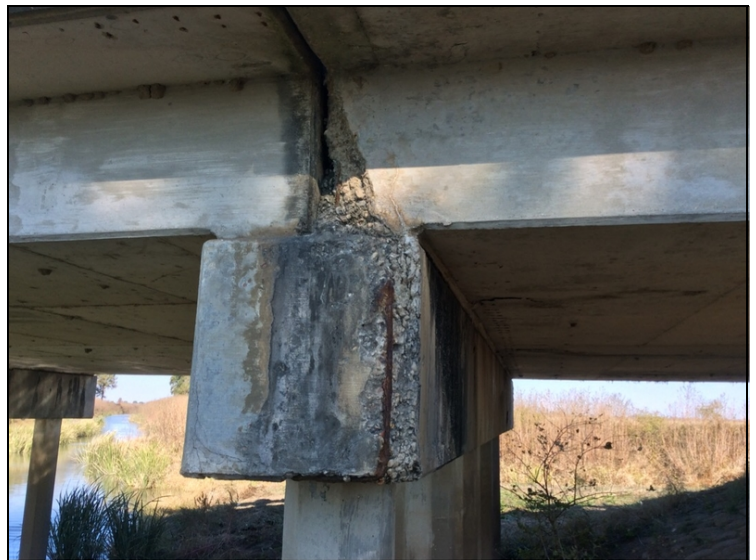
Left end of Caps Bents 2, 4, & 5 has deterioration with rebar exposed.

Left end of Caps Bents 2, 4, & 5 have deterioration with rebar exposed rebar.

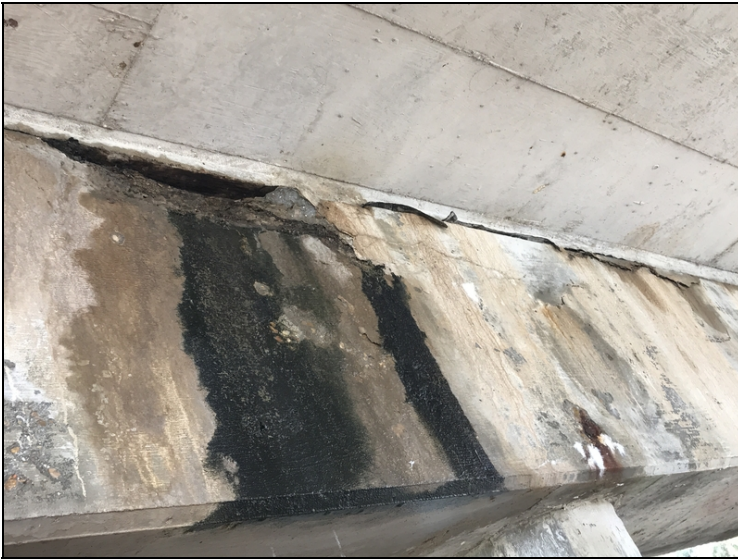
bent 2 cap span 2 side

Majority of Caps have cracking, several have small spalls and/or shelled out areas, mostly on ends of caps.  
Majority of face of Caps has some small shelled out areas with rebar exposed due to inadequate steel coverage.

Majority of Caps have cracking, with rust stains & delaminated areas, several have small spalls, mostly on ends of caps.
